Effects of Vapor-Based Decontamination Systems on Selected Building Interior Materials: Chlorine Dioxide

Mark D. Brickhouse
Teri Lalain
Philip W. Bartram
Monica Hall
Zoe Hess
Brent Mantooth
Louis Reiff
EDGEWOOD CHEMICAL AND BIOLOGICAL CENTER
RESEARCH AND TECHNOLOGY DIRECTORATE

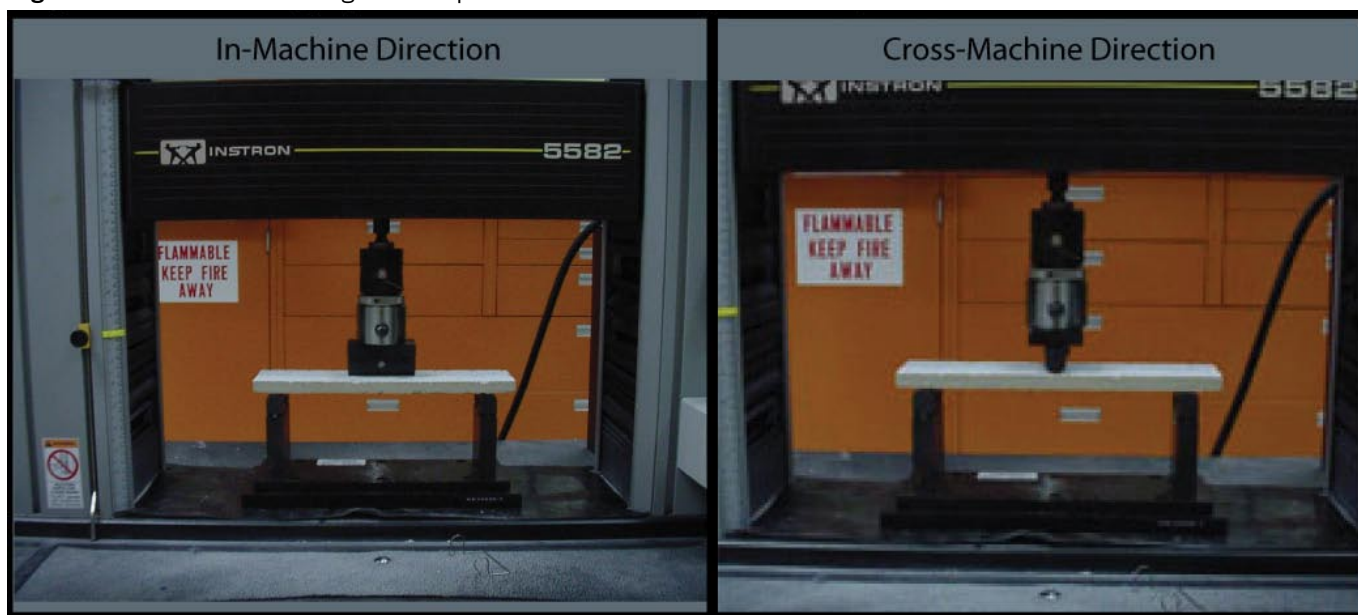
Figure 8.1: Acoustical Ceiling Tile Coupon Test

The acoustical ceiling tile samples were removed from storage, visually inspected, and measured. The samples were brought to moisture equilibrium such that the weight of the sample did not change by more than 1% on successive weighings at a minimum interval of two hours. The sample preparation was conducted within a range of 18–24 °C and 48–75% RH. The testing was conducted in accordance with ASTM Test Method C367-99. The Instron fixture for the ceiling tile test was installed prior to testing. The Instron universal testing machine operation was verified by suspending a certified weight from the fixture and recording the weight. For each test, the coupons from chamber positions 1 through 8 were selected for testing; this selection consisted of all coupons placed in the chamber during a single fumigation trial. Ceiling tile coupons were tested in two directions — with the mandrel parallel to the axis of the

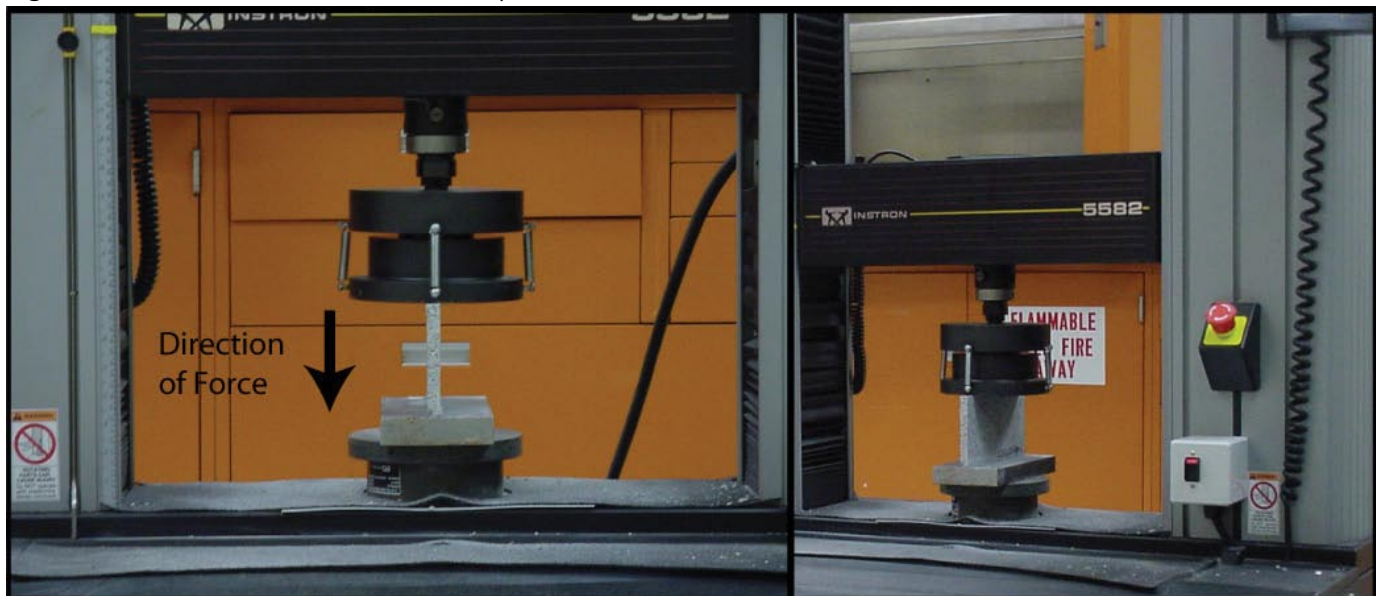
Figure 10.1: Concrete “Cinder Block” Coupon Test

to testing. The testing was conducted in accordance with ASTM Test Method C140-03. The Instron fixture for the concrete cinder block test was installed prior to testing. The Instron universal testing machine operation and calibration verification was conducted by suspending a certified weight from the fixture and recording the weight. A photograph of a test sample loaded into the Instron test fixture is shown in Figure 10.1. Three sets of three coupons were tested for each concentration (0 ppm, full-target, and half-target). The load required to rupture the coupons was measured in N. No precision or bias requirements have been established for this test method. The results for control coupons were compared to the results for decontaminant-exposed samples. A statistical analysis of the data was conducted to determine whether the decontaminant-exposed coupon results were statistically different from the control coupon results.

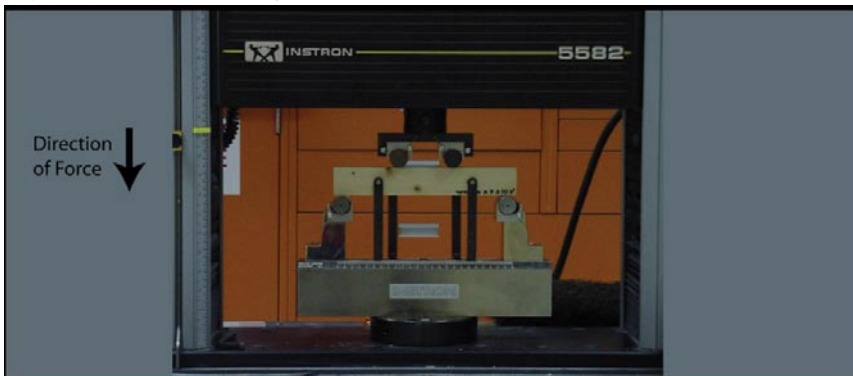
Figure 11.1: Wood Coupon Test

five coupons were tested for each concentration (full-target and half-target), and four sets were tested for the controls (0 ppm). The load required to rupture the wood coupons was measured in N. No precision or bias requirements have been established for this test method. The results for control coupons were compared to the results for decontaminant-exposed samples. A statistical analysis of the data was conducted to determine whether the decontaminant-exposed coupon results were statistically different from the control coupon results. A photograph of a wood sample loaded into the Instron is provided in Figure 11.1.

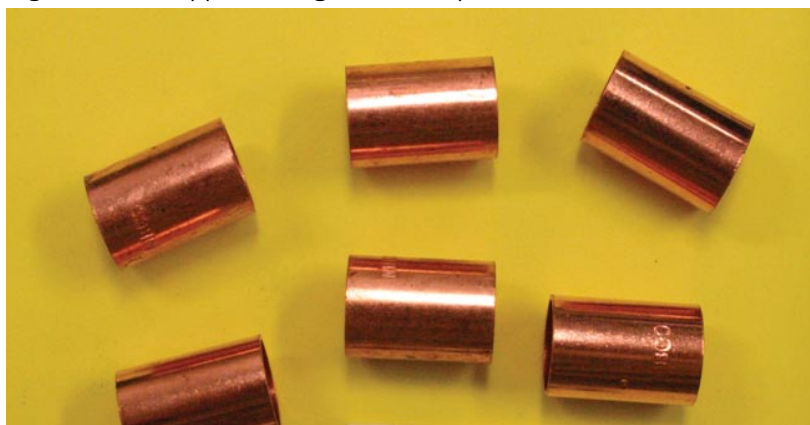
Figure 13.1: Copper Tubing Prior to Exposure to Chlorine Dioxide

Aluminum (0.5" W x 0.5" L), copper (0.5" D x 0.5" L), and steel EMT conduit (0.5" D x 0.5") coupons were exposed to CD to determine the fate of the decontaminant on the metals. Coupons cut from metals purchased from Home Depot were exposed to chlorine dioxide concentrations of 1000 and 2000 ppm for 12 and 6 h, respectively, to give a total CT of 12000 ppm-hr for each experiment. The metals were exposed at 25 °C, 75–90% RH; control sets were exposed under the same conditions at 0 ppm CD. Fourteen coupons of each metal in small plastic containers were placed on the inside bottom of a PlasLabs model 830-ABC glove box (PlasLabs, Inc., Lansing, MI) during each exposure. The coupons were removed from the glove box after exposure and stored for 90 days in the plastic containers. After storage, each of the 14 coupons was placed in a 2-ounce wide-mouth glass jar with cap. Chloride, chlorite, chlorate, perchlorate, and other anions were removed from each sample by extraction in water (10 mL) with rocking. The extracts were then passed through a 0.22- μ m syringe filter and injected directly into the chromatograph to determine retention time and detector response for each analyte present in the sample.⁹ Dilution of samples with deionized distilled water was conducted when appropriate. The anions were then identified and quantified by comparison with standard solutions.

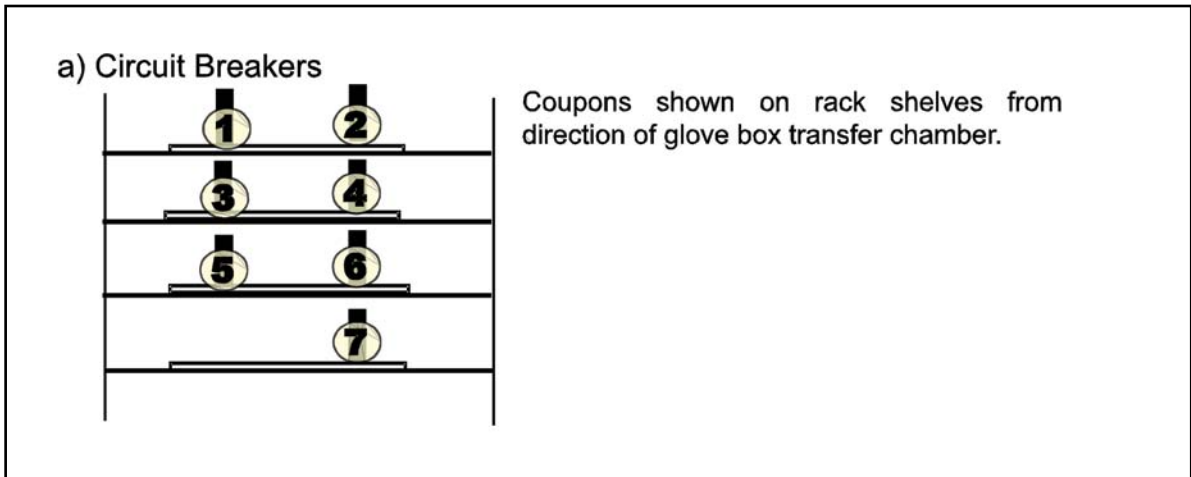
Figure A.2: IOP DS04016 Figure 2, “Circuit Breaker Placement in Chambers”

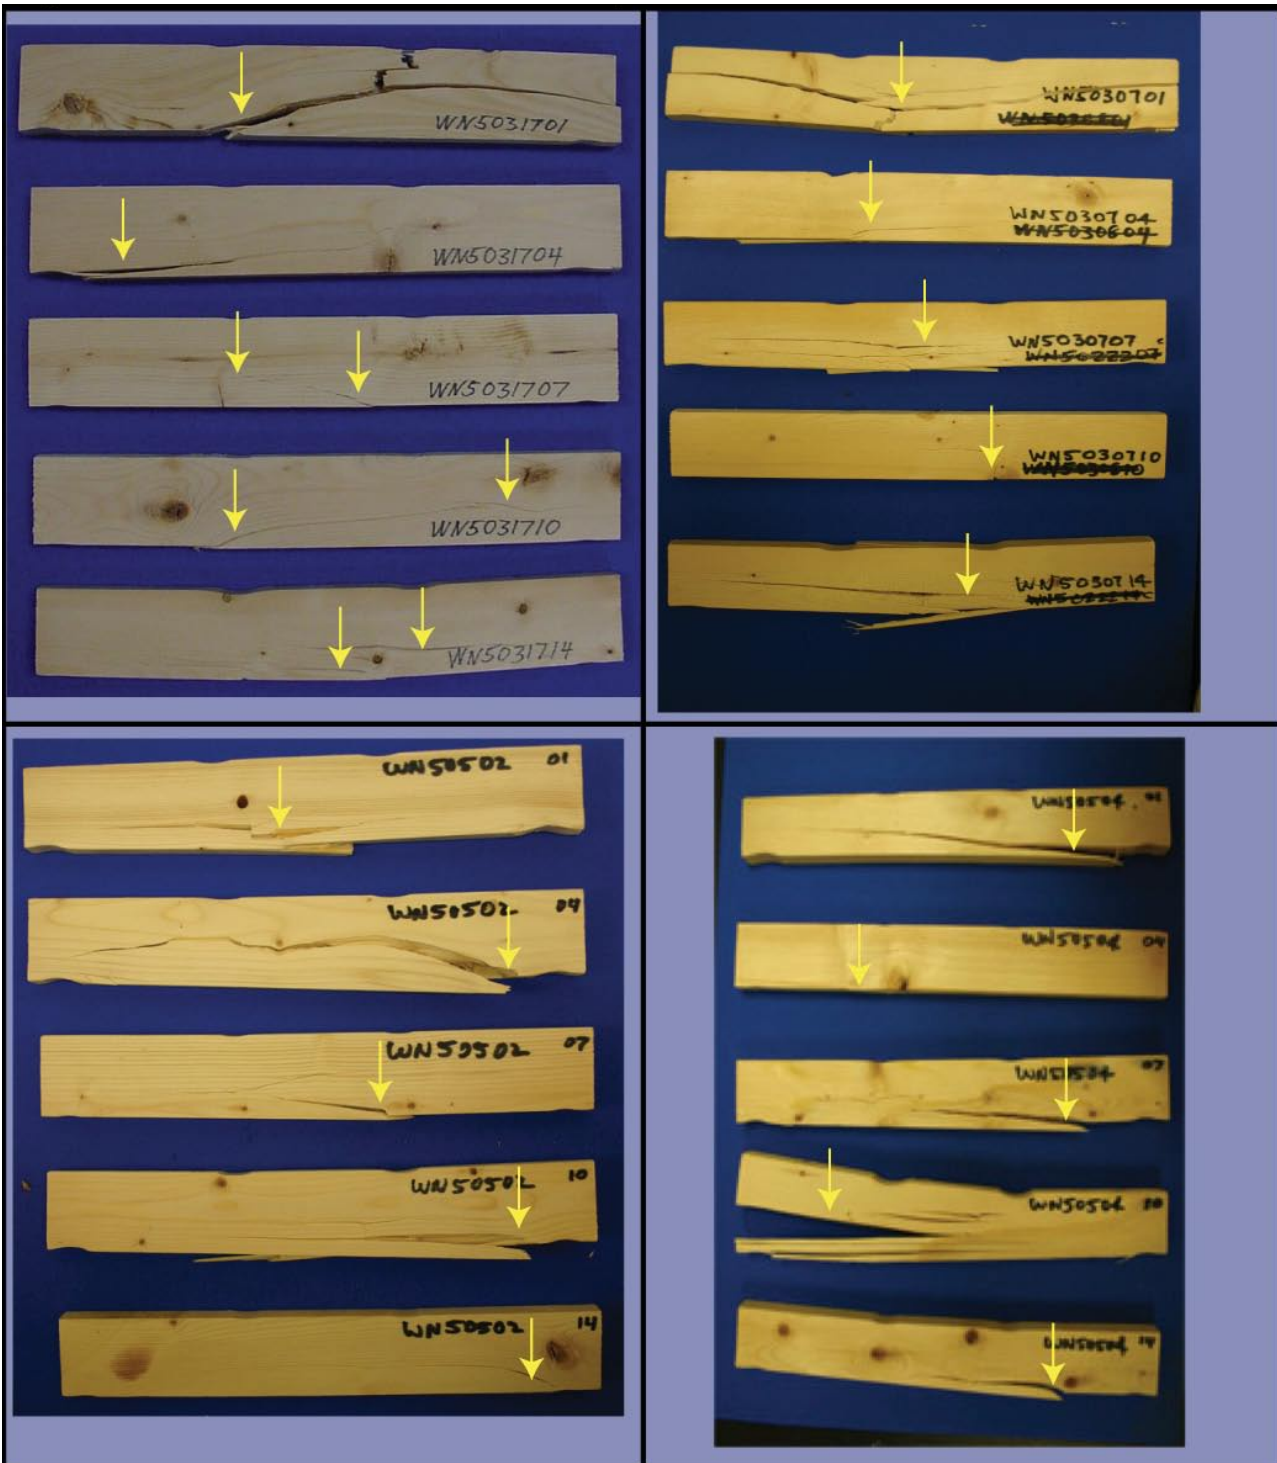
Figure C-1: Location of Break, Wood Coupons – Chlorine Dioxide Control Set
