EXHIBIT K-3
EVALUATION REPORT
FISH STRANDING
(REVISED)

EFFECTS OF VESSEL WAKE STRANDING OF JUVENILE SALMONIDS IN THE LOWER COLUMBIA RIVER, 2002 – A PILOT STUDY

September 26, 2002

**S. P. Cramer & Associates, Inc.
39330 Proctor Blvd.
Sandy, OR 97055
(503) 826-9858
www.spcramer.com**

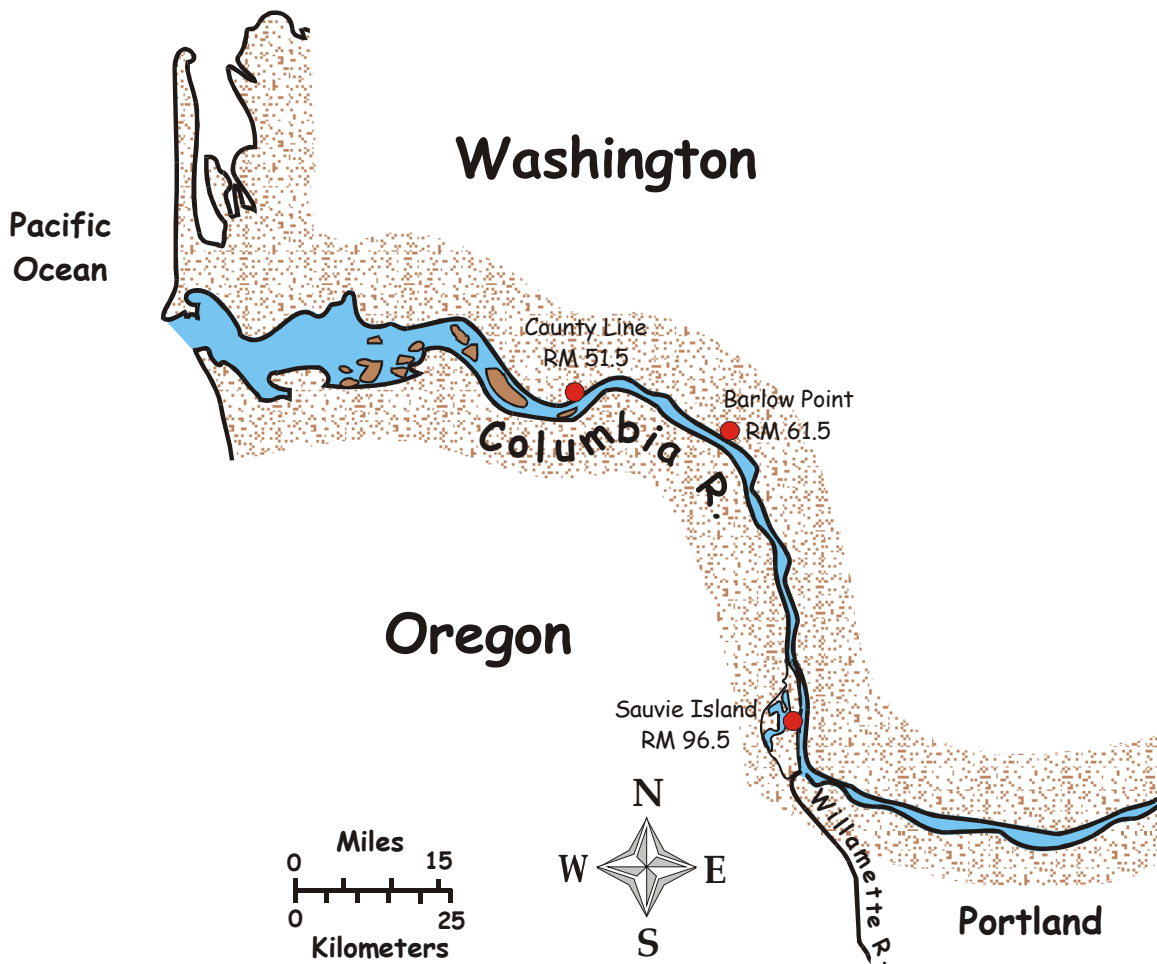
Figure 1. Map of lower Columbia River and locations of juvenile stranding survey sites.

The three locations selected for stranding surveys were all located between the mouth of the Willamette River and the mouth of the Columbia River. The sites included Willow Bar on Sauvie Island (RM 96.5), Barlow Point (RM 61.5) and County Line Park (RM 51.5) (Figure 1). The Sauvie Island and Barlow Point sites were selected because of previous observations of stranding by National Marine Fisheries Service (NMFS) personnel. The County Line Park location was selected because it was one of the sites surveyed in the study by Hinton and Emmett (1994). These sites were selected because we expected to observe stranding, and should not be considered representative of all beaches in the lower Columbia.

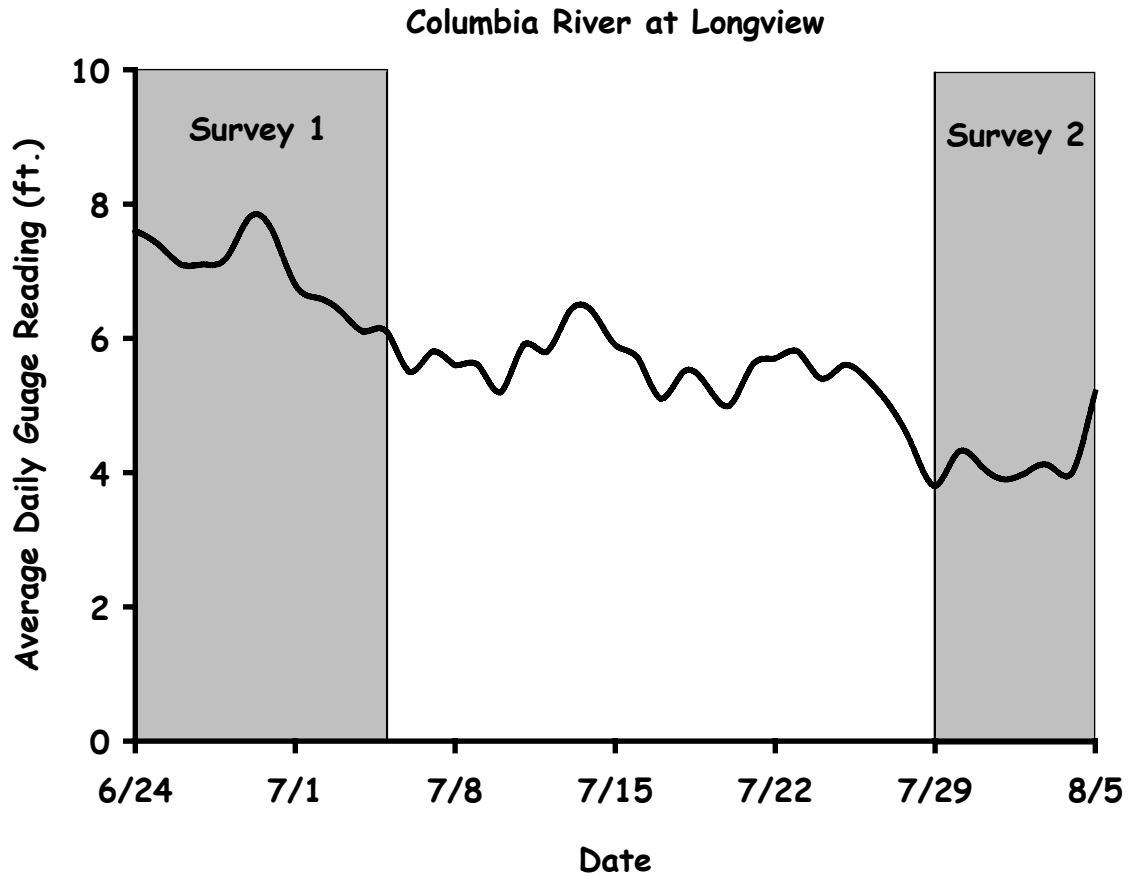
Figure 3. Average daily gauge reading at Longview, Washington from July 24, 2002 to August 5, 2002. Data obtained from USACE online data website (<http://www.nwd-wc.usace.army.mil/cgi-bin/DataQuery>).

River stages in the lower Columbia were approximately 3 feet higher during the first survey period than the second. The average daily gauge reading in Longview for the first survey period ranged from 6.1 feet to 7.8 feet, and from 3.8 to 4.3 in the second survey period (Figure 3).

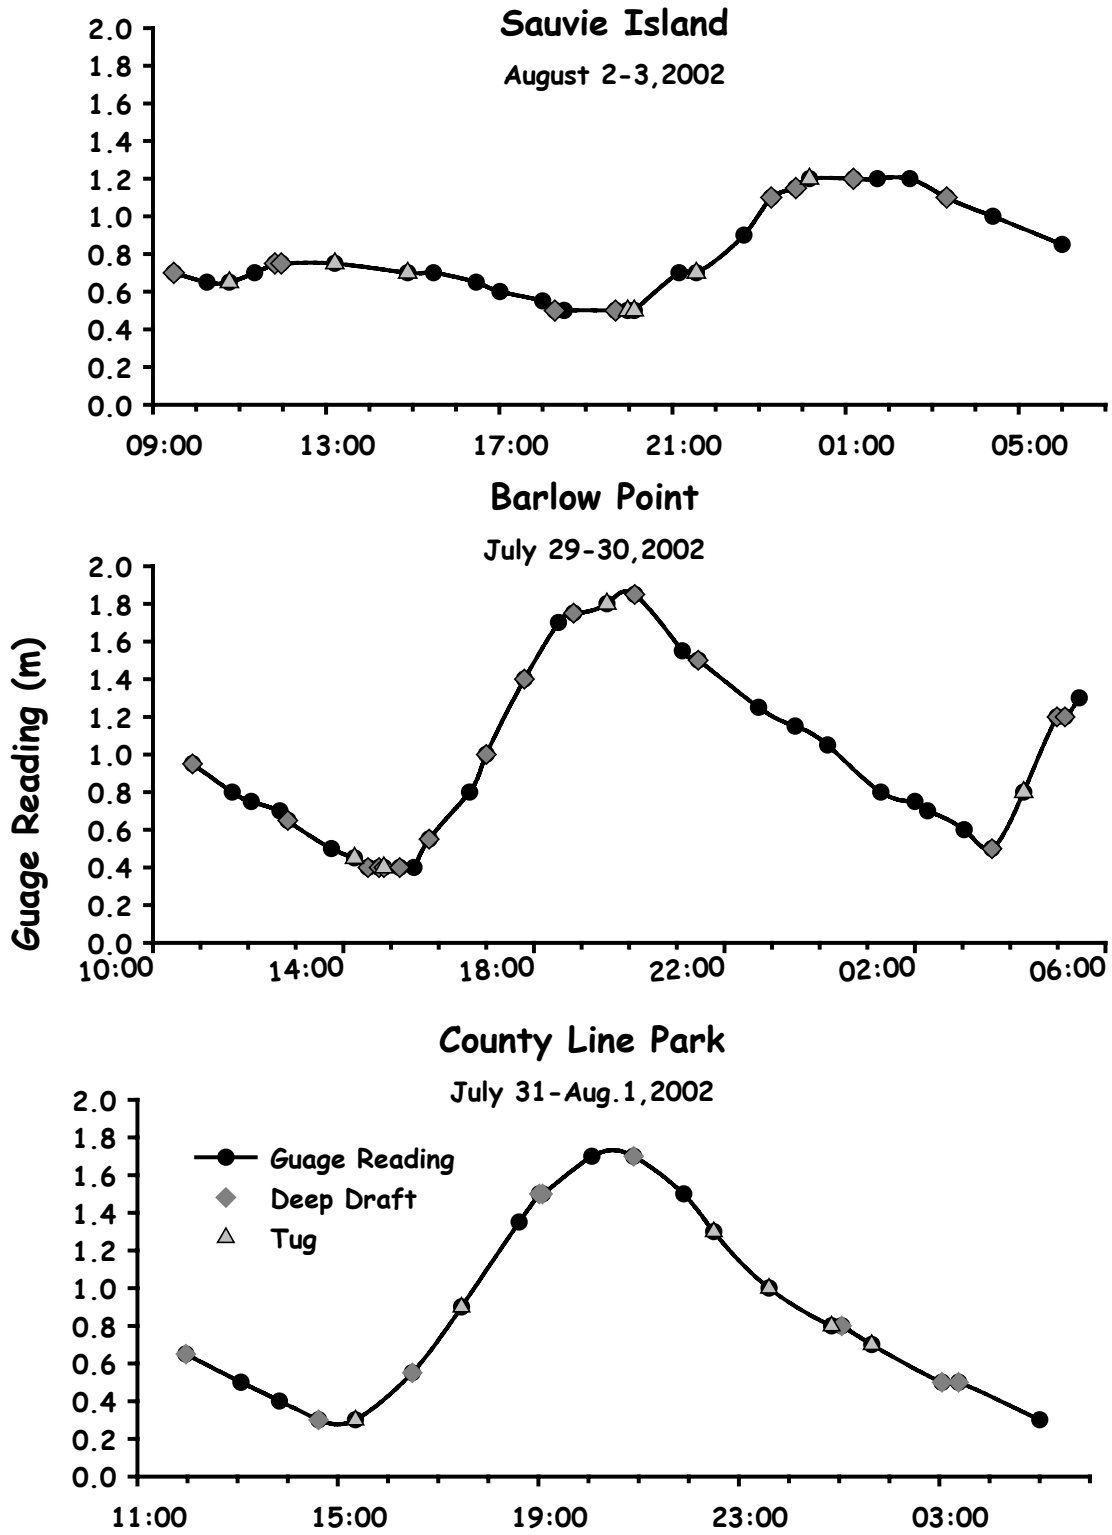
Figure 5. Baseline gauge readings at each of the three survey sites during the second survey period.

Tidal changes caused a 1.6m change in gauge levels at County Line Park and as little as a 0.2m change in levels at Sauvie Island during the first survey (Figure 4, Figure 5). Tidal influences were greater at Barlow Point and Sauvie Island during the second survey, but were greater at County Line Park during the first survey. There doesn't appear to be any relation between timing of vessel passage with tidal stage or time of day (Figure 4, Figure 5).

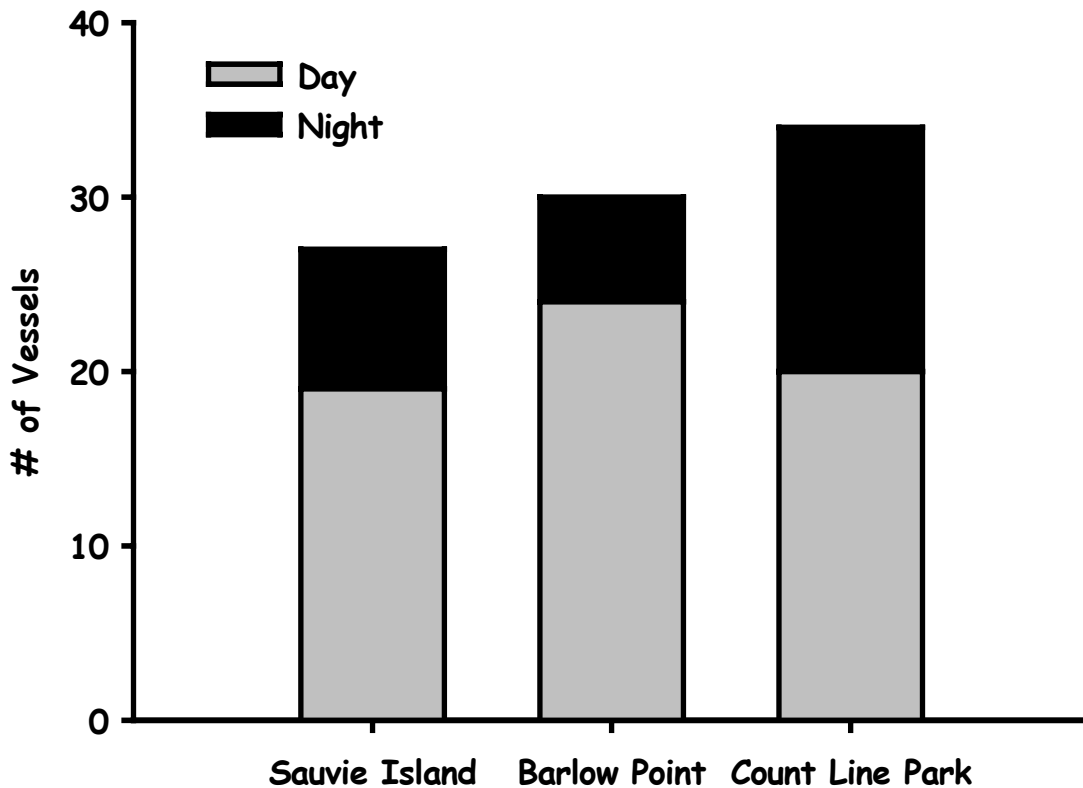
Figure 6. Number of vessels observed at each survey during day and night surveys.

A total of 91 vessels were observed during surveys including 35 tugs and 56 deep draft vessels (Table 2). Thirty-eight vessels were observed during the first round of surveys compared to 51 in the second (Table 2). A majority of vessels (63 of 91) were observed during day surveys (Figure 6).

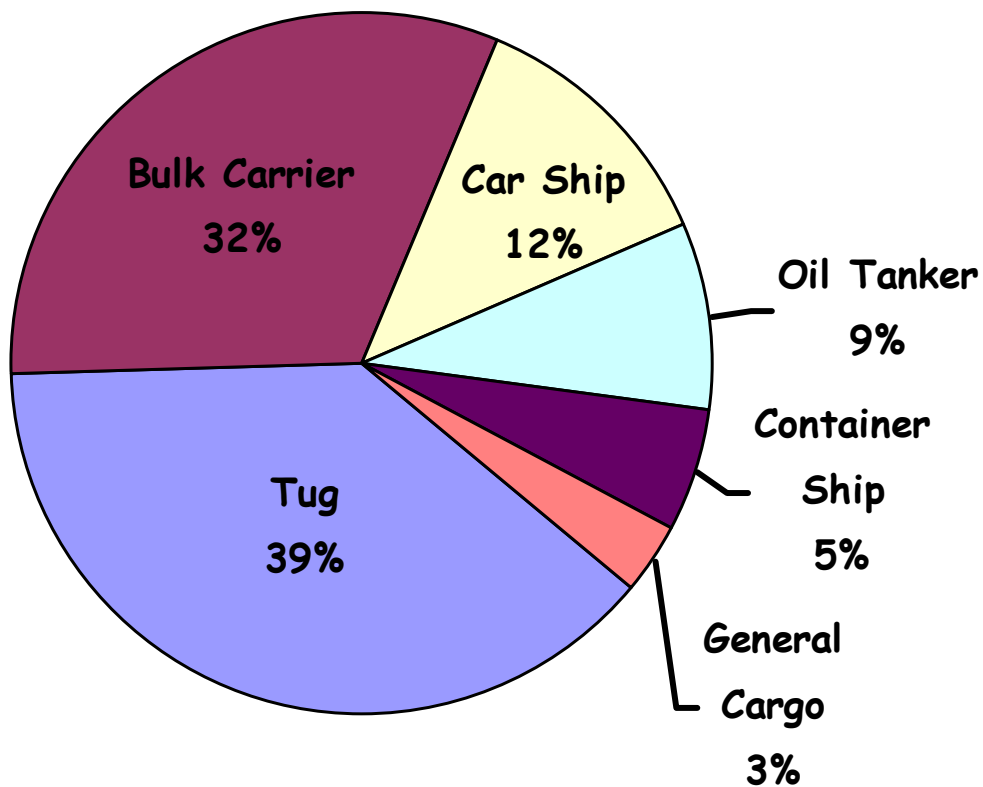
Figure 7. Percentage composition of total observations of each vessel type.

Six different types of vessels were observed. Tugs were the dominant vessel type at 39% of observations. Among deep draft vessels, bulk carriers comprised another 35% of total observations, and the remainder were car ships, oil tankers, container ships, and general cargo carriers (Figure 7). Pictures of each of the vessel types can be seen in figures 8 through 10 except general cargo carrier. Photos were not available because these vessels only passed at night.

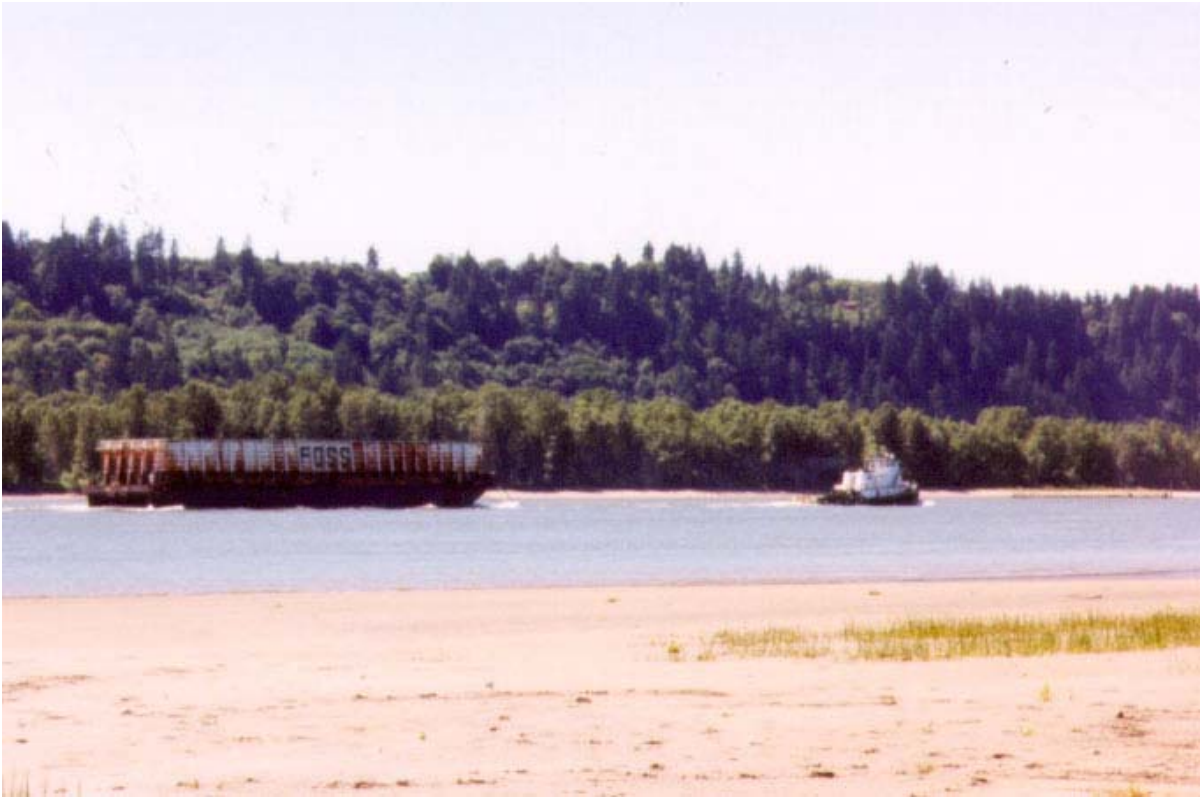
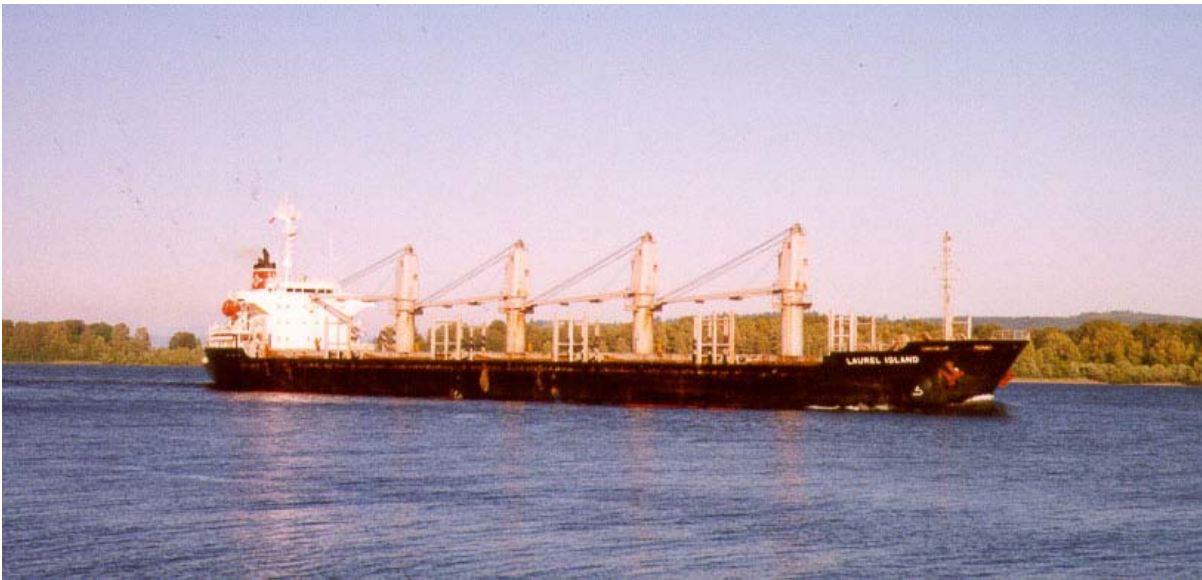
Figure 8. Top: Picture of tug at Barlow Point. Bottom: Picture of the Laurel Island, a bulk carrier at Sauvie Island.

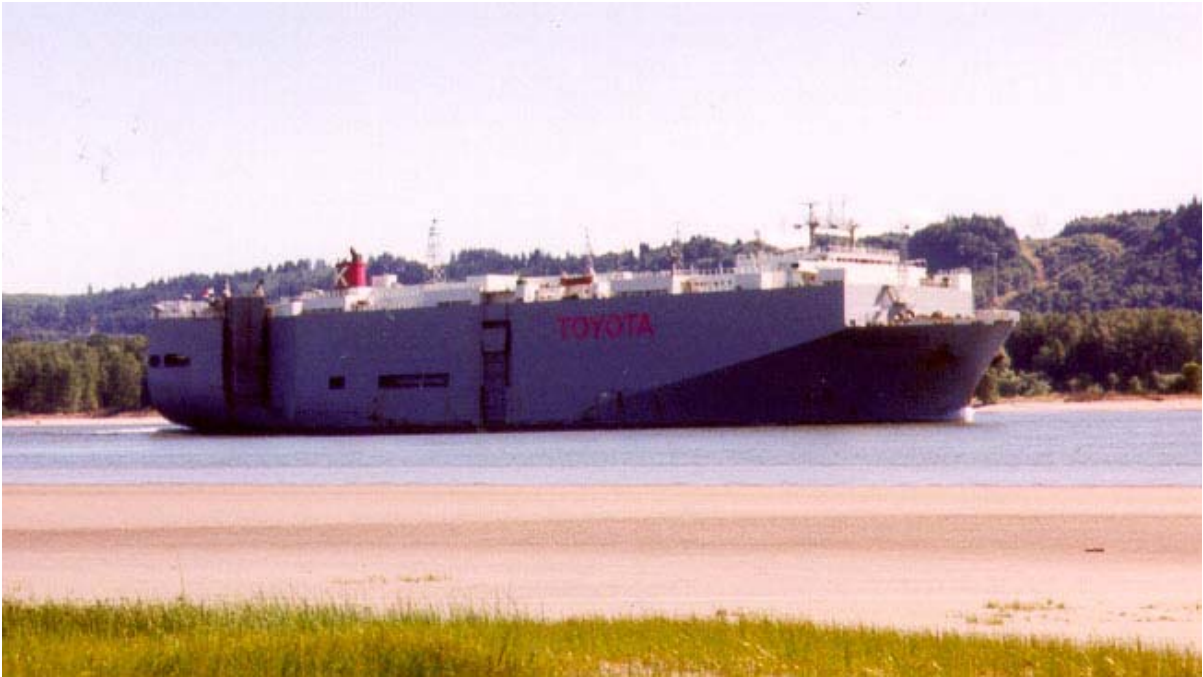
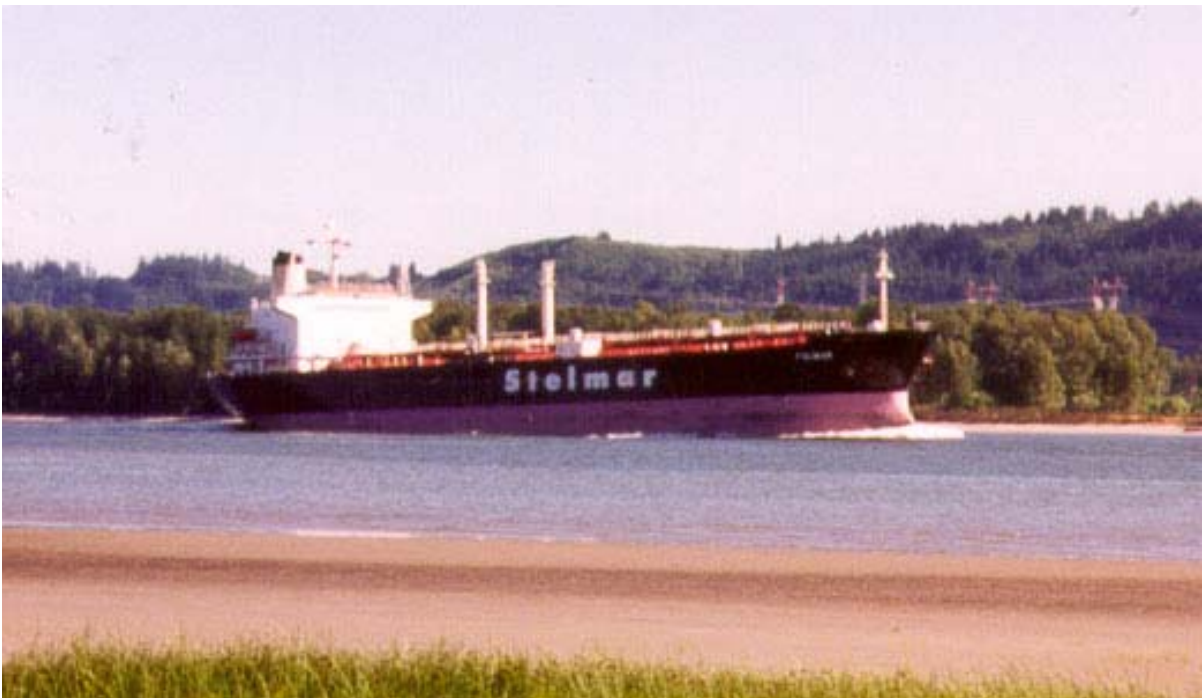
Figure 9. Top: Picture of the Century Highway #1, a car ship at Barlow Point. Bottom: Picture of the Fulmar, an oil tanker at Barlow Point.

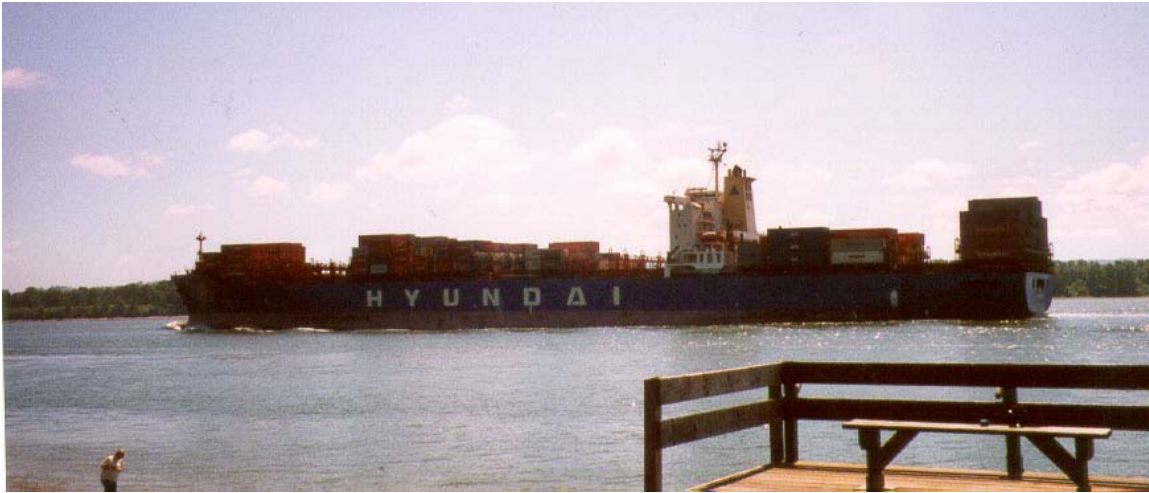
Figure 10. Picture of the Hyundai Admiral, a container ship at County Line Park.

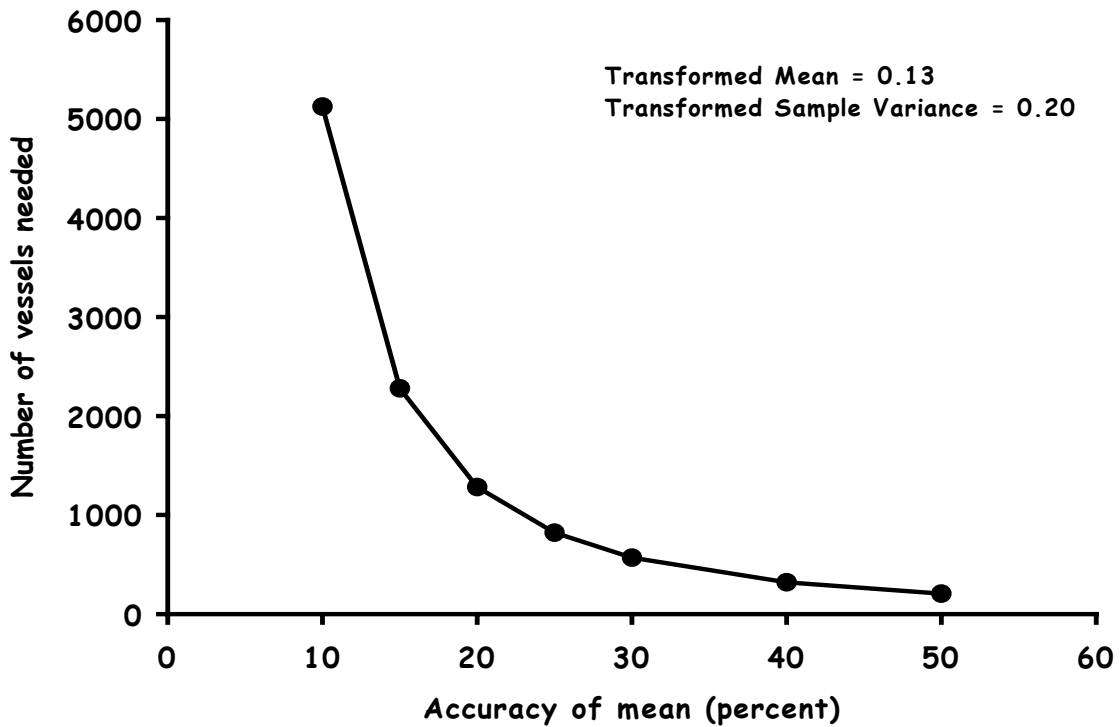
Figure 13. Number of vessels needed to estimate fish stranded per vessel with a given accuracy, expressed as +/- x percent of the mean. Top graph is based on untransformed data, and bottom graph is based on logarithmically transformed data. Transformed using the natural log.

Our observations indicated a non-normal distribution of salmonids stranded per deep draft vessel, and a high degree of variance (Figure 12). Based on this data after it was transformed using the natural log and methods of Eckblad (1991), we estimate that to achieve a mean accuracy of +/- 20% from actual values, 1300 vessels would need to be observed using a completely random design (Figure 13). A stratified sampling design would substantially reduce the necessary sample sizes. This analysis is included as an example for further refinement in future study plans rather than a definitive assessment of sample needs.
