HETA 91-254-2186

MARCH 1992

ROPES & GRAY PHOTOCOPY CENTER
BOSTON, MASSACHUSETTS

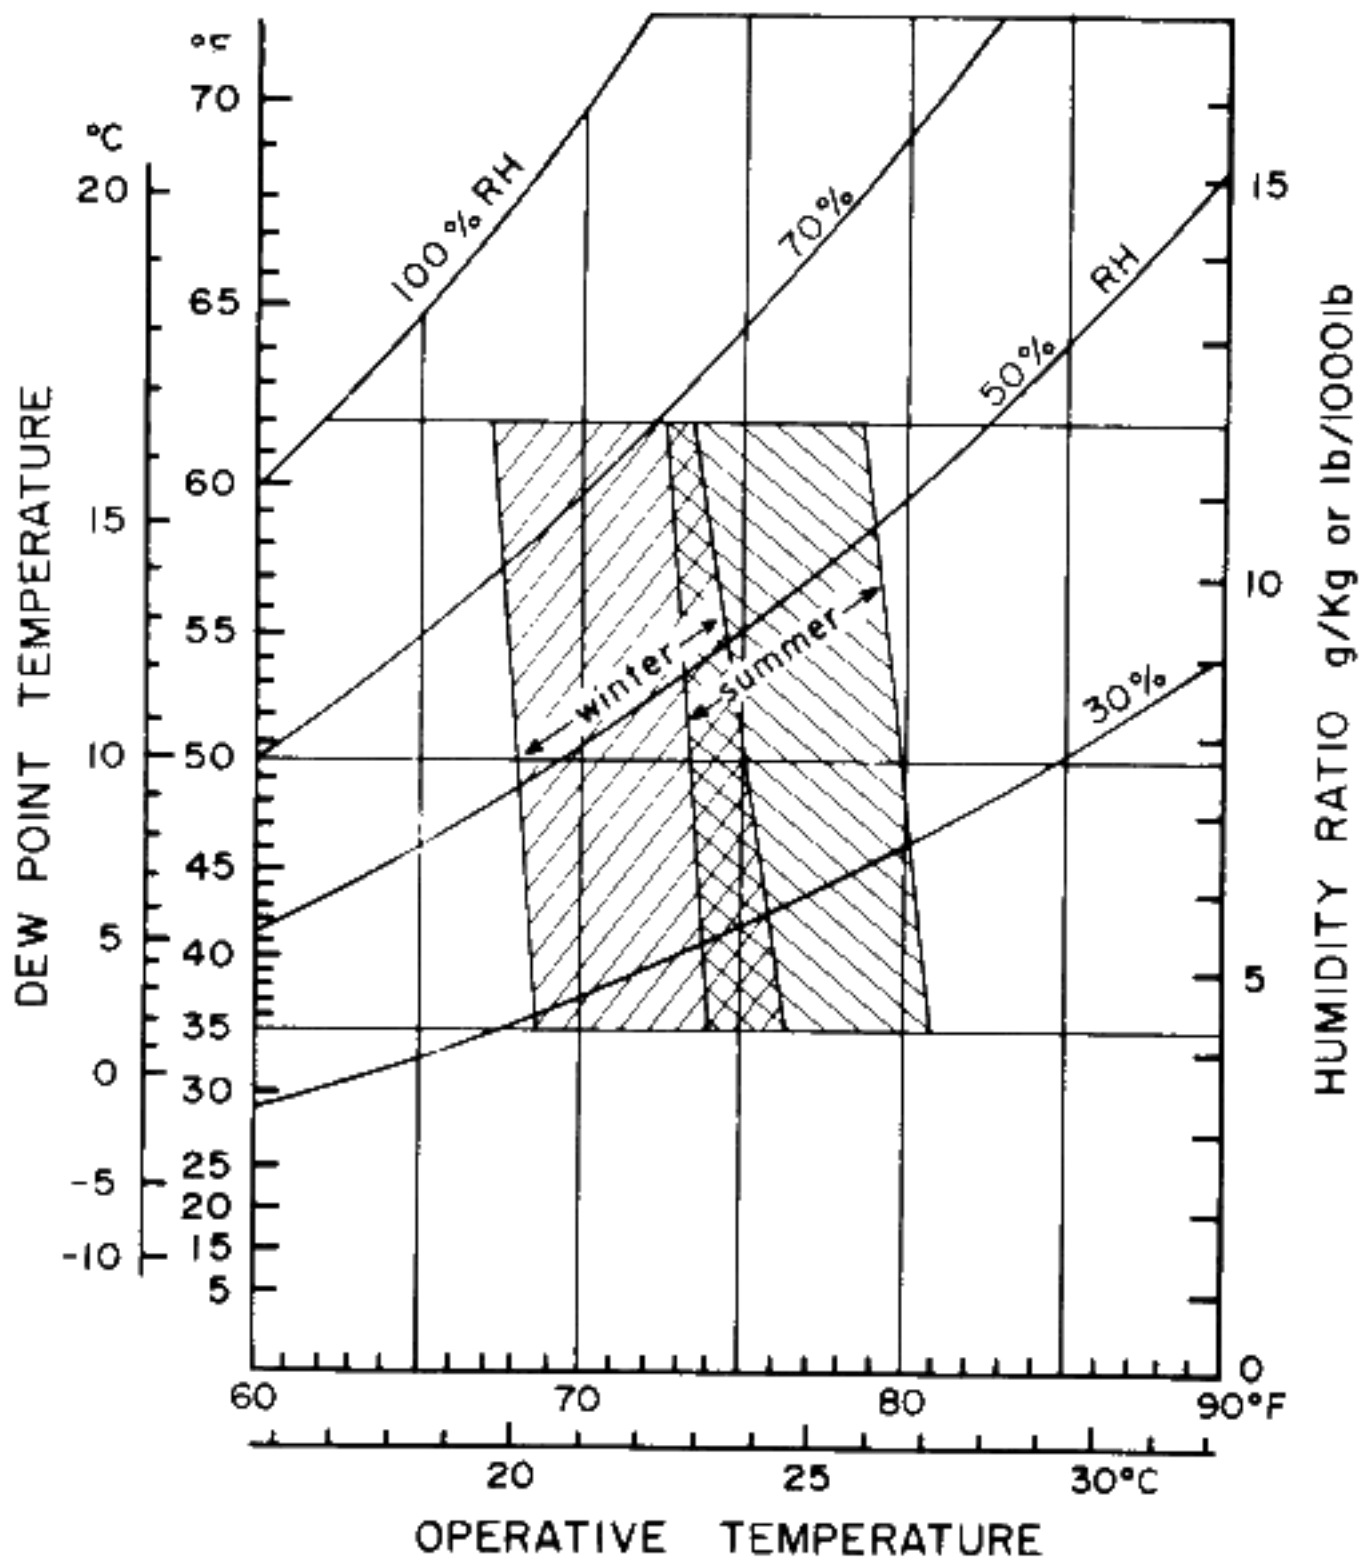
Figure 1
Thermal Comfort Chart

ANSI/ASHRAE Standard 55-1981 specifies conditions in which 80% or more of the occupants would be expected to find the environment thermally comfortable.²⁹

Real-time measurements for CO₂, RSP, temperature and RH are shown in Tables 3 and 4. Carbon dioxide concentrations ranged from 300 to 825 ppm, with the highest values obtained in the binding area. Outdoor CO₂ concentrations ranged from 325 to 375 ppm. All CO₂ measurements taken within the facility were below the ASHRAE consensus standard of 1000 ppm for indoor environments (ASHRAE 62-1989). Real-time measurements for respirable suspended particles revealed airborne concentrations ranging from none-detected to 0.05 milligram per cubic meter (mg/m³), below the EPA 24-hour PM₁₀ standard of 0.15 mg/m³. Dry bulb temperatures and RH ranged from 75 to 79°F and from 34 to 43% in the photocopy center, respectively. Outdoor temperatures ranged from 55 to 72°F, and the RH ranged from 26 to 49%. The indoor temperature and RH measurements taken fall within the ranges recommended by ASHRAE in standard 55-1981, Thermal Environmental Conditions² for Human Occupancy (see Figure 1). Real-time CO measurements revealed levels that could not be detected above the LOD of 1 ppm. Measurements taken in the binding area for temperature, O₃, RSP, and CO₂ concentrations revealed values that were consistently higher than the values found in other locations.
