**Migration Behavior of Adult Pacific Lamprey in the Lower Columbia River and
Evaluation of Bonneville Dam Modifications to Improve Passage, 2001**

Report of research for

Portland District
U.S. Army Corps of Engineers
P.O. Box 2946
Portland, Oregon 97208-2946
Contract E96950021

December 2003

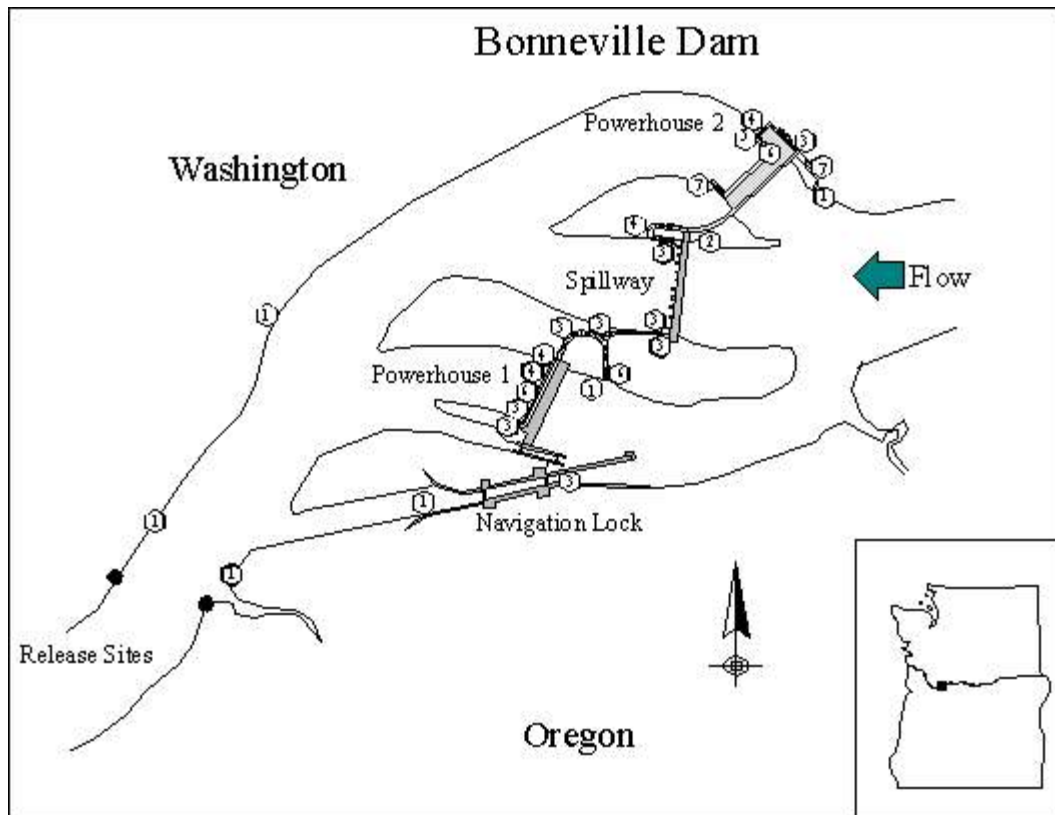
Figure 1. Study area at Bonneville Dam on the lower Columbia River (solid square in insert). Release sites used in 2001 are indicated by solid dots. Radio receiver sites (with the number of antennas used at each site) are indicated by hexagons.

We collected and radio tagged adult lamprey at the Adult Collection and Monitoring Facility on the Washington shore of Bonneville Dam, River Kilometer (RKm) 235. We released radio-tagged fish downstream from the dam at the Hamilton Island boat ramp on the Washington shore (RKm 231) and at the mouth of Tanner Creek (RKm 232) on the Oregon shore (Fig. 1).

At Bonneville Dam, there are two powerhouses oriented perpendicular to river flow, with a spillway between them (Fig. 1). A complex system of fishways allows fish to pass at the southern powerhouse (PH1), at the spillway, and at the northern powerhouse (PH2). At The Dalles Dam (RKm 308), fish may pass upstream via a fishway adjacent to the spillway on the north shore (North Fishway), or via a more complex system of entrances and collection channels that lead to a fishway at the powerhouse (East Fishway, Fig. 2). John Day (RKm 347) and McNary (RKm 467) Dams have similar fishway configurations: one fishway is adjacent to the spillway on the north shore (North) and one is at the powerhouse on the south shore (South, Figs. 3-4). At all dams, fish can also pass upstream during operation of navigation locks; however, we only monitored lamprey passage via this route at Bonneville Dam (Fig. 1).

Lamprey passage was monitored by fixed-site receivers located on each dam (Figs. 1-4), at the dam tailraces, and at the mouths of major tributaries. Receiving stations in the tailraces and in tributaries had a scanning receiver with a Yagi aerial antenna. At the dams, receiving stations had digital spectrum processors coupled with a scanning receiver and one or more underwater coaxial cable antennas (range 9 m) to receive transmissions on a number of frequencies simultaneously. These receivers were strategically positioned to allow assessment of passage through discrete areas of the fishways: entrances, collection channels, transition areas, ladders, and counting stations. Both the outside and inside of each main fishway entrance were monitored by at least one antenna.

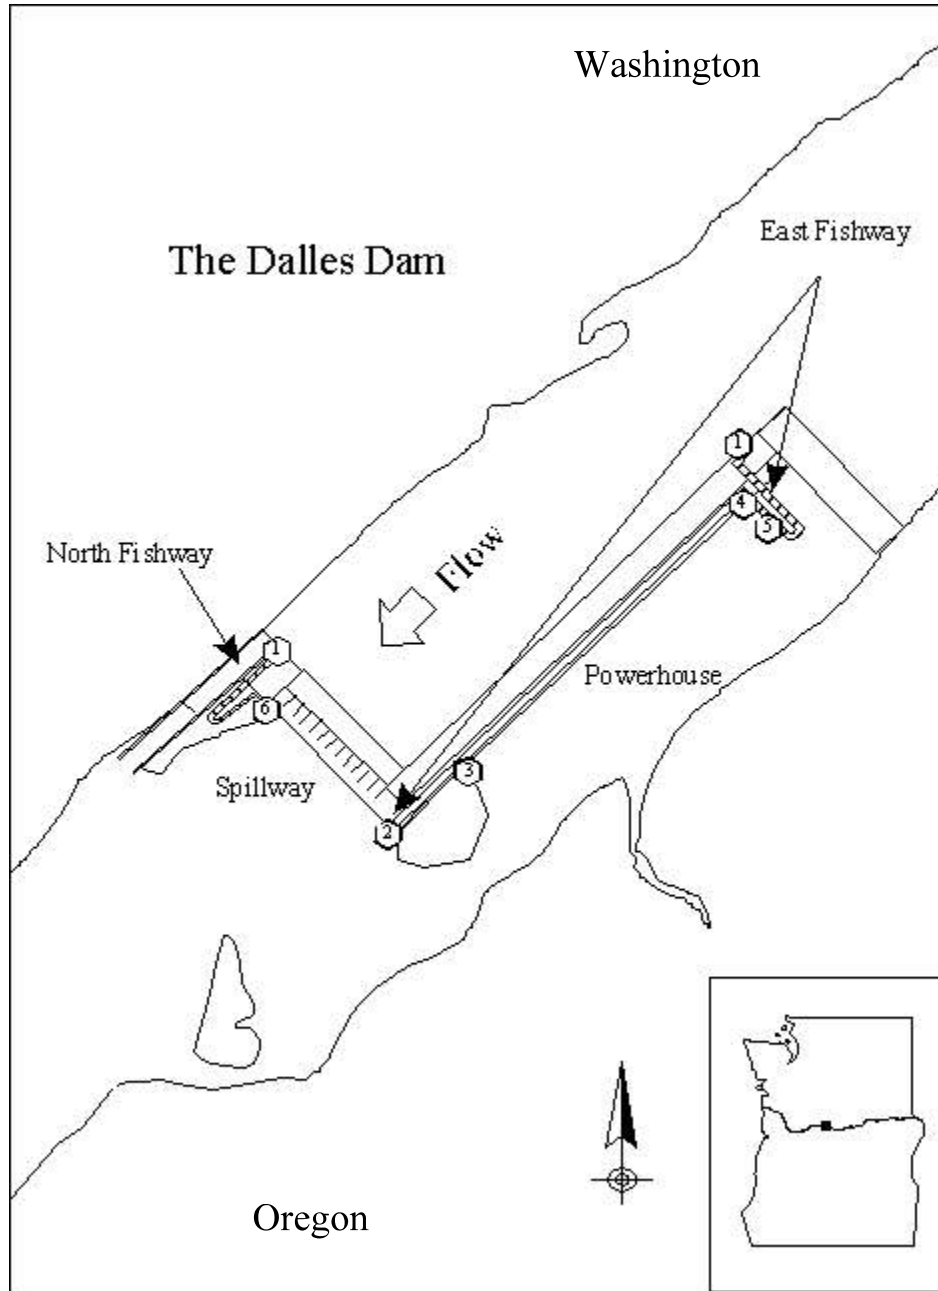
Figure 2. Study area at The Dalles Dam on the lower Columbia River (solid square in insert). Radio receiver sites (with the number of antennas at each site) are indicated by hexagons.

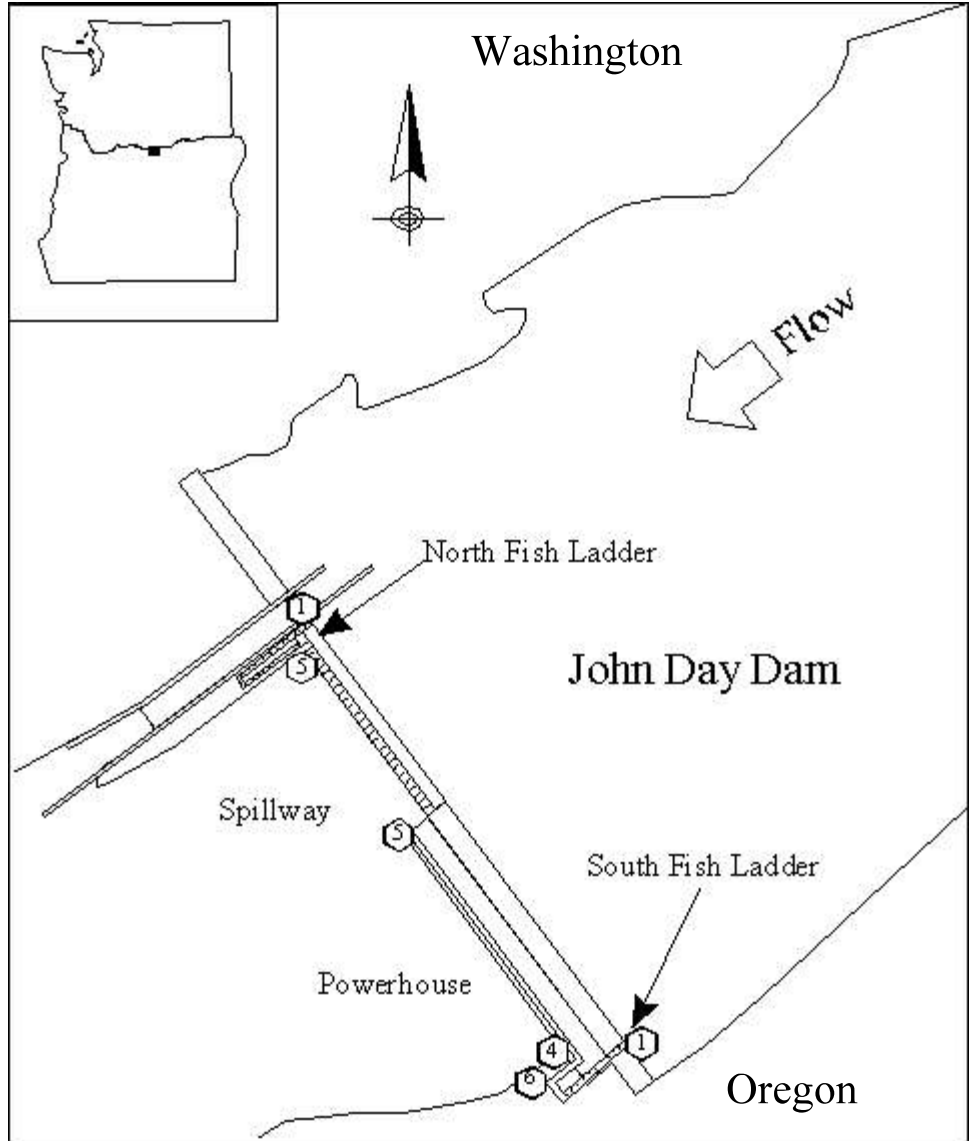
Figure 3. Study area at John Day Dam on the lower Columbia River (solid square in insert). Radio receiver sites (with the number of antennas at each site) are indicated by hexagons.

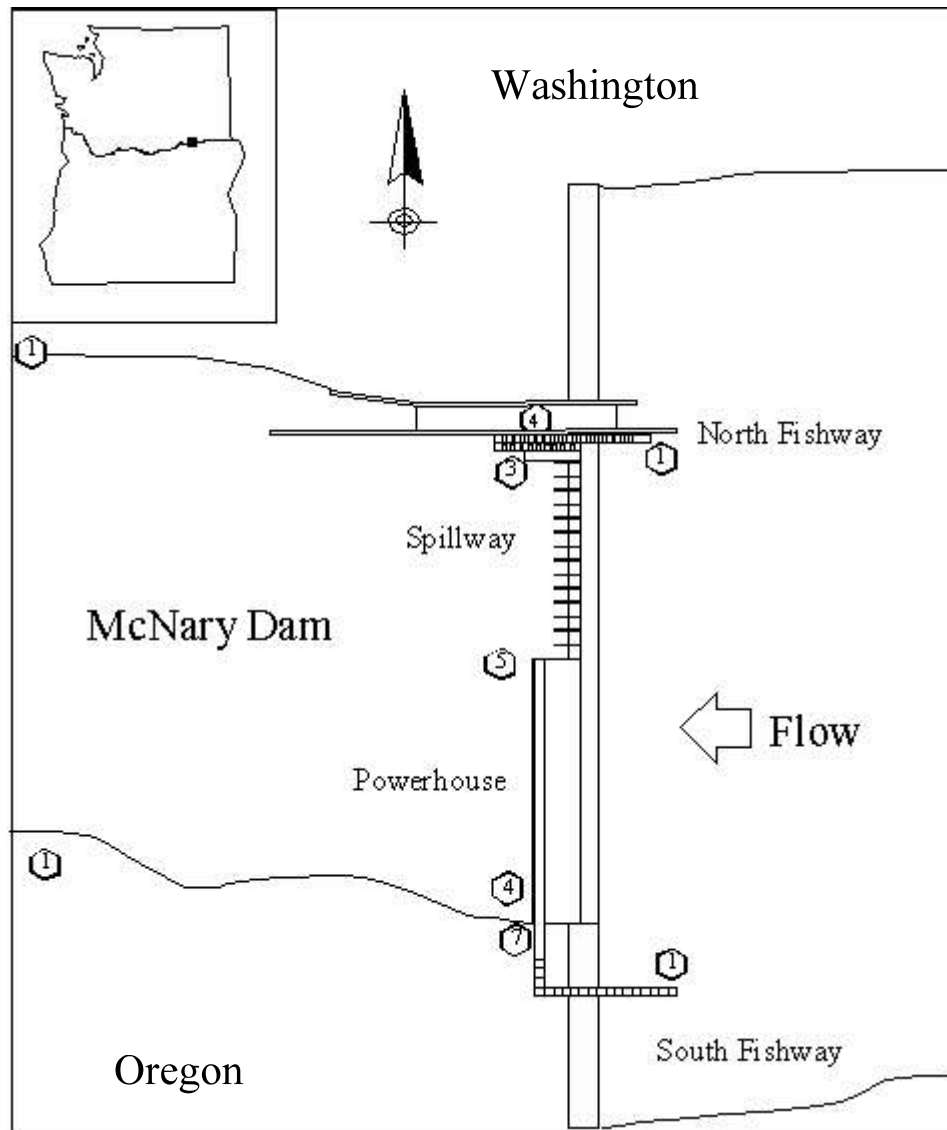
Figure 4. Study area at McNary Dam on the lower Columbia River (solid square in insert). Radio receiver sites (with the number of antennas at each receiver) are indicated by hexagons.

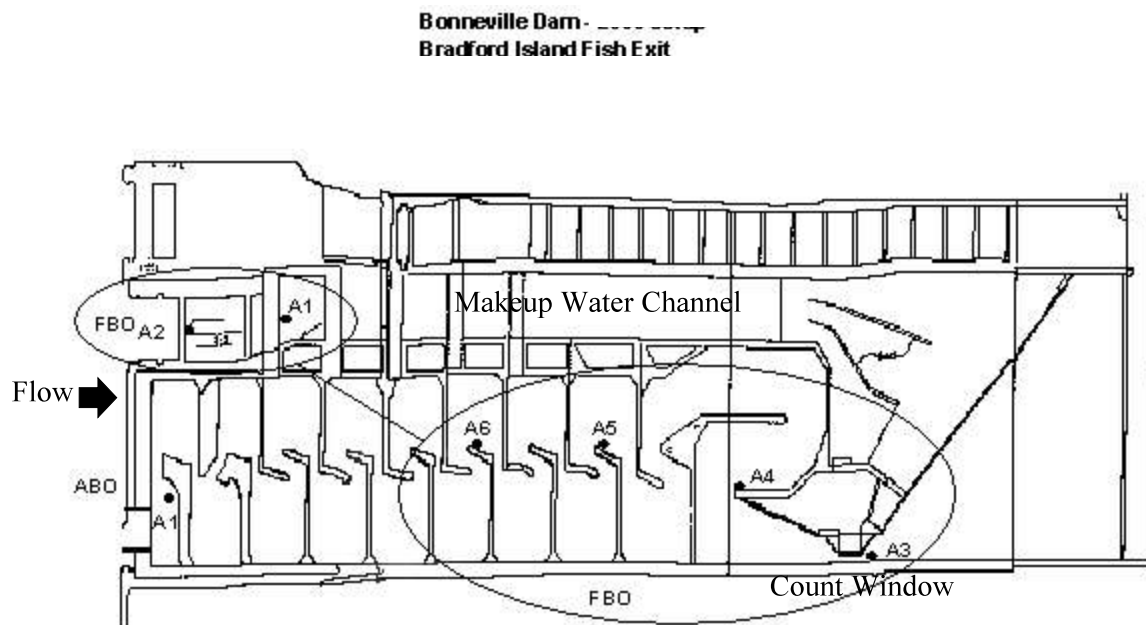
Figure 5. Location of the receivers (FBO and ABO) and individual antennas (FBO A3 at the counting window, A4, A5, and A6 in the serpentine weir section, A1 and A2 in the makeup water channel, and ABO A1 at the ladder exit) at the top of the Bradford Island fishway in 2001.

downstream from the counting window (at the upstream end of the picketed lead, Fig. 5). There were three antennas located in the serpentine slot weirs above the counting window, and an antenna at the top of the serpentine weir area. Two additional antennas were positioned in the make-up water channel that runs parallel to the serpentine weir area (Fig. 5). At the top of the Washington-shore fishway, an antenna was placed immediately downstream from the counting window (upstream end of picketed lead), four antennas were positioned through the serpentine weir area, and one antenna monitored passage at the fishway exit (Fig. 6). Two additional antennas were placed in the make-up water channel.

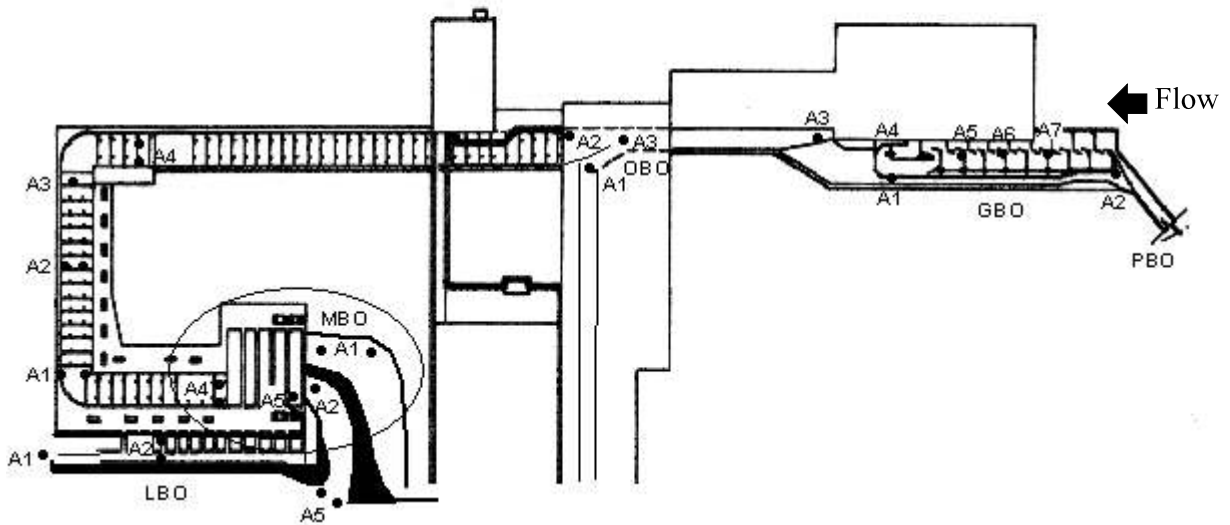
Bonneville Dam-
WA Shore Fish Ladder

Figure 6. Location of the receivers (GBO and PBO) and individual antennas (GBO A3 at the counting window, A4, A5, A6, and A7 in the serpentine weir section, A1 and A2 in the makeup water channel, and PBO at the ladder exit) at the top of the Washington-shore fishway in 2001.

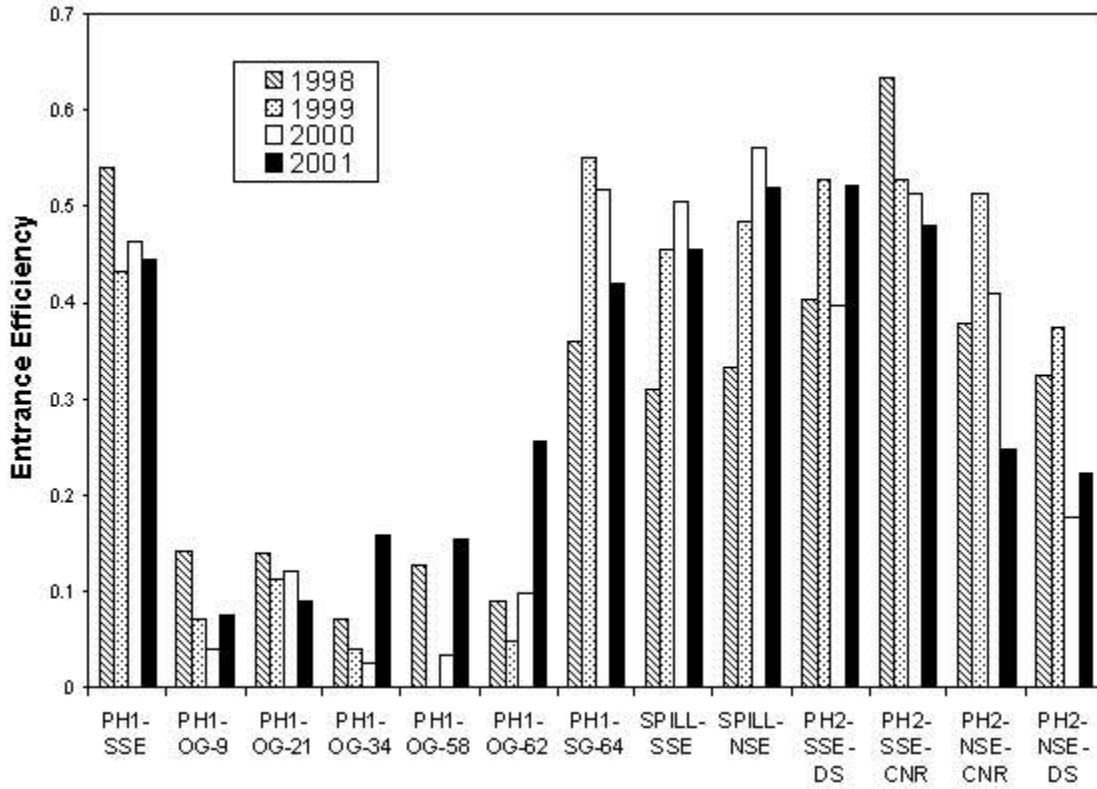
Figure 17. Entrance efficiency (percentage of lamprey that successfully entered of those that approached) at each of the Bonneville Dam fishway entrances from south to north along Powerhouse 1 (PH1), the spillway (SPILL), and Powerhouse 2 (PH2) in 1998-2001. Orifice and sluice gate entrances at PH1 are denoted by OG and SG, respectively (orifice entrances were not monitored at PH2 in 2000). Main entrances at PH2 include those downstream (DS) and in the corners (CNR).

Examination of entrance efficiency at individual entrances revealed that, as in previous years, lamprey generally had lower entrance success at orifice entrances than at main entrances (Fig. 17). However, entrance efficiency at PH1 gates 34, 58, and 62 was higher in 2001 than in previous years of monitoring. We also noted relatively low entrance efficiency at the northernmost PH2 entrances (Fig. 17)

Overall entrance efficiency increased at the spillway entrances but decreased at the individual entrances in 2001. This apparent discrepancy resulted from the tendency for lamprey to move between the two spillway entrances prior to entering. As in previous years, entrance efficiency at the northern spillway entrance (Cascades Island, SPILL-NSE) was higher than at the southern spillway entrance (Bradford Island B-Branch, SPILL-SSE)(Fig. 17).

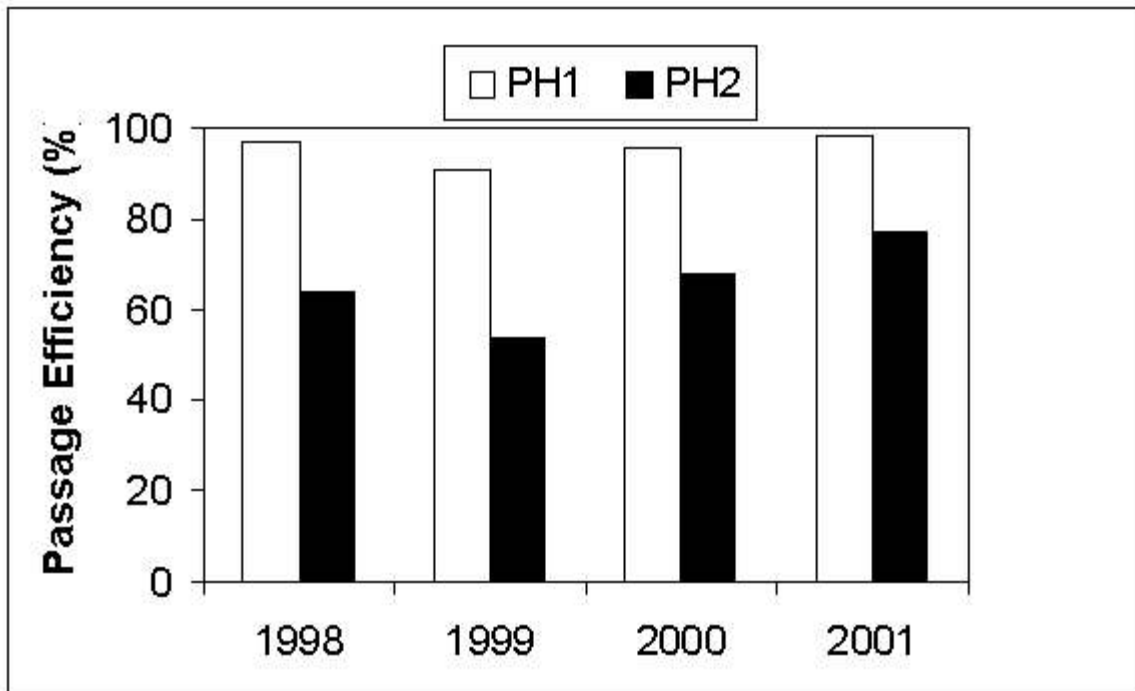
Figure 18. Transition area passage efficiency (percentage of lamprey that passed through the transition area of those that approached this area) at the Bonneville Dam fishways (Bradford Island = PH1, Washington-shore = PH2) in 2001 (after installation of metal plates over diffuser grating at PH2) as compared to the period before installation of attachment plates (1998-2000).

One objective of our work in 2001 was to test the efficacy of providing attachment sites for lamprey moving through the PH2 transition area. We found that lamprey passage through this area in 2001 (77% of those that approached the PH2 transition area moved through) was higher than in all previous years except 1997. Consequently, the addition of attachment plates apparently benefitted lamprey passage in this area.

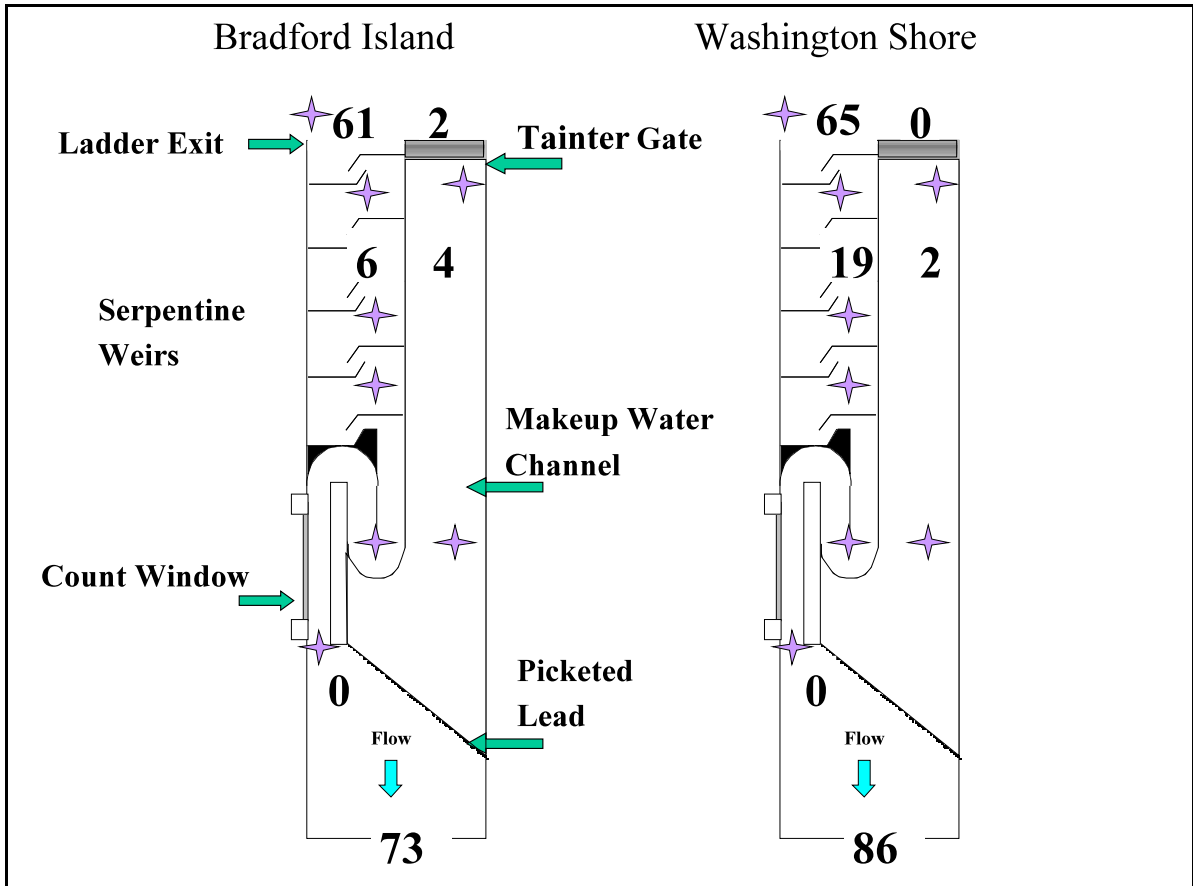
Figure 19. Diagram of the count station areas at the tops of the Bradford Island and Washington-shore fish ladders. Numbers in the fishways indicate the number of lamprey that fell back downstream at each location of the 73 fish that approached the Bradford count window and the 86 fish that approached the Washington-shore count window. Numbers above each diagram indicate the number of lamprey that successfully exited into the forebay. Stars indicate antenna locations.

Of the 70 fish that passed the Bradford Island count window, 9 did not exit at the top of the ladder (Fig. 19). Five of these 9 fell back downstream, passing the count window, and 4 entered the MWC via grates in the wall. Of the four that passed into the

MWC, two fell back downstream and two passed upstream and into the dam forebay via the Tainter gate. The last position of each fish prior to falling back downstream is shown on Figure 19.

Lamprey tended to hold for extended periods in the Bradford Island makeup water channel, compared to the highly variable, but generally lower residence times observed in the serpentine weir section (Fig. 20). At both counting station areas, lamprey were delayed or obstructed at the serpentine weir areas (particularly those farthest upstream) more than at the counting window (Figs. 19-21).

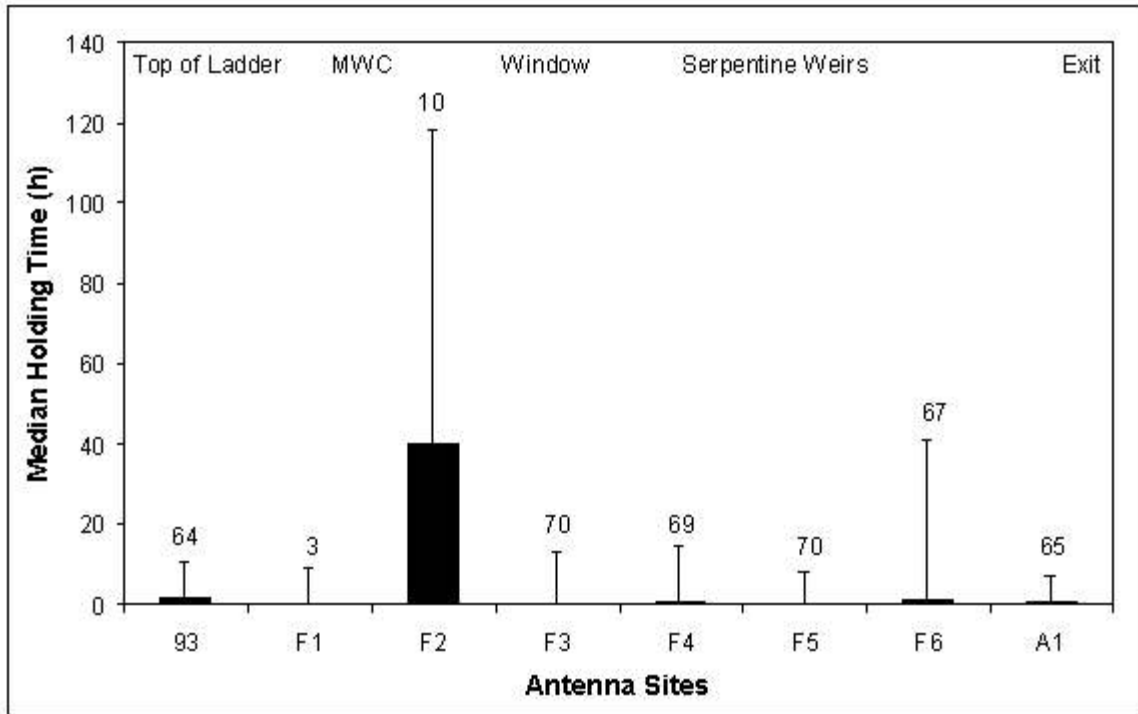
Figure 20. Median holding time at each antenna site (Fig. 5) for the Bradford Island count station area (i.e., median hours from first detection at an antenna site to the first detection at the next upstream antenna site with standard deviation denoted by error bars and sample size over each bar). Features of each site are indicated at the top of the plot (e.g., F1 and F2 are the antennas inside the makeup water channel (MWC), A1 is at the exit, etc.).

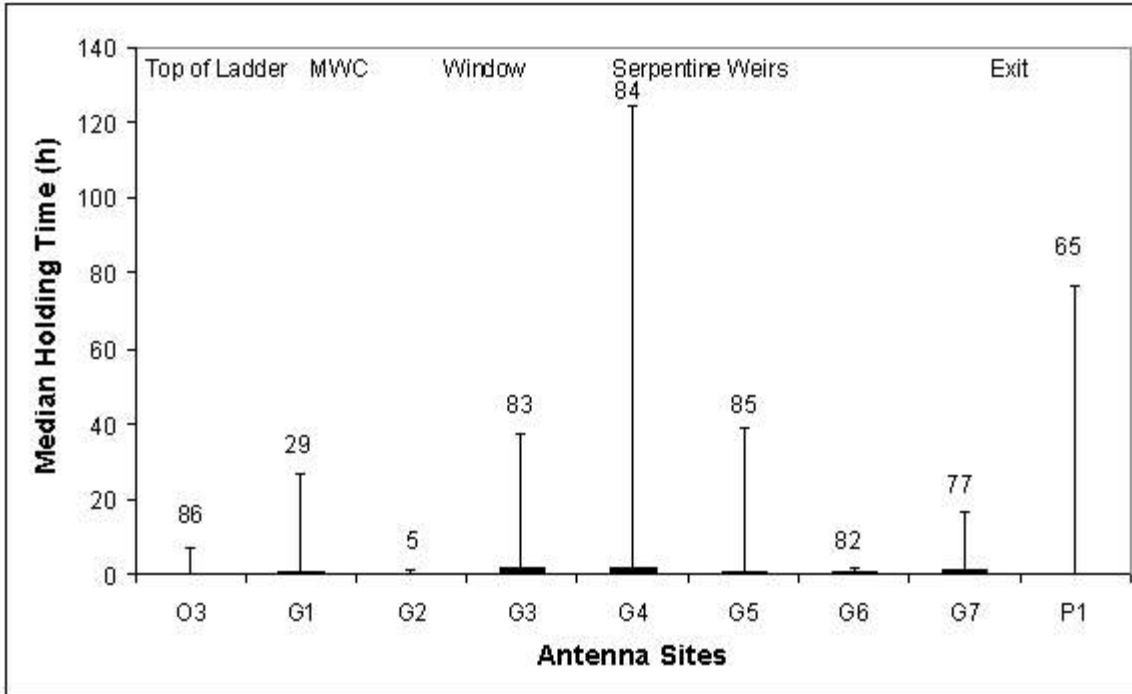
Figure 21. Median holding time at each antenna site (Fig. 6) for the Washington-shore count station area (i.e., median hours from first detection at an antenna site to the first detection at the next upstream antenna site with standard deviation denoted by error bars and sample size over each bar). Features of each site are indicated at the top of the plot (e.g., G3 is the antenna at the count station window, P1 is at the exit, etc.).

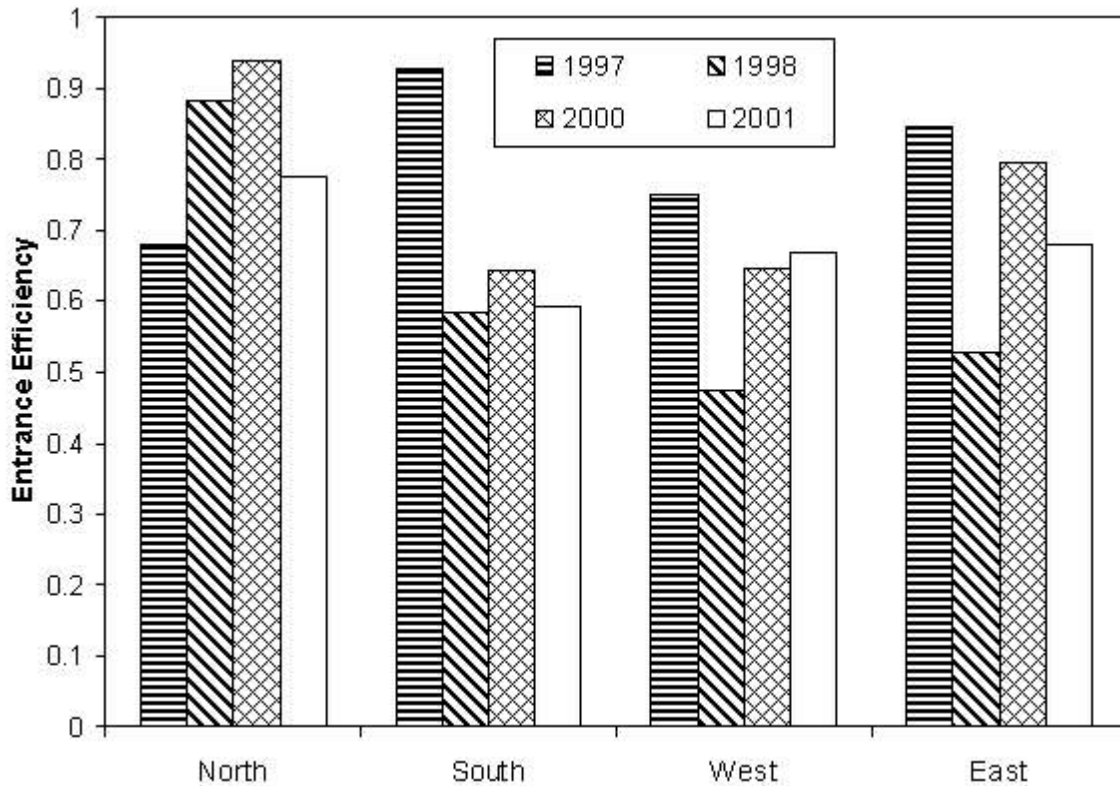
Figure 26. Entrance efficiency (proportion of lamprey that successfully entered of those that approached) at each of The Dalles Dam fishway entrances: the North Fish Ladder entrance on the Washington shore (North), the East Fish Ladder entrance at the south end of the spillway (South), the East Fish Ladder entrance at the west end of the powerhouse (West) and the East Fish Ladder entrance at the east end of the powerhouse (East) in 1997, 1998, 2000, and 2001.

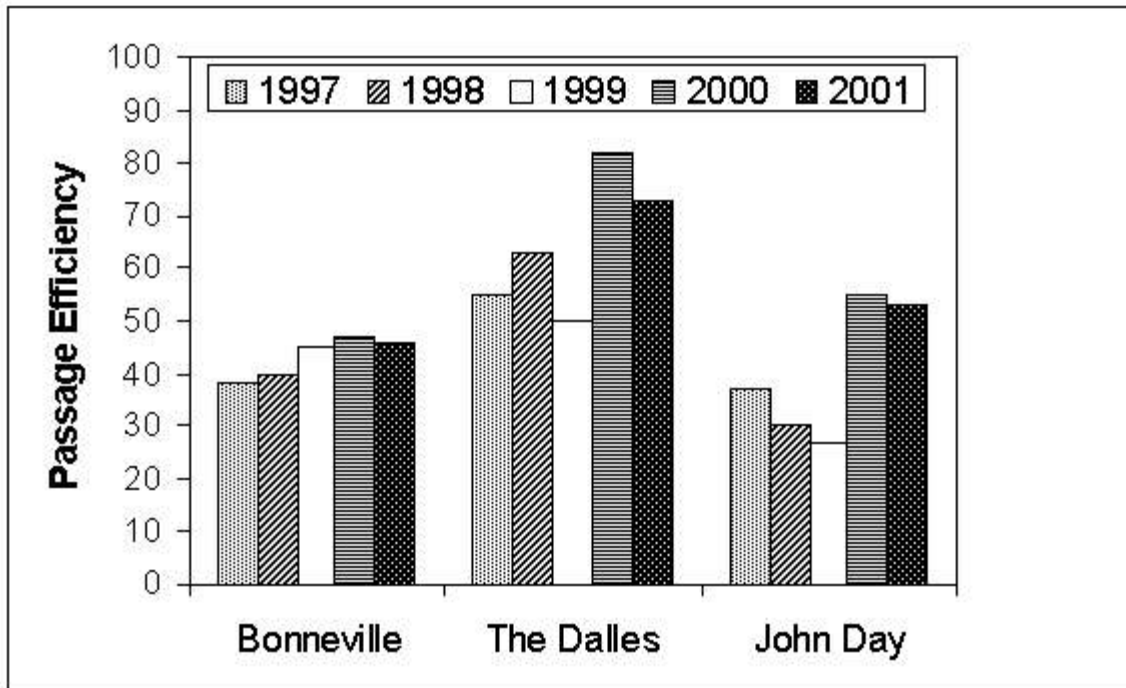
Figure 28. Overall passage efficiency (the number of lamprey that passed over each dam divided by the number that approached it) for Bonneville, The Dalles, and John Day Dams in 1997-2001.

Overall passage efficiency differed among dams (Fig. 28). In 2001, passage efficiency declined slightly at Bonneville Dam for the first time during our radiotelemetry investigations. Declines in passage efficiency relative to 2000 at The Dalles and John Day Dams were also noted (Fig. 28). In addition to lower passage efficiency at Bonneville Dam in 2001, we found that median passage time at this dam was approximately double that recorded in previous years (Fig. 29). In contrast, passage times in 2001 at The Dalles and John Day Dams were similar or slightly lower than in 2000.

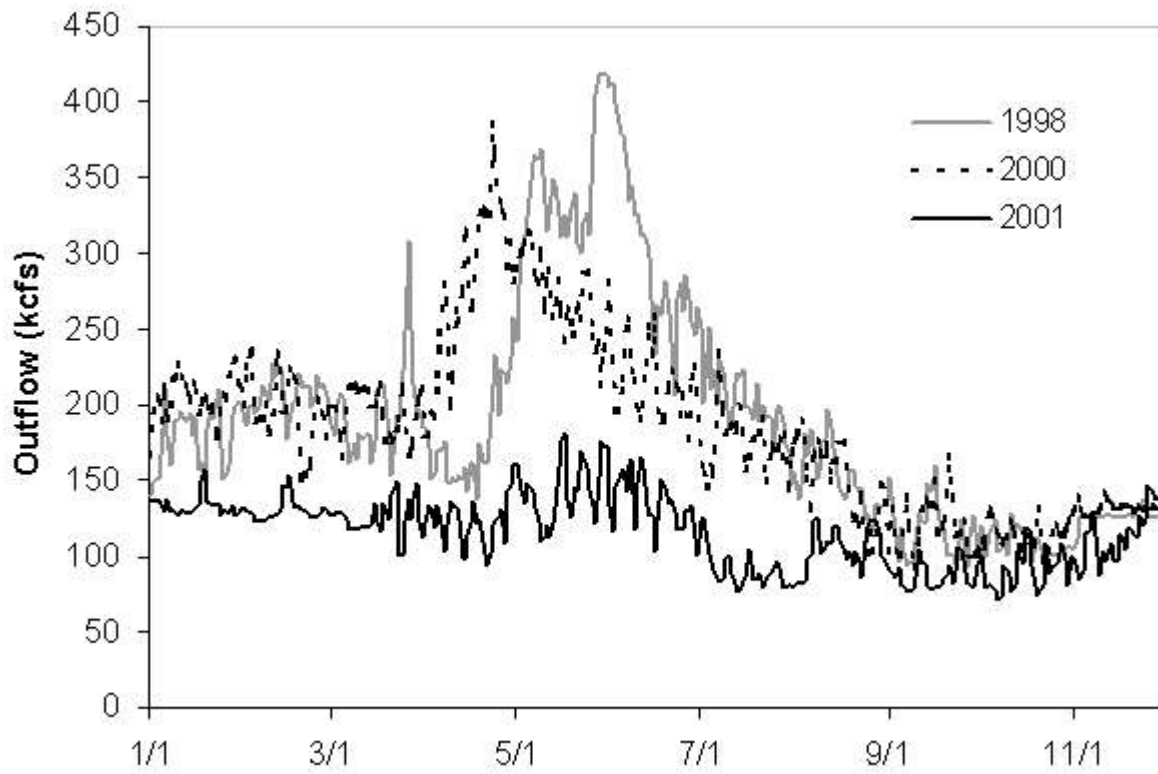
Figure 30. Outflow (kcfs) measured at the Bonneville Dam tailrace in 1998, 2000, and 2001.

Conditions and dam operations in the lower Columbia River differed radically in 2001 from previous years of study. Low water conditions resulted in extremely low flow (Fig. 30) and essentially no spill (Fig. 31) during the study period in 2001 at Bonneville Dam. In addition, priority for power generation was at Bonneville Powerhouse 2 in 2001 (Fig. 31), while Powerhouse 1 had priority during the study period in 2000 (Fig. 32) and previous years of study.

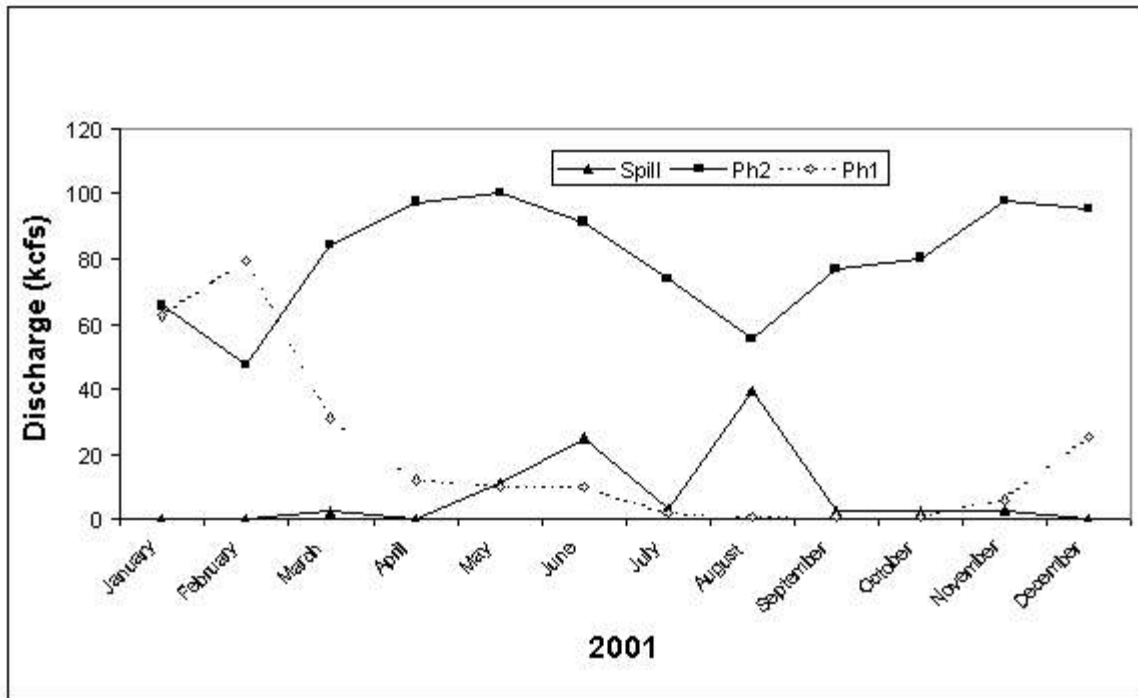
Figure 31. Mean monthly discharge (kcfs) at PH1, PH2, and the spillway in 2001.

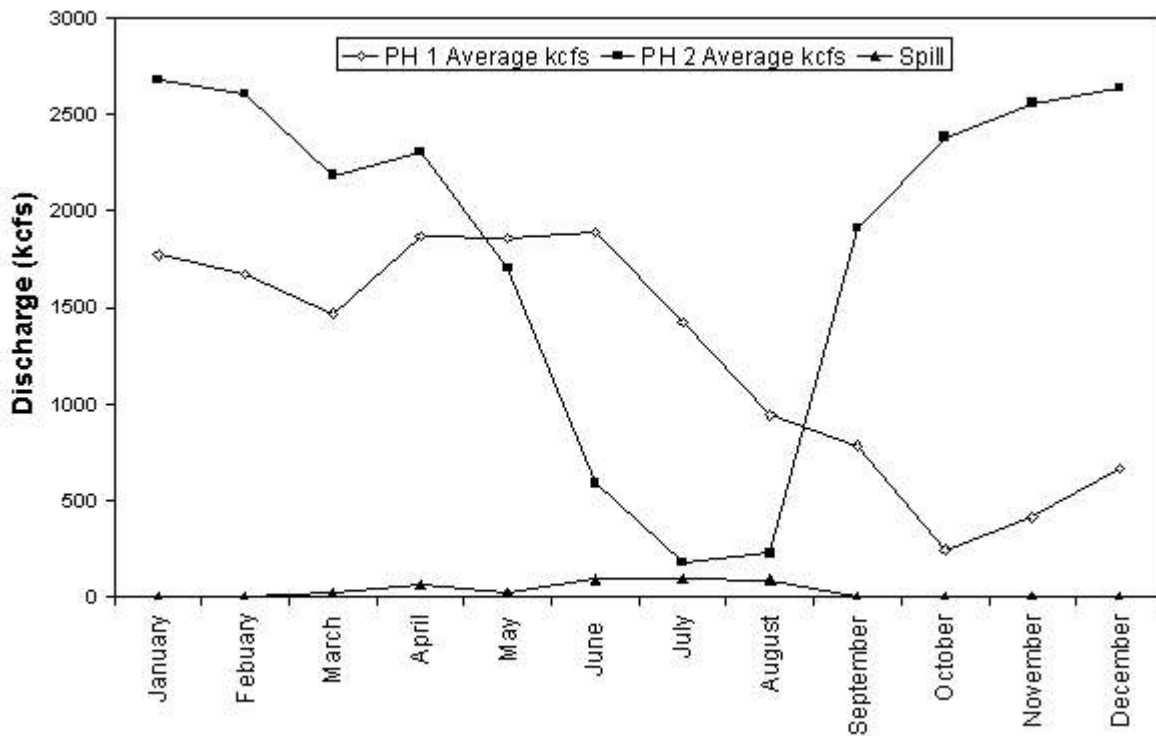
Figure 32. Mean monthly discharge (kcfs) at PH1, PH2, and the spillway in 2000.
