**Oral Testimony of John S. Bresland  
Chairman and Chief Executive Officer  
U.S. Chemical Safety Board  
Before the U.S. Senate Committee on Health, Education, Labor, and Pensions  
Subcommittee on Employment and Workplace Safety  
July 29, 2008**

**Testimony of John S. Bresland  
Chairman and Chief Executive Officer  
U.S. Chemical Safety Board  
Before the U.S. Senate Committee on Health, Education, Labor, and Pensions  
Subcommittee on Employment and Workplace Safety  
July 29, 2008**

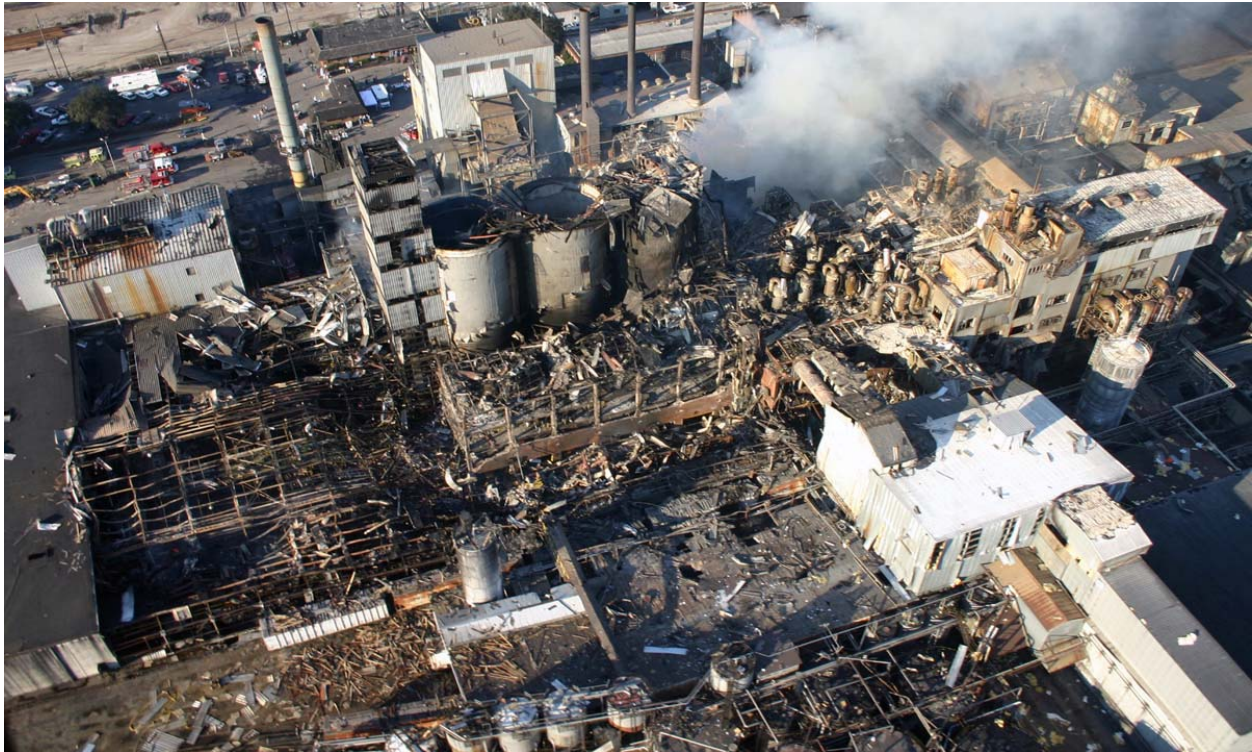
Figure 1. Aerial photograph of Imperial Sugar Port Wentworth facility after explosion.

Like Senator Isakson, Senator Chambliss, and Secretary Foulke, I traveled to Port Wentworth and witnessed first-hand the tremendous devastation at the Imperial Sugar refinery (Figure 1).

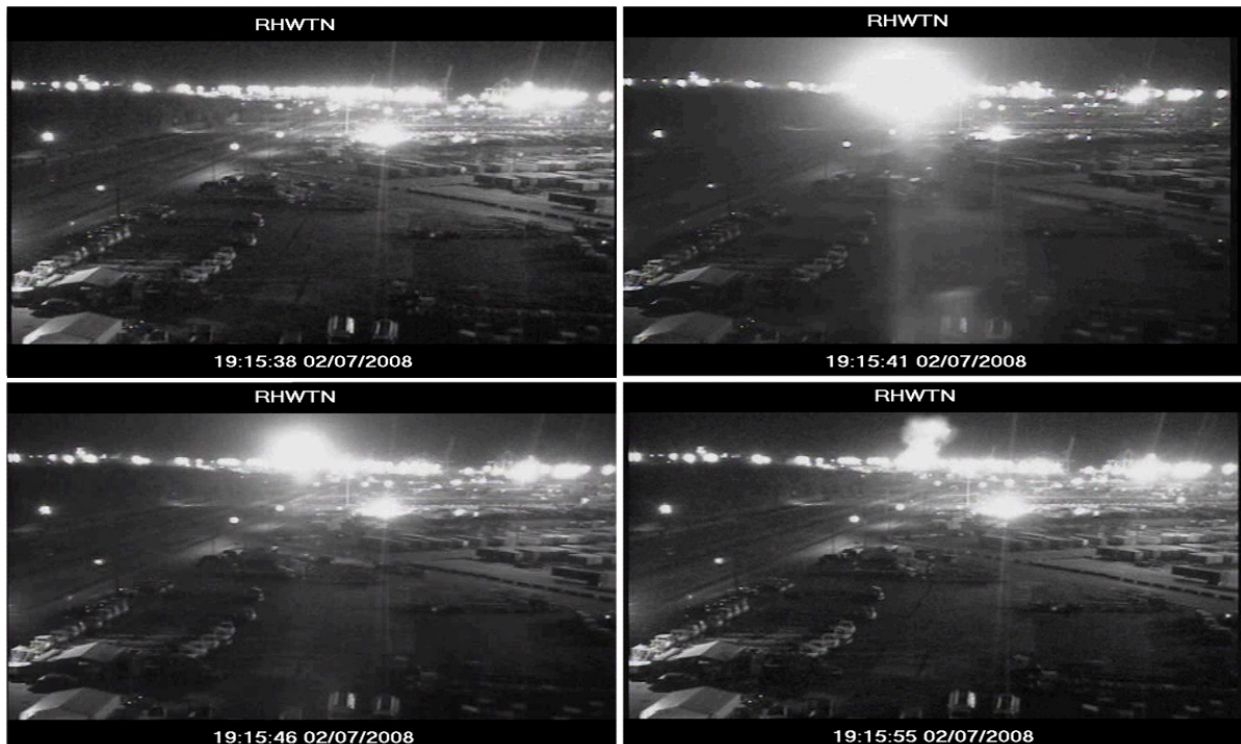
Figure 2. Surveillance camera captures secondary dust explosion from two miles away.

Like most catastrophic dust explosions, what happened at Imperial was a multi-stage event. At 7:15 p.m. on the evening of February 7, there was a primary explosion in the packaging plant, followed three to five seconds later by a much larger secondary dust explosion. The explosion blew through the roof of the building and rose high into sky; the moment of the blast was captured in images from a surveillance camera almost two miles from the refinery (Figure 2).

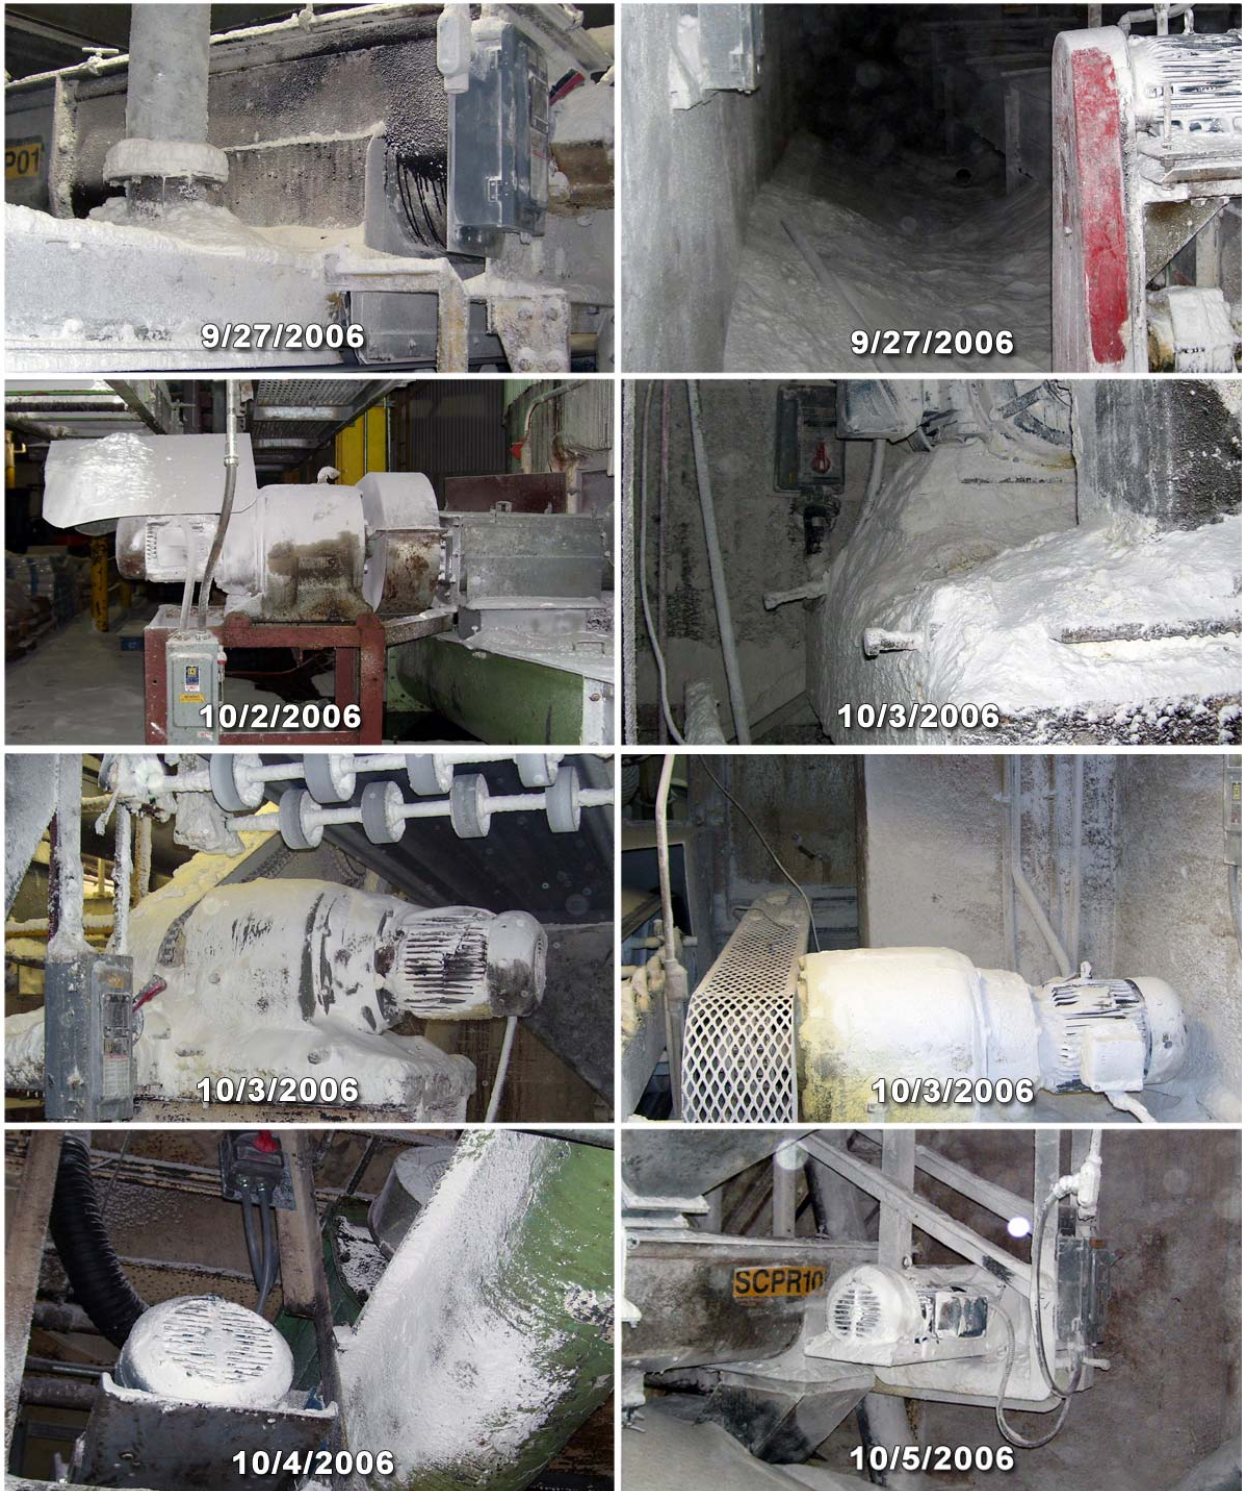
Figure 3. Photographs of sugar accumulations inside the Imperial Sugar Port Wentworth facility from September – October 2006.

The photographs on the easel were taken in September and October 2006 at different locations inside the sugar packaging building at Imperial's Savannah refinery. They confirm the existence of substantial dust accumulations on various ducts, motors, switch boxes and processing equipment.

These accumulations – ranging in depth from an inch or two up to several feet – far exceed the NFPA-recommended limit of 1/32 of an inch.

The CSB obtained pre-explosion photographs taken at the Imperial facility by a third-party in September and October 2006. These photographs, which show different locations inside the packaging building, confirm the existence of substantial dust accumulations on various walls, pipes, ducts, motors, switch boxes, and pieces of processing equipment. The pictures show an inch or even more of accumulated sugar on elevated surfaces. On several production floors, the photographs show a foot or more of accumulated sugar (Figure 3).
