NASA/SP-2002-4526

# ***MEMOIRS OF AN AERONAUTICAL ENGINEER***

**Flight Tests at Ames Research Center:  
1940-1970**

**Seth B. Anderson**

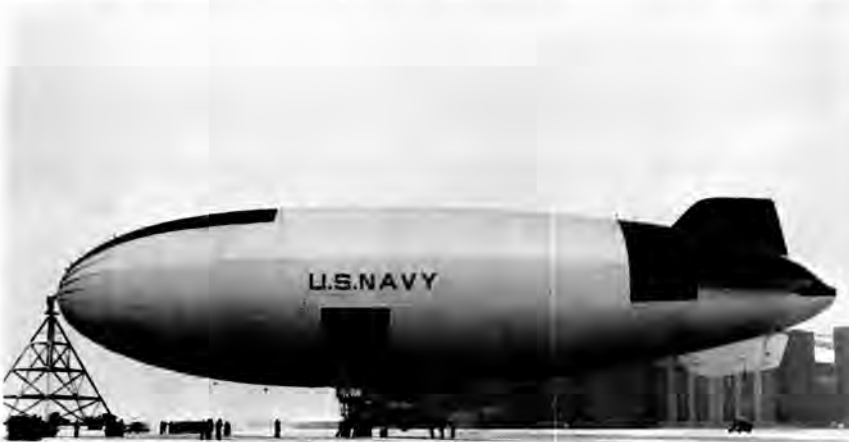
*The K-21 Airship.*

The Bureau of Aeronautics asked NACA to evaluate the handling qualities of a K-21 airship (fig. 33), which had been modified with aircraft-type control columns in place of the usual (separate) elevator and rudder control wheels. The purpose of the flight tests was to identify and quantify the causes of the poor handling qualities of the airship so that designers could incorporate improved mechanical control characteristics in future designs.

results showed that the column control forces were uncomfortably large because of high control friction (25 pounds) and high inertia inherent in the control system. It was recommended that spring tabs be used to lower control forces and that friction and inertia be reduced to more closely compare with those of aircraft systems.

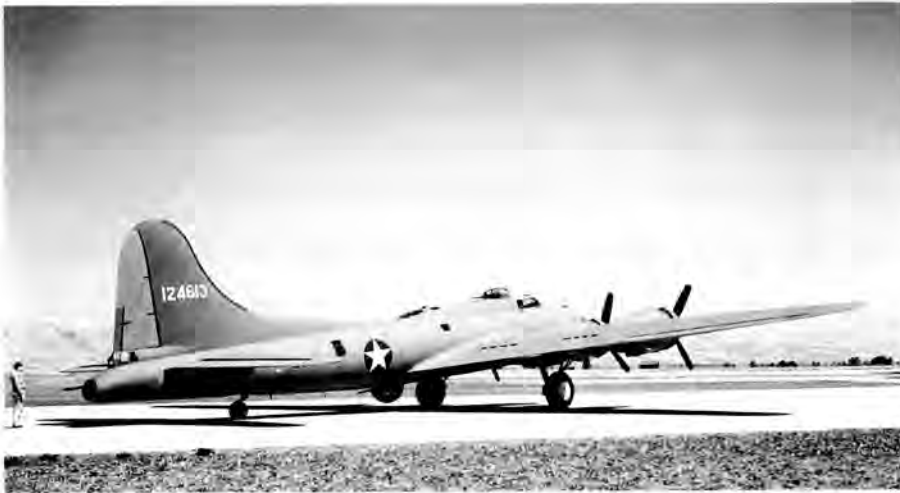
*The Boeing XB-17F with turbocharged engines (1942).*

83 Figure 35. The Boeing XB-17F was truly a flying fortress armed with 12 (and sometimes 13) caliber 0.50 machine guns fired from numerous gun turrets and a tail-gunner enclosure (Aug. 1942) AAL-2499

The XB-17F (fig. 35) served another important flight-research function in helping define handling-qualities criteria for large (bomber) aircraft. Tests were conducted in a short period from September 1942 to January 1943 (20 flight hours) at the request of the

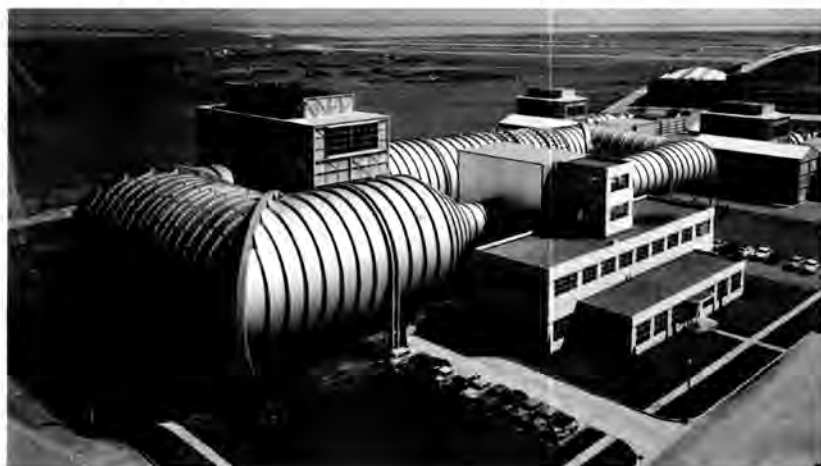
*The Ames 16-Foot High Speed Wind Tunnel.*

The Army Air Forces asked both Langley and Ames to find an acceptable solution for this difficult problem. Model tests in the Ames 16-foot high-speed wind tunnel suggested a quick and easy fix by adding flaps on the lower surface of the wing at 33% chord to offset the loss in lift caused by shock-induced flow separation. This partially helped the problem. Again, Ames was not permitted to flight test this recommendation because Lockheed wanted full credit for improving a basic design deficiency. Flight tests showed that if the flaps were extended *before* diving, the aircraft could recover from angles of dive up to 45 degrees. Without flap extension, the maximum dive angle was limited to 15 degrees to avoid penetrating the severe compressibility region.

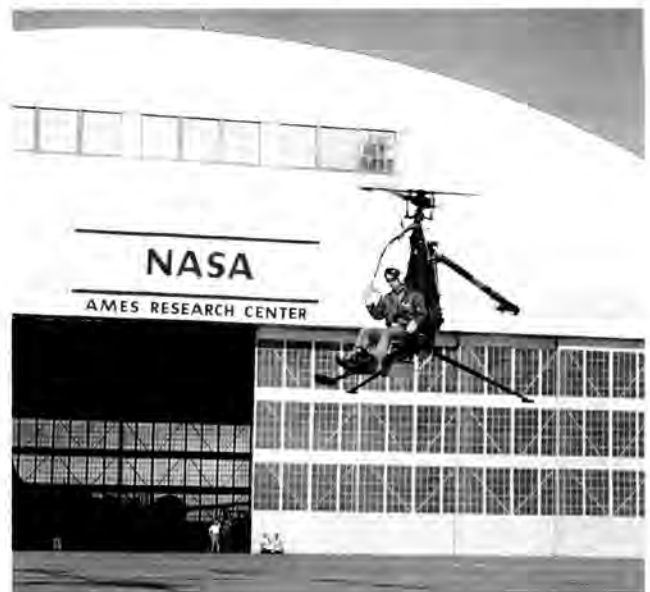
*The Hiller YRO-1 Rotorcycle (June 1963).*

Figure 54. The handling qualities of the Hiller Rotorcycle were evaluated. The Rotorcycle was a small, 500-pound, single-place helicopter. Tests indicated that the vehicle was unsafe because of low yaw-control capability to the right; the design also had poor crashworthiness. (Sept. 1963) A-31028

As previously noted, in studying handling-qualities requirements questions remained regarding the effect of aircraft size and weight on the pilot's judgment of response needs. One of the smallest vehicles flown at Ames was the Hiller YRO-1 Rotorcycle (fig. 54). This one-man helicopter, originally designed for the armed services for rescue and liaison purposes, was small and collapsible so that it could be parachuted to a "downed" pilot. Because of its simplicity, it could be assembled quickly for escape purposes. It was powered by a four-cylinder, two-cycle, 43-horsepower Nelson engine and had a gross weight of 500 pounds. Evaluations were made of its pitch, roll, and directional characteristics in hover close to the ground.

In general, the vehicle had very unsatisfactory control characteristics and would not have been suitable even for a quick, short hop back to friendly territory. Lateral control response was different for left and right control inputs and undesirable roll-pitch cross-coupling accompanied abrupt control inputs. Directional control was too sensitive in hover and was considered dangerous for general use. It was easy to lose all directional control to the left if rotor speed (rpm) was allowed to decay to a low value. Watching a skilled test pilot's attempt to touch down while the vehicle

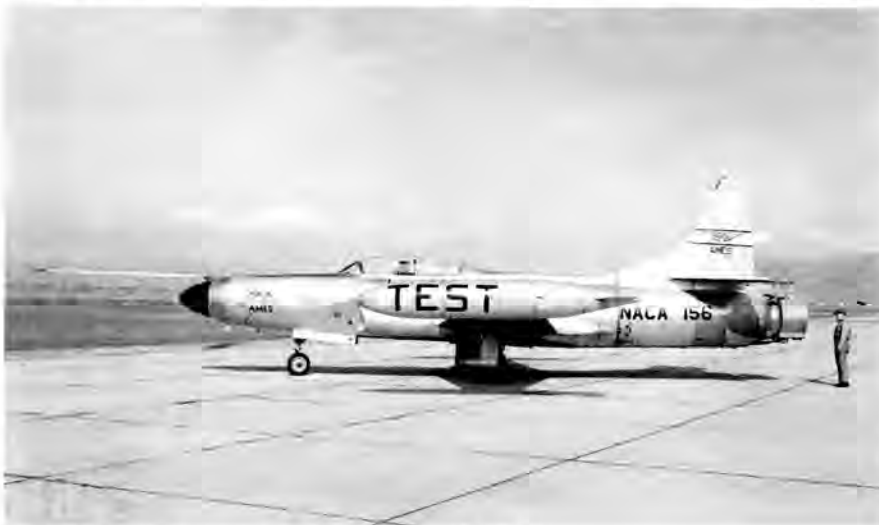
*In-flight thrust reversers on the Lockheed F-94C.*

reverser in detail (figs. 62 and 63) for application to its 707 jet transport as an expeditious way to reduce ground rollout after landing. The Douglas Company was interested in using the device for *in-flight* speed control and for flightpath control in landing approach. It was incorporated for a short time on the engines of the Douglas DC-8 jet transports, but was discontinued after the consequences of inadvertent, asymmetric deployment in flight were examined. A thrust-reverser application was made also on a North American F-100 Super

Sabre fighter. The system was tested in the Ames 40- by 80-Foot Wind Tunnel and in flight by USAF Wright Field personnel. Large pitch trim changes and reverser exhaust heating problems discouraged use of the reverser for fighter aircraft at that time.

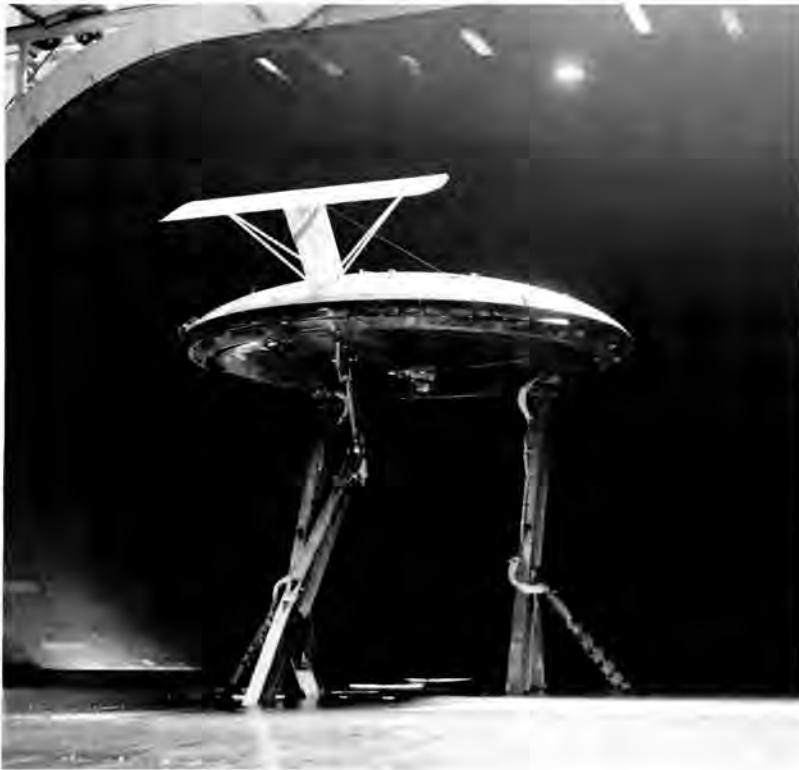
*The VZ-9AV VTOL aircraft (Jan. 1963).*

Vertical lift was obtained from a 5-foot-diameter axial-flow fan mounted in the center of the disk, tip-turbine driven by the exhaust from three J-69 turbojet engines. The total exhaust was ejected downward around the circumference of the disk for vertical lift, and the efflux could be vectored aft for forward acceleration and also to provide roll, yaw, and pitch control (fig. 68). The jet sheet at the rear of the disk induced a large lift component calculated to be able to support the aircraft at a forward speed of 45 mph. Loss of propulsive power, however, would mean that the aircraft would not have control for a "glide" to a safe landing.

Full-scale 40- by 80-foot wind-tunnel tests made at Ames (fig. 69) in the early 1960s obtained aerodynamic force and moment data for the purpose of determining stability, control, and propulsion-system flow characteristics for transition and cruise flight. These tests indicated that the design had serious deficiencies that were far too complex to solve with state-of-the-art technology.

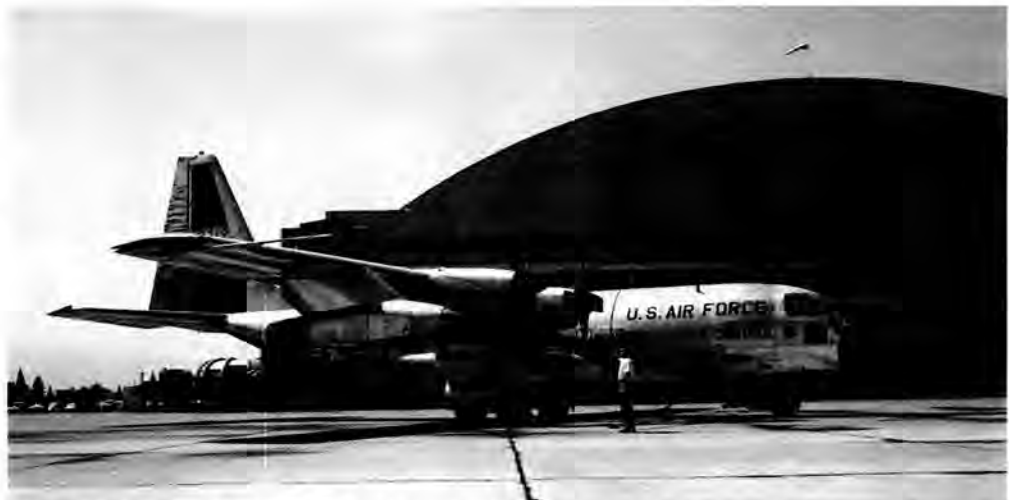
*The Lockheed NC-130B STOL turboprop-powered aircraft in front of the NASA hangar (Sept. 1961).*

A more advanced STOL transport, the Lockheed NC-130B (fig. 71), was thoroughly flight tested by Ames starting in 1962. For high lift, the trailing-edge flaps were deflected 90 degrees and the ailerons drooped 30 degrees. Airflow separation at these large surface deflections was minimized by a blowing-type BLC system which also provided air flow for improved rudder and elevator effectiveness. Two T-56 turboshaft engines driving load compressors mounted on out-board wing pods provided high pressure air for the BLC system.

The gains in landing performance were impressive. Compared with the standard C-130B, minimum approach speed was reduced from 106 knots to 63 knots and the landing distance was cut in half. Although only small gains in takeoff performance were possible in the STOL configuration, takeoff speeds were as low as 61 knots. To decrease takeoff distance, higher thrust-to-weight engines would be required. Wave-off or go-around capability was also unusual

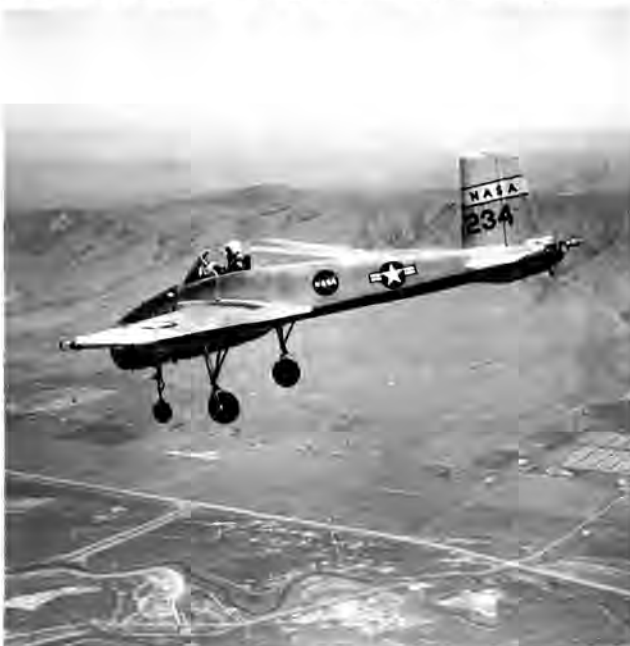
*X-14 in level flight at 4,000 ft.*

Ames’ X-14’s flight research made valuable contributions to the design of future VTOLs. Perhaps the most significant of those contributions was the clarification of roll, pitch, and yaw control-power require-

ments. This included requirements for handling ground-effect disturbances, trim changes in transition flight, and maneuvering. The X-14A was also used to examine unique methods of control in hover and low-speed flight. One was the use of small tip-turbine-driven fans to augment lateral control force for improving roll angular acceleration. Another was a direct side-force lateral maneuvering system using a vane mounted in the engine exhaust (fig. 78). This device eliminated the necessity of rolling the aircraft to achieve a sideward thrust component for translation. Also documented were the requirements for dealing with engine gyroscopic cross-coupling (previously noted), aerodynamic suck-down, and the effects of hot-gas ingestion in hover operation.

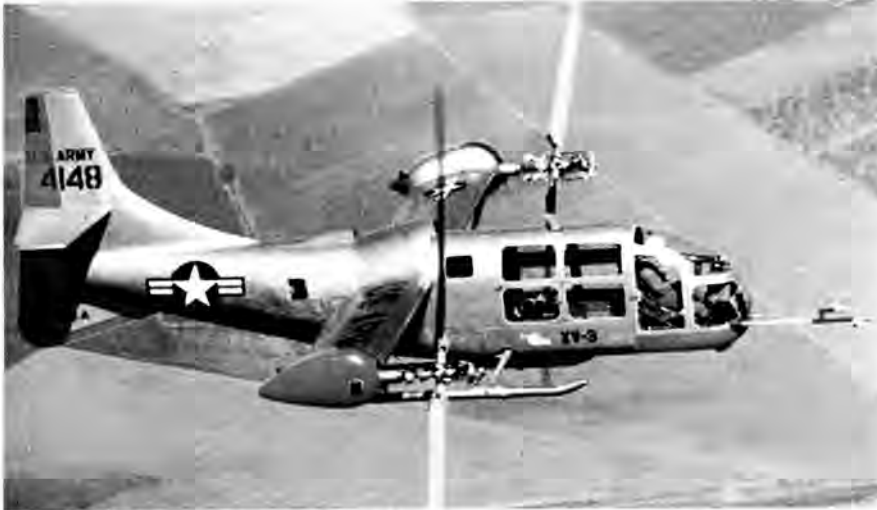
*The Bell XV-3 experimental tilt rotor.*

The Bell Helicopter Company's XV-3 tilt-rotor concept (fig. 84) was unique in that it combined the rotor of a helicopter with the wing of an airplane to obtain VTOL operation. It is also another example of Ames taking a strong lead to find solutions to problems inherent in this VTOL concept. First flown in 1955, it was periodically tested in flight and in the 40- by 80-foot wind tunnel at Ames over an 11-year period.

wide airspeed/angle-of-attack transition corridor, and that it could be flown through transition from conventional to rotorcraft flight with only minor trim changes (fig. 85). However, it had several design deficiencies which limited the operational envelope. First, it was underpowered (it could not hover out of ground effect), had poor cruise flight performance, and needed a more sophisticated control system to improve basic handling qualities. Second, evaluation flights showed that it could not be flown beyond 140 knots because of low-damped pitch and lateral-directional oscillations. This serious design deficiency was not identified in early wind-tunnel tests. Flight tests were required to show the destabilizing effect of the large chord, slow-turning rotors on aeroelastic and dynamic stability associated with high blade-flapping amplitude in airplane cruise mode (fig. 86).

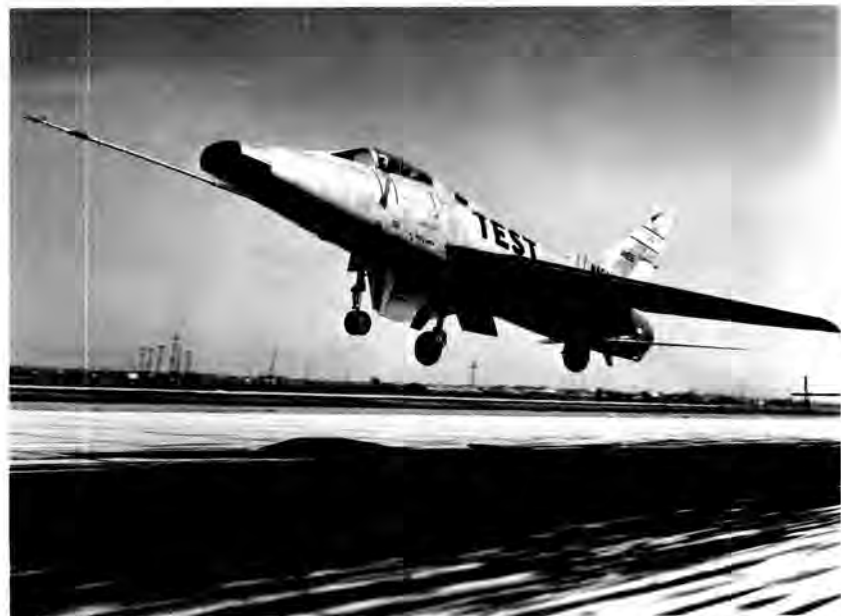
*The North American F-100A Super Sabre.*

With BLC applied to the trailing-edge flaps, increases in flap lift increment of 100% were realized. Landing approach speeds were reduced by about 10 knots, and roll capability at 170 knots was increased 30%. Further reduction in approach speed was limited by pilot ability to control flight-path angle and to arrest sink rate. Another factor was a reduction in engine thrust available to maintain airspeed when maneuvering during low-speed flight. A modification to the engine inlet (fig. 99) was made to improve pressure recovery for test purposes.

Improvements obtained with BLC on the highly deflected leading-edge flap were equally impressive. Compared with the slatted leading edge, stall speed was reduced 9% and landing approach speed decreased 9%. Most important were better handling characteristics consisting of the elimination of objectionable wing buffet, improved stalling characteristics, and elimination of static longitudinal instability in the landing approach. An upper limit on usable angle of attack was apparent from three factors: (1) an adverse pitch change with thrust, (2) sideslip due to roll about the inclined pitch axis, and (3) low directional stability.

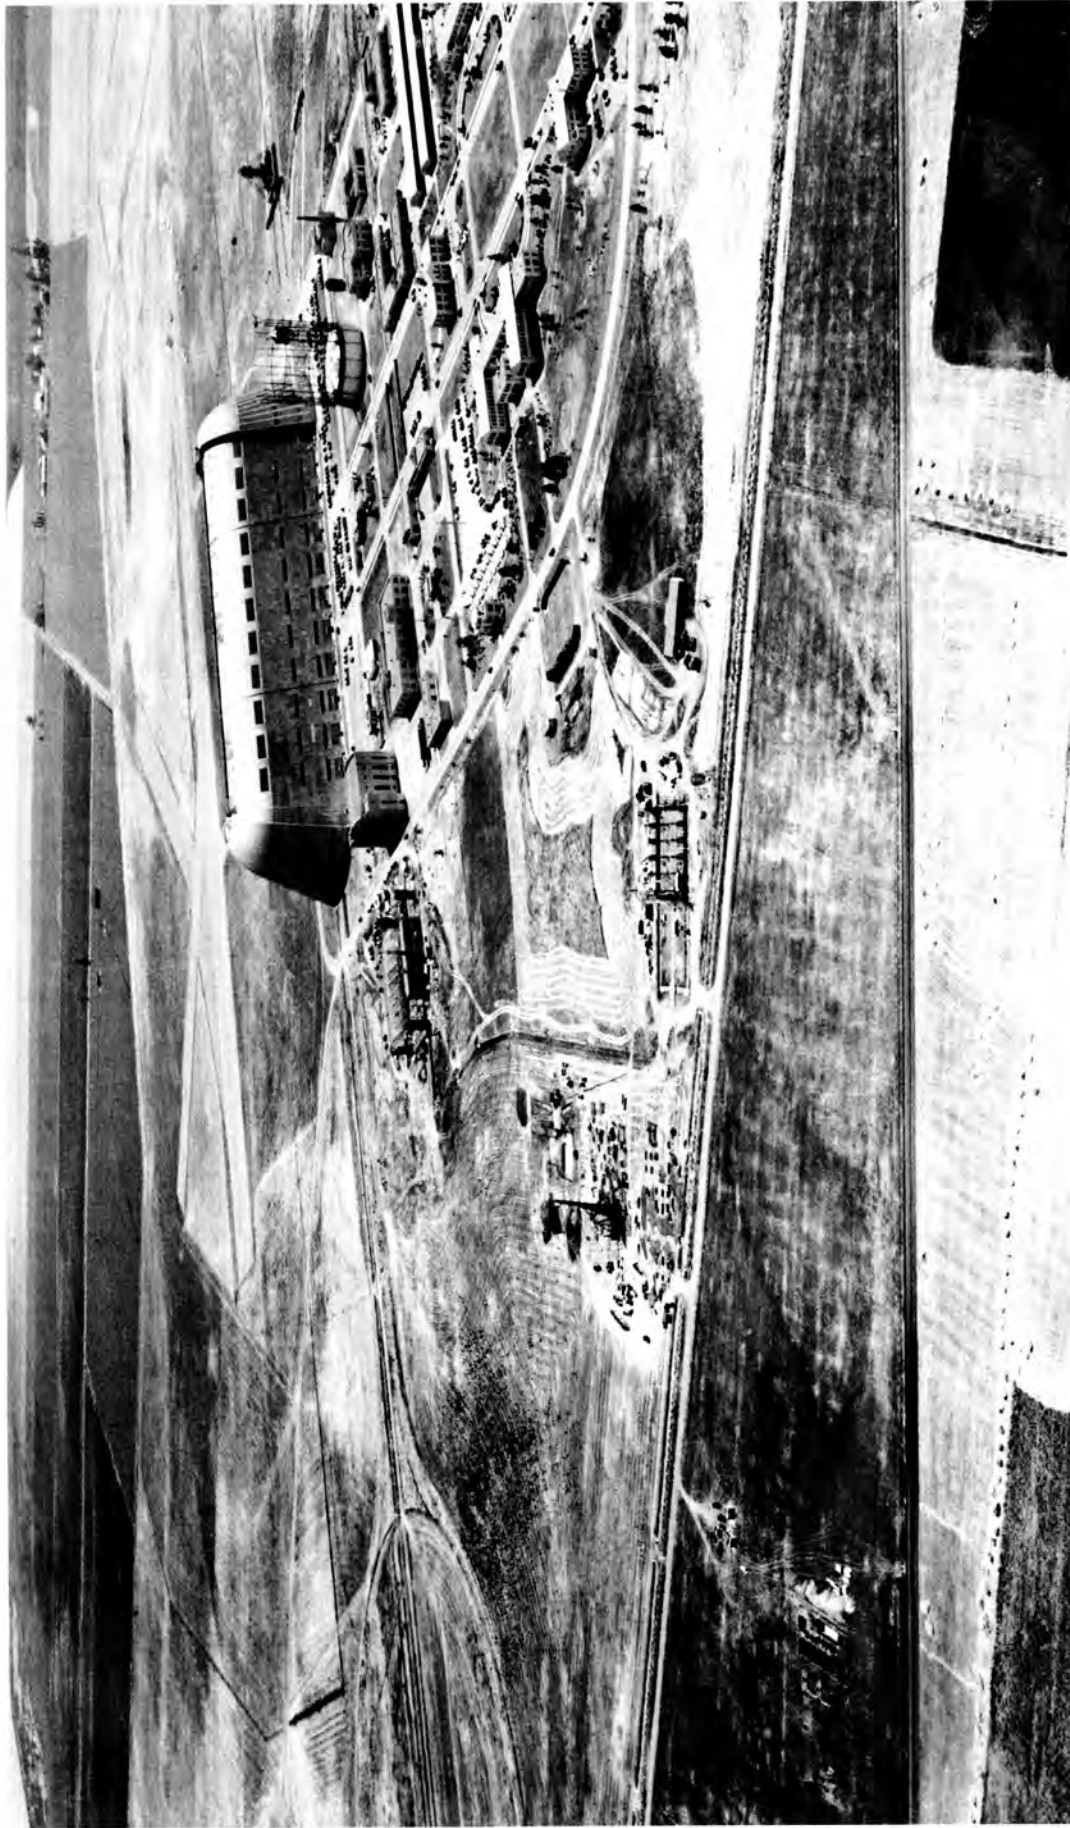
Figure 2. Aerial view looking east shows early construction of the first NACA Ames hangar (building N-210) near the north end of the USS Macon dirigible hangar and directly across from the Navy free-air balloon facility. The long straight road at the middle of the picture bordering the west side of the field is De France Avenue.

A storage tank for helium gas for lighter-than-air vehicles and a mooring mast are at the hangar south end. The metal top of the tank is free to move vertically thus maintaining a constant helium pressure regardless of the gas volume. Dirt runways used by Navy aircraft in the 1930s are visible beyond the top of Hangar 1. (May 1940) 07-320-1E

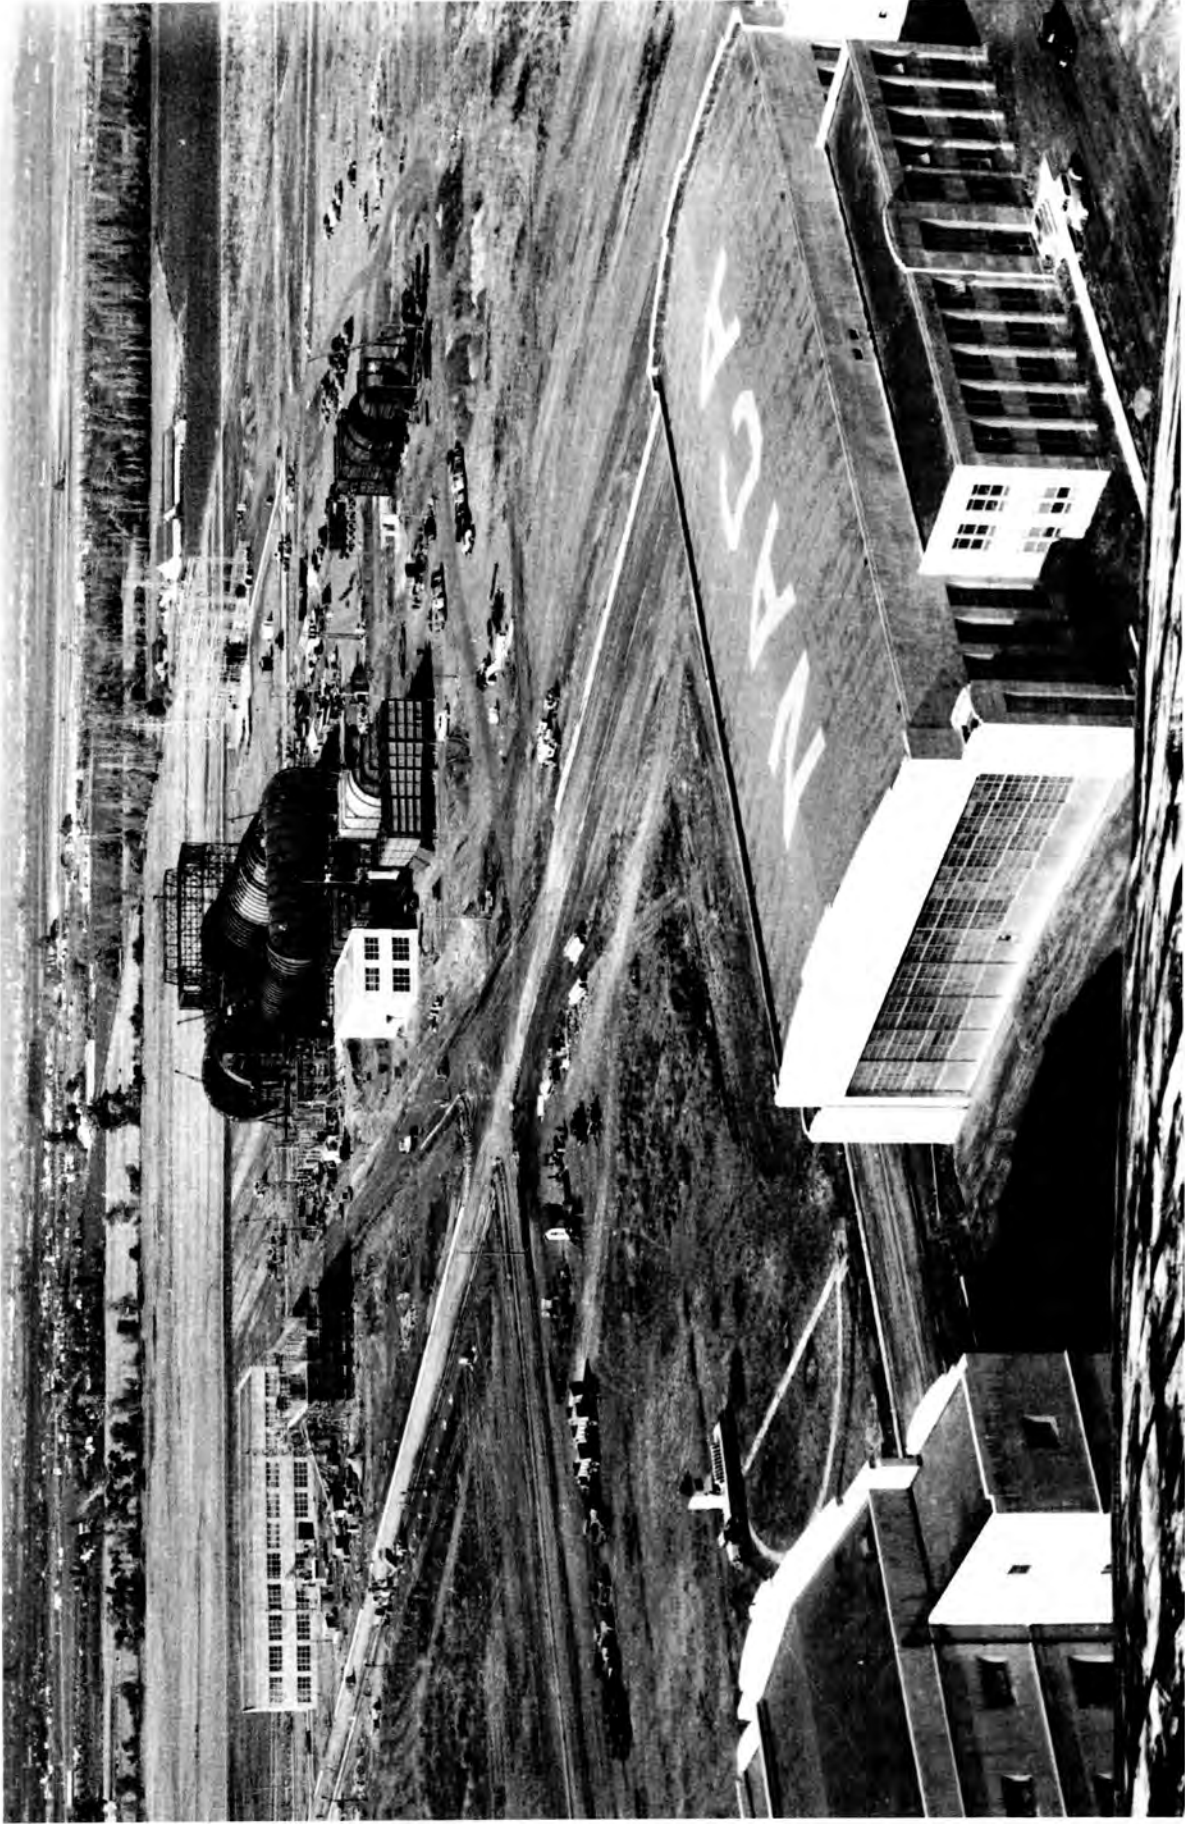
Figure 4. The flight research hangar (building N-210) was completed in September 1940. Rooms for offices are on the east side. The NACA logo on the hangar roof was for aerial recognition. Starting construction of the 7- by 10-foot and 16-foot wind tunnels is in the background. There were only a few cars on unimproved roads. (Oct. 1940) M-921

A 1940 view (fig. 4) shows the layout of the early Ames facilities. The Flight Research building (N-210) is in the immediate foreground with "NACA" painted on the roof for aerial recognition. My office was on the first floor at the far north end. Another view (fig. 5) taken slightly later gives a second perspective of the hangar location. A 1942 photo (fig. 6) taken from the top of the USS *Macon* hangar shows two Sikorsky OS2U-2 aircraft parked in front of the south hangar door of building N-210. Cars were parked on the hangar apron; no one locked car doors, even on weekends. The offices on the east side of the building were for flight research and flight engineering and also served as temporary quarters for all administrative functions, including the office of the engineer in charge, personnel, fiscal, and library. The only other research activity in the building had to do with theoretical aerodynamics.

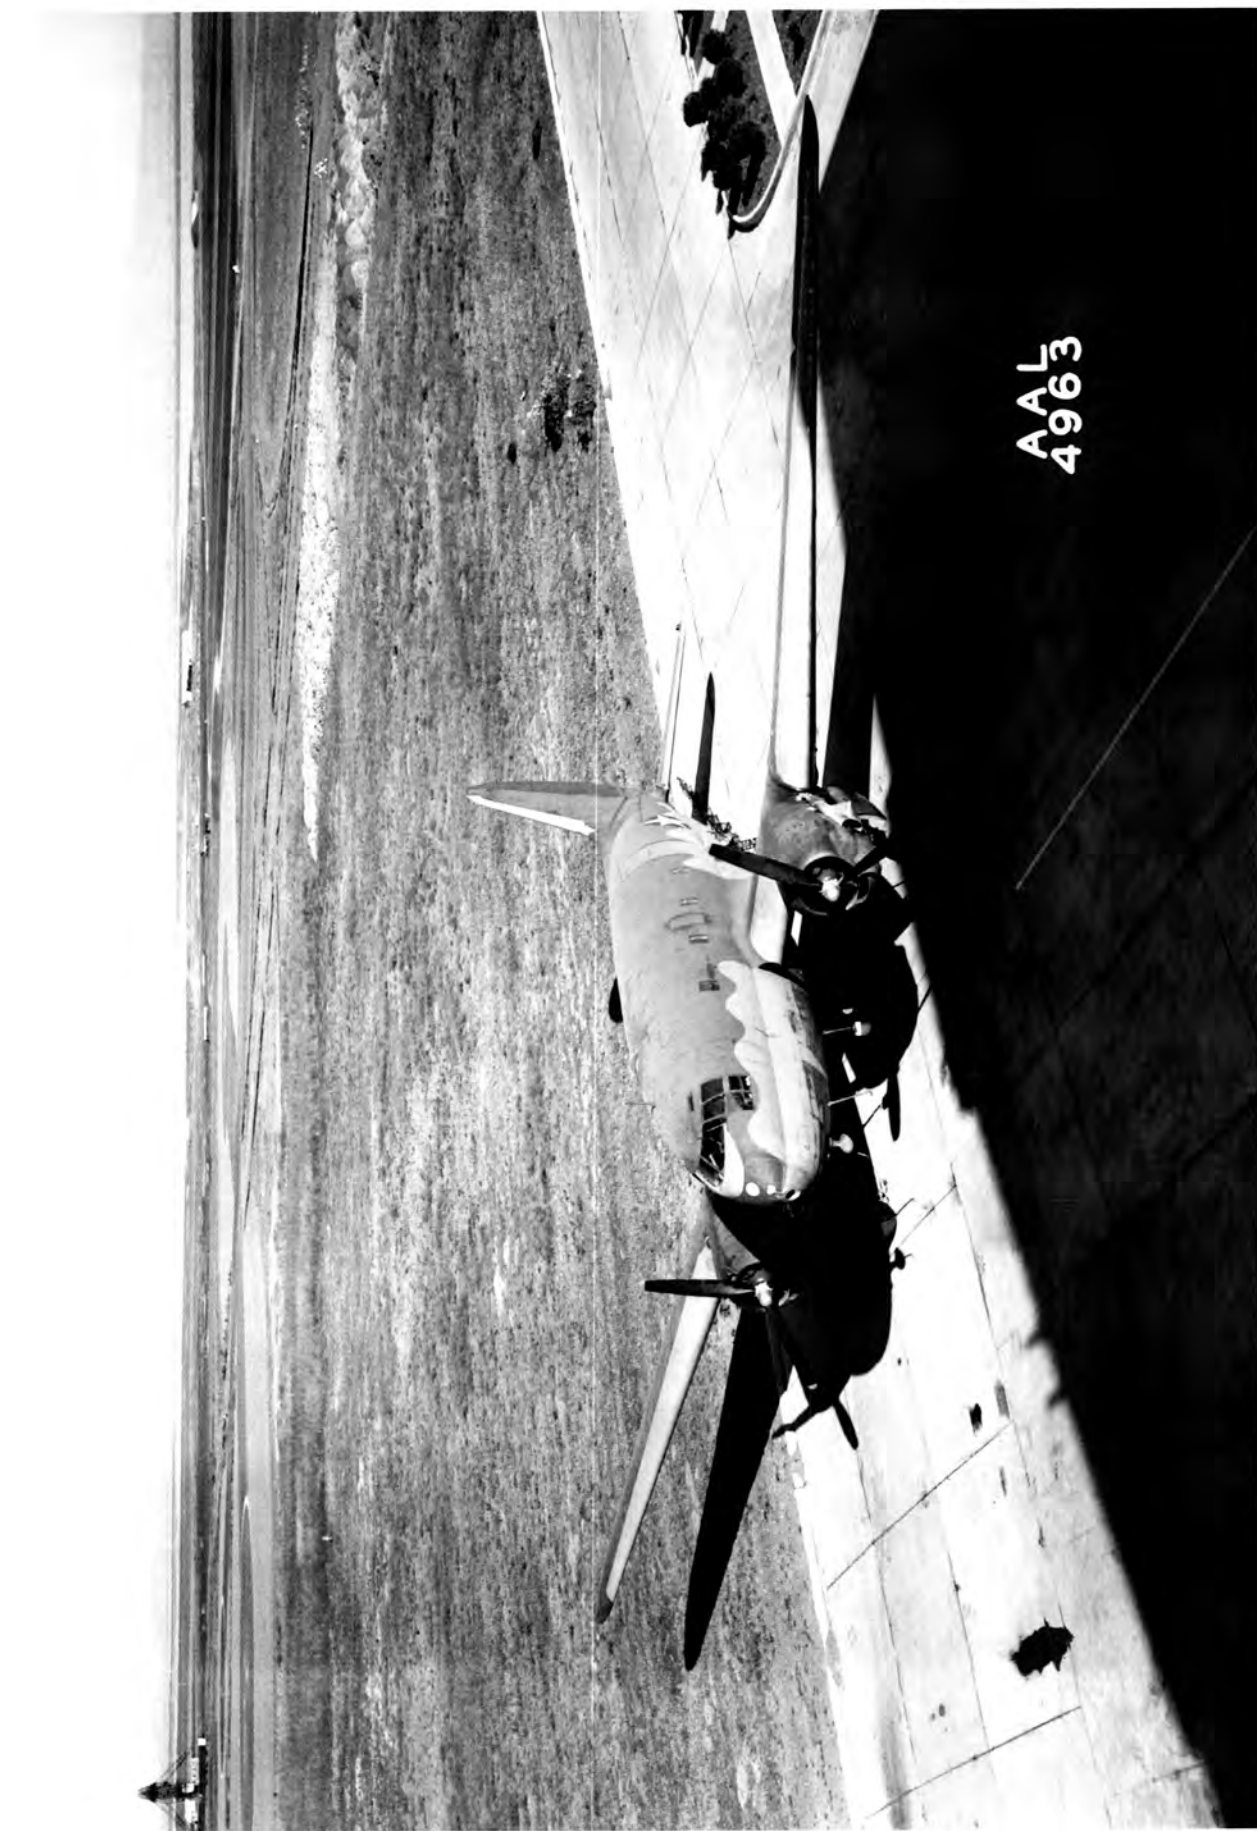
55 Figure 7. A Curtiss C-46A-5 transport, a flying icing-studies laboratory, enters the north end of building N-210. Wide open spaces and the mooring mast for the ill-fated USS Macon dirigible are shown in the upper left. (Mar. 1943) AAL-4963

The wide open spaces are emphasized in the March 1943 view (fig. 7) of a C-46A-5 Curtiss Commando military transport used for icing and limited handling-qualities studies. The wing and tail surfaces were heated by engine exhaust gases for anti-icing. An O-47A aircraft (fig. 8) parked on the unimproved apron on the south side of building N-210, was also used for icing systems research.

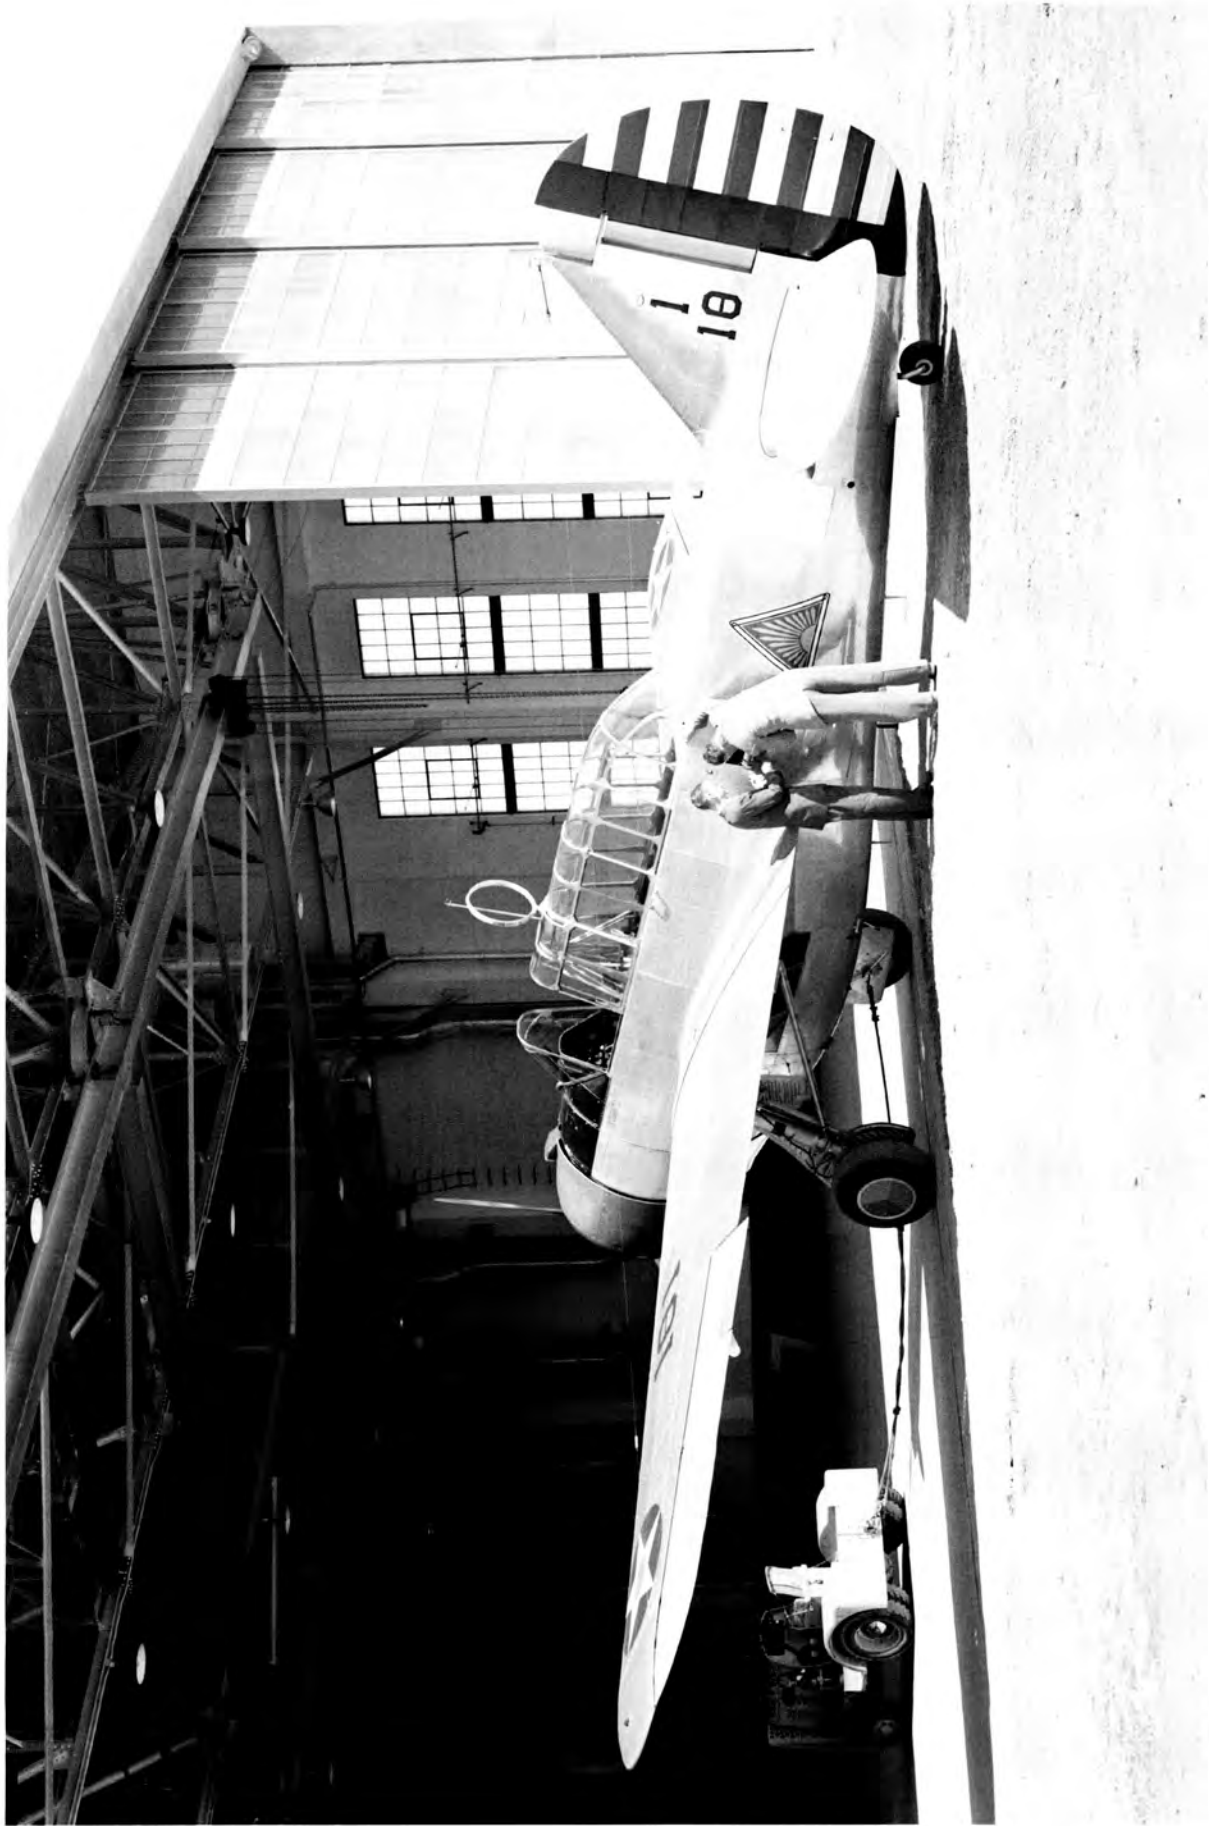
Figure 8. The O-47A aircraft, parked on the yet to be improved south hangar apron, is inspected through the baggage door in preparation for loading instruments. Note that rigid aircraft tow bars were a luxury. (Aug. 1942) M-831

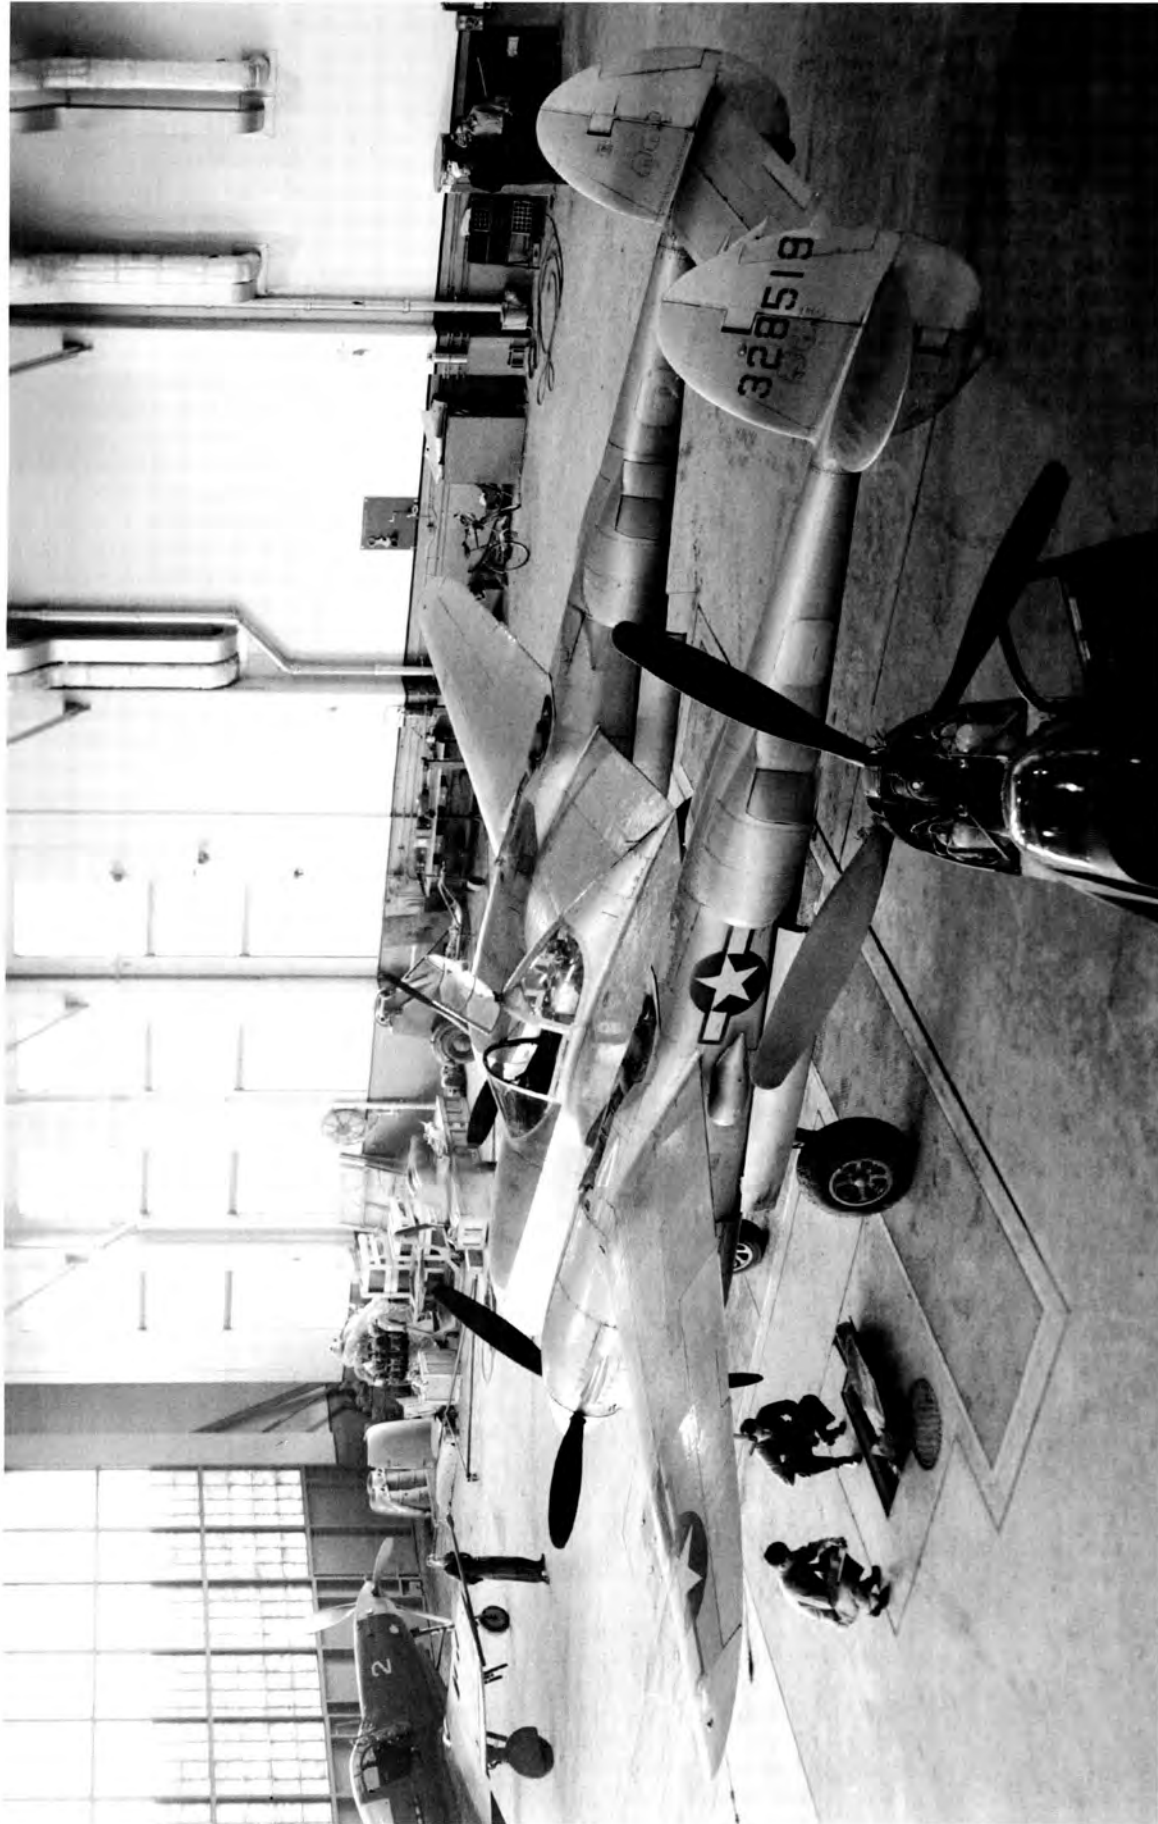
Figure 10. A Lockheed P-38F Lightning fighter is shown on the scales for a weight and balance check. In the background is a Bell P-39 Airacobra with an on-looking "busy" crew chief. A Bell P-63 Kingcobra, used in aileron flutter tests is in the foreground with the "car-type" cockpit door open.

An important item in preparing for flight testing was adjusting aircraft weight and balance. Shown on the scales in figure 10 is a Lockheed P-38F Lightning fighter used in handling-qualities studies. The Bell P-39 Airacobra was involved in load measurements, and a Bell P-63 Kingcobra, in aileron flutter tests. All three test programs were conducted simultaneously because of the urgency to return the aircraft to squadron use.

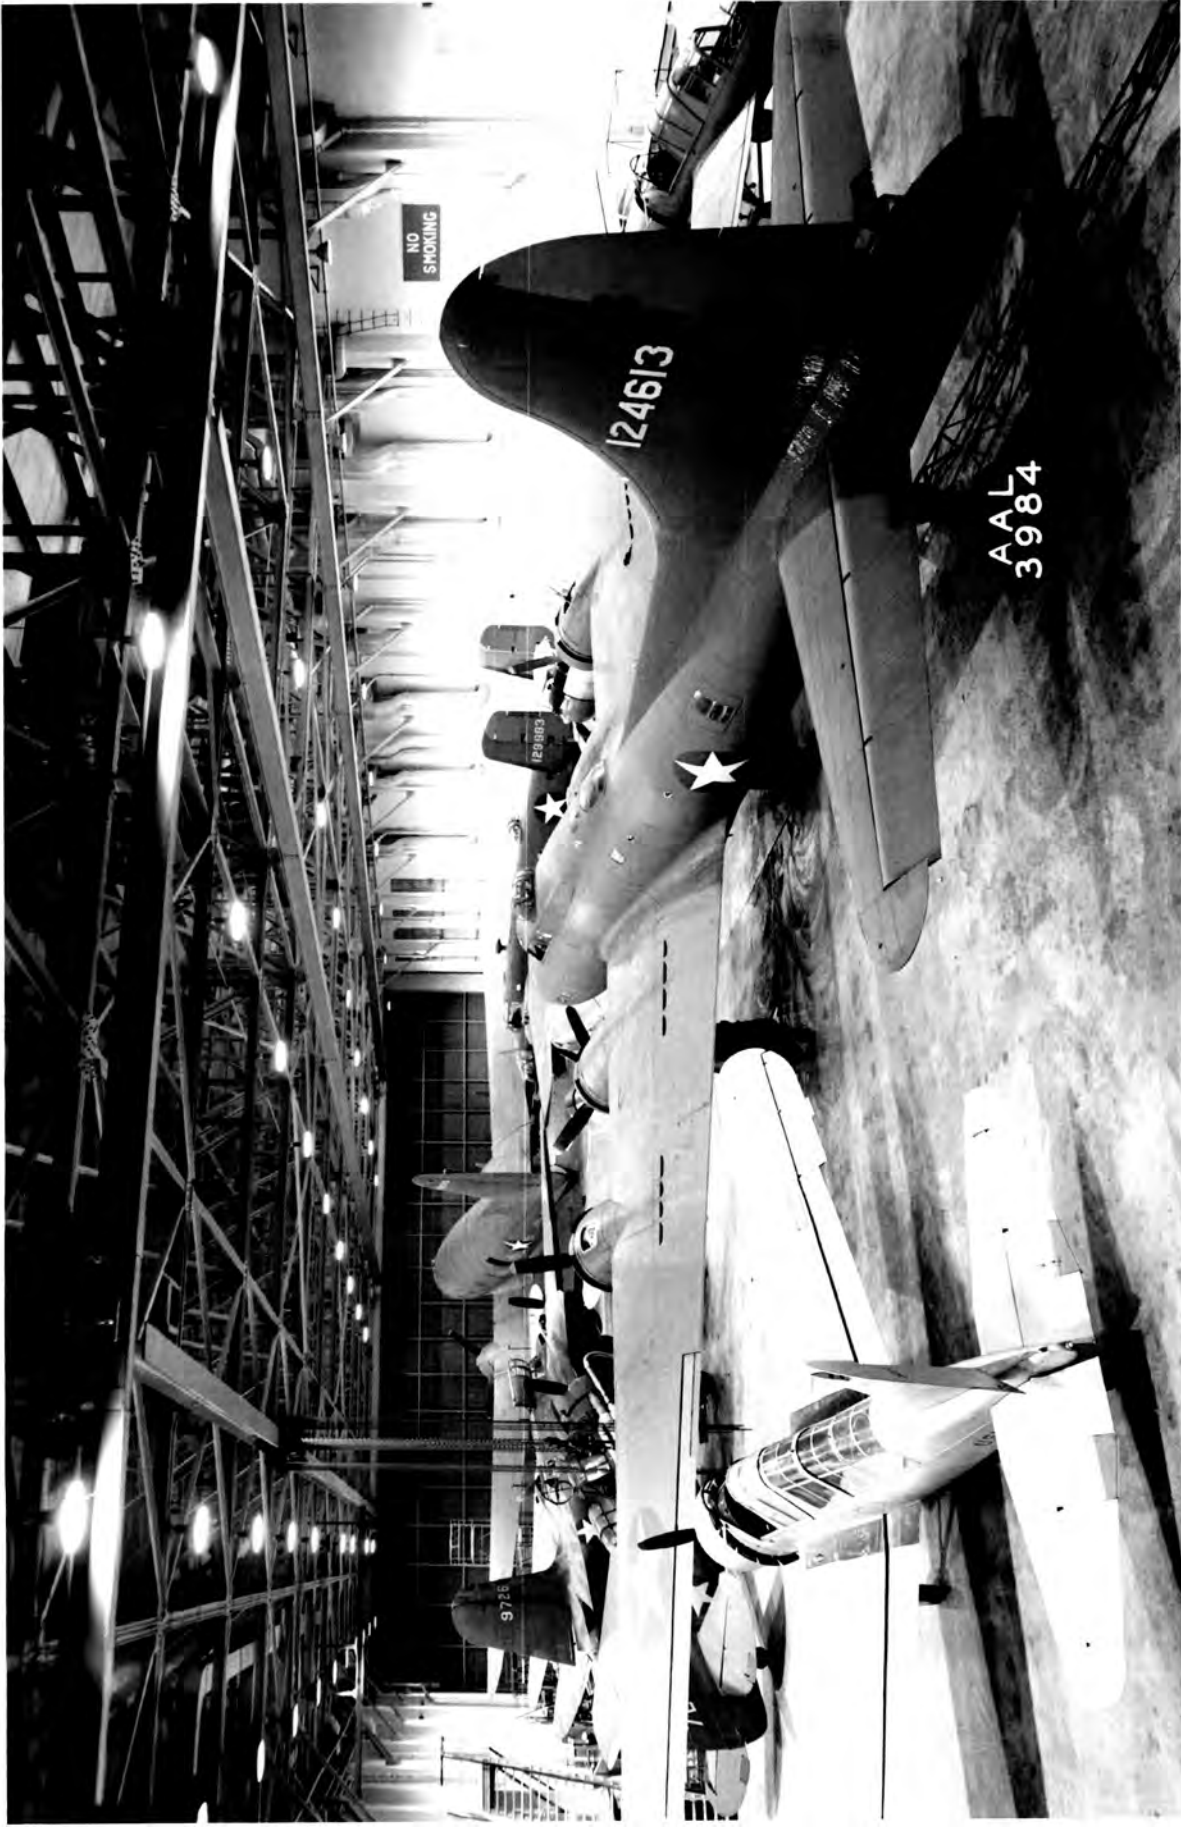
Windows in the doors and walls at the north end provided good interior lighting. (Feb. 1945) A-7116
