NASA/SP-2002-4526

# ***MEMOIRS OF AN AERONAUTICAL ENGINEER***

**Flight Tests at Ames Research Center:  
1940-1970**

**Seth B. Anderson**

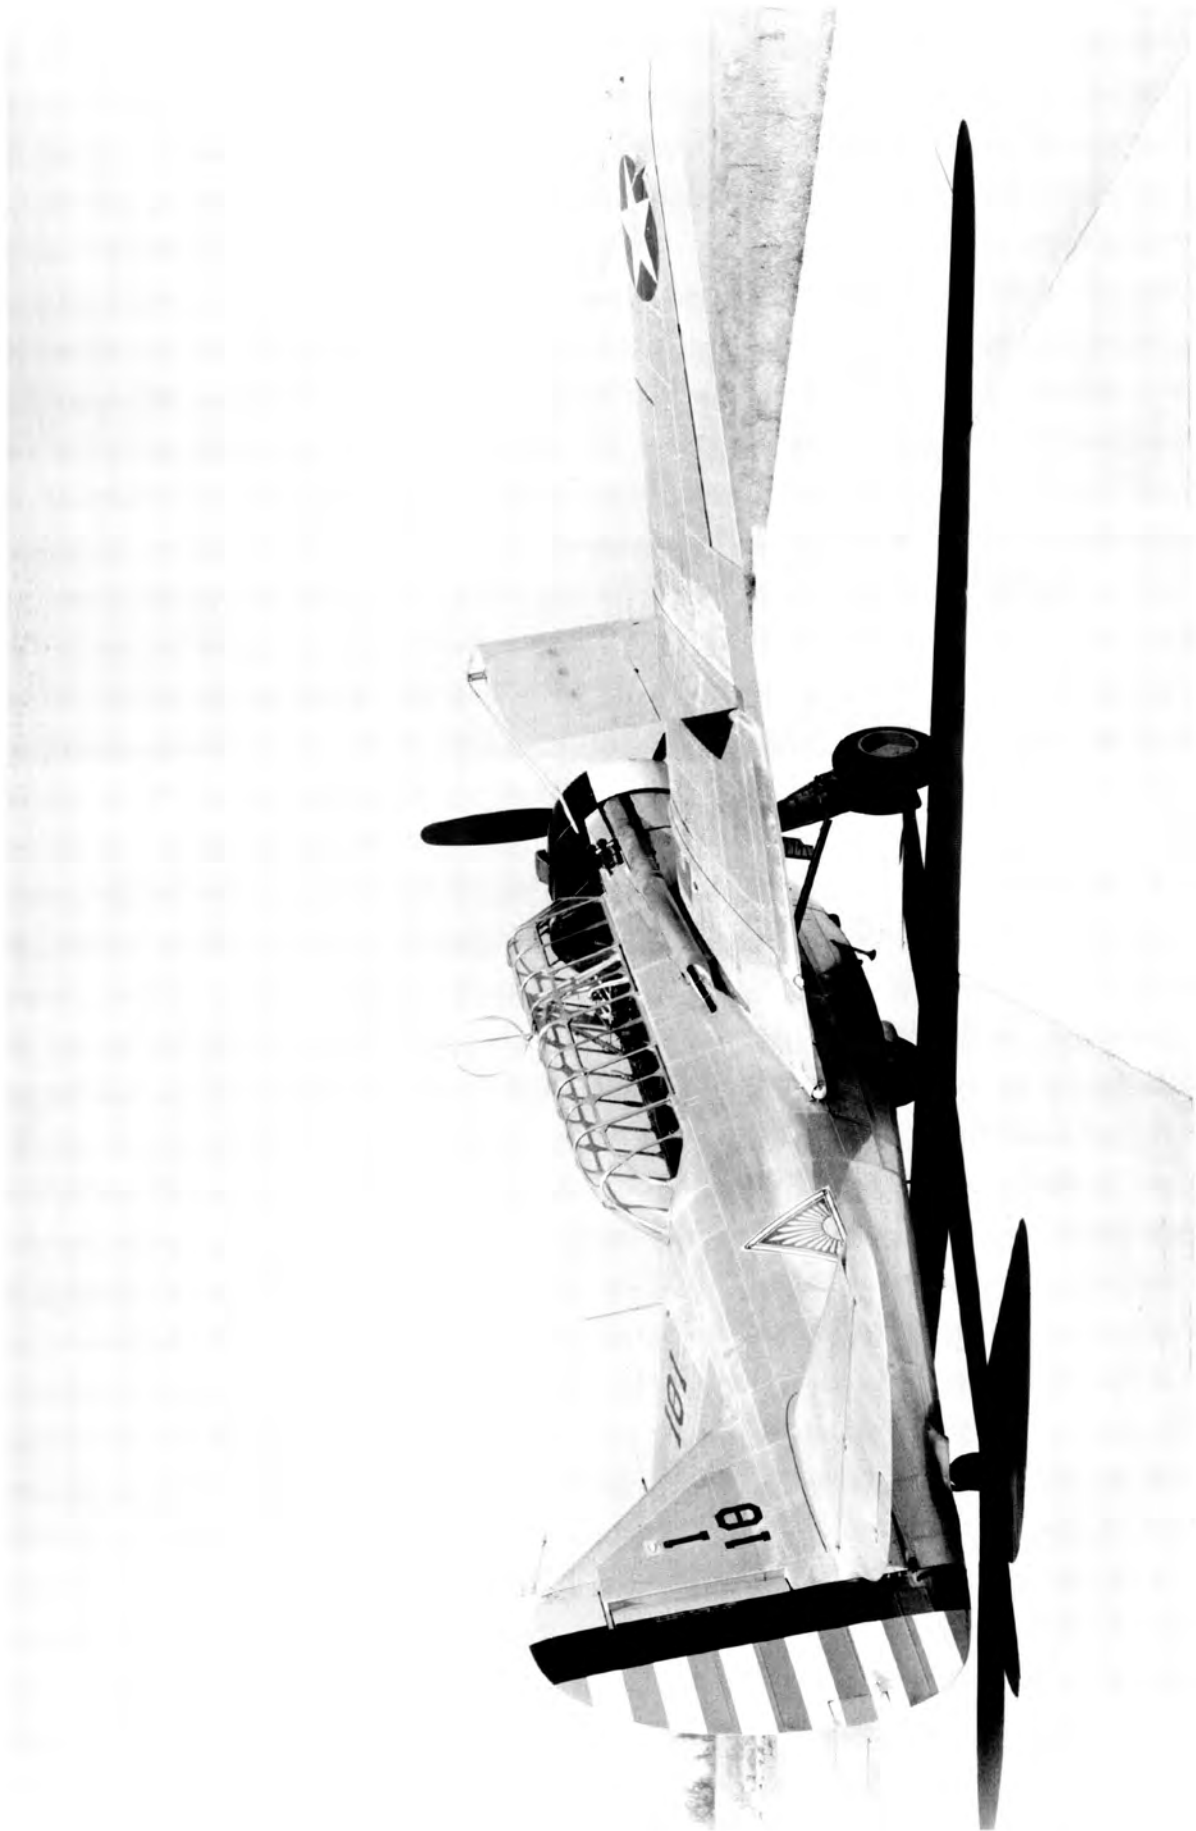
Figure 13. A new three-place North American O-47A observation airplane with Army Air Corps markings was the first aircraft to arrive at Ames. The circular antenna on top of the canopy is for direction finding.

A close look shows that help from the front cockpit was needed for directional control when using a rope (instead of a tow bar) to tow the aircraft. (Sept. 1940) M-925

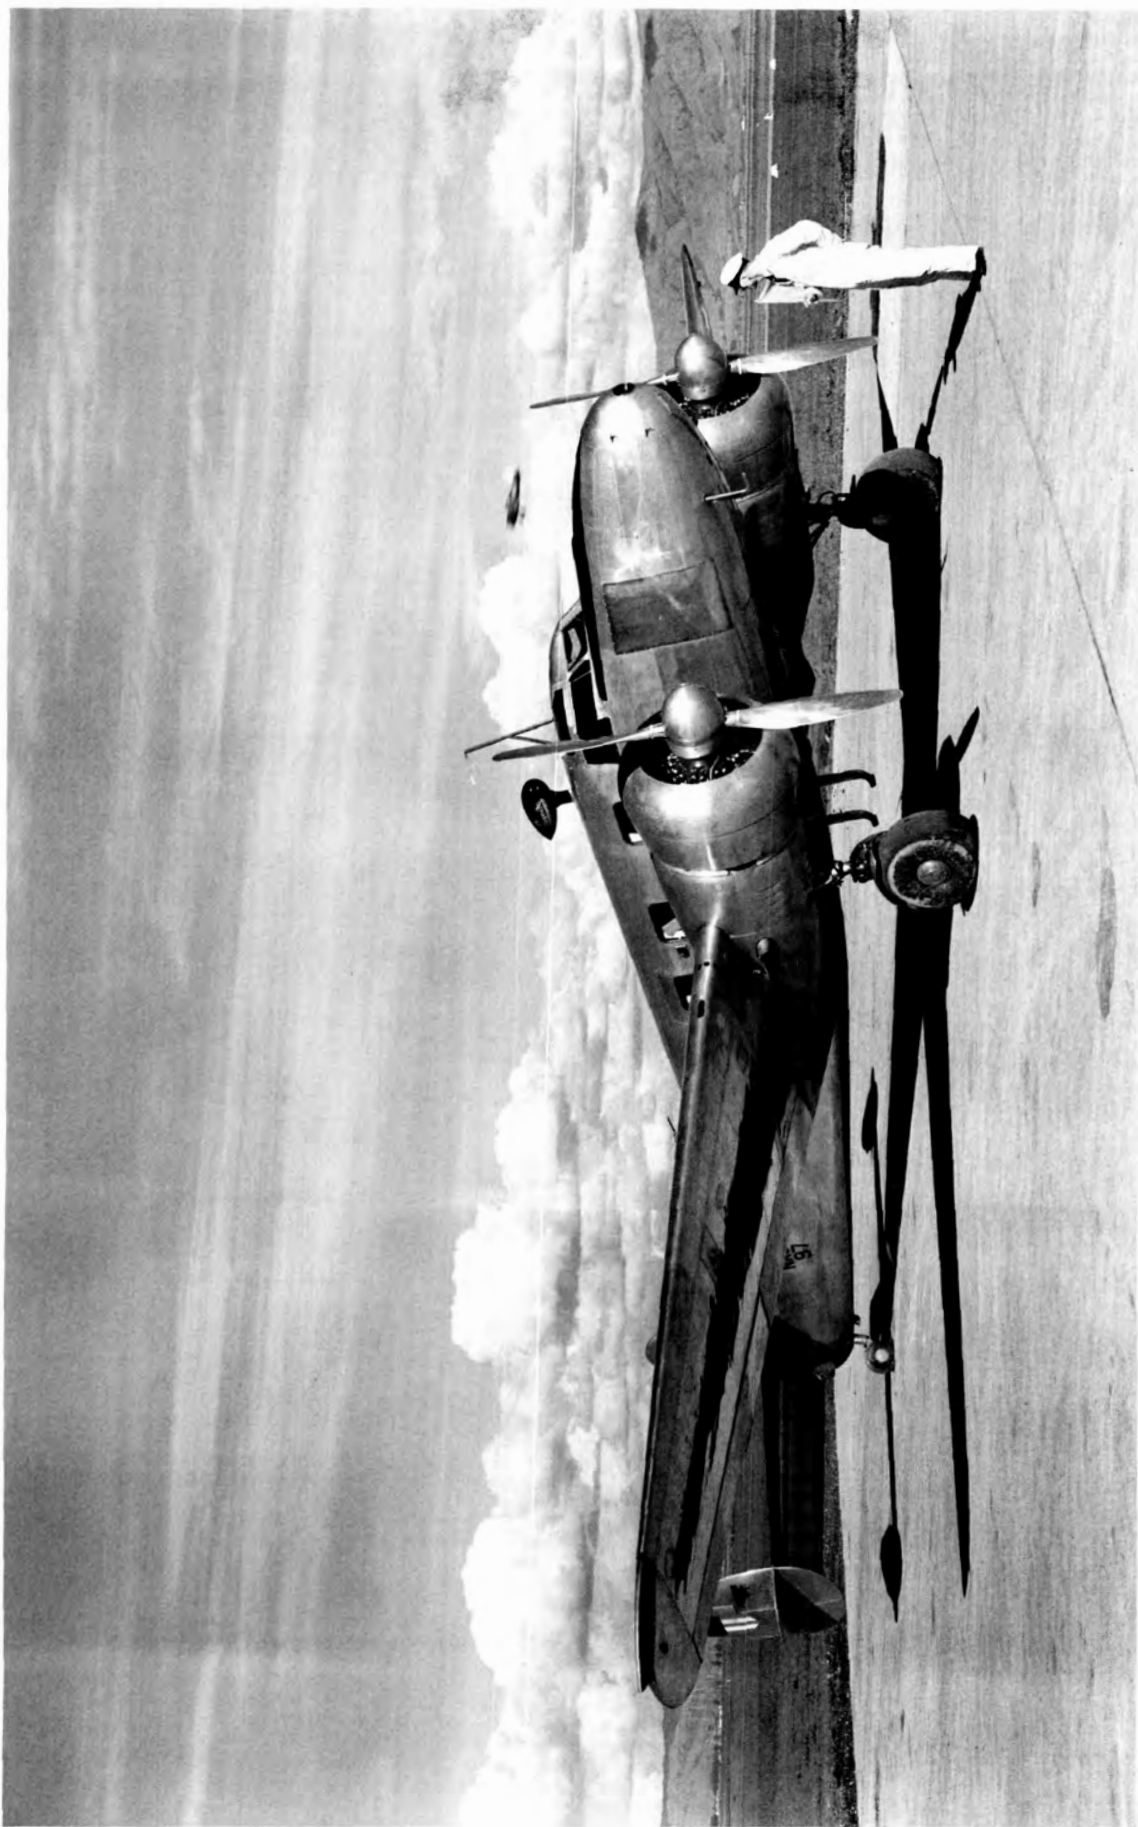
Figure 15. The Lockheed 12A powered by Pratt & Whitney 450-horsepower engines. This aircraft was flown in very severe icing conditions after modification by the Lockheed Company to provide hot air deicing for the wings. An instrumented third vertical tail (barely visible in the photo) was added by Ames to study ice protection for this part of the aircraft.

The second aircraft tested early in 1941 was a Lockheed 12A Electra which had been modified by Lockheed for use in conducting icing research in detail (fig. 15). Engine exhaust pipes, running through the wings' leading edges, heated the wing skin to prevent the formation of ice. The aircraft was flown into the most severe known icing conditions in tests that proved the feasibility of the exhaust heat method. This icing project was unique in that this was the first time a NACA research program was taken into the proof-of-concept stage in order to help solve a major flight operational problem. The thermal ice prevention system won the 1947 Collier Trophy, an annual award commemorating the most important achievement in American aviation. The people in Ames' Flight Engineering Section had demonstrated the value of flight testing in achieving important results.

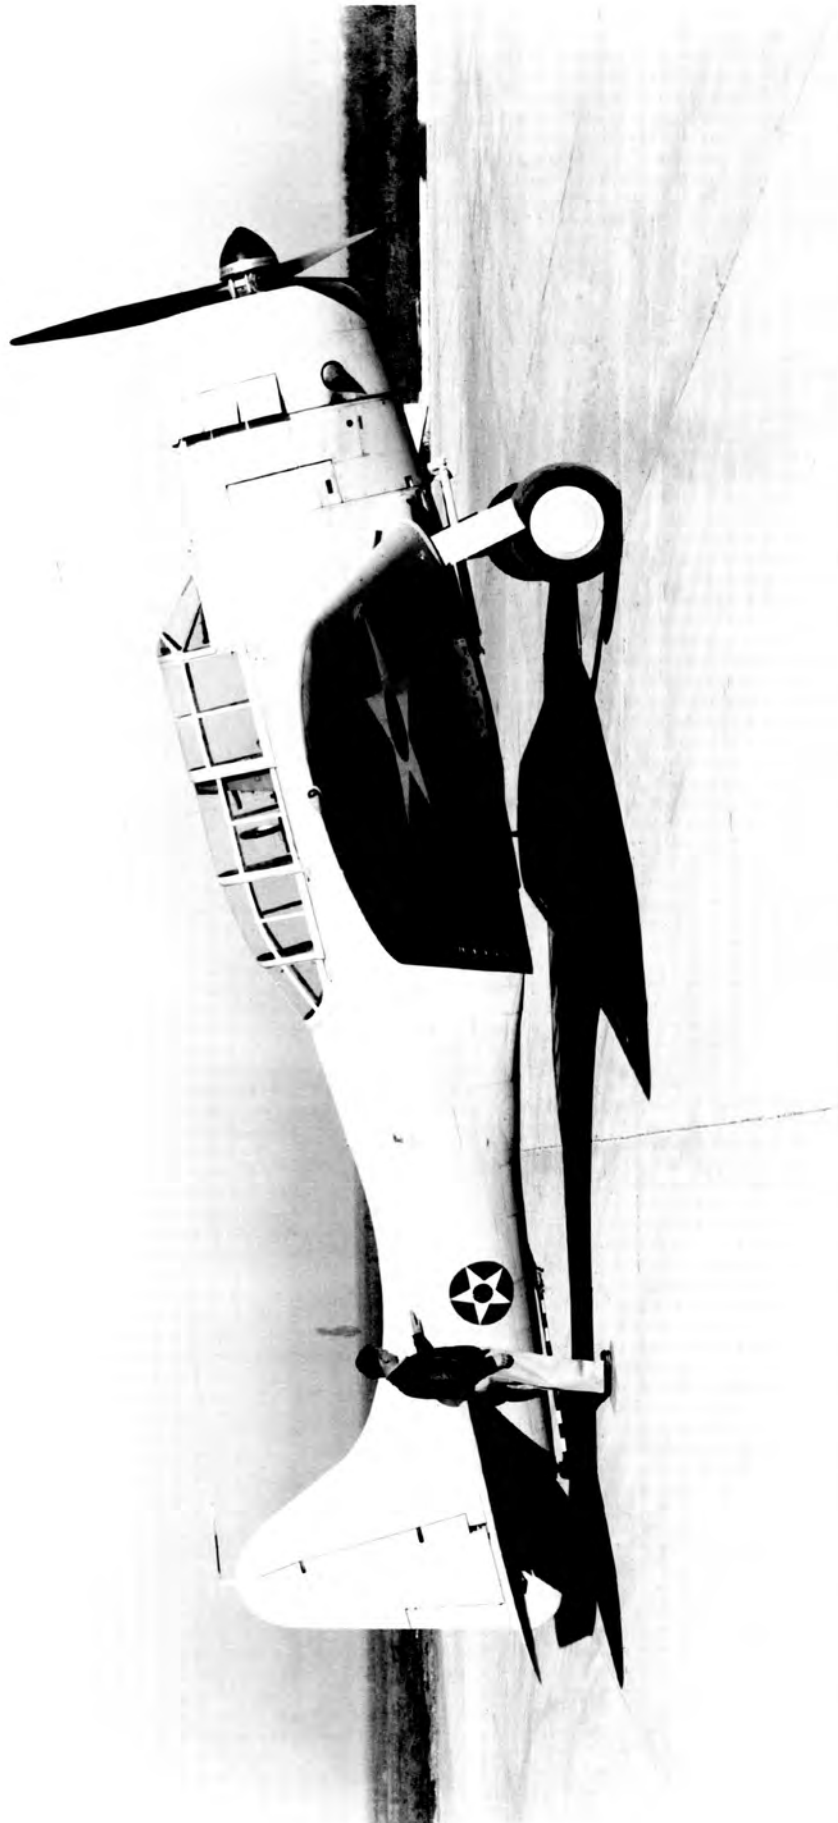
Figure 16. The Douglas SBD-1 Dauntless was the first aircraft used exclusively for handling-qualities research at Ames. This aircraft had low drag and was flown to 400 mph (0.70 Mach) in stability and control tests. (Oct. 1941) AAL-1646

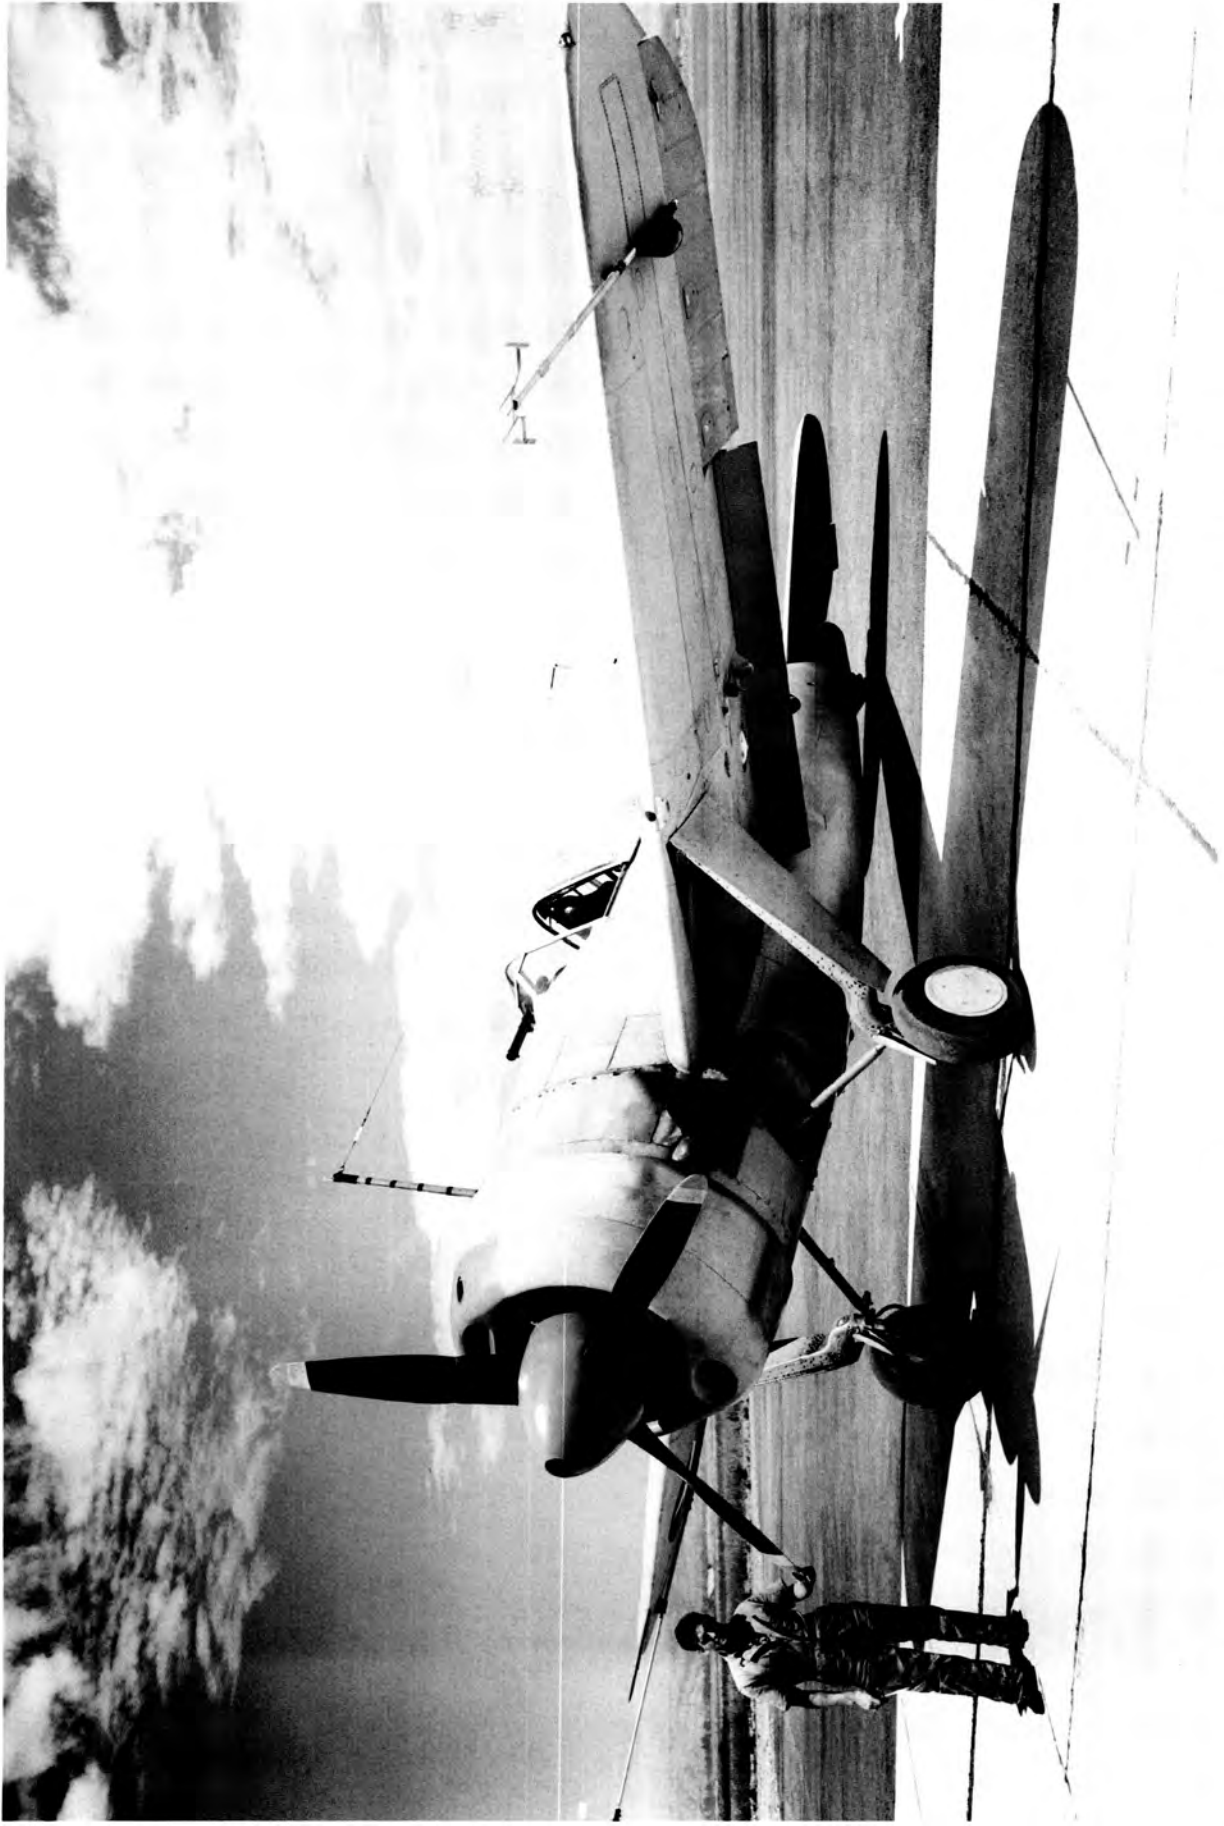
Figure 18. The dorsal fin installed on the P-51 was one of several modifications tested in efforts to improve directional stability in maneuvering flight. This "fix" was retrofitted to all wartime models of the Mustang. (June 1944) AAL-5549

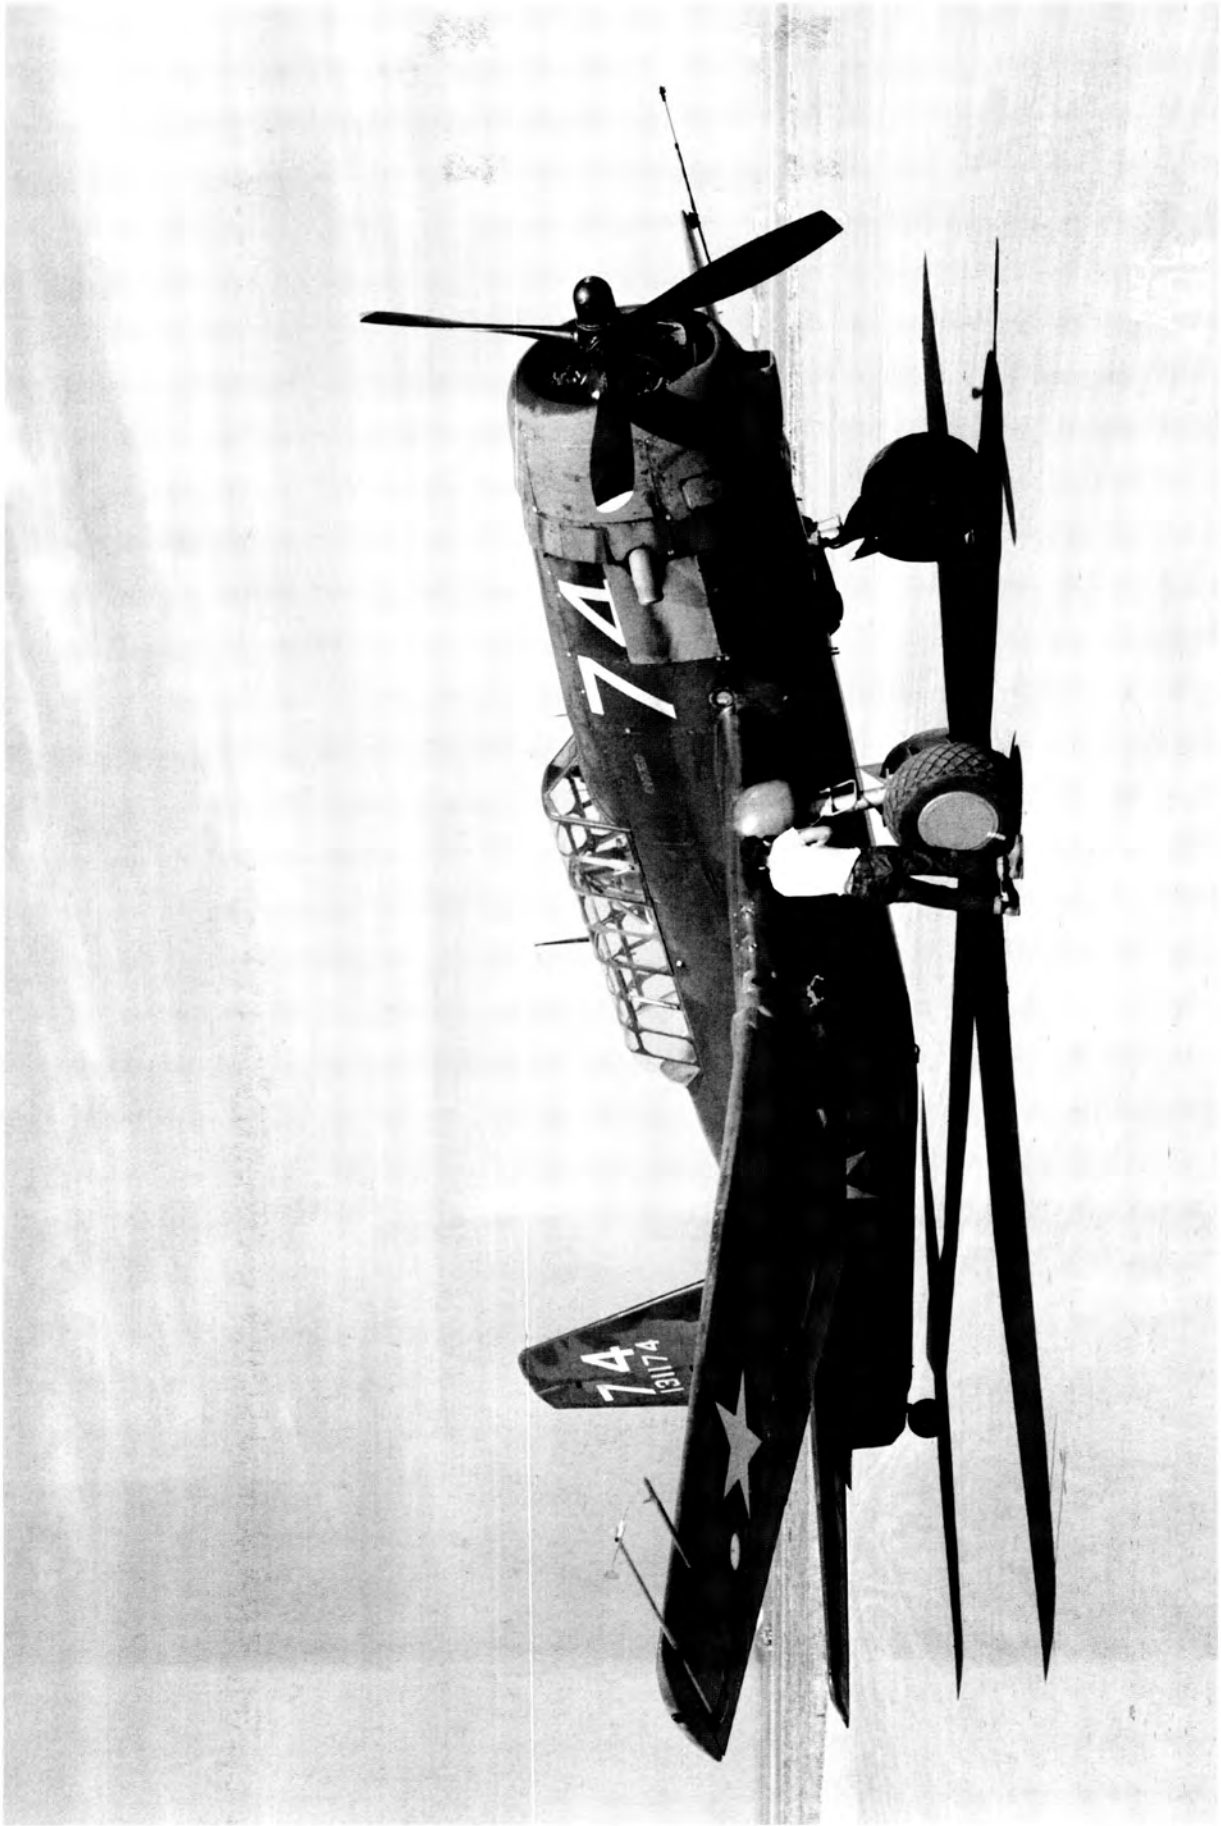
Figure 21. Vultee A-35A Vengeance equipped with research airspeed and yaw vane booms. Short engine exhaust stacks and fuselage proximity resulted in an extremely noisy cockpit with high concentrations of carbon monoxide. (Sept. 1943) AAL-4516

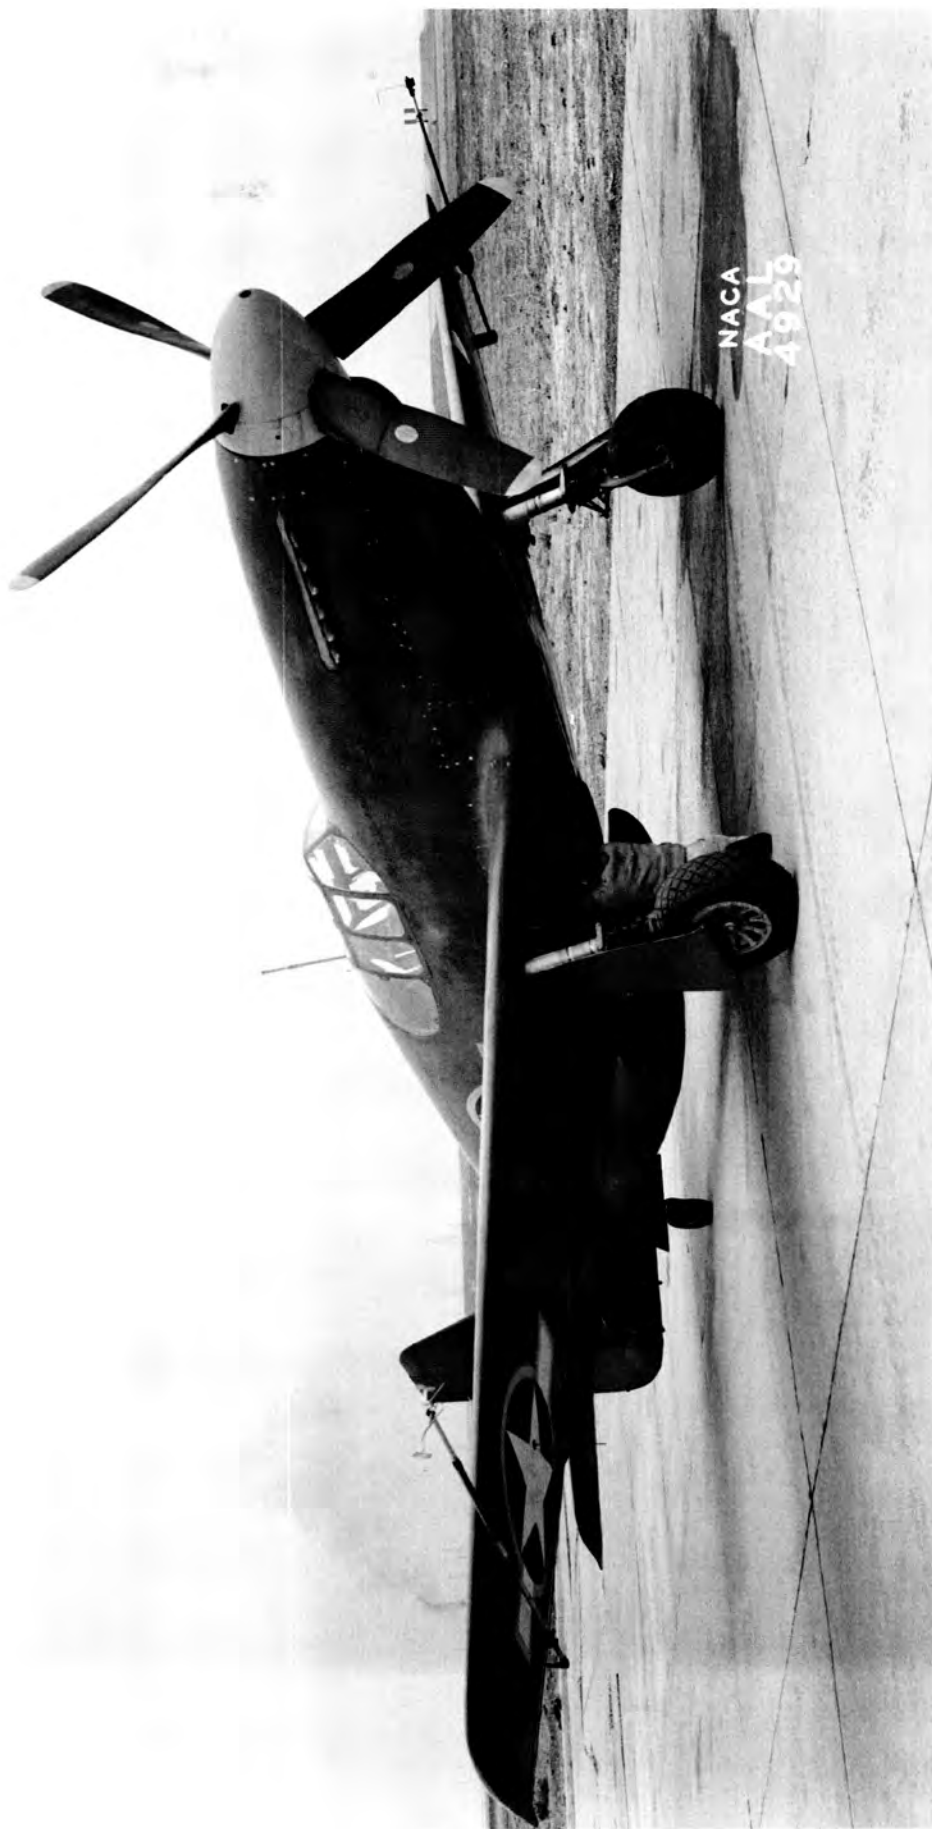
Figure 22. With dive brakes open, the A-35 could dive vertically without exceeding the 300 mph indicated airspeed limit. (Sept. 1943) AAL-4519

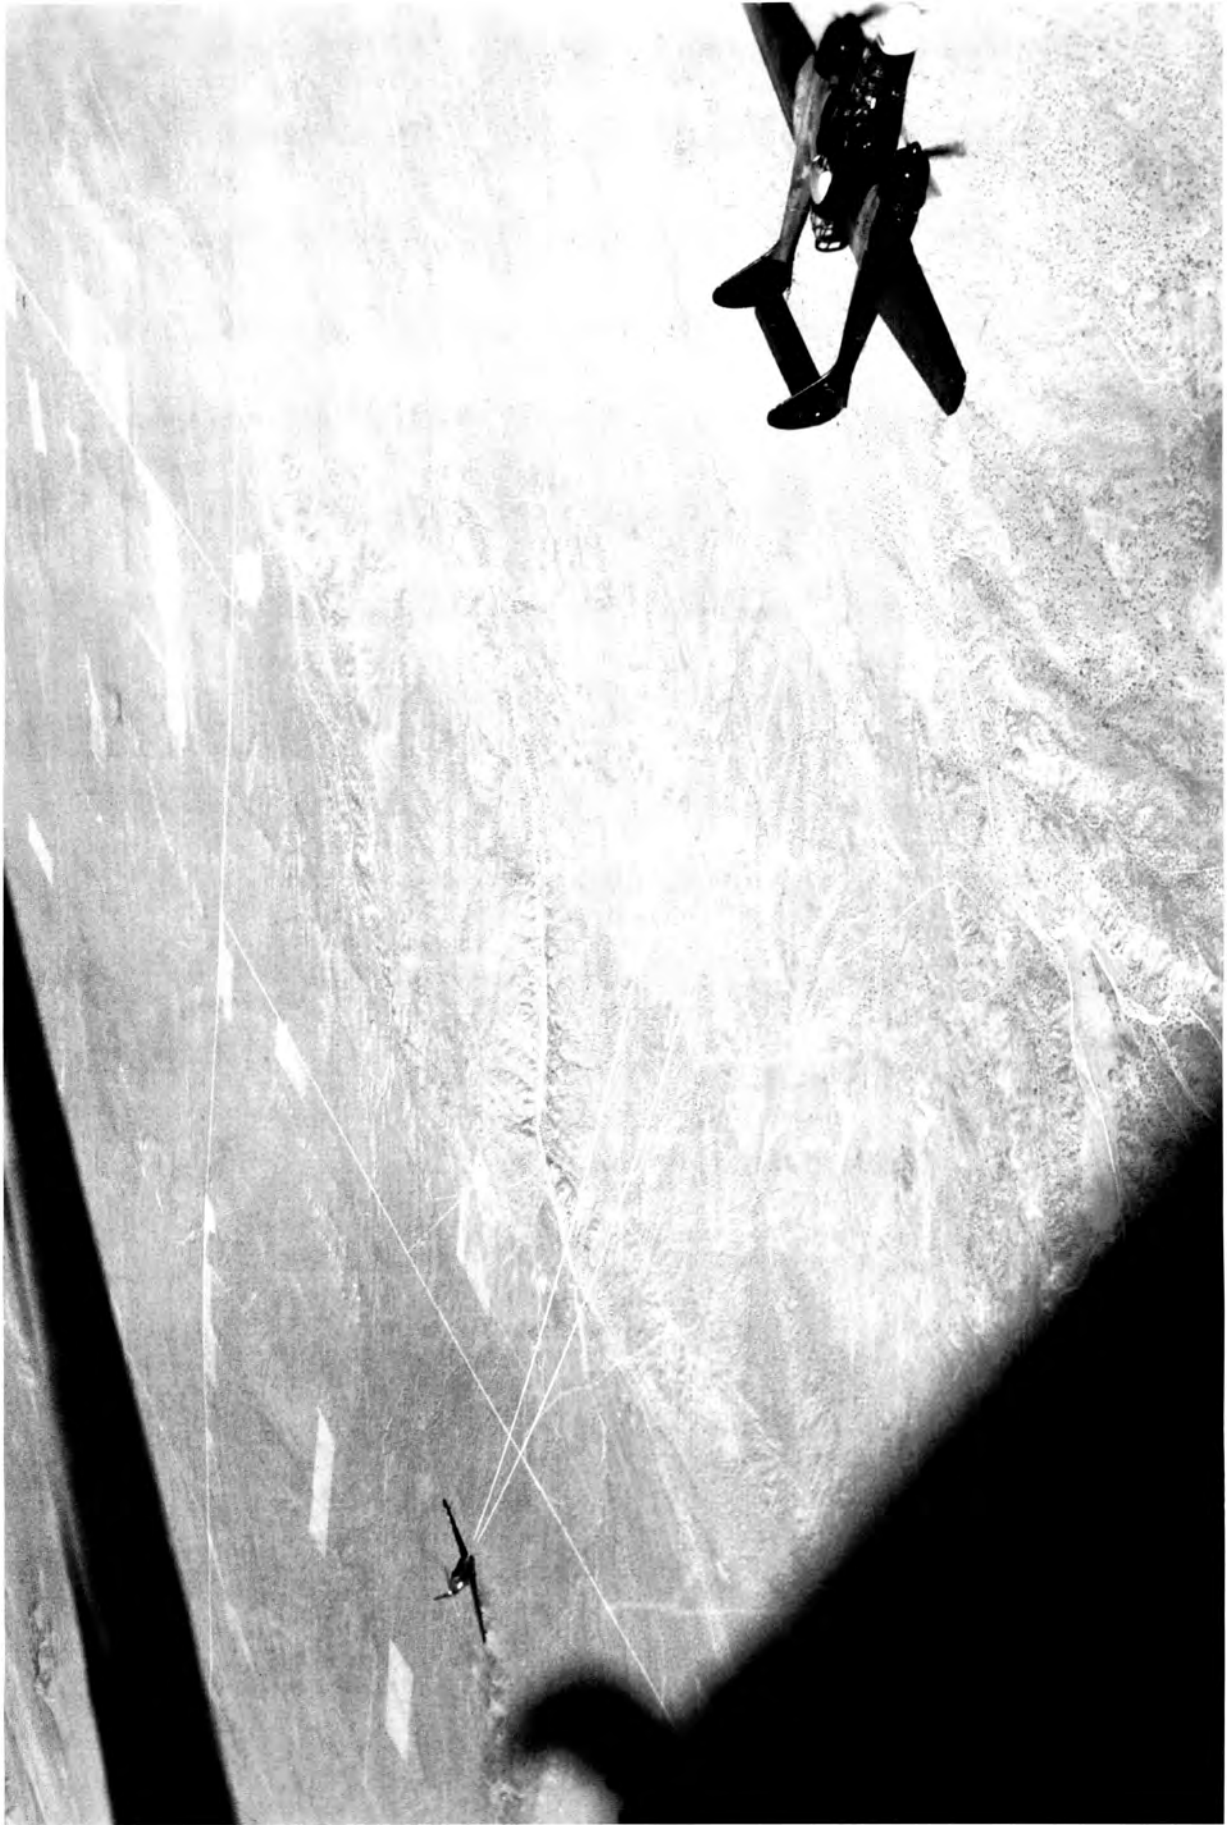
Figure 24. North American P-51B towed to an altitude of 28,000 feet by a Northrop P-61 Black Widow over Muroc Dry Lake, California. After the pilot released the tow cable, drag measurements were obtained at various airspeeds in a 20-minute unpowered flight. (Sept. 1944) A-6538

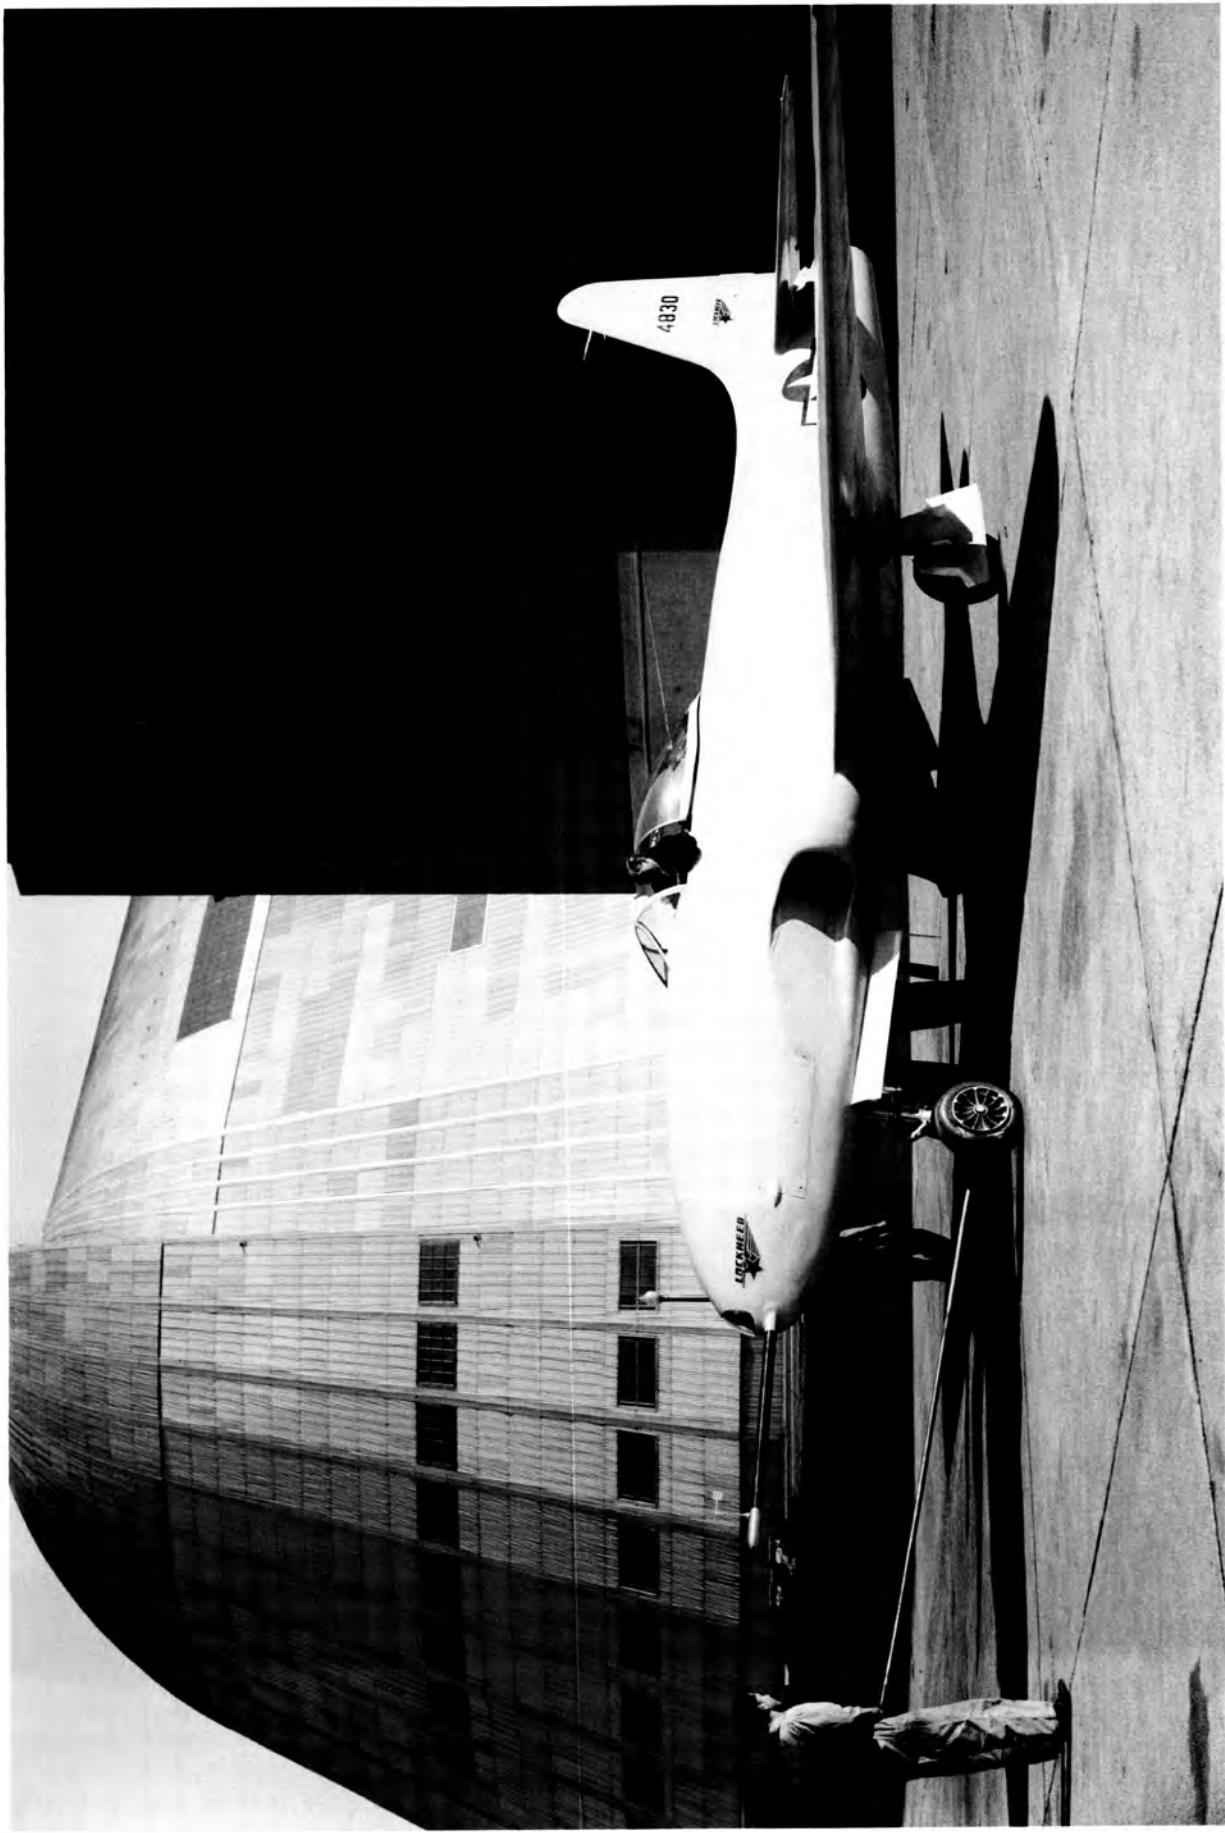
Figure 25. Lockheed YP-80 "secret" airplane pushed out from the south end of building N-210. It arrived in September 1944, and was instrumented in a secured "Blue Room." It was powered by a GE J-33 turbojet engine and was flown to Mach 0.866, a speed record for the time. (1946) A-6776

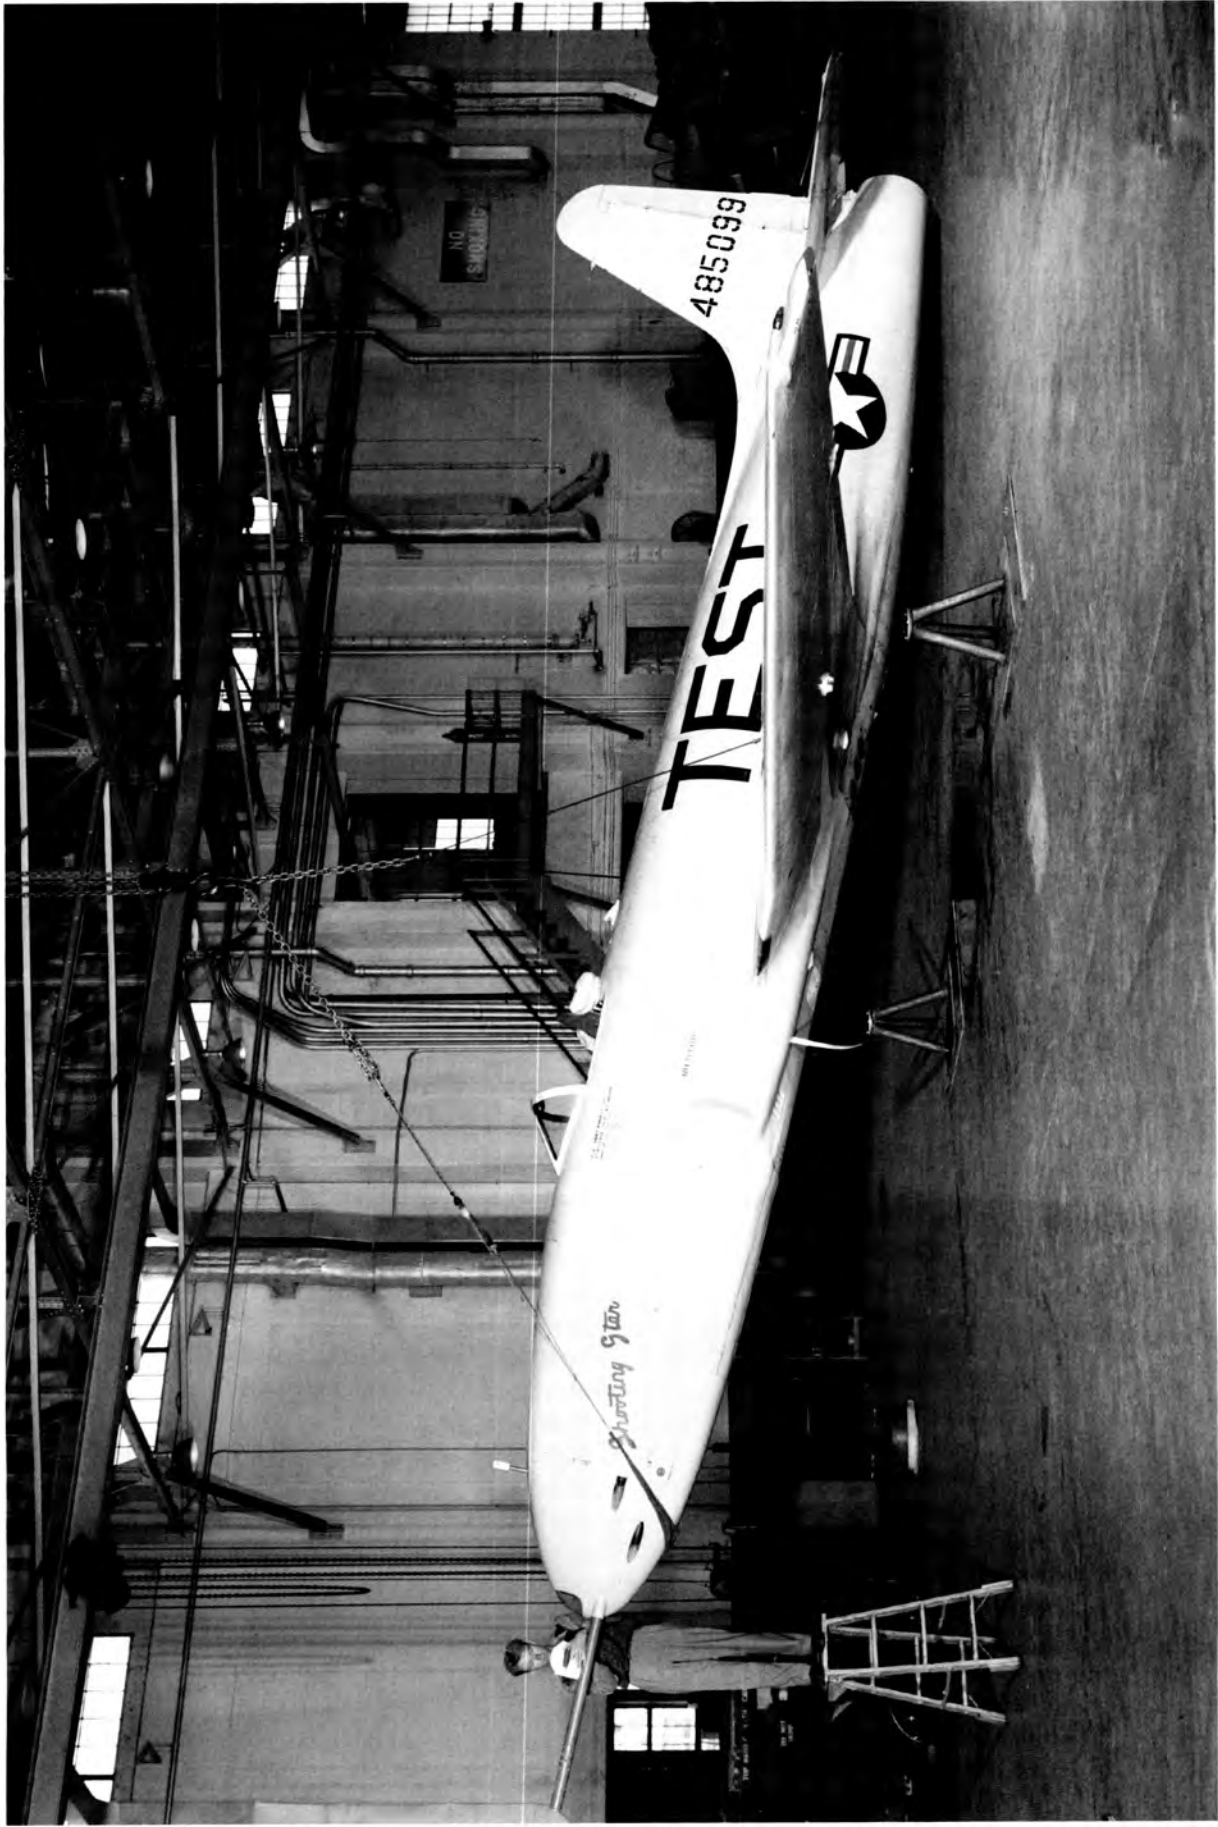
Figure 27. Measurements being taken to obtain the vertical center of gravity of the Lockheed P-80A by weighing the aircraft in nose-up and nose-down positions with the landing gear retracted. The cockpit canopy is missing. (Stairs leading to the second floor loft in building N-210 are in the background.) (Aug. 1947) A-11935

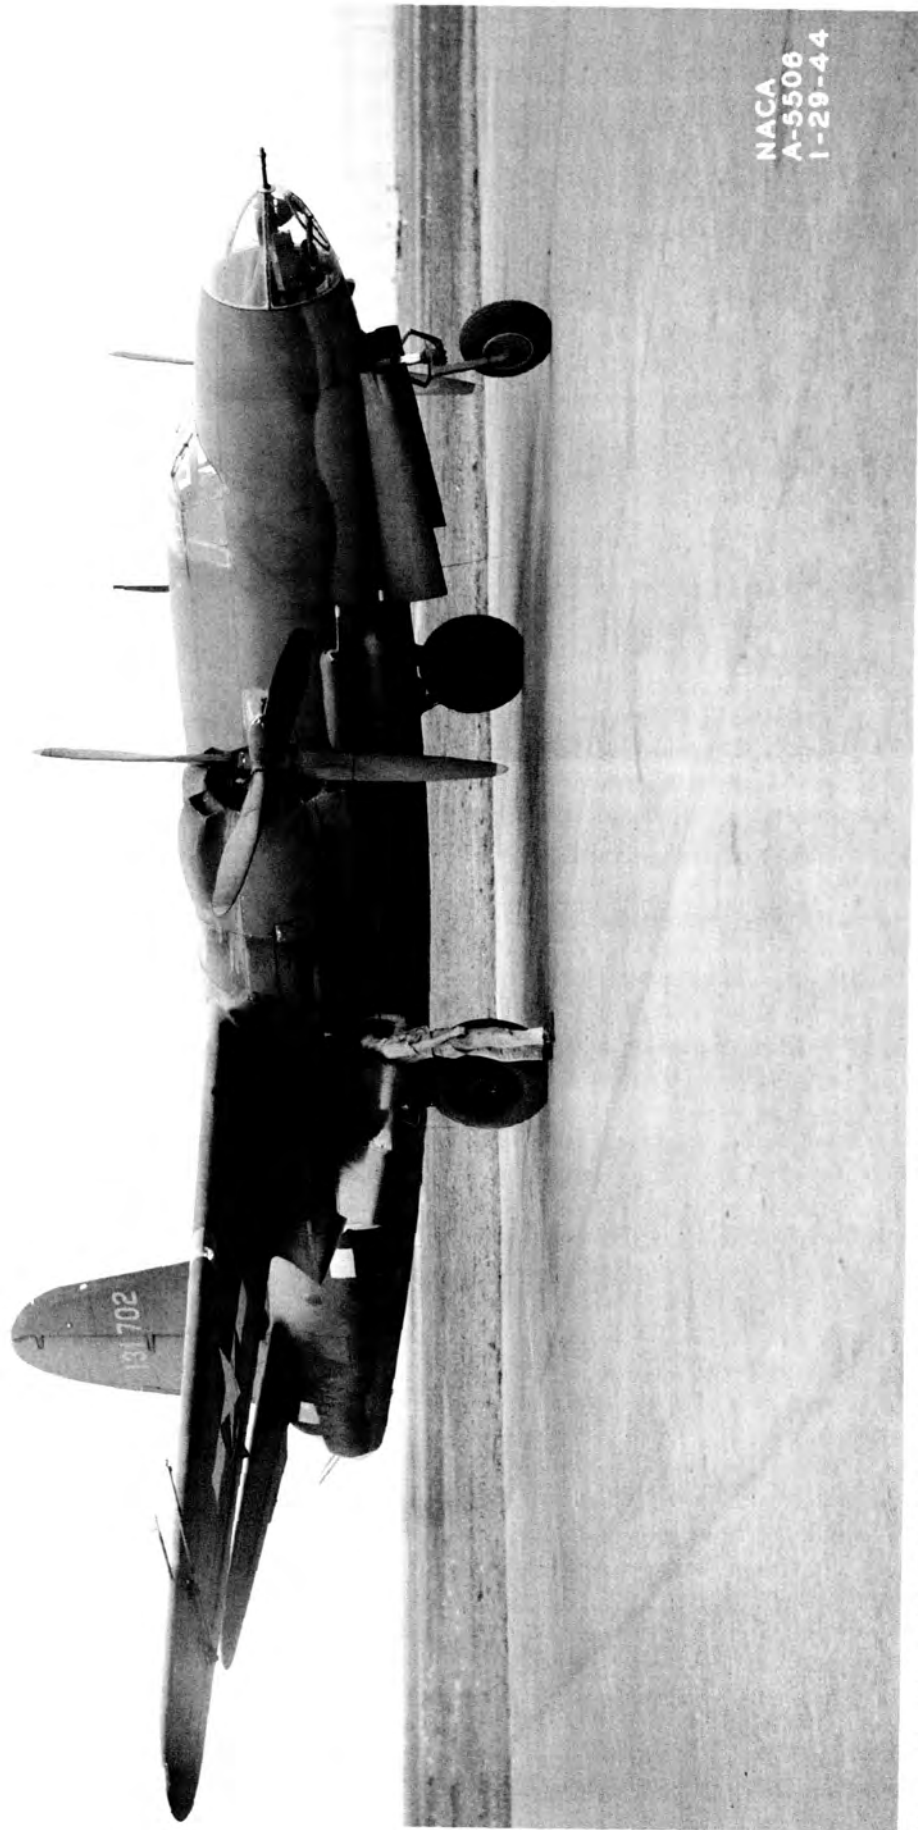
Figure 28. Martin B-26B-21 Marauder medium bomber with 6-foot extended wing tips. Entrance to the cockpit was through the bomb bay. Note machine gun protruding through the nose. (Sept. 1943) AAL-5506
