NASA/SP-2002-4526

# ***MEMOIRS OF AN AERONAUTICAL ENGINEER***

**Flight Tests at Ames Research Center:  
1940-1970**

**Seth B. Anderson**

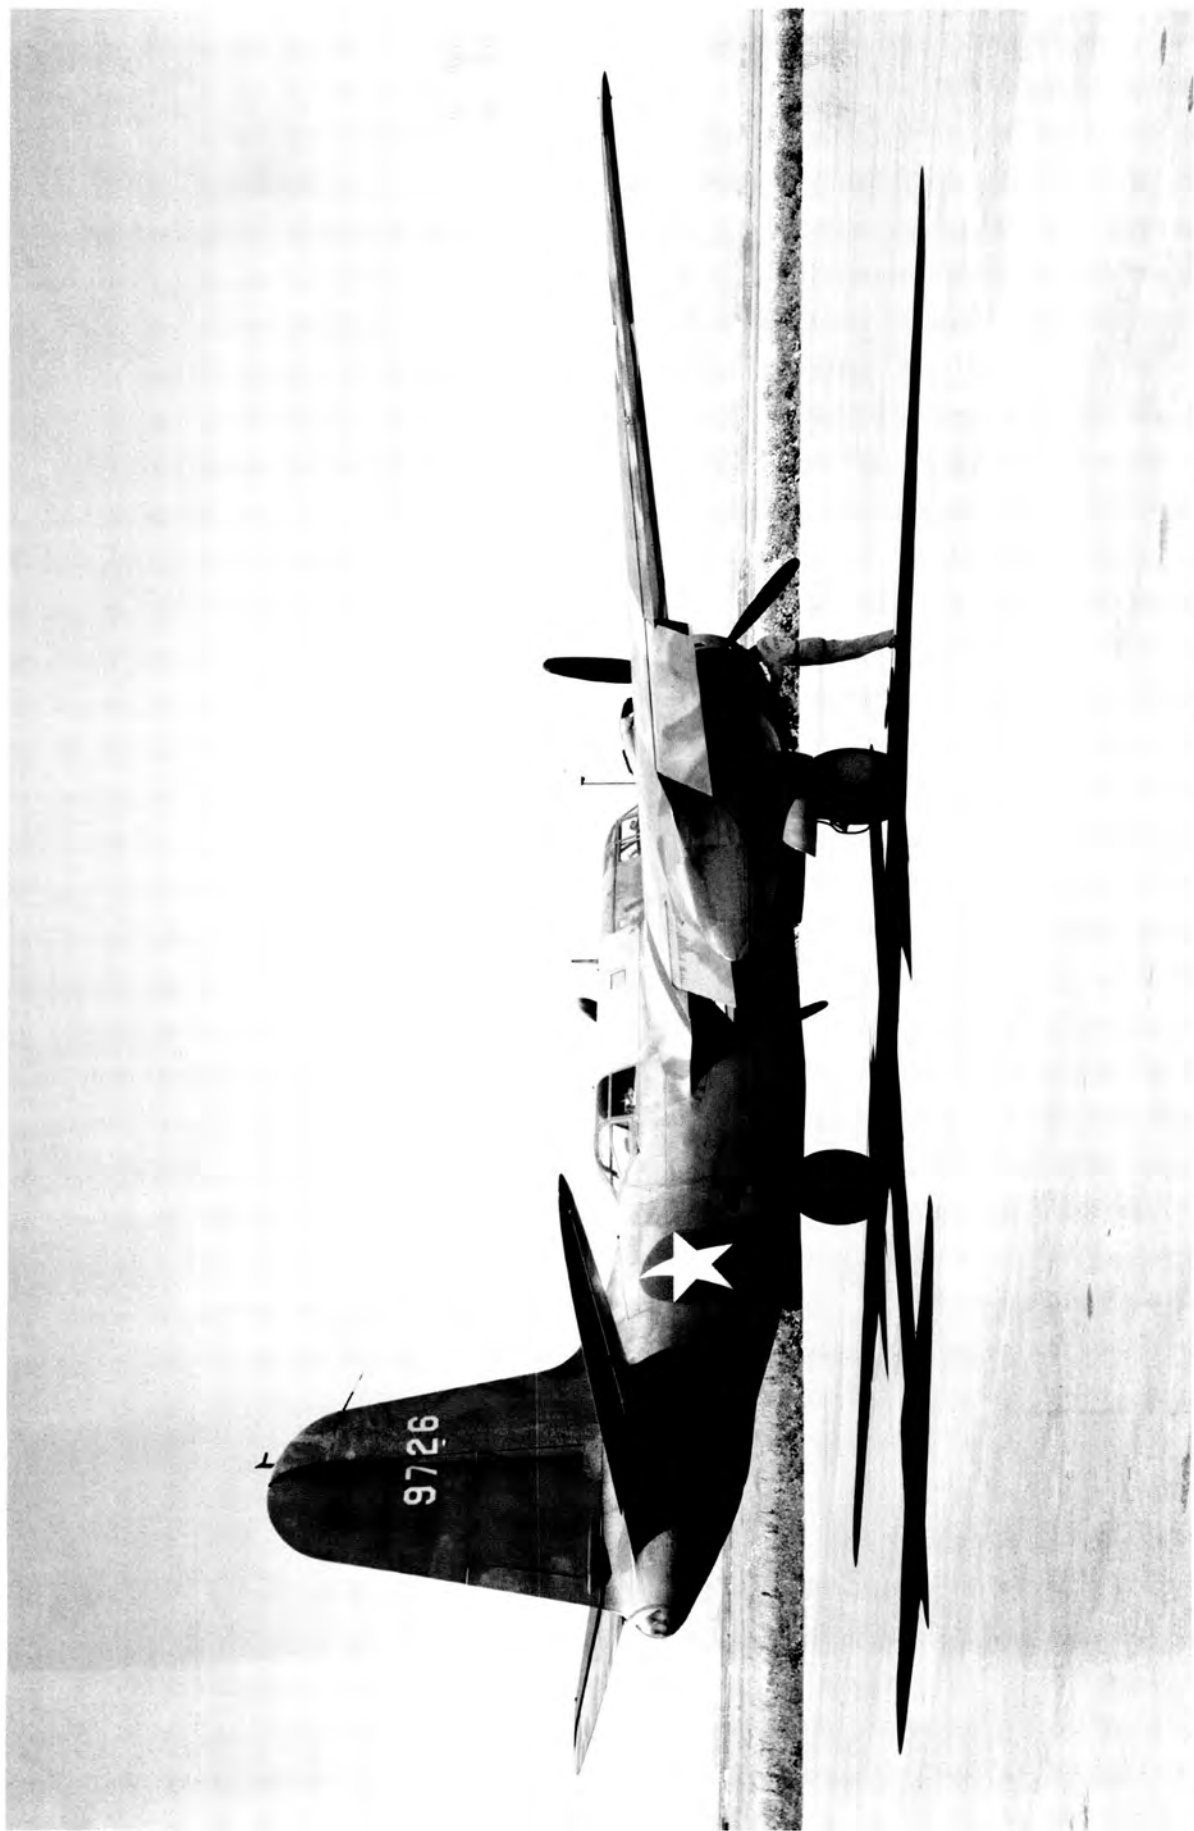
Figure 28. Martin B-26B-21 Marauder medium bomber with 6-foot extended wing tips. Entrance to the cockpit was through the bomb bay. Note machine gun protruding through the nose. (Sept. 1943) AAL-5506

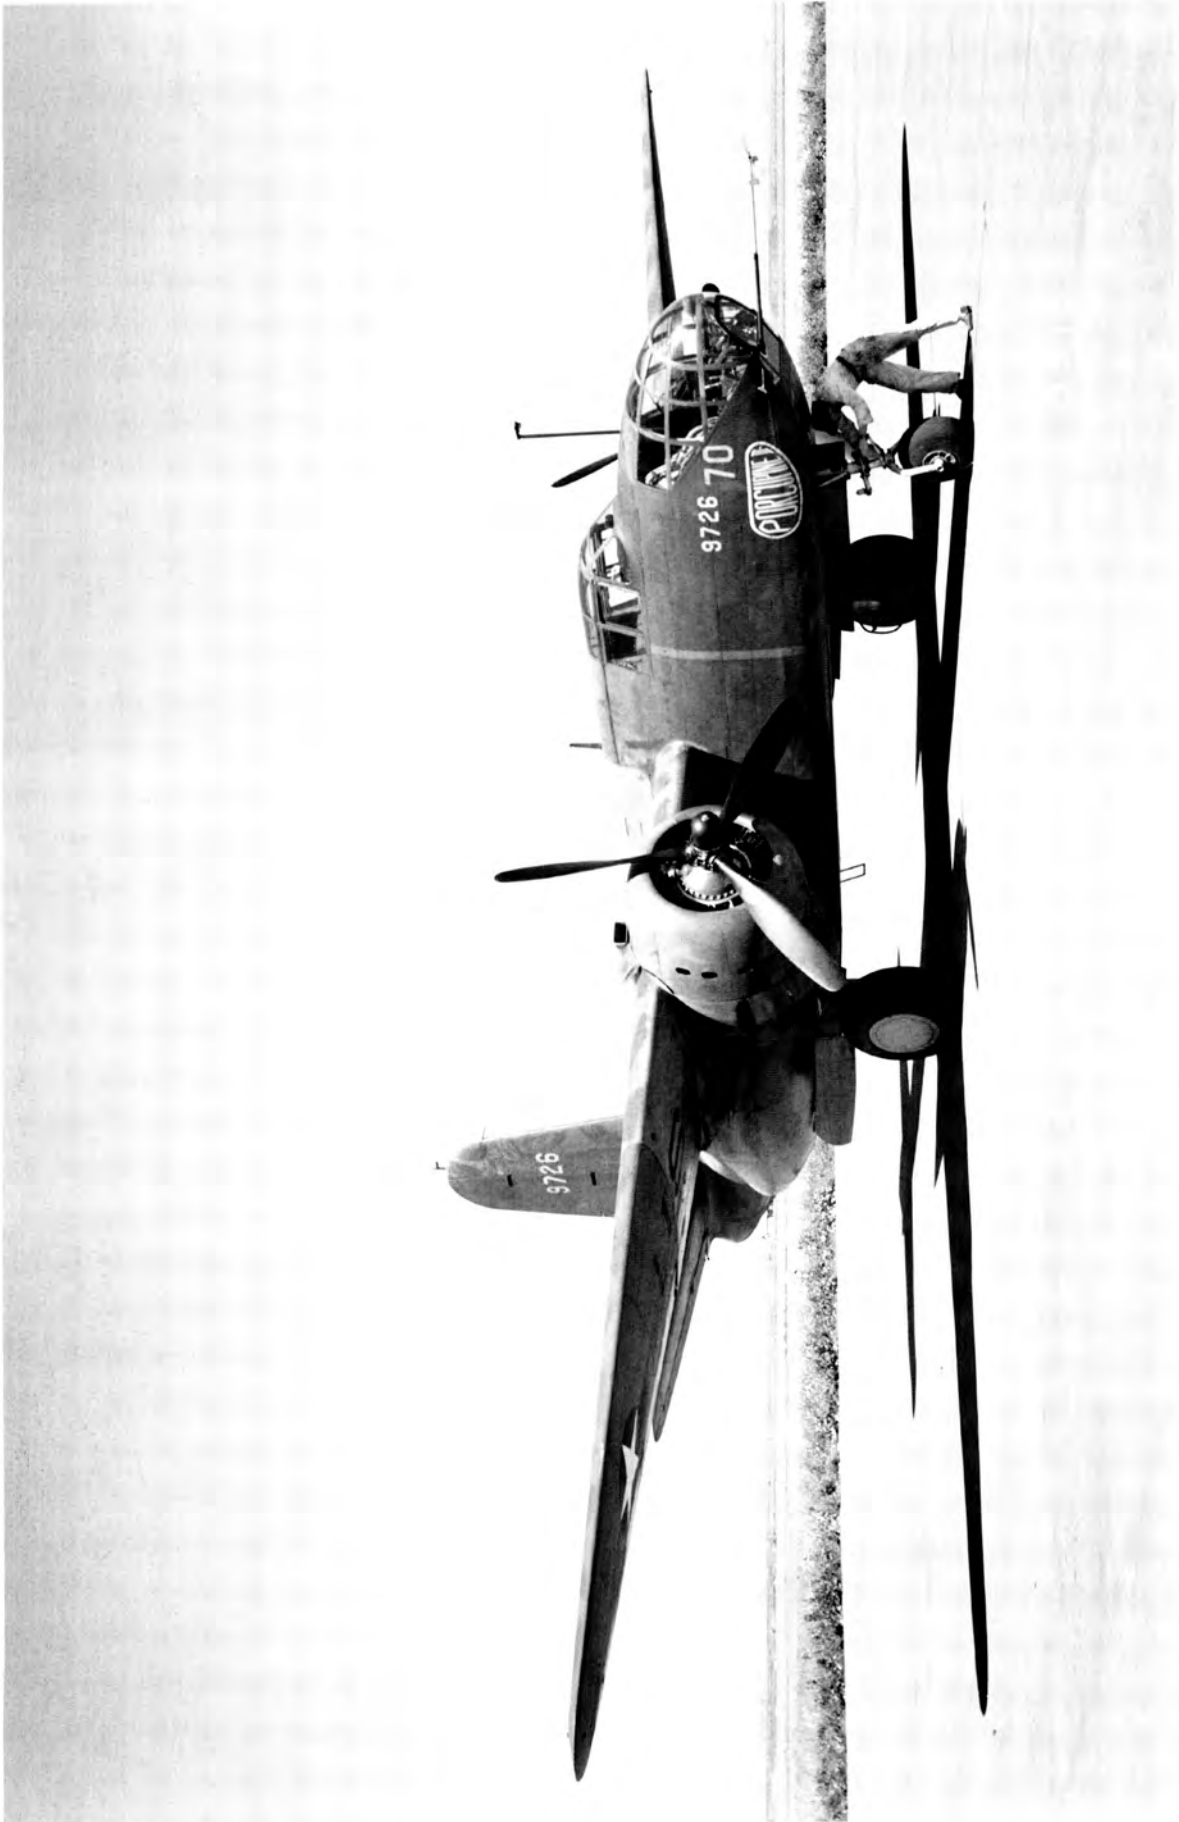
Figure 30. Douglas A-20A Havoc with yaw vane and airspeed swivel head installed on a fuselage nose boom. Flutter motion of the vanes could not be observed from the pilot's cockpit. A yaw vane is on top of the mast in front of the pilot's windshield. Cockpit entrance and egress were through the bomb bay. (Apr. 1943) AAL-3913

for vibration tendencies, and because the boom could not be seen from the pilot's position (fig. 30), I unbuckled my parachute and crawled forward from the rear cockpit and occupied the navigator seat to observe the boom through the clear acrylic in the nose of the aircraft. After several dives to speeds approaching 400 mph with rates of descent over 25,000 feet per minute, I noted the onset of unsteadiness in the free-swiveling vane system. Since there was no direct escape from the nose area, I quickly returned to the rear cockpit after the aircraft had returned to level flight and slipped into my parachute harness for the flight back to Moffett.

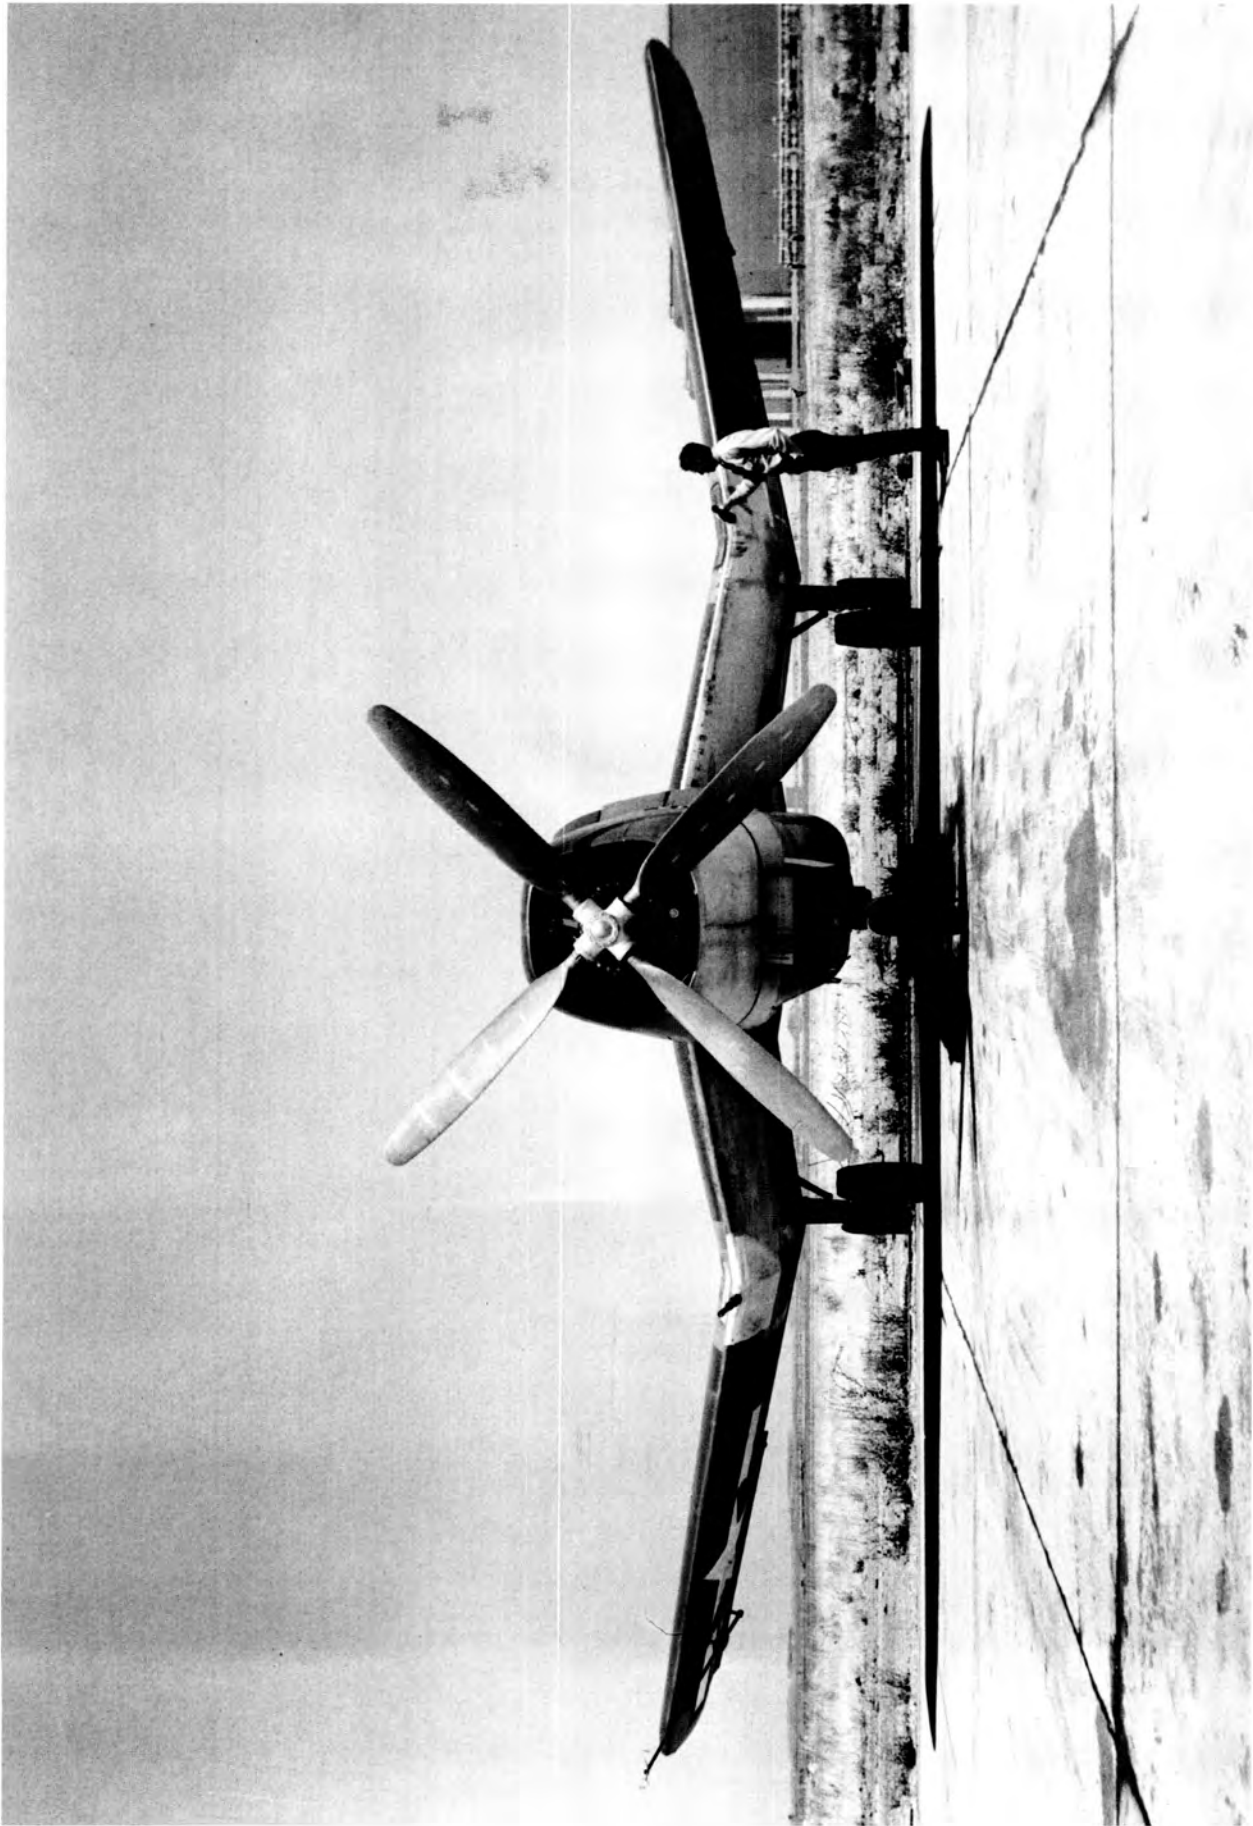
Figure 31. Douglas XSB2D-1 aircraft used in high-speed and takeoff performance tests. Gull-wing design resulted in a shorter, lighter landing gear. (July 1945)  
A-8290

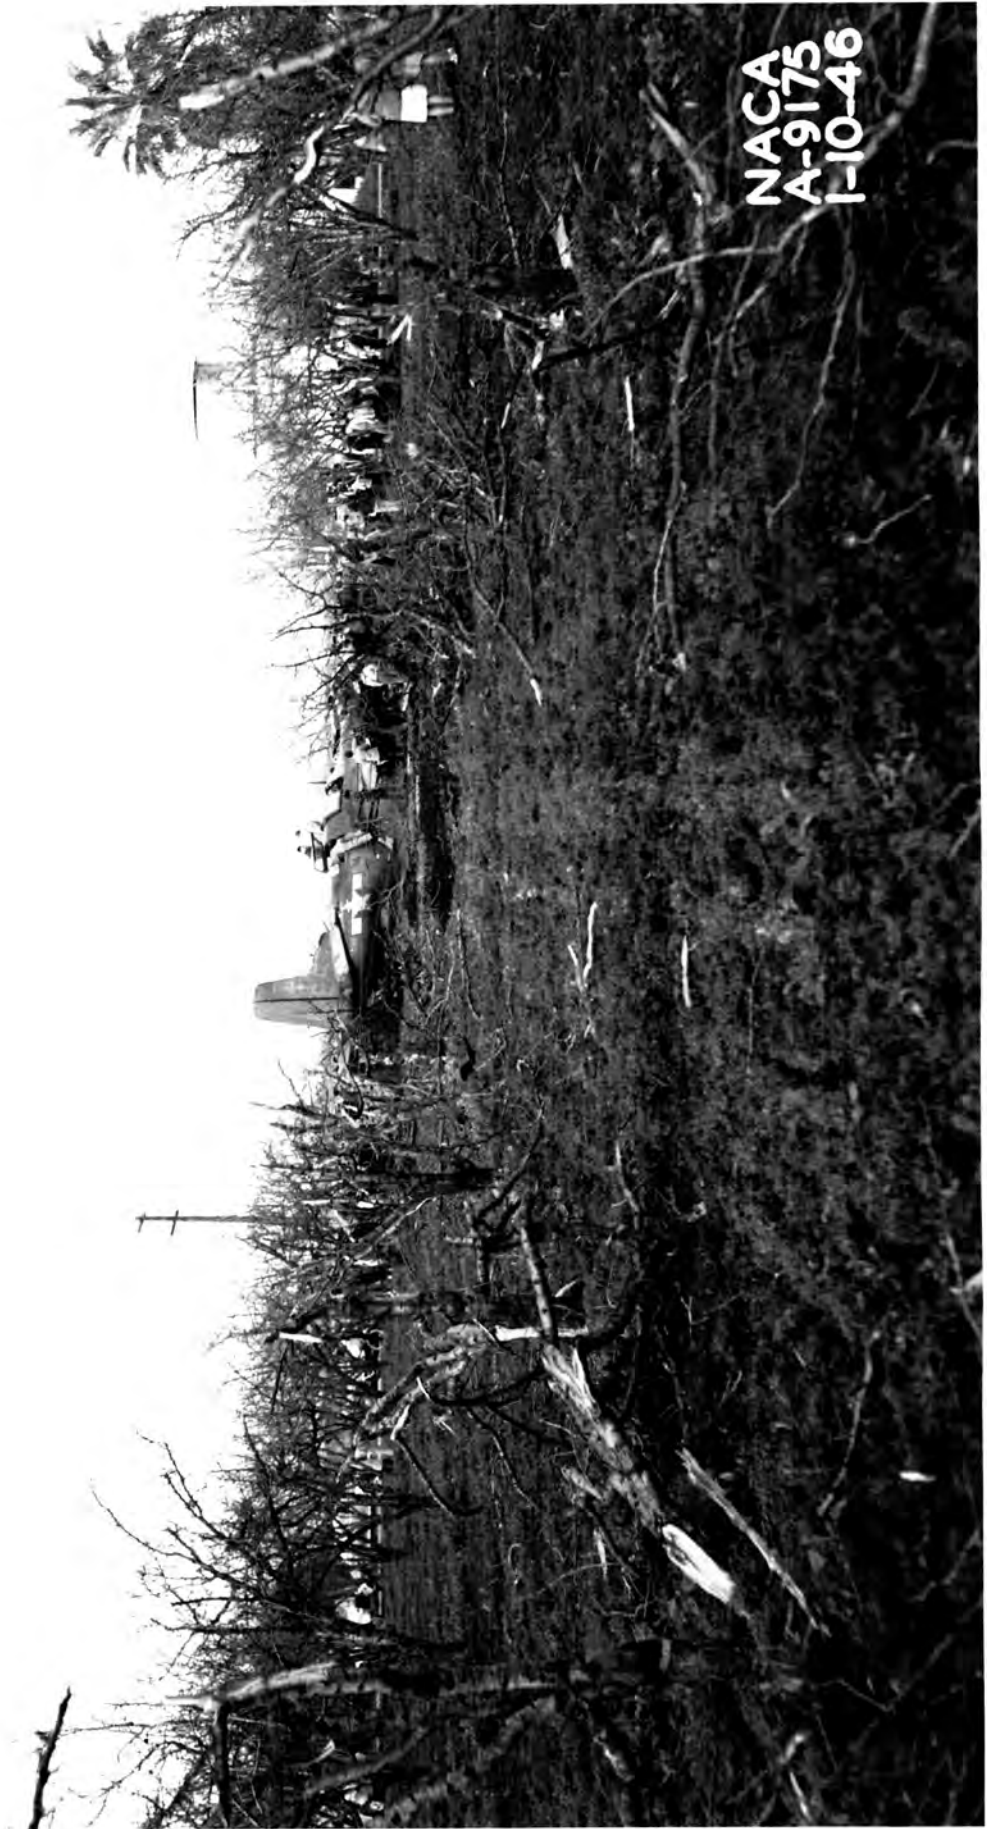
Figure 32. Crash landing of a Douglas XSB2D-1 in an orchard in Sunnyvale, California (near Moffett Field), caused by engine failure. Note the spectator crawling into the rear cockpit to remove the clock. (Jan. 1946) A-9175

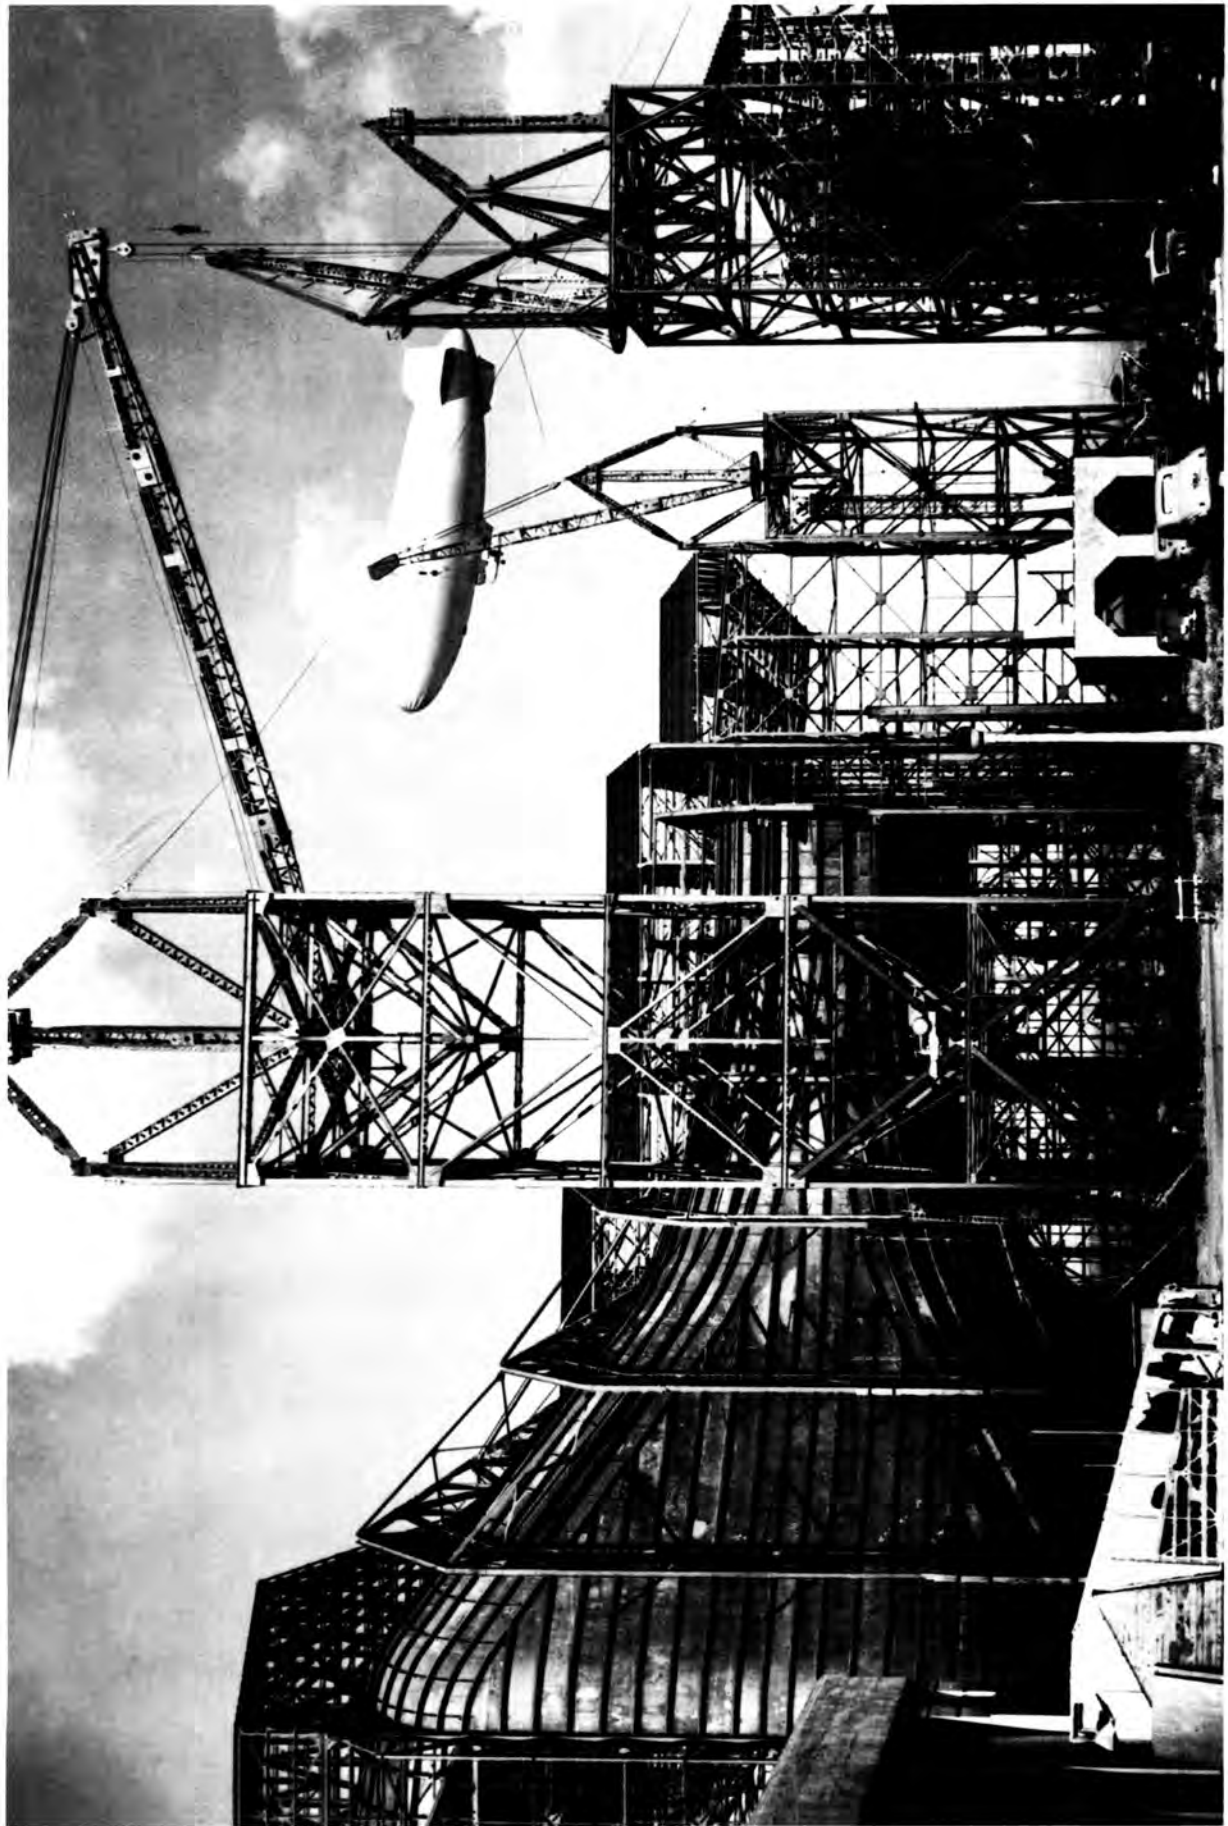
Figure 33. K-21 blimp seen through 40- by 80-foot wind-tunnel construction. Flight controls were modified to improve the K-21's handling qualities for long-duration blimp missions. (June 1943) A-FST-37

The Bureau of Aeronautics asked NACA to evaluate the handling qualities of a K-21 airship (fig. 33), which had been modified with aircraft-type control columns in place of the usual (separate) elevator and rudder control wheels. The purpose of the flight tests was to identify and quantify the causes of the poor handling qualities of the airship so that designers could incorporate improved mechanical control characteristics in future designs.

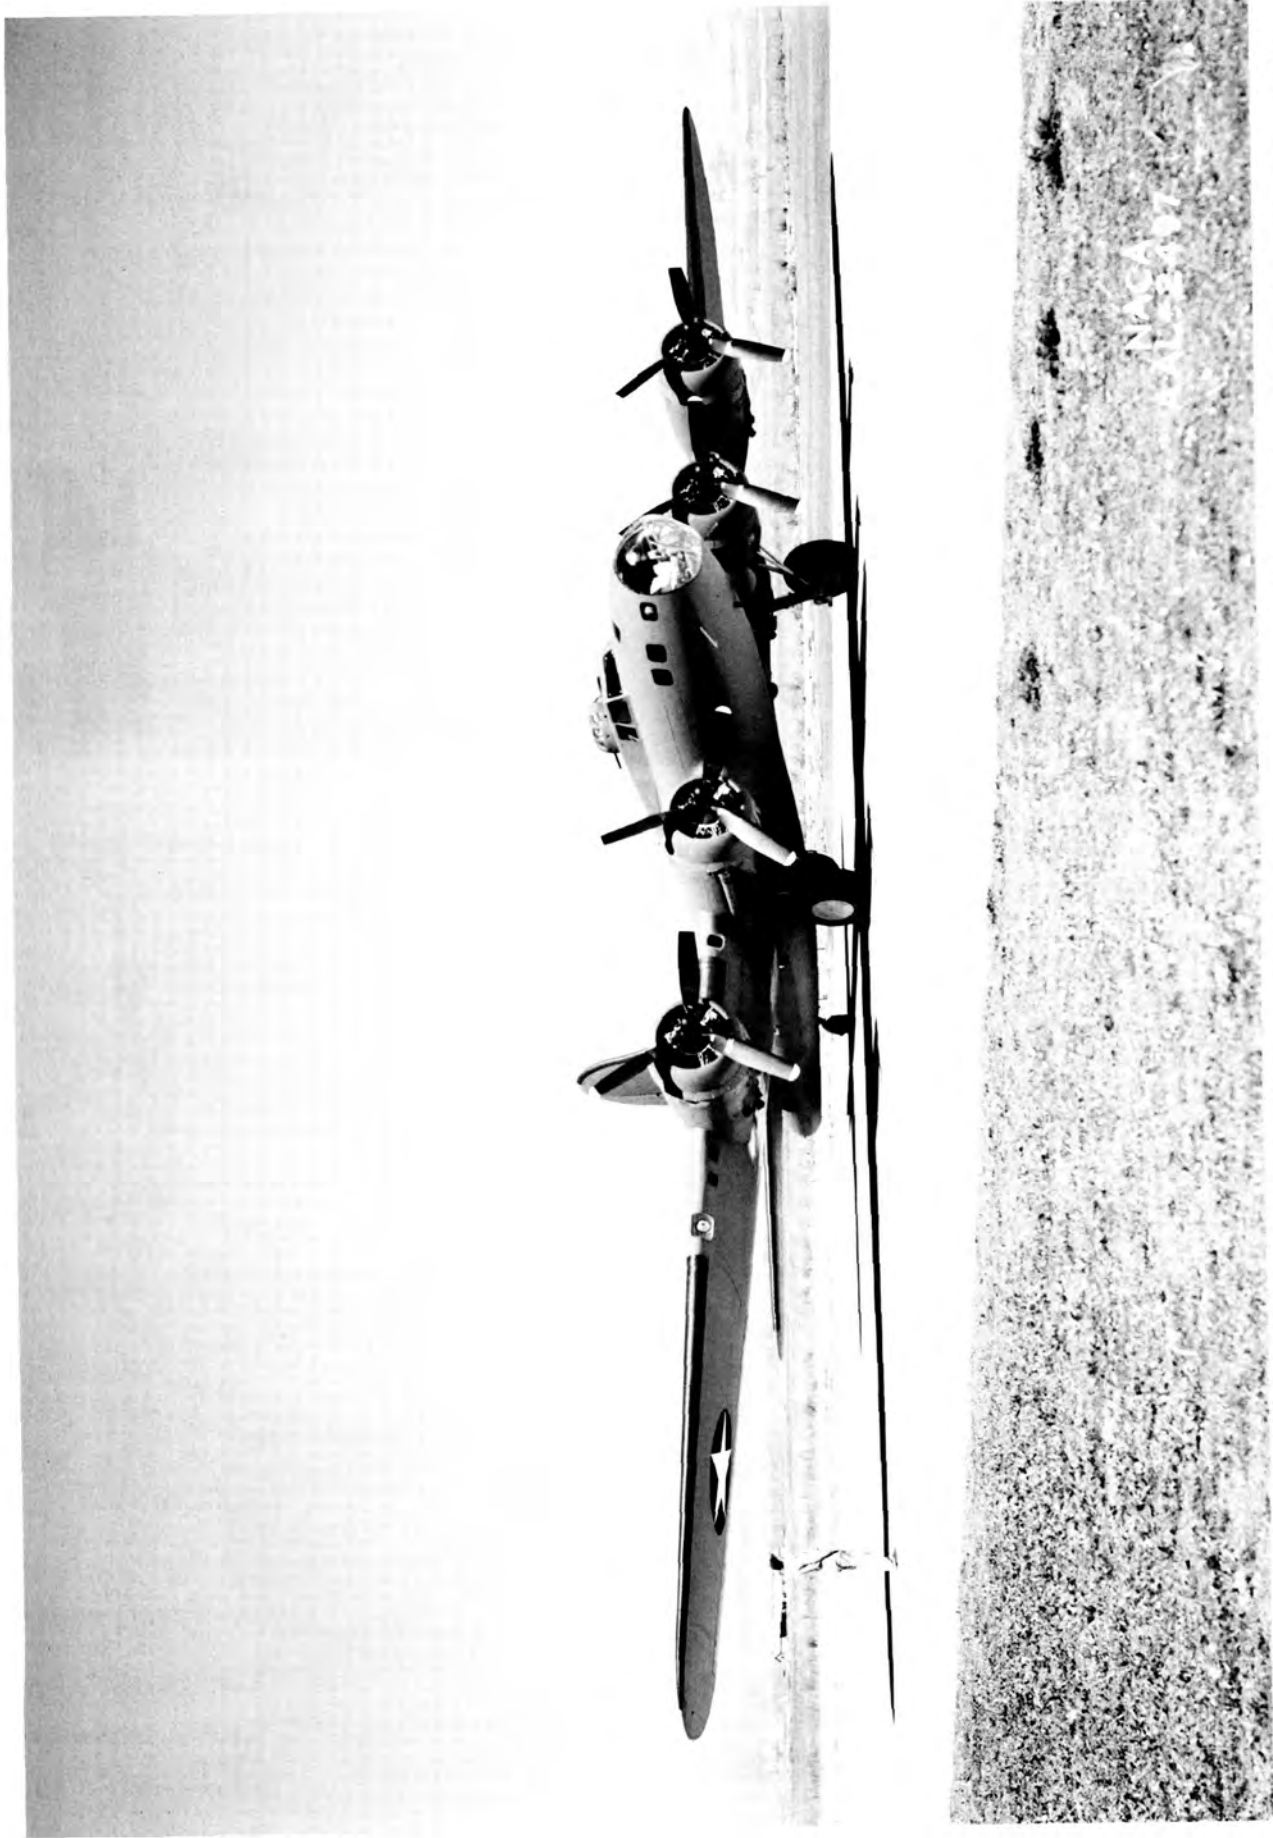
Figure 34. Boeing XB-17F with turbocharged engines. It was used in developing icing protection systems and for research on handling qualities. (Dec. 1942)  
AA1-2497

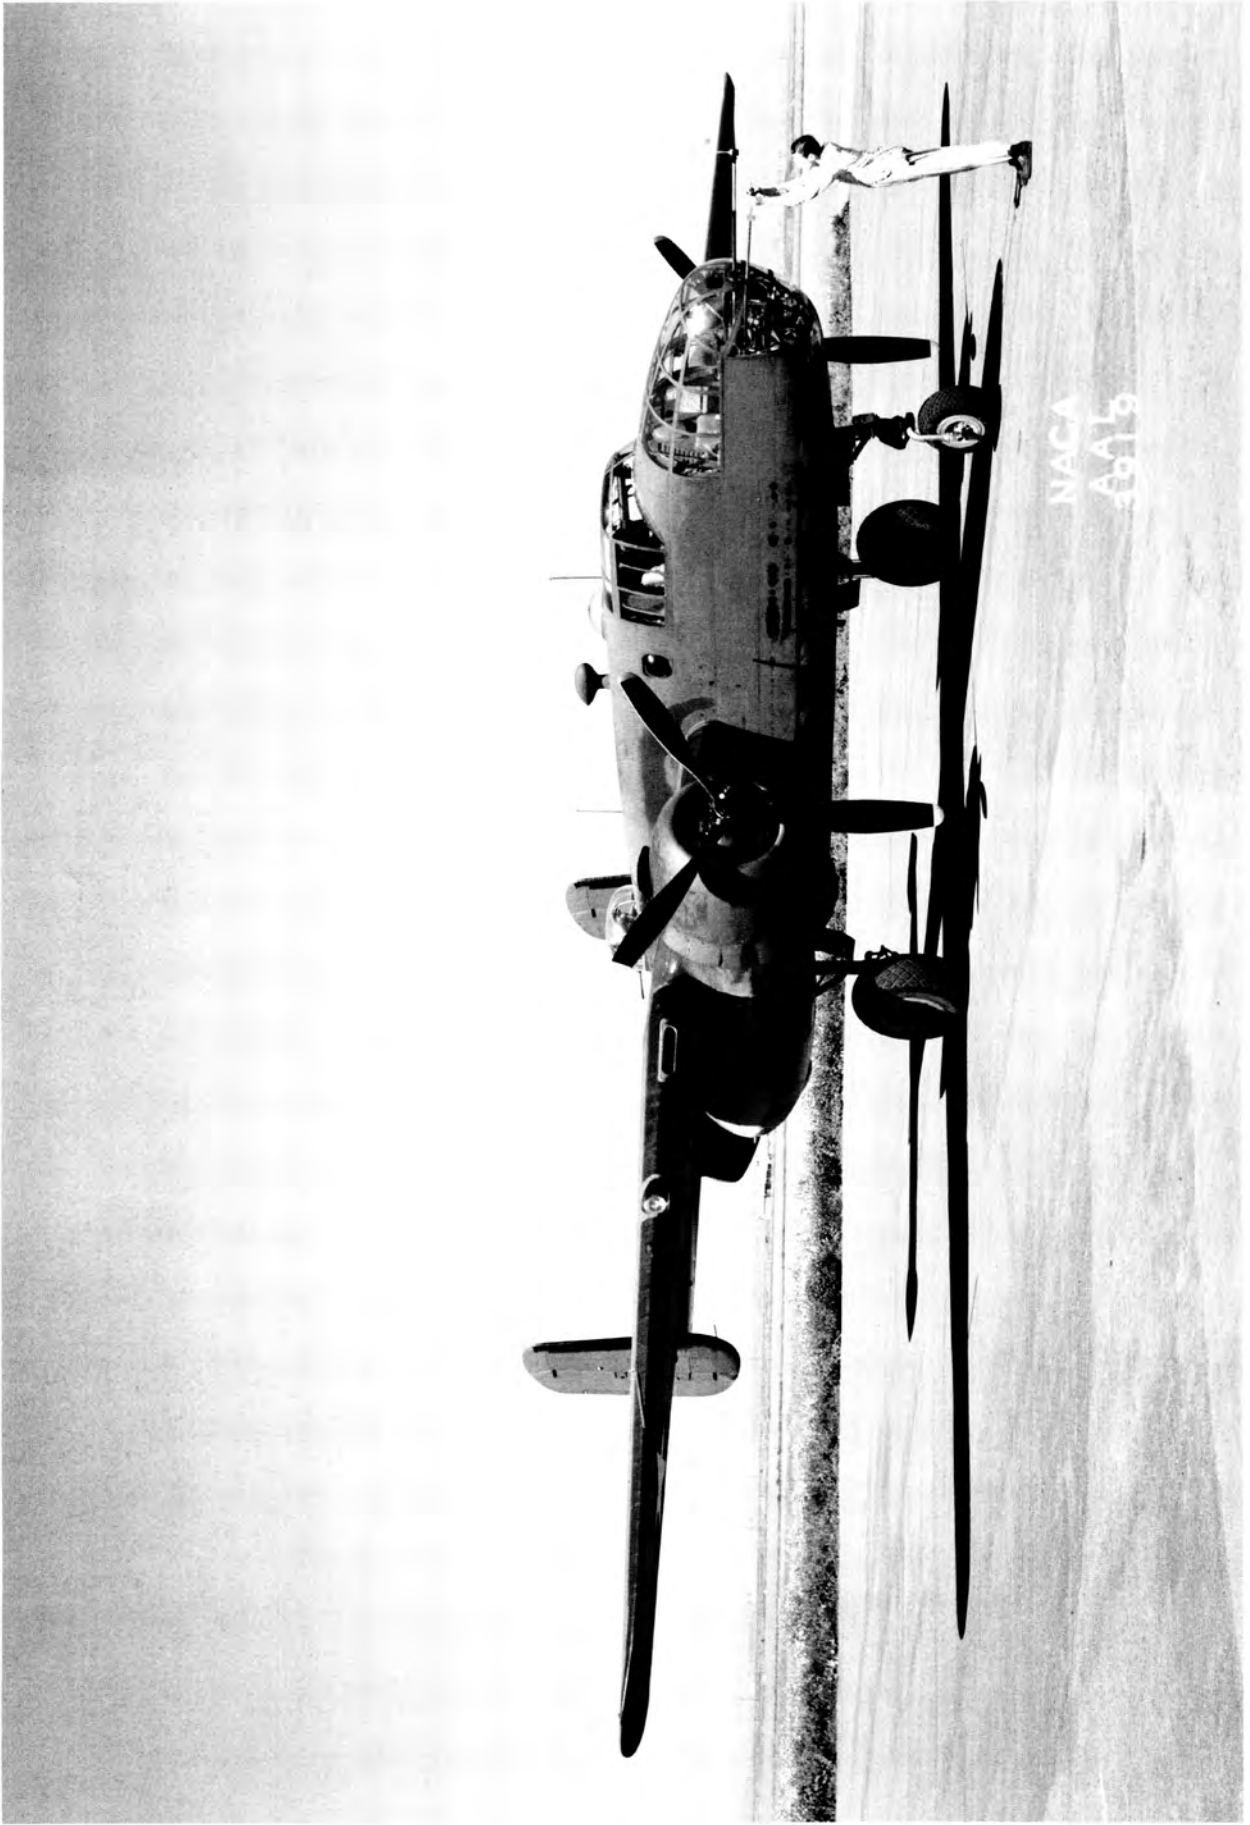
Figure 36. North American B-25D Mitchell with research instrumentation used in handling-qualities studies. The B-25 carried a crew of five. (Mar. 1943)  
AAL-3919

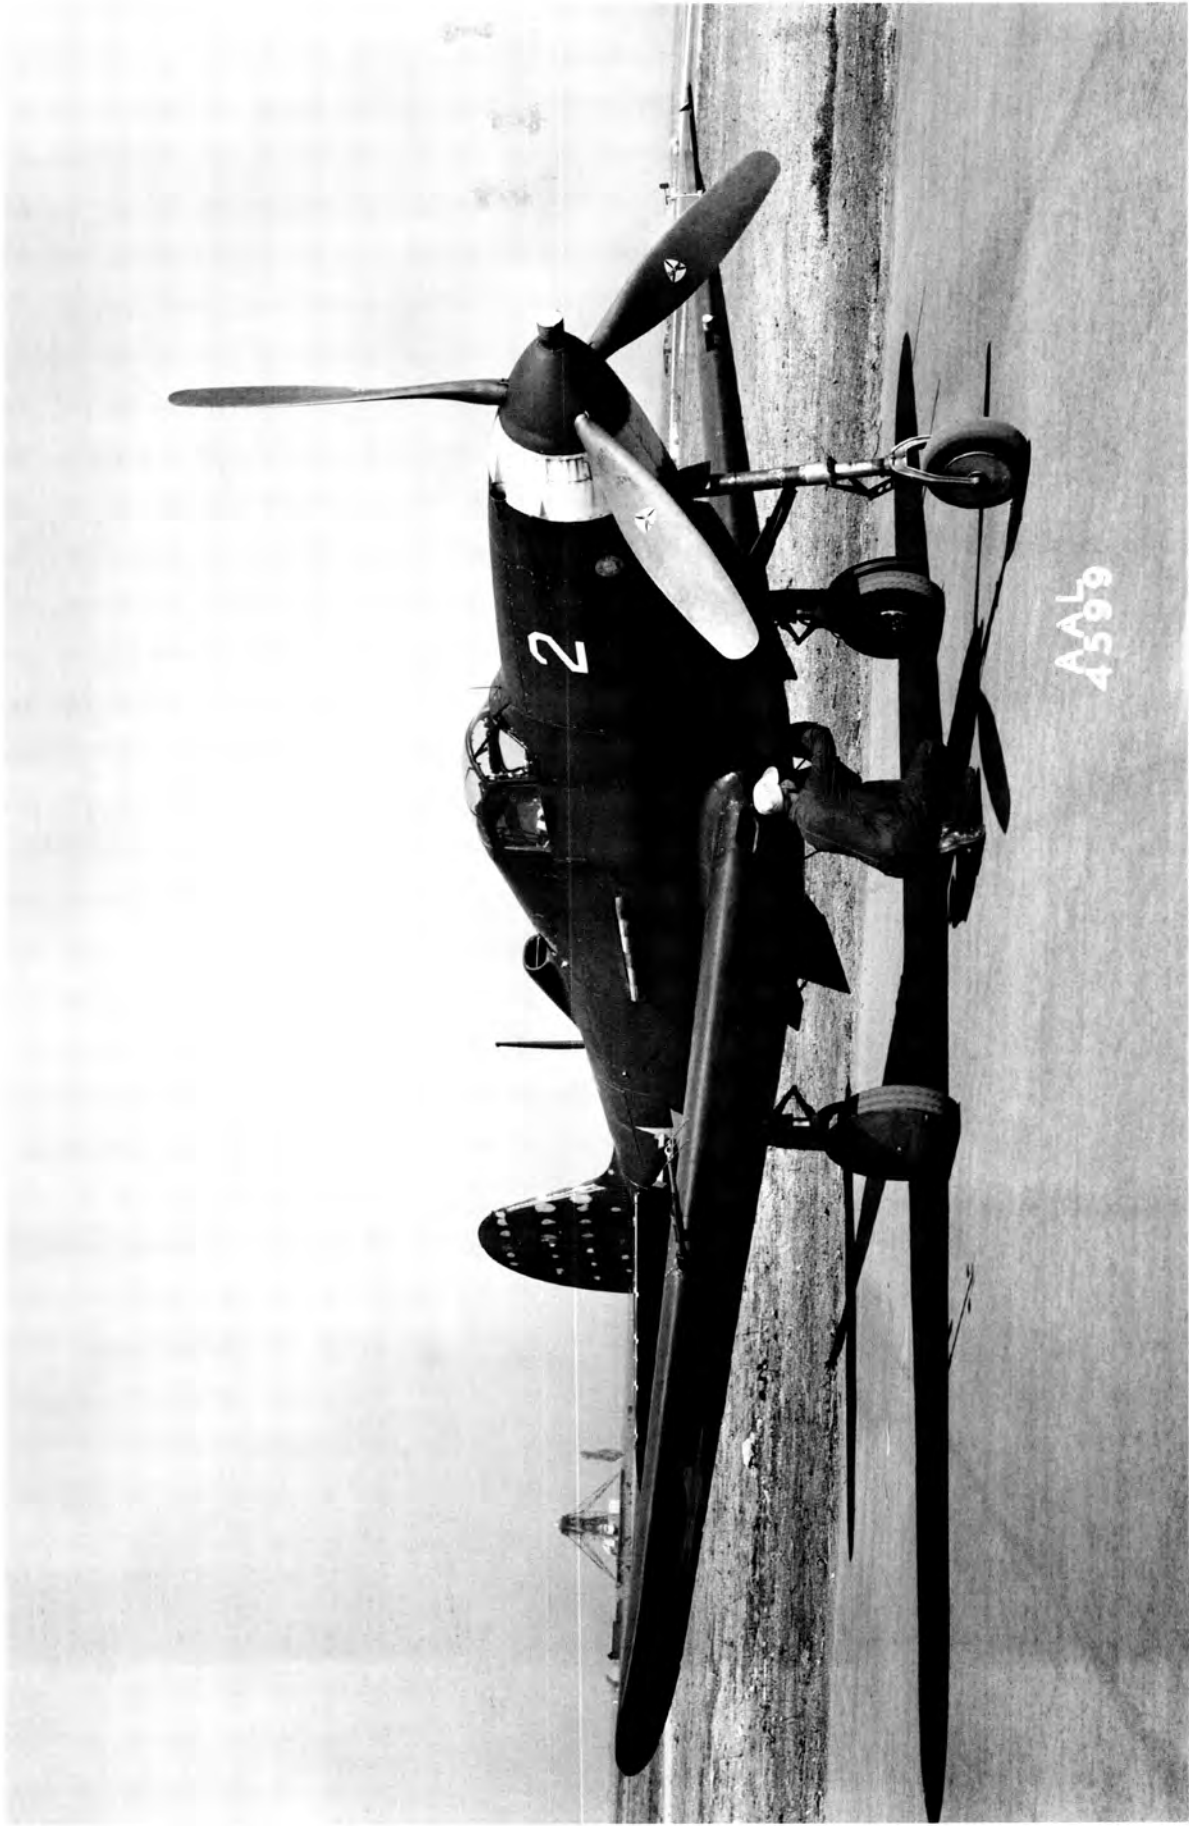
Figure 39. Bell P-39 Causes of vertical tail failure in maneuvering flight of the P-39 Airacobra were investigated. An Allison liquid-cooled engine was located behind the pilot and connected to the propeller gearbox by a long driveshaft. This allowed for the installation of the 37-mm cannon shown extending through the propeller spinner. (Jan. 1943) AAL-4599

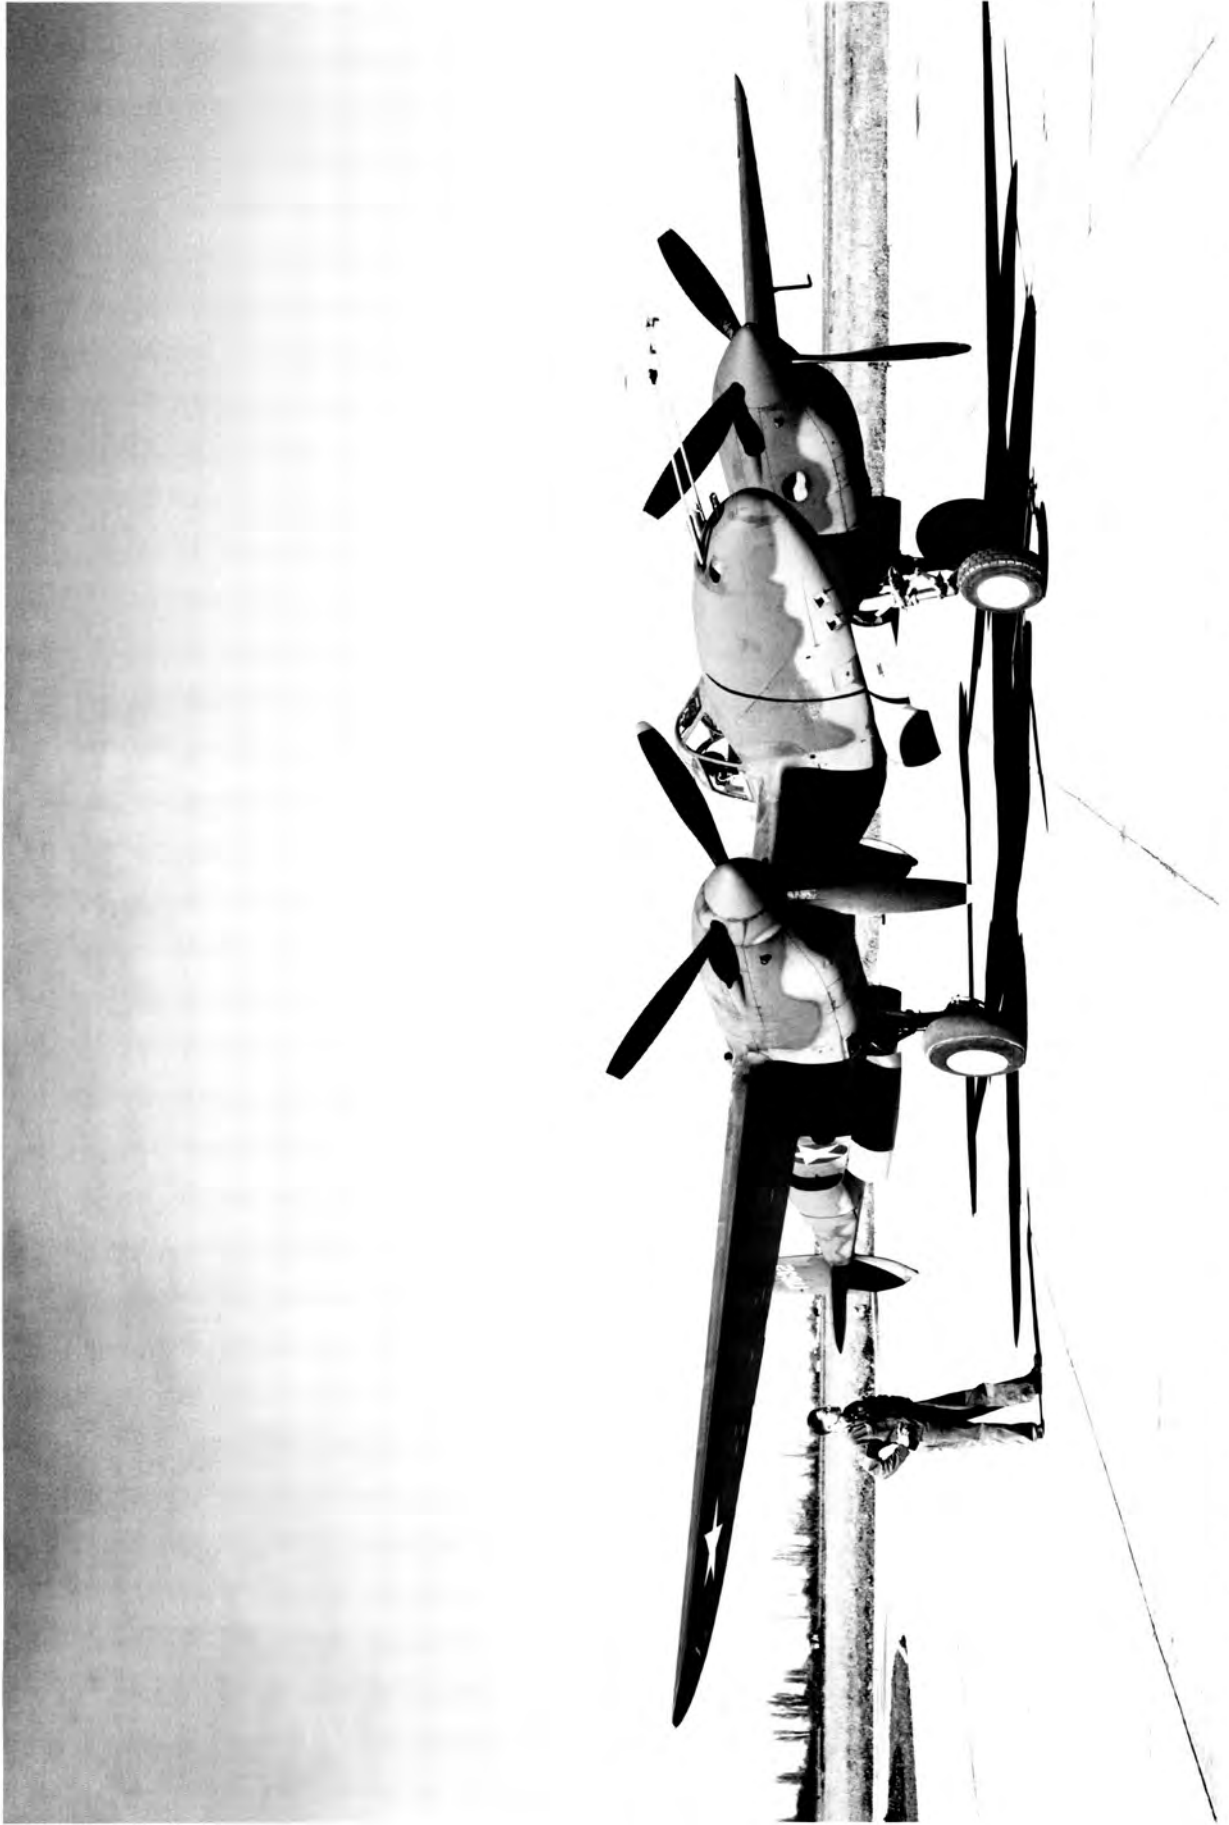
Figure 40. The Lockheed P-38J-15 Lightning shown with research instrumentation booms for use in handling-qualities tests. The free-swiveling airspeed head corrected flow misalignment caused by angle of attack and sideslip. The long booms tended to vibrate excessively at high airspeeds. (Aug. 1944) AAL-3507

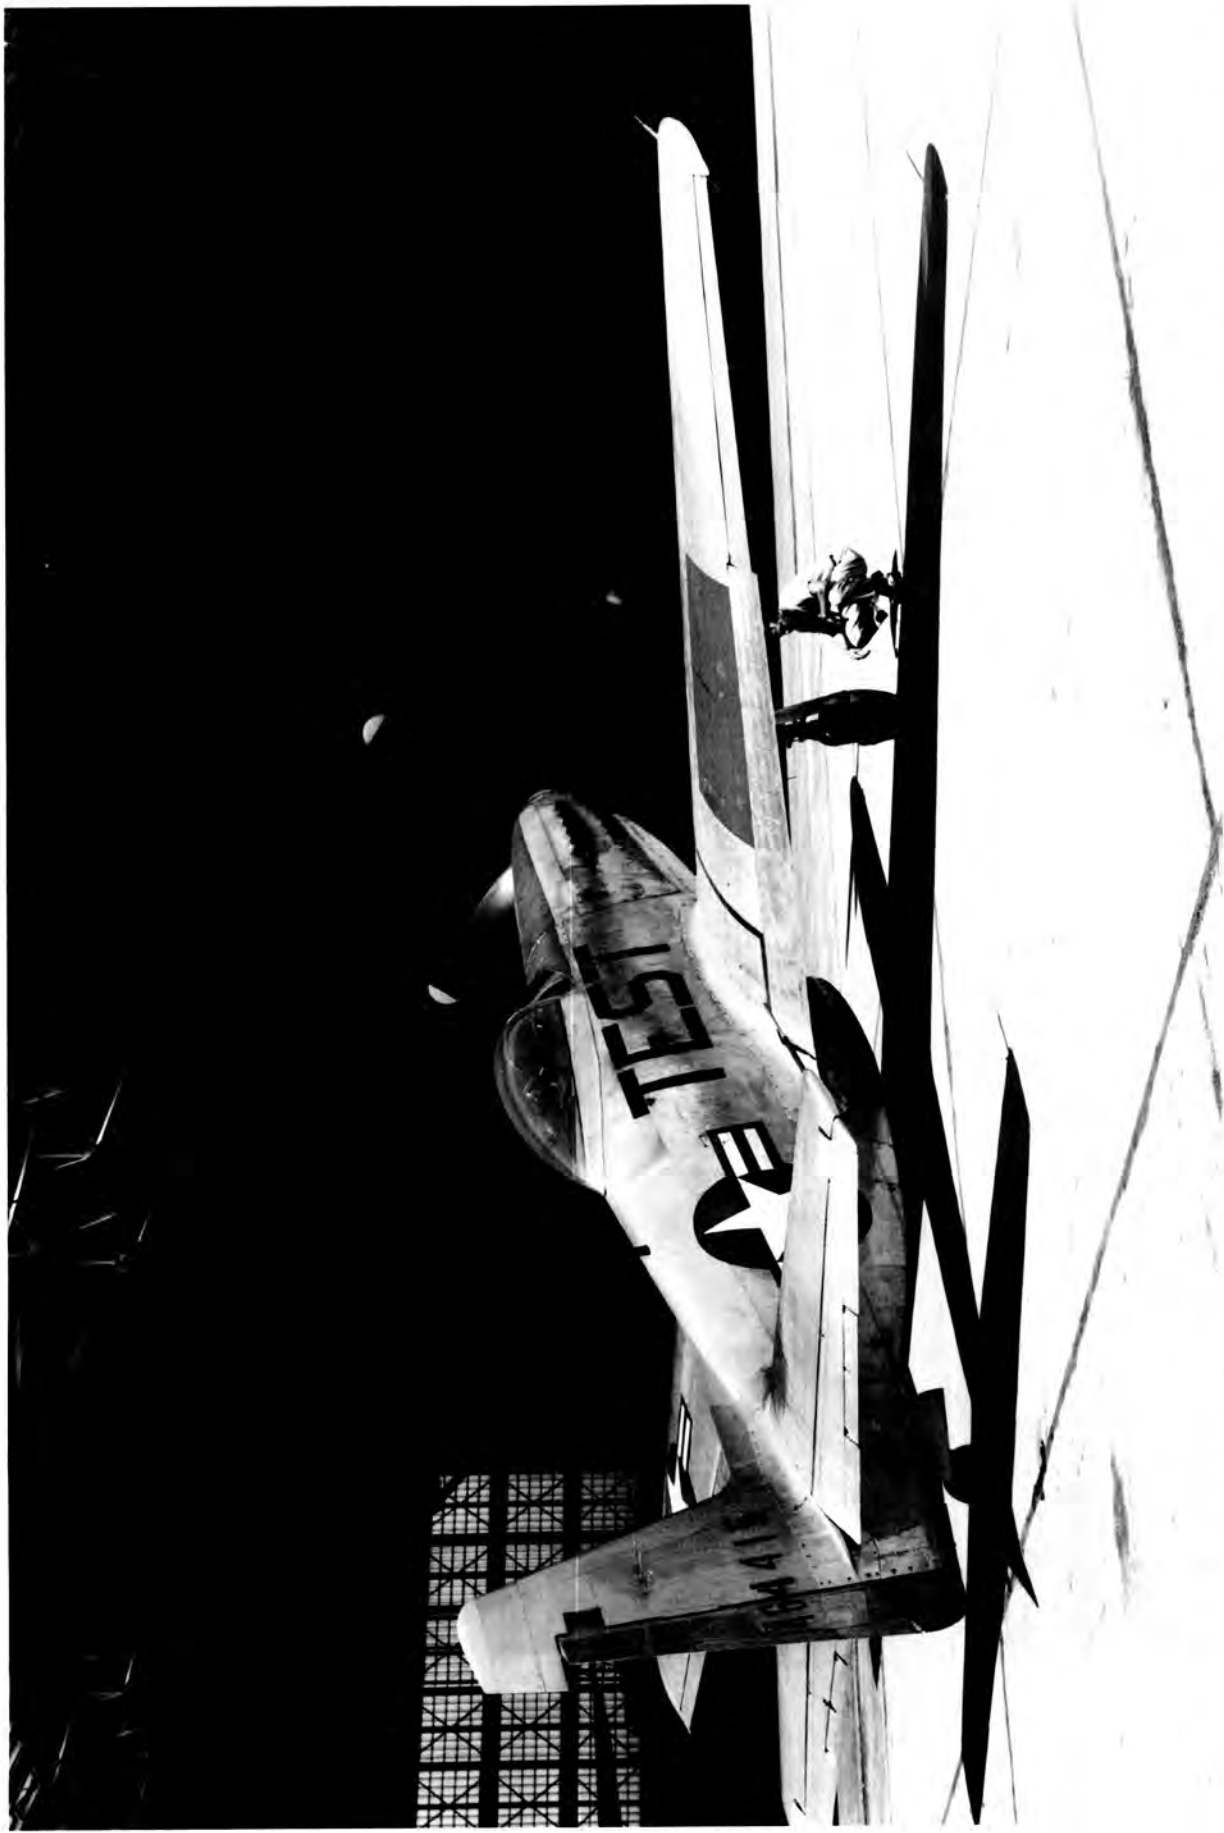
89 Figure 41. This North American P-51H was used to test negative trailing-edge flap deflection as a means of improving pitch control in Mach 0.81 dives. A small reduction in diving tendency was noted. (June 1947) A-11703
