NASA/SP-2002-4526

# ***MEMOIRS OF AN AERONAUTICAL ENGINEER***

**Flight Tests at Ames Research Center:  
1940-1970**

**Seth B. Anderson**

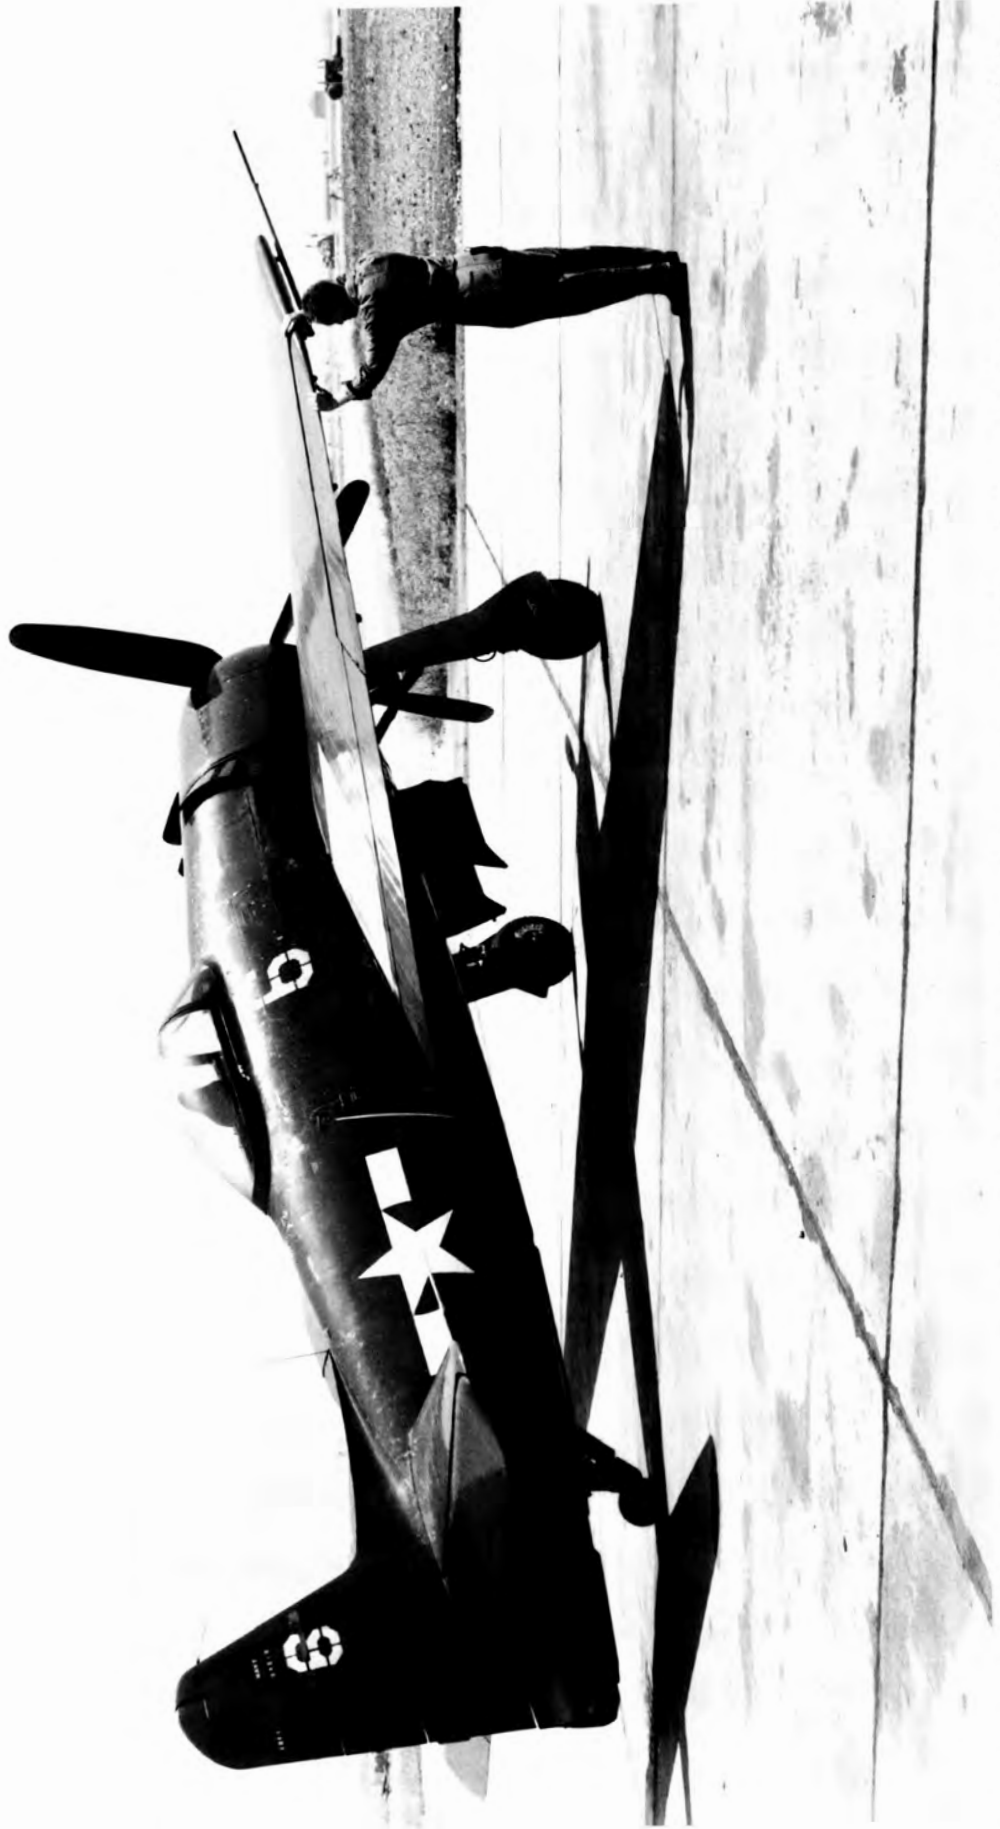
Figure 42. Grumman F8F-1 Bearcat was used in tests of reflexed trailing-edge flaps. No improvement in pitch control was noted at transonic Mach numbers. (July 1947) A-11695

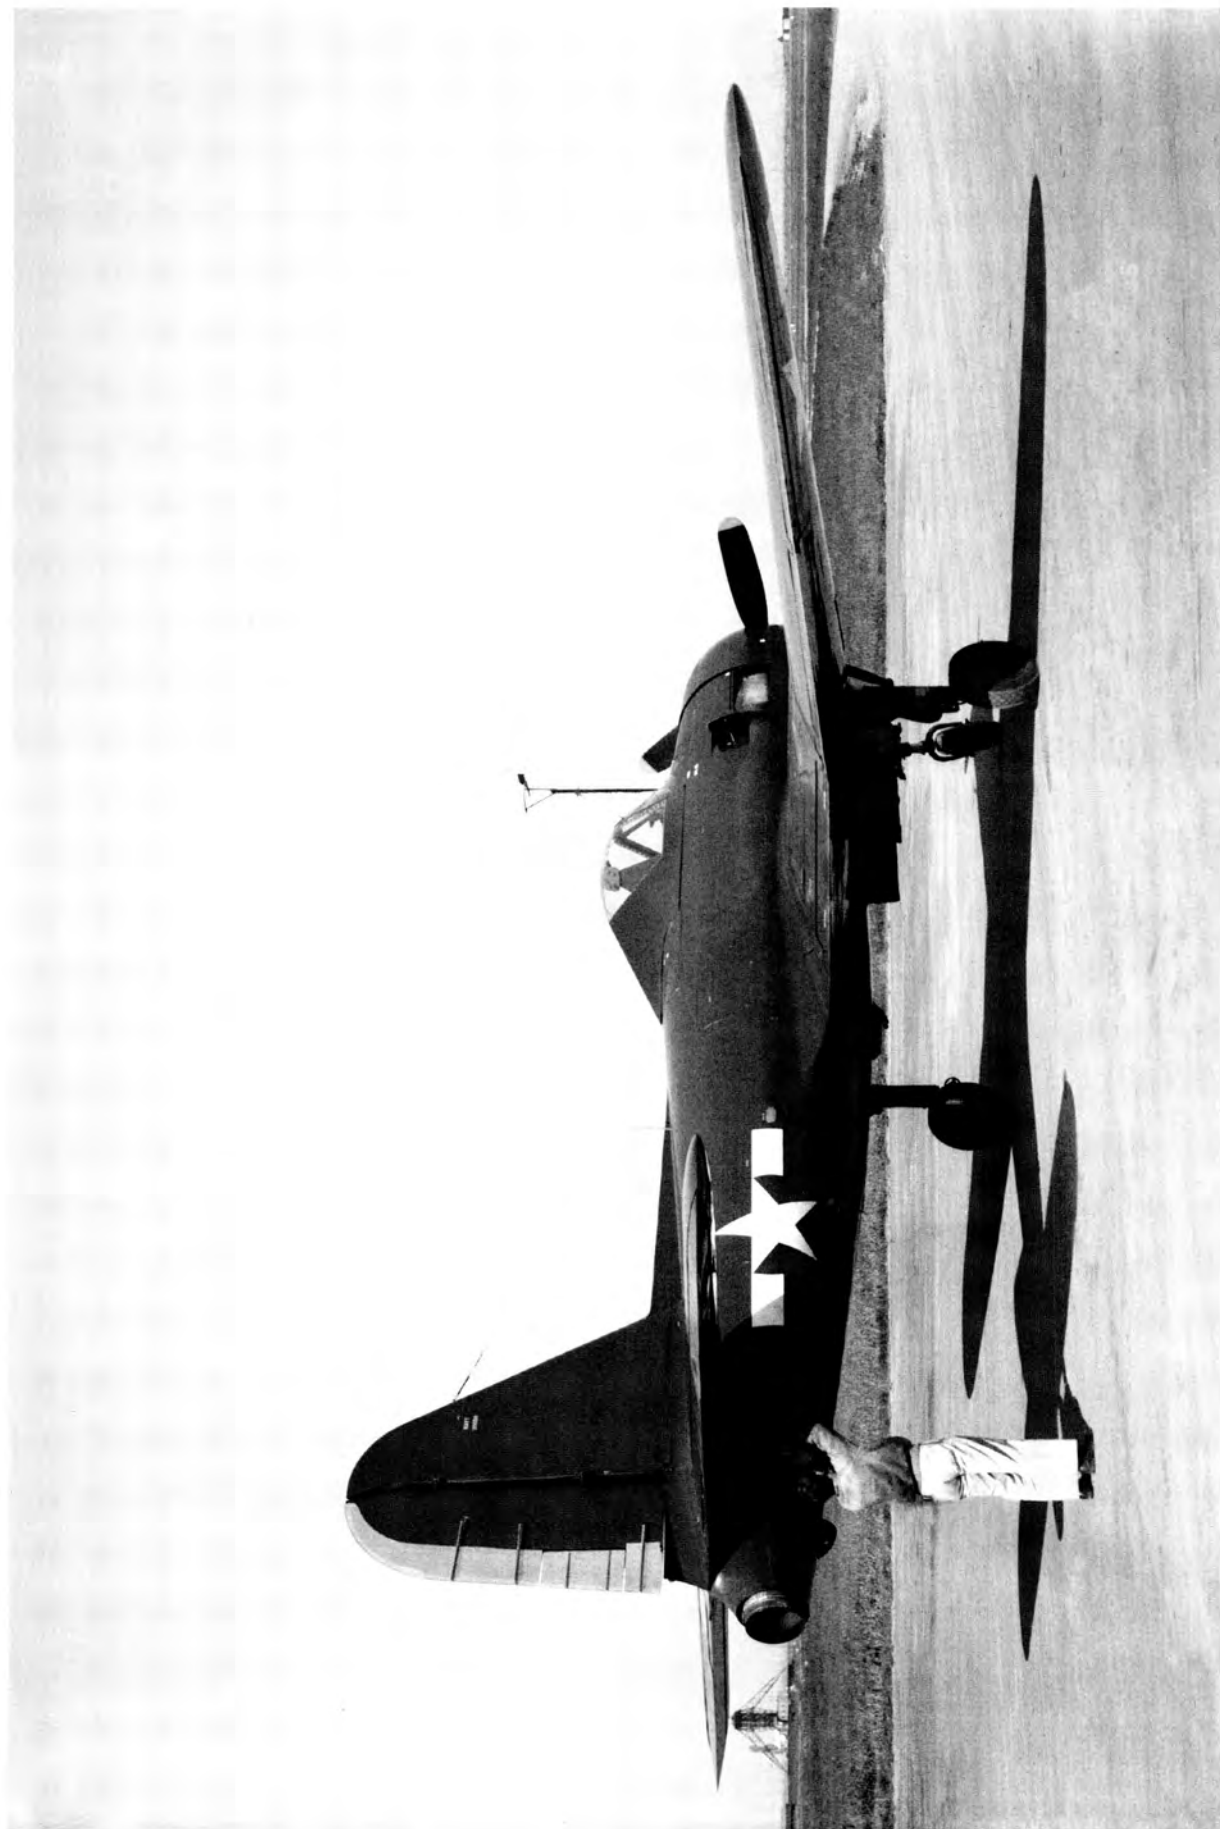
Figure 44. Ryan FR-1 Fireball Navy carrier-based fighter with unique dual power plant consisting of a Wright 1,350-horsepower piston engine in the nose and a GE J-16 turbojet in the tail. (Feb. 1945) A-7222

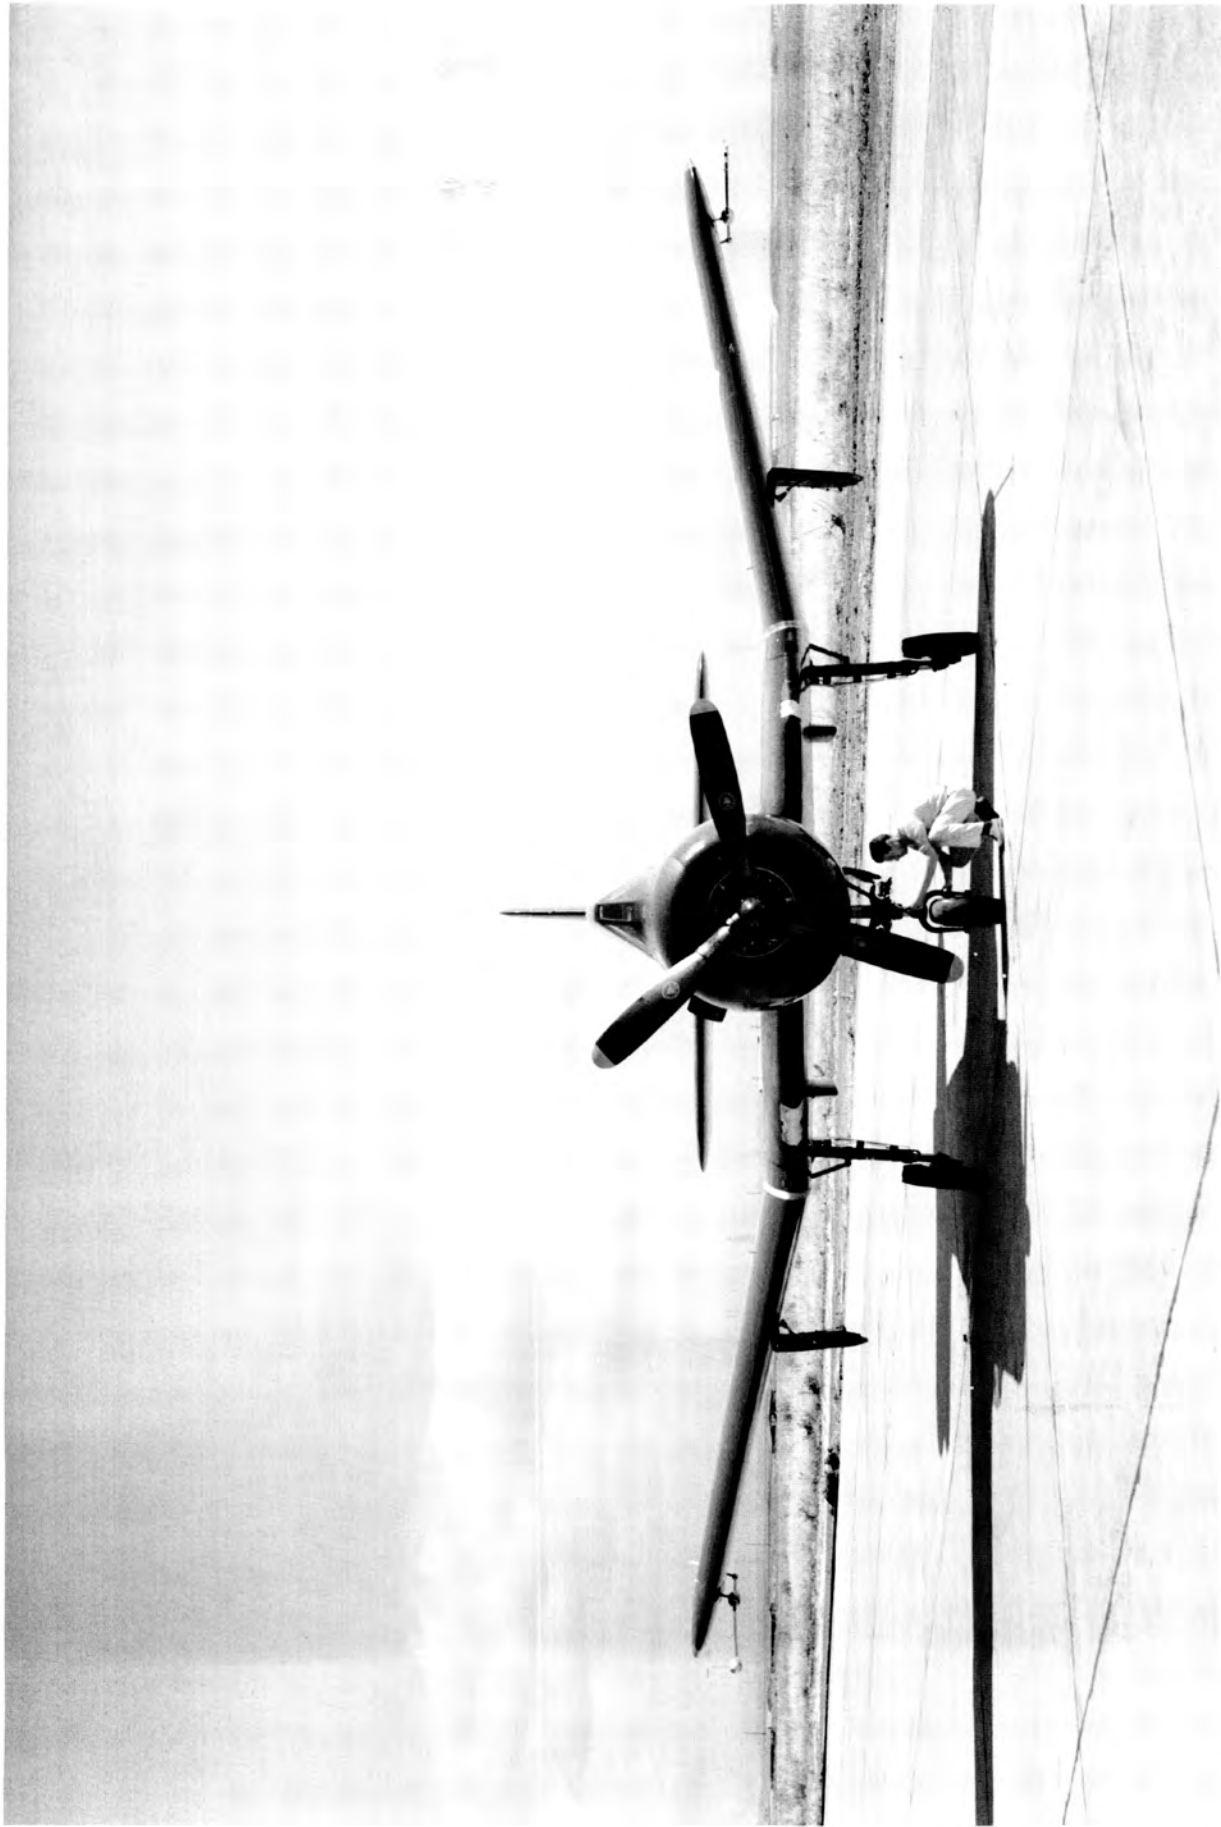
93 *Figure 45. Wind-tunnel tests showed that the lateral stability of the FR-1 Fireball could be improved by increasing the wing dihedral to some optimum degree. Shown here is the FR-1 with the largest dihedral tested—11.5 degrees. (May 1945) A-7959*

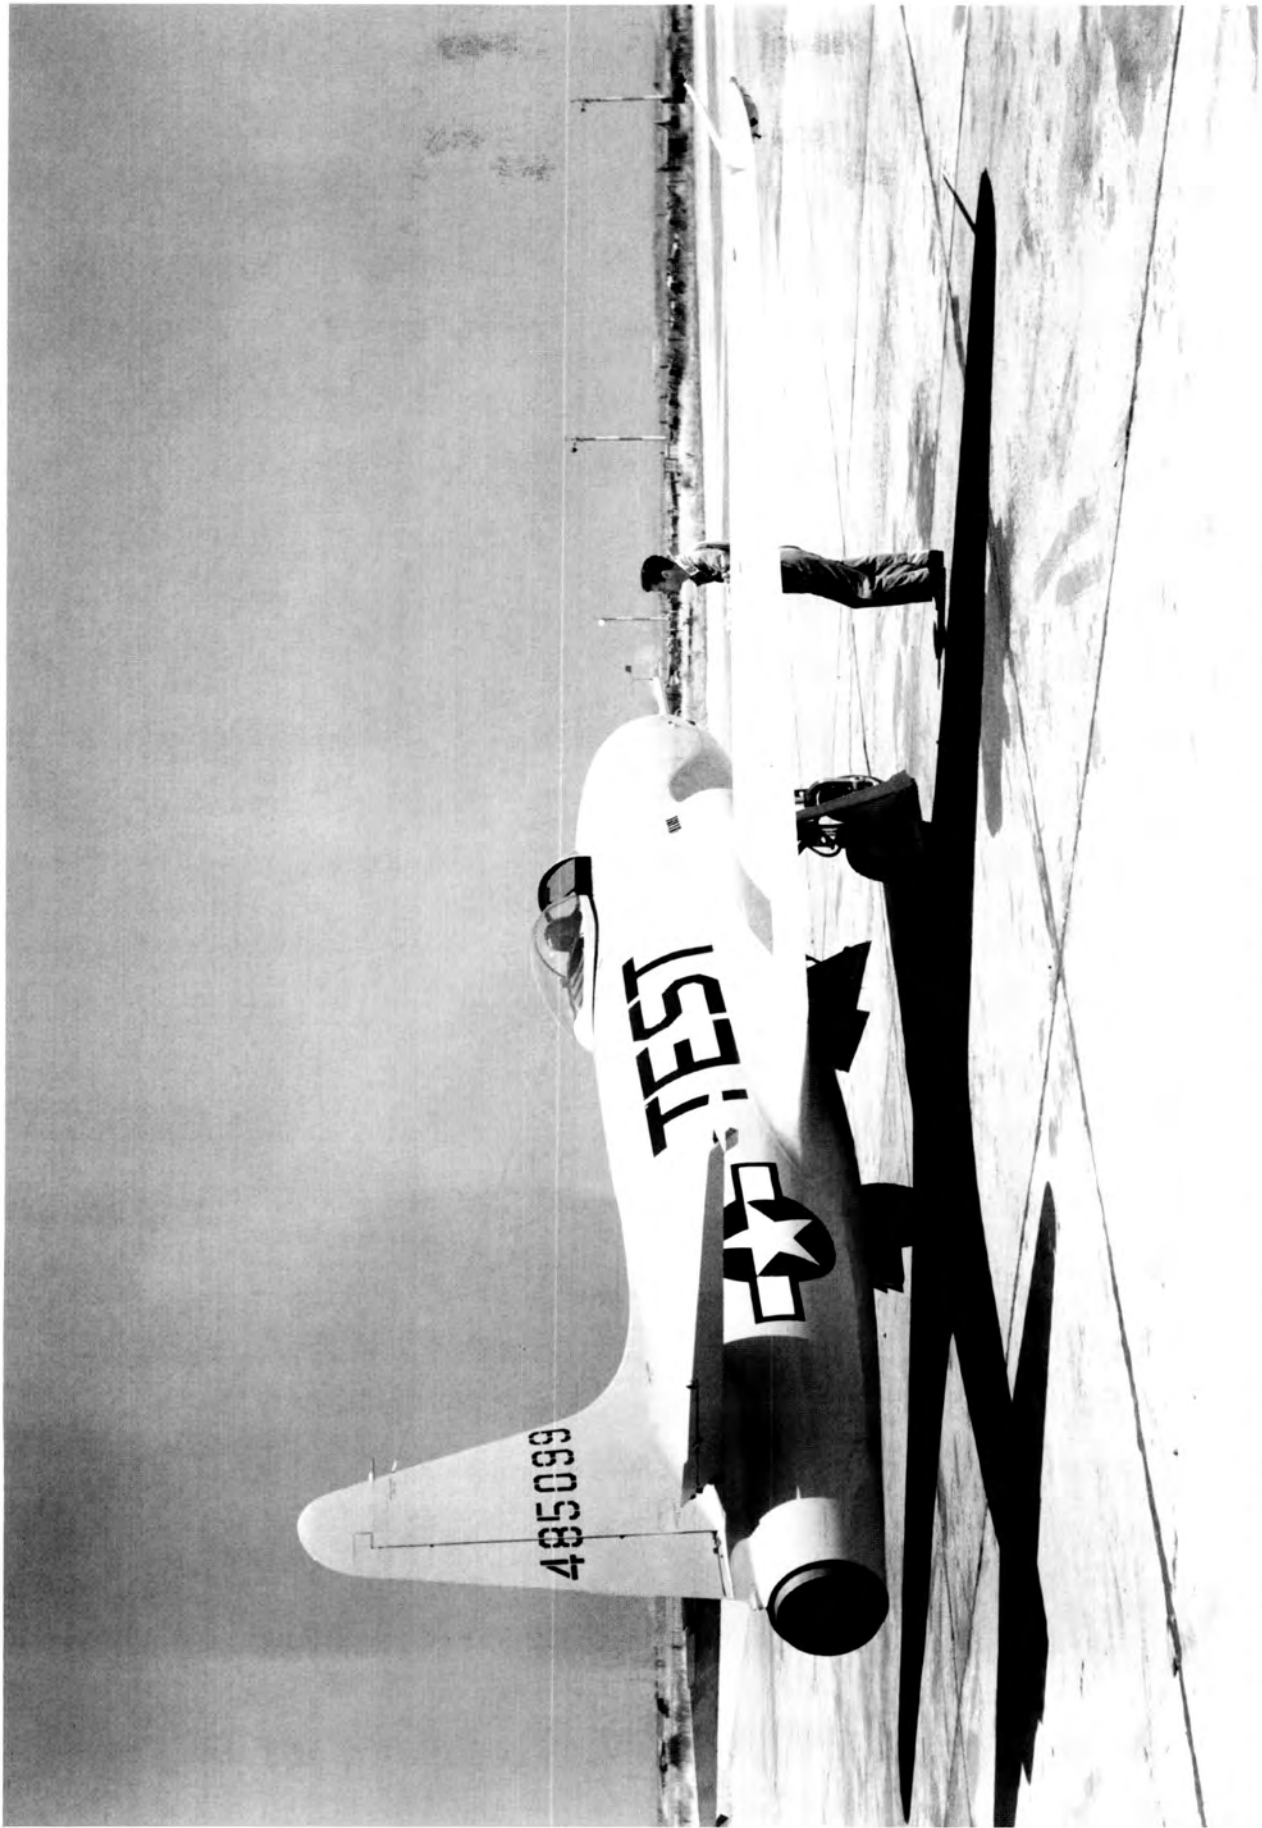
Figure 47. The Lockheed P-80A had a strong diving tendency starting at Mach 0.78 (see fig. 48). (Oct. 1951) A-10141

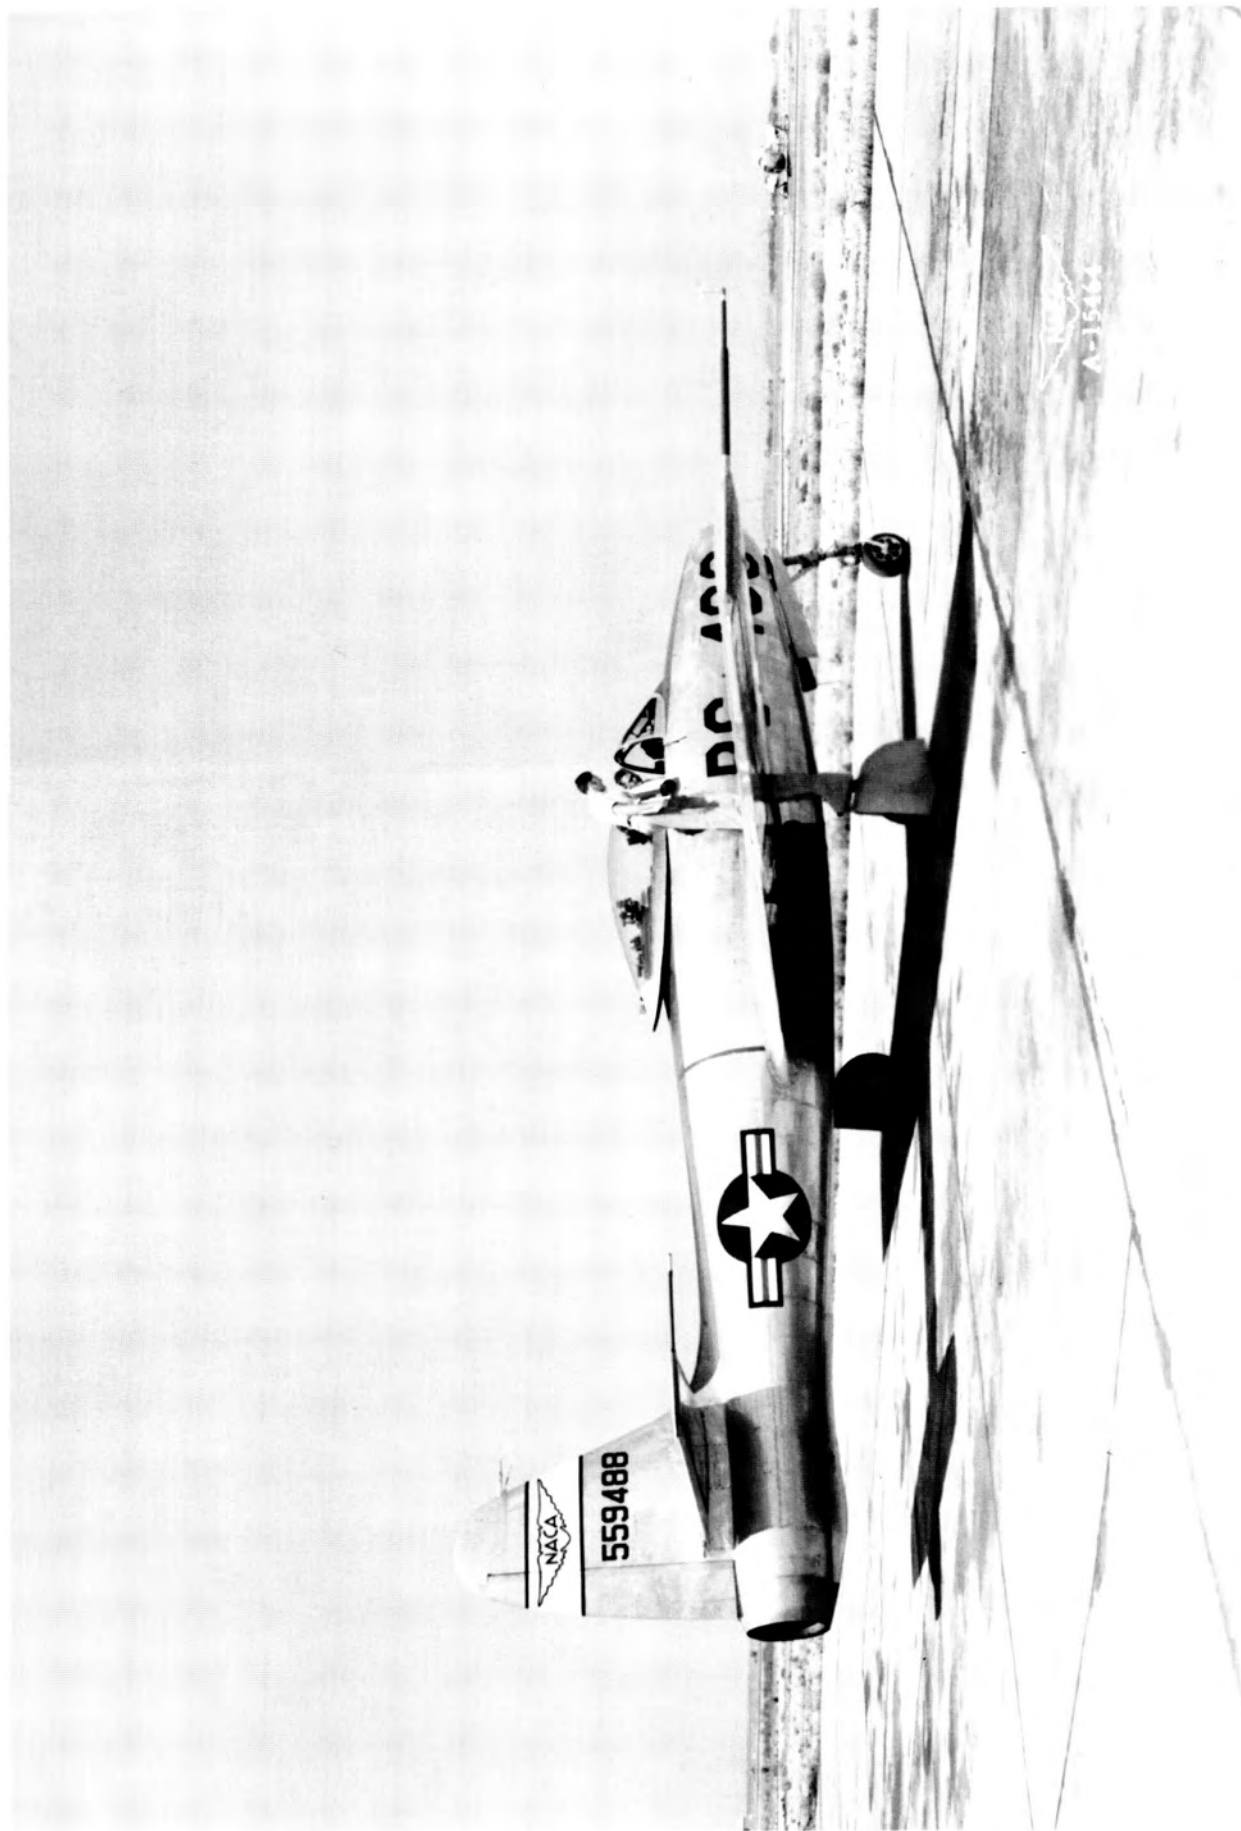
Figure 48. The Republic P-84A had a climbing tendency starting at Mach 0.78 (see fig. 47) A-15464

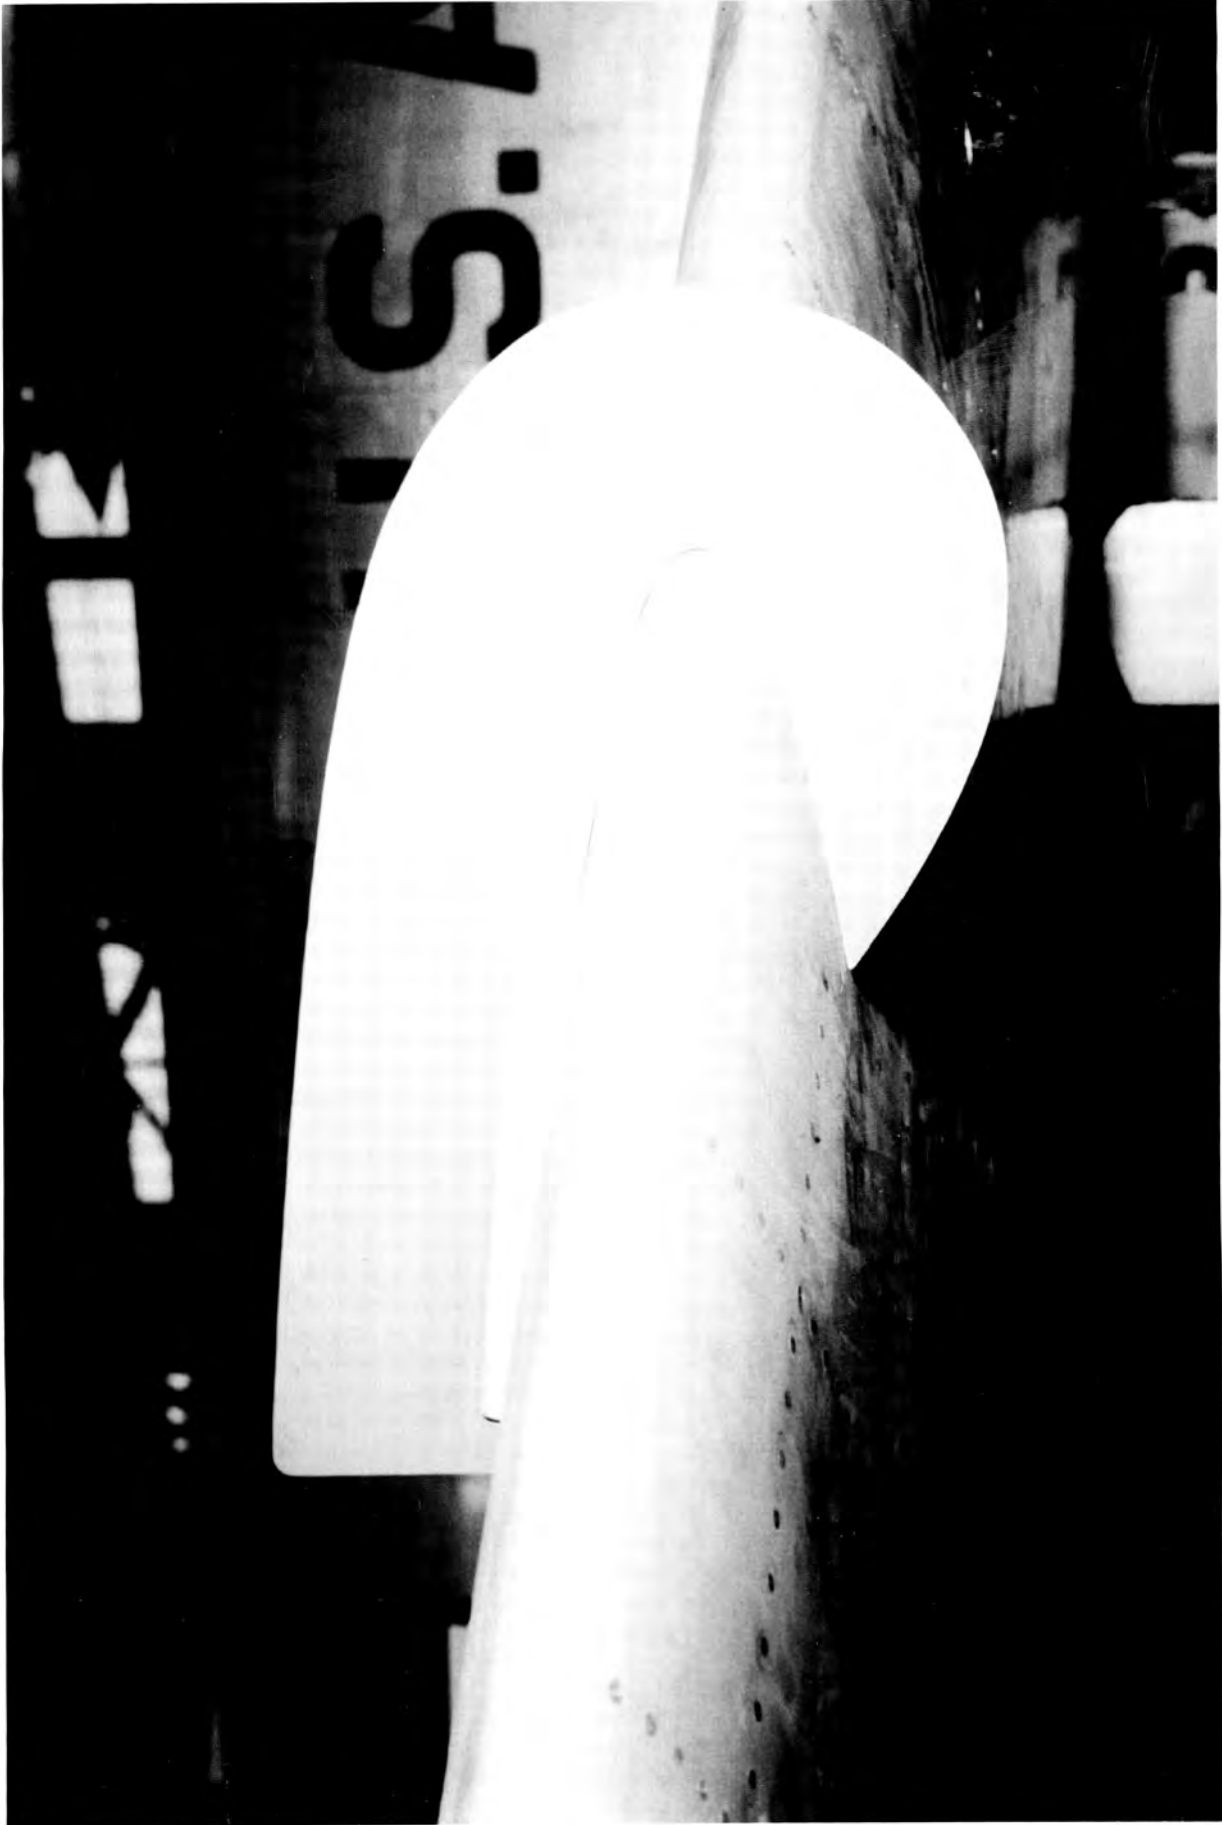
Figure 50. Short-chord fence was installed on the wing leading edge of an F-86A to reduce tendency for the outboard flow of the boundary layer in an effort to improve stall behavior. (May 1954) A-19282

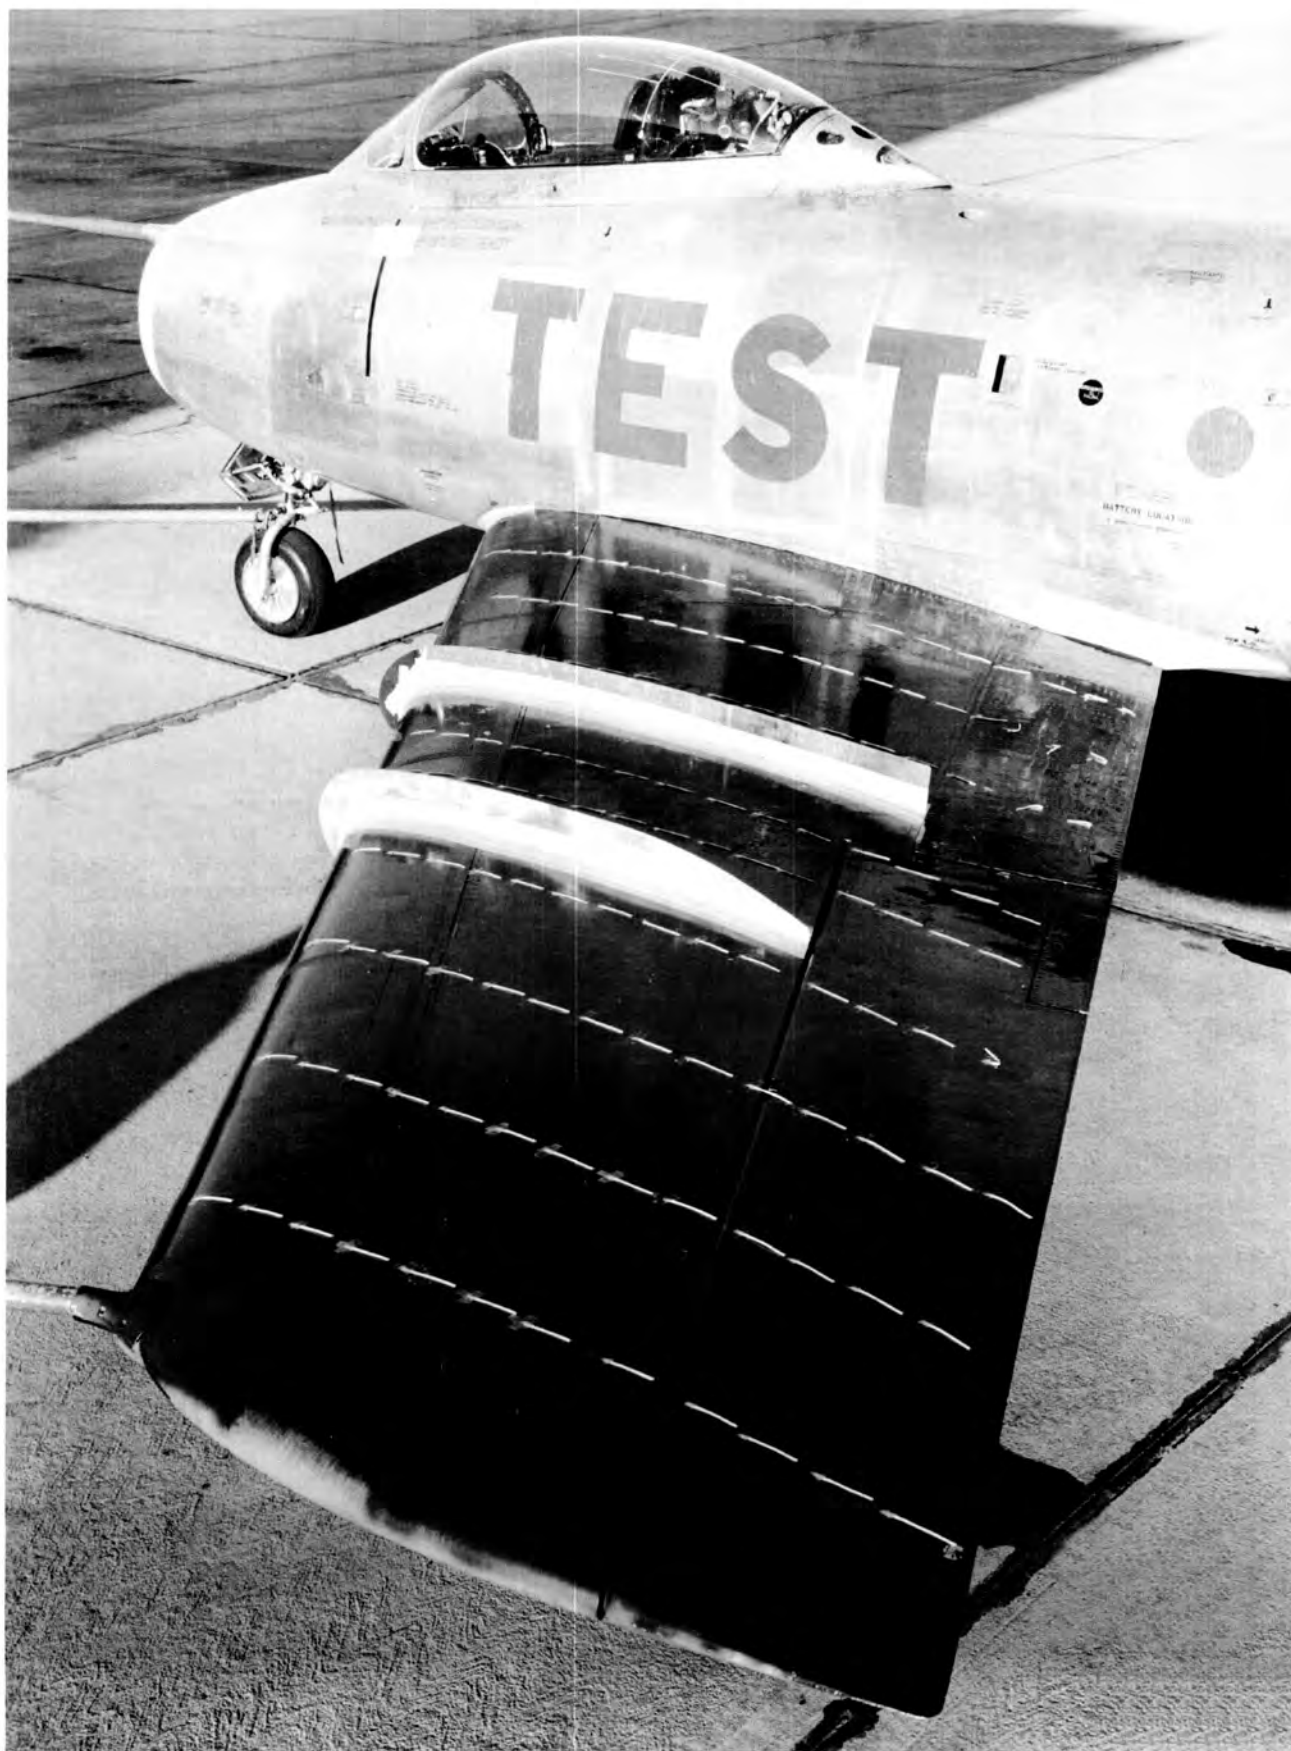
*Figure 51. Multiple fences on F-86A wing reduced flow separation outboard with less roll-off at stall. Additional fences strongly reduced wing maximum lift. (Nov. 1952) A-17733*

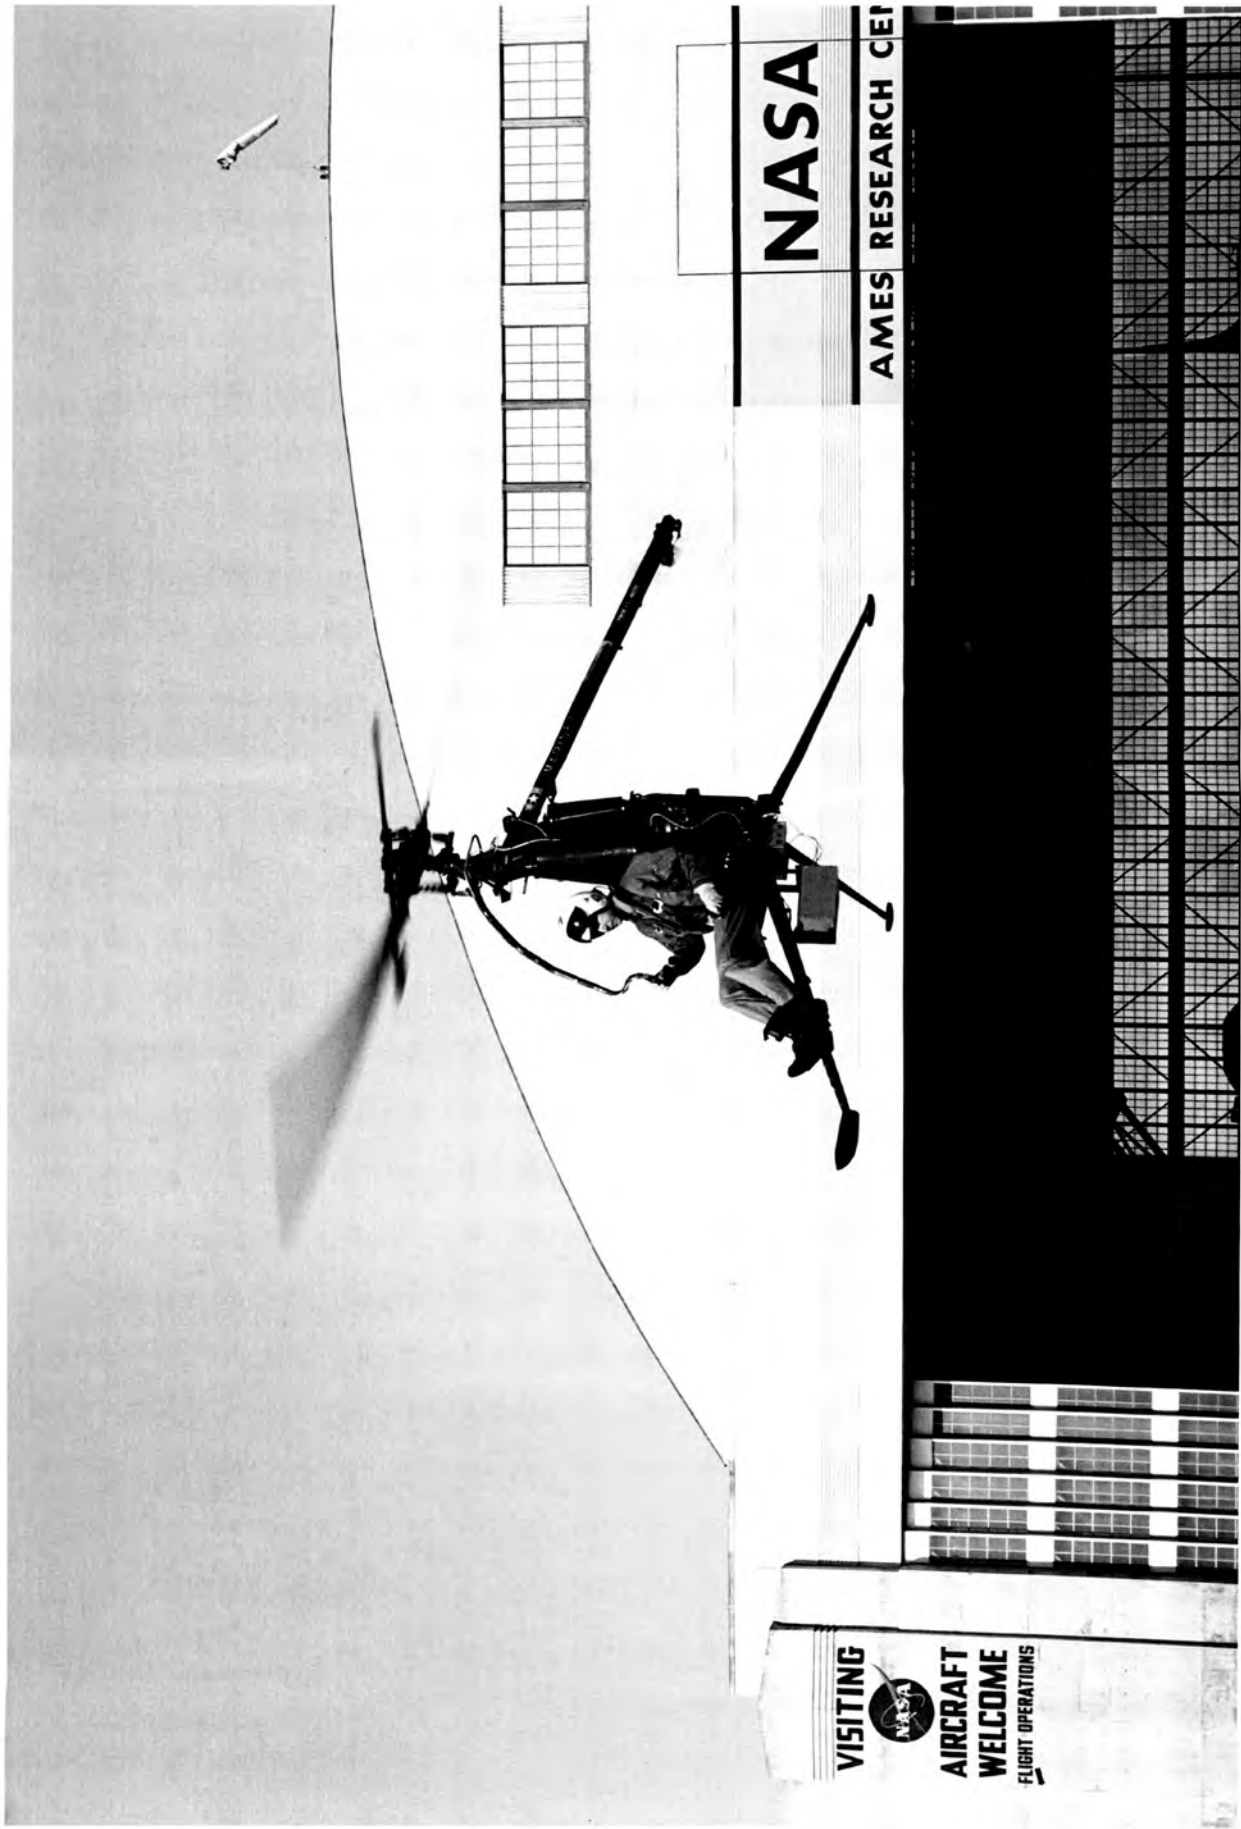
Figure 54. The handling qualities of the Hiller Rotorcycle were evaluated. The Rotorcycle was a small, 500-pound, single-place helicopter. Tests indicated that the vehicle was unsafe because of low yaw-control capability to the right; the design also had poor crashworthiness. (Sept. 1963) A-31028

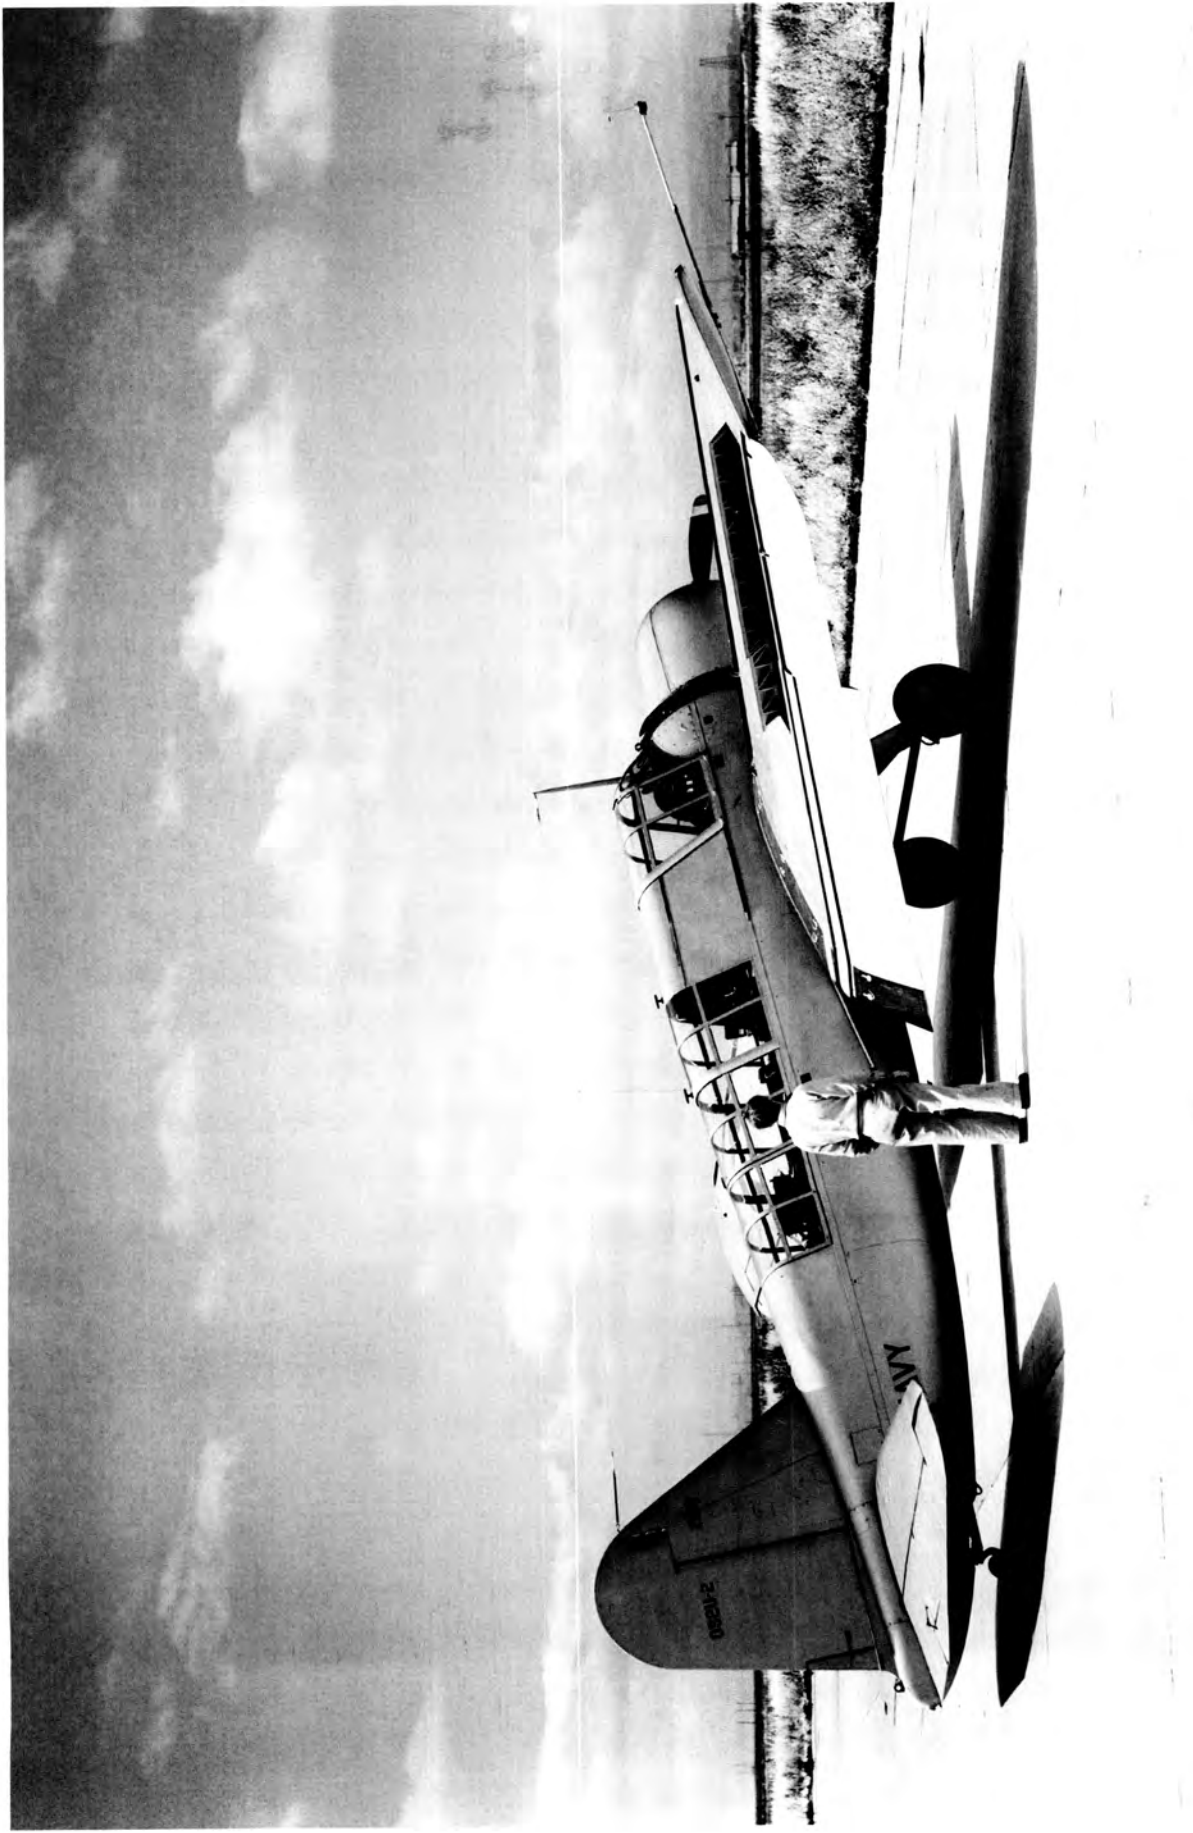
Figure 55. Vought-Sikorsky OS2U-2 Kingfisher single-engine Navy aircraft with flaps and spoilers deflected. The Kingfisher was powered by a 450-horsepower Pratt & Whitney engine; it was a versatile Navy observation aircraft, sometimes flown with floats. (Mar. 1942) AAL-2237

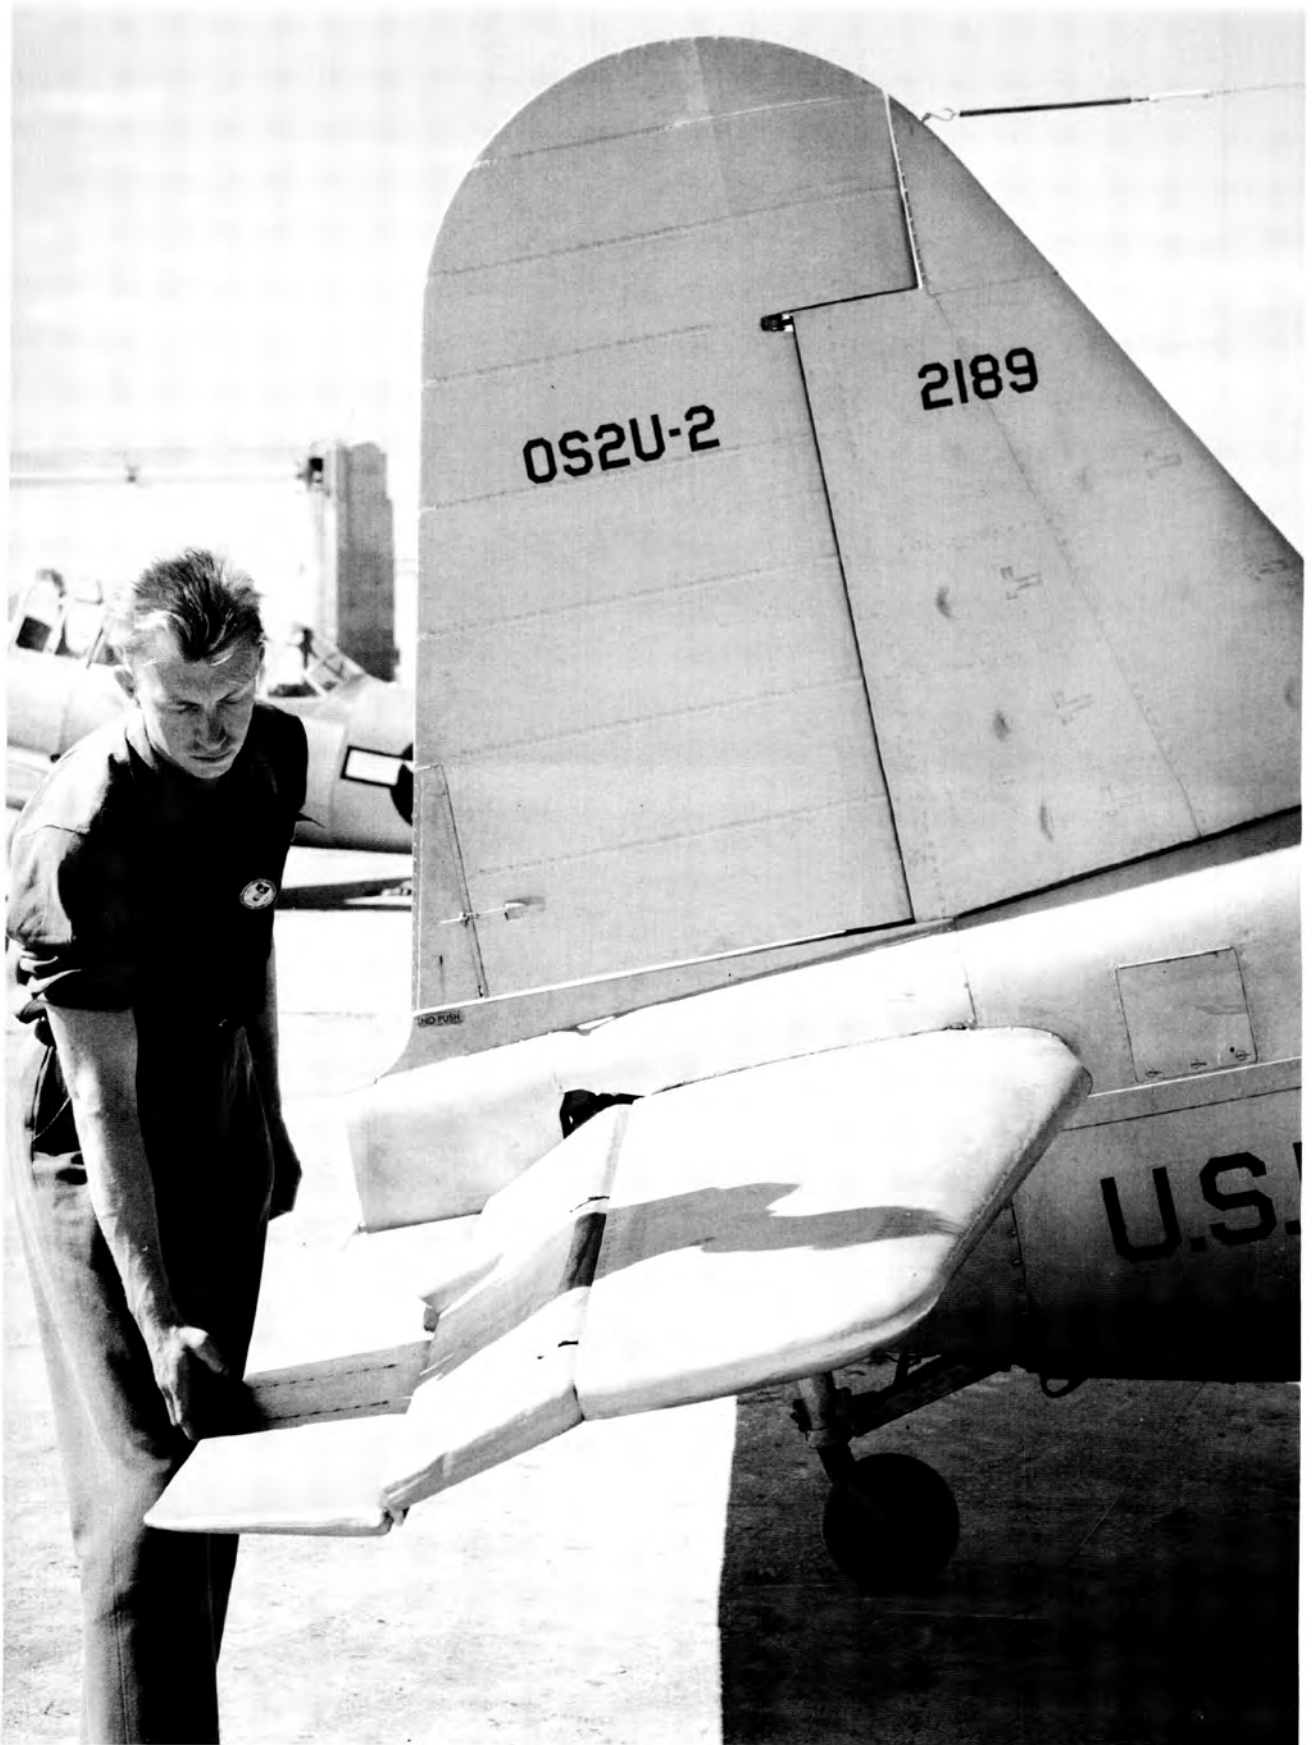
Figure 56. Ames-designed, double-hinged horizontal tail mounted on the OS2U-2 Kingfisher provided increased lift for maneuvering and landing (Vultee BT-13 in background). (Feb. 1945) A-7431
