NASA/SP-2002-4526

# ***MEMOIRS OF AN AERONAUTICAL ENGINEER***

**Flight Tests at Ames Research Center:  
1940-1970**

**Seth B. Anderson**

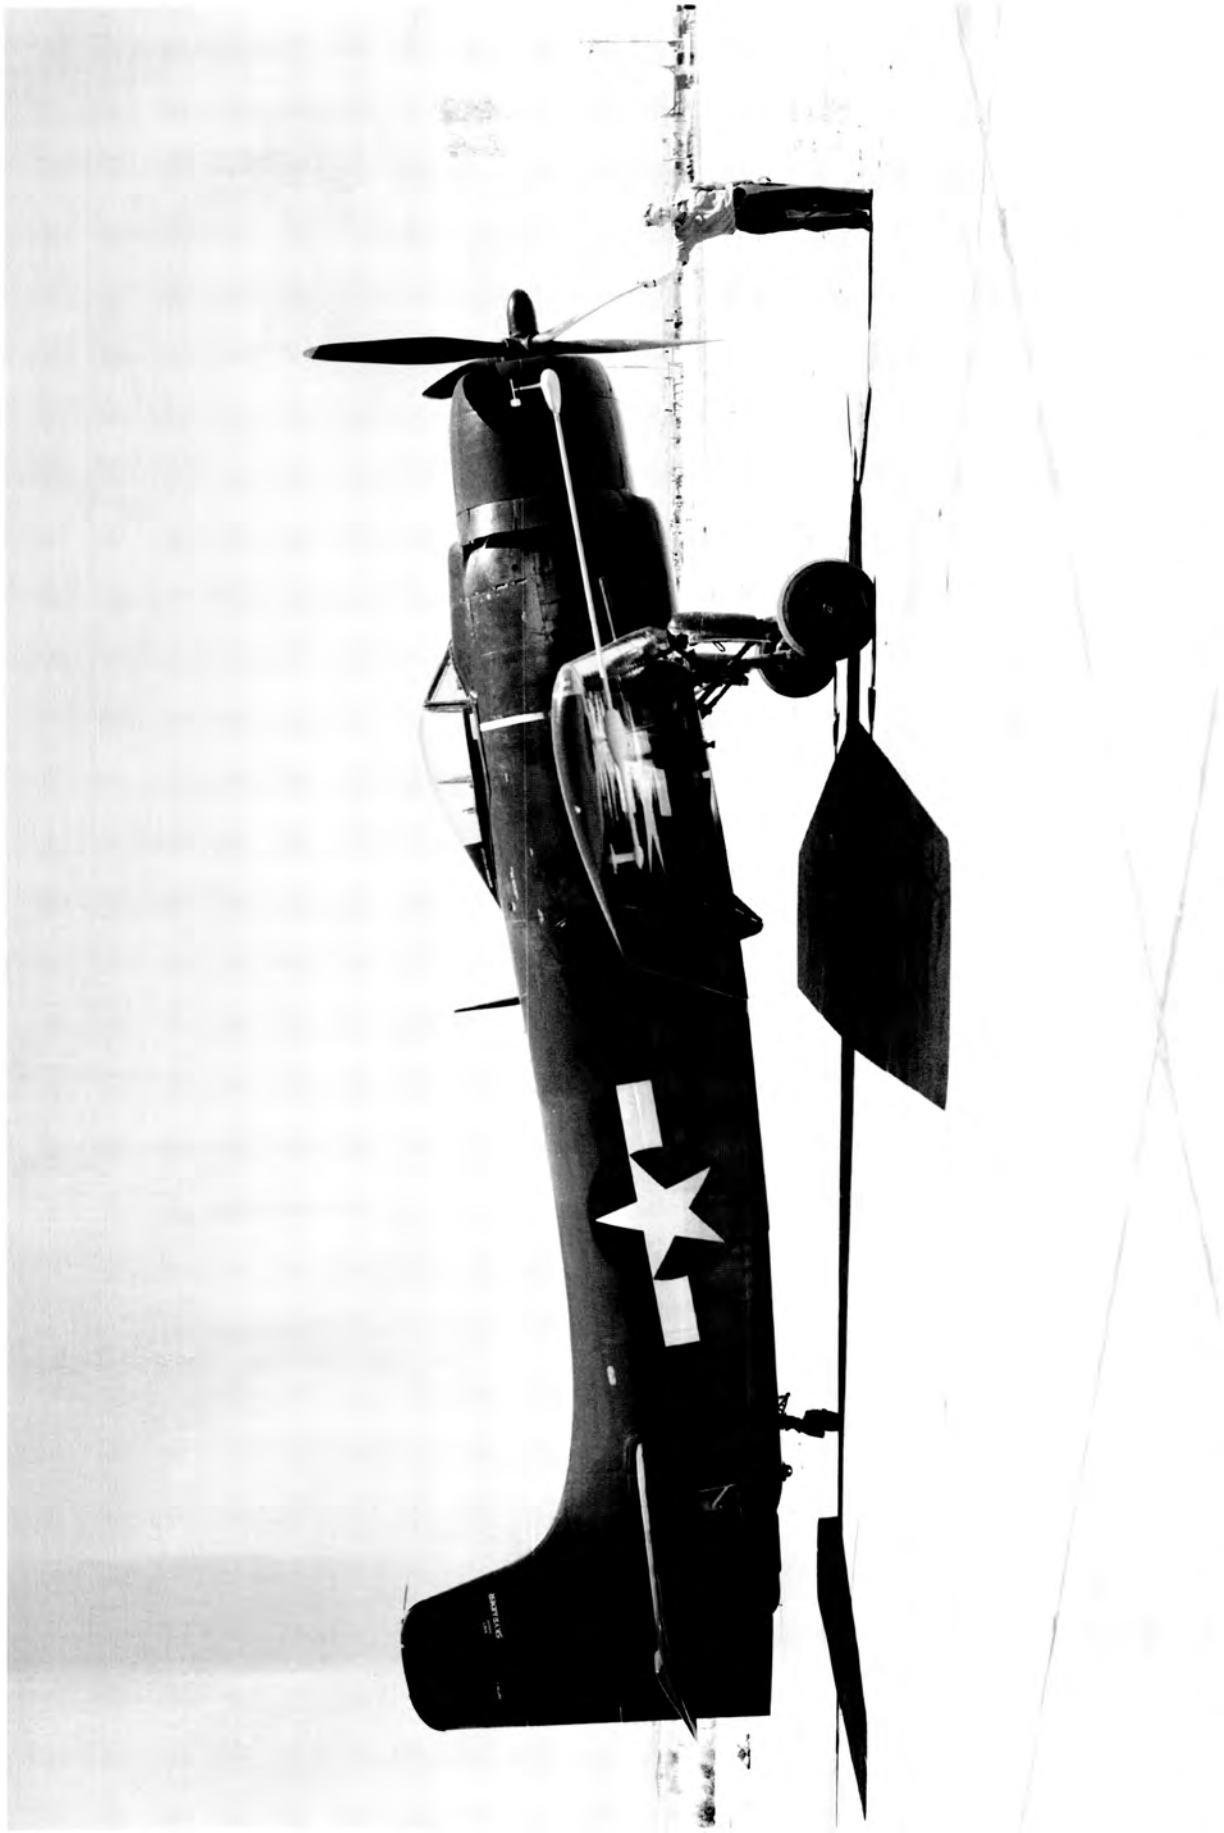
Figure 57. Douglas XBT2D-1 Skyraider, a Navy carrier-based aircraft, powered by a Wright R-3350 2,700-horsepower engine with research instrumentation. The aircraft had serious handling-quality deficiencies, including lack of stall warning and large roll-off at stall. (June 1946) A-10034

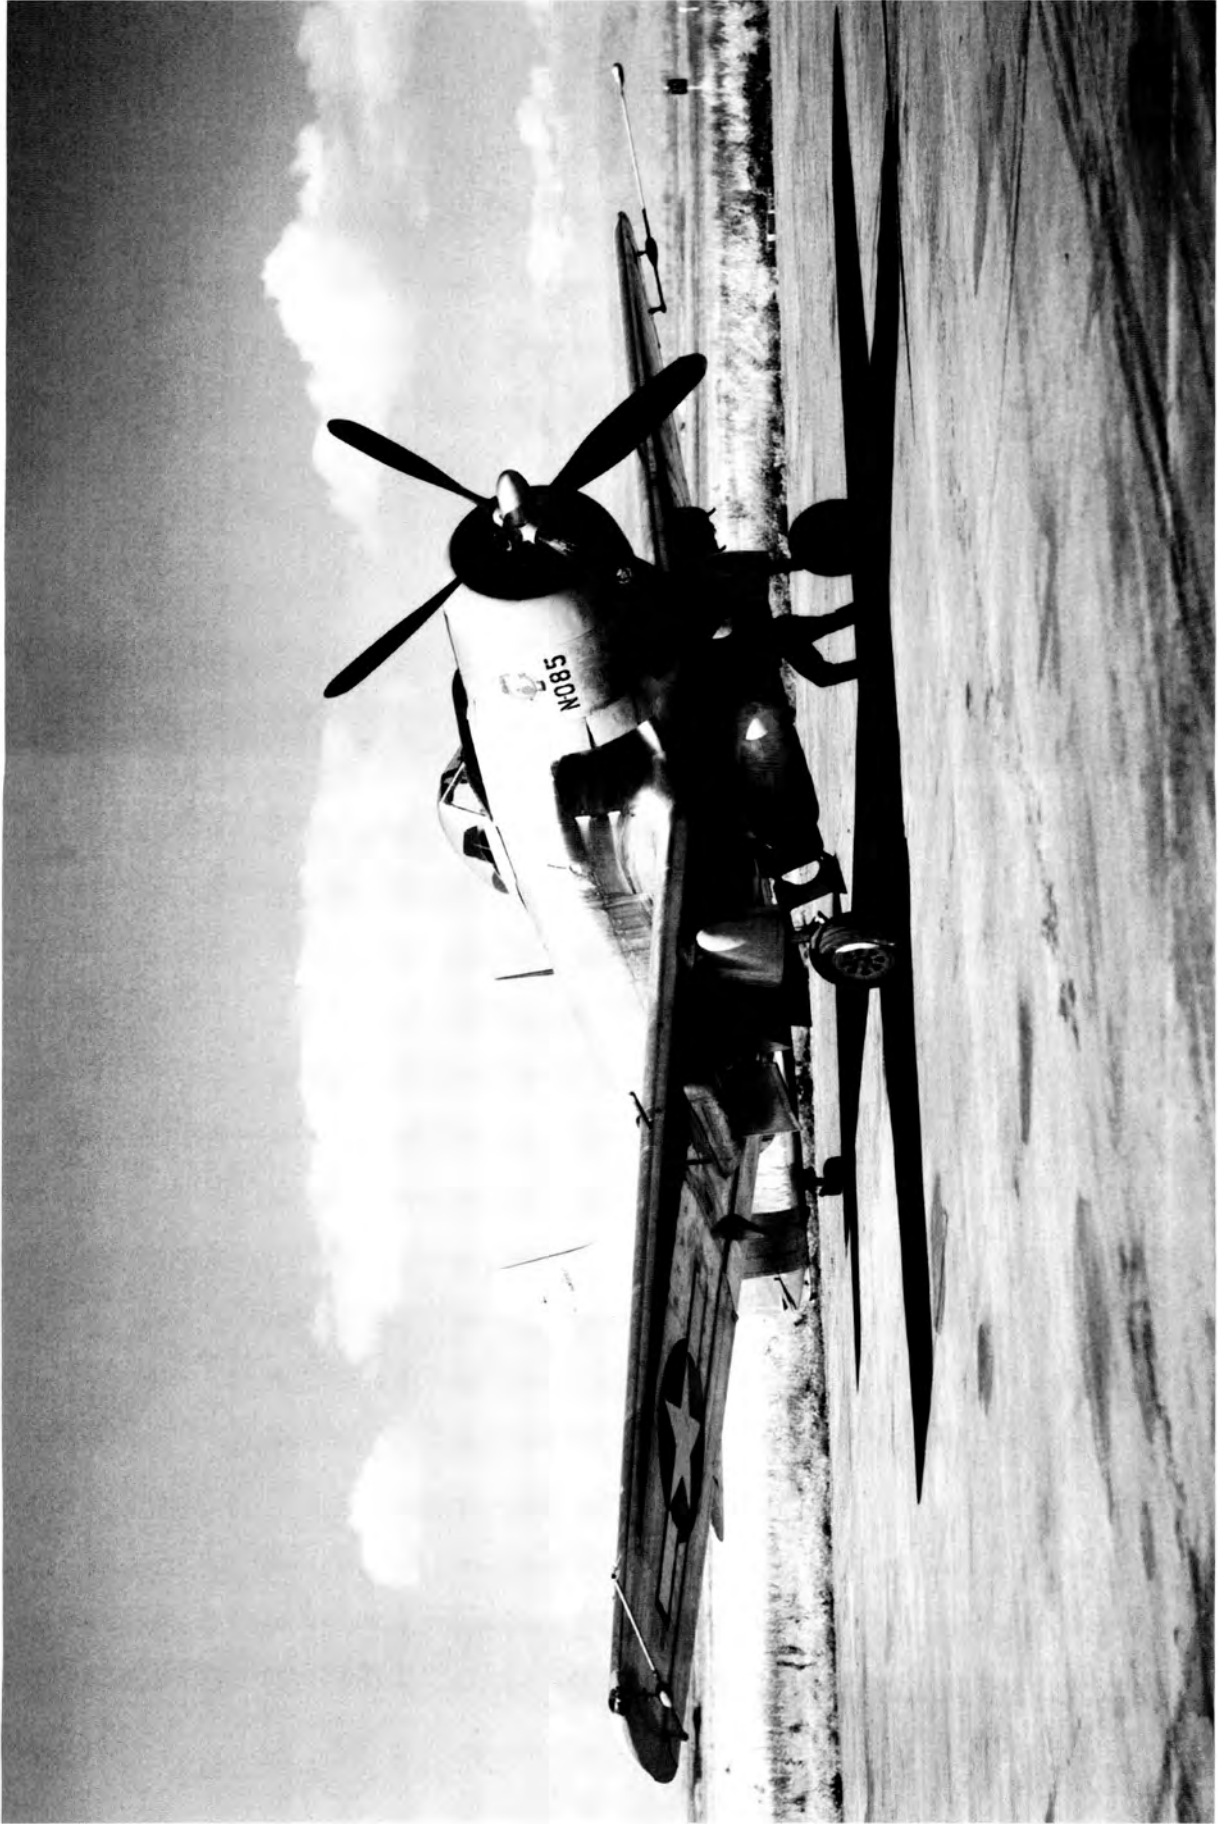
Figure 58. Douglas XBT2D-1 Skyraider carrier-based aircraft with 2,000-pound torpedo attached. The Skyraider was a dive-bomber land-based airplane that was also carrier-based. This installation did not influence flying qualities. (July 1946) A-7985

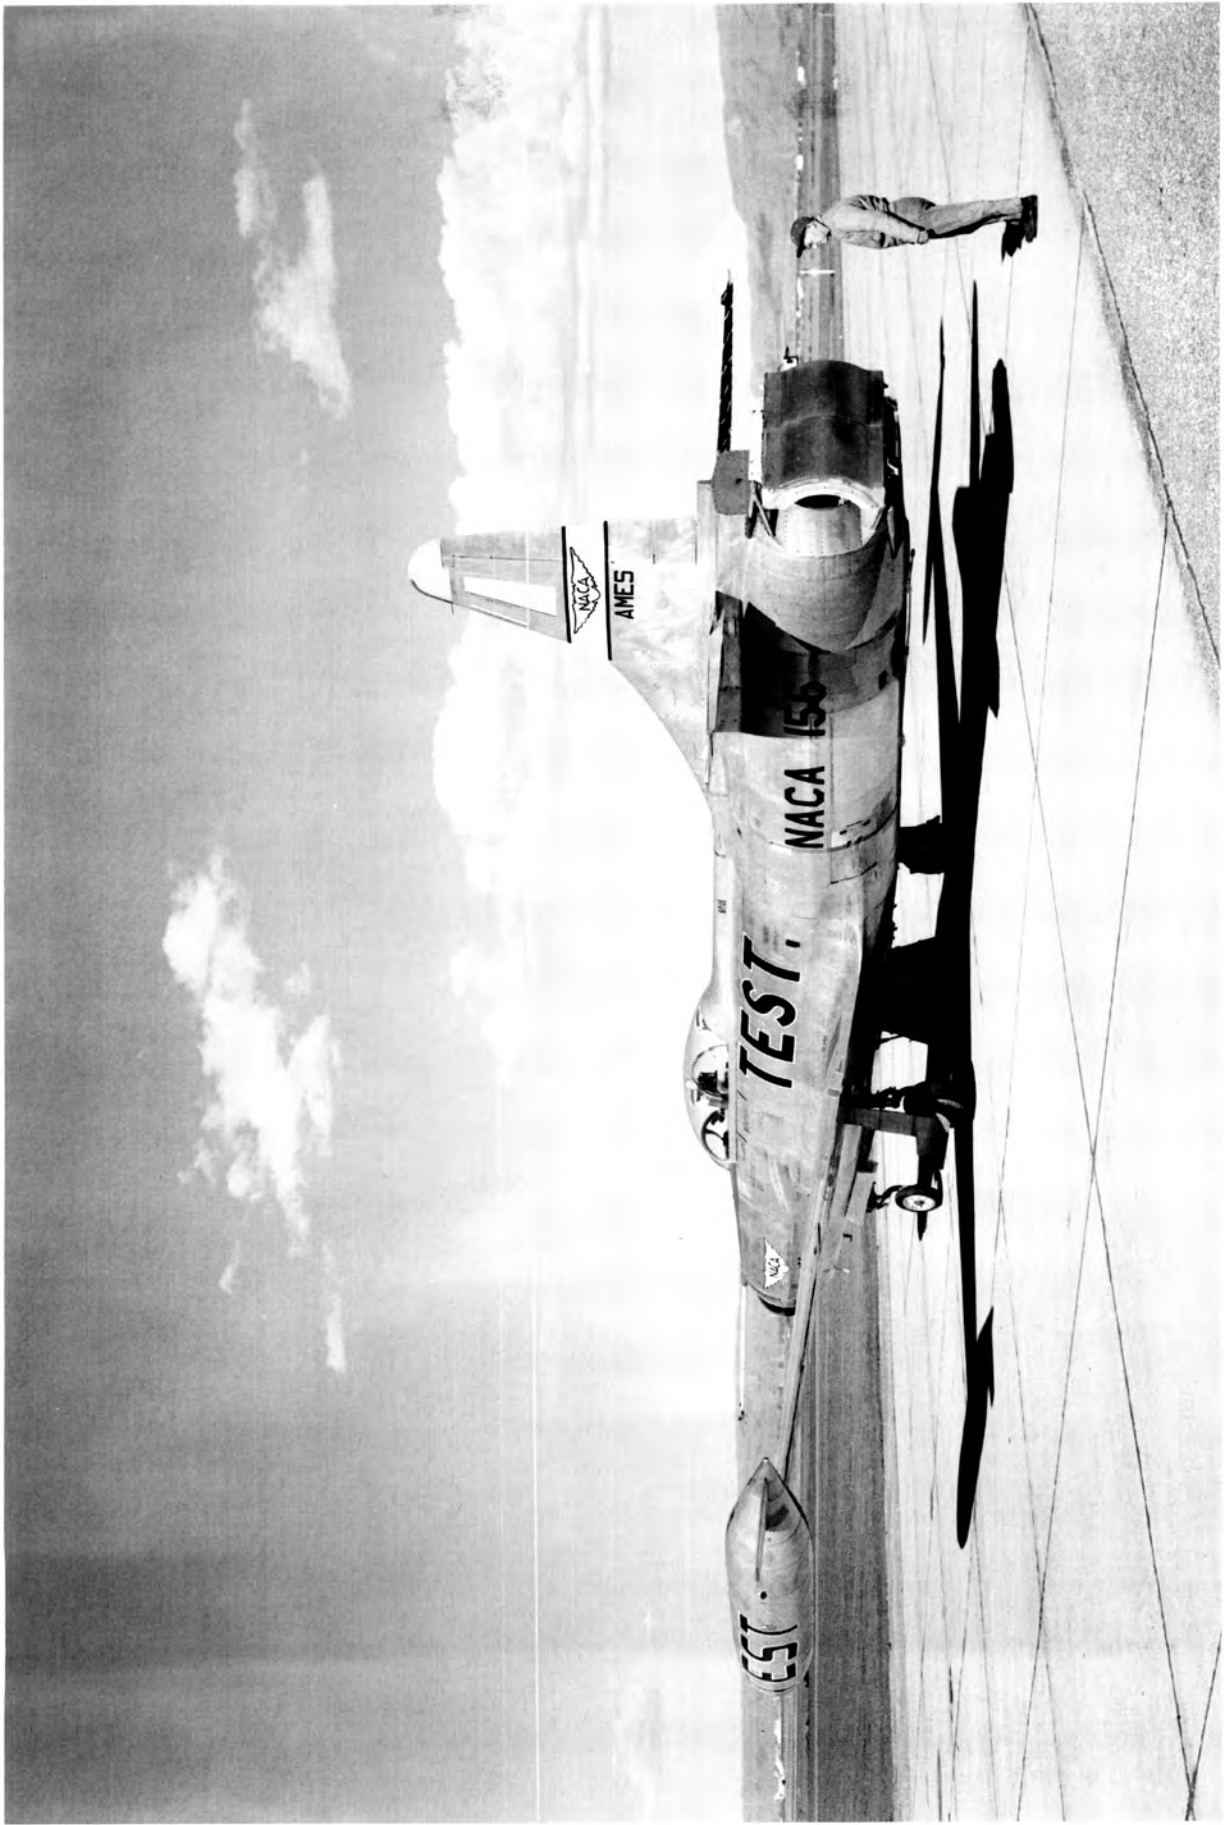
Figure 59. Lockheed F-94C Starfire with Ames-designed, -built, and -flight-tested target-type thrust reverser deployed. Ground roll was reduced 50% by using full reverse thrust. (Feb. 1958) A-23663

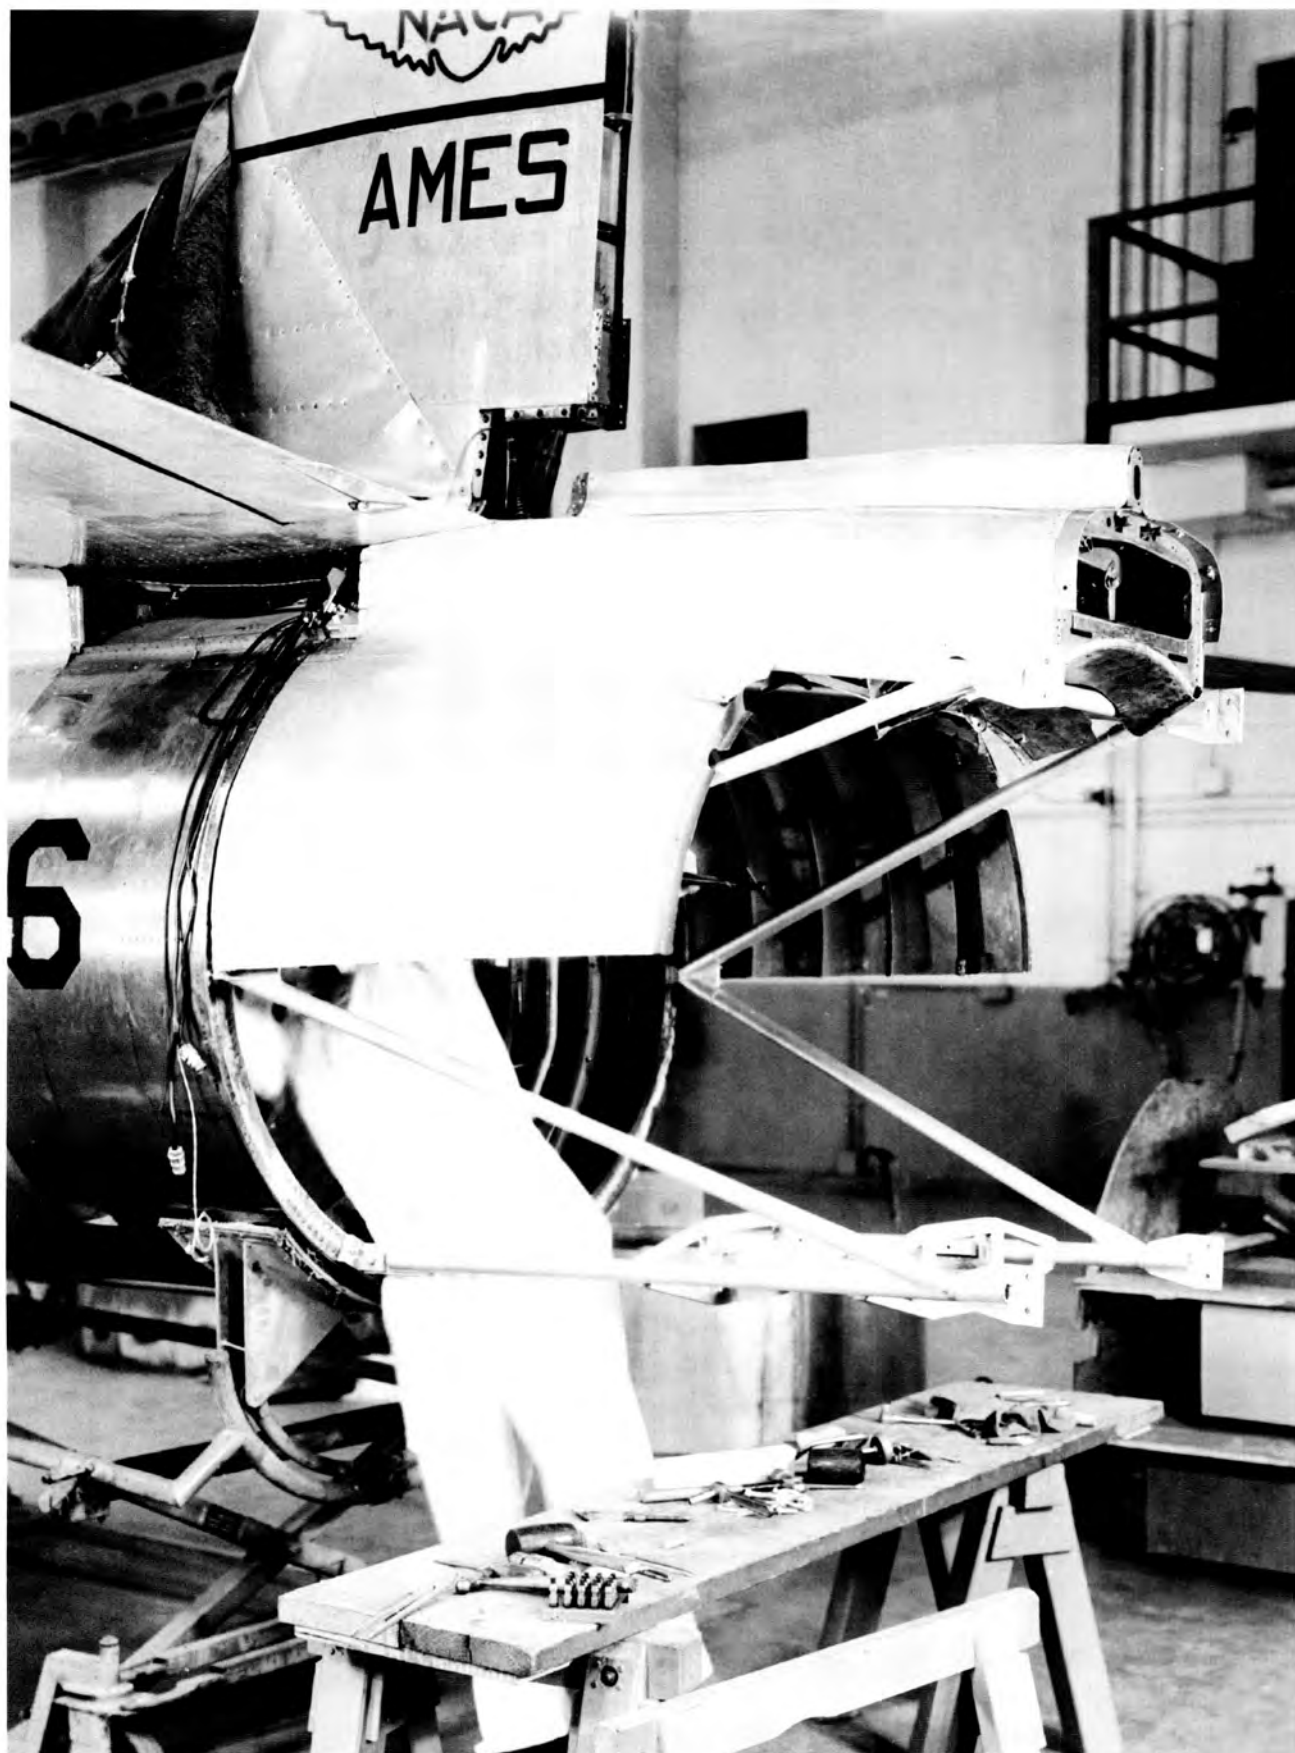
Figure 60. The F-94C's rear fuselage was modified in the Ames sheet metal shop to accommodate installation of Ames-designed thrust reverser. Afterburner equipment used on the F-94C has been removed. (Aug. 1957) A-22727

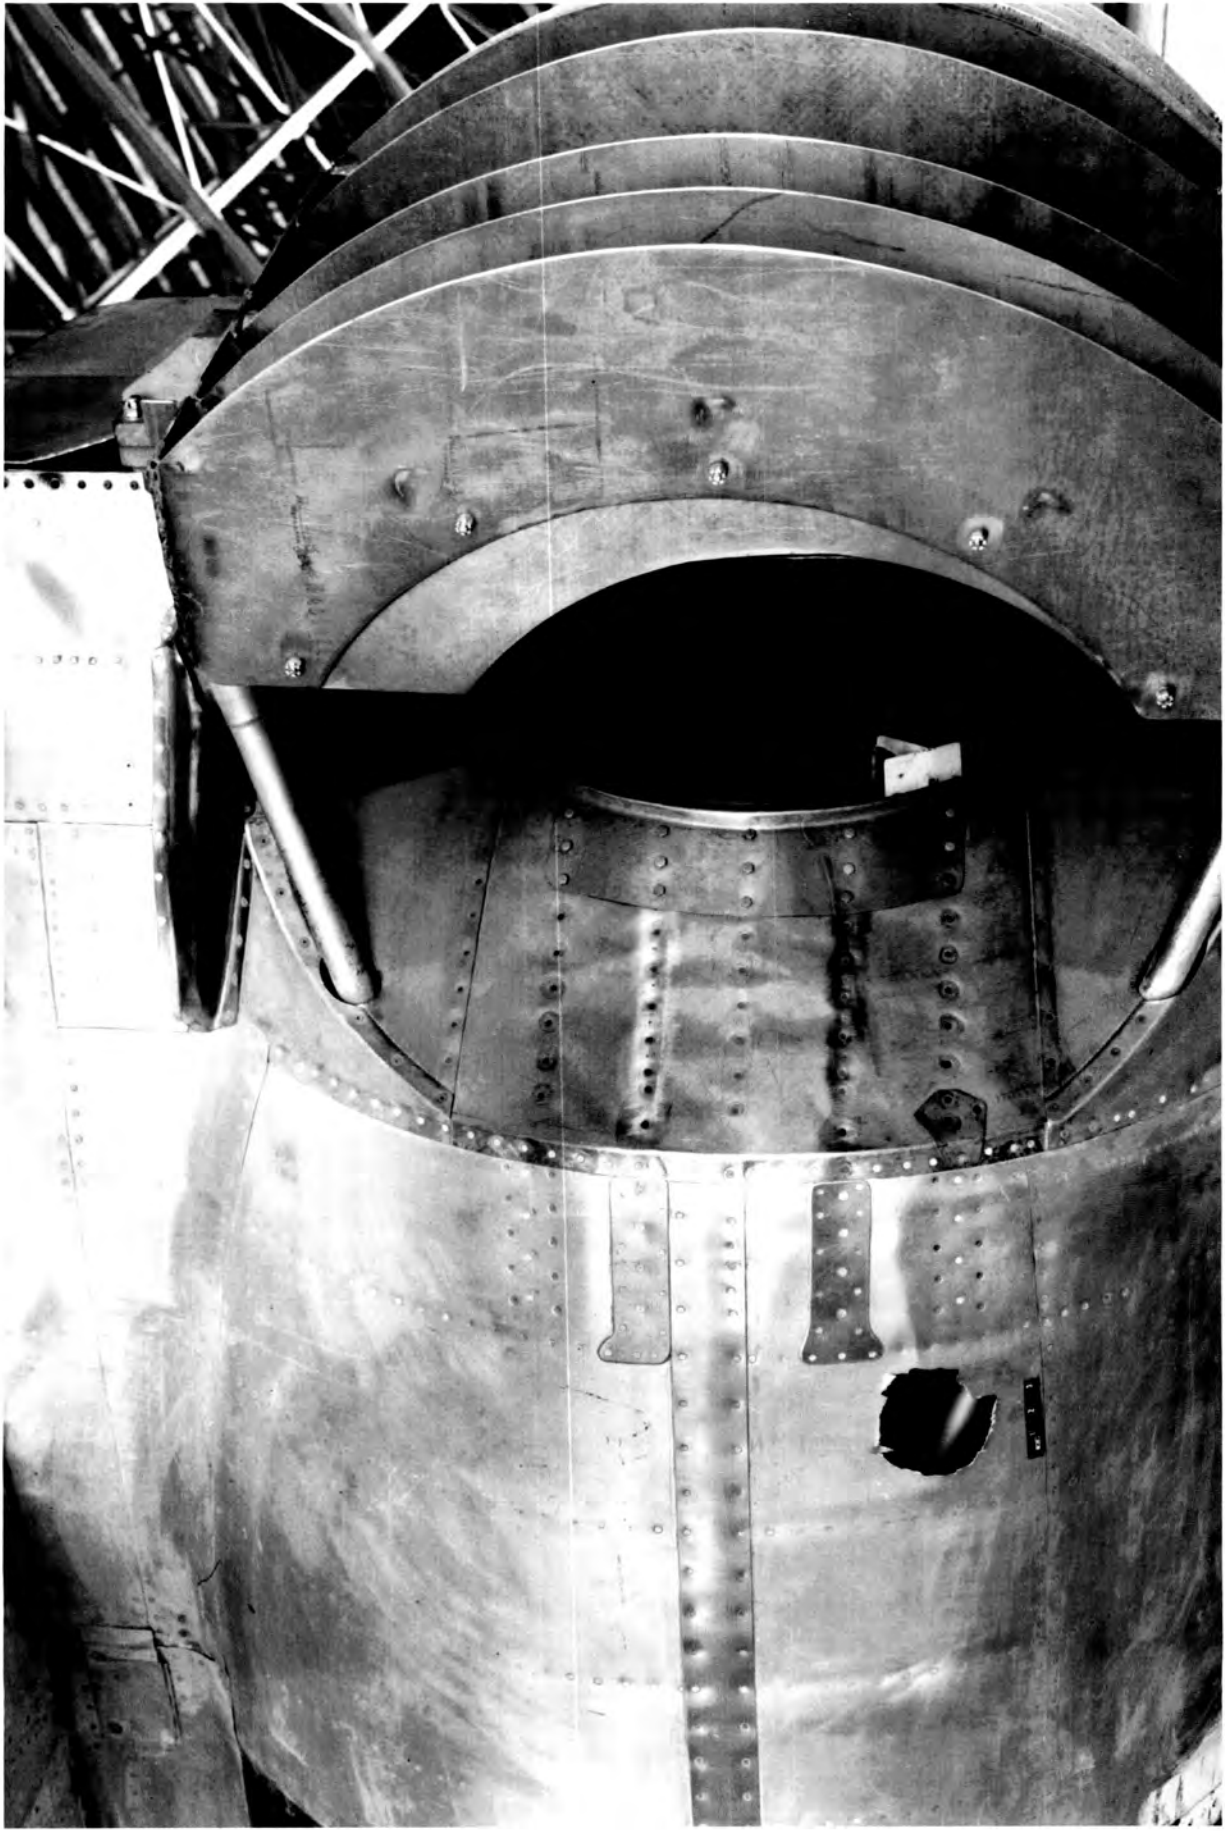
Figure 61. Close-up of damage to rear fuselage of F-94C Starfire caused by hot engine exhaust gases during prolonged use of thrust reverser in landing rollout. Fairing to cover rear portion of reverser has yet to be added. (Sept. 1957) A-23157

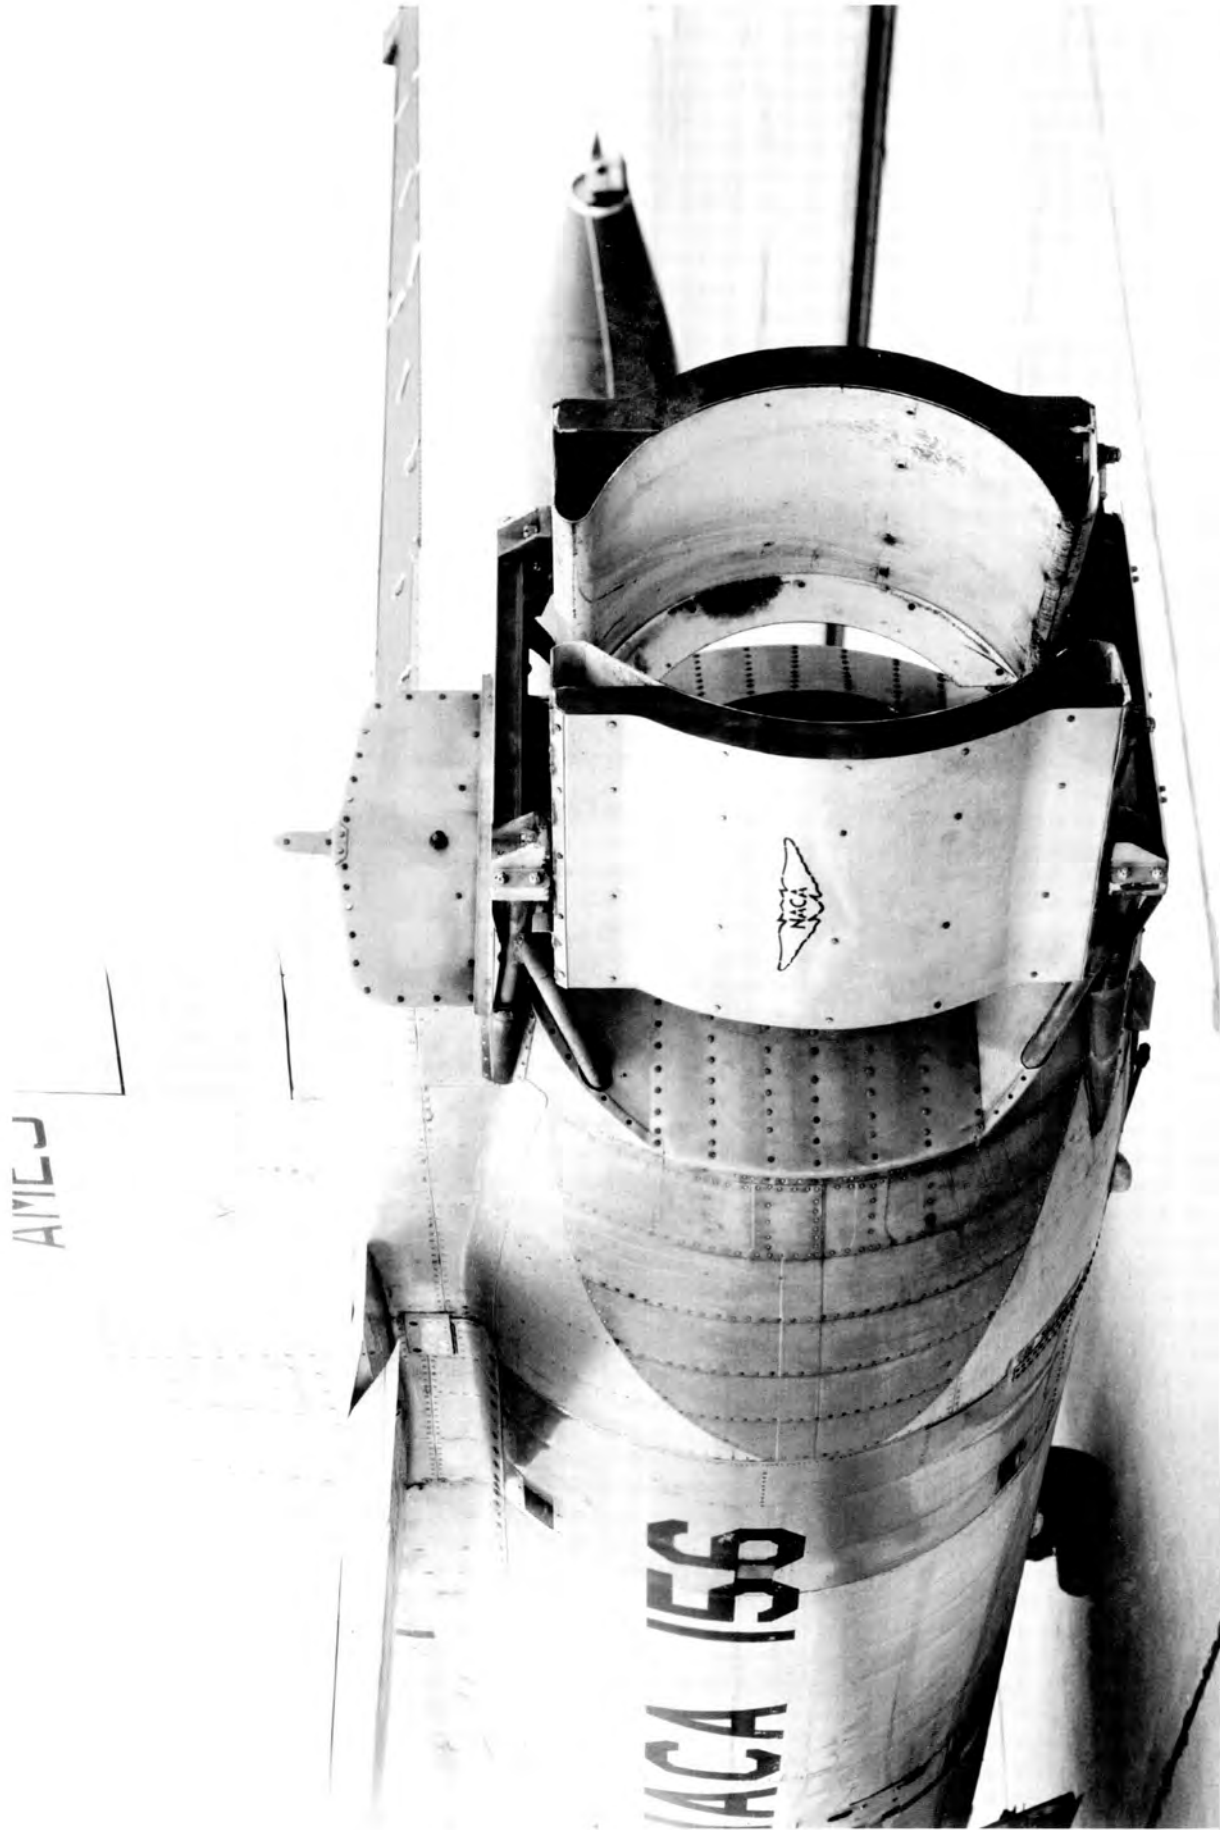
Figure 62. Close-up of target-type thrust reverser in forward thrust position (on F-94C Starfire). Titanium skin was added on the rear fuselage to withstand high-temperature environment. (1958) A-24153-2A

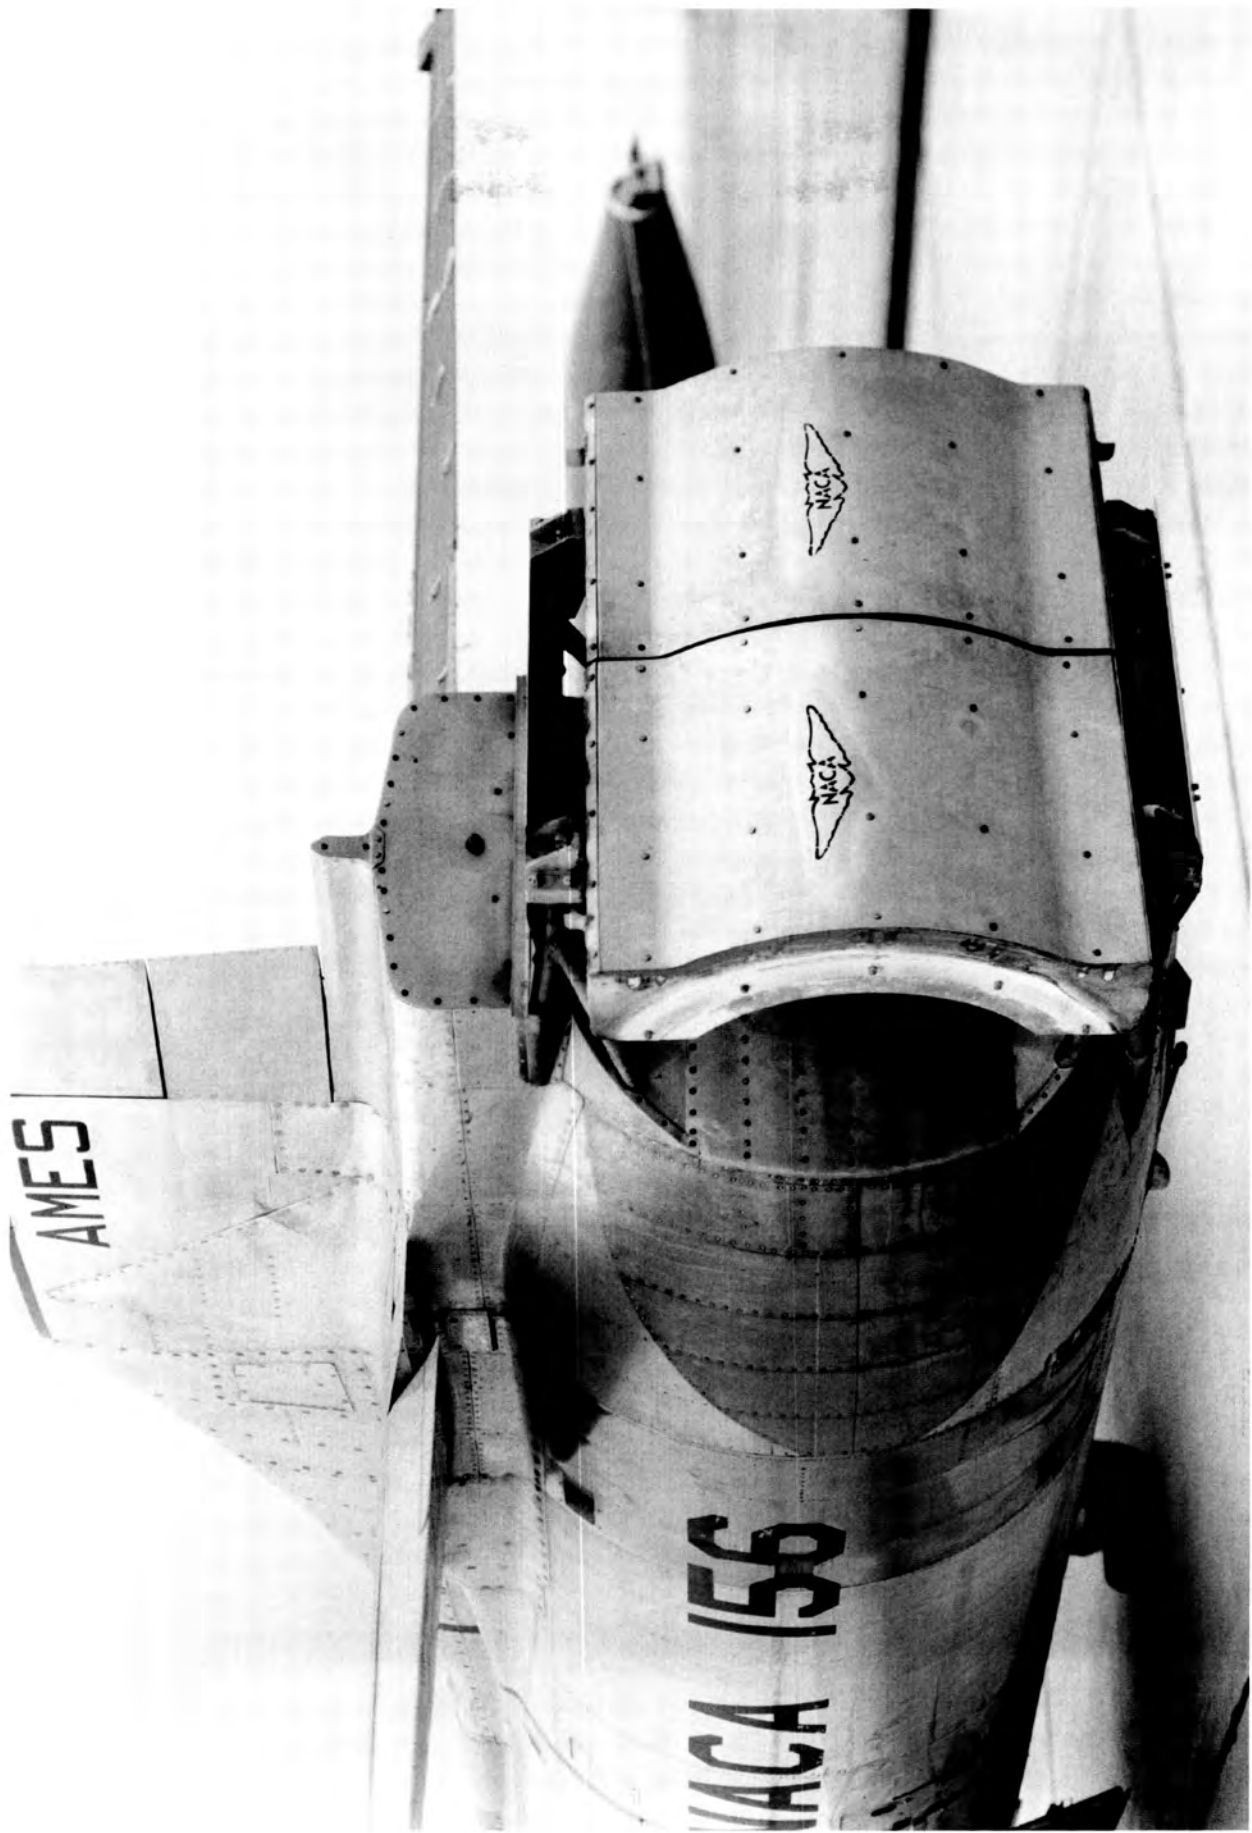
Figure 63. The thrust reverser on the F-94C Starfire was moved by an Ames-developed hydraulic actuator system. (1958) A-24153-1B

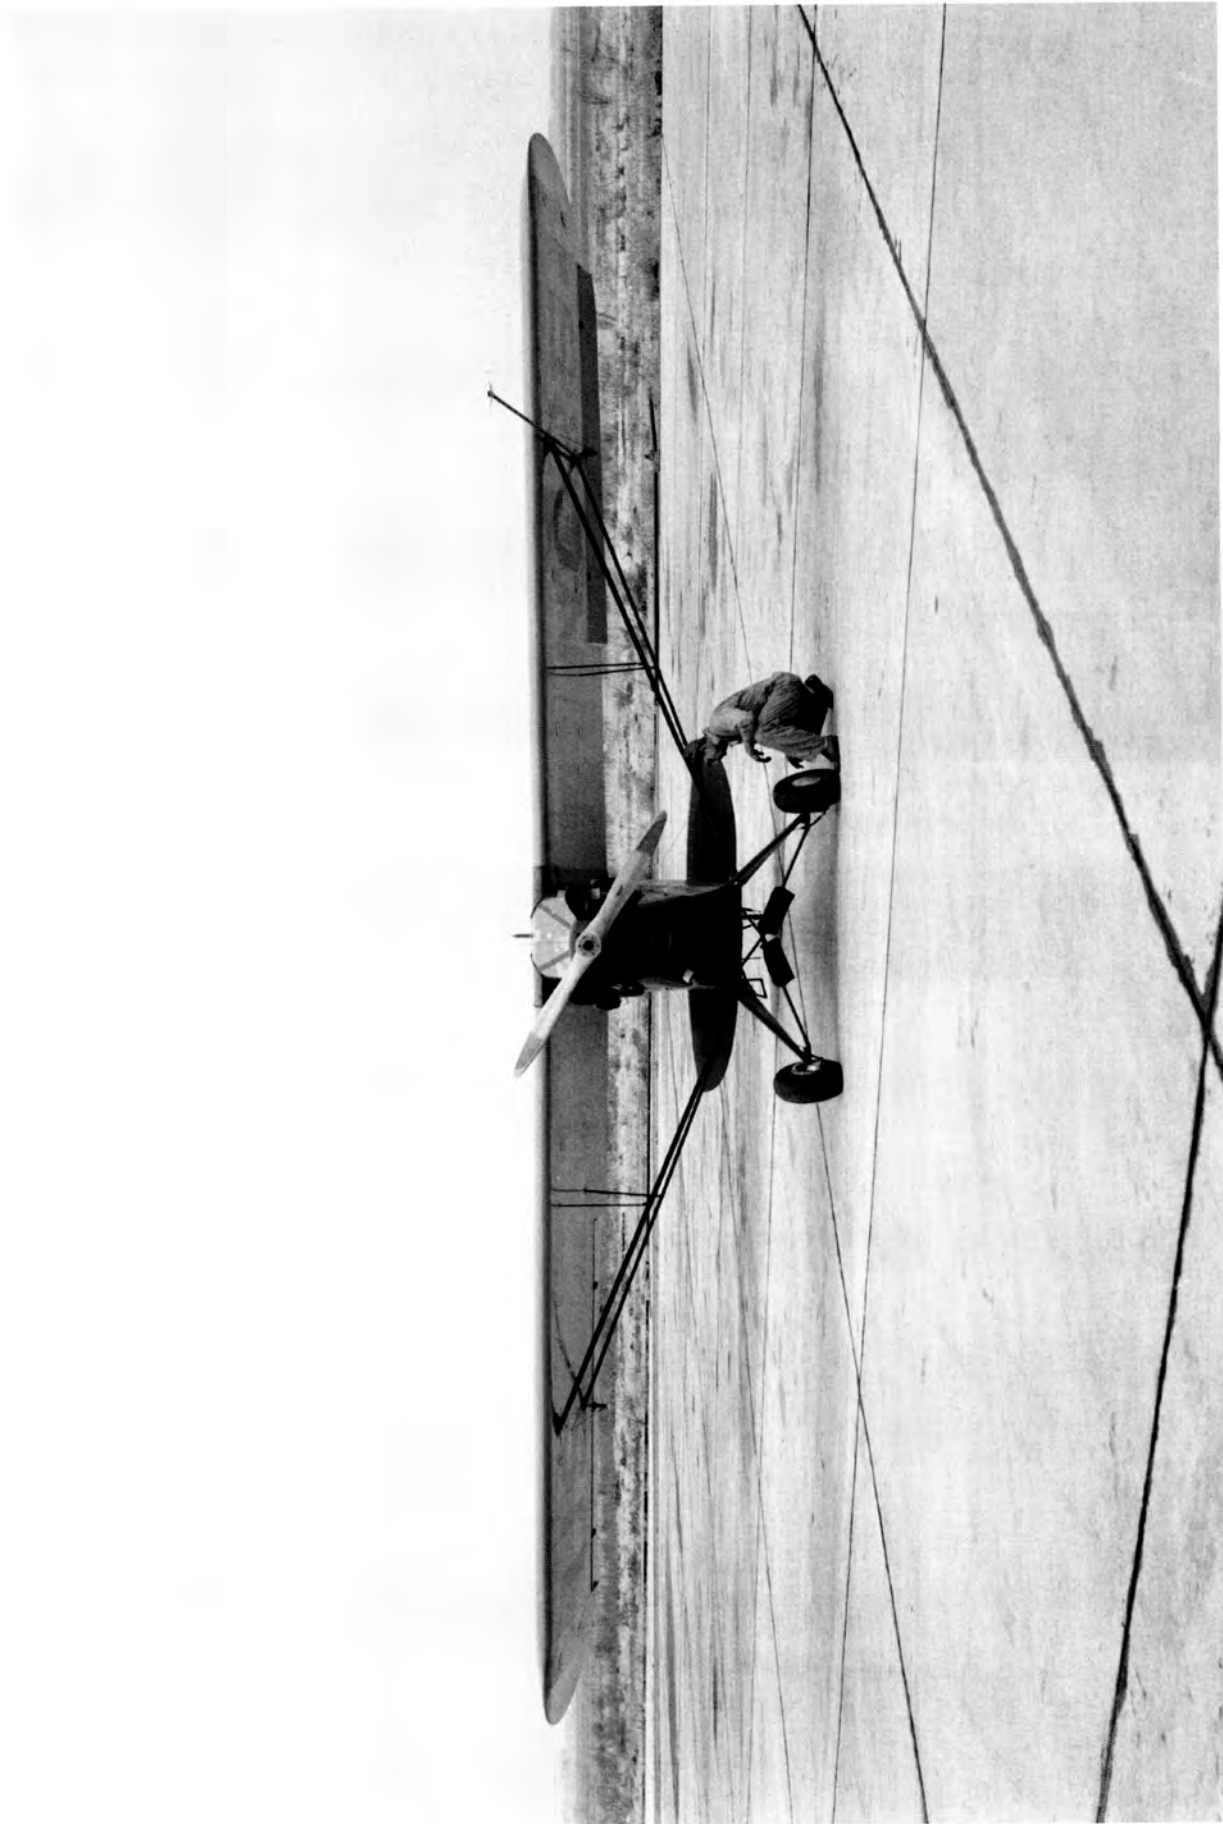
Figure 66. Piper J-4 Cub with the main wheels of the landing gear casted 25 degrees. This free-swiveling mechanism complicated operation in crosswinds on narrow taxiways. (Oct. 1948) A-13573

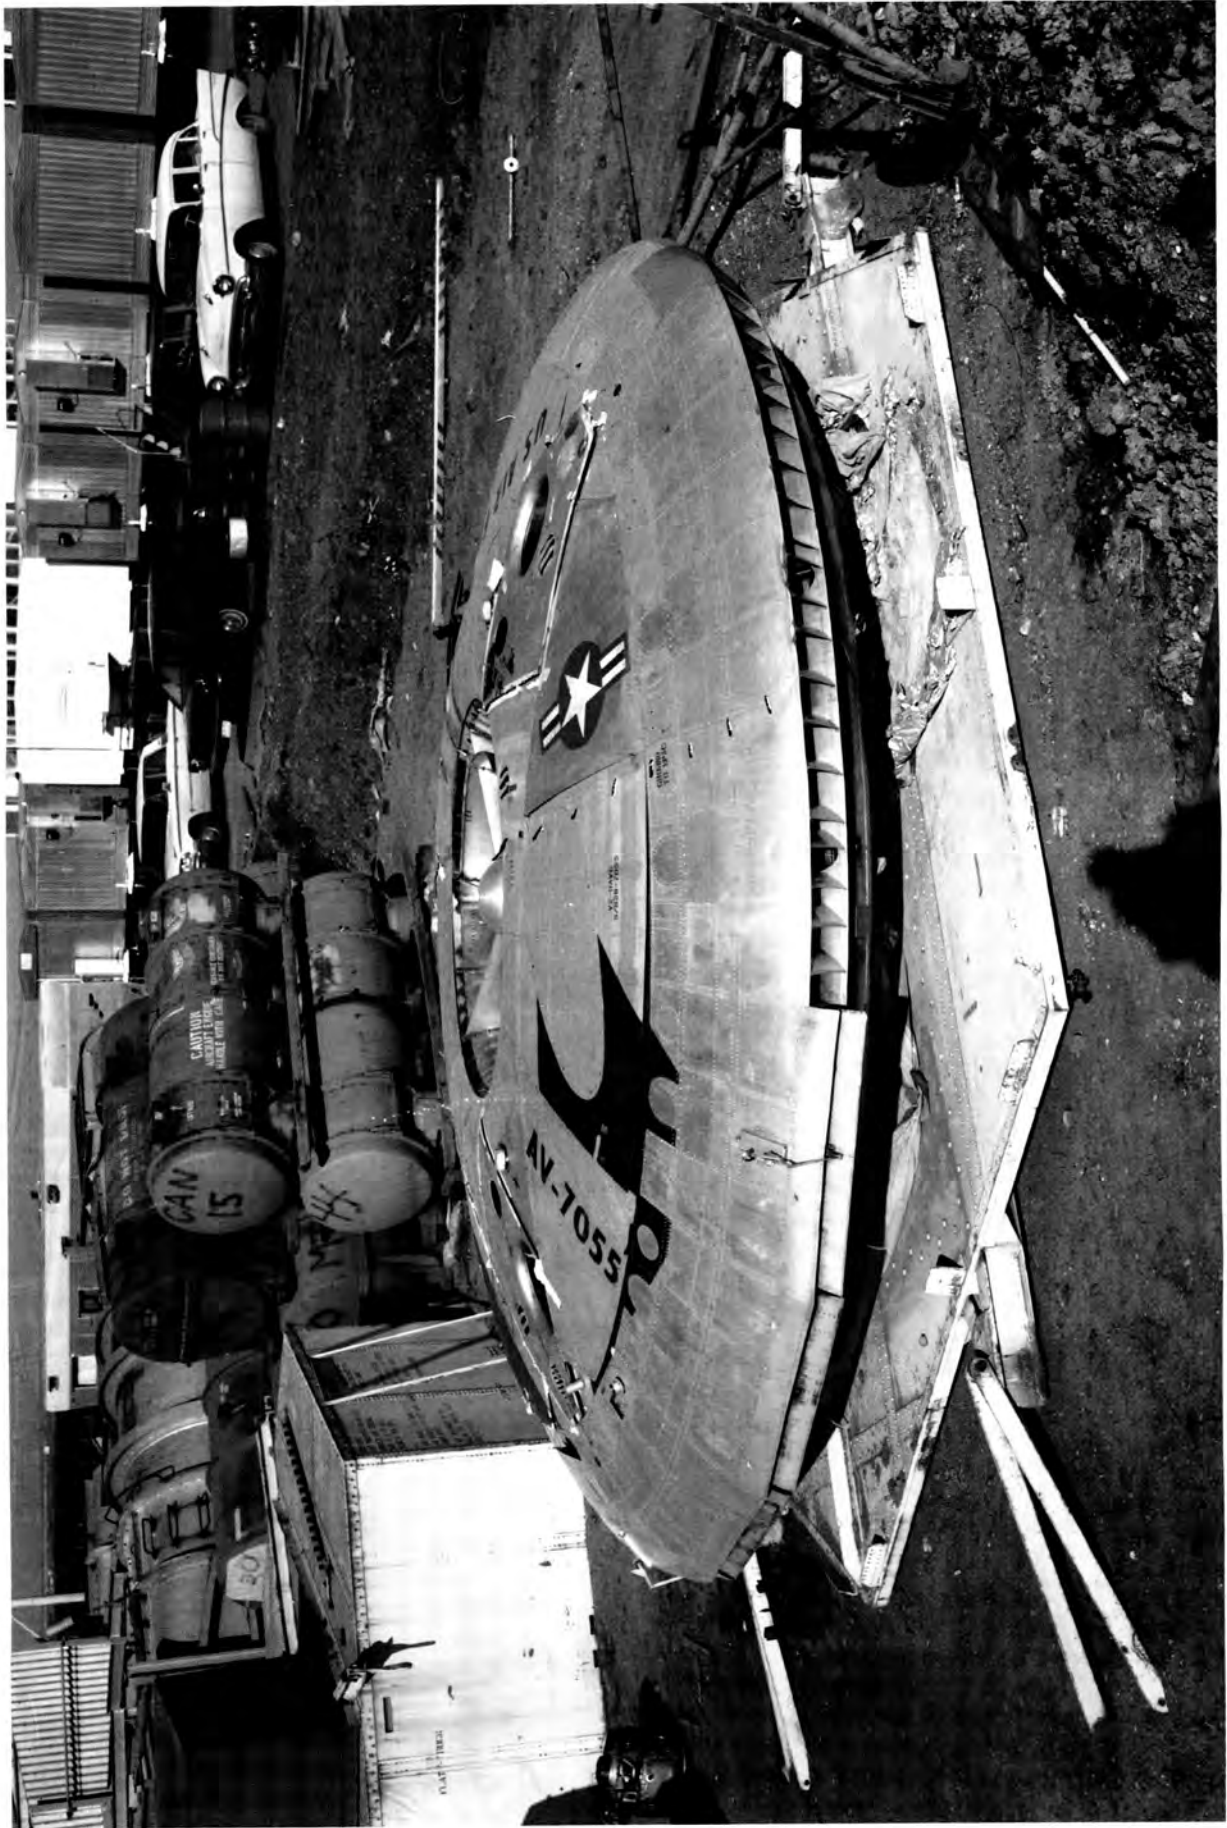
Figure 68. A five-foot-diameter fan at the center of the VZ-9AV VTOL vehicle provided vertical lift and airflow to louvers and vanes at the periphery for thrust-vector attitude and translation control. The aircraft was not a success. An Ames test pilot called it a 3,000-horsepower siren. (Dec. 1959) A-36474

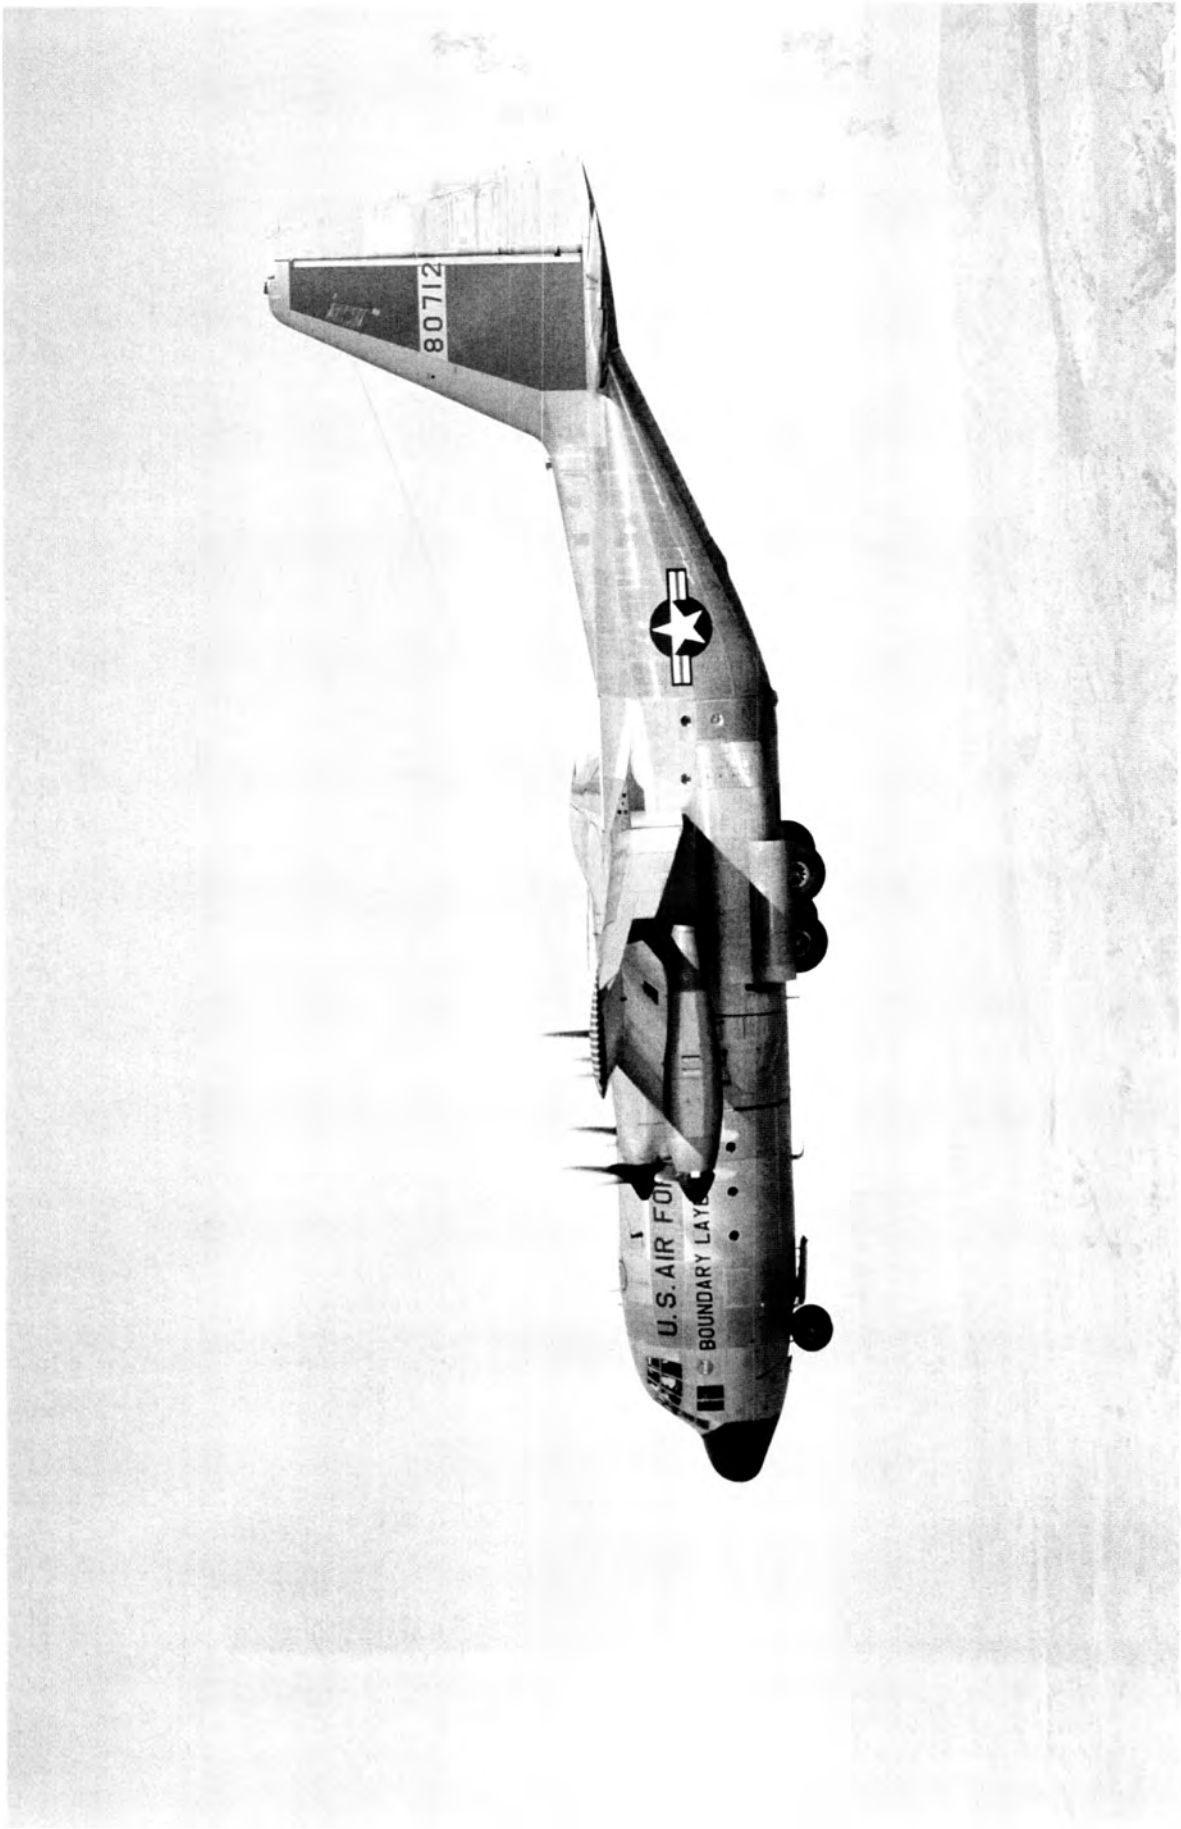
Figure 70. YC-134A STOL aircraft built by Stroukoff Aircraft Corporation under U.S. Air Force contract with ailerons drooped and trailing-edge flaps deflected 60 degrees. An internally located J-30 turbojet with load compressor provided suction for boundary-layer control systems. Only a modest improvement in landing performance was realized with this system. (Mar. 1959) A-2073
