NASA/SP-2002-4526

# ***MEMOIRS OF AN AERONAUTICAL ENGINEER***

**Flight Tests at Ames Research Center:  
1940-1970**

**Seth B. Anderson**

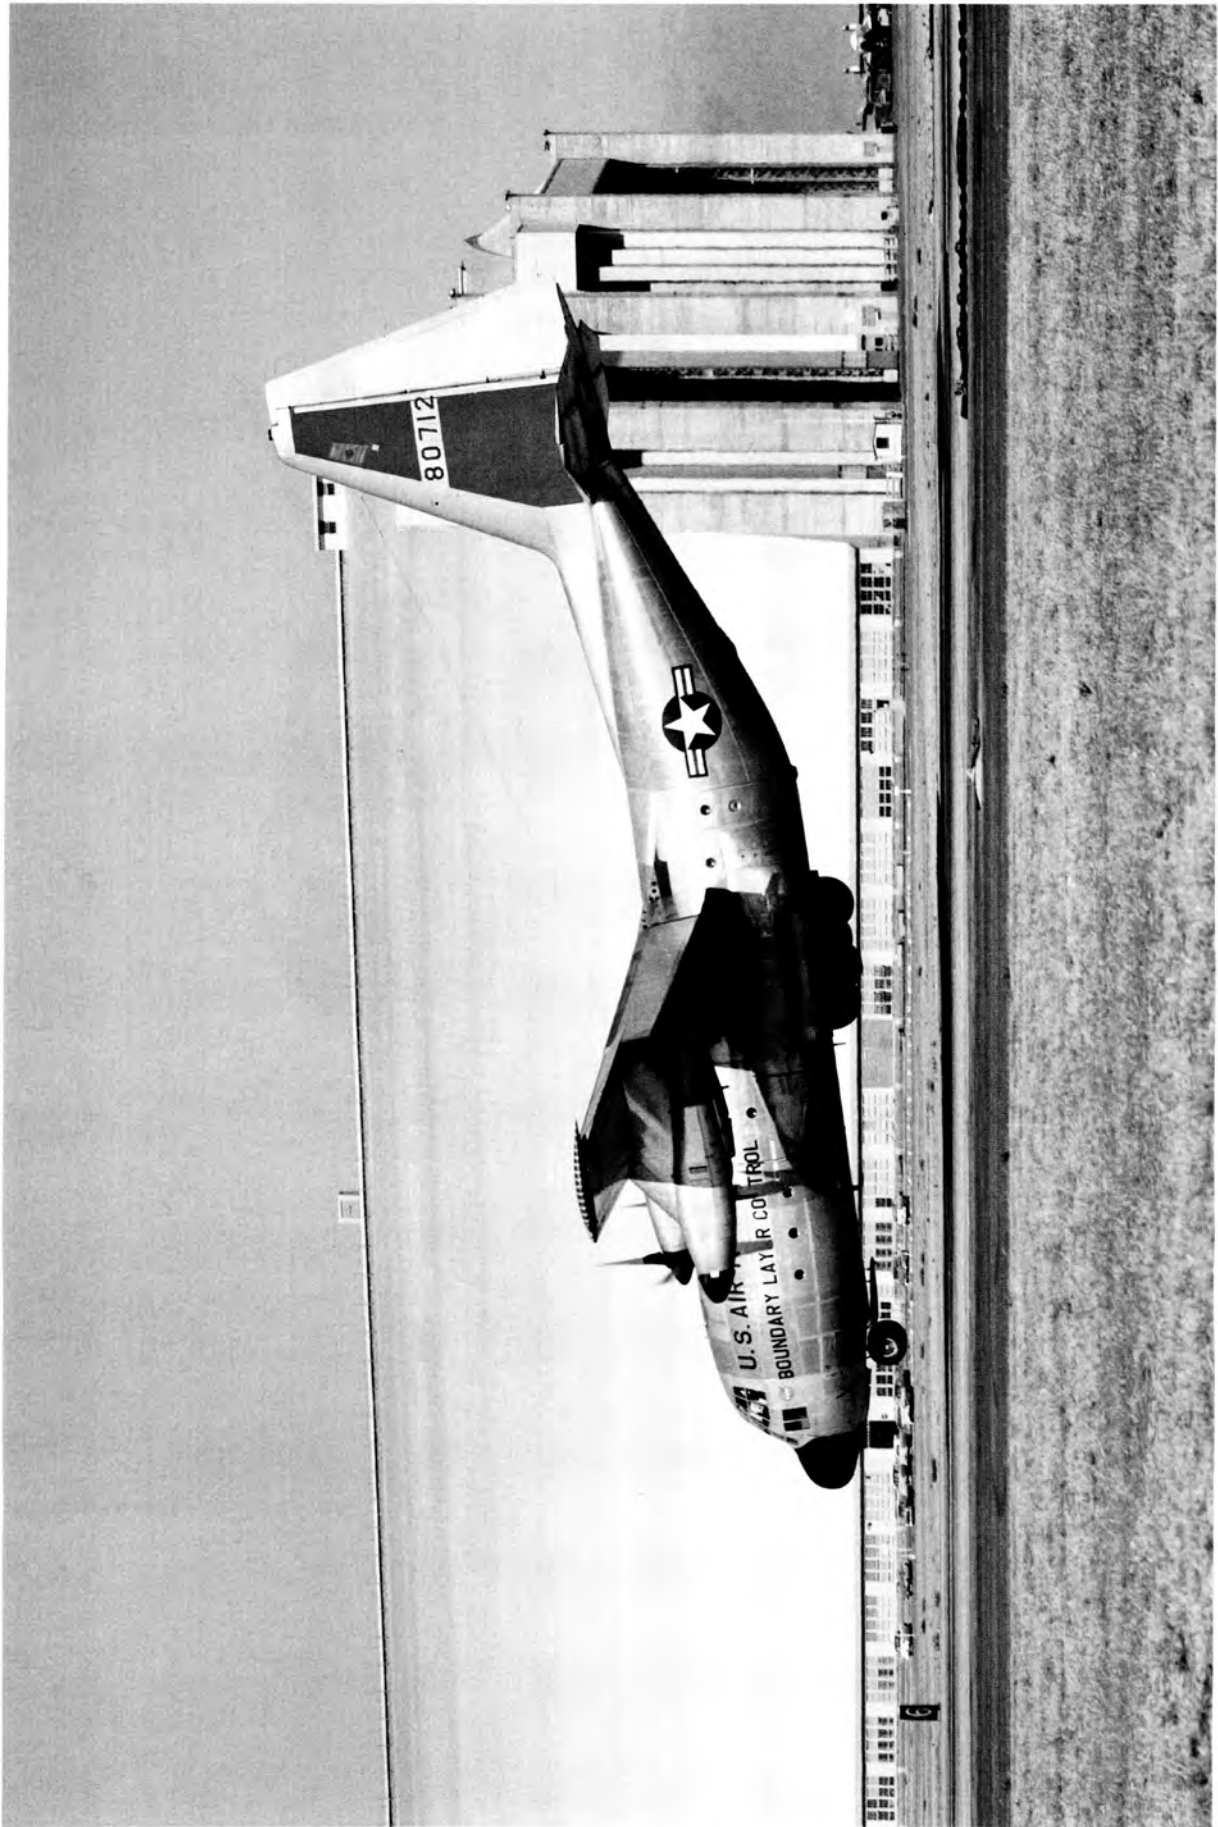
Figure 71. Lockheed NC-130B STOL turboprop-powered aircraft with ailerons drooped 30 degrees. Note trailing-edge flaps deflected 90 degrees for increased lift. Two T-56 turboshaft engines, which drove wing-mounted load compressors for boundary-layer control, are mounted on outboard wing pods. Landing approach speed was reduced 30 knots with boundary-layer control. (Nov. 1962) A-28387

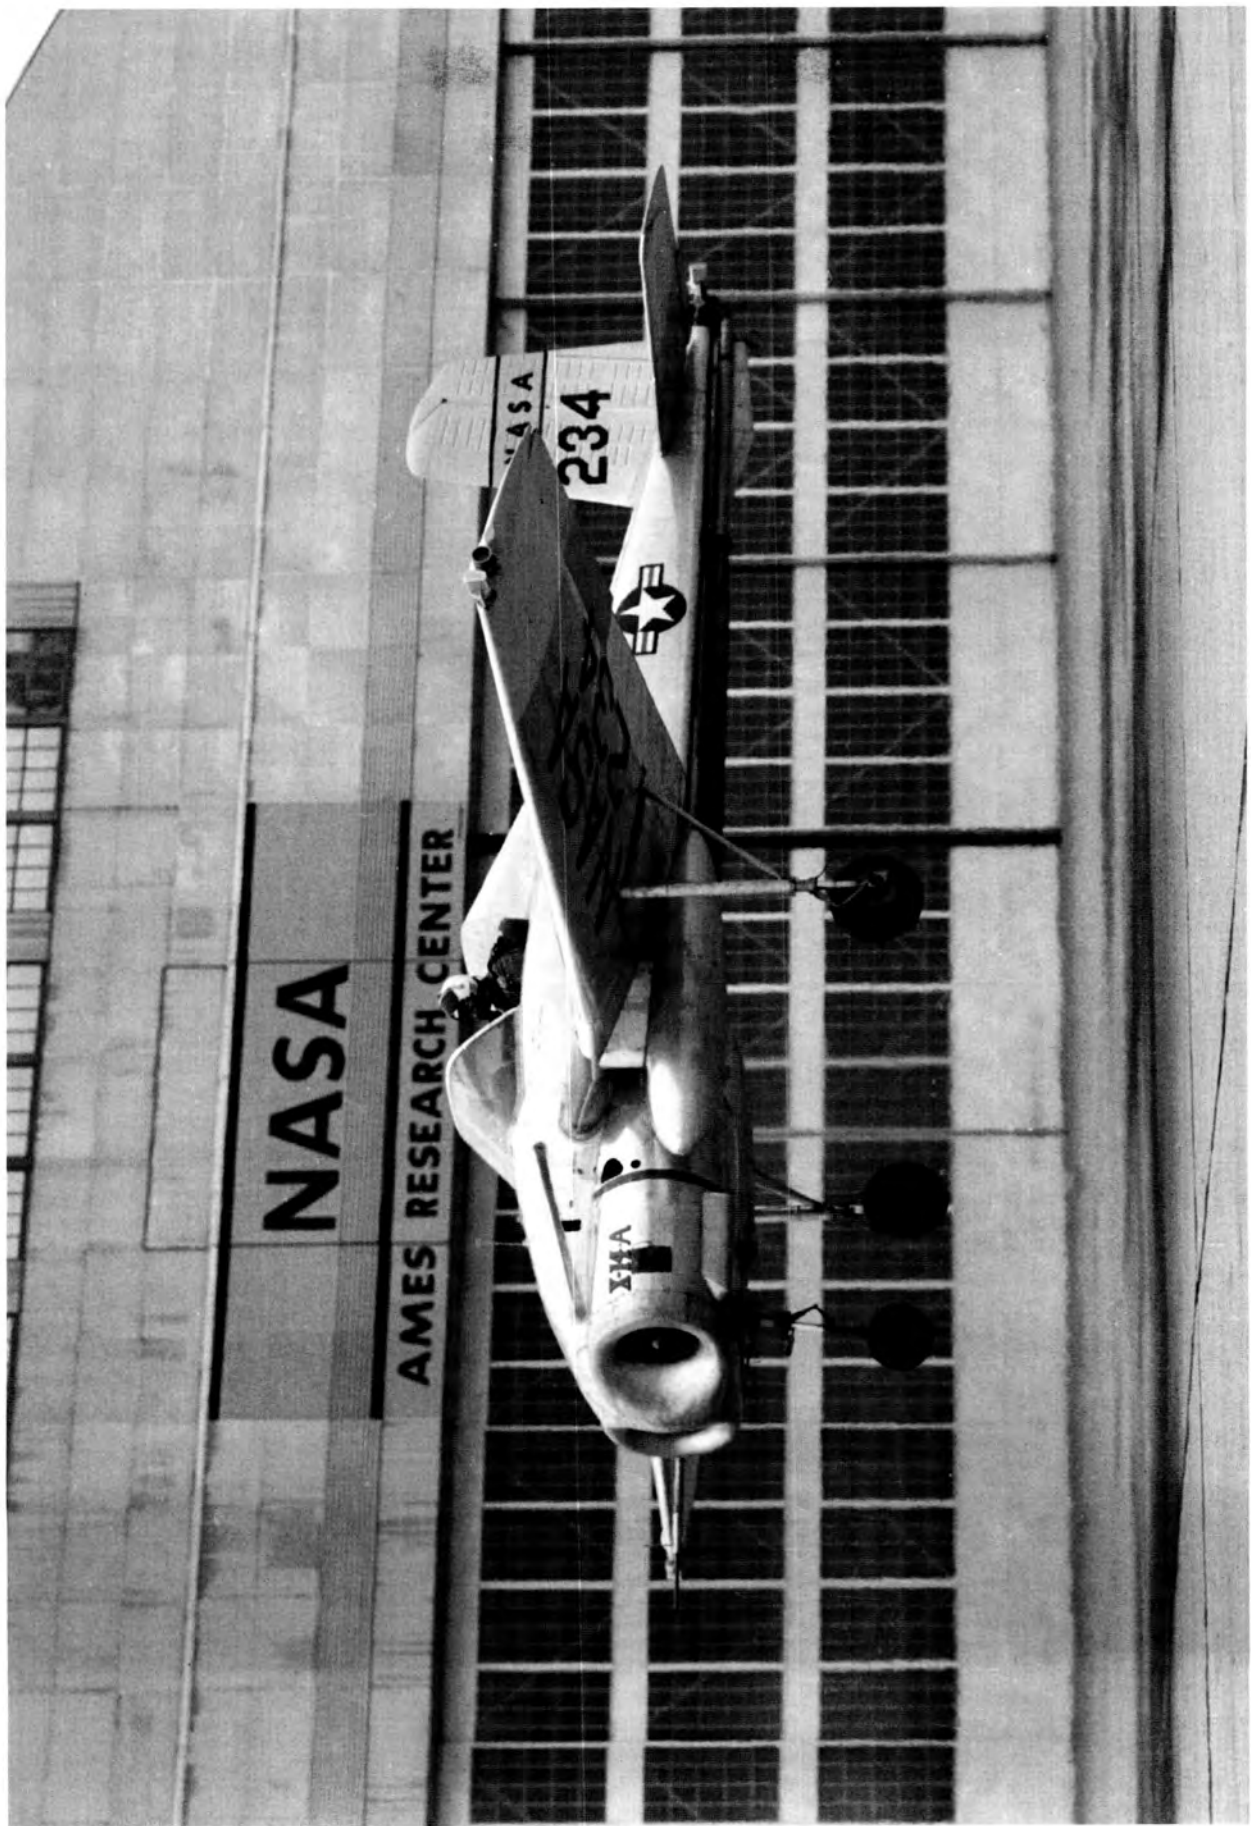
Figure 76. The Bell X-14B single-place, open cockpit, twin-engine, jet-lift VTOL aircraft over Highway 101 in approach to Moffett Field, California. The X-14 was used by Ames to advance state-of-the-art jet-powered VTOL aircraft. (1980) AC74-4562-14

Early in 1960, Ames used the X-14, built by the Bell Aircraft Company with USAF funding, to advance the state of the art for jet-powered VTOL aircraft (fig. 76). The X-14 was a single-place, twin-engine deflected turbojet using Bristol Siddeley Viper engines with cascade thrust diverters. Compressor bleed air was ducted to reaction nozzles at extremities of the aircraft to provide attitude control for hover and low-speed flight.

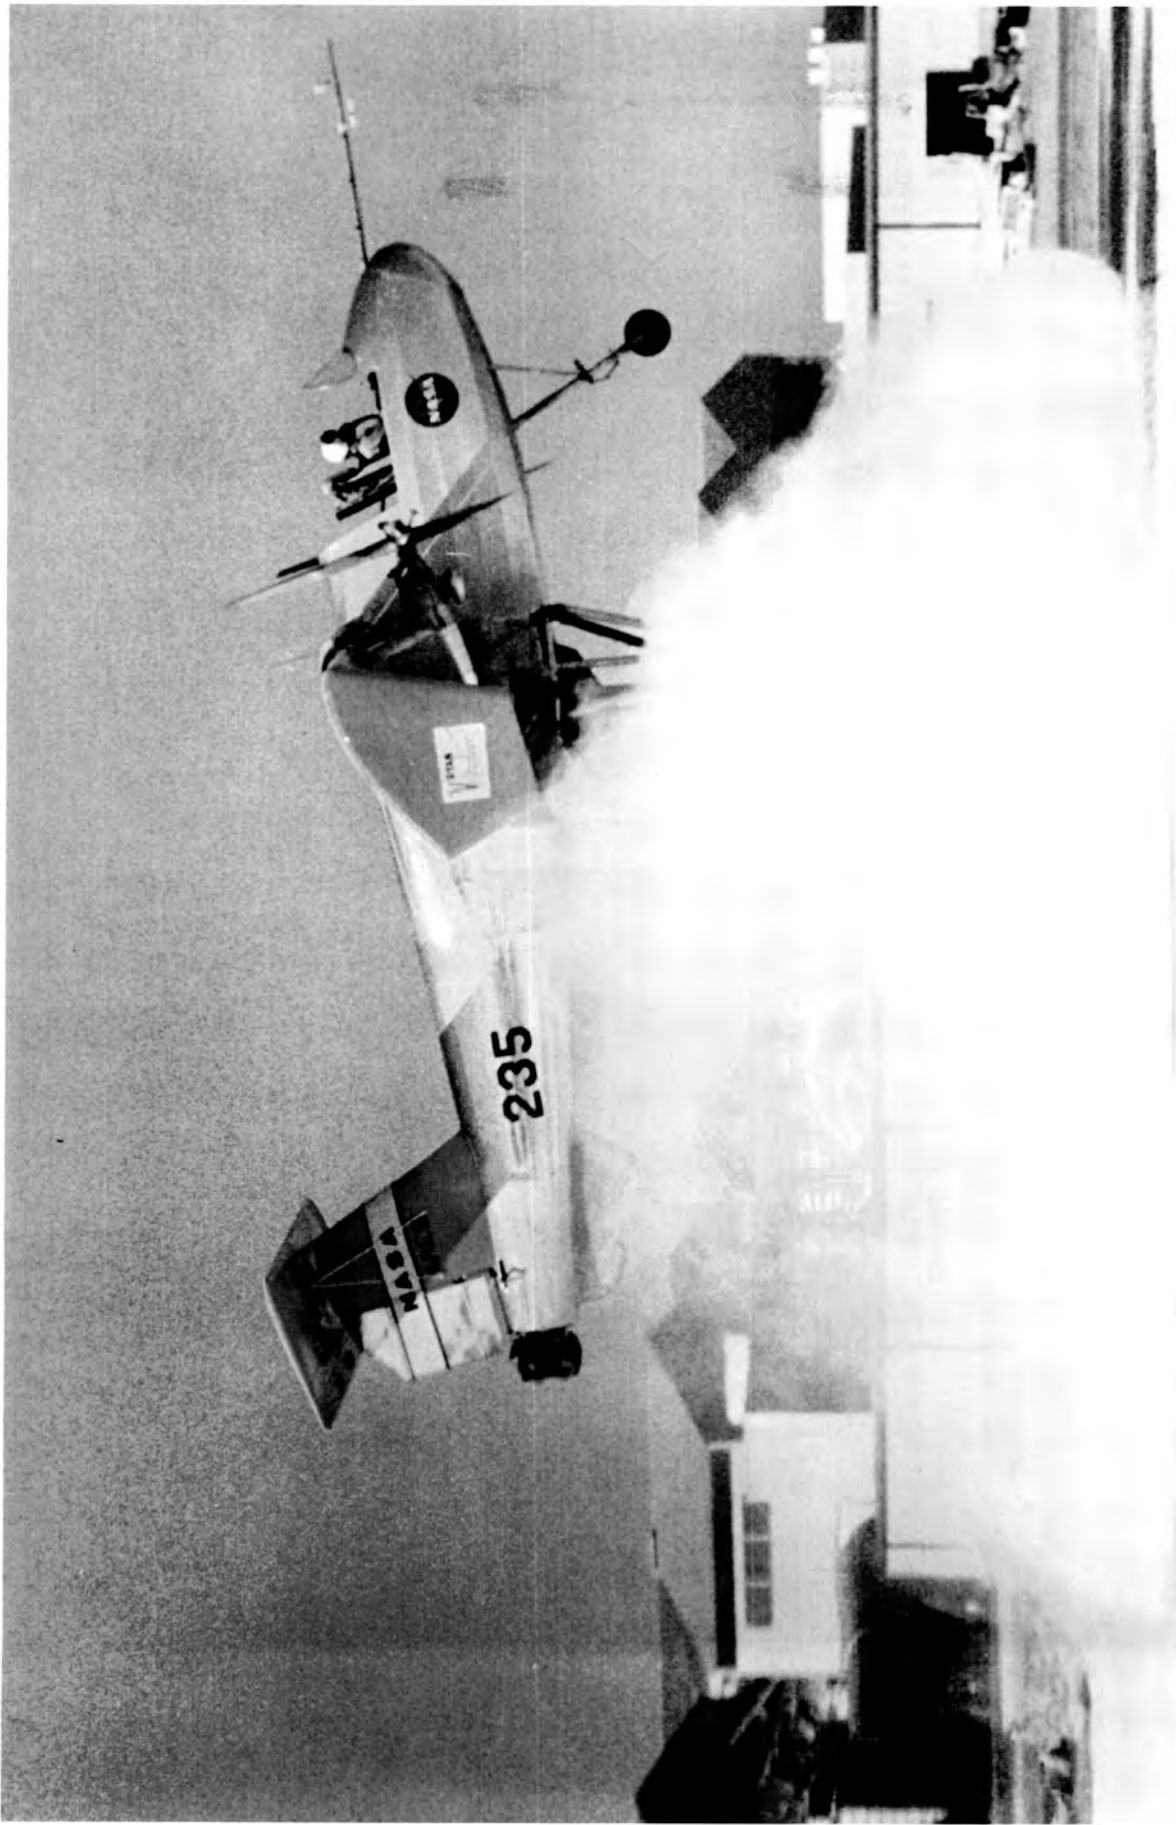
Figure 83. Recirculation of propeller slipstream of Ryan VZ-3RY aircraft is indicated by smoke pattern. Recirculation caused a loss of lift and reduced lateral control at heights above the surface less than 15 feet and at airspeeds less than 20 knots. Engine exhaust vectored at rear of fuselage provided pitch and yaw control. (Apr. 1963) ACD00-0193-4

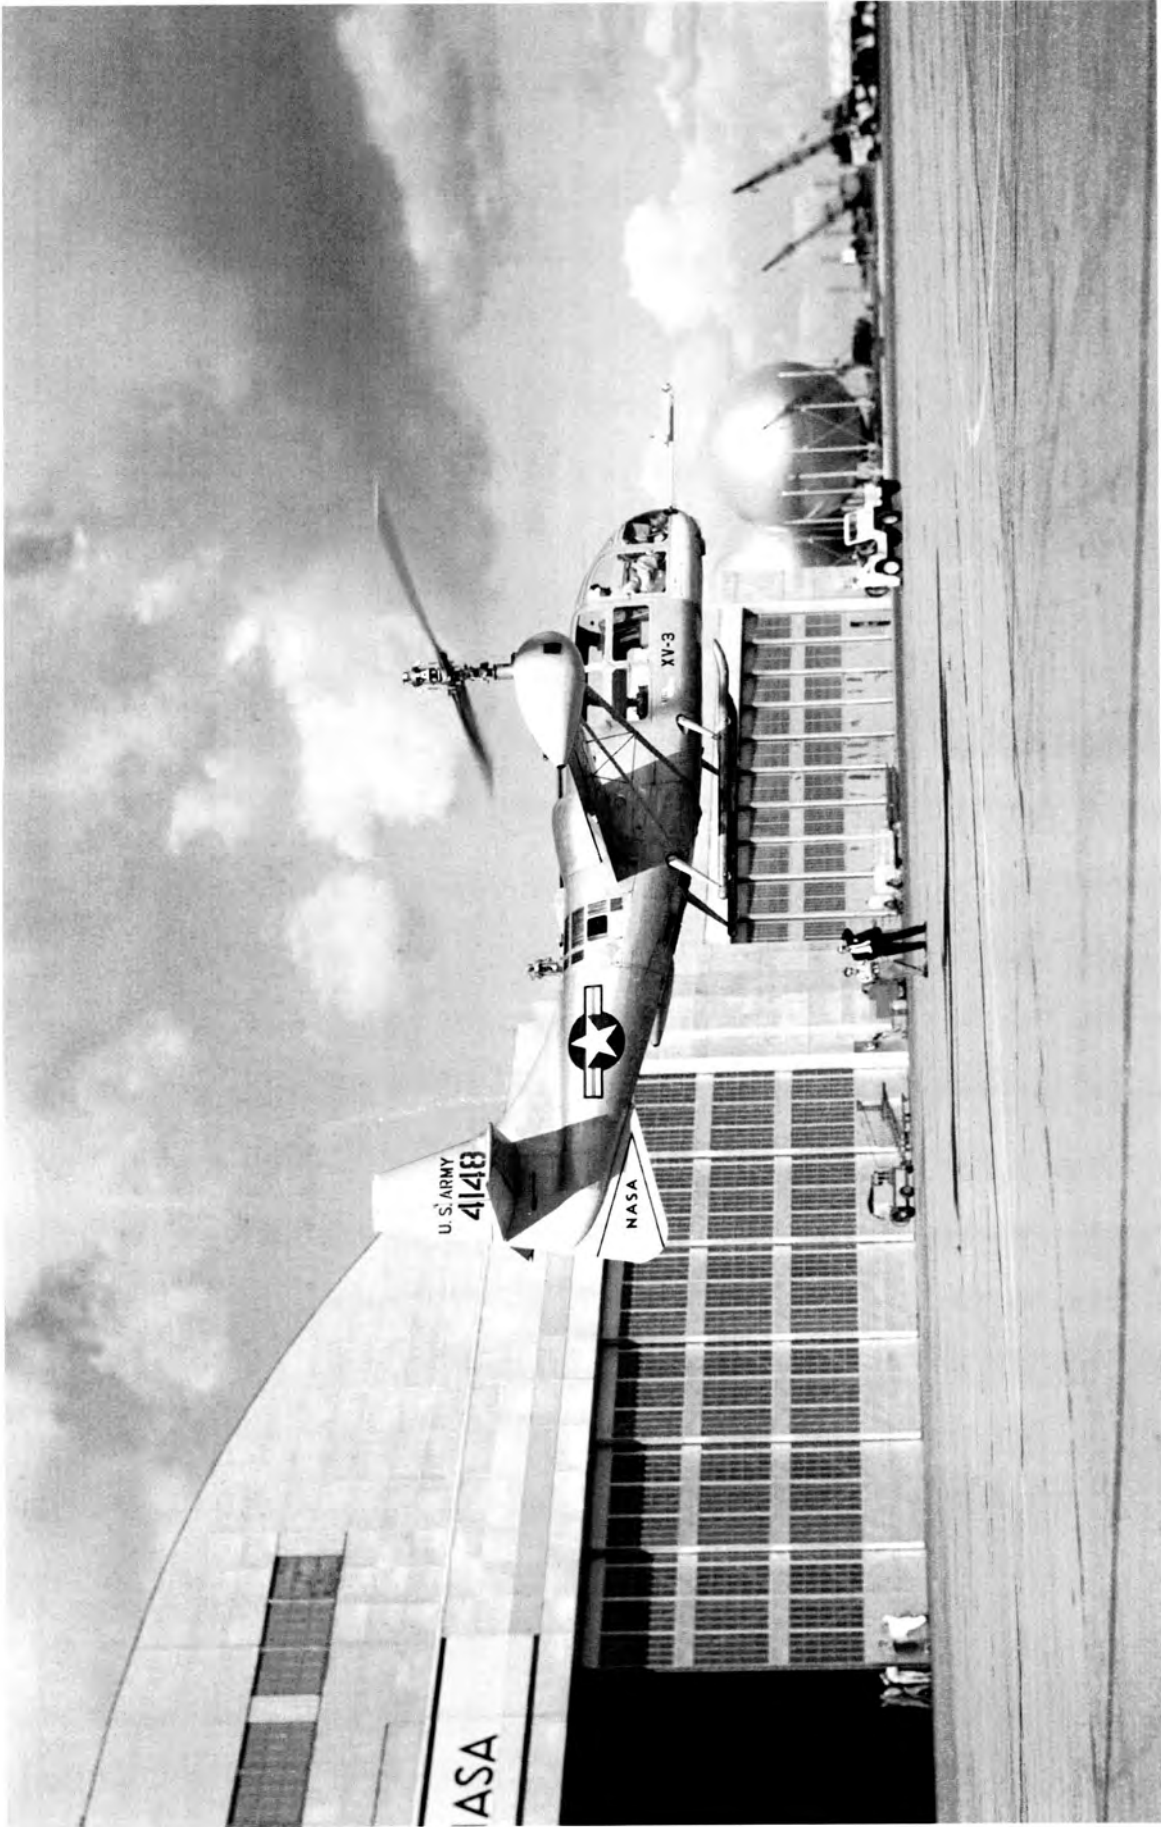
Figure 84. Bell XV-3 VTOL tilt-rotor aircraft hovering in front of building N-211 at Moffett Field. The XV-3 design combined a helicopter rotor and a wing. A 450-horsepower Pratt & Whitney piston engine drove the two rotors. The XV-3, first flown in 1955, was the first tilt rotor to achieve 100% tilting of rotors. The vehicle was underpowered, however, and could not hover out of ground effect. Note the large ventral fin, which was added to improve directional stability in cruise. (Oct. 1962) A-25685

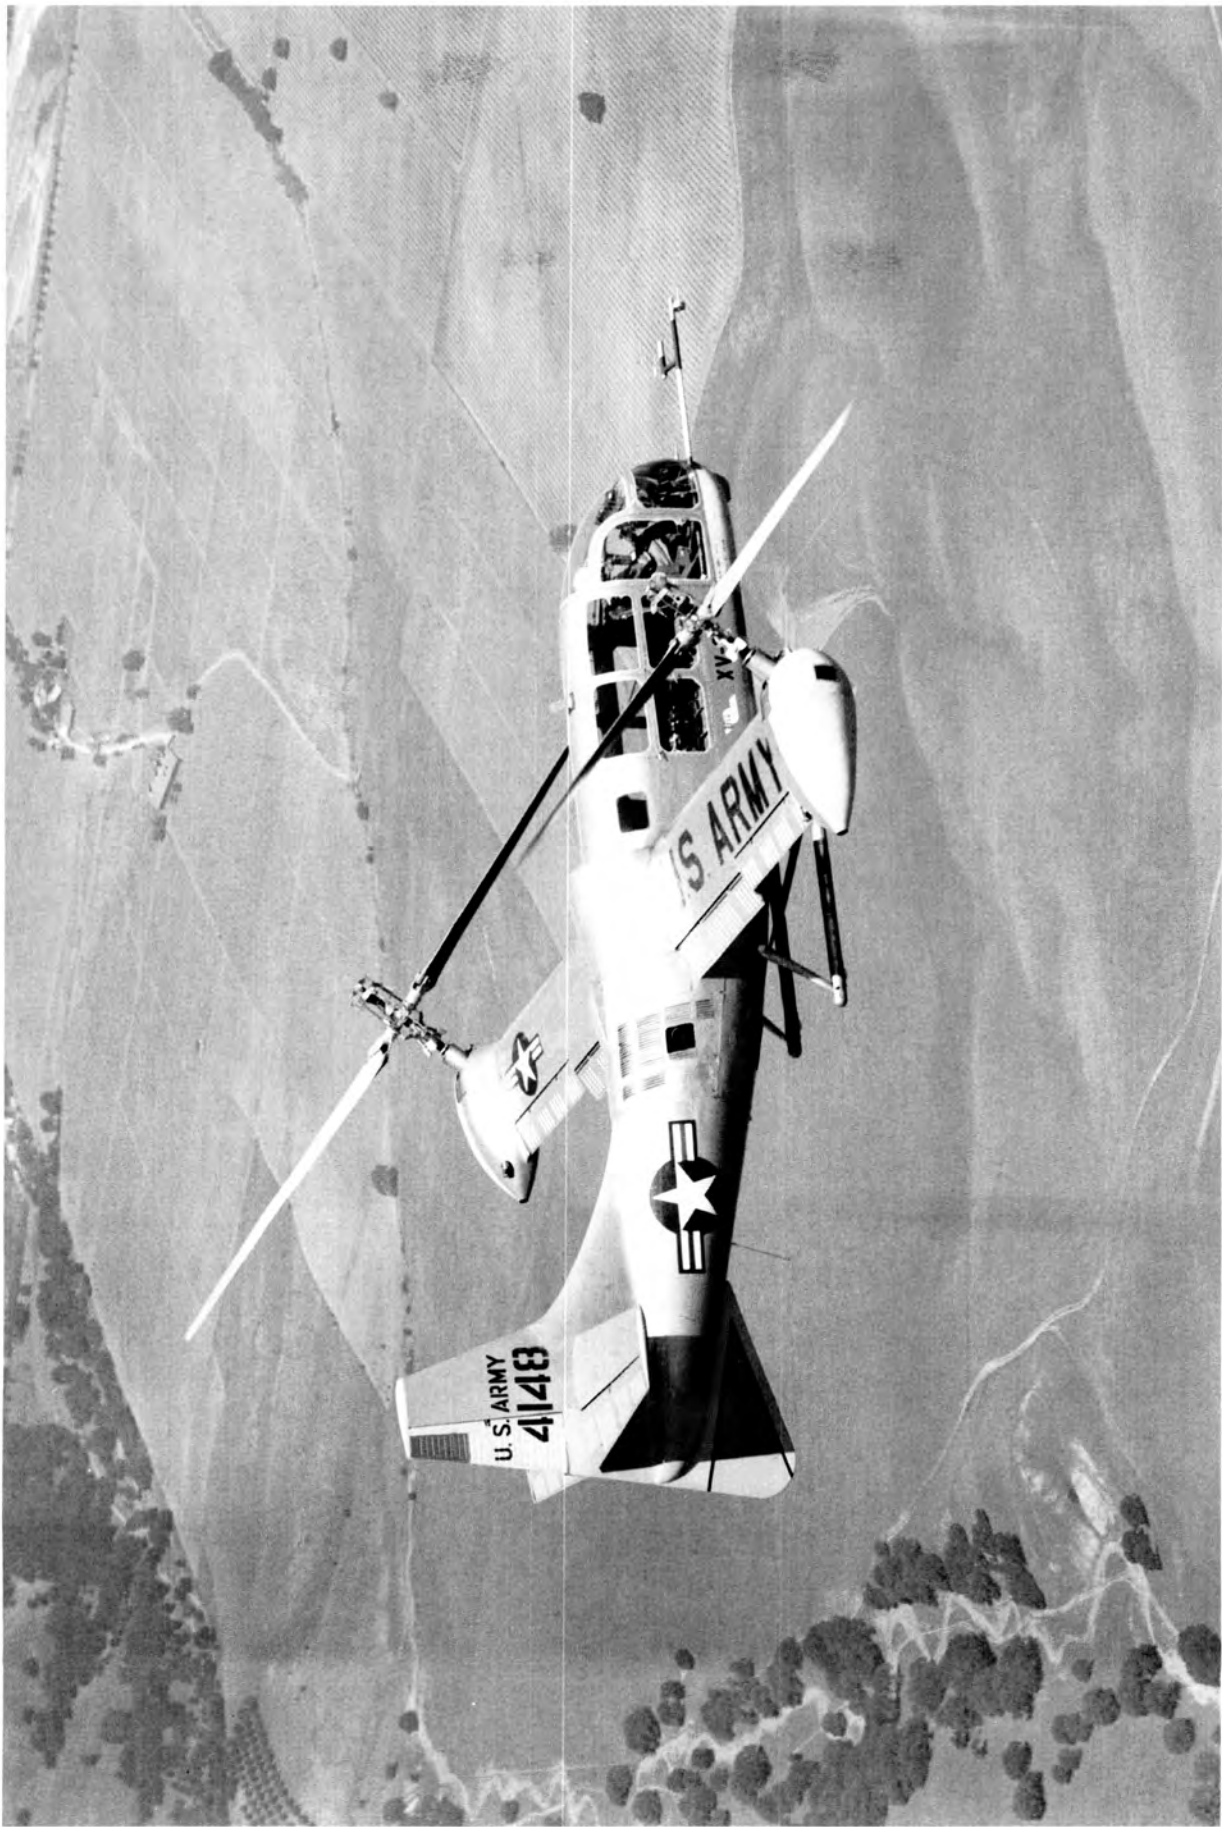
Figure 85. The Bell XV-3 rotors tilted 45 degrees, halfway through transition from rotorcraft to conventional flight. There were no trim changes or flightpath control problems during transition. (Apr. 1961) A-26671

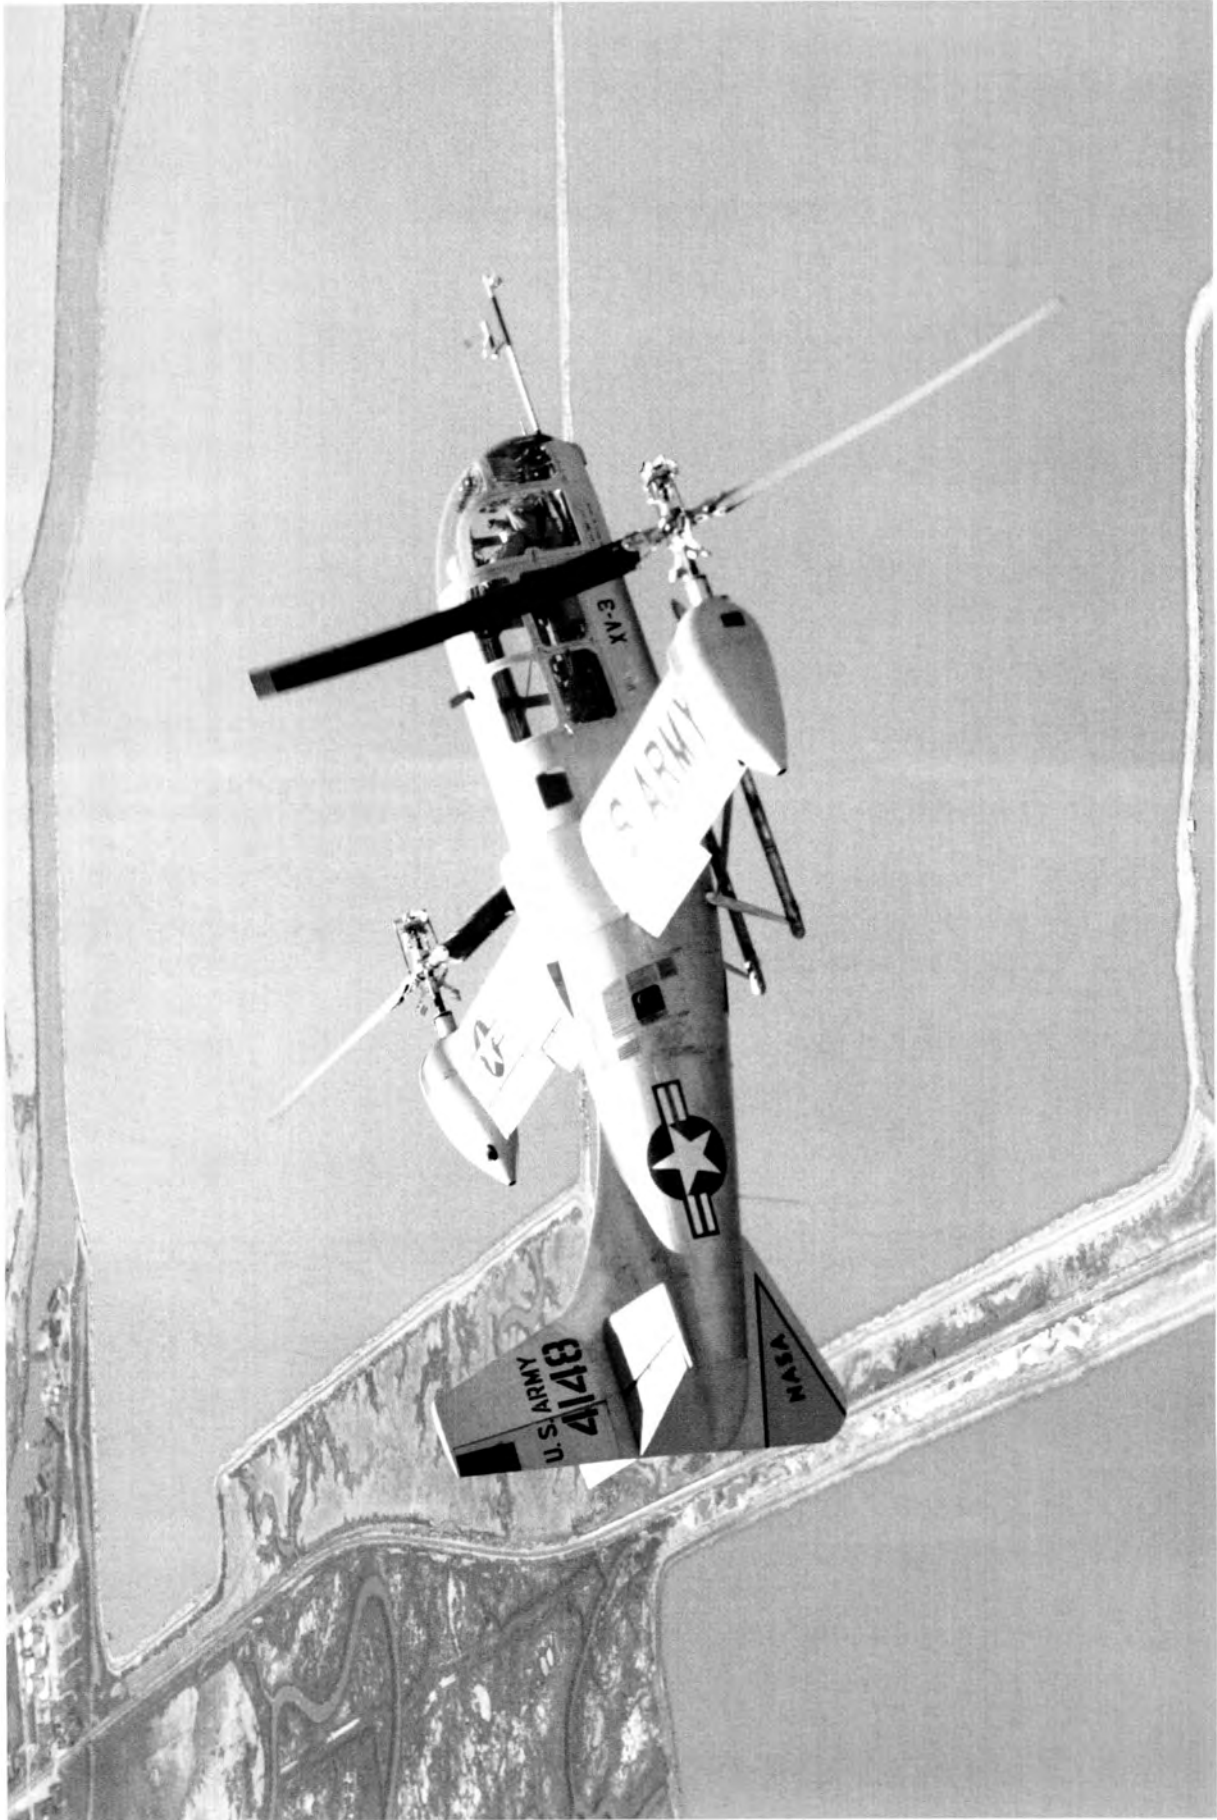
Figure 86. Bell XV-3 with rotors fully tilted for conventional cruise flight. Note large rotor-blade angle which reduced pitch and yaw static stability. Maximum cruise speed of the XV-3 was limited to 140 knots because of low damped lateral-directional oscillations. (Apr. 1961) A-26672

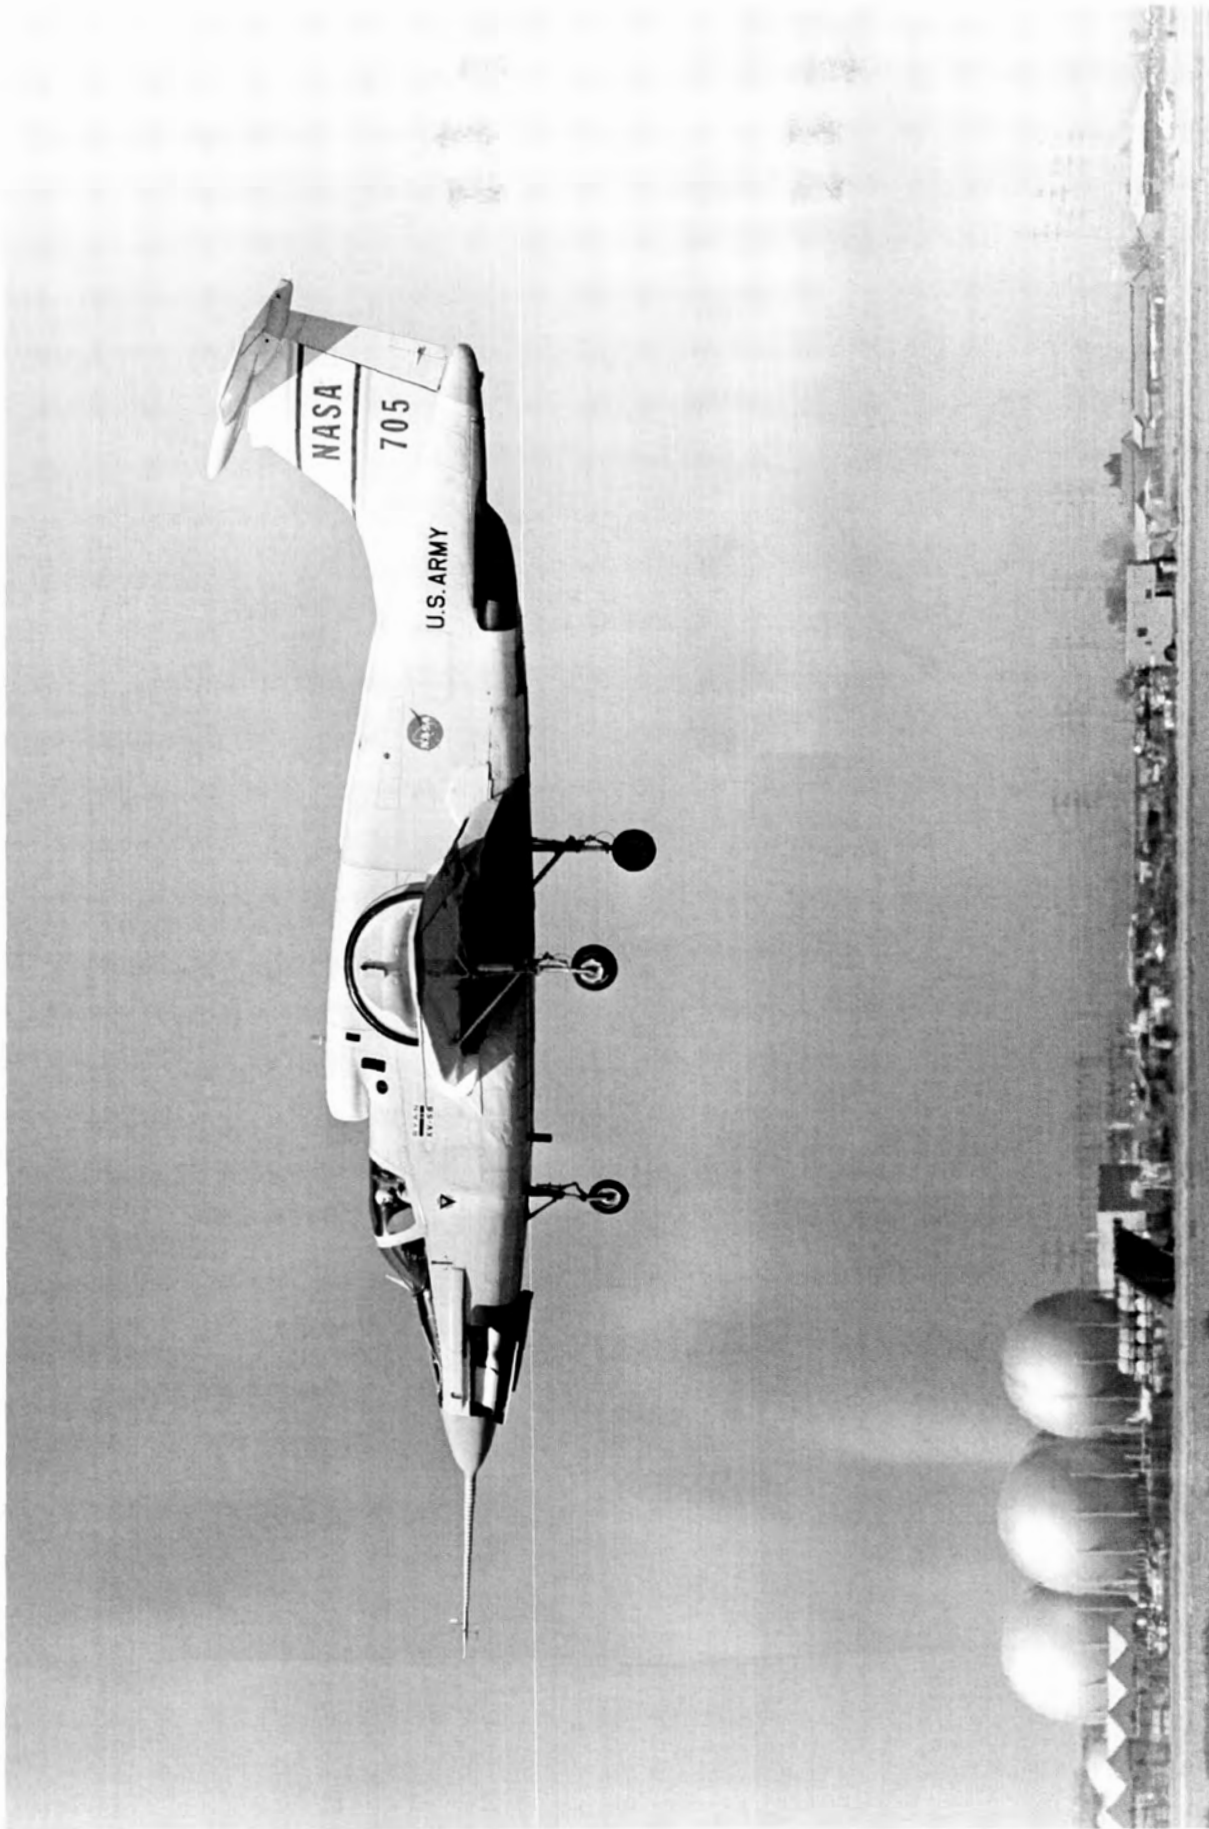
Figure 87. Ryan XV-5B fan-in-wing VTOL aircraft in hover at Moffett Field, California. The wing lift-fan doors are open and the nose-fan pitch-control doors are in operation. This two-place, 0.80-Mach research aircraft was powered by two GE J-85 jet engines and first flew July 1964. A-42628-11

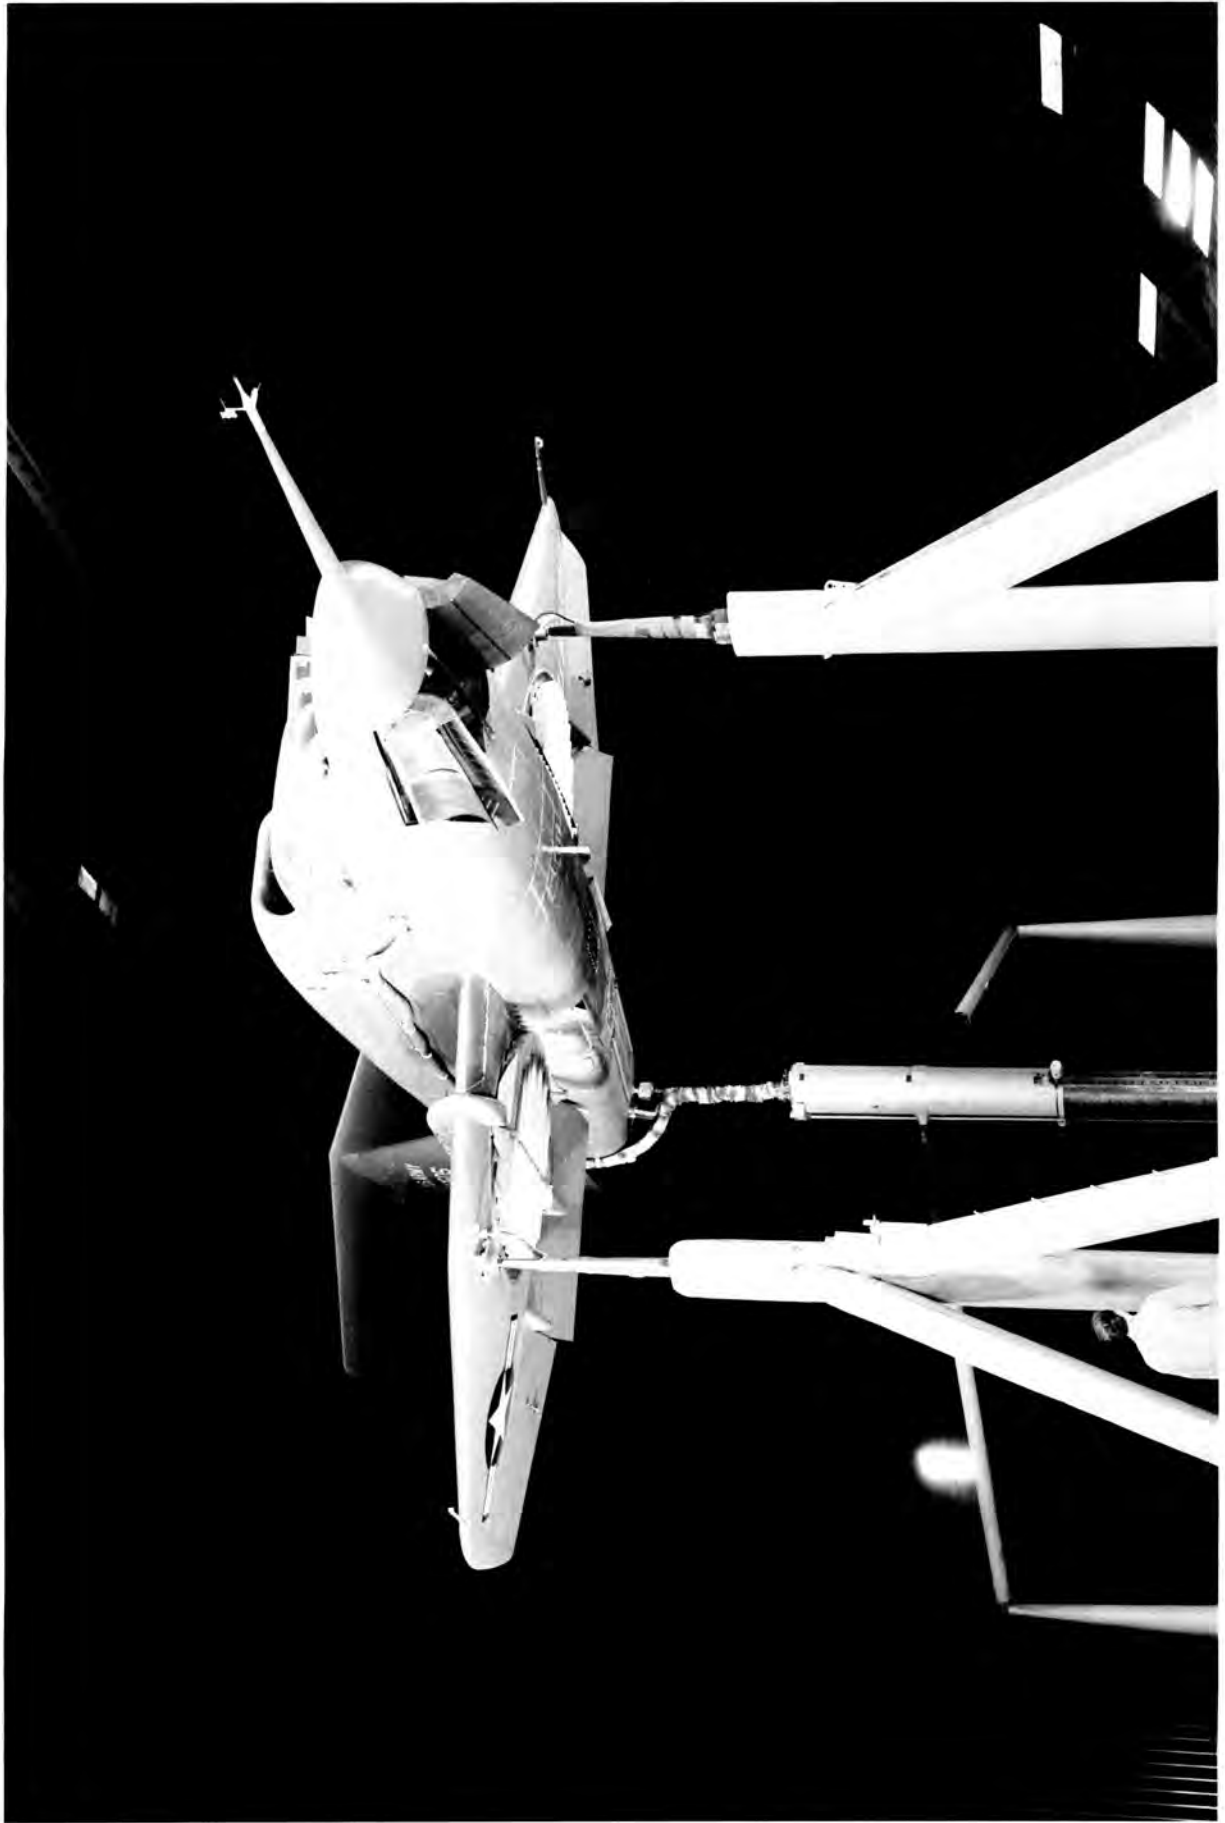
Figure 88. This full-scale model of the Ryan XV-5 VTOL is shown mounted in the Ames 40- by 80-foot wind tunnel. The propulsive lift system was tested to determine power-on performance characteristics in preparation for flight tests. (Oct. 1962) A-32745

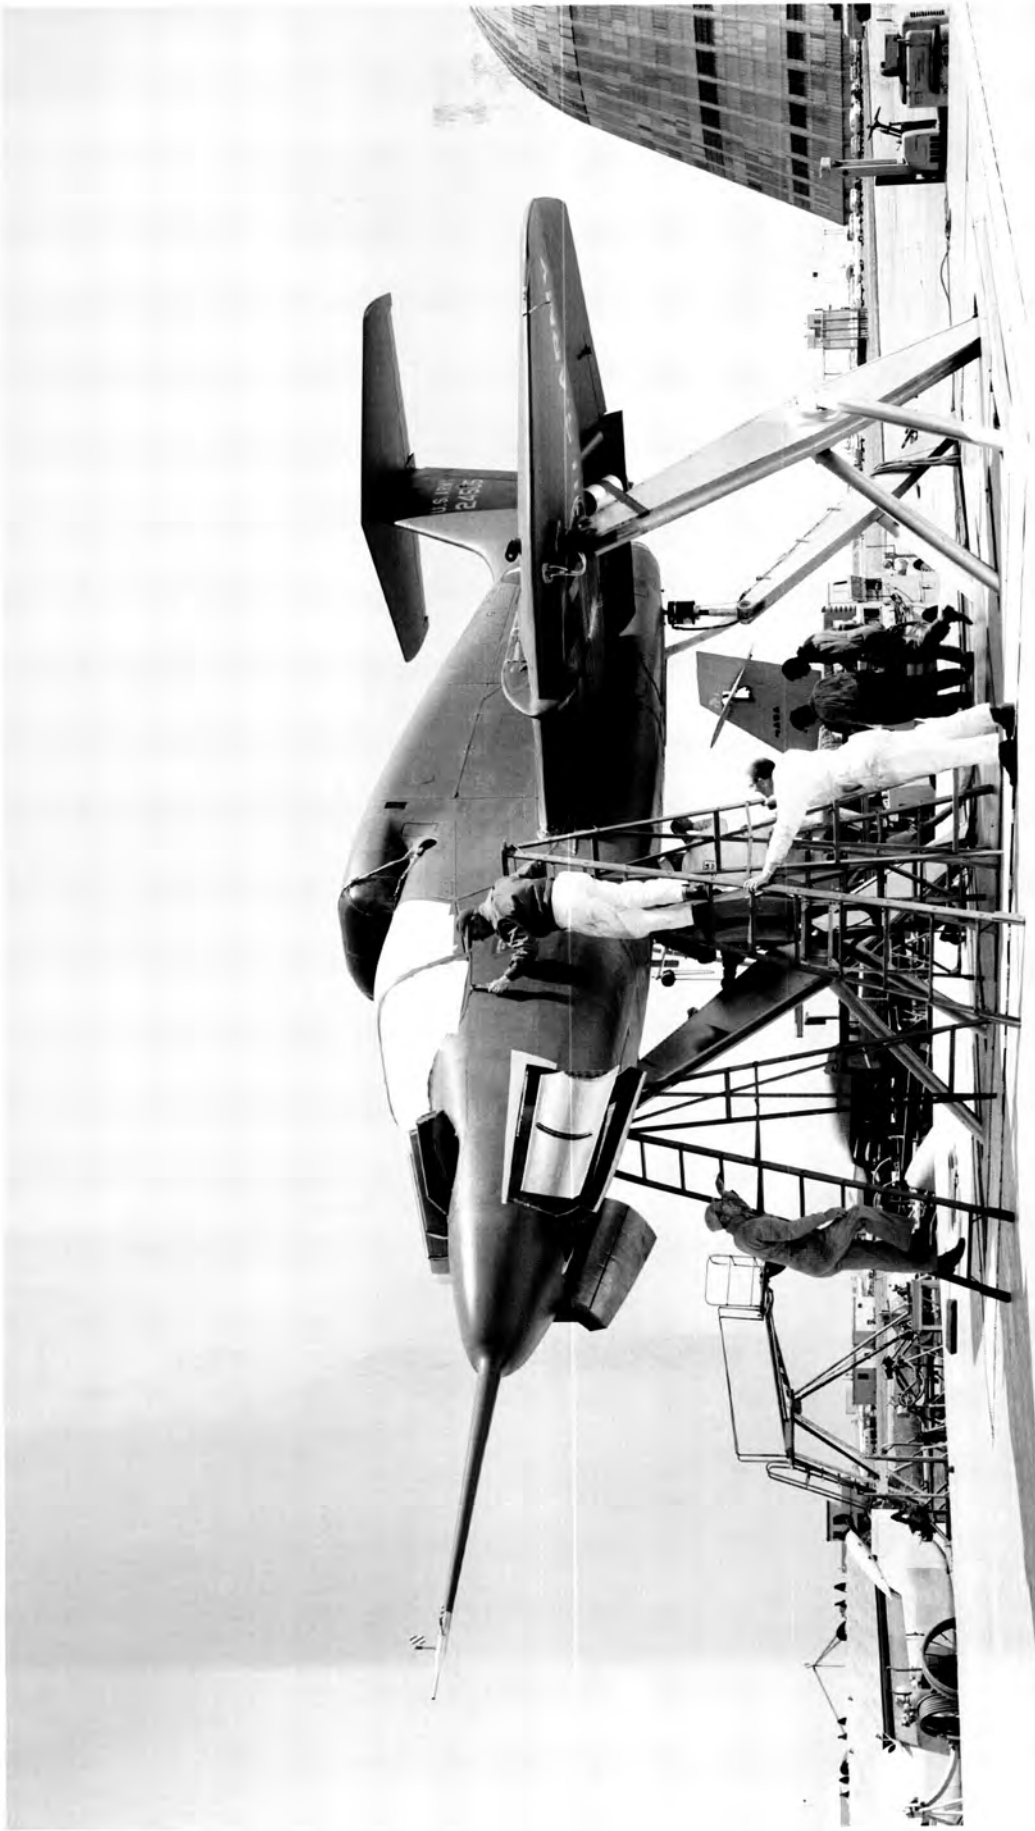
Figure 89. A full-scale model of the Ryan XV-5 VTOL mounted on an adjustable-height ground rig for power-on tests in ground effect. The nose-fan doors were modulated for pitch control. (Nov. 1962) A-32532

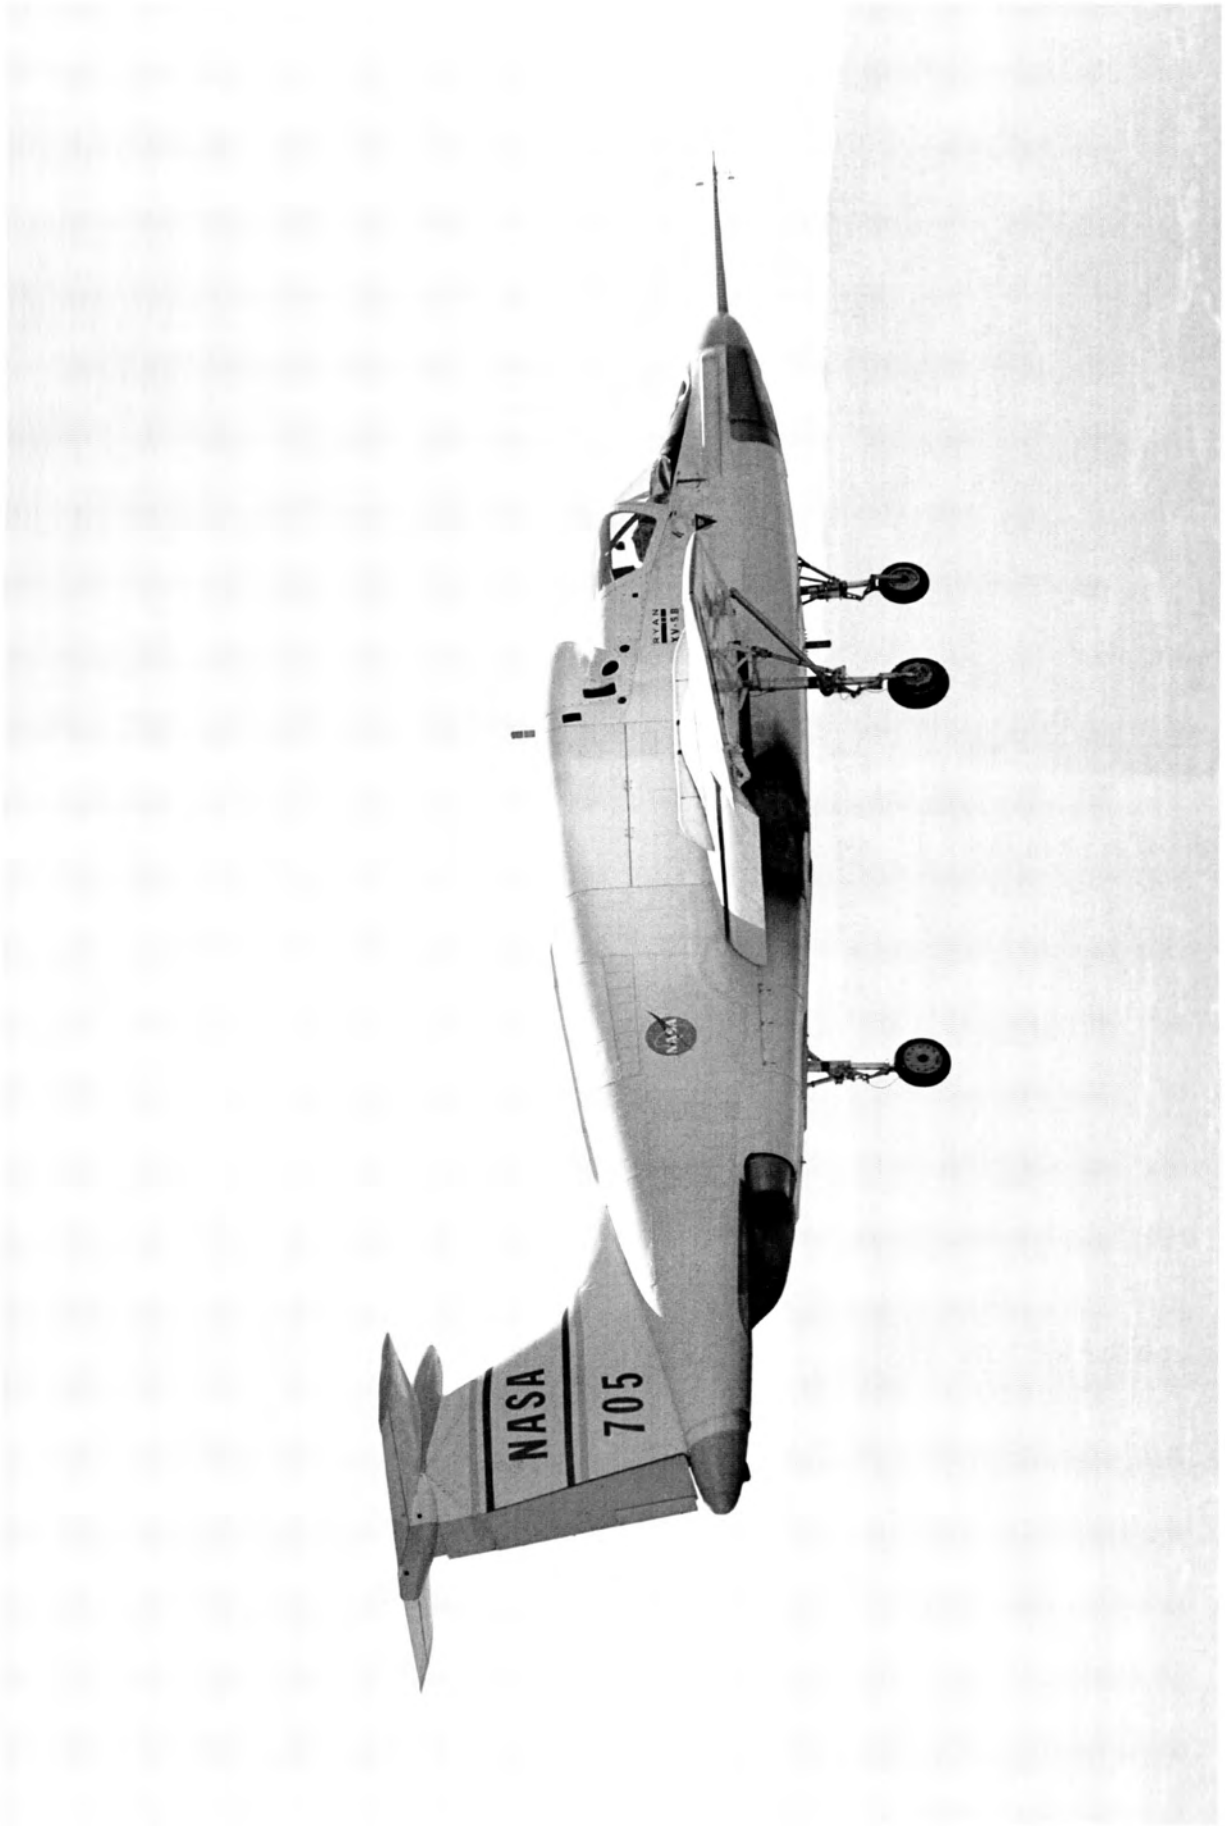
Figure 90. The Ryan XV-5B VTOL aircraft with widened main landing gear and low-speed control improvements for low-speed cruise flight. The horizontal tail was programmed to move 12 degrees in transition to powered-lift flight. (May 1969) A-42200-5
