NASA/SP-2002-4526

# ***MEMOIRS OF AN AERONAUTICAL ENGINEER***

**Flight Tests at Ames Research Center:  
1940-1970**

**Seth B. Anderson**

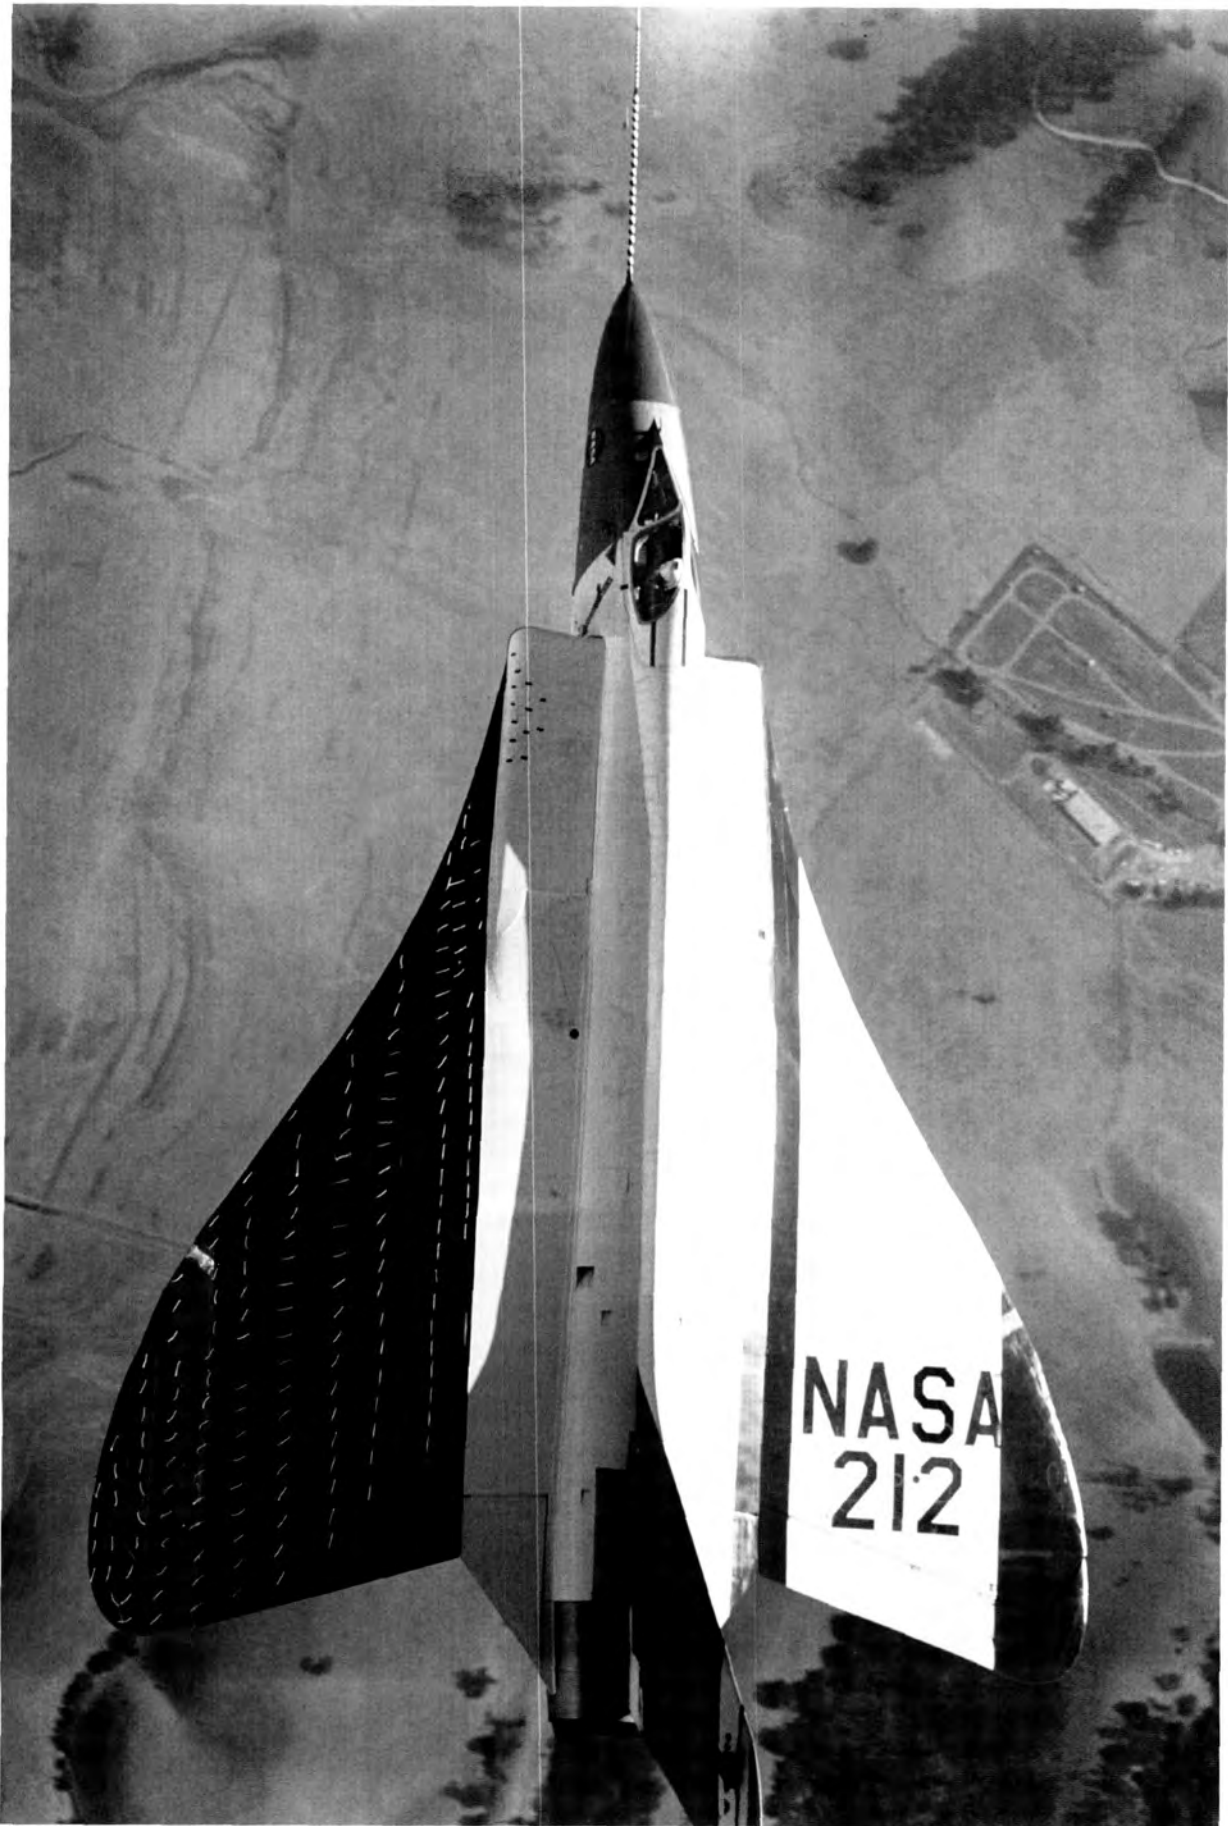
Figure 91. Douglas F5D Skylancer fighter modified with ogee wing planform designed for Mach 2 flight. Shown is the effect of vortex flow on wing tuft alignment in low-speed, high angle-of-attack flight. (Sept. 1965) A-33500-3

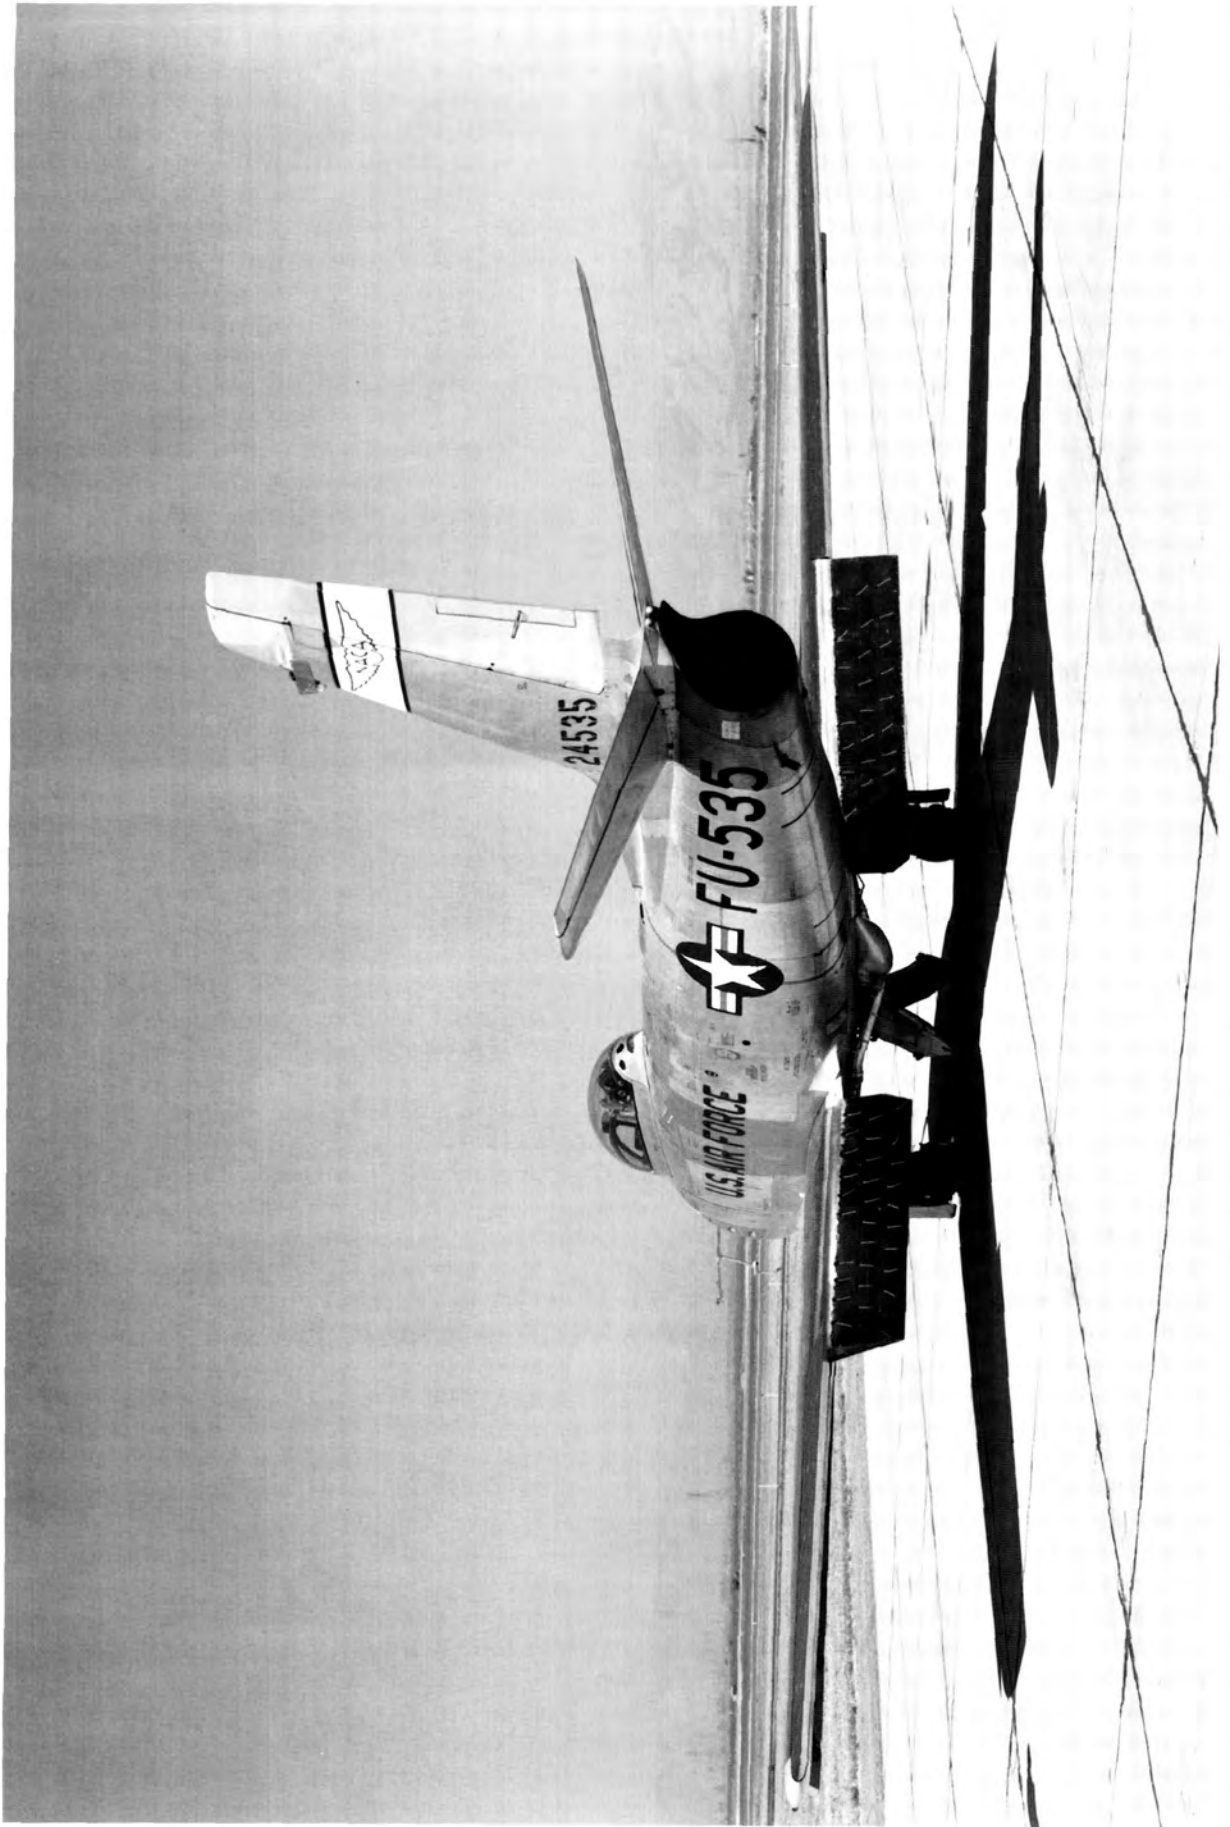
Figure 95. North American YF-93 with a more traditional-type scoop engine-air inlet (see fig. 94). Maximum high-speed capability was about the same for the submerged and scoop inlets when the afterburner was off. (Mar. 1953) A-16591

**North American F-86**—Two types of BLC—suction and blowing—were used to reduce boundary-layer flow separation on an F-86 swept-wing aircraft (fig. 96). Suction was obtained from an ejector pump system which used a diffuser to improve efficiency. The following points were of interest: (1) the magnitude of lift increments owing to suction or blowing, (2) the effect on the low-speed flying qualities and serviceability of the airplane, and (3) the manner in which the pilot made use of the lift increments provided by BLC.

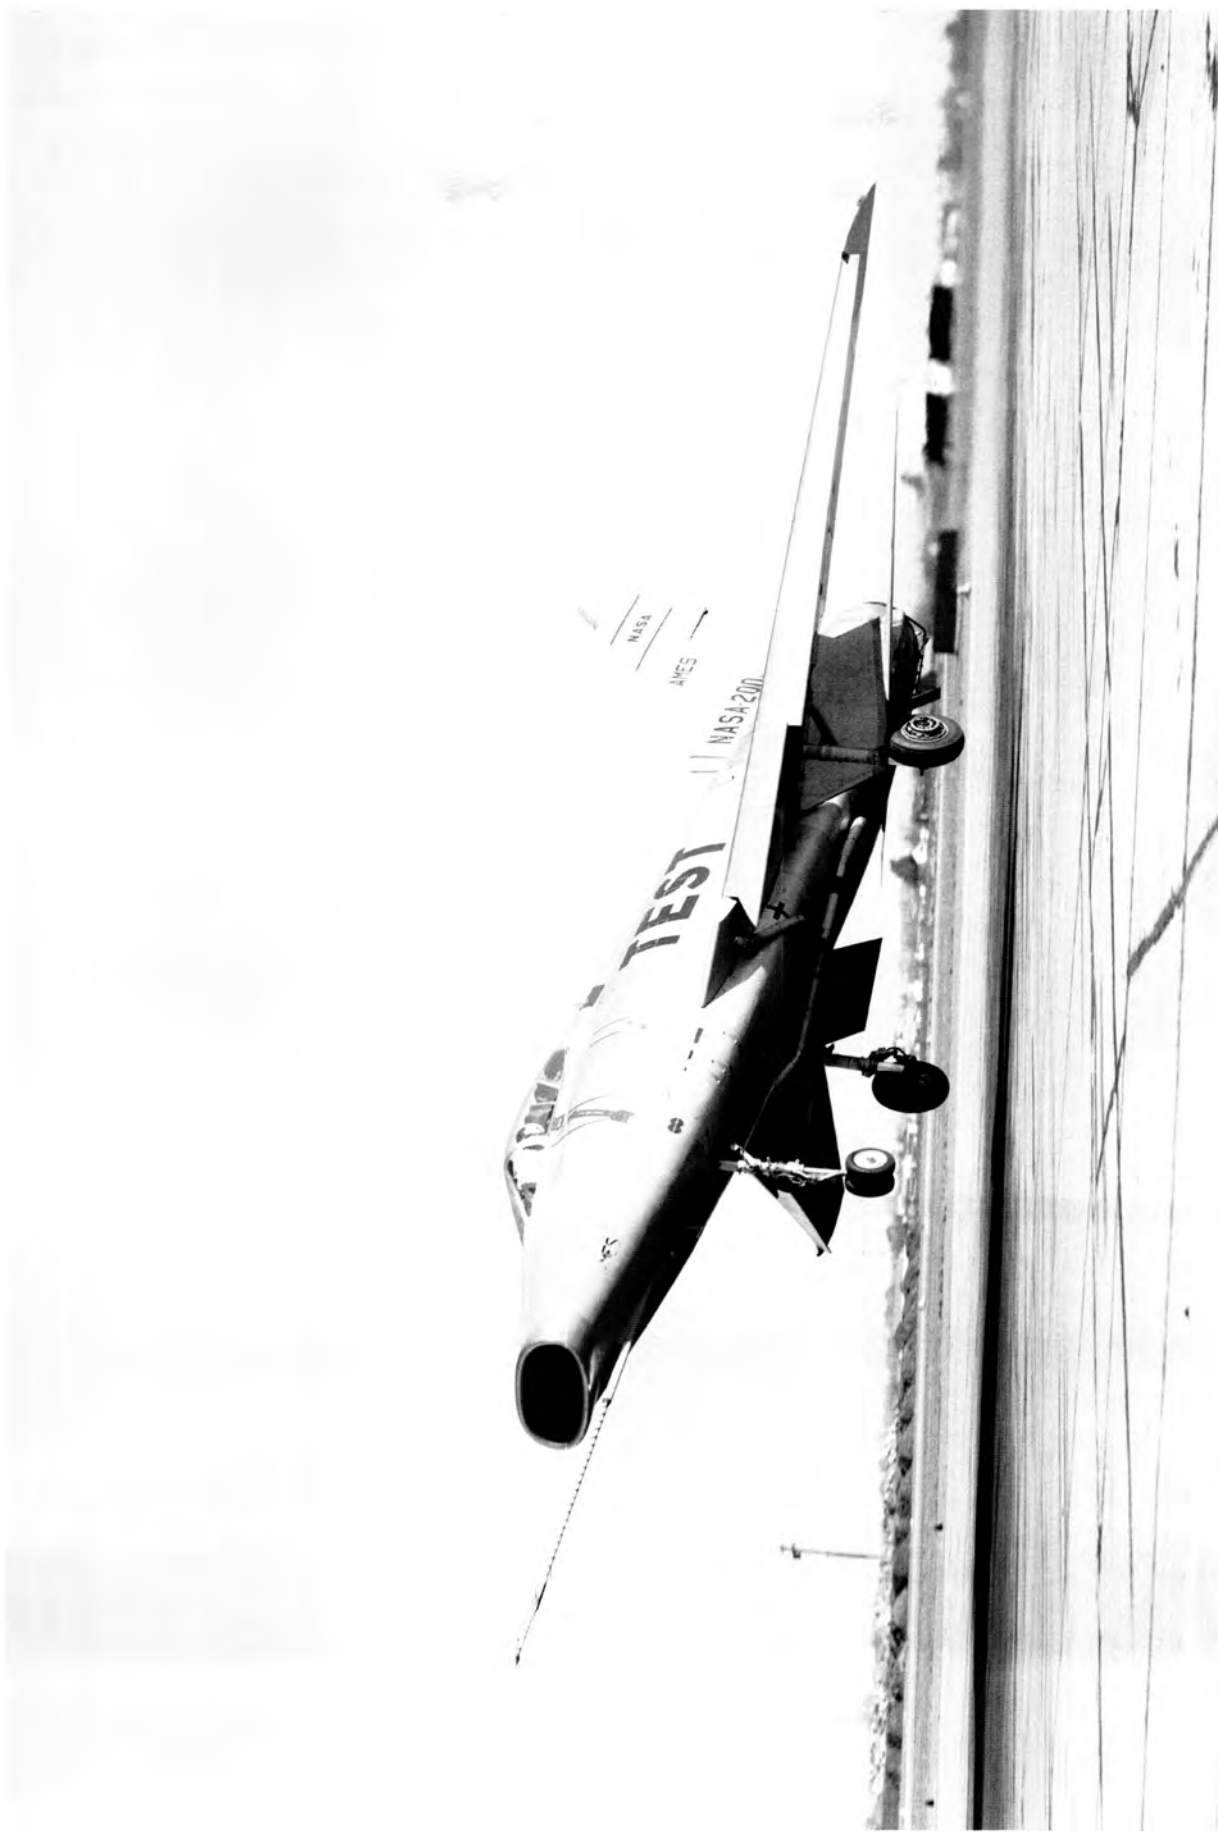
Figure 96. North American F-86A Sabre swept-wing aircraft used for low-speed tests of suction-type and blowing-type boundary-layer control systems. Several performance advantages were shown for both systems. (June 1955) A-20518

**North American F-100A**—To extend boundary-layer control studies to wings of greater sweep and reduced thickness ratio, tests were conducted on a modified F-100A (fig. 97) with

blowing BLC on the trailing-edge flaps deflected 45 degrees and on leading-edge flaps (fig. 98) deflected 60 degrees. There are two points of interest regarding lift improvements: (1) the effect on the pilot's choice of approach speed, and (2) the amount of increased wing lift usable for low-speed operation by preventing wing leading-edge stall.

With BLC applied to the trailing-edge flaps, increases in flap lift increment of 100% were realized. Landing approach speeds were reduced by about 10 knots, and roll capability at 170 knots was increased 30%. Further reduction in approach speed was limited by pilot ability to control flight-path angle and to arrest sink rate. Another factor was a reduction in engine thrust available to maintain airspeed when maneuvering during low-speed flight. A modification to the engine inlet (fig. 99) was made to improve pressure recovery for test purposes.

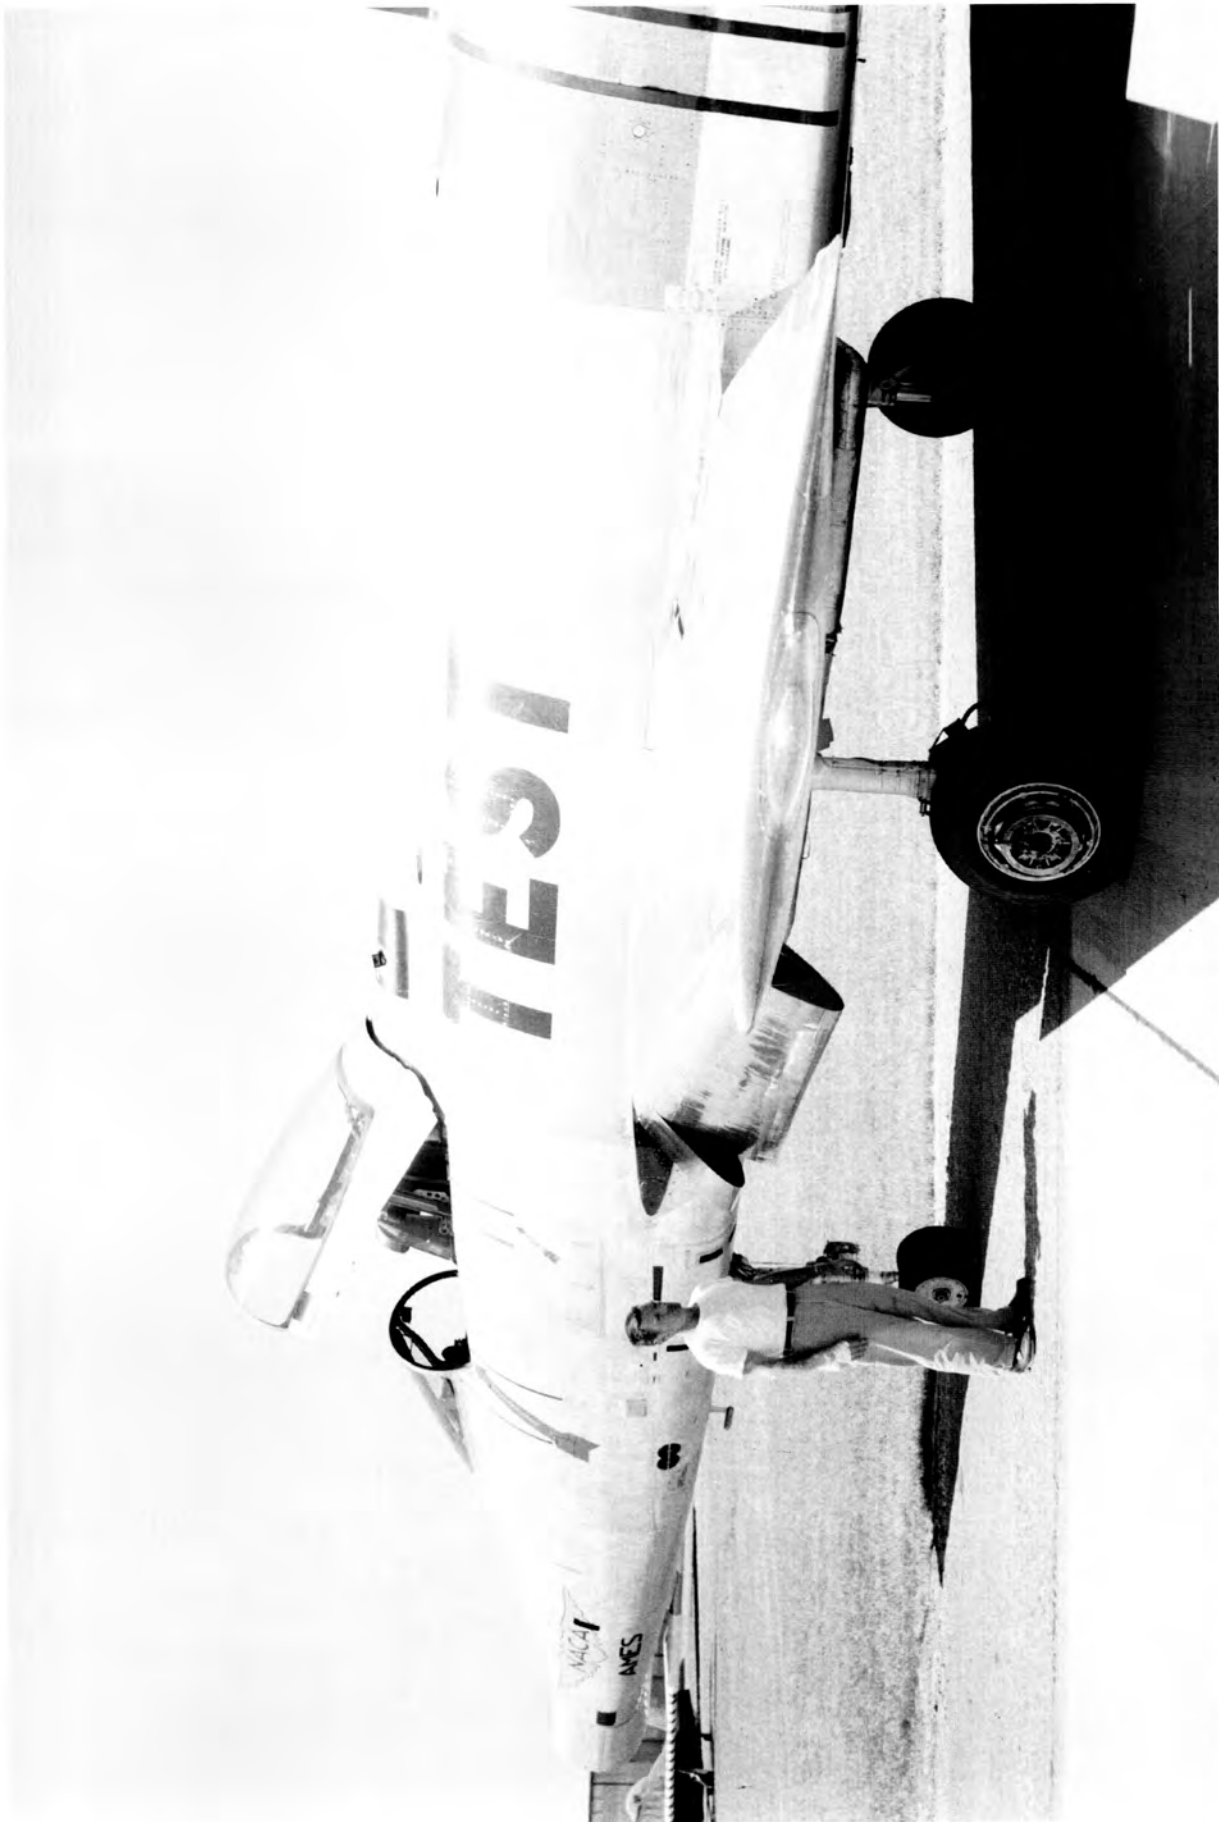
Figure 97. Blowing-type boundary-layer control on the leading- and trailing-edge flaps of North American's F-100A Super Sabre provided large reductions in takeoff and landing approach speeds. Approach speeds were reduced by about 10 knots. (Mar. 1960) A-24696

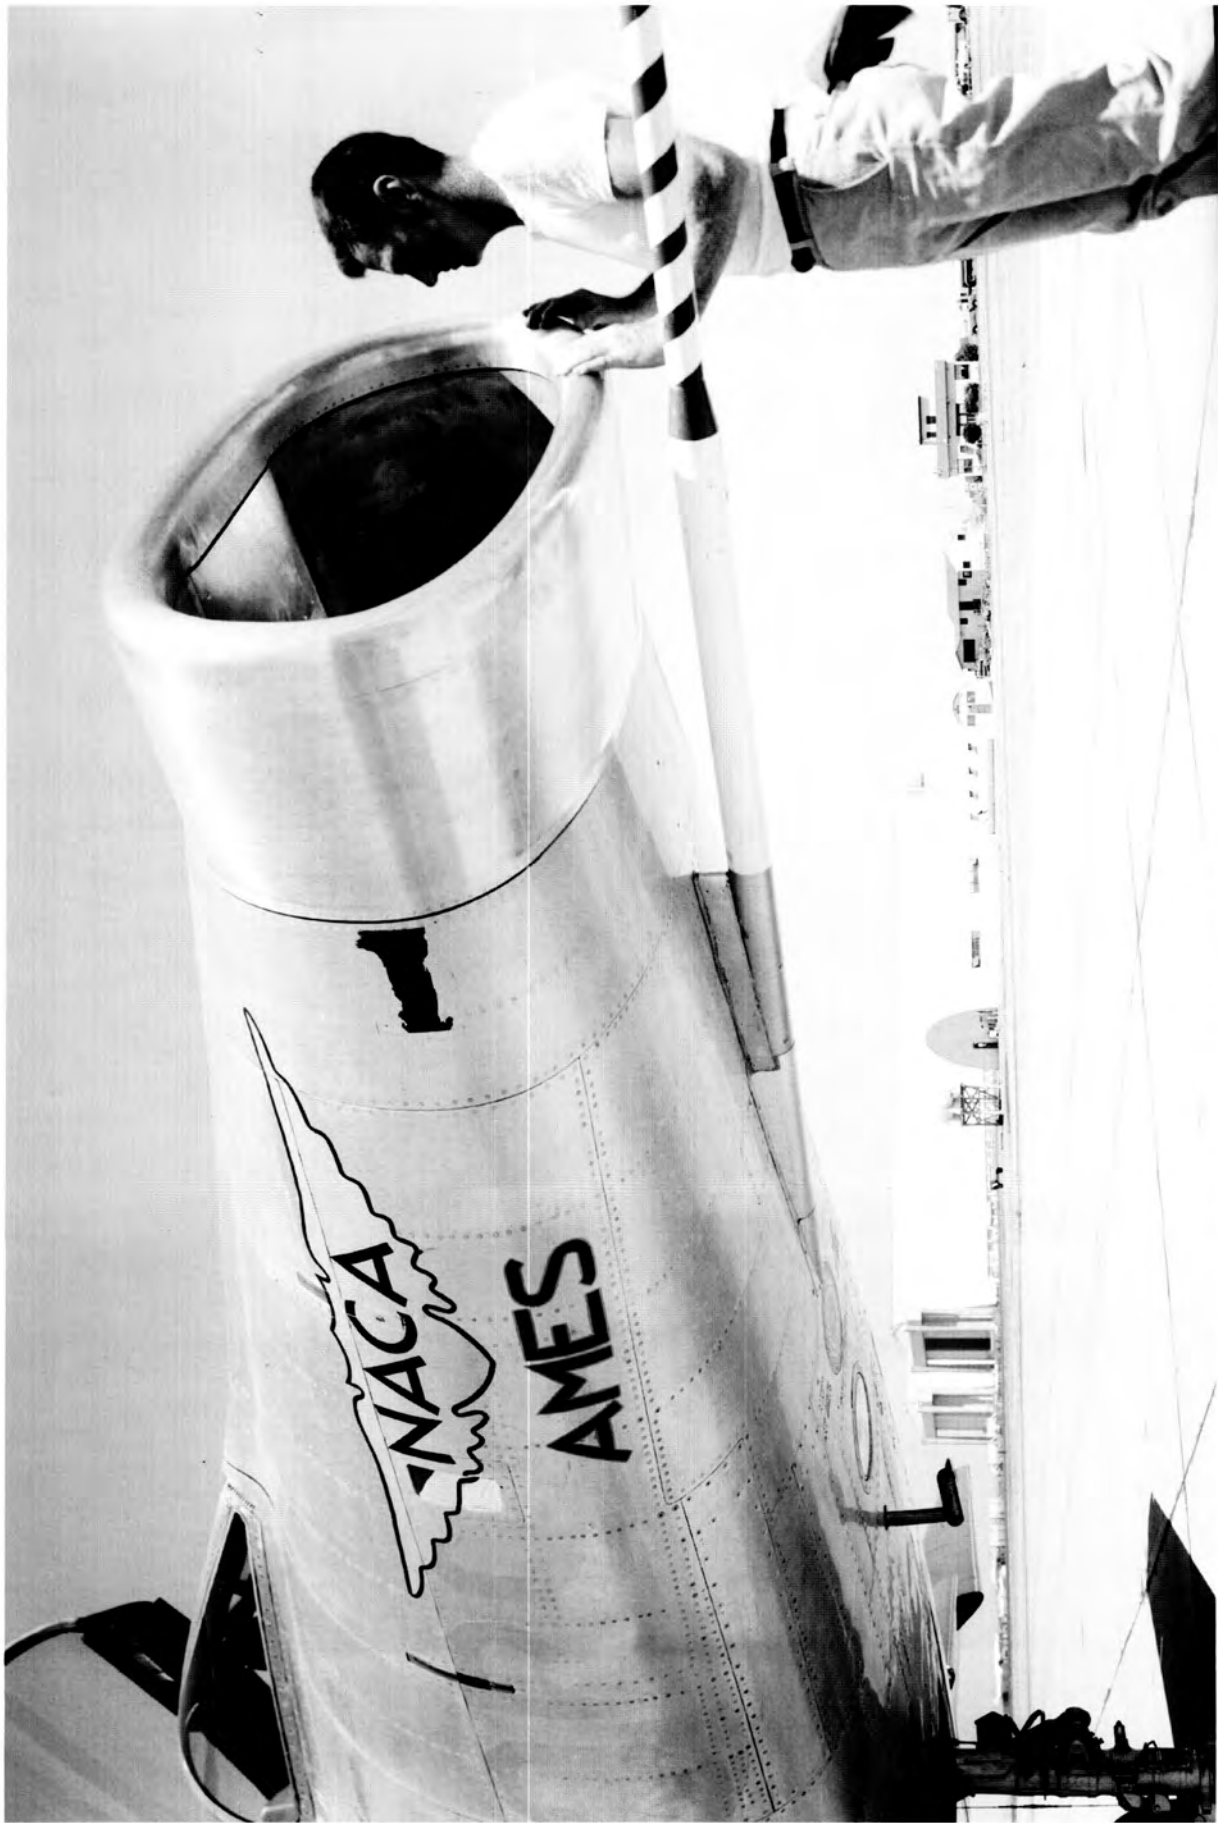
Figure 98. North American F-100 Super Sabre wing leading edge deflected 60 degrees for increased lift with boundary-layer control; takeoff performance was improved 10%. (Mar. 1960) A-24041

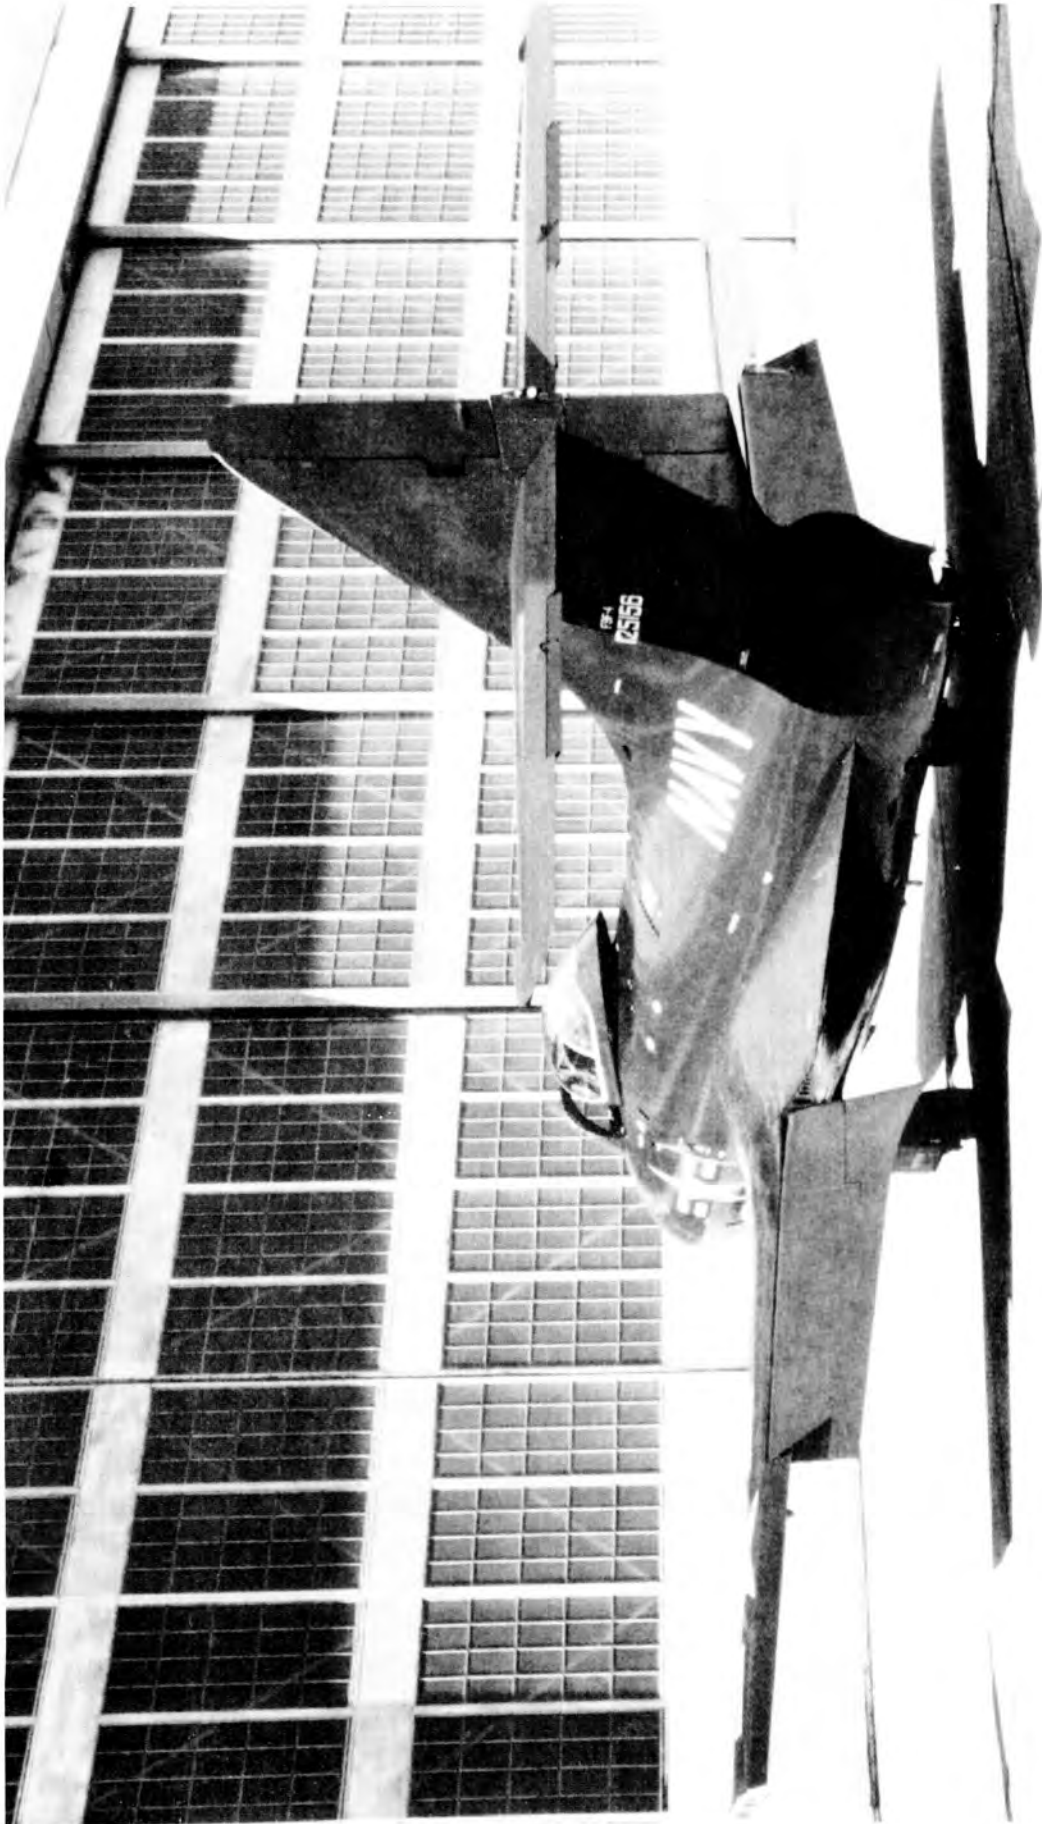
Figure 99. North American F-100 Super Sabre with rounded engine inlet; engine static thrust was increased by improving pressure recovery for better maneuvering in approach. (Mar. 1960) A-24039

**Grumman F9F-4**—Application of BLC to a Navy operational fighter was sponsored by the Bureau of Aeronautics in late 1956, and a Grumman F9F-4 was lent to Ames for flight evaluation. The aircraft (fig. 100) was modified to use a high-energy compressor bleed-air blowing system over the trailing-edge flap deflected 45 degrees.

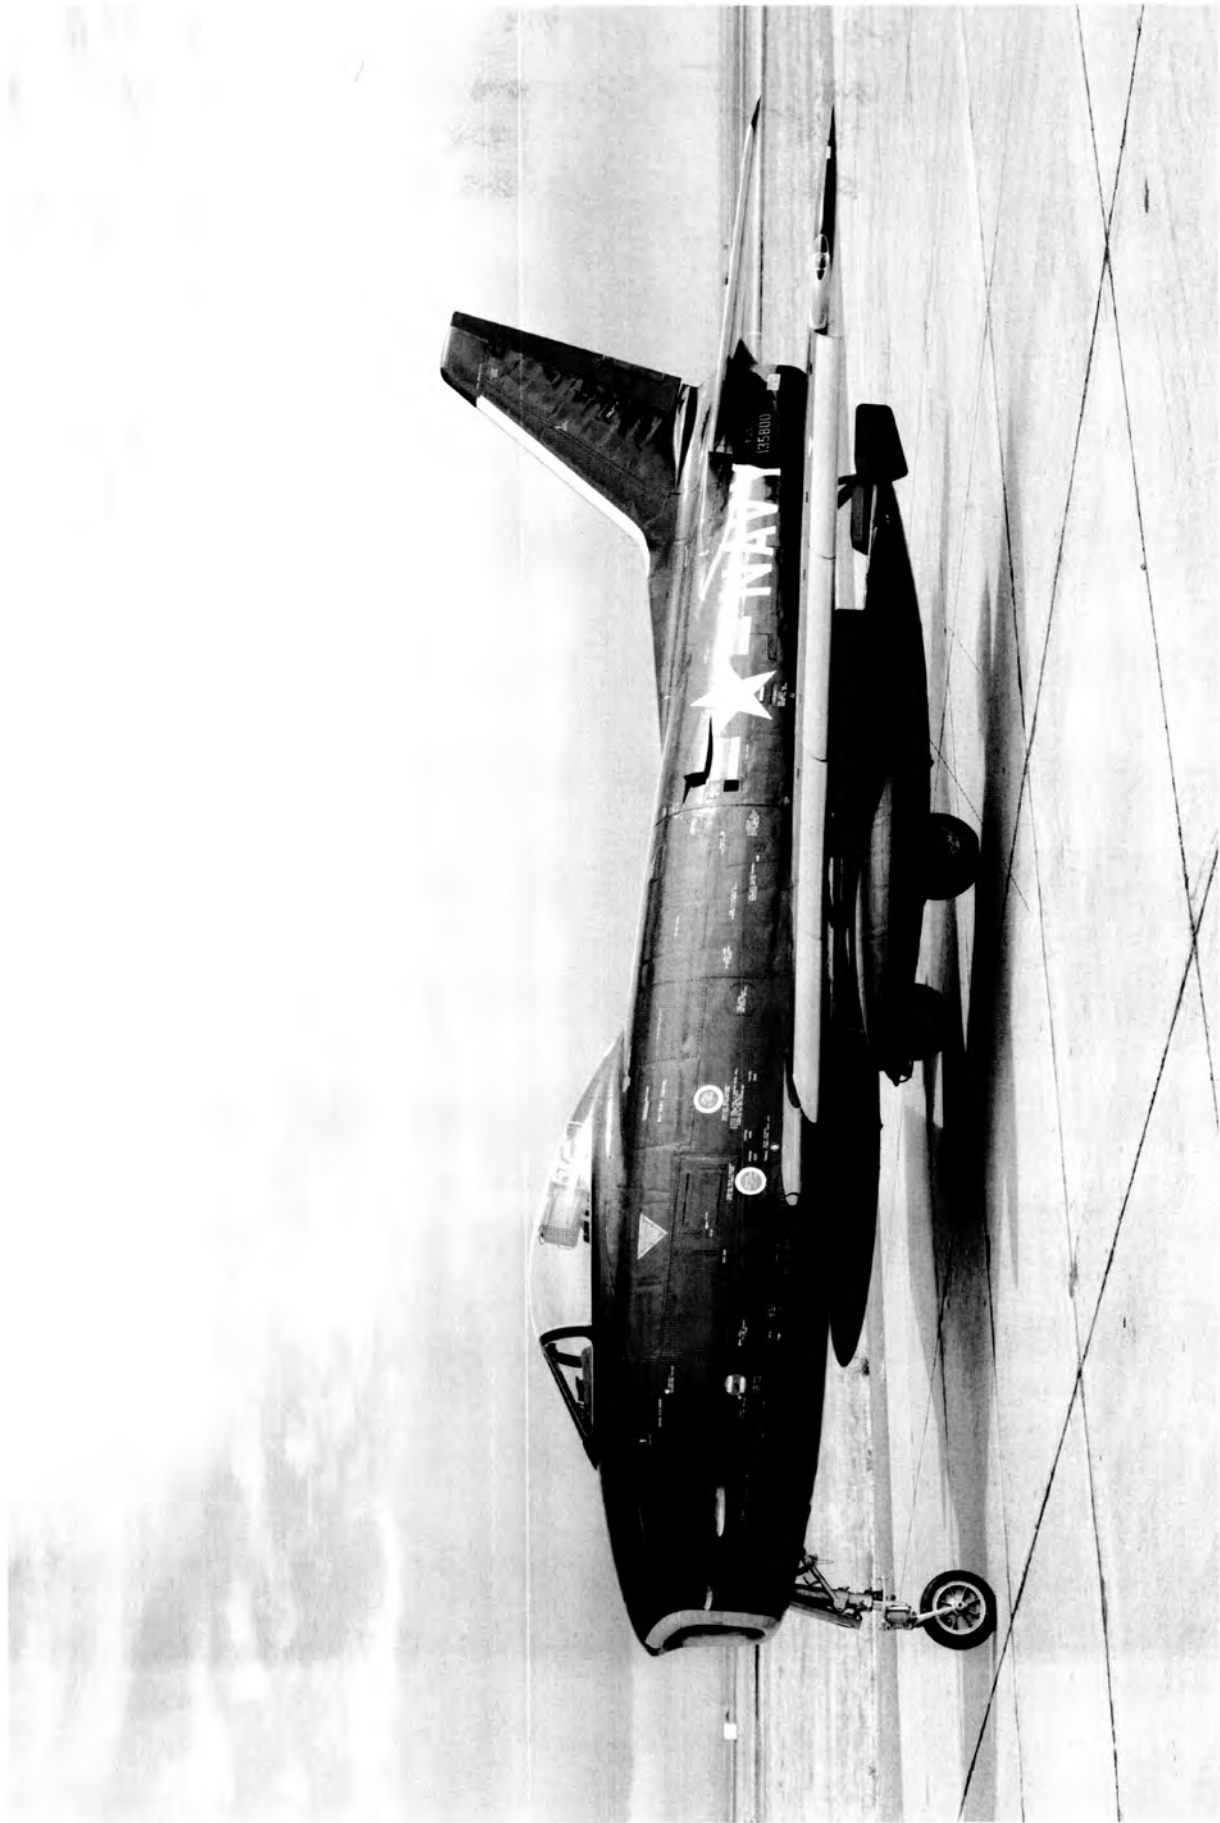
Figure 100. A 10-knot reduction in the approach speed of the F9F-4 Cougar, a Navy fighter, was achieved by applying blowing boundary-layer control on the trailing-edge flap deflected 45 degrees. (Nov. 1955) A-20173

**North American FJ-3**—Another Navy aircraft designed for carrier operation and tested at Ames was the FJ-3 (fig. 101). This aircraft was similar to the Air Force F-86, but had a stronger (heavier) landing gear for carrier landings and catapult takeoff. The ability to achieve desired low-speed performance with added weight was an important safety concern. Previous Ames flight tests had shown that appreciable lift improvements were available by using BLC on trailing-edge flaps. Ames expertise in designing, constructing, and installing BLC systems was recognized worldwide.

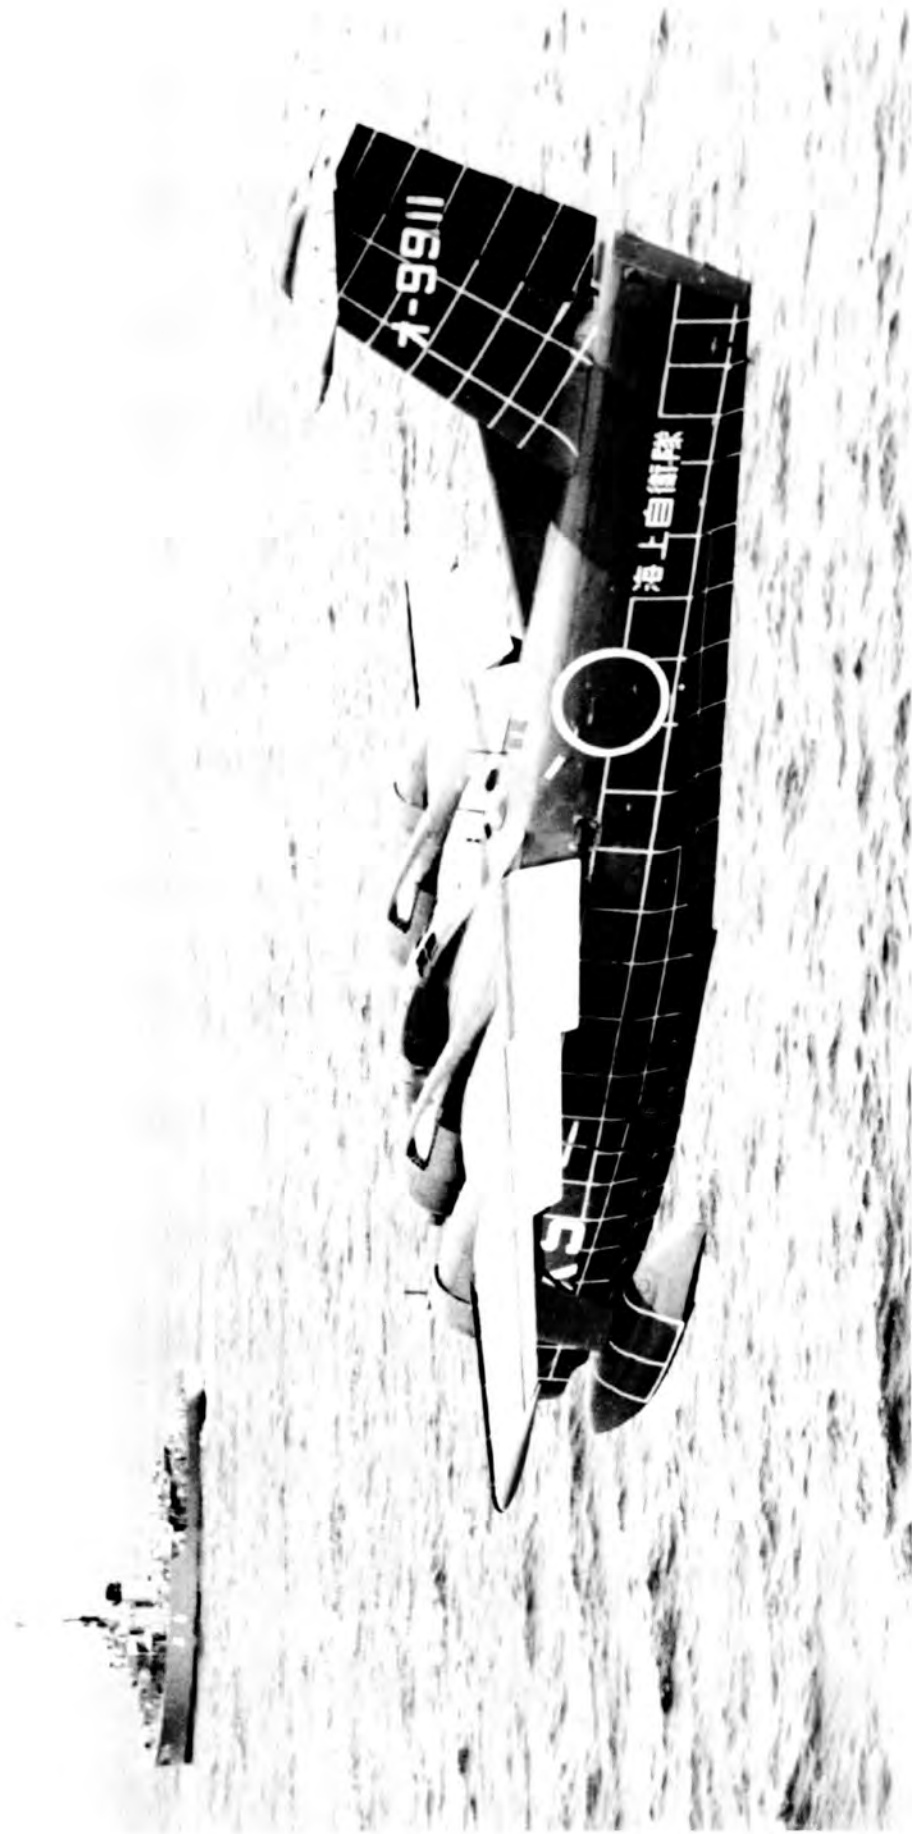
Figure 101. North American FJ-3 Fury swept-wing Navy carrier aircraft modified to test area suction- and blowing-type boundary-layer control on the trailing-edge flaps. A 10-knot reduction in carrier approach speed greatly improved the FJ-3's operational utility. (Sept. 1954) A-19681

A unique Ames flight-research program involved a 1964 study of the handling qualities of a deflected-slipstream STOL seaplane (fig. 102). This aircraft had four propellers and boundary-layer control (BLC) on all control surfaces and on the trailing-edge flaps. This enabled the aircraft to fly at relatively low airspeeds to reduce structural loads when landing in high sea states. The aircraft, designated the UF-XS, was designed and built by the Shin Meiwa Company for the Japanese Maritime Self Defense Force to operate in a sea state corresponding to 10-foot waves—a very hostile environment. The first flight occurred in December 1962.

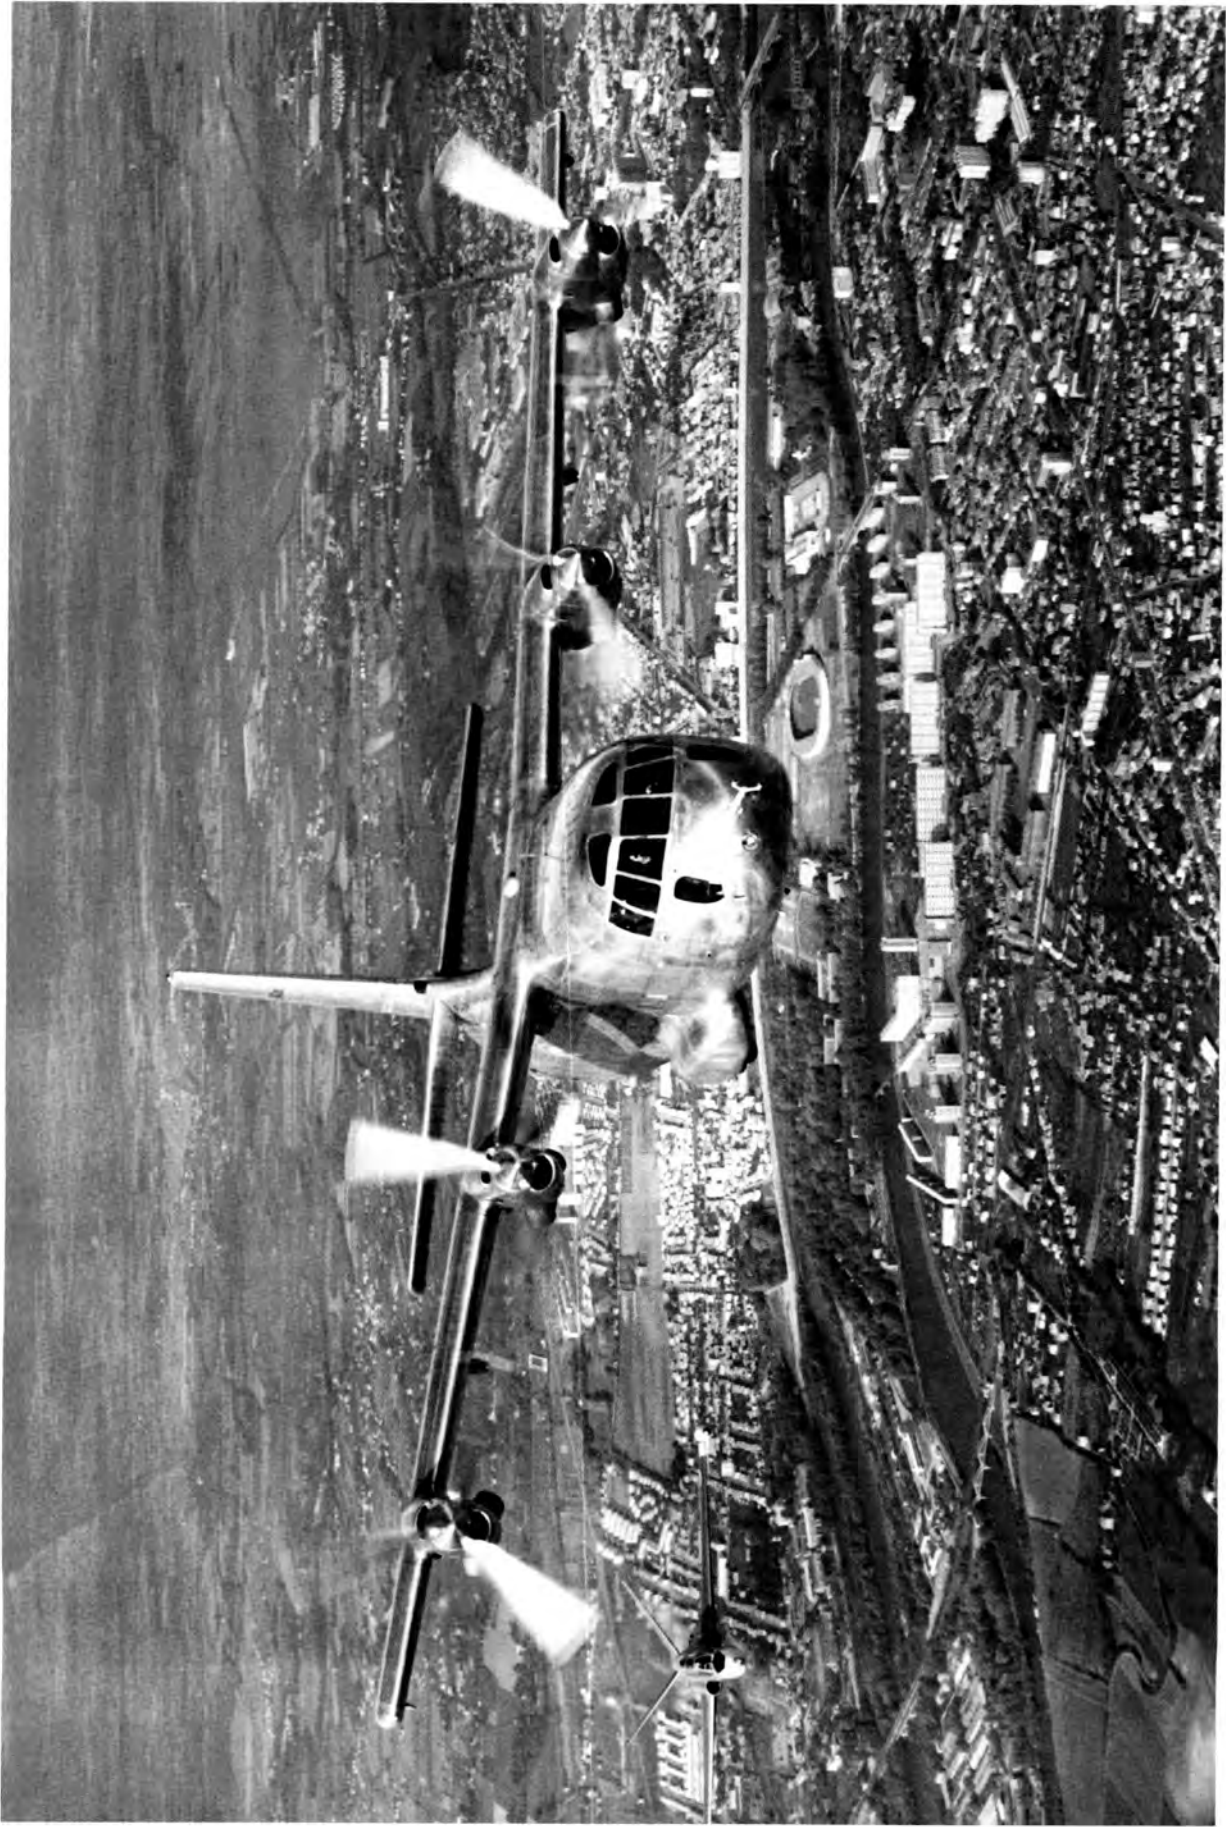
Figure 102. Japanese UF-XS STOL seaplane used blowing boundary-layer control applied to all control surfaces and trailing-edge flaps. Automatic stabilization equipment was required for low-speed flight. Operation in a sea state corresponding to 10-foot waves was possible with the boundary-layer control system. The special hull shape of the UF-XS reduced water spray pattern during takeoff and landing. (June 1965) A-33534

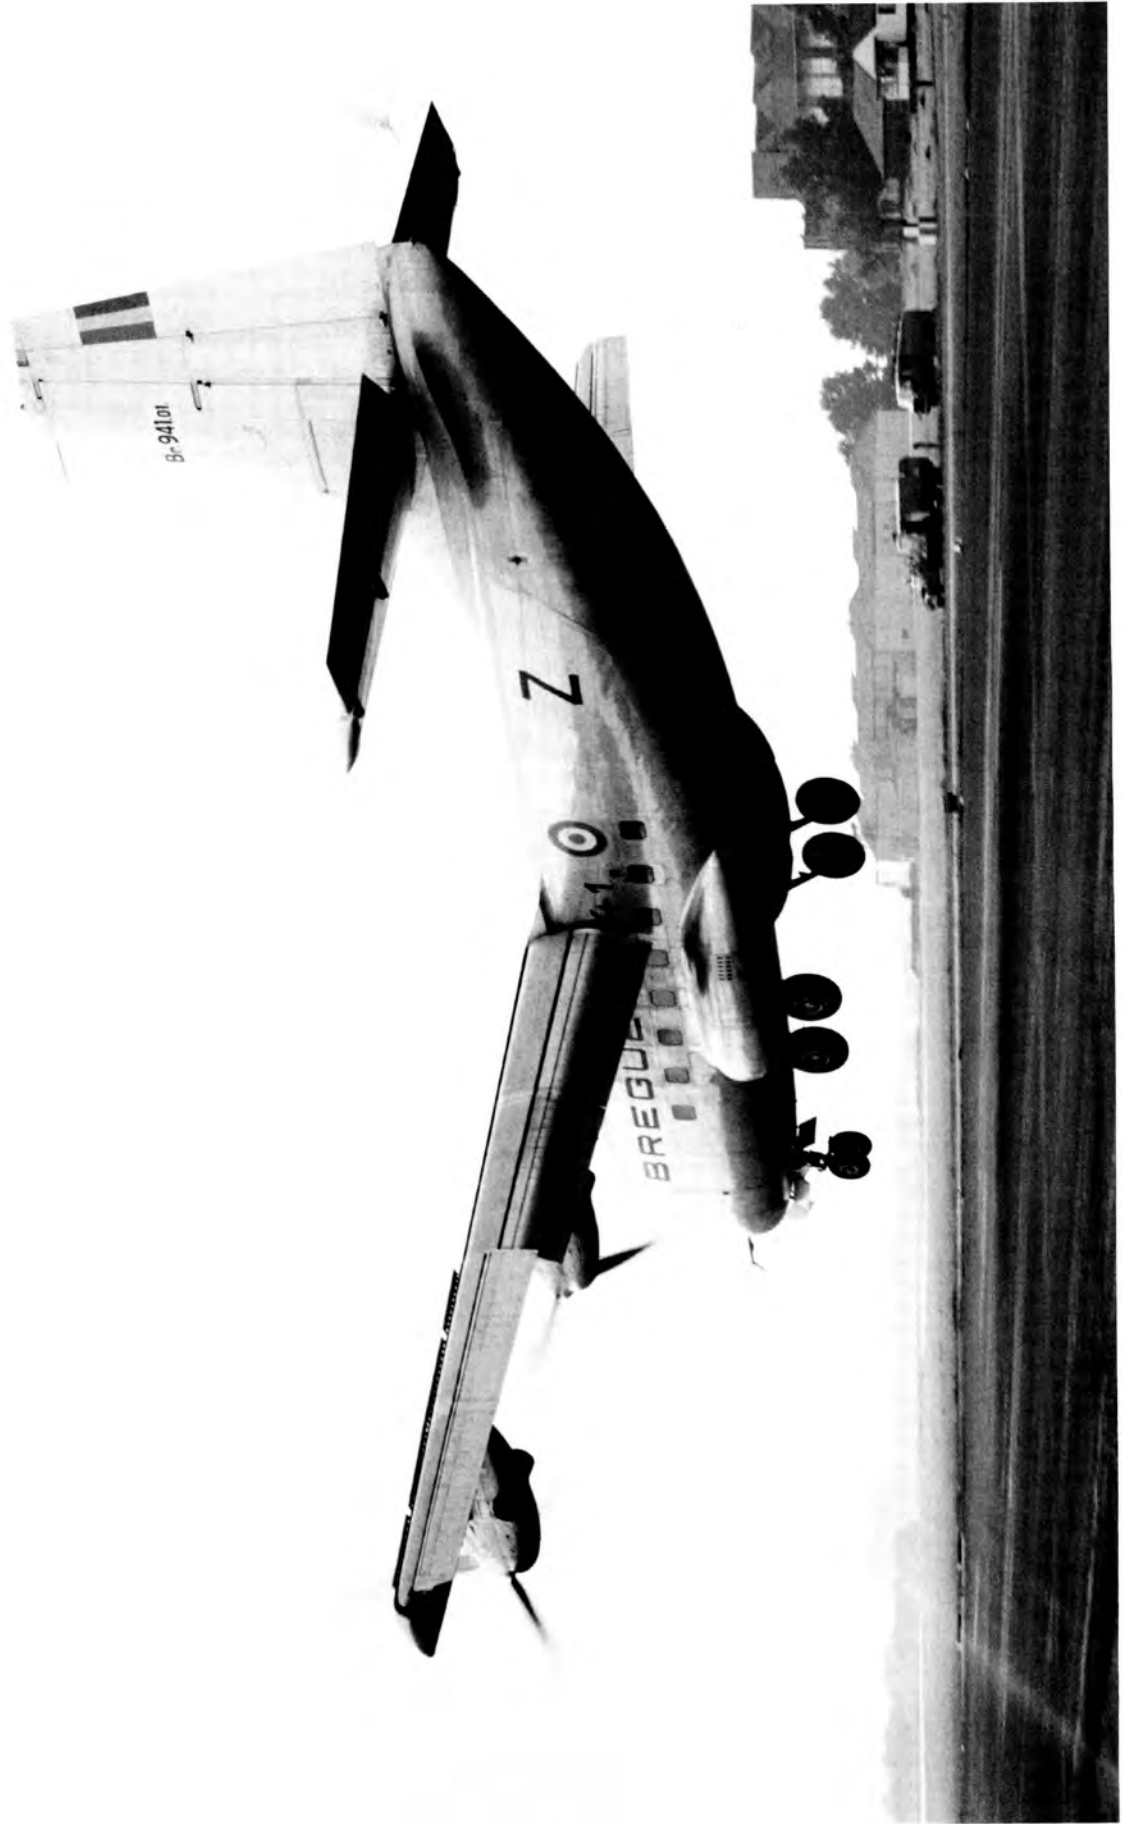
*Figure 103. Propellers on the French Breguet 941 are interconnected to provide engine-out safety and more efficient cruise with one engine out. The 941 had outstanding maneuverability and STOL performance. AD00-0193-2*

Ames had already established an authoritative international reputation for defining handling-qualities specifications for STOL aircraft when a second contact was made with representatives of the French Breguet Aircraft Company in 1963. Breguet had demonstrated the feasibility of using highly deflected triple-slotted flaps, cross-shafting for interconnected propellers, a control stick instead of a wheel, and differential outboard propeller pitch control to obtain outstanding maneuverability and STOL performance. These features were incorporated into an assault transport, the 40,000-pound Breguet 941 (fig. 103), which had four 1,500-horsepower turboprop engines. The 941 achieved good STOL capability by having most of the wing immersed in the slipstream and by using highly deflected flaps (98 degrees). Because of a mutual interest in studying the operational problems, performance, and handling qualities of STOL airplanes, Ames researchers made arrangements to conduct a limited 10-hour flight-test program on the 941 aircraft at Centre d'Essais en Vol (French Flight Test Center) at Istres, France, in 1963 (fig. 104).
