NASA/SP-2002-4526

# ***MEMOIRS OF AN AERONAUTICAL ENGINEER***

**Flight Tests at Ames Research Center:  
1940-1970**

**Seth B. Anderson**

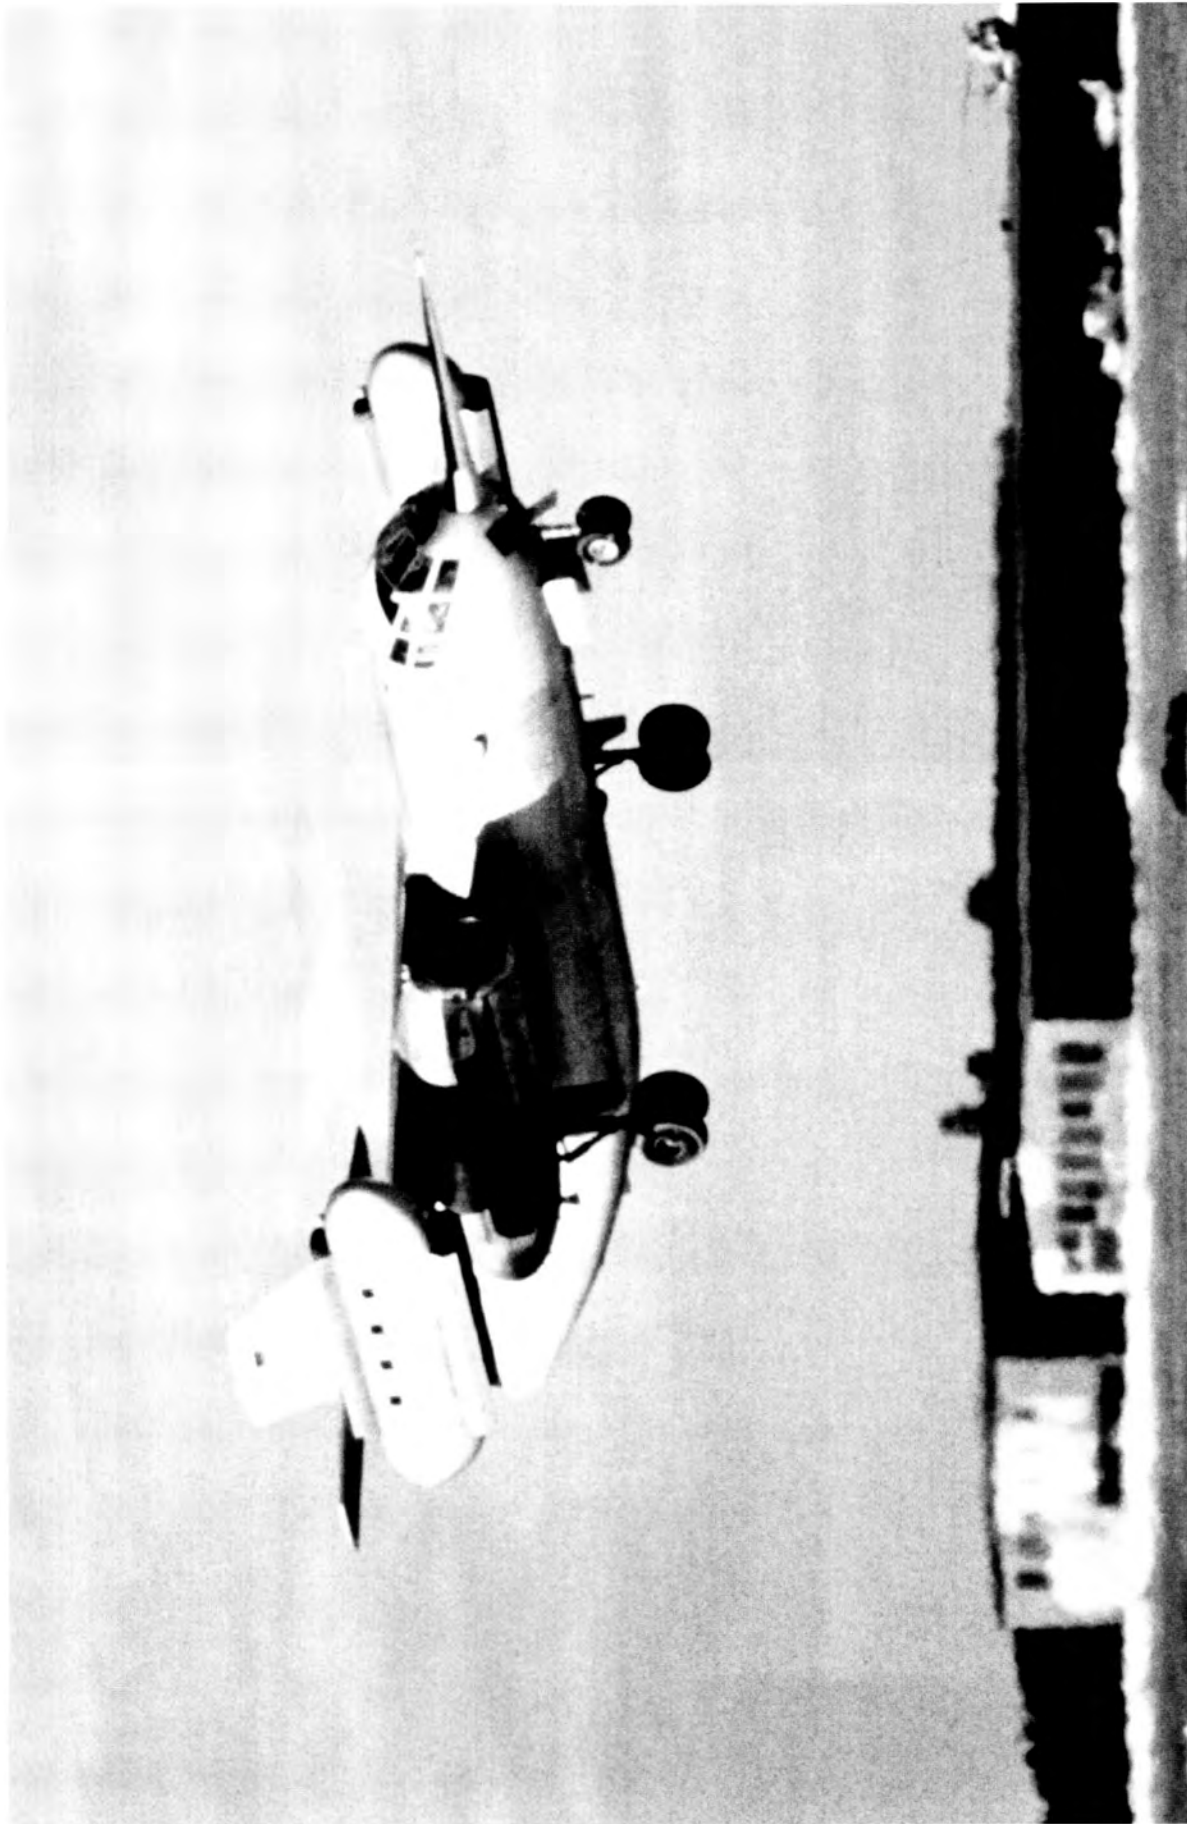
Figure 105. The Dornier DO-31, an experimental V/STOL transport, in forward flight. Four turbojet lift engines were mounted in each of two removable wing pods; they were modulated for roll control in hover and low-speed flight. Two vectored-thrust Pegasus main engines (15,000 pounds thrust each) provided Mach 0.6 cruise speed. (Dec. 1969) A-42712-2

The DO-31 had a cruise speed of Mach 0.60 and was a unique technological achievement. It was a high-wing, mixed-propulsion, VTOL transport with two main engines (vectored lift-cruise) and eight lift engines (fig. 106). For operational simplicity, all eight lift engines could be started simultaneously and controlled by a single lever. The aircraft was superior to other VTOL research aircraft in that it was large enough to constitute a first-generation transport with a mixed propulsion system and had an advanced control and stabilization system. The controls and displays were duplicated to allow IFR operational testing.

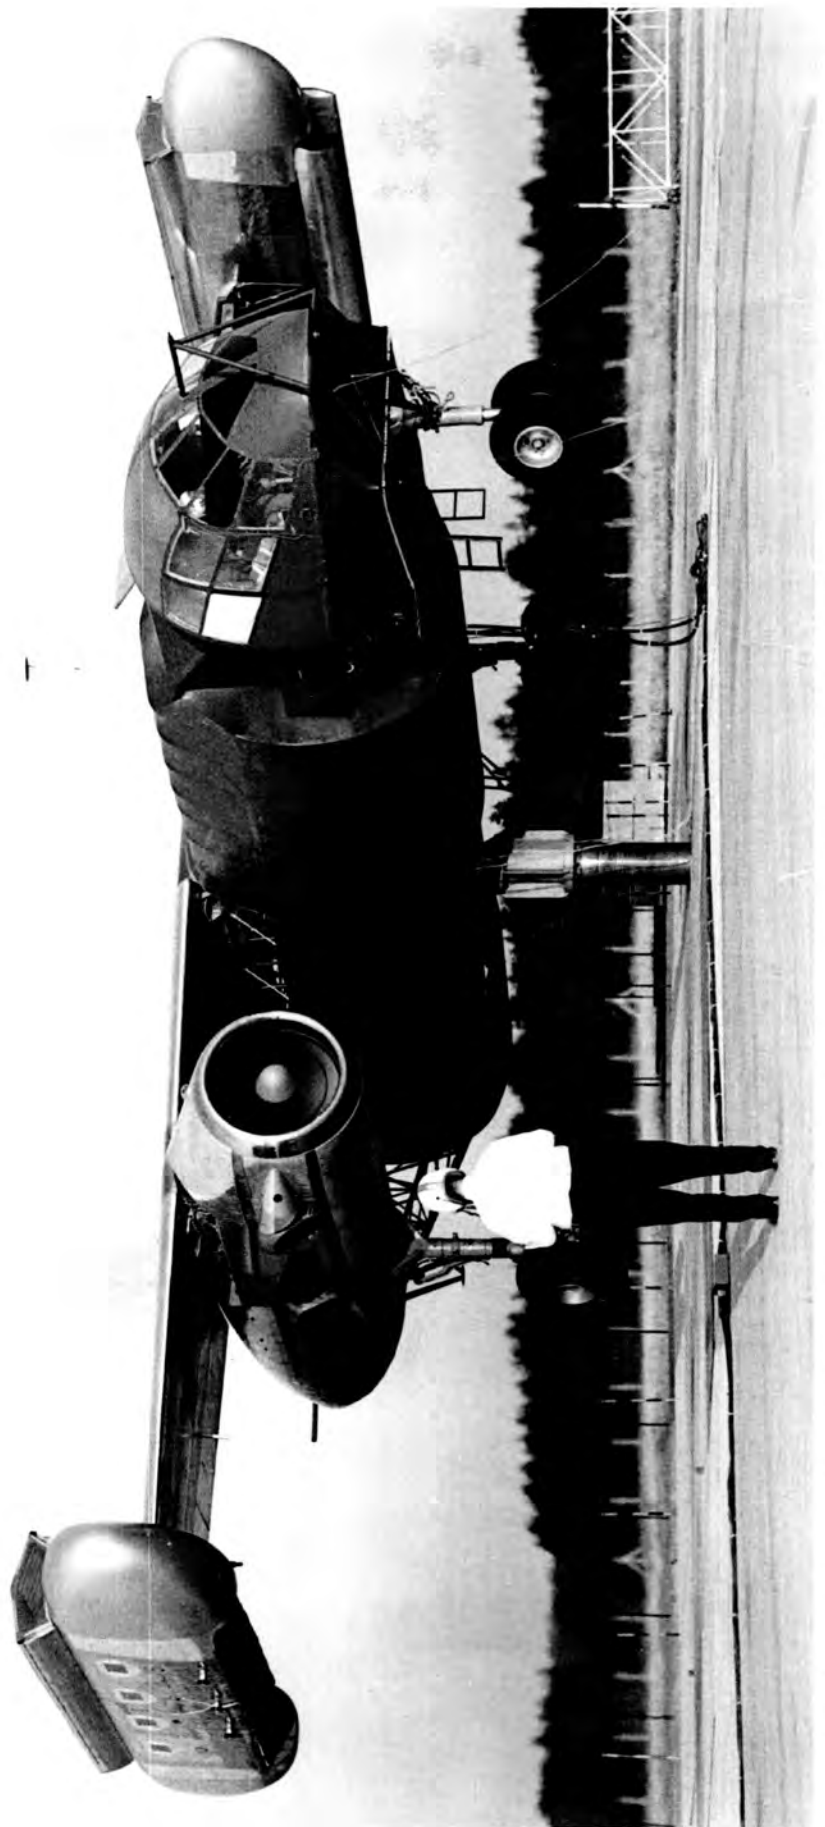
Figure 106. Dornier DO-31 10-engine jet-lift V/STOL transport hovering at Oberphaffenhoven, Germany. Among other things, use of 10 turbojet engines eliminated runway snow-removal problems. (Mar. 1970) A70-3897

A hover rig (fig. 107) simulating the DO-31 was mounted on a telescoping base. The rig could be detached and flown in free-flight sideward and forward to 40 knots and to altitudes of 300 feet. It was used to develop the cockpit architecture and operational techniques for managing 10 jet engines in startup and hover flight. It proved valuable in pilot training and in total systems checkout.
