**HAZARD EVALUATION AND TECHNICAL ASSISTANCE REPORT  
HETA 90-170-L2053  
JOHNSON JUNIOR HIGH SCHOOL  
LARAMIE COUNTY SCHOOL DISTRICT #1  
CHEYENNE, WYOMING  
JULY 1990**

HETA 90-170  
JULY 1990  
JOHNSON JUNIOR HIGH SCHOOL  
CHEYENNE, WYOMING

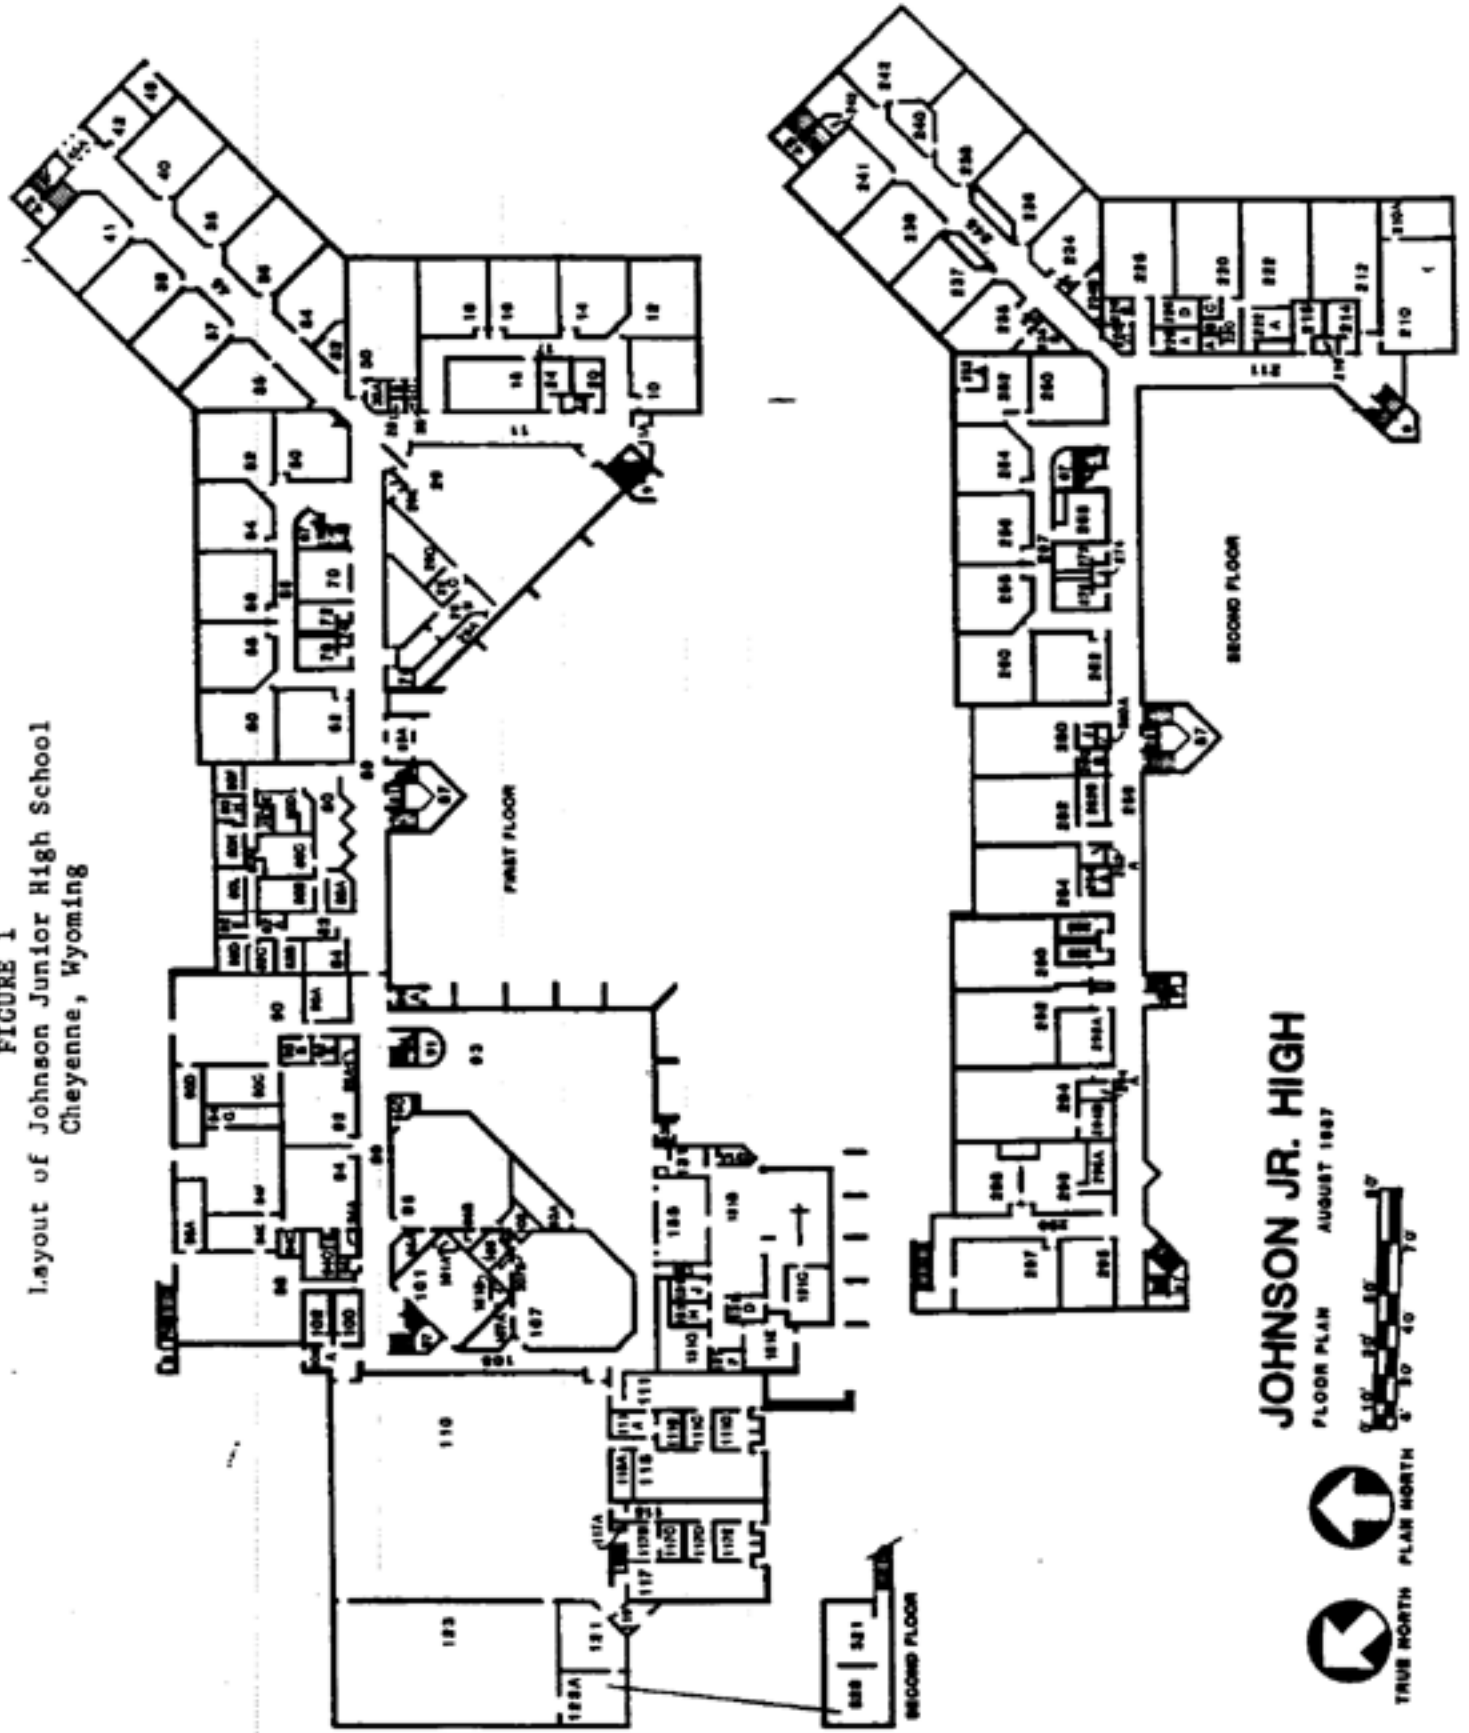
FIGURE 1  
Layout of Johnson Junior High School  
Cheyenne, Wyoming

In the metals room (Rm #98, Figure 1), there were two welding booths, a mini foundry complete with furnace and mold pouring locations, and a variety of metal working machines. The pour area was ventilated through a particulate/charcoal filter system ("Smoke-Eater") and the exhaust was circulated back into the room. The welding stations were controlled by another identical system. There was a local exhaust on the wall behind the foundry furnace which exhausted to the outside. The internal scrubbing systems were unable to handle the emissions from the poured molds and the welding fumes. The room quickly became filled with smoke and strong odors. This room had been the source of numerous odor complaints from teachers in other rooms in the building.

6. The "Smoke-Eater" systems in the Metals Shop should be replaced with efficient local exhaust ventilation which will exhaust to the outside. This includes the area above the mold pouring and foundry furnace, and the welding stations. An engineering firm should be consulted about the best method for exhausting these areas given the operation that is to be done.
