ENGINEERING EVALUATION OF 55-YEAR-OLD TIMBER COLUMNS RECYCLED FROM AN INDUSTRIAL MILITARY BUILDING

Forest Prod. J. 50(4):71-76.

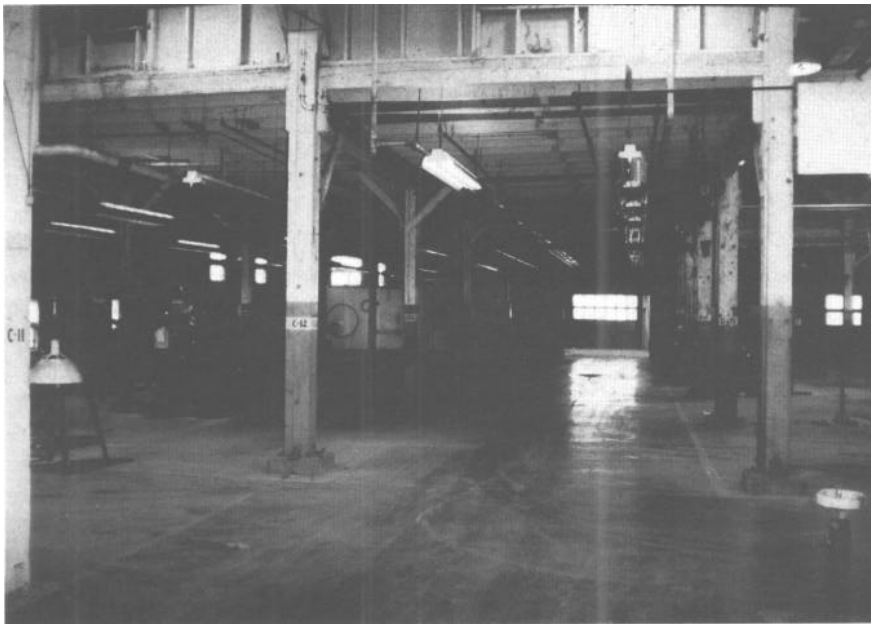
Figure 1. —The 8- by 8-columns supporting the mezzanine floor of building 503.

Sixty 12-foot- (3.6-m-) long 8 by 8 Douglas-fir columns were collected and shipped to the Forest Products Laboratory (FPL) for testing. These columns had been used to support the mezzanine floor of building 503 (Fig. 1). Before dismantlement, we marked specific timbers to be saved for testing. An inspection of the building indicated that the timber had been installed green, and many members had developed significant drying checks and/or splits. To investigate the effect of these defects on column strength, we selected 30 members that were considered "checked" and 30 members considered "unchecked." Although the selection criteria were rather qualitative, a member typical of what we considered to be checked is shown in Figure 2.

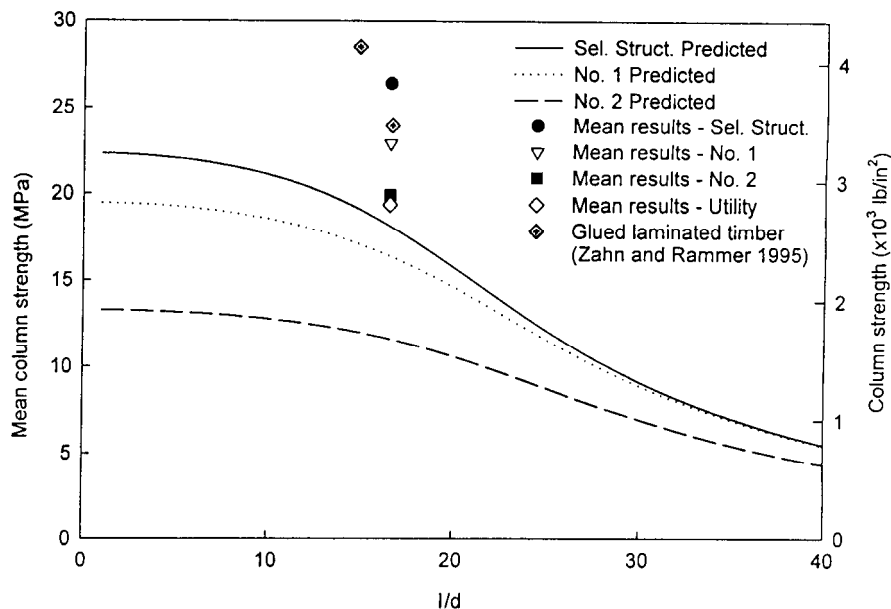
Figure 4.—Comparison of NDS design equations and test results.

A comparison of the calculated column strength F_c^* and the column capacity f indicates that the tested columns are a minimum of 40 percent greater in strength than would be calculated by current design methods. This result is consistent with results obtained for dimension lumber in the In-Grade Testing program, where the compression test results were found to be considerably higher than those calculated by ASTM D 245 clear wood (9). A comparison of the tested column strength with design equations graphed over a range of l/d ratios is shown in **Figure 4**.
