Railing Systems for Longitudinal Timber Deck Bridges

Ronald K. Faller and Barry T. Rosson, Midwest Roadside Safety Facility,
University of Nebraska-Lincoln

Michael A. Ritter and Paula D. Hilbrich Lee, USDA Forest Service,
Forest Products Laboratory

Sheila R. Duwadi, Federal Highway Administration

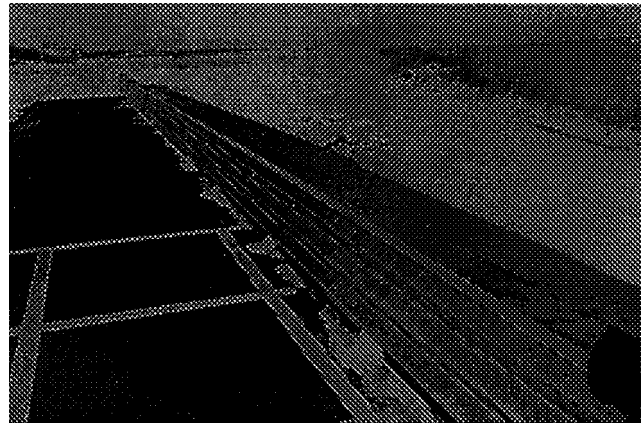
Figure 3 – Steel thrie beam bridge railing successfully crash tested to AASHTO PL-2 (photograph taken prior to testing). Drawing units are millimeters.

The PL-2 railing included a steel rail and steel channel section, as shown in Figure 3. The steel rail was a modified version of that tested at PL-1. Minor changes in the railing geometry and the addition of a steel channel section above the rail were necessary to resist the increased loads at PL-2.

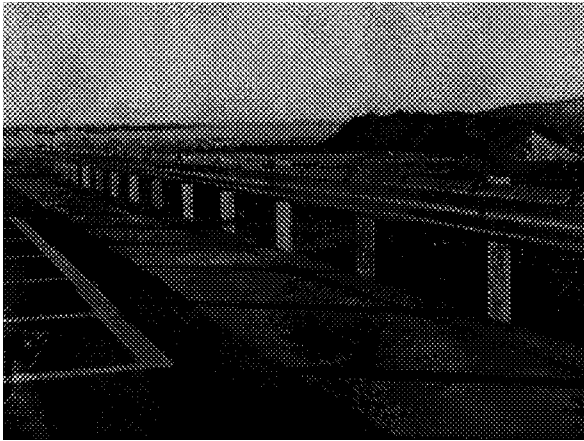
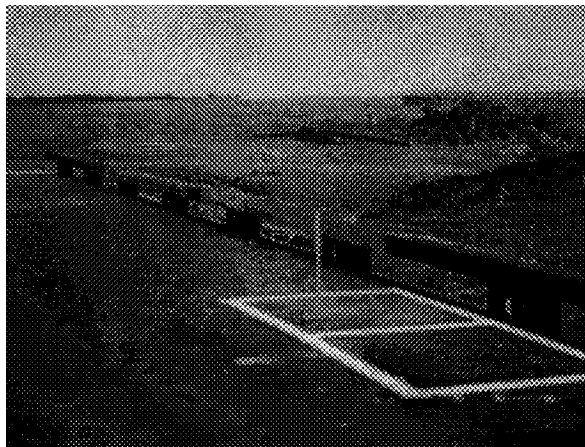
Figure 4 – Photographs of bridge railings successfully crash tested to NCHRP 350 TL-1 (photographs taken prior to testing).

Photographs and drawings of the TL-1 railings are shown in Figures 4 and 5, respectively.

The flexible steel rail consisted of a 12-gauge W-beam rail mounted to a breakaway sawn lumber post. The lower end of the post was placed between two steel angles that were connected to the vertical edge of the bridge deck with lag screws.

The semi-rigid steel rail consisted of a 12-gauge W-beam rail mounted to a steel wide flange post. The post was bolted to a steel plate which was bolted to the bridge deck surface.

The low-height, curb-type timber rail was constructed with a glulam timber rail and supported with scupper blocks. The curb and scupper blocks were connected to the bridge deck with bolts and timber connectors.
