# Association of State Dam Safety Officials (ASDSO)/EPRI Spillway Gate Workshop

January 5 & 6, 2000

Final Report, June 2000

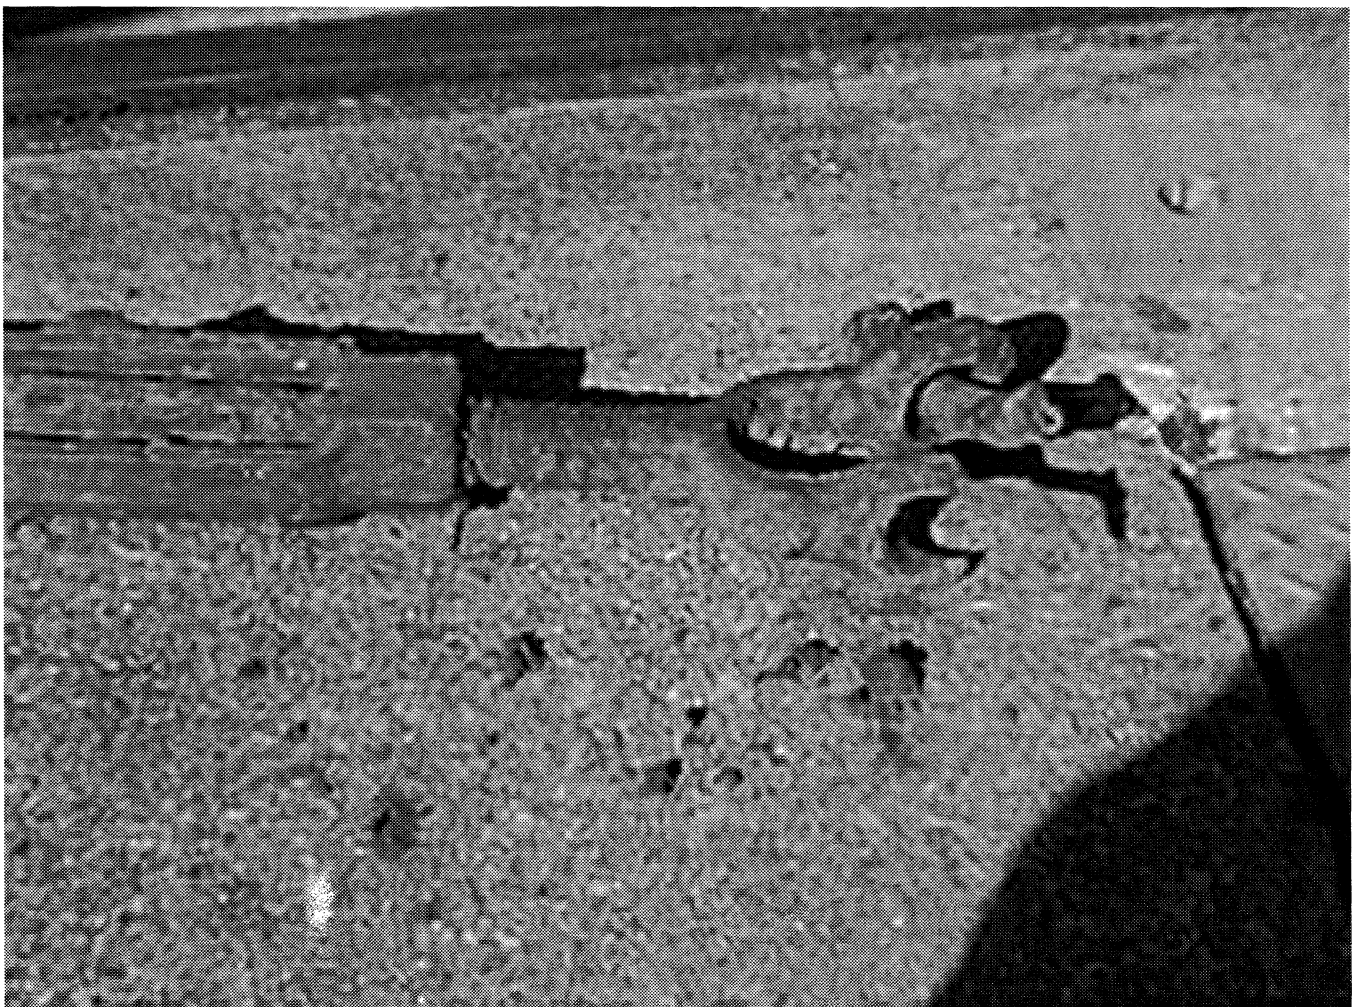
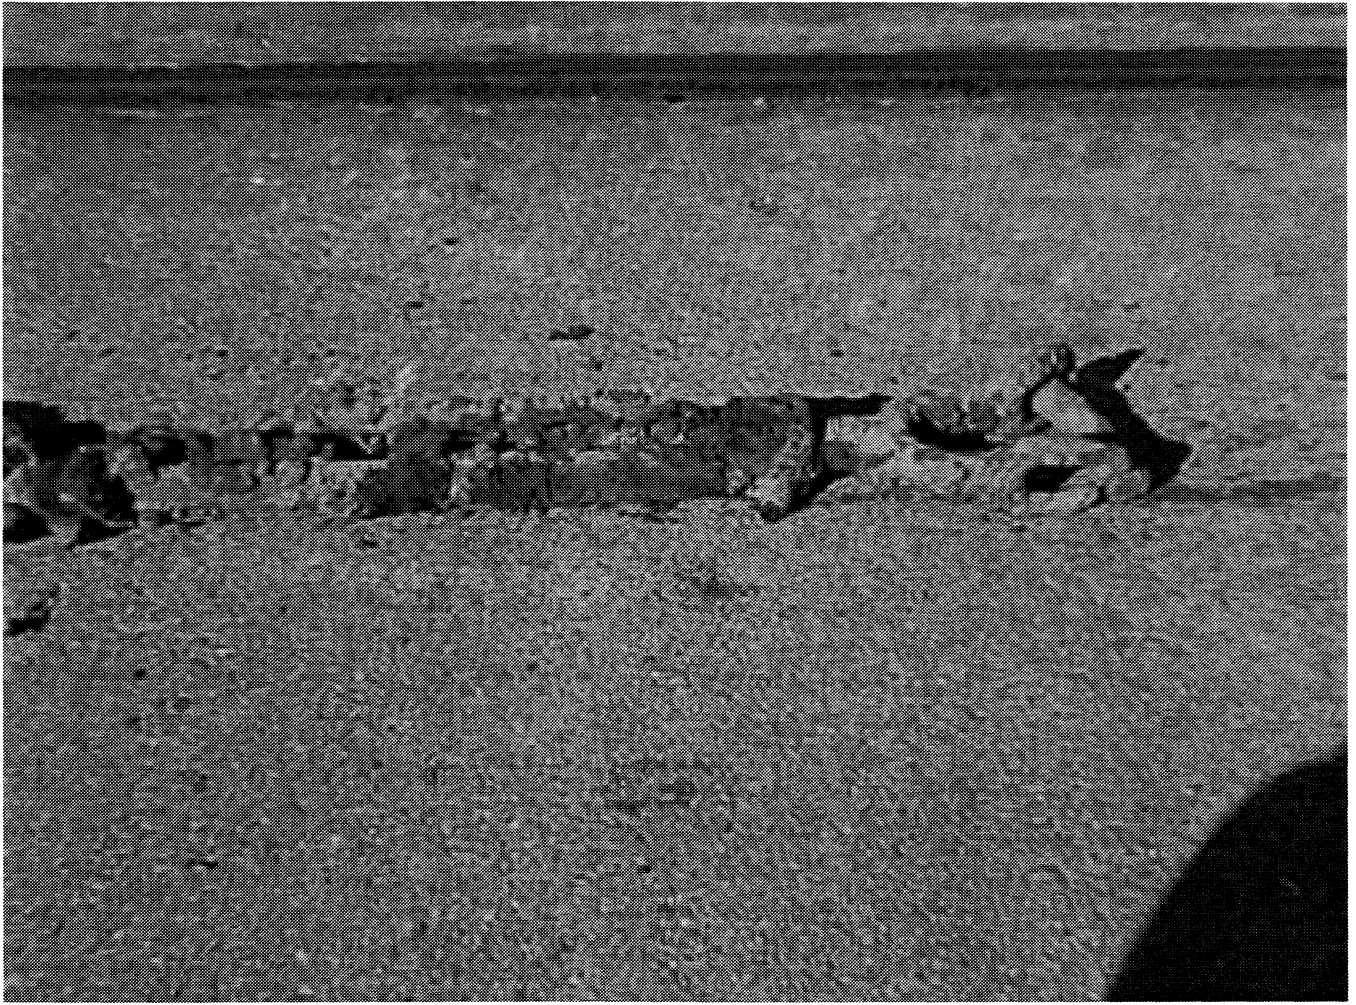
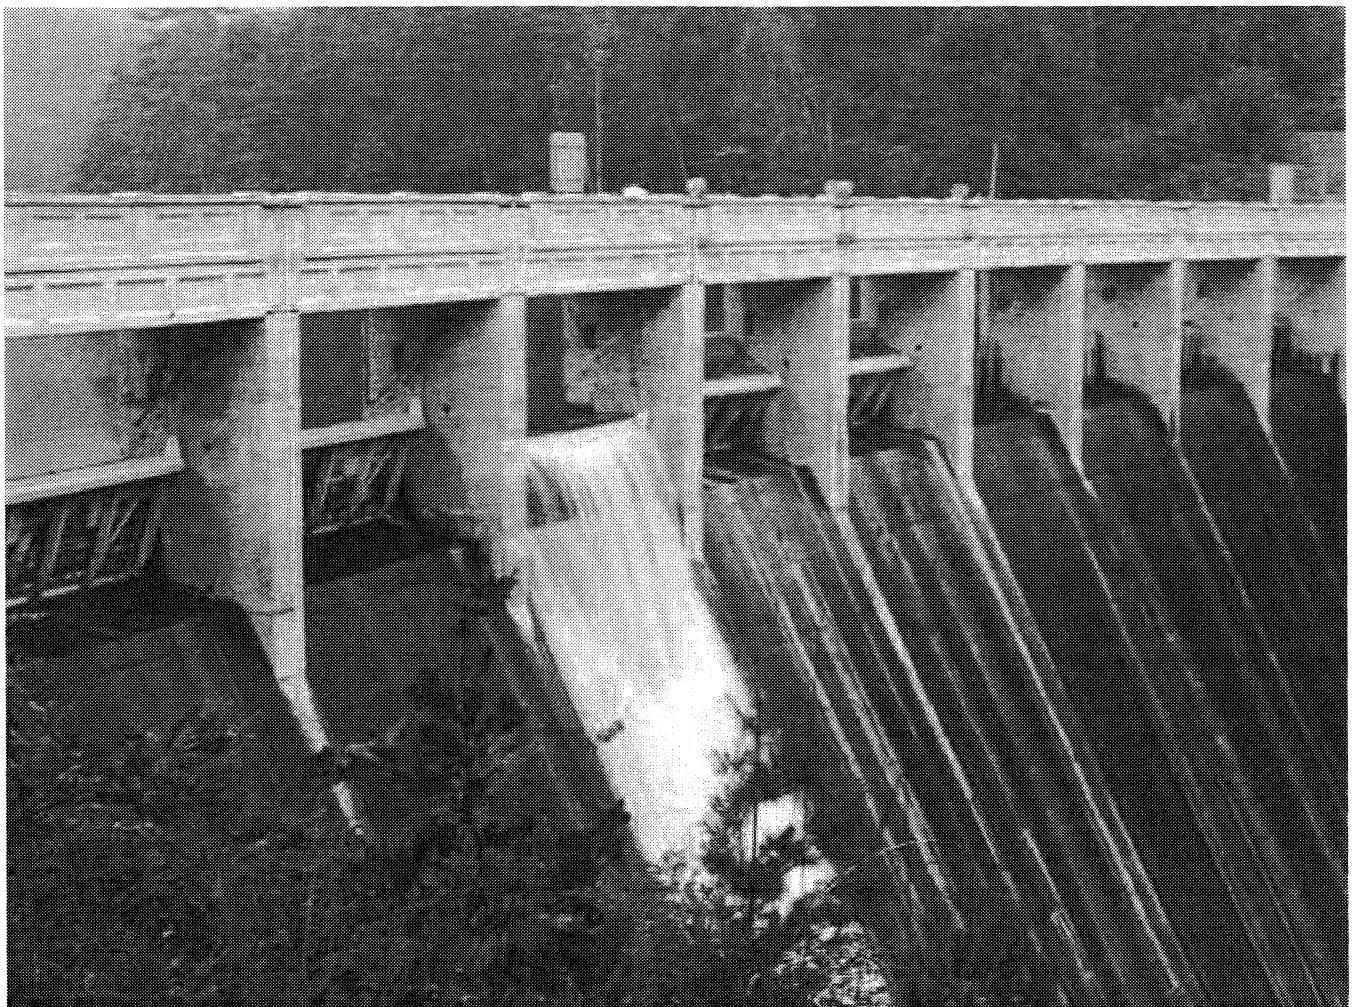
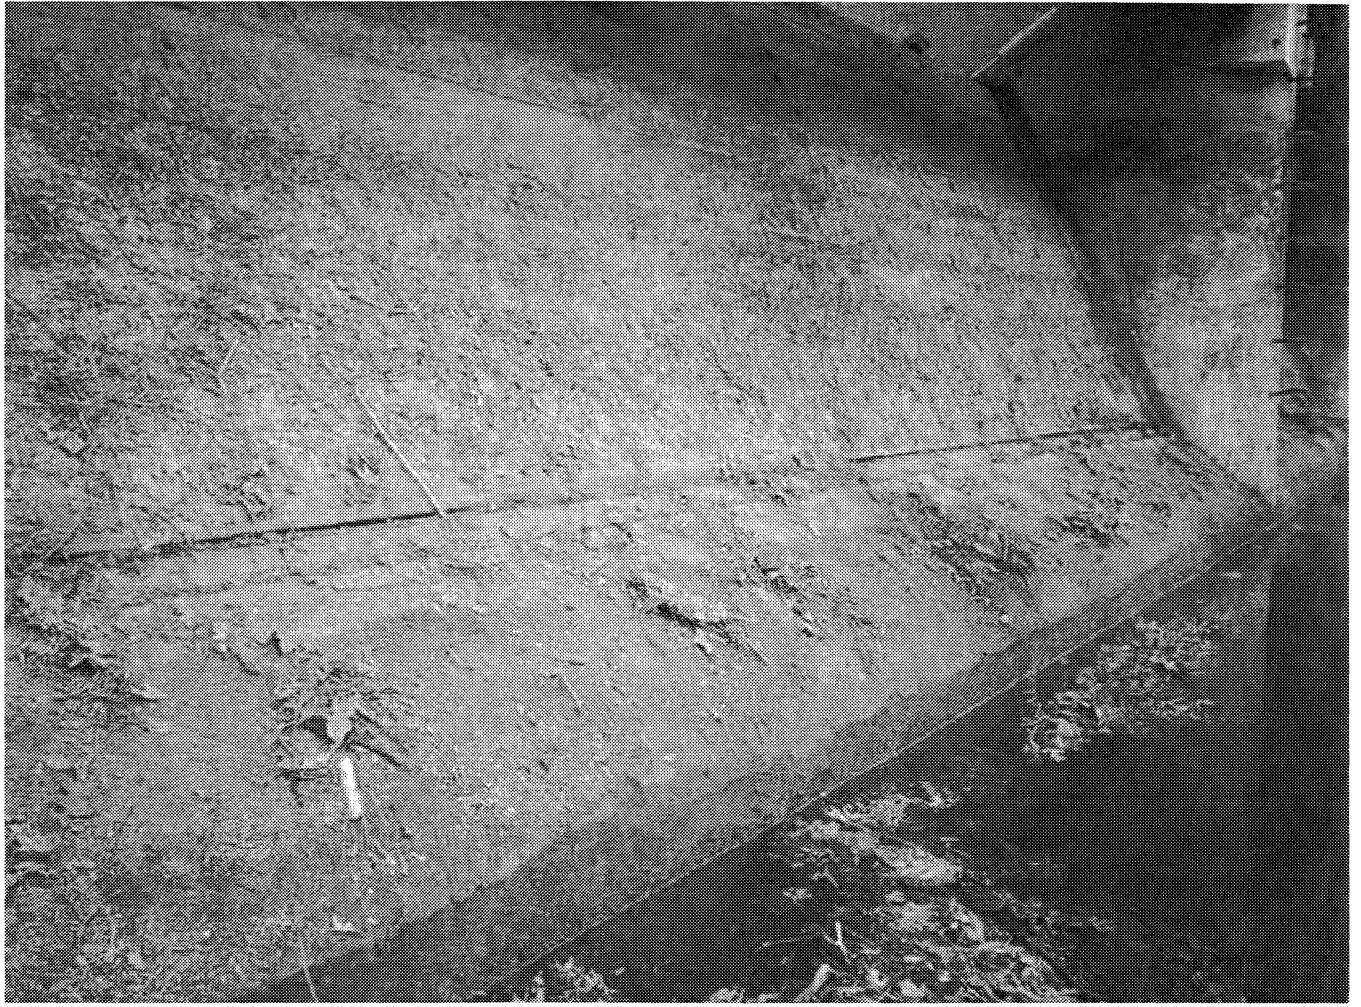
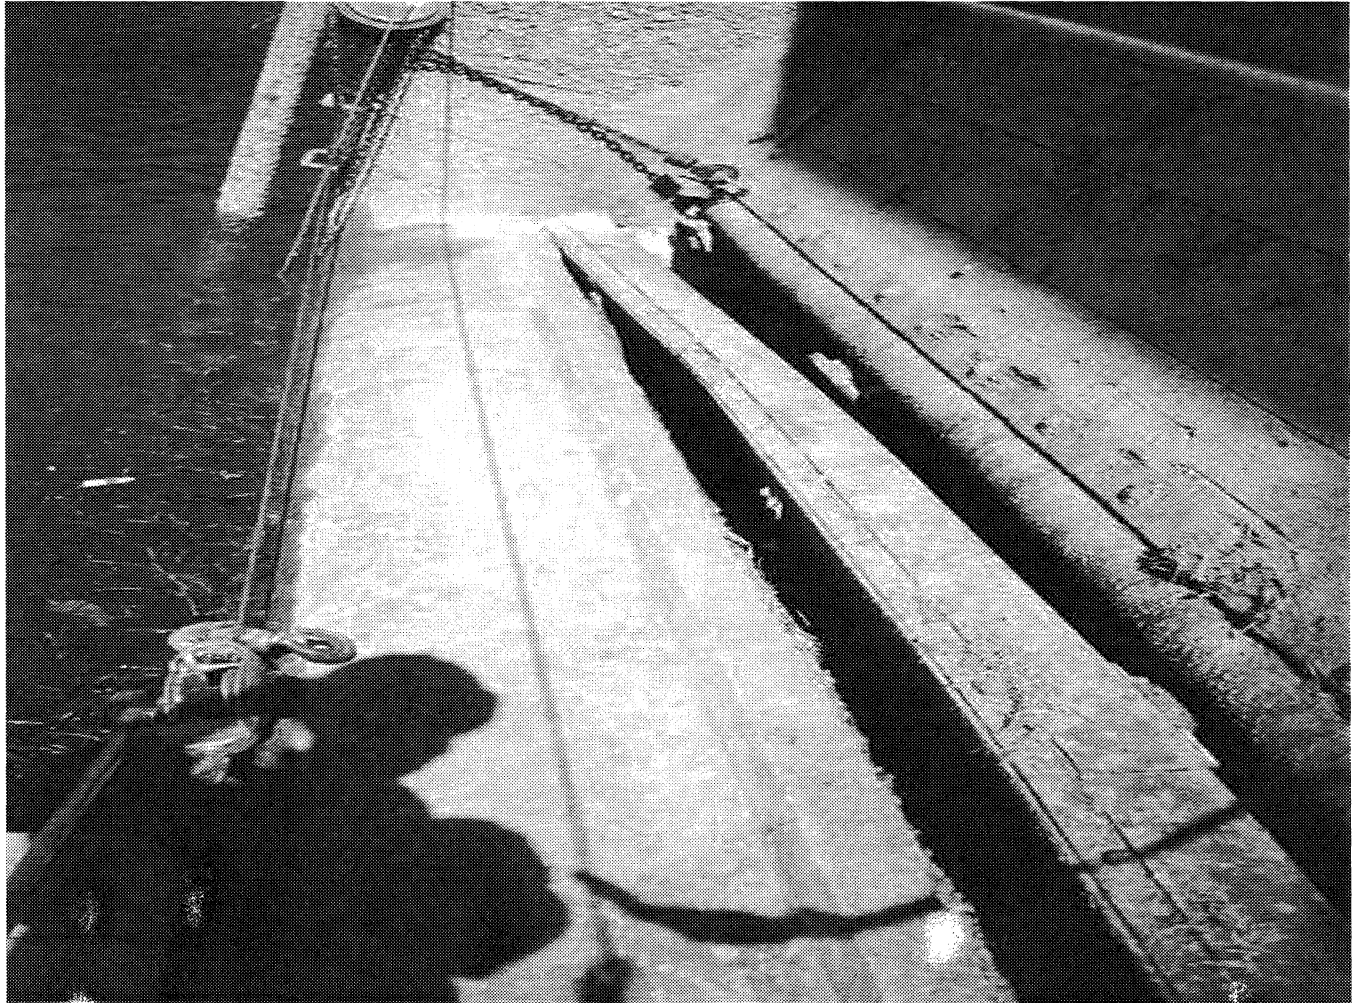
# Gate Failures on GPC System

- Failure of Turnbuckles at Lifting Eyes
- Failure of Embed Channel Anchorage

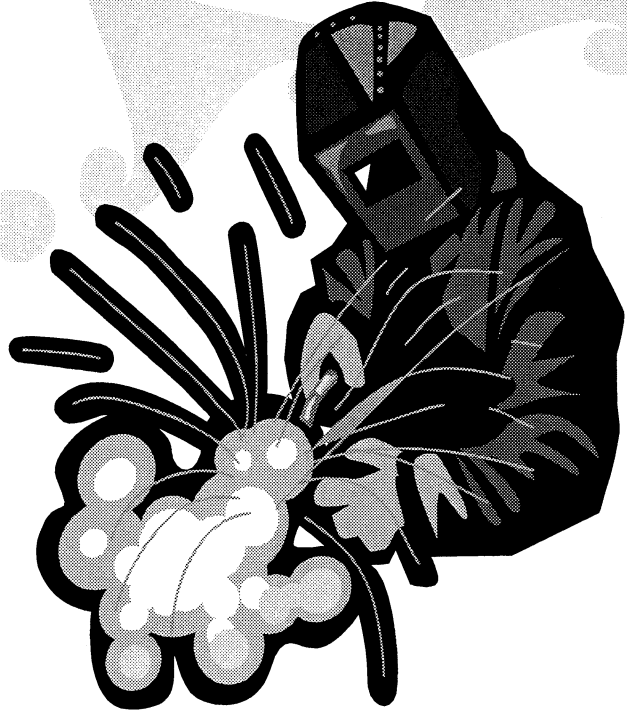
# Gate Components Wear Out

- ▲ Side rollers
- ▲ Trunnion bearings
- ▲ Wire rope & chain attachments wear or corrode
- ▲ Seals wear or tear
- ▲ Pier embeddings become worn or undermined

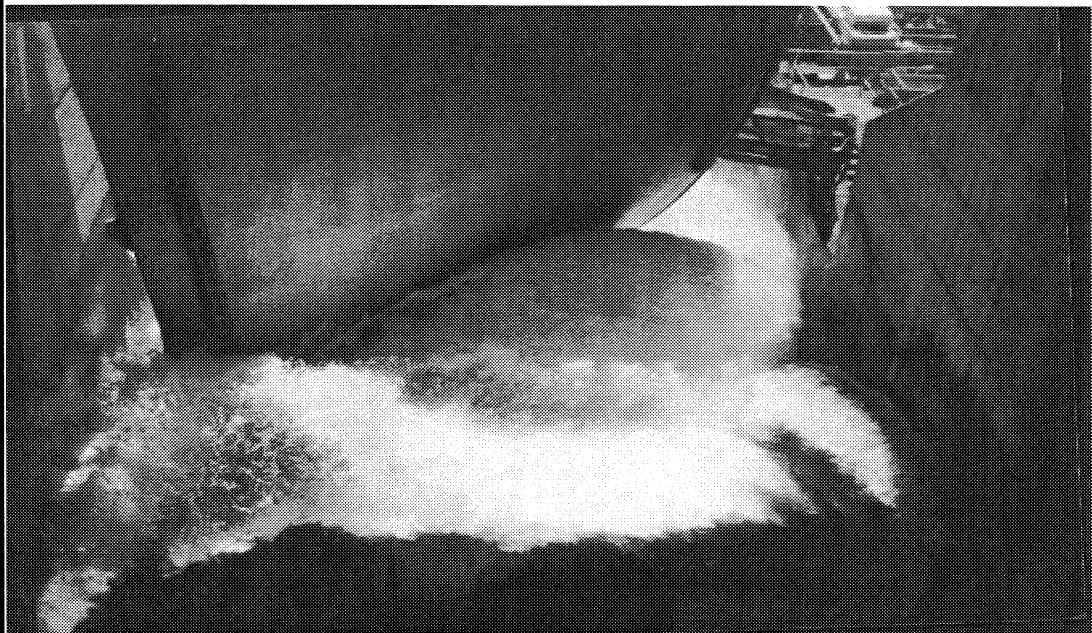
## Upstream View of Failure - Folsom

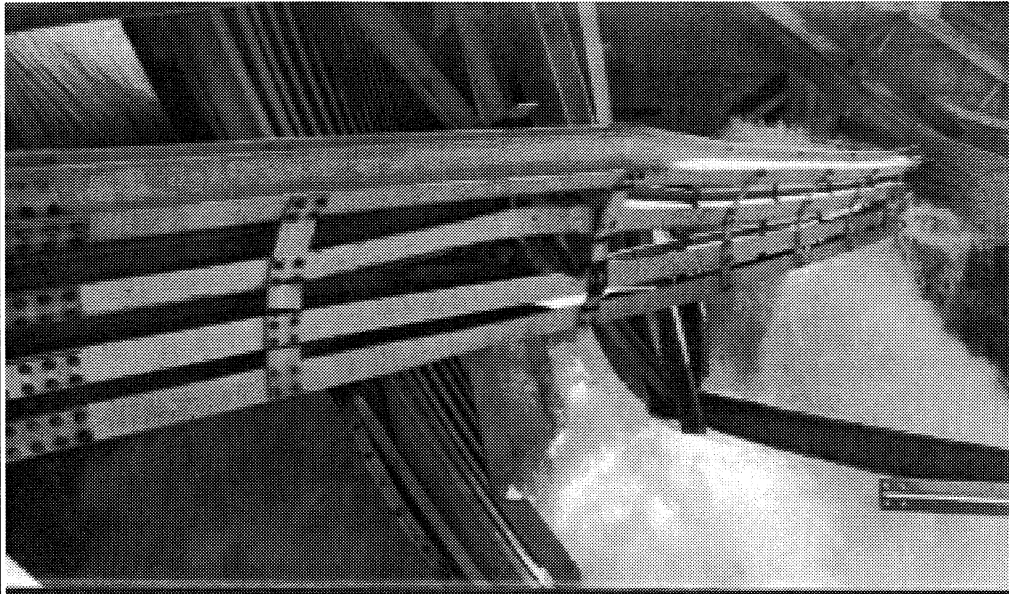
## Downstream View of Failure - Folsom

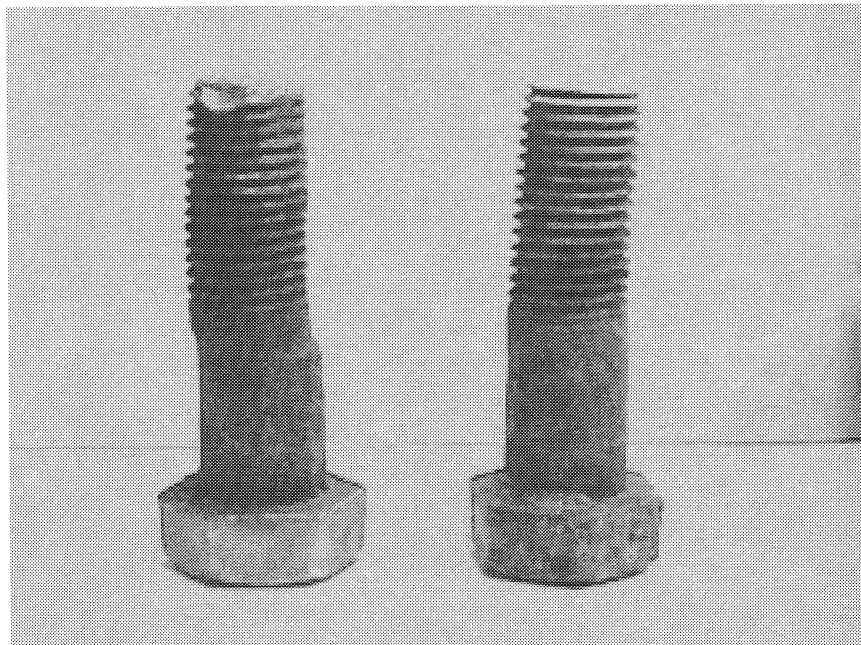
## PINE FLAT DAM - FAILED BOLTS TRUNNION/STRUT CONNECTION - 1" DIA A307 Removed December 1999

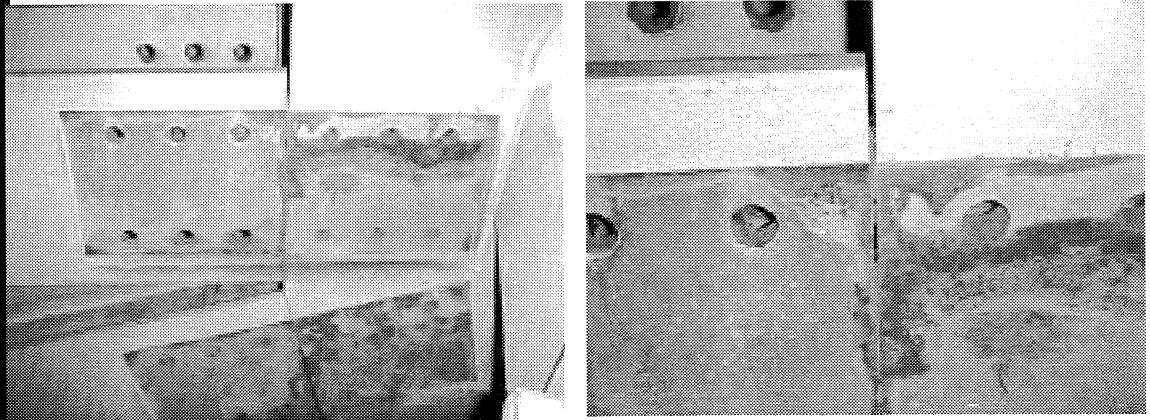
## Pine Flat Dam - Trunnion/Strut Connection

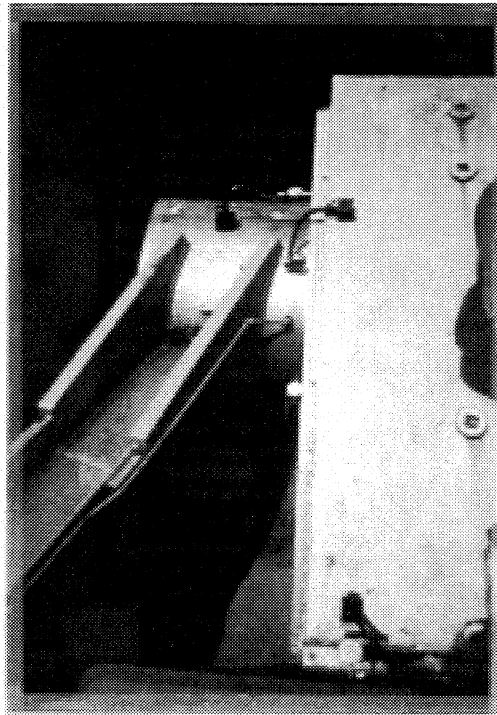
# Trunnion Assembly Wear

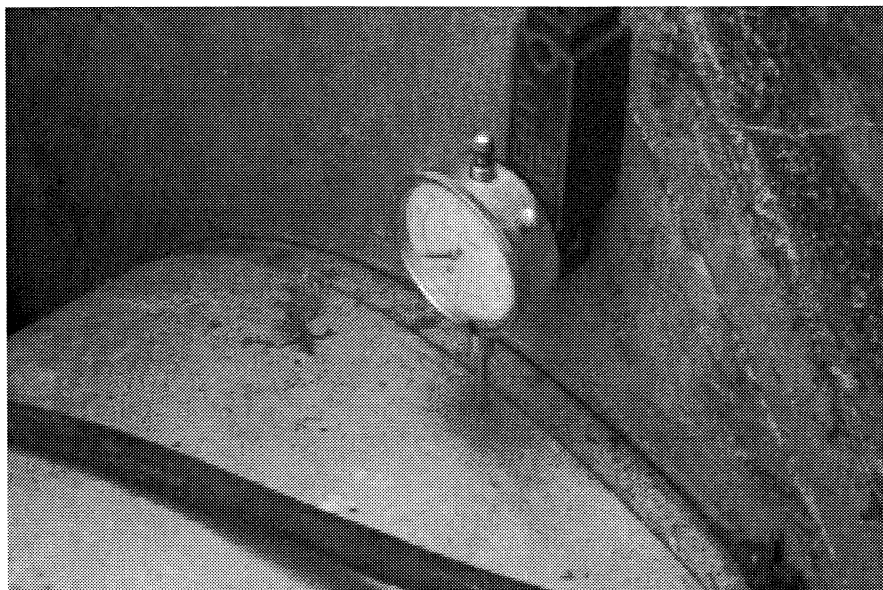
# Trunnion Assembly Wear

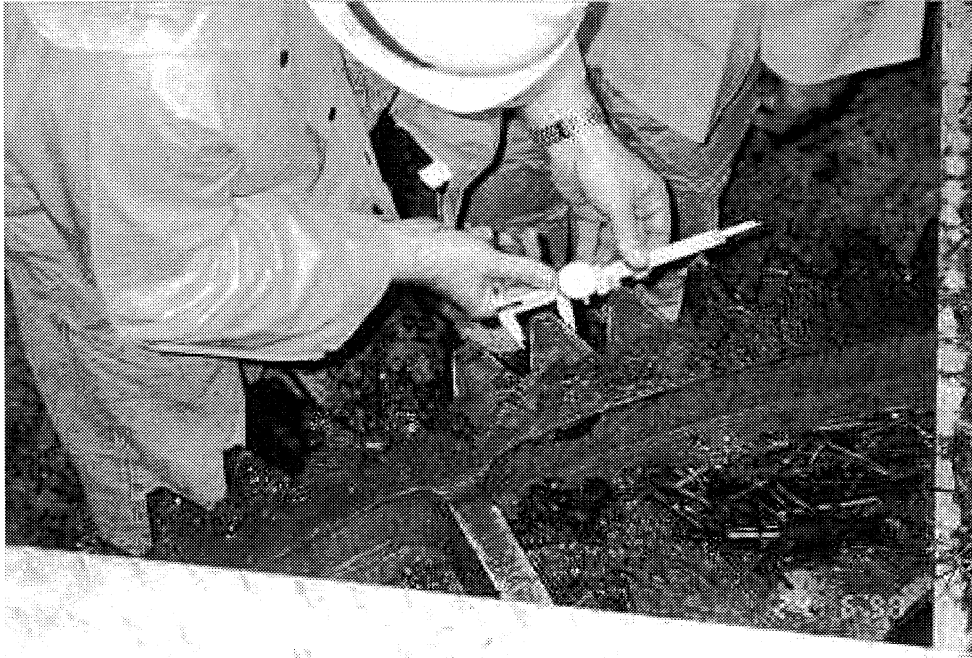
# Tooth Wear Measurement

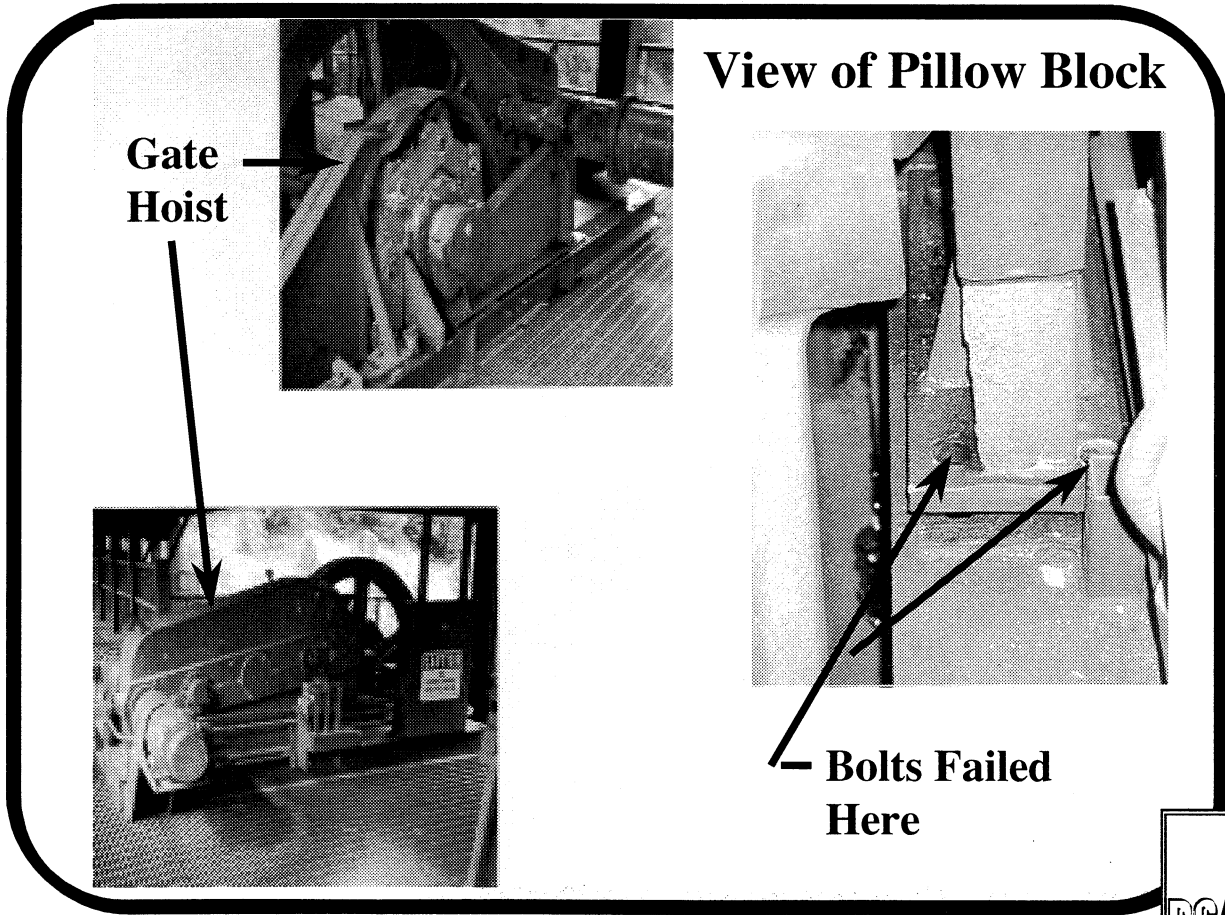
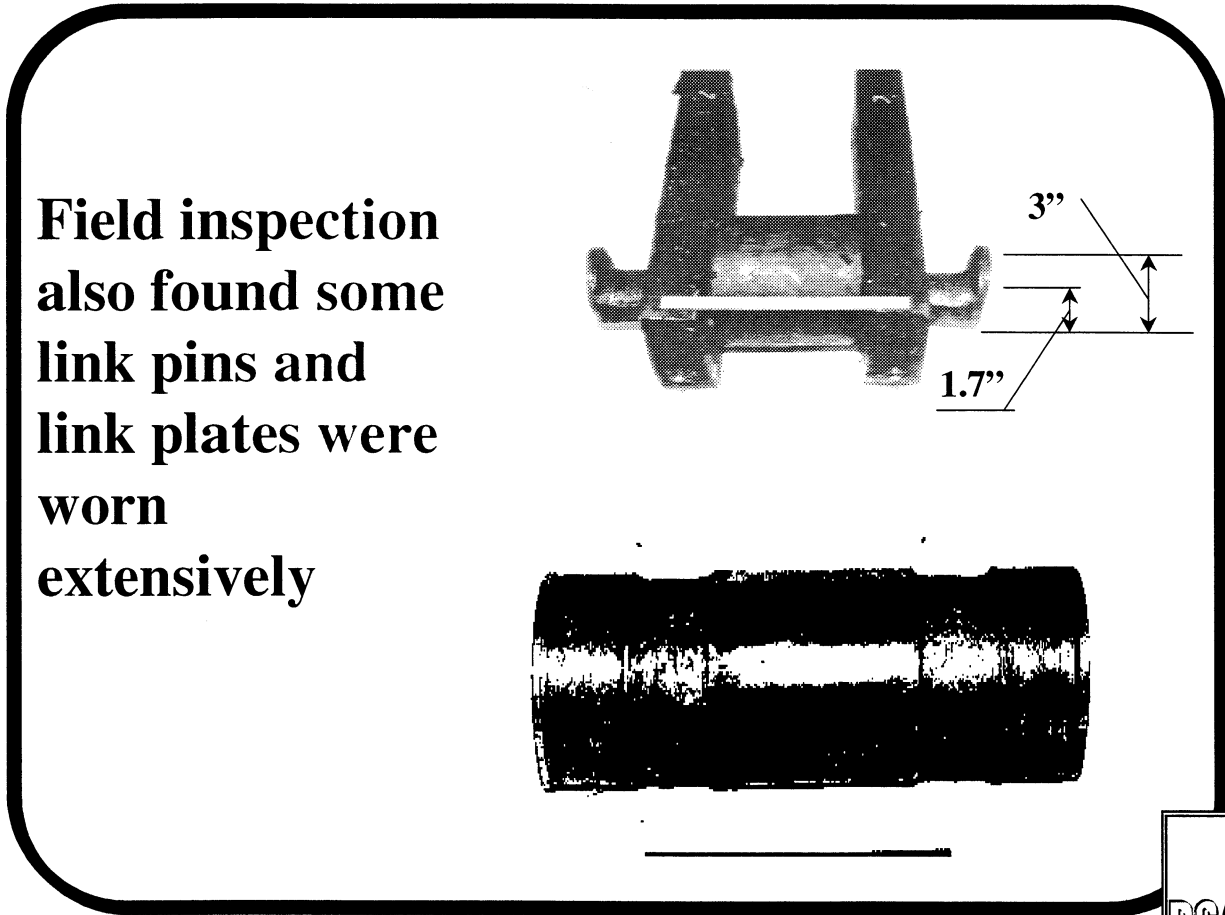
- **In 1998, the gate hoist mechanism at gate no. 3 failed during a routine raising of the gate.**
- **Field examination showed that two anchor bolts on the pinion side of the pillow block bearing support were fractured, and the pillow block bearing support was badly distorted.**

Mr. Chan discussed the results from PG&E's inspection of their Poe River project following the failure of Gate #3 to open. After thorough analysis of the situation, PG&E determined that the lack of adequate lubrication led to a series of failure mechanisms, resulting in the break of one of the hoisting chains and, ultimately, the binding of the gate. The experience highlighted the criticality of proper and ongoing training programs for operations and maintenance (O&M) personnel to assure successful gate performance.

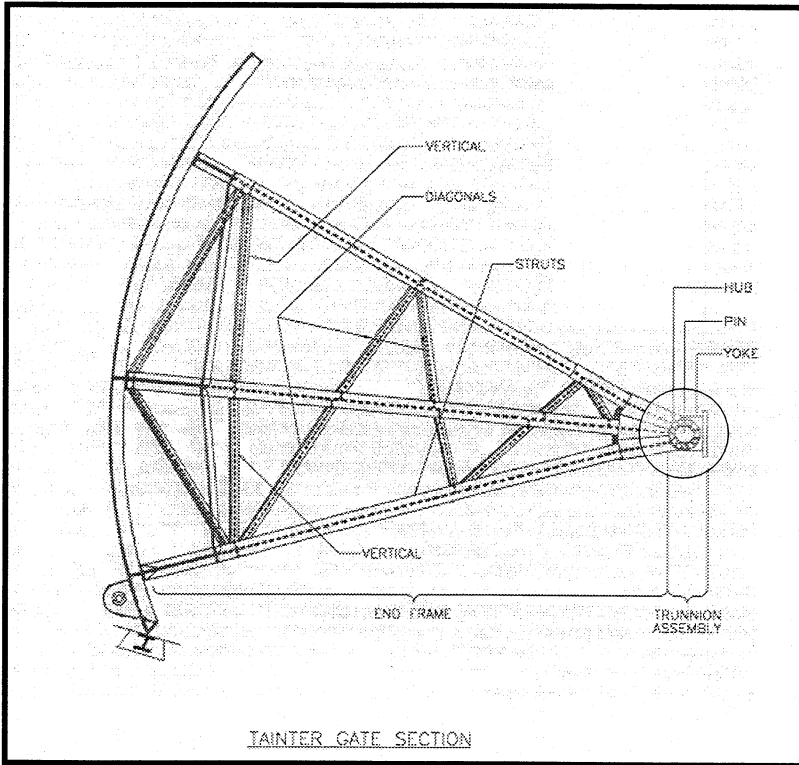
## Trunnion Assembly

**Description:** Trunnion Assembly consists of the Trunnion Hub, Pin and Yoke. The Trunnion carries the horizontal load from the End Frames to the Trunnion Girder. The Trunnion Assembly consists of a Hub around the Pin. The Pin connects the End Frame to the Trunnion Yoke. The End Frames are typically skewed from the point of connection with the Horizontal Girder to the Trunnion Assembly, causing a horizontal load downstream and a transverse load into the Pier at the Trunnion. The Hub typically has heavy flanges to transmit the horizontal load to the pin and the transverse load into the Pier. Grease fittings are installed in the Hub to allow for lubrication of the pin.

**Inspection:** Misalignment (both horizontal and transverse) between the Hub, Pin and Yoke. A solid grout pad between both the Trunnion Girder (for horizontal loads) and the Pier face (for transverse loads). A bushing should be present between the Hub and the Pin and Yoke. Any grease present in the Trunnion Assembly should be new and pliable. Water ponding on members and gusset plates at the Trunnion Assembly. Corrosion or loss occurring on the assembly.

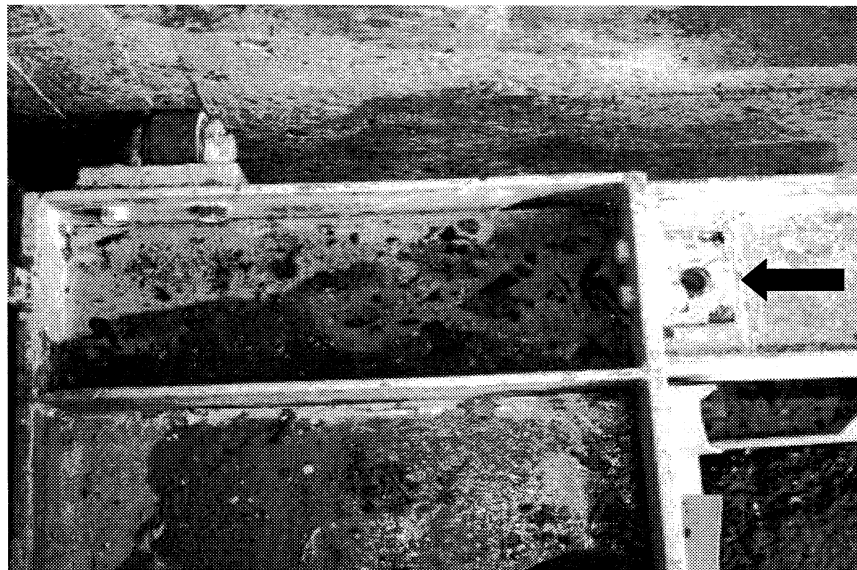
# Corroded Gate Members

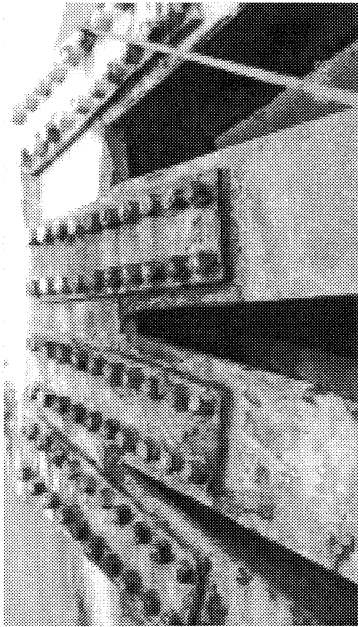
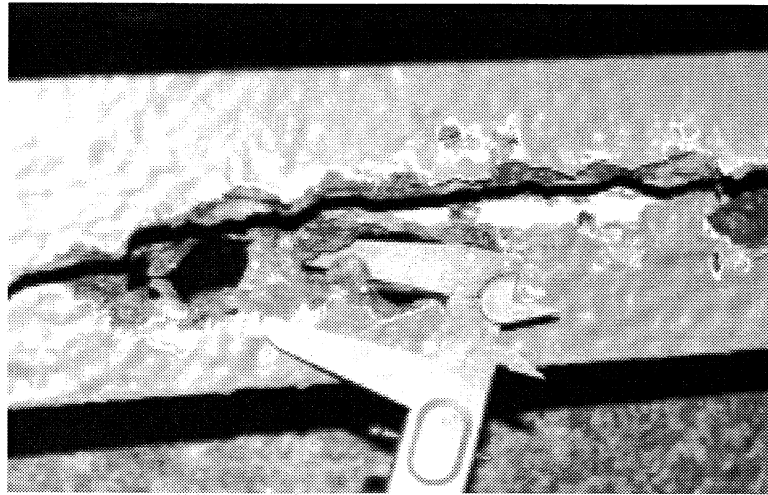
# Corroded Gate Members

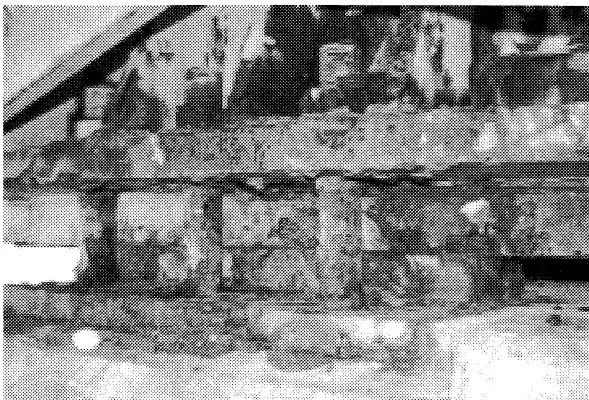
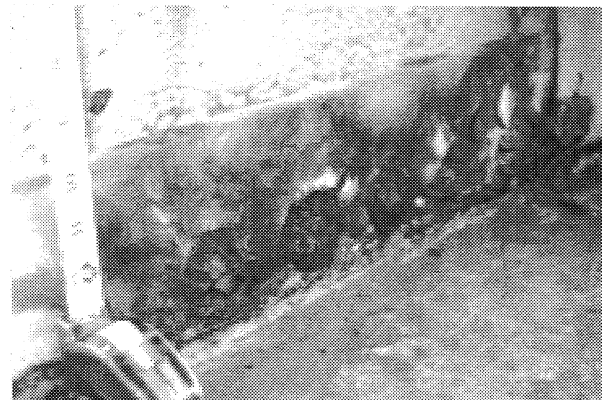
# Inadequate Drainage

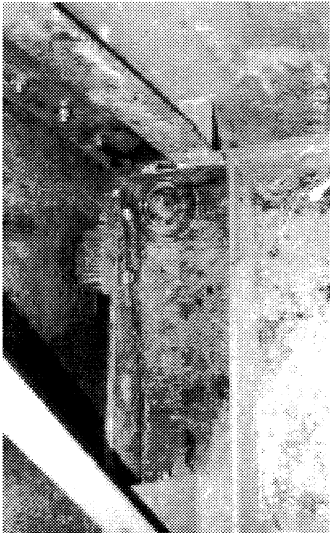
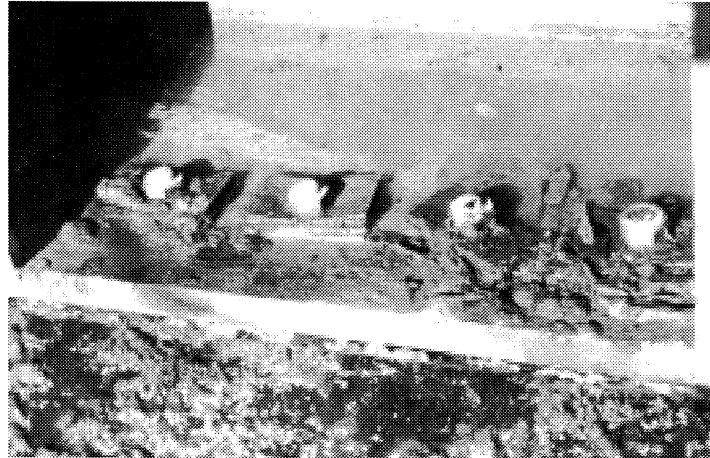
# Inadequate Drainage

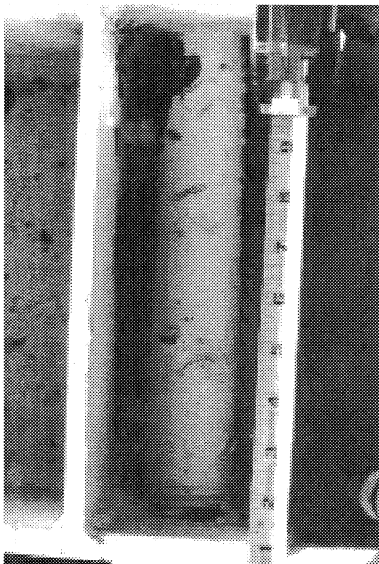
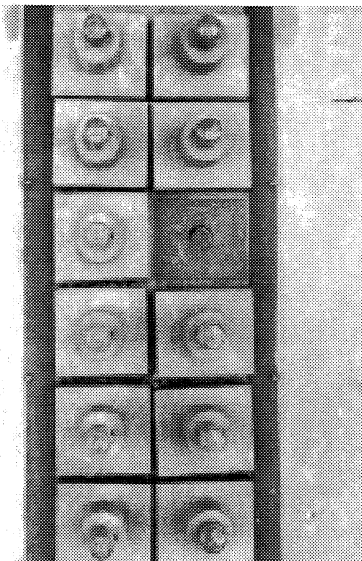
# Hoist Connections
