NIOSH HEALTH HAZARD EVALUATION REPORT

HETA # 2003-0318-2936 Evaluation of Two Exhaust Stack Configurations on Two Houseboats at Table Rock Lake, Missouri

June 2004

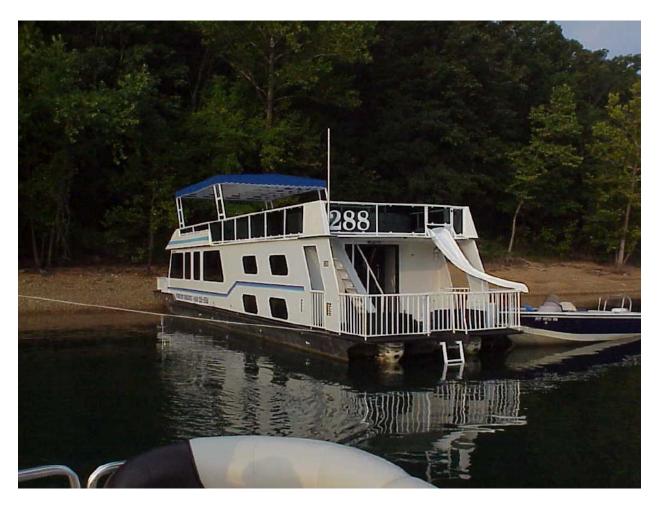
Figure 1. **Houseboat #1.** 2000 Fun Country Marine Houseboat with Vertical Exhaust Stack.

Velocity measurements of exhaust from the stack on houseboat #1 indicated an average face velocity of 730 fpm. The flagpole stack on houseboat #2 indicated an average face velocity of 3340 fpm. The temperature and humidity measurements collected in the flagpole exhaust stack on houseboat #2 indicated temperatures between 99 °F and 100 °F, and humidity levels between 54% and 55%.

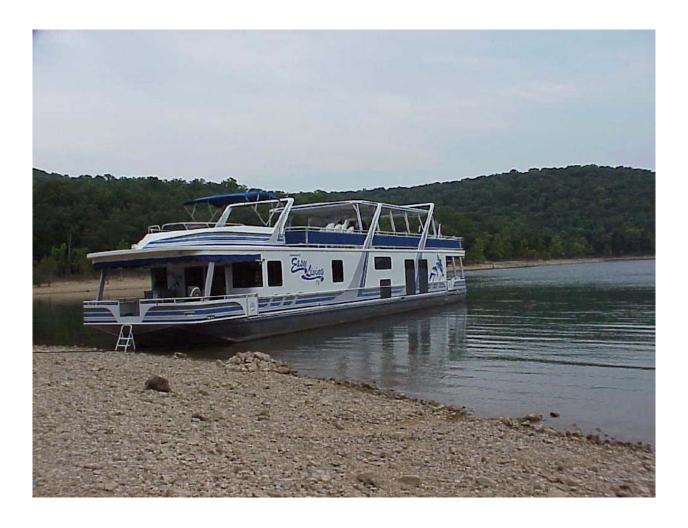
Figure 2. **Houseboat #2.** 2002 Sumerset Houseboat with Flag Pole Exhaust Stack.

The evaluation at Lake Cumberland found problems with the stack design where CO gases were discharged with the water on the side of the boat. Based on those results, design changes were made to help alleviate the problem on houseboat #2 at Table Rock Lake. The design changes included the removal of a 3 foot (2 inch inner diameter) section of flexible exhaust hose, and the removal of a 180° angle.
