Suisun Bay National Reserve Fleet Assessment Project

Update – JULY 2008

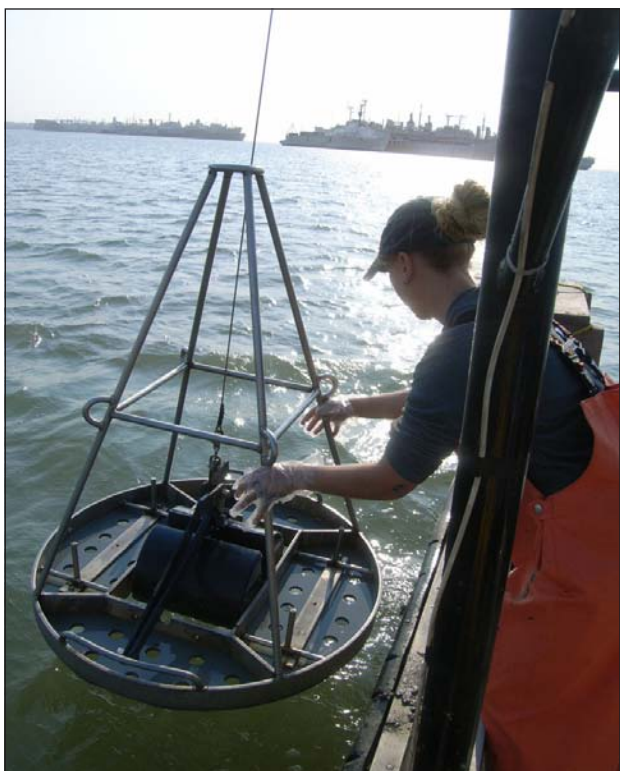
Photo, above left: A VanVeen sampler is used to collect surface sediment samples. The sediment in this grab sampler will be transferred to glass jars for shipping to the analytical laboratories.

Photo, above right: NOAA scientist screens sediment samples for the presence of paints chips.

Photo, bottom right: Sediment samples were screened for paint chips and other debris. Some samples contained large amounts of juvenile resident clams.

Scientists used a metal hinged bucket known as a Van-Veen grab to collect surface sediment samples. The grab, when dropped to the bay floor, collected an intact chunk of surface sediment. The sediment was photographed, homogenized, and transferred to laboratory-cleaned jars and shipped to several analytical laboratories. Additionally, surface sediment samples were sieved and visually examined at the field lab for paint chips or other debris.
