Fatality #7 – April 21, 2009

Falling Material - Tennessee - Construction Sand and Gravel

Santana Dredging Corporation - Santana Dredging Corporation

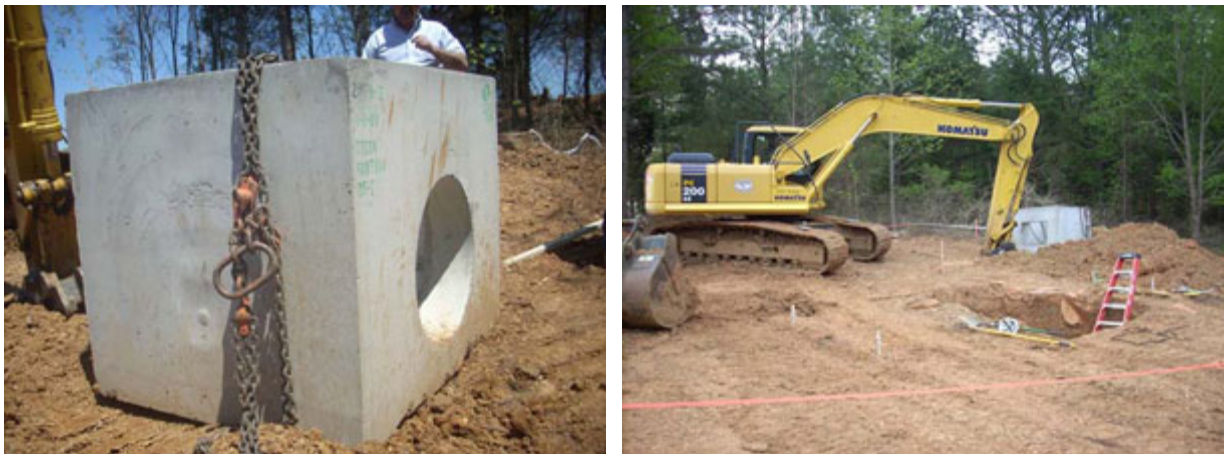
METAL/NONMETAL MINE FATALITY - On April 21, 2009, a 51-year old contract laborer with 3 years of experience was fatally injured at a sand and gravel dredging operation. The victim was inside an excavation ditch while an excavator was maneuvering a concrete box into place. The chain used to attach the four leg sling from the box to the excavator broke. The box fell into the hole and struck the victim crushing him.

- Identify hazards associated with the task to be performed, review those hazards with all personnel involved, and implement measures to ensure persons are properly protected.
- Communicate lift plans to all persons working in the lift zone to ensure that no one is under a suspended load.
- Stay clear of a suspended load.
- Attach taglines to loads that may require steadying or guidance while suspended.
- Use sling or chain assemblies (rigging) specifically intended for lifting and adequately rated for the loads being lifted.
- Carefully inspect all rigging prior to each use.
