Re: Contract No. 1435-01-05-CT-39236
Report No. 440 38570
“Pipeline Damage Assessment from Hurricane Ivan in the Gulf of Mexico”

PIPELINE DAMAGE ASSESSMENT FROM HURRICANE IVAN IN THE GULF OF MEXICO

REPORT NO. 440 38570

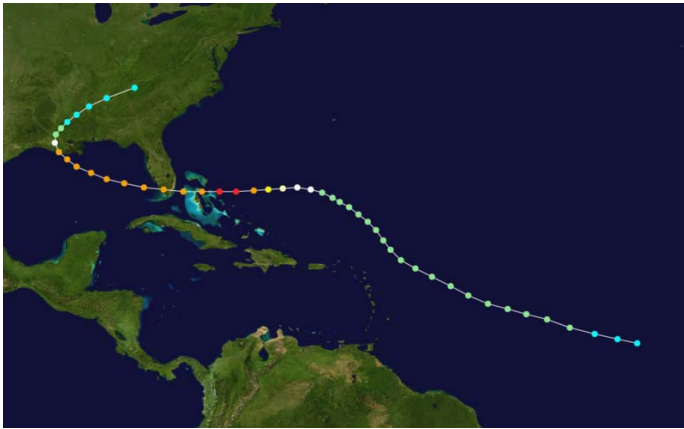
Figure 3 – Path of Hurricane Andrew

through the Gulf of Mexico in August 1992, following the path shown in Figure 3. About 36 major platforms and 145 satellite well jackets and caissons were damaged and more than 480 pipelines and flow lines were damaged by the passage of Hurricane Andrew. Hurricane Andrew was a category-4 level storm with sustained winds up to 140 miles per hour and significant wave heights estimated to be at 35-40 feet. Hurricane Andrew passed to the west of the Mississippi Delta, with its path overlaying some 700 structures, felling 22, and

damaging to some degree about 65 others. Consequently, the westward path of Hurricane Andrew, shown in Figure 3, resulted in few pipelines being damaged by mudslides in this hurricane event.

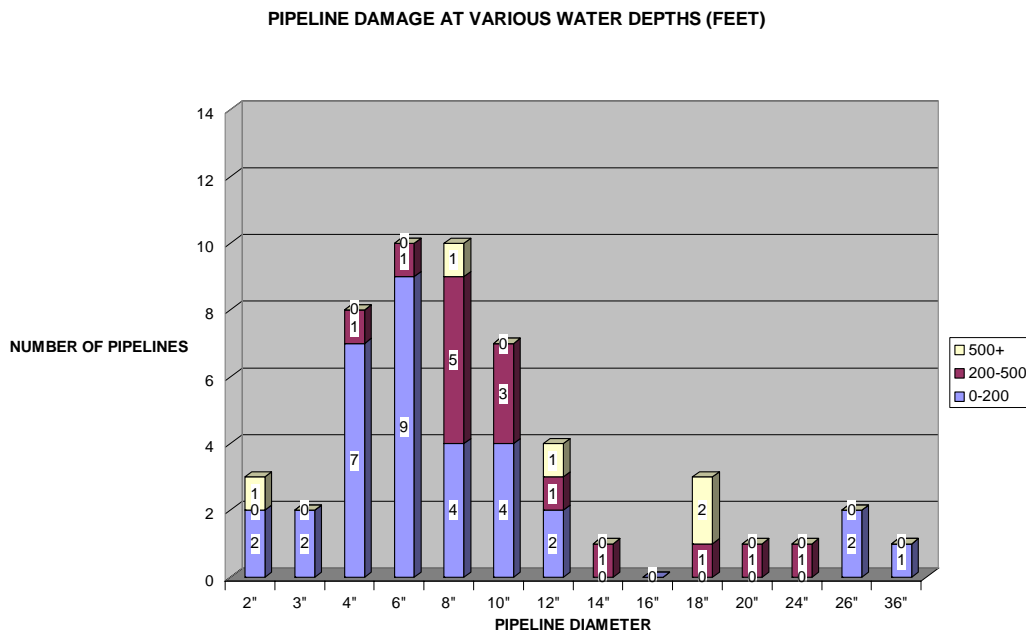
Figure 10-1– Number of Pipeline Damages by Diameter and Water Depth

Hurricane Ivan pipeline damage experience indicated that pipeline crossings are an area that may merit special attention for greater hurricane resistant design. Hurricane Andrew and Hurricane Ivan damages were similar in the fact that there was damage to pipelines in shallow water that would not be expected to move, if they were buried, or had adequate cover. The number of pipeline damages that were unrelated to risers, mudflows, platforms, and subsea tie-ins that were damaged resulted in 53 segments. The majority of the 53 pipeline damage occurred in shallow water, less than 200 feet in depth, as shown in Figure 10-1.

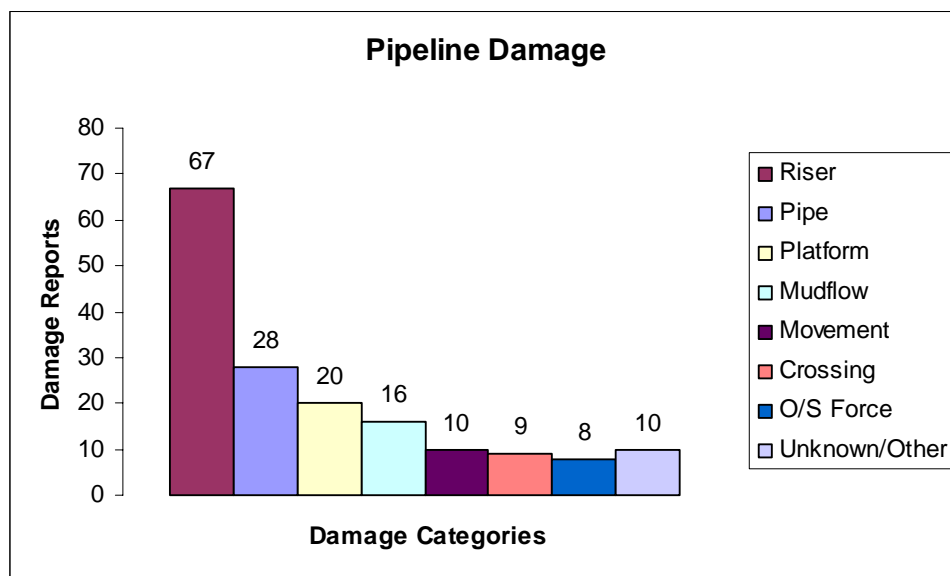
Figure 13-1 - Categorized Pipeline Damage Reports

The discussion of the mitigation activities did not identify any new hazards that were previously unknown, and confirmed that appropriate risk controls are in place for the prevention of hurricane damage. The next step was the assessment of the effectiveness of the various mitigation activities. This assessment was based upon the historical performance of the pipelines in hurricane events, and a subjective analysis of the results of the pipeline damage relative to the three categories of damage. The damage categories were further broken down into eight categories, as represented in Figure 13-1. These categories were useful in looking for common failure modes, locations or factors relative to the pipeline characteristics to evaluate the hypothetical root causes.

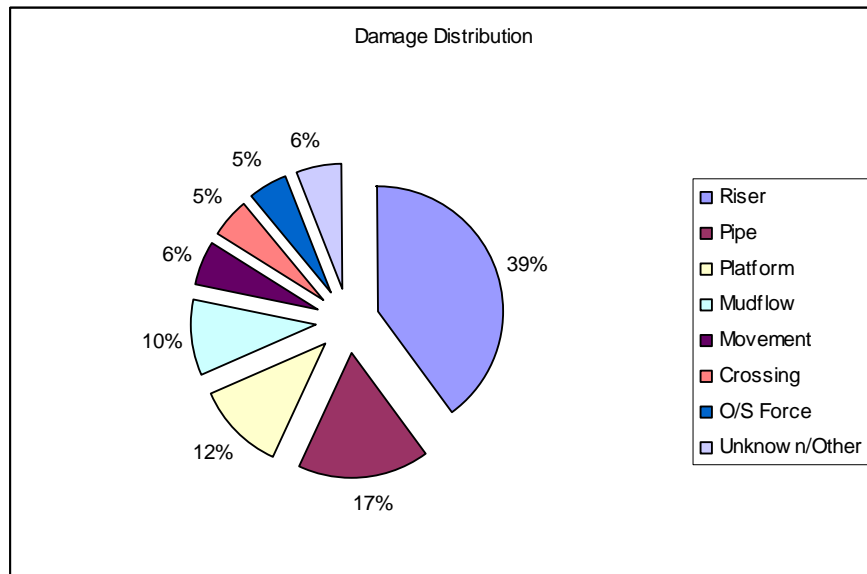
Figure 13-2 Pipeline Damage Distribution by Study Category

- Platform failures with common lines at the platform
- Parallel pipelines in mudflow areas perpendicular to the maximum current
- Water depths less than 200 feet

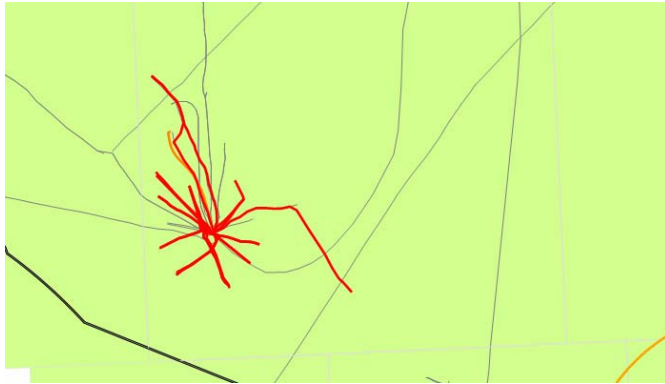
Figure 28 - Reported Damages in MP 64

For example, the following map shown in Figure 28 contains pipeline damage report information received for MP 64, as shown in red. The grey pipelines are those lines that have indicated no damage, or for which a report has not been submitted. Additionally, none of these damage
