**A STUDY OF ATSC (8-VSB) DTV COVERAGE IN WASHINGTON, DC,  
AND GENERATIONAL CHANGES IN DTV RECEIVER PERFORMANCE**

**Project TRB-00-1  
Interim Report**

Technical Research Branch  
Laboratory Division  
Office of Engineering and Technology  
Federal Communications Commission

OET Report  
FCC/OET TRB-00-2

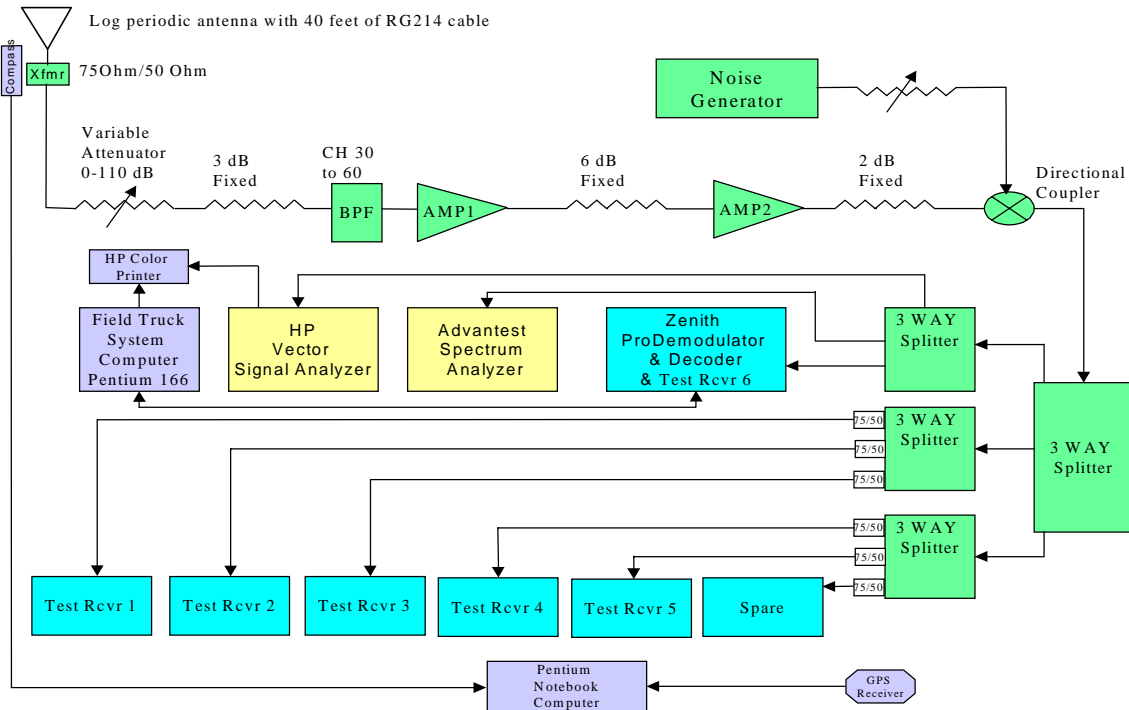
Figure 1

A block diagram of the equipment configuration for measurements using the 30-ft. mast-mounted "outdoor" log-periodic antenna is shown in Figure 1.

The Commission has outfitted a field measurements vehicle to make the measurements required in this study. The truck implementation fundamentally follows the guidelines contained in the document entitled "ATSC Test Vehicle Design Information" prepared by the ATSC and the Model HDTV Station technical subcommittee. Photographs of the test vehicle and its equipment complement are included in Appendix F.

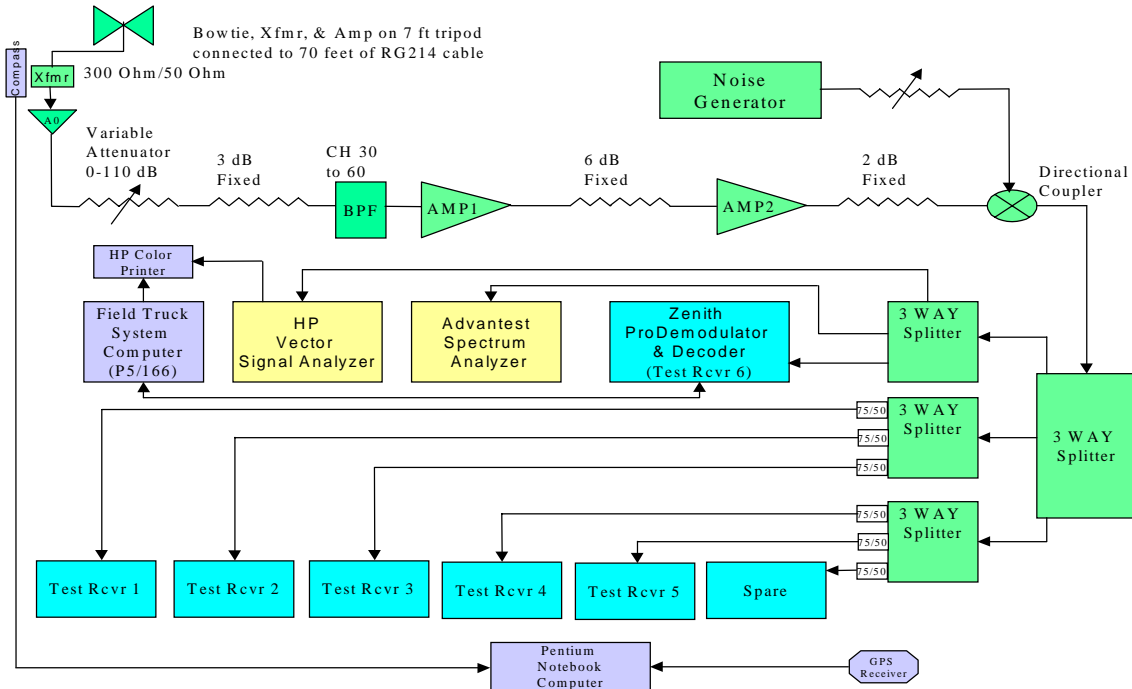
**Figure 2**

The block diagram of the equipment configuration used for measurements using the 7-ft. tripod-mounted "indoor" antenna is shown in Figure 2.

A vector signal analyzer (VSA) is the primary measurement instrument for making signal and noise power measurements within the test bed. The VSA, along with a swept-filter spectrum analyzer and the channel equalizer tap outputs of a Zenith ProDemodulator, is also relied upon for characterization of site conditions such as received signal strength, band tilt, adjacent-channel signals, and multipath reception. The system computer, a color printer, and a color plotter connected to the swept-filter spectrum analyzer provide the means for documenting these site conditions.

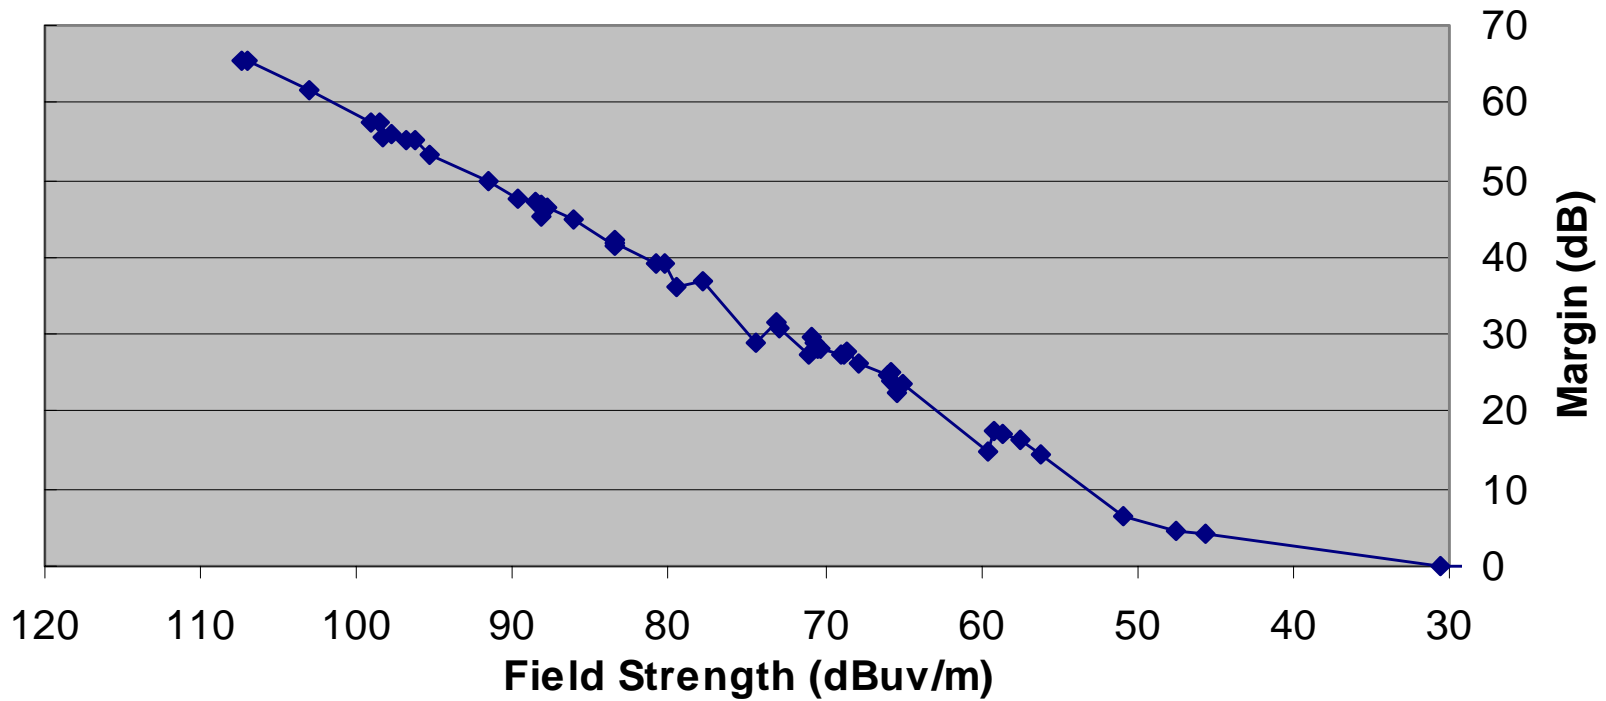
Chart C-5.

**Ch 34 DTV Field Strength vs Margin  
Mast Antenna  
Coverage Sites**

Site margin statistics represent the amount of signal loss, in decibels, that a site can experience before the threshold of errors is reached in the reference receiver. Plotting site margin against field strength provides an indication of the effects of non-white-noise impairments over the coverage area.

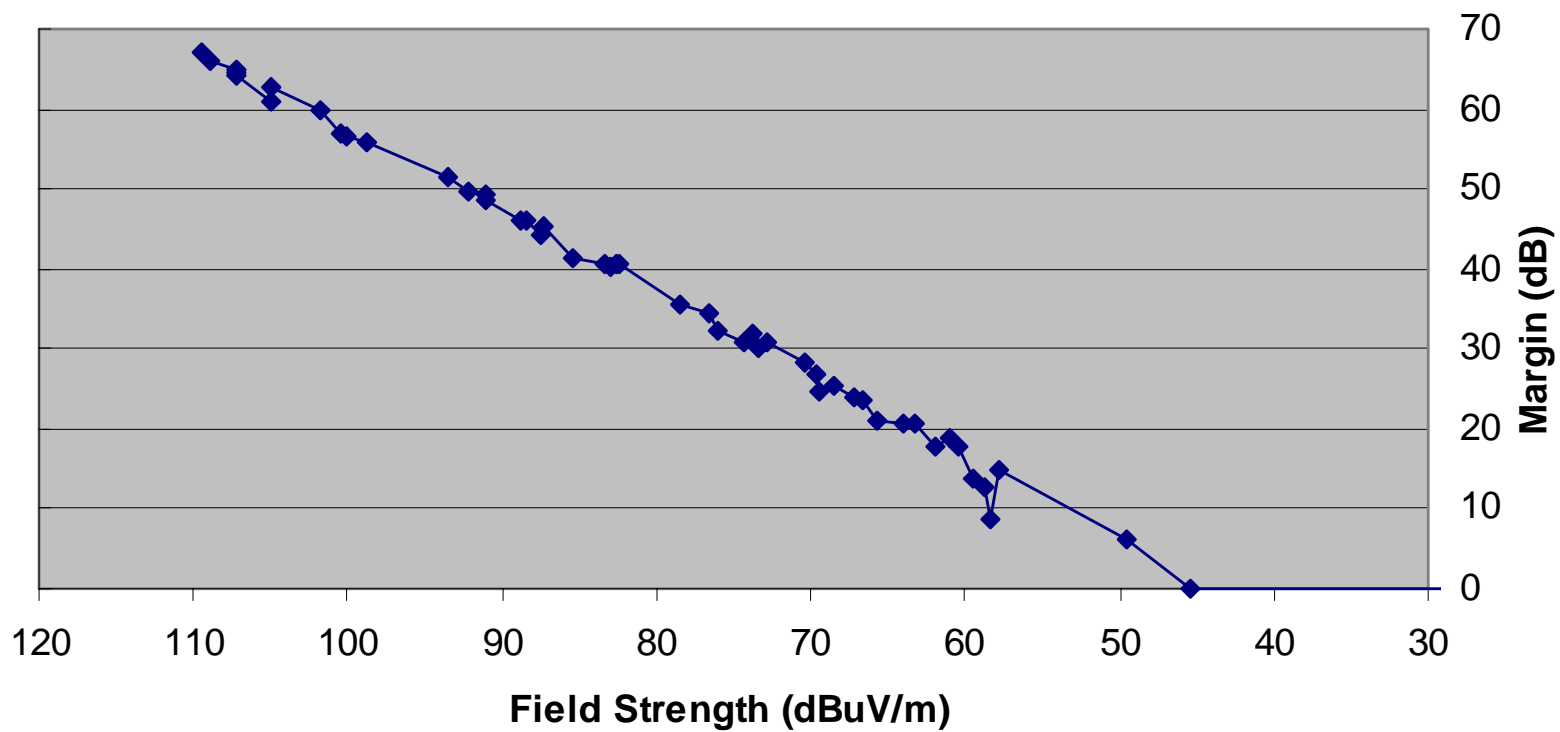
Chart C-6.

### Ch 48 DTV Field Strength vs Margin Mast Antenna Coverage Sites

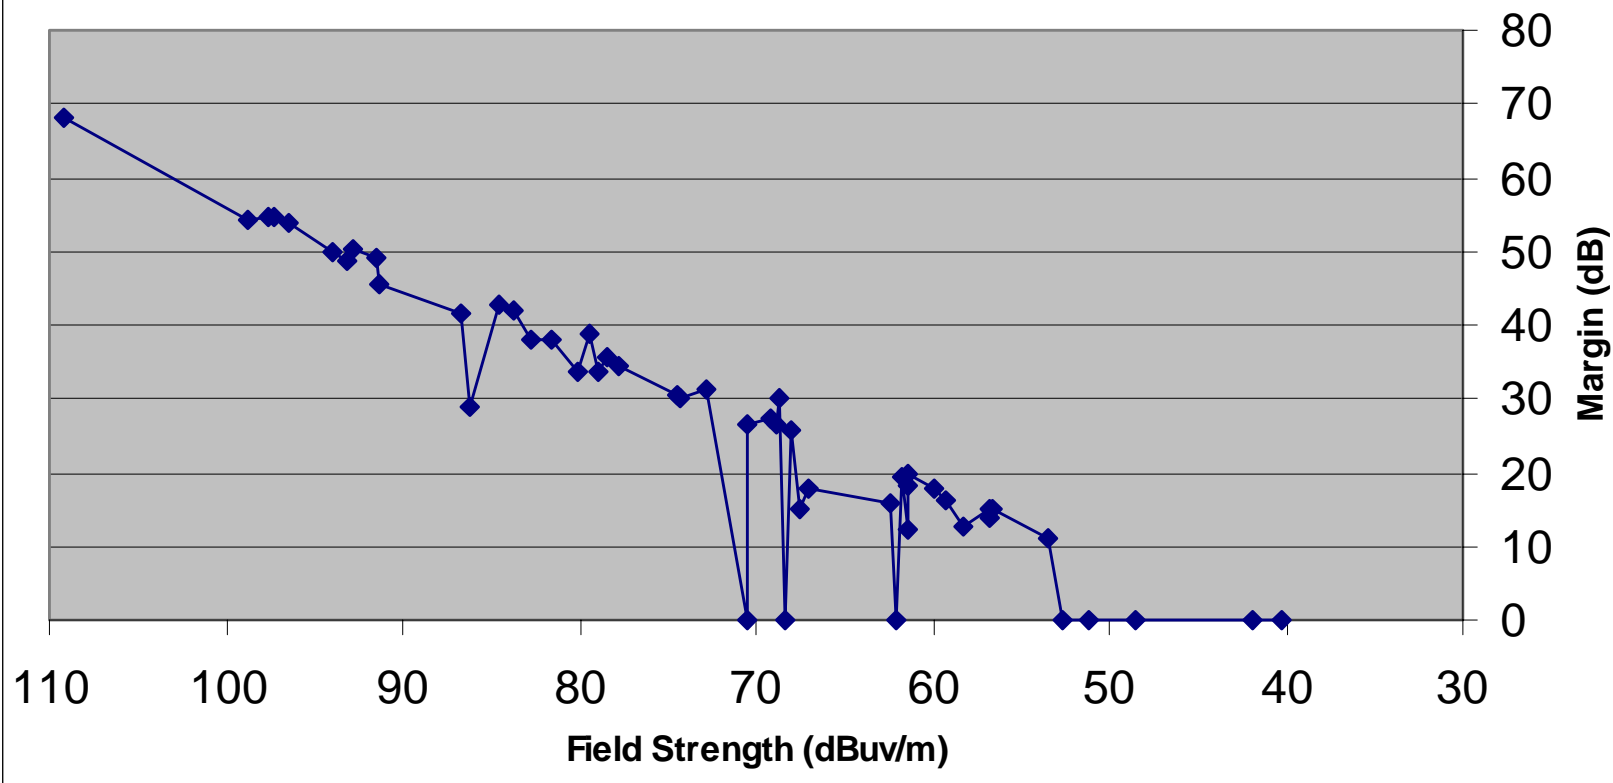
Chart C-7.

### Ch 34 DTV Field Strength vs Margin Tripod Antenna Coverage Sites

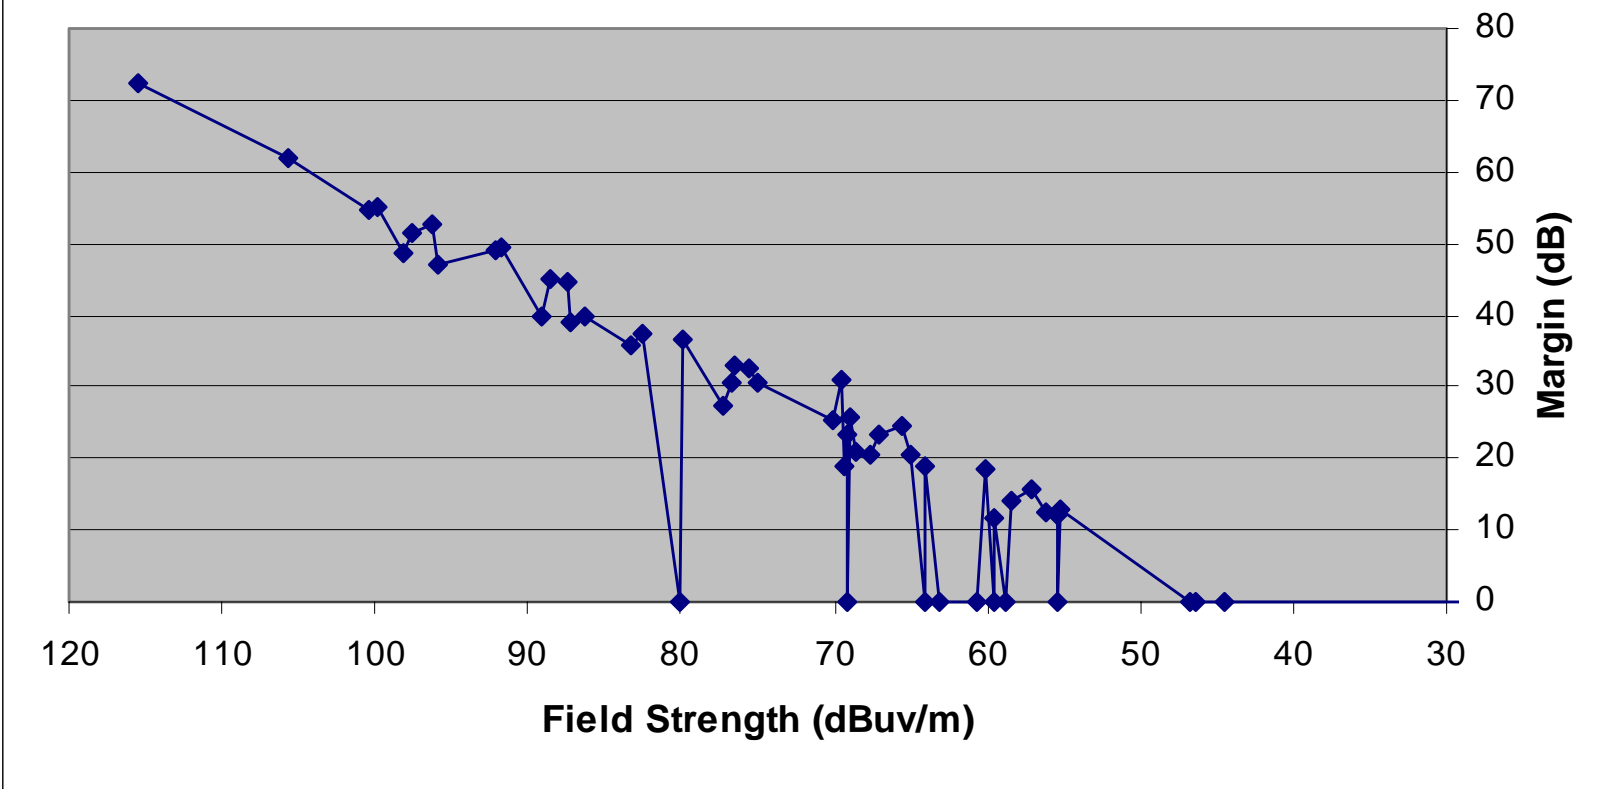
Chart C-8.

**Ch 48 DTV Field Strength vs Margin**  
**Tripod Antenna**  
**Coverage Sites**

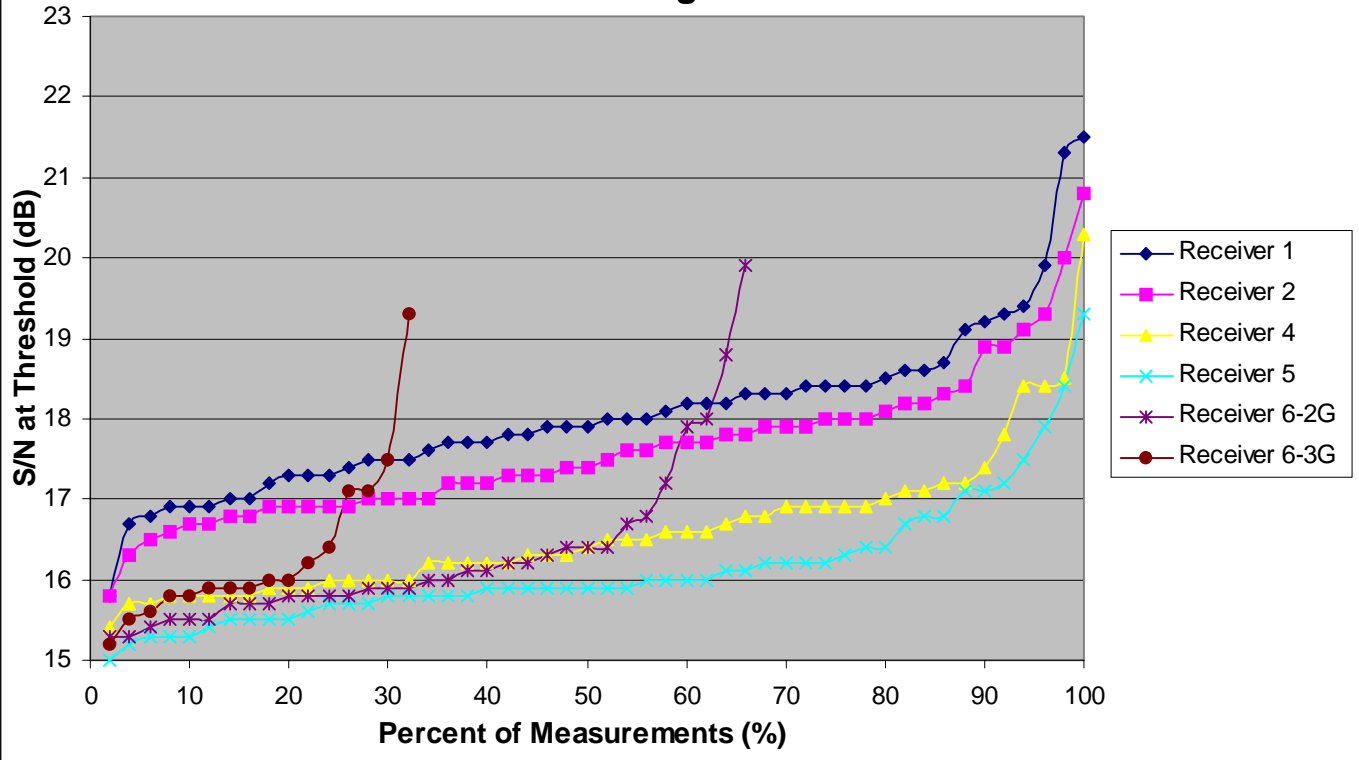
**Chart D-1.  
Threshold of Visibility**

### DTV S/N Cumulative Distribution Ch 34 on Mast Antenna Coverage Sites

Receiver 1	18.0 dB
Receiver 2	17.7dB
Receiver 4	16.5 dB
Receiver 5	15.9 dB
Receiver 6-2G	16.0 dB
Receiver 6-3G	15.95 dB

Lending some credence to the argument that evolving 8-VSB receiver performance is a significant factor in improved measured coverage are the charts presented in Appendix D. For the coverage sites, the improvement in the median values for S/N ratio at threshold for the mast-mounted antenna between the first-generation receiver and the best-performing, latest-generation prototype is approximately 2 dB, and approximately 2 – 2.5 dB for the tripod-mounted antennas.

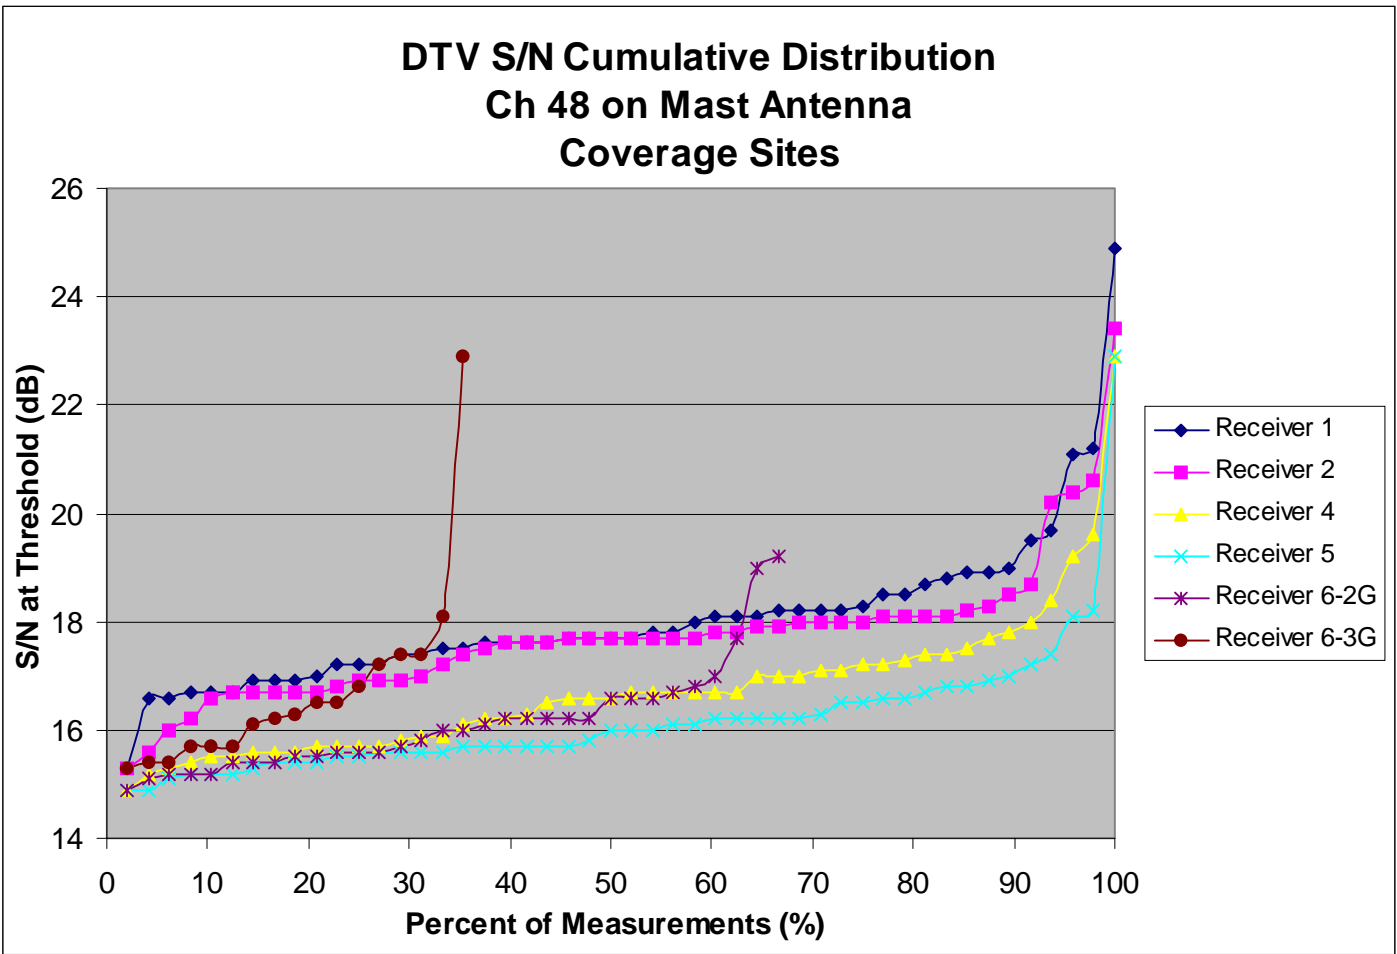
**Chart D-2.  
Threshold of Visibility**

Receiver 1	17.7 dB
Receiver 2	17.7 dB
Receiver 4	16.6 dB
Receiver 5	16.0 dB
Receiver 6-2G	16.0 dB
Receiver 6-3G	16.3 dB

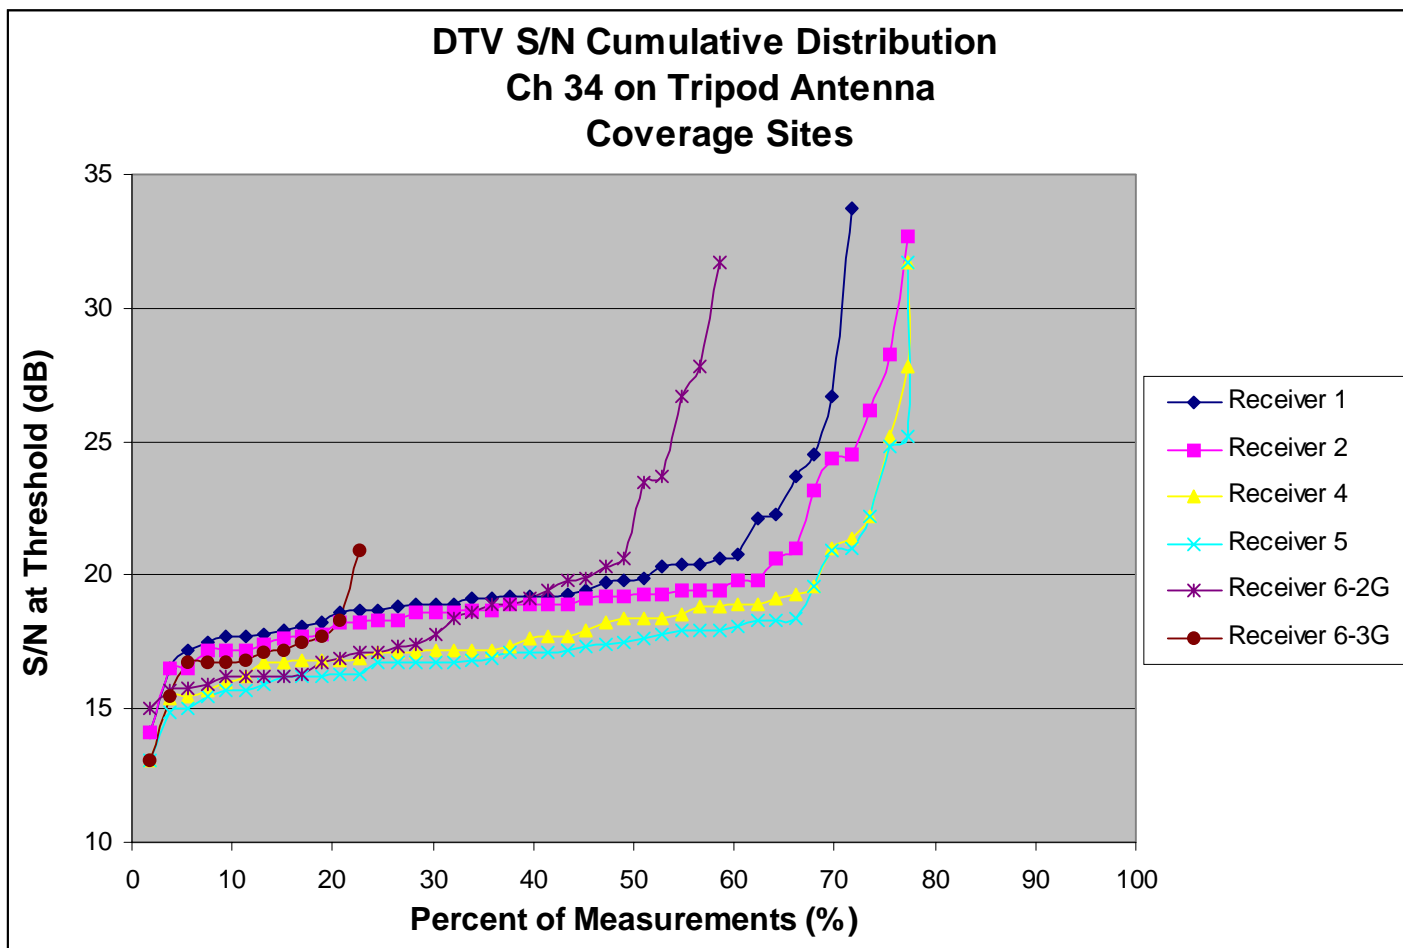
**Chart D-3.  
Threshold of Visibility**

Receiver 1	19.15 dB
Receiver 2	18.8 dB
Receiver 4	17.25 dB
Receiver 5	17.0 dB
Receiver 6-2G	17.8 dB
Receiver 6-3G	16.95 dB

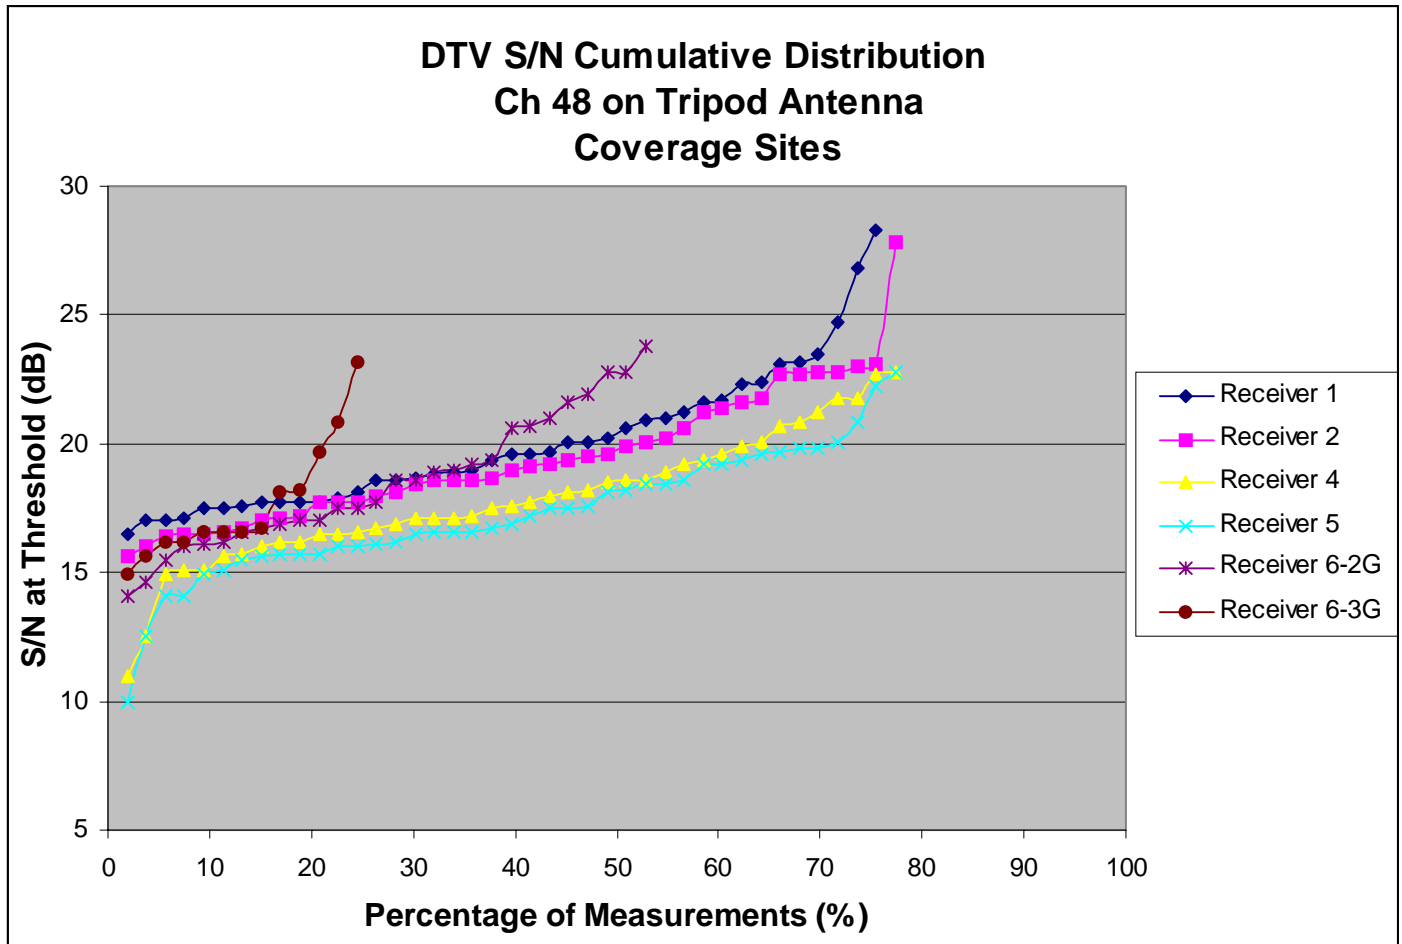
**Chart D-4.  
Threshold of Visibility**

Receiver 1	19.2 dB
Receiver 2	18.65 dB
Receiver 4	17.35 dB
Receiver 5	16.65 dB
Receiver 6-2G	18.15 dB
Receiver 6-3G	16.6 dB

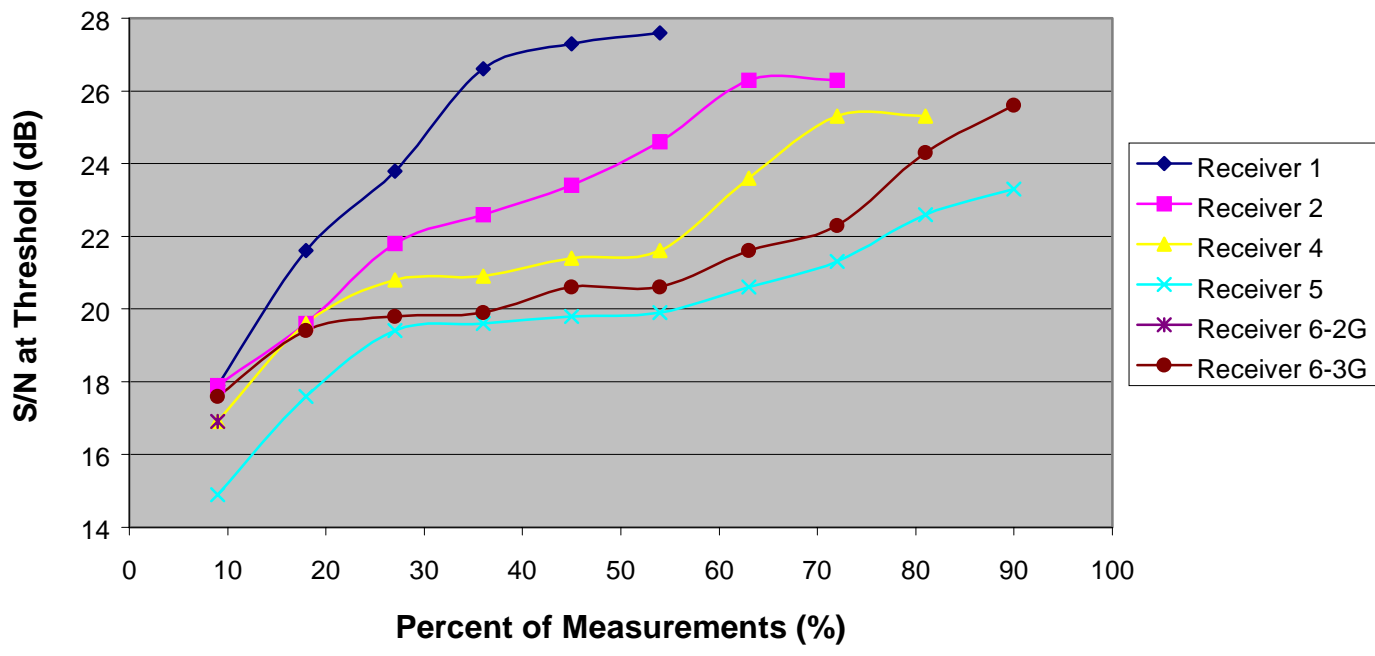
**Chart D-5.  
Threshold of Visibility**

**DTV S/N Cumulative Distribution  
Ch 34 on Mast Antenna  
High Multipath Sites**

Receiver 1	25.2 dB
Receiver 2	23.0 dB
Receiver 4	21.4 dB
Receiver 5	19.9 dB
Receiver 6-2G	16.9 dB (single data point)
Receiver 6-3G	20.6 dB

Examination of the charts for the strong-signal, high-multipath sites reveals an increase in the spread of the median S/N ratios at threshold between the earliest-generation receivers and the latest to about 6 dB. This appears to support the argument that improvements to later-generation receivers has been primarily in their equalizer performance. While statistical analysis using the Wilcoxon Signed Pairs Test was not able to establish significant differences between the data sets from some pairs of receivers for the strong-signal, high-multipath sites because of insufficient numbers of data points, it is clear that there are statistically significant differences in performance between first-generation and third-generation receivers. The simple fact that Receiver 1 was not able to produce a picture at the majority of these sites, while the two third-generation receivers were able to do so with only one exception, bears out this conclusion. Additionally, when Receiver 2 was compared to the third-generation receivers, in all cases the data showed significant statistical differences.

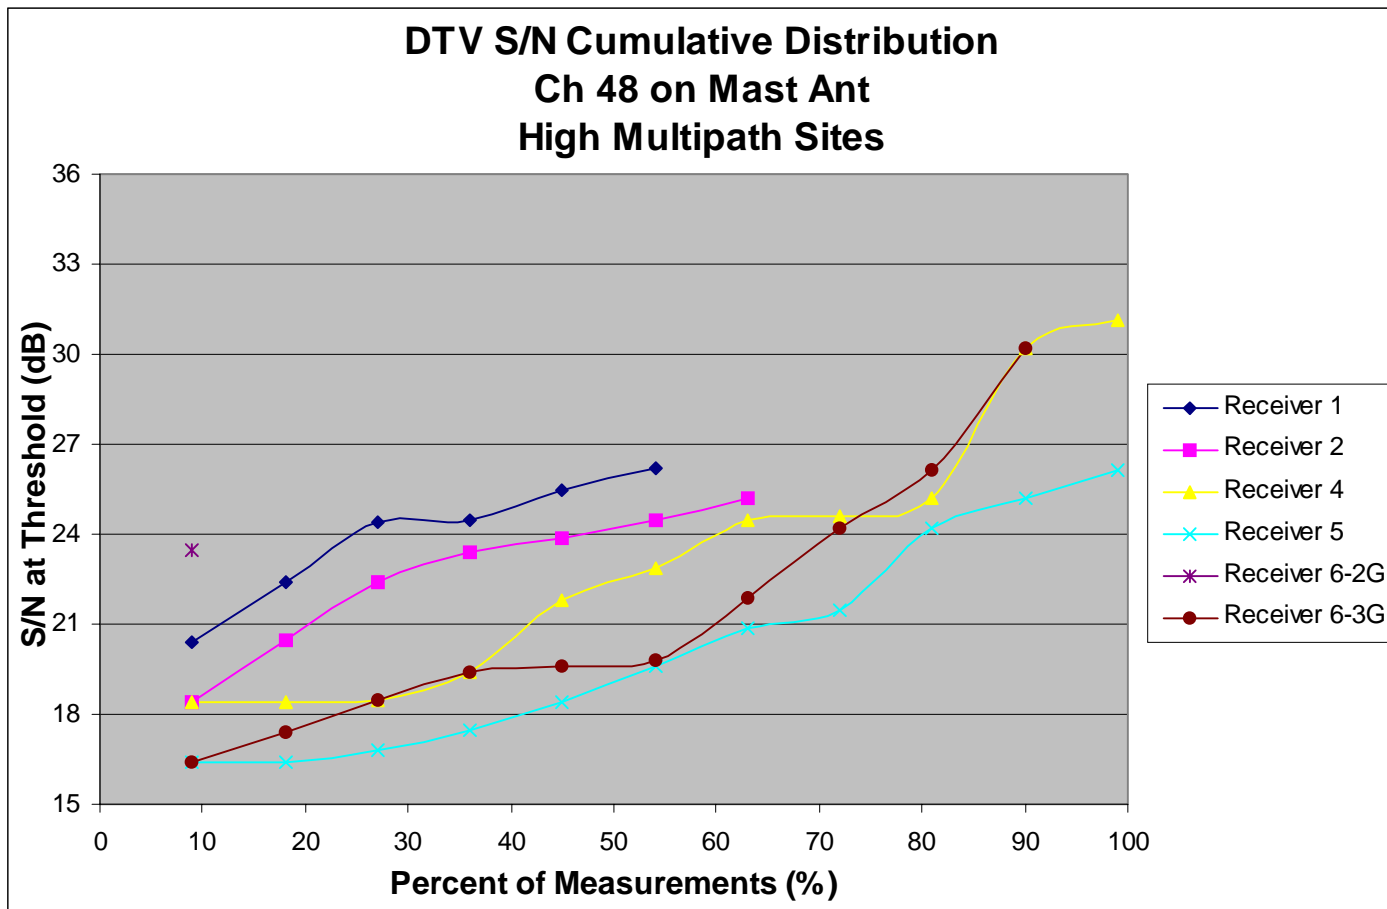
**Chart D-6.  
Threshold of Visibility**

Receiver 1	24.45 dB
Receiver 2	23.4 dB
Receiver 4	22.9 dB
Receiver 5	19.6 dB
Receiver 6-2G	23.5 dB (single data point)
Receiver 6-3G	19.7 dB

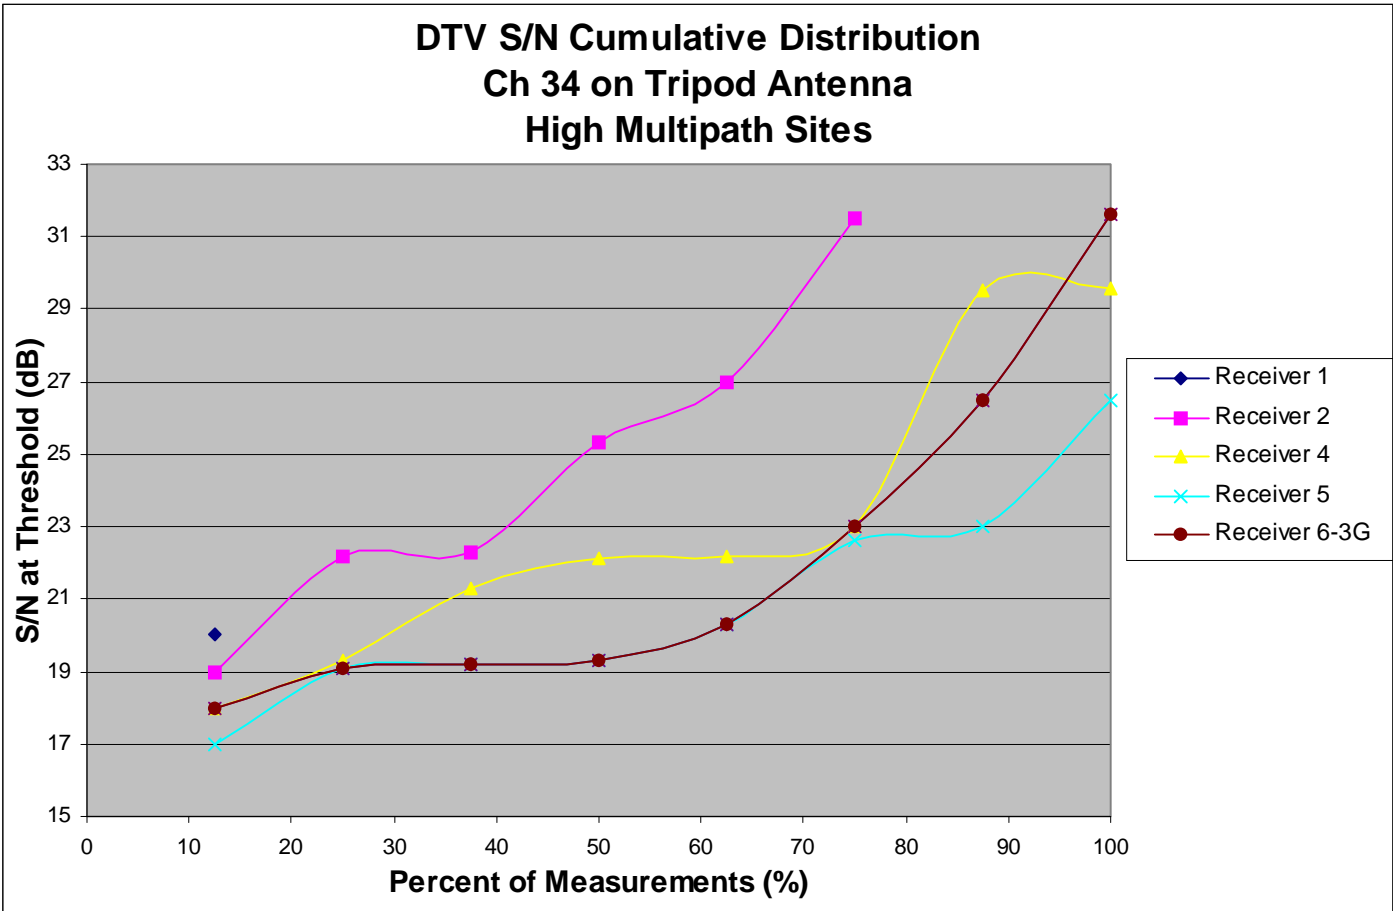
**Chart D-7.  
Threshold of Visibility**

Receiver 1	20.0 dB (single data point)
Receiver 2	23.8 dB
Receiver 4	22.15 dB
Receiver 5	19.8 dB
Receiver 6-2G	-----
Receiver 6-3G	19.8 dB

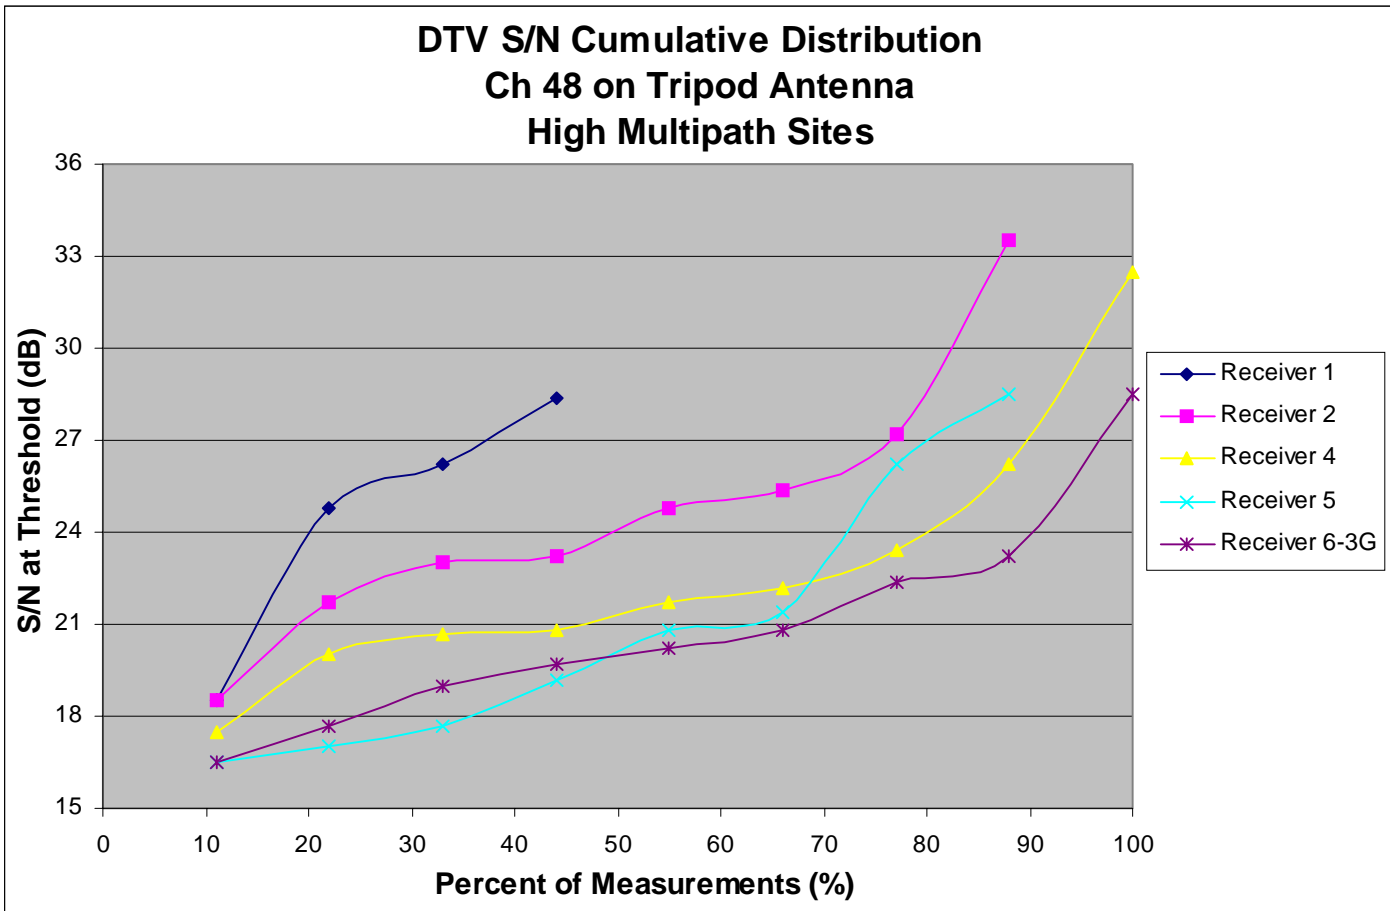
Receiver 1	25.5 dB
Receiver 2	24.0 dB
Receiver 4	21.7 dB
Receiver 5	20.0 dB
Receiver 6-2G	-----
Receiver 6-3G	20.2 dB

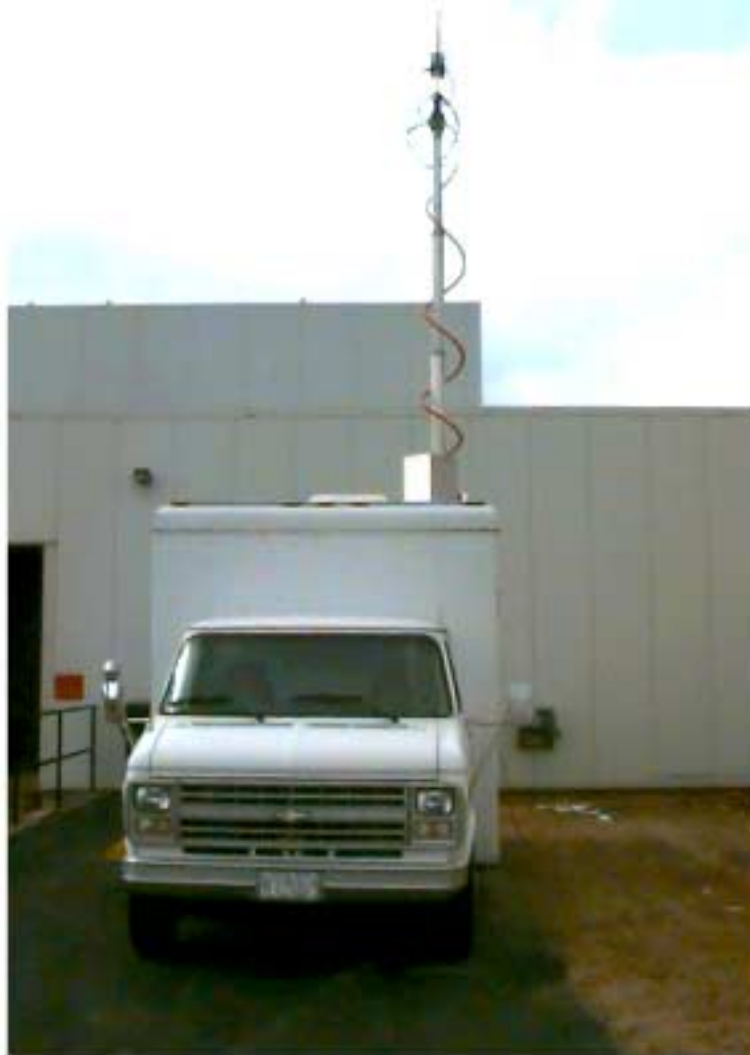
**Photo F-1.**  
**Front View of Vehicle with Antenna Mast Extended**

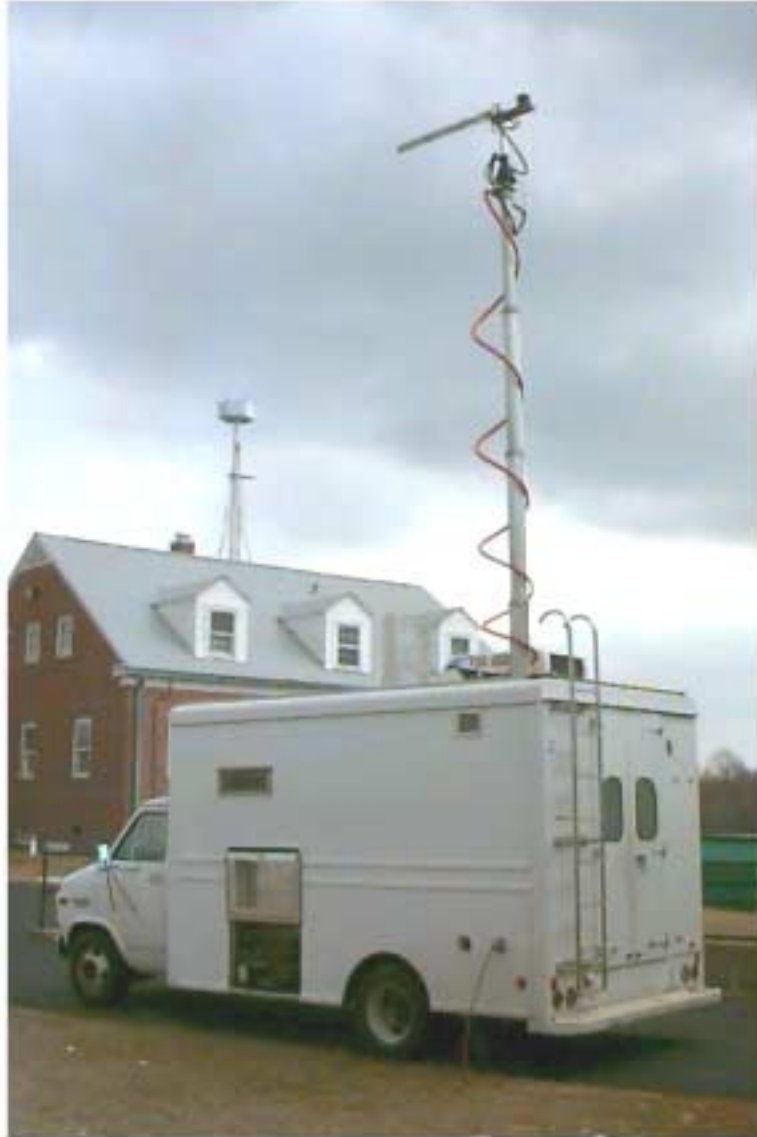
**Photo F-2.  
Port Side View of Vehicle with Antenna Mast Extended**

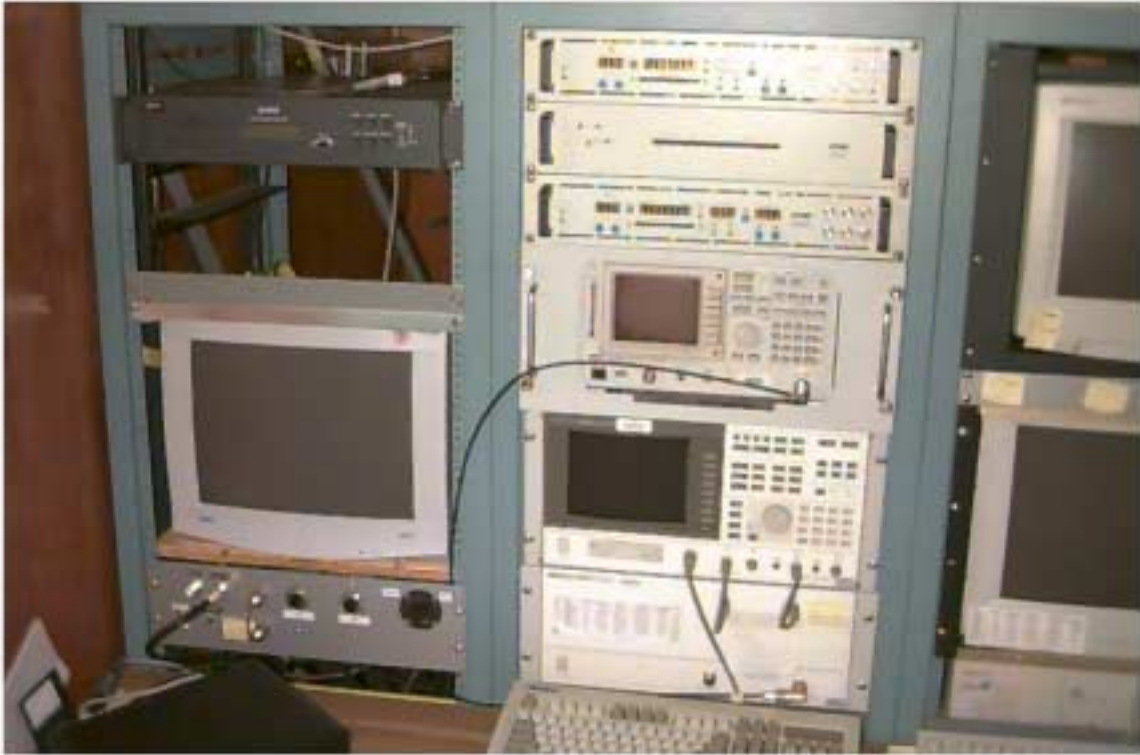
**Photo F-3.**  
**Starboard Half of Equipment Rack Showing Signal Attenuator Panel, Data  
Collection Receivers, Vector Signal Analyzer, and Spectrum Analyzer**

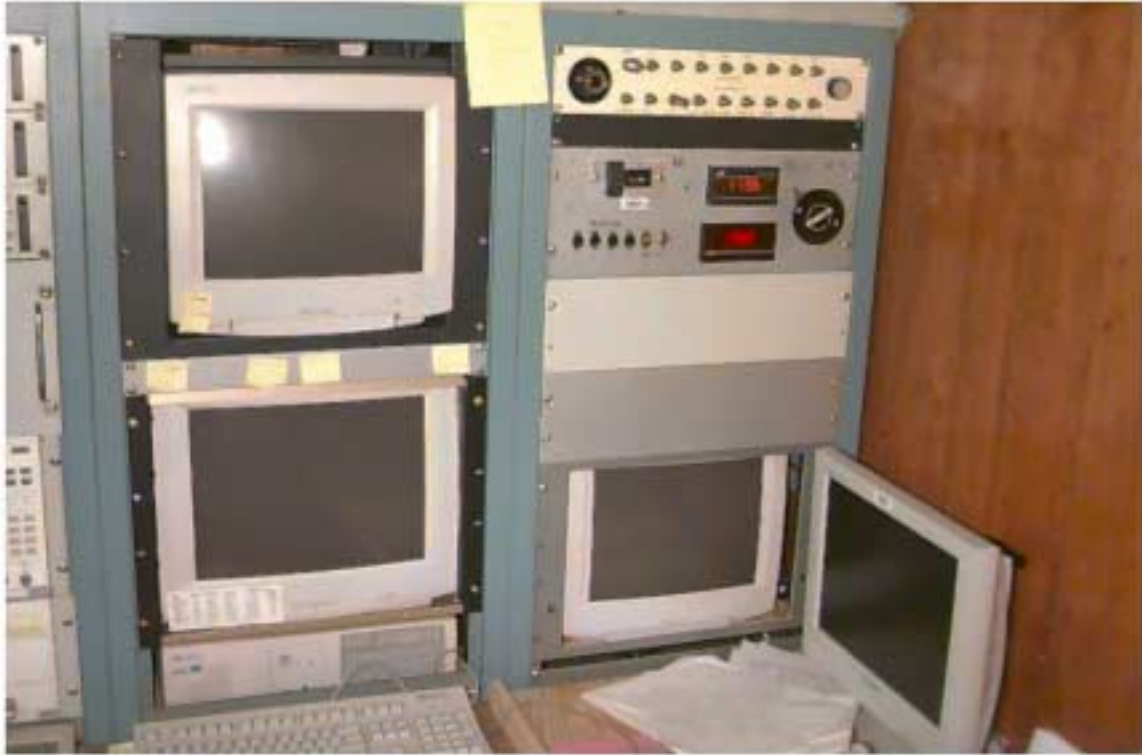
**Photo F-4.  
Port Half of Equipment Rack Showing Data Collection Computer, Picture  
Displays, and Genset and Antenna Controls**

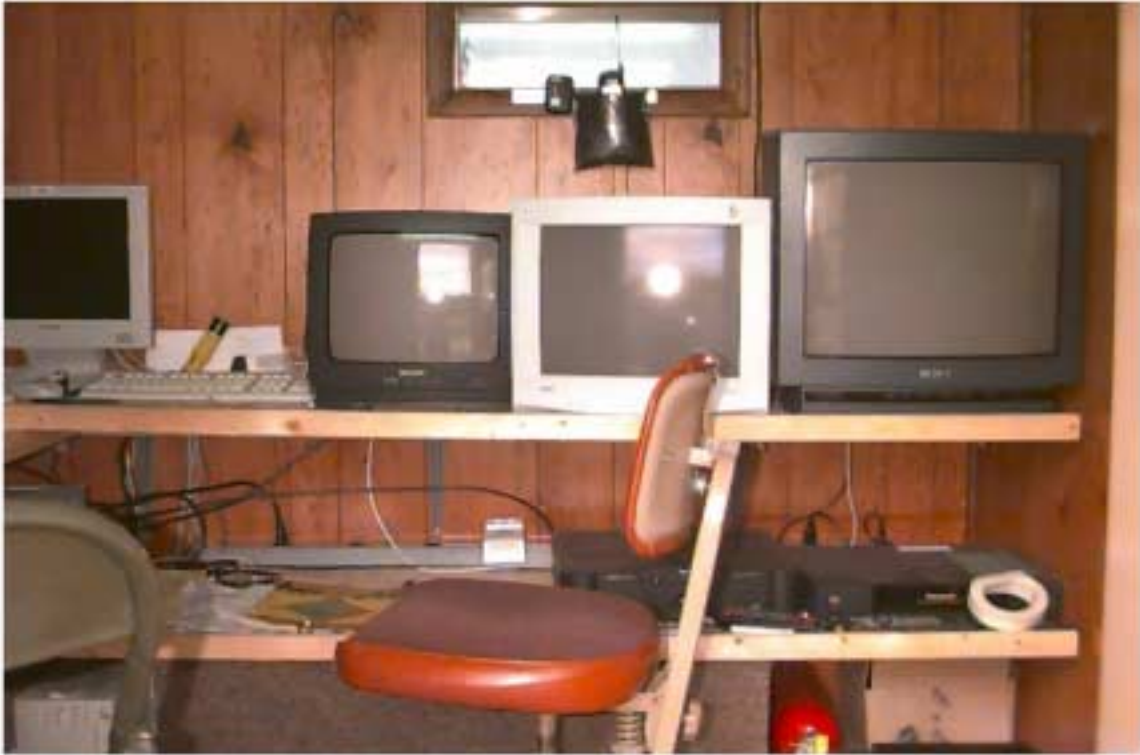
**Photo F-5.  
Port Side of Operator Compartment Showing  
Picture Displays and Receiver Shelf**

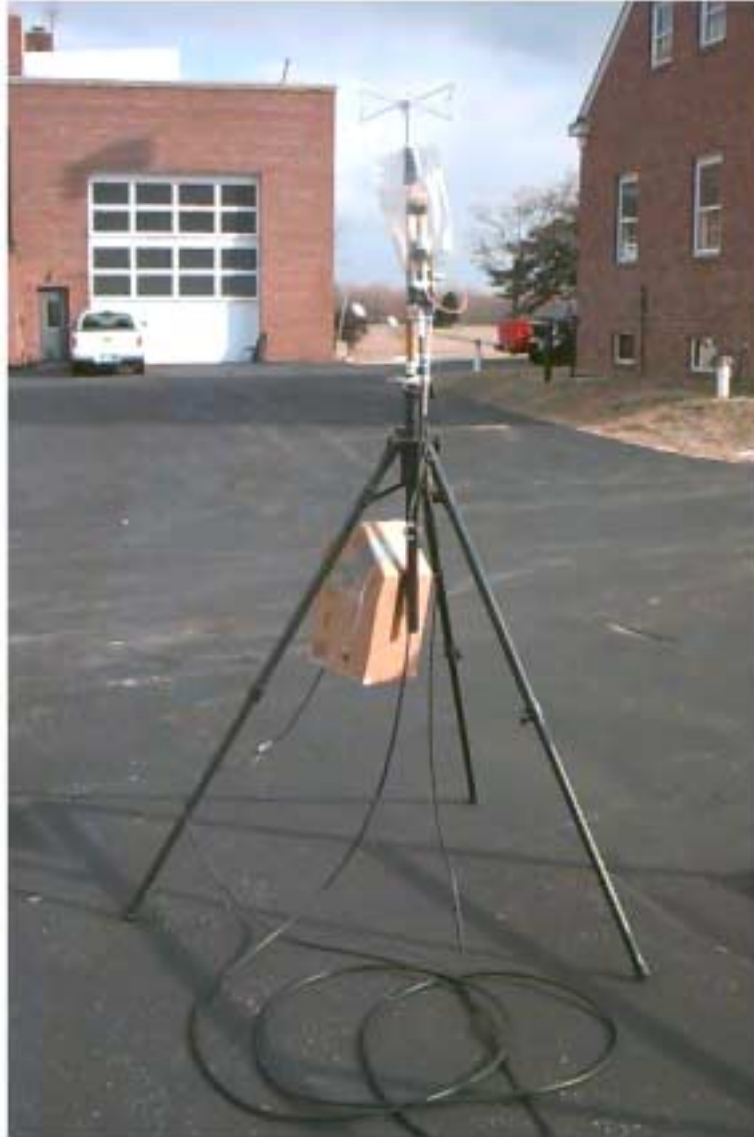
**Photo F-6.  
Tripod-Mounted Bowtie Antenna with Preamplifier  
and Remote Spectrum Display Viewing Box**

While most of the data collected with the tripod-mounted antenna was done using a typical “bow tie” indoor-type antenna, at sites where the bow tie antenna did not produce a reliable picture on the site characterization receiver, a “Silver Sensor” directional indoor-type antenna was substituted.
