Simulations Conducted in Modified Artificial Attic Containment System

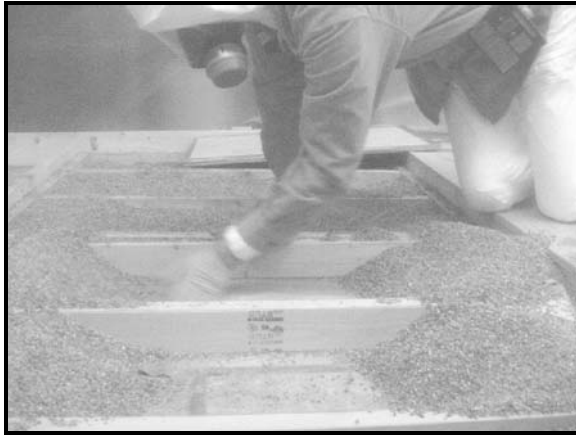
Figure 29: Vermiculite Being Cleared in Artificial Attic Space of Main Containment - Simulation of digging a trench to install electrical wiring.

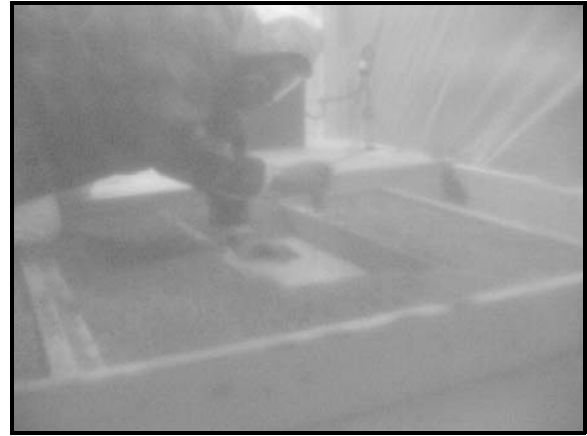
Figure 30: Hole Being Cut From Attic Space of Main Containment - Simulation of cutting a hole to install a ceiling fan.

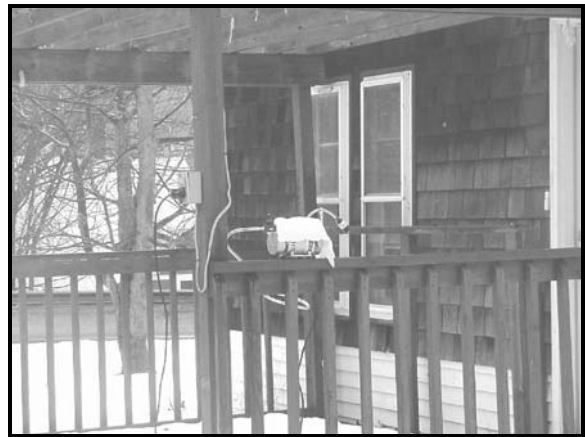
Figure 32: Ambient Air Monitoring Pump and Cassette on Front Porch of Vermont House for Collection of Background Samples
