EPA/600/R-09/017
February 2009

**Arsenic Removal from Drinking Water by Adsorptive Media
U.S. EPA Demonstration Project at Rollinsford, NH
Final Performance Evaluation Report**

**Battelle
Columbus, OH 43201-2693**

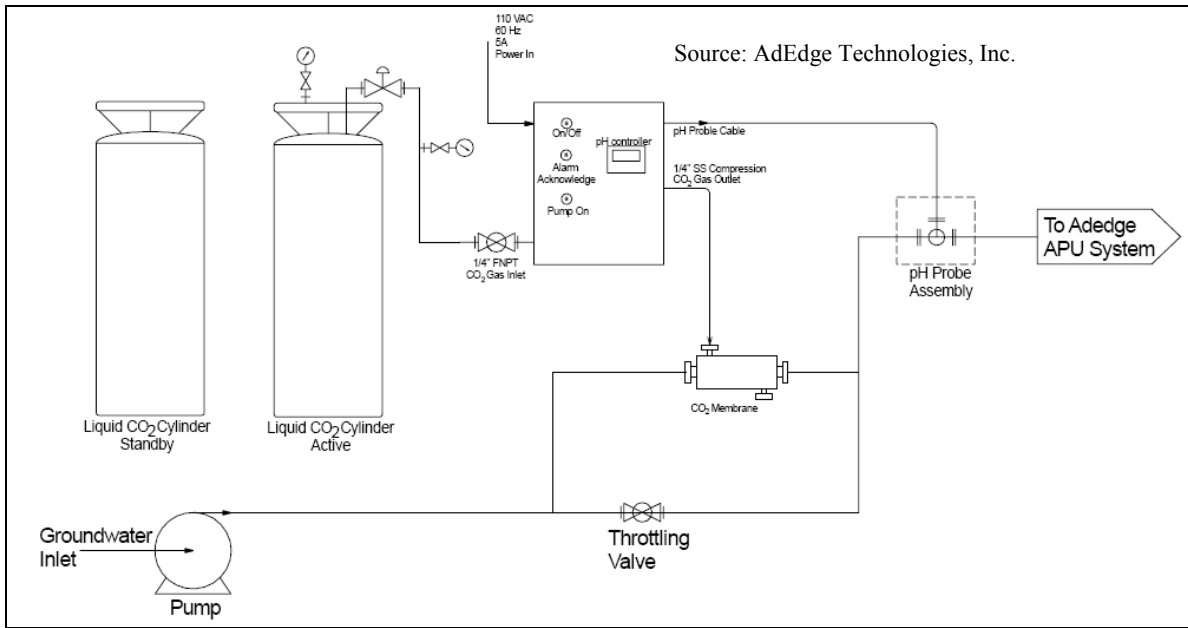
Figure 4-4. Diagram of CO₂ pH Adjustment System (top) and pH/PID Control Panel (bottom)

- After exiting the control panel, CO₂ was introduced into the water through a Celgard microporous hollow fiber membrane module contained within a stainless steel sanitary cross (see properties and specifications in Table 4-4). The sanitary cross was located in a side stream from the main water line to allow only a portion of water to flow through the membrane module to minimize the pressure drop. CO₂ gas entered into the top of the membrane module with water passing through the membrane module in a direction perpendicular to the gas flow. The membrane dispersed CO₂ gas into water, forming fine bubbles for rapid mixing to achieve a quick pH change.

- Located downstream from the sanitary cross was a Cole Palmer Model A-27011-01 glass pH probe, which read pH levels of the treated water. The pH controller monitored signals from the pH probe and set off alarms if the readings were ±0.5 pH units outside of the target set point. When the alarm was triggered, the solenoid valve in the panel shut off the flow of CO₂ gas.

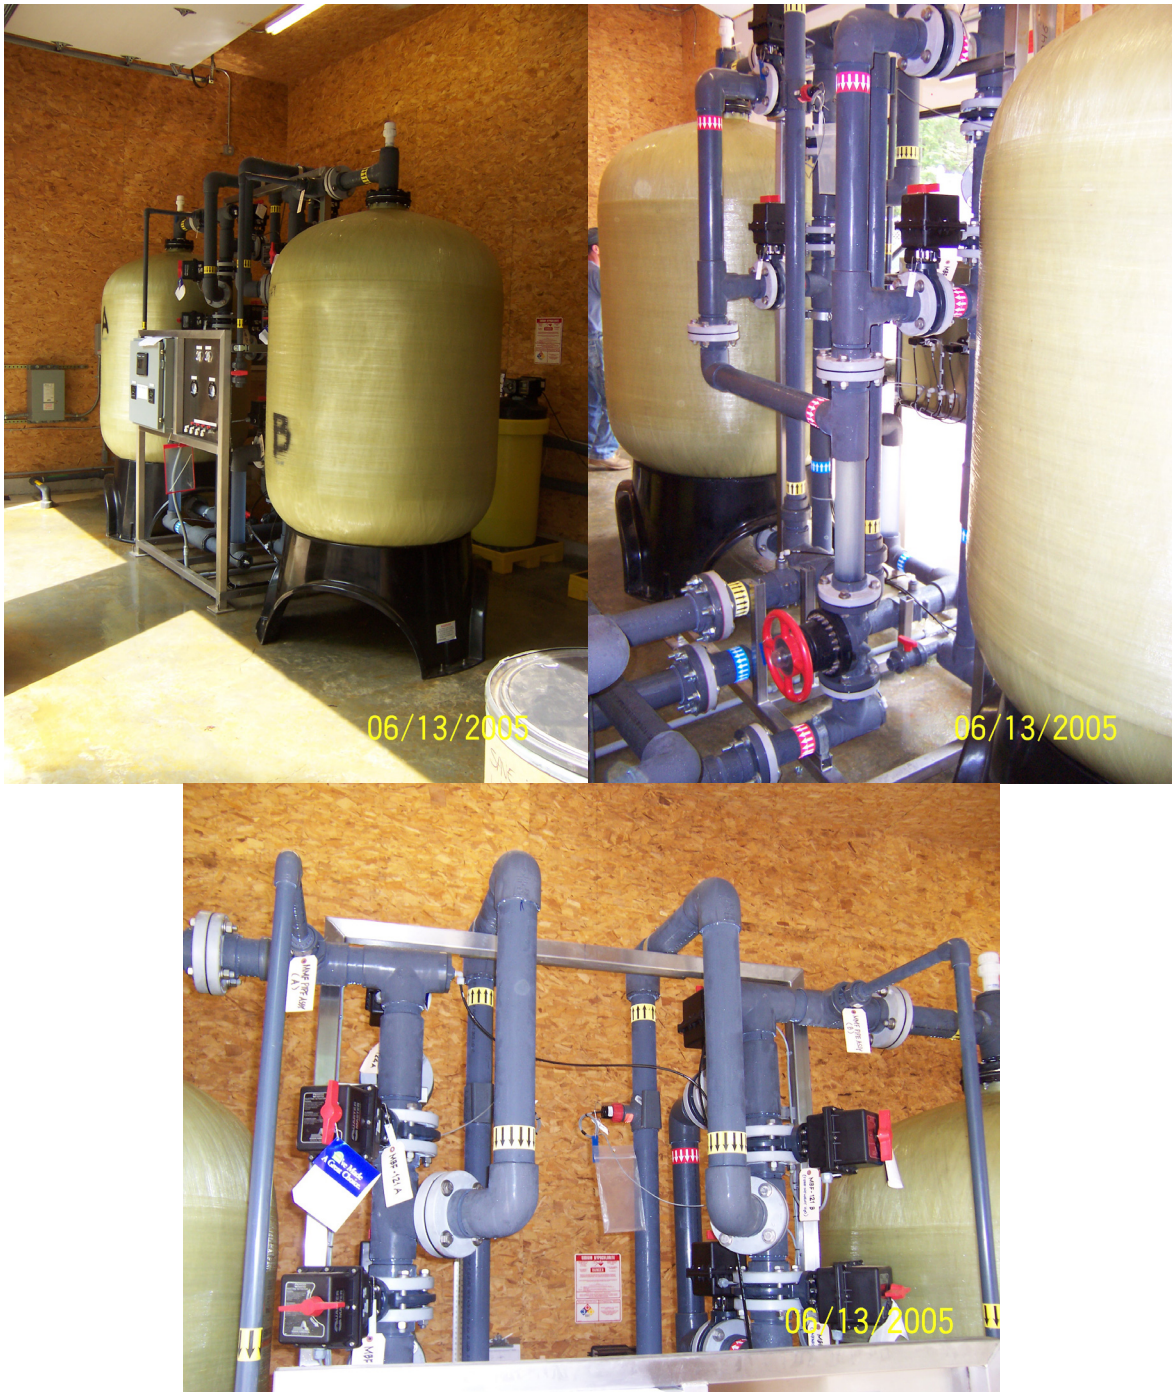
Figure 4-7. APU-RWS Treatment System (top left) with Valve Tree (bottom) and Backside of System Piping Including Backwash Sight Glass (top right)

The APU-RWS system consisted of two 48-in-diameter, 72-in-tall pressure vessels in parallel configuration, each initially containing 30 ft³ of AD-33™ media supported by a gravel underbed. The vessels also were FRP construction, rated for 150 psi working pressure, and piped to a valve rack mounted on a polyurethane-coated, steel frame. The APU-RWS system plumbing design eliminated the diaphragm valves, Fleck controller valves, and restrictive orifices, and replaced them with a nested system of fully ported actuated butterfly valves and a new control panel. The APU-RWS valve-tree design was based on a series of systematic hydraulic tests on similar, but larger-capacity systems at STS's Torrance, CA, fabrication shop and at the Brown City, MI, arsenic removal demonstration site in March and April 2004. The test results indicated that the fleck controller valves and restrictive orifices were the main sources of excessive pressure loss experienced at Desert Sands, NM, Brown City, MI, and Queen Anne's County, MD, arsenic removal demonstration sites. A summary of the hydraulic test results are provided in the Six Month Reports for the Desert Sands, Brown City, and Queen Anne's County sites (Coonfare et al., 2005; Condit et al., 2006; Oxenham et al., 2006).

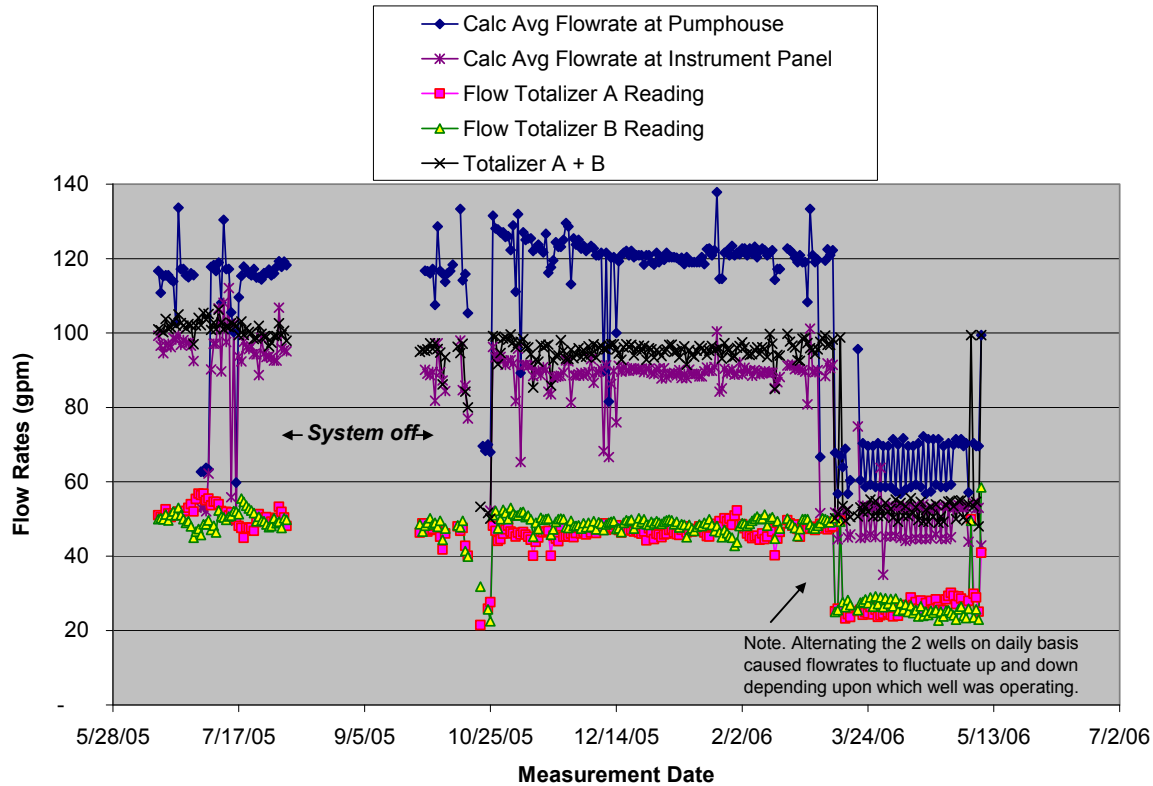
Figure 4-10. Flowrate Measurements for Phase 2, APU-RWS System

Similar to Run 1 under Phase 1, combined flowrates (denoted by “×” in Figure 4-10) to the system varied significantly from 48 to 106 gpm due, again, to operation of only one supply well during 23% of the system run time. Operation of only one well was done at the request of the NHDES as an attempt to improve system performance for arsenic removal. With both wells running, flowrates ranged from 80 to 106 and averaged 97 gpm. With either Well No. 3 or 4 running, flowrates ranged from 48 to 105 and averaged 58 gpm. With 30 ft³ of media in each vessel, EBCTs ranged from 4.0 to 5.6 min with both wells running and from 4.0 to 10.0 min with only one well running.

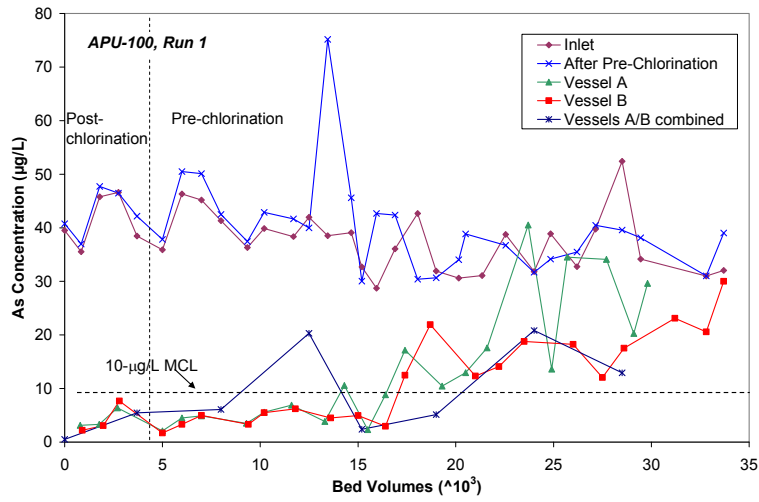
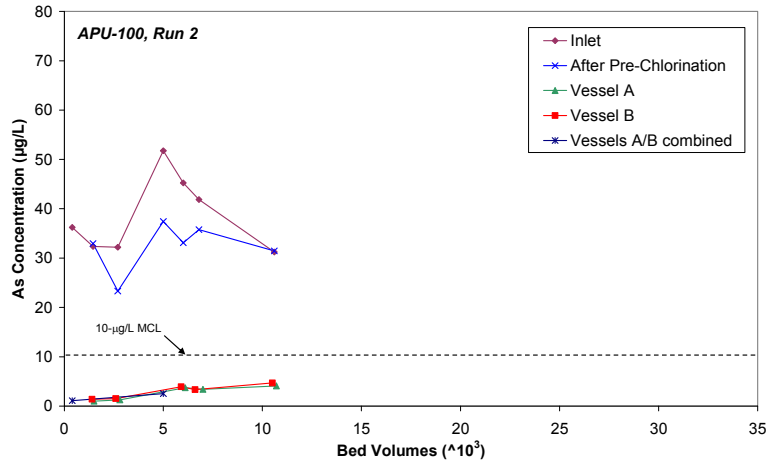
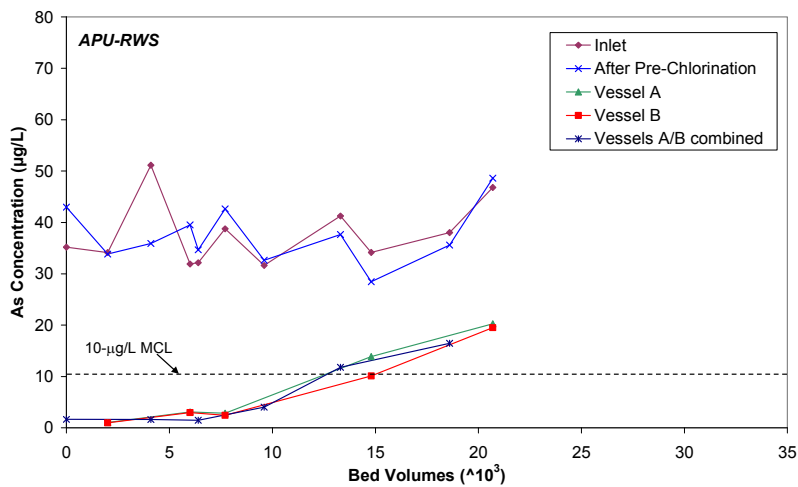
Figure 4-15. Total Arsenic Breakthrough Curves

BV. Total arsenic concentrations measured at the AP location at about 13,500 BV and at the TT location at about 12,500 BV were unusually high at 75.2 and 20.3 µg/L, respectively. It was not clear why these concentrations were higher than the other relevant data points. Based on these data, breakthrough of arsenic at 10 µg/L occurred somewhere between 12,500 and 17,000 BV, representing about 17 to 23% of the vendor-estimated working capacity of 74,000 BV.

After the media was changed out, the APU-100 system processed approximately 10,000 BV before it was bypassed due to unacceptably high inlet pressure. Breakthrough of arsenic at this time was at about 4 µg/L (middle graph in Figure 4-15), which comprised primarily As(III) (see Figure 4-14) following the switch back of the chlorine injection point to after the adsorption vessels on December 2, 2004, due to elevated inlet pressure problems as discussed in Section 4.4.2.
