EPA/600/R-07/072
August 2007

**Arsenic Removal from Drinking Water by Adsorptive Media
U.S. EPA Demonstration Project at
Chateau Estates Mobile Home Park in Springfield, OH
Final Performance Evaluation Report**

**Battelle
Columbus, OH 43201-2693**

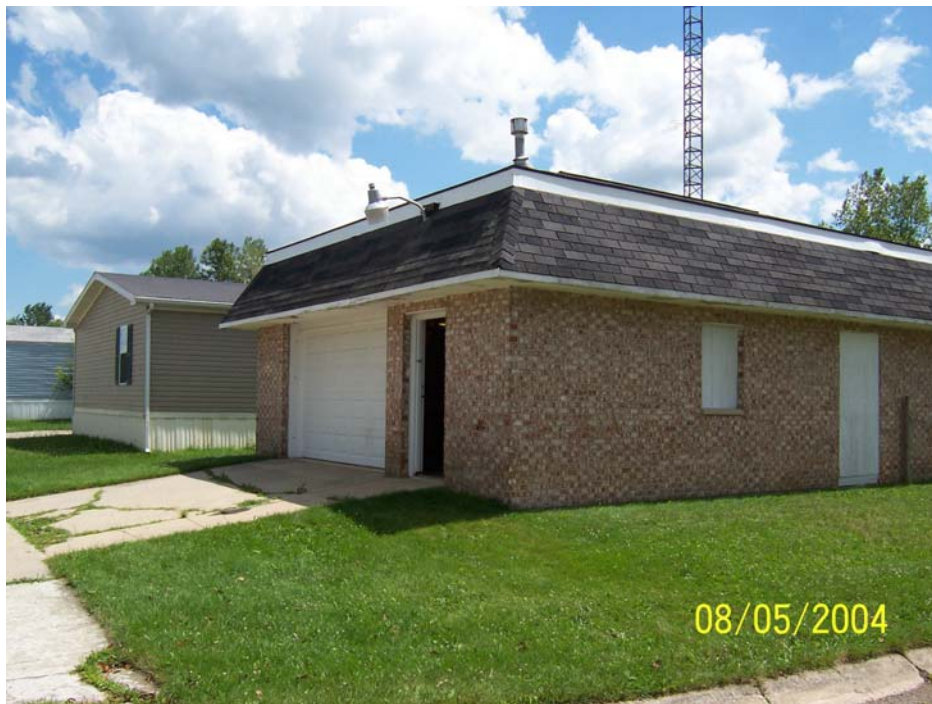
Figure 4-1. Preexisting Treatment Building at Chateau Estates Mobile Home Park

The preexisting water treatment system consisted of chlorination using a 12.5% NaOCl solution and the addition of polyphosphate as a sequestering agent for corrosion and scale control. Figure 4-2 shows the chlorine and polyphosphate storage tanks and chemical metering pumps. Following chlorination and polyphosphate addition, the water was stored in a 2,000-gal hydropneumatic tank (Figure 4-3) prior to entering the distribution system.

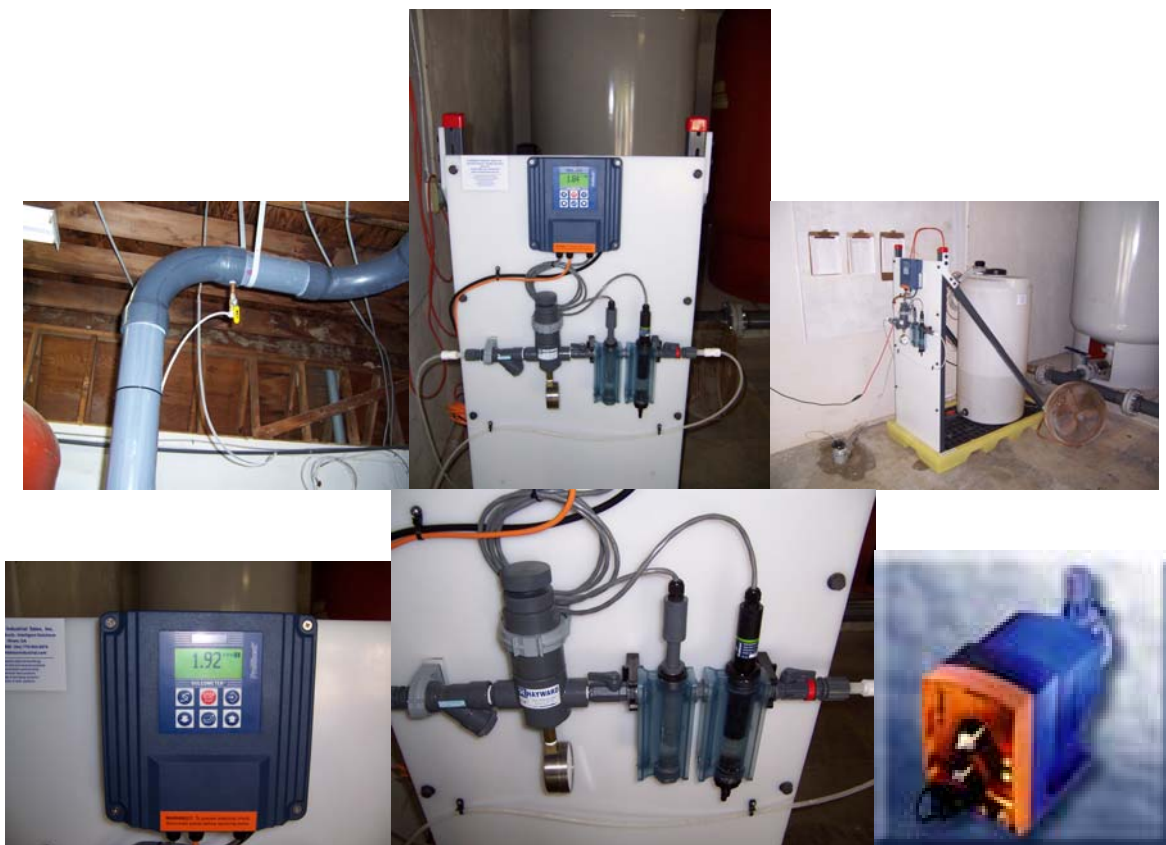
Figure 4-6. Chlorine Injection System

(Clockwise from Top: Chlorine Injection Point; Chlorine Monitor/Control Module; Chlorine Injection System; Metering Pump; Chlorine Sensor; Chlorine Monitor/Controller)

The most significant operational issue observed was related to the chlorine injection system. In spite of repeated efforts to fine tune the chlorine injection system and even reconfigure the system piping to allow the injection to be controlled by well pump flowrates instead of on-demand flowrates, as much as 4 and 3.8 mg/L (as Cl₂) total and free chlorine, respectively, were measured in the treated water, which were significantly higher than the 1.5 and 1 mg/L (as Cl₂) of total and free residuals targeted for the treatment. The problem seems to be resolved by the addition of an inline filter placed just before the chlorine monitor to reduce clogging and coating of the chlorine probe due to iron particulates.

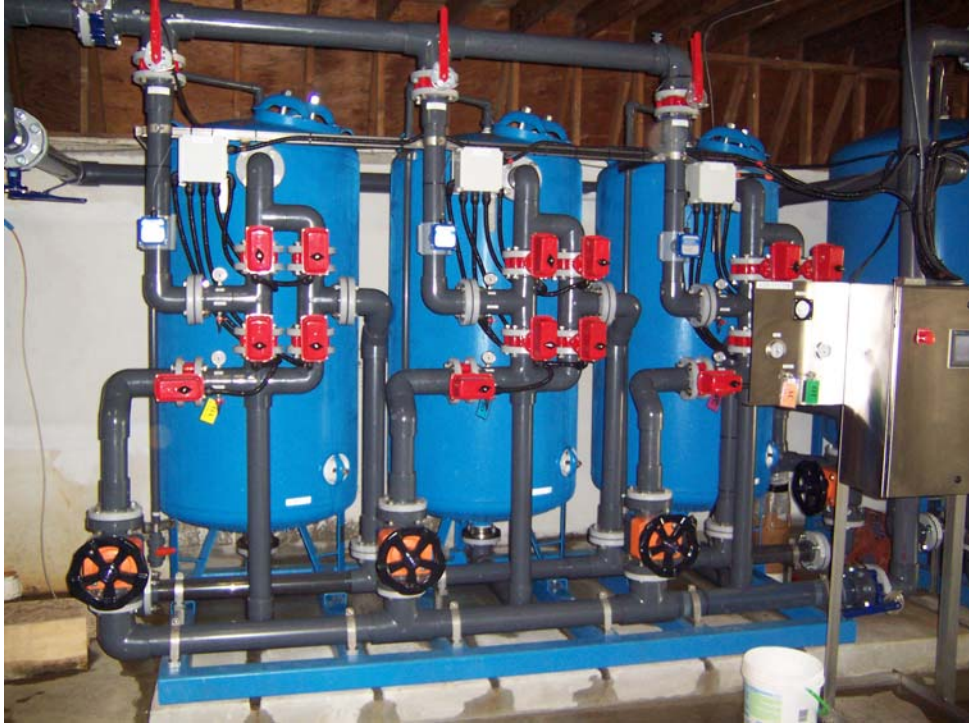
Figure 4-7. AD-26 Treatment System

For the AD-26 system that filtered arsenic laden-iron solids and manganese solids, backwash was performed every two to three days based on a set time. Backwash was adjusted on February 9, 2006, from once every 2 days for 15 min per vessel to once every 3 days for 9 min per vessel, with a 2- or 1.5-min filter-to-waste rinse at a flowrate of 130 gpm. After the adjustment, the total amount of wastewater produced should have been reduced from approximately 6,630 to 4,100 gal for the three vessels although this volume reduction was not observed (see Section 4.4.3).

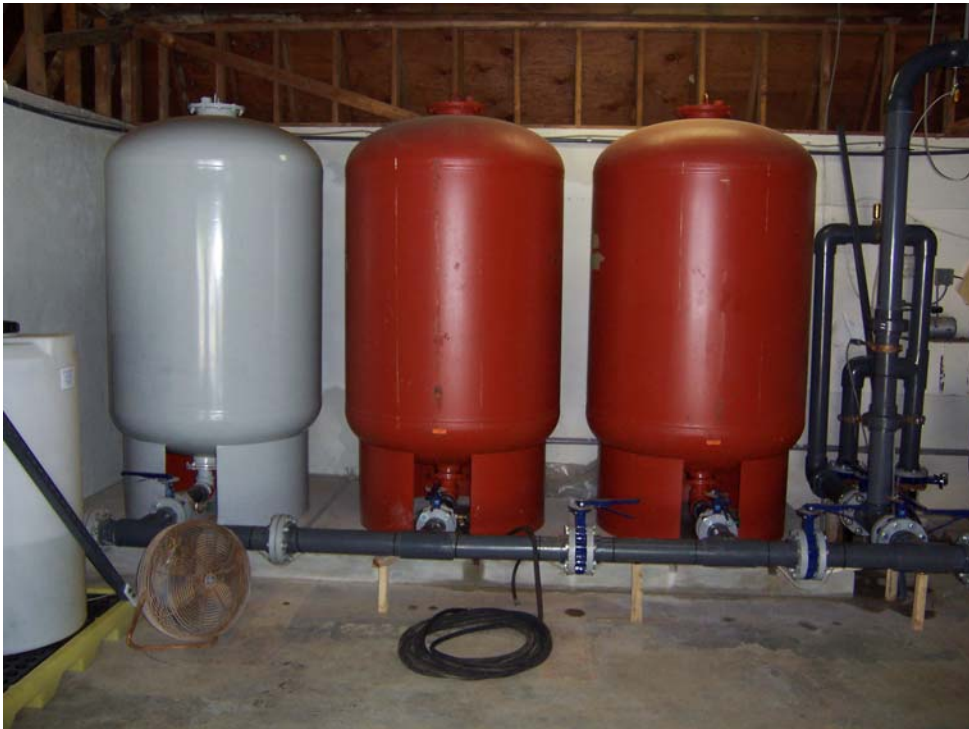
Figure 4-8. Hydropneumatic Tanks

- **Hydropneumatic Tanks.** The filtered water from the AD-26 system entered the three hydropneumatic tanks for storage until needed to meet demand. Each tank had a storage capacity of 528 gal for a total capacity of 1,584 gal. Figure 4-8 is a photograph of the three hydropneumatic tanks.

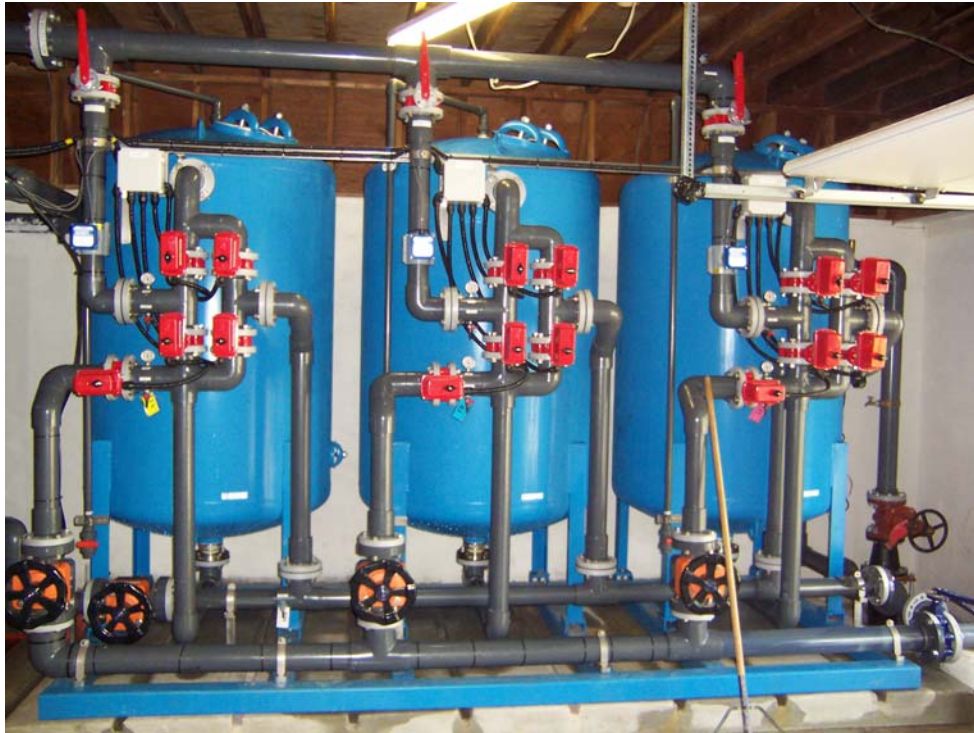
Figure 4-9. AD-33 Treatment System

- **Arsenic Adsorption System.** Upon demand, the water stored in the hydropneumatic tanks flowed through the APU arsenic adsorption system at a varying flowrate. As discussed in Section 4.1, flowrates ranging from 18.1 to 58.2 gpm and averaging 33.0 gpm (Figure 4-4) were recorded from the existing hydropneumatic tank to the distribution system during a predemonstration water demand study. The APU system consisted of three 48-in-diameter, 60-in-sidewall high carbon steel pressure vessels also configured in parallel. Each of the APU vessels contained approximately 38 ft³ (114 ft³ total) of AD-33 media. Assuming a flowrate of 33.0 gpm (or 11.0 gpm/vessel), the media empty bed contact time (EBCT) in each vessel would be 25.8 min, which is at least five times higher than that recommended by the vendor. Similar to the AD-26 system, the APU system was controlled by a series of electrically actuated butterfly valves and the PLC unit.

Figure 4-9 is a photograph of the APU system. Figure 4-10 presents a photograph of the APU control panel.

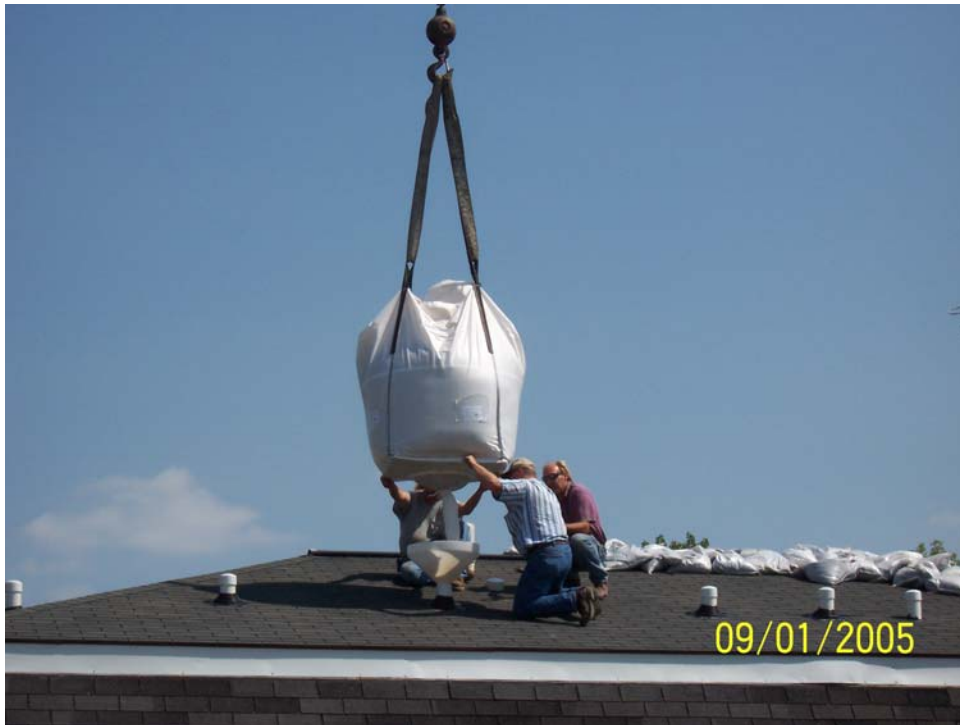
Figure 4-11. AD-33 Media Loading

Upon completion of system installation, the media vessels were tested hydraulically before media loading on September 1, 2005. For the APU system, six 100-lb bags of coarse gravel (for a total of 600 lb [or 6 ft³]), three 100-lb bags of fine gravel (for a total of 300 lb [or 3 ft³]), and one and one fifth 1,100-lb supersacks of the AD-33 media (for a total of 1,330 lb [or 38 ft³]) were loaded sequentially into each vessel containing approximately half a tank of water. Figure 4-11 shows a photograph of loading the AD-33 media from a supersack through a hatch on the roof of the building. Each AD-26 vessel was loaded with five 100-lb bags of fine gravel (for a total of 500 lb [or 5 ft³]) and then approximately 41 55-lb bags of the AD-26 media (for a total of 2,255 lb [or 19 ft³]) with the vessel containing about half a tank of water. Figure 4-12 is a composite of pictures showing the media bags and loading the underbedding into one of the AD-33 vessels.

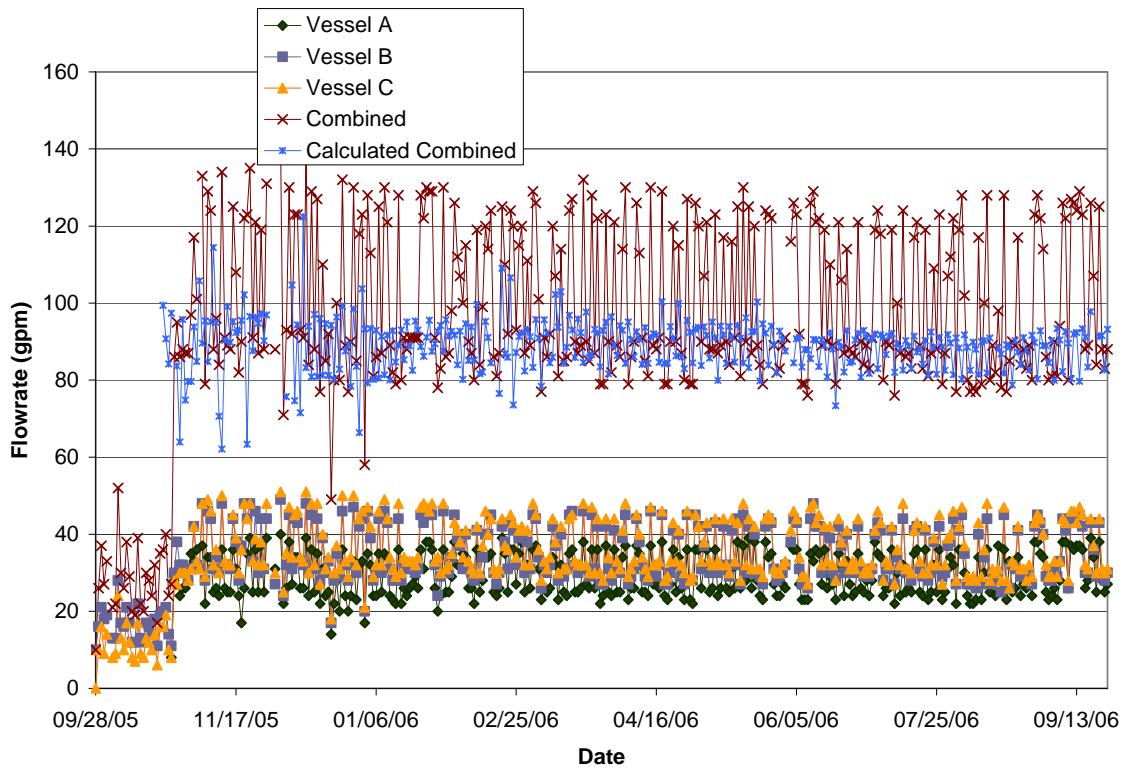
Figure 4-14. AD-26 Oxidation/Filtration System Flowrates

Flowrates through the three AD-26 vessels were monitored using individual totalizers/flowmeters installed at the exit side of the vessels. Before the system piping retrofit, instantaneous on-demand flowrate readings taken from the meters ranged from 6 to 28 gpm for Vessels B and C, with combined flowrates ranging from 17 to 52 gpm and averaging 29 gpm (Table 4-5 and Figure 4-14). As noted

above, little or no flow passed through Vessel A during this time period. After the system piping retrofit, the system operated at the well pump flowrates. The instantaneous flowrate readings taken from the meters ranged from 14 to 51 gpm for the three vessels with combined flowrates ranging from 49 to 140 gpm and averaging 101 gpm. The combined flowrates from the meter readings are compared in Figure 4-14 with the calculated flowrates derived by dividing the combined throughput values by the corresponding operating hours. As expected, the calculated flowrates were less scattered, excluding a few outlier readings, than the instantaneous readings (i.e., 62 to 122 gpm [averaged 89 gpm] versus 49 to 140 gpm [averaged 101 gpm]) due to the different times the readings were recorded. The average flowrate obtained from the meter readings was closer to the operating time-weighted average (i.e., 117 gpm) of the West and East Wells flowrates (i.e., 130 and 90 gpm, respectively).

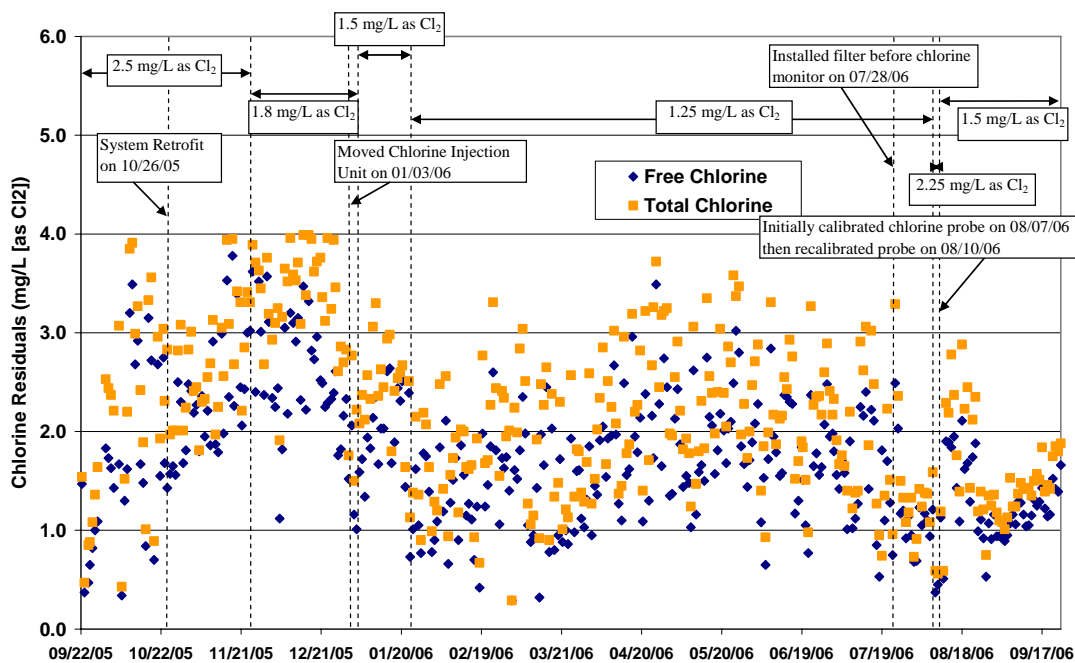
Figure 4-15. Free and Total Chlorine Residuals at Entry Point

residuals continued to scatter significantly between 0.29 and 3.49 mg/L (as Cl₂) for free chlorine and between 0.29 and 3.72 mg/L (as Cl₂) for total chlorine from January 27 through July 28, 2006.

Another potential contributing factor to the erratic free and total chlorine residual readings might be the presence of iron particles in the chlorinated water, which clogged and/or coated the polyethylene tubing leading from the inline mixer to the chlorine monitor/control module and the chlorine probe and flow sensor assemblies. As a result, erroneous measurements might have been made by the chlorine probe, causing incorrect feedback to the chlorine monitor/controller for erratic chlorine injection rates. In an attempt to resolve this issue, an AD2710S iron removal cartridge was installed just before the chlorine monitor/controller and after the polyethylene tubing on July 28, 2006. Due to a significant amount of iron particles removed, the frequency of the cartridge change-out was increased from monthly to approximately twice a month on September 1, 2006. The resulting free and total chlorine residual readings became much less scattered, with concentrations ranging from 0.37 to 2.11 and from 0.56 to 2.88 mg/L (as Cl₂), respectively. The average free chlorine concentration was 1.20 mg/L (as Cl₂), very close to the set value of 1.25 mg/L (as Cl₂). Since then, the plant operator included cleaning of the relevant system components, including the chlorine probe trap, chlorine probe, and flow meter trap, as part of the routine system O&M activities.

The vendor recommended calibration of the chlorine probe every three months. Because it had not been calibrated since system startup, the chlorine probe was recalibrated by the plant operator following the vendor's instructions on August 7, 2006. Due to a miscommunication, the chlorine probe was calibrated with water from the entry point (or the TT sample tap) instead of water from the chlorine probe holder which caused the free and total chlorine concentrations to drop through the treatment train. To correct the drop in chlorine level, the free chlorine set point was increased from 1.25 to 2.25 mg/L (as Cl₂). A call to the vendor was made and the miscommunication was identified. The chlorine probe was then recalibrated

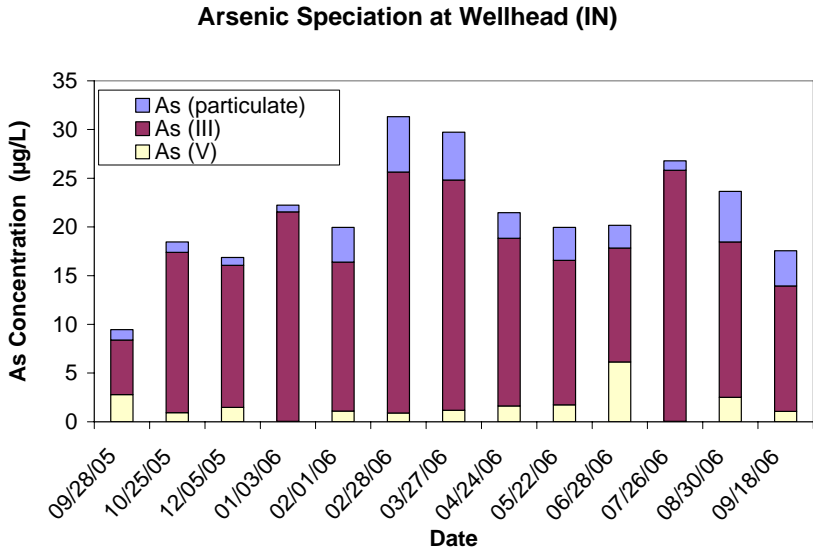
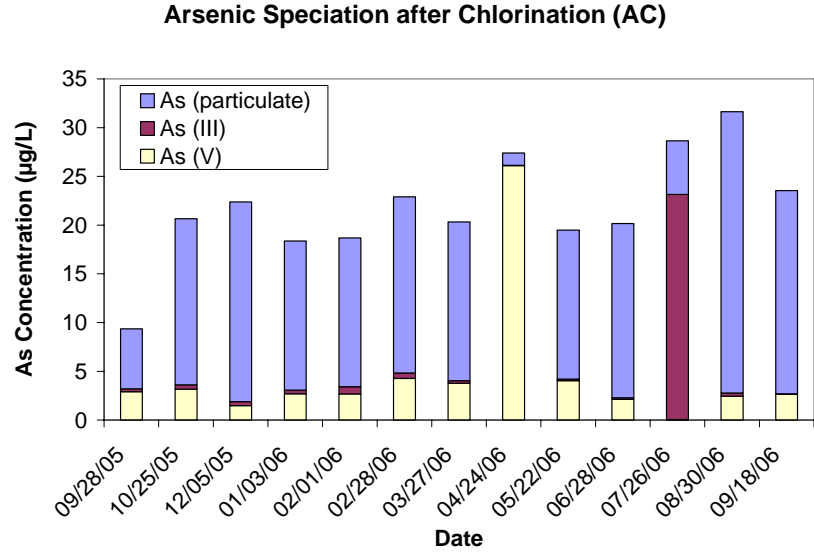
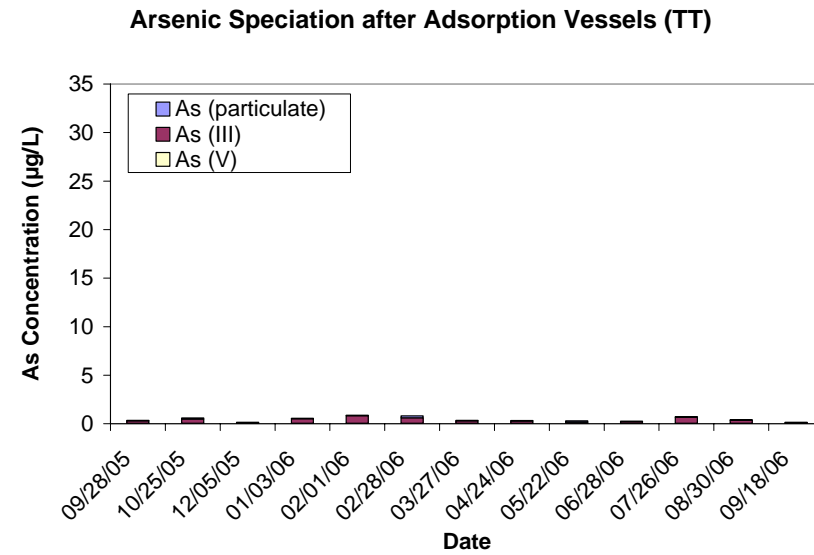
Figure 4-17. Concentrations of Various Arsenic Species at IN, AC, OT and TT Sampling Locations

Chlorination oxidized As(III) to As(V) that, in turn, was attached onto the iron solids also formed upon chlorination. The samples collected downstream of the chlorine injection point at the AC location showed a decrease in soluble arsenic concentration from an average of 18.5 µg/L in source water to an average of 6.4 µg/L after chlorination and a corresponding increase in particulate arsenic concentration from an average of 2.8 µg/L in source water to an average of 15.3 µg/L after chlorination. The majority of particulate arsenic was filtered out by the AD-26 oxidation/filtration media, leaving only 0.5 to 2.1 µg/L of total arsenic, existing mainly as soluble As(V), to be further removed by the AD-33 adsorption vessels. By the end of the demonstration period, total arsenic concentrations in the treated water after the AD-33 adsorption vessels were reduced to less than 0.5 µg/L. Figure 4-18 presents arsenic breakthrough curves from the AD-26 oxidation/filtration and AD-33 adsorption systems.

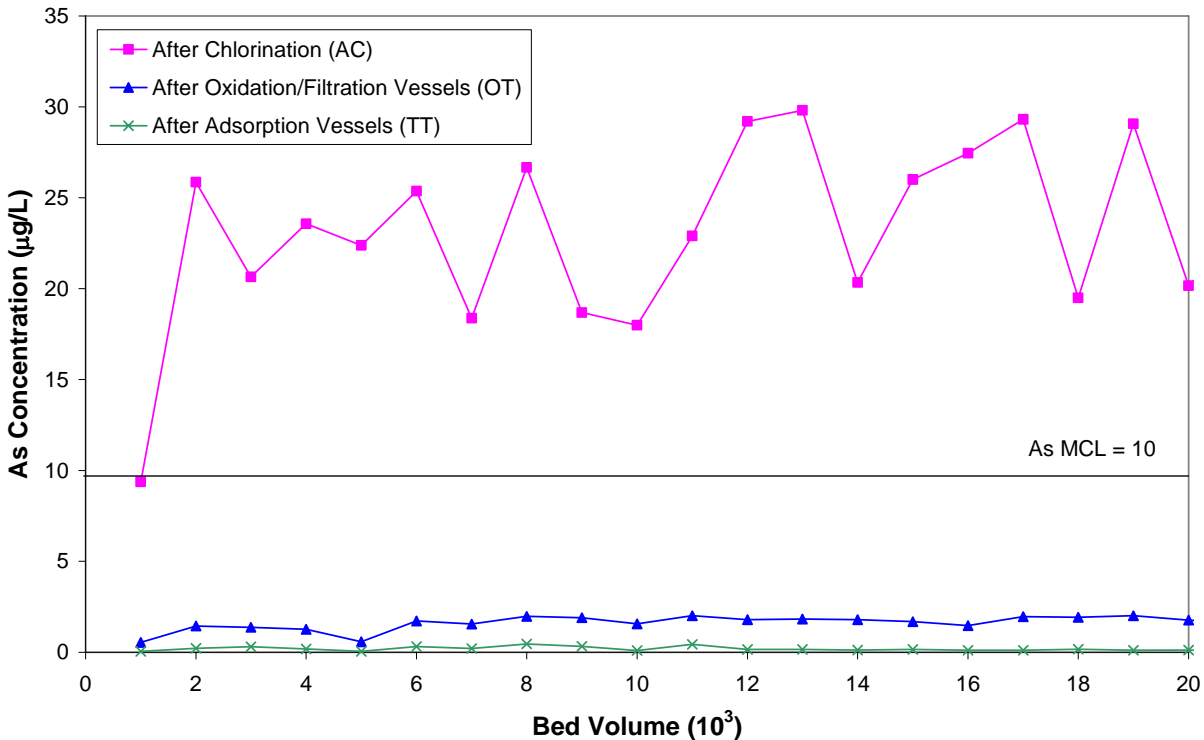
Figure 4-18. Total Arsenic Breakthrough Curves for AD-26 Oxidation/Filtration and AD-33 Adsorption Systems

The treatment system reduced the arsenic levels from between 9.5 and 35.4 µg/L (averaged 22.7 µg/L) in raw water to <10 µg/L in the treated water. As(III) was the predominating arsenic species in raw water, ranging from 5.6 to 25.8 µg/L and averaging 16.9 µg/L in both wells. Upon chlorination, As(III) was oxidized to As(V) that, in turn, was attached to the iron solids also formed during chlorination. The majority of arsenic was removed in the particulate form by the AD-26 media, leaving only 0.5 to 2.1 µg/L in solution, existing mainly as As(V), to be further polished by the AD-33 media. The system also reduced total iron concentrations from an average of 1,000 µg/L to less than the method detection limit (MDL) of 25 µg/L, while the total manganese concentrations decreased from an average of 35.6 to 0.1 µg/L.
