Project Status Report

Upper Mississippi River
Long Term Resource Monitoring Program
U.S. Geological Survey

Vegetation Response to a Water Level Experiment¹

PSR 97-07

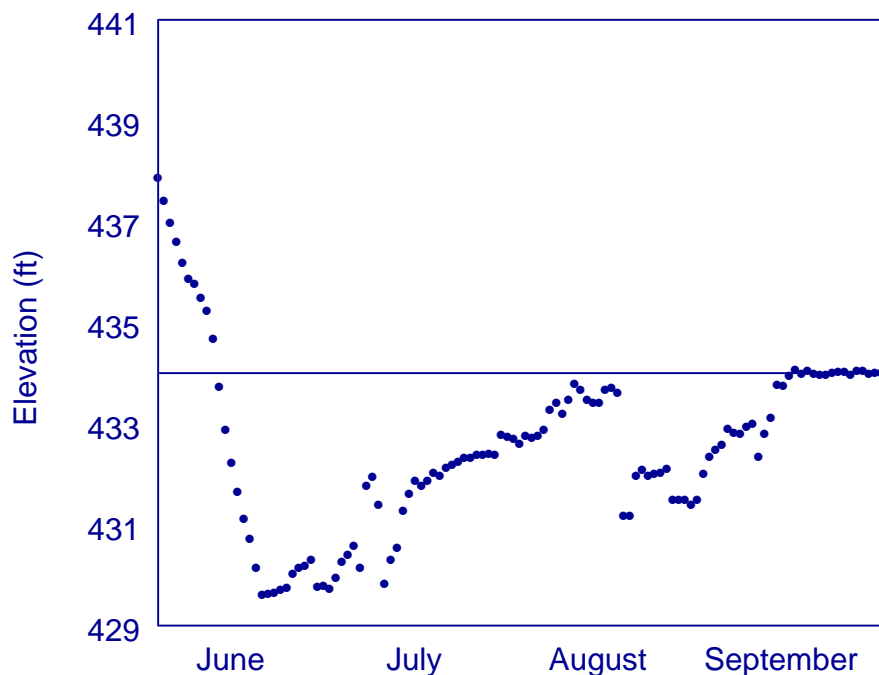
Figure 1. Water levels just upriver of Dam 25 during the summer of 1995.

All three navigation pools within the St. Louis District were closely regulated to provide a drawdown for vegetative growth, as well as to provide a safe and dependable navigation channel. An example of water levels during the summer of 1995 is shown for Pool 25 (Figure 1). The horizontal line at 434 ft represents the water elevation normally maintained. High discharges as a result of the Flood of 1995 dropped in early June to a range where water levels could be managed by the dams. Starting in mid-June, water levels were held at least 2 ft lower than the project pool elevation until mid-July. Water levels were then gradually raised until mid-August. Higher discharges at that time necessitated lowering water levels at the dam for another month.

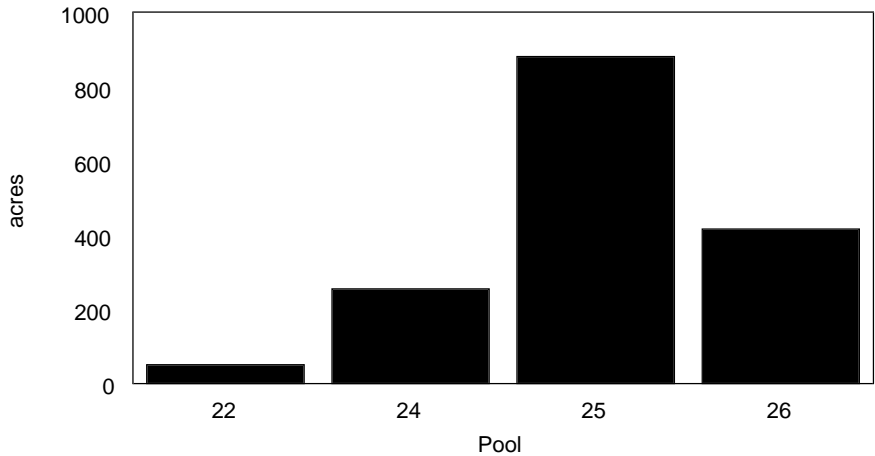
Figure 2. The amount (acres) of emergent vegetation estimated from photo interpretation.

We obtained aerial infrared photographs (1:15,000 scale) on July 27, 1995, for the lower stretches of the three pools where water levels were held lower than normal and for Pool 22 where no drawdown occurred. These photographs were interpreted using the standard Long Term Resource Monitoring Program vegetation classification system, specifically searching areas near the water line that had signatures representing the above plants. The estimate of plants from photo interpretation for eight-mile stretches just upriver of the dams is shown in figure 2. In Pools 24 through 26, between 255 and 880 acres of plants were measured near the water line compared to just 51 acres in Pool

22, which was not managed to provide additional vegetative growth. The acreage figures may be underestimated because vegetation swaths under 2 m wide were generally not included.
