Environmental Technology Verification Report

Inactivation of MS2 virus in Drinking
Water

Trojan Technologies, Inc.
UVSwift Ultraviolet System
Model 4L12
Chula Vista, California

Trojan Technologies Inc. UVSwift Ultraviolet System Model 4L12

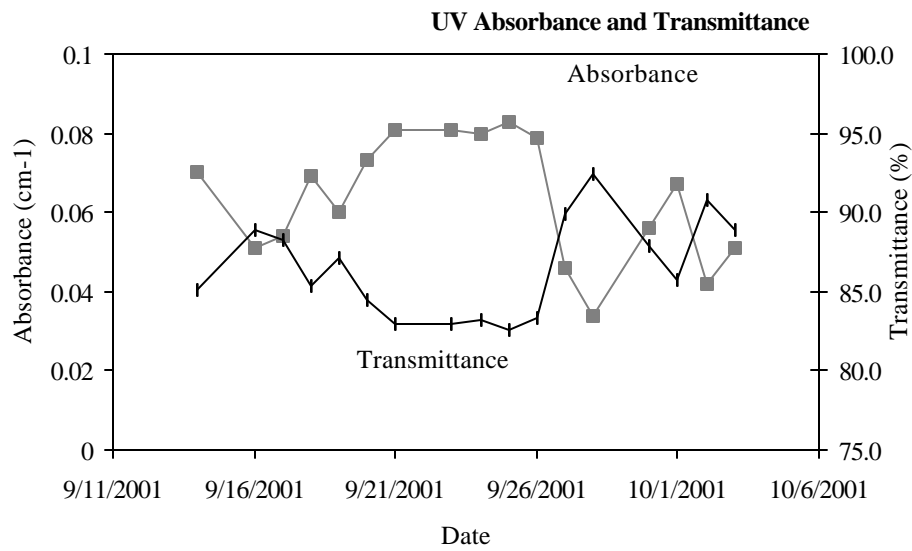
Figure 1-2. Source Water Characteristics for Trojan 4L12 UVSwift Verification Testing

The objective of this recommended Initial Operations task was to obtain a chemical, biological and physical characterization of the feed water. Chapter 1 of this report includes the description of the source water quality during the course of the ETV testing in terms of key water quality parameters including: UV-254 absorbance and UV-254 transmittance, Total Chlorine, Total Organic Carbon, Total Alkalinity, Calcium, Magnesium, and Hardness.

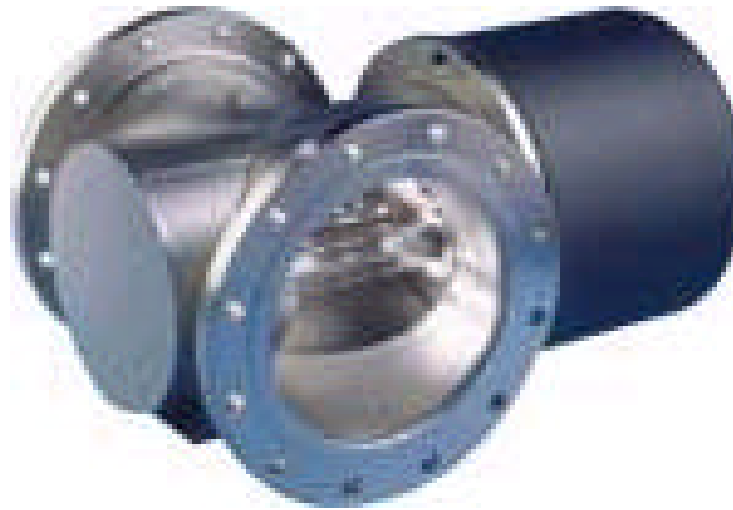
Figure 2-1. Photograph of UVSwift Unit

The UV reactor is made of corrosion-resistant materials, including stainless steel and Ethylene Propylene Diene Monomer (EPDM) and Viton materials for the seals, and quartz for the sleeves. The main components of the UVSwift 4L12 system are:

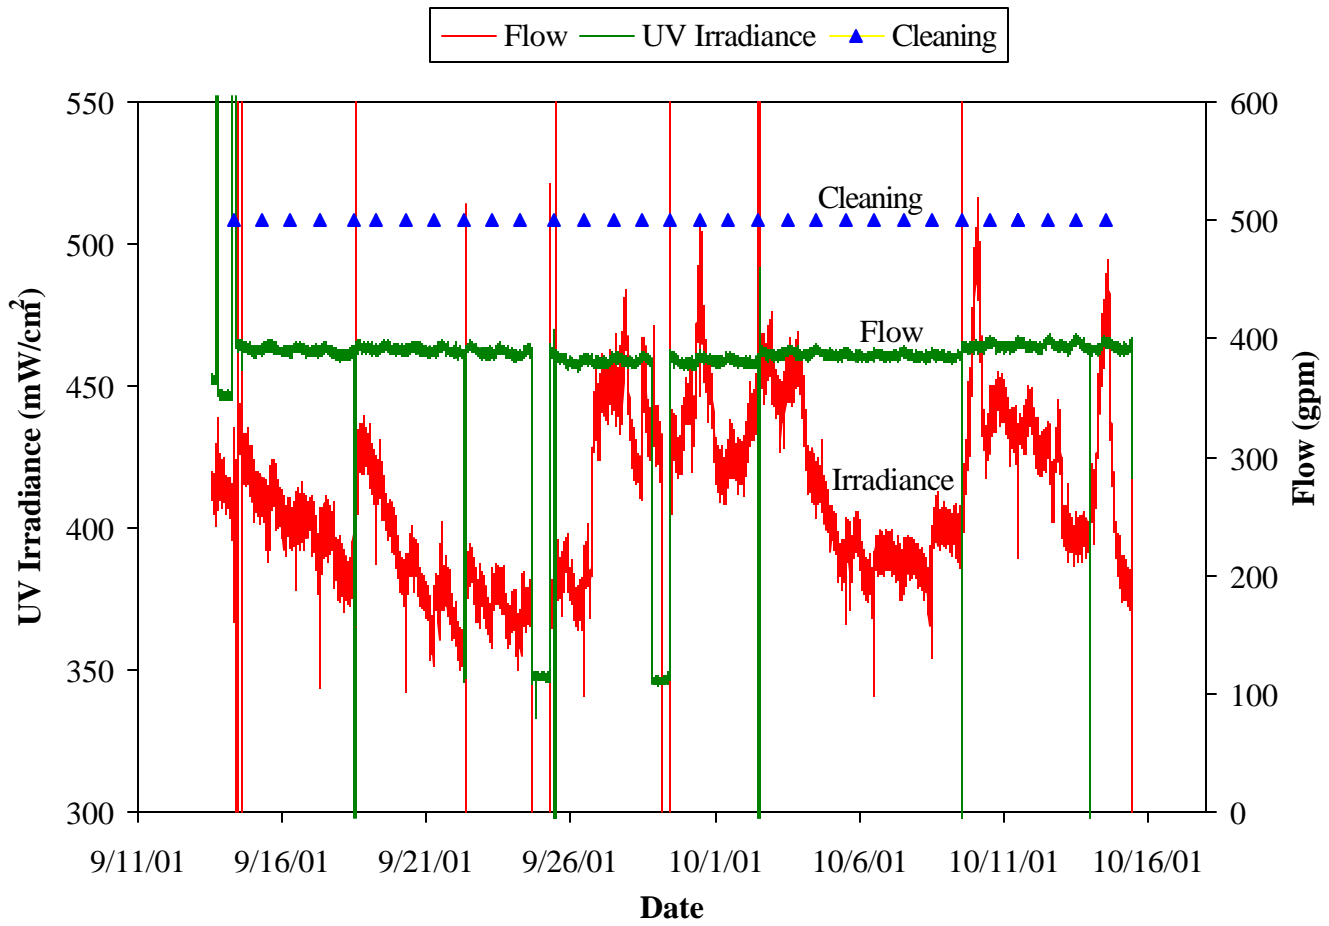
Figure 4-2. Operational Data during Testing Period

The operational data collected during this period included flow rates and UV irradiance collected by the data logger. This data is presented in Figure 4-2. The flow was maintained within 10% of 400 gpm during the entire length of the testing except for periods of shutdown. These periods of shutdown included periods of low flow (100-150 gpm) on 9/24/01 and 9/28/01. It was observed during testing that the UV irradiance reached a minimum value during the cleaning cycles and a maximum just after a shutdown period. As presented on Figure 4-2, these extremes in UV irradiance serve to indicate system shutdowns, and can be explained as follows. During a cleaning cycle the wiper assembly passes over the quartz window of the irradiance sensor and shadows the UV light resulting in minimum values if this value was recorded by the datalogger (which recorded readings every 2 minutes). After a shutdown period when the unit was restarted the power level setting was reset to the maximum value (100%) resulting in high UV irradiance value until the power setting was lowered to 81% by the operator.

The cleaning cycles are also indicated on Figure 4-2. All three modes of cleaning auto, manual and fixed mode were tested and were found to operate reliably. After the first week, fixed interval mode cleaning, with an interval of 24 hours, was used the majority of the time except when sensor calibration was being performed. Table 4-1 summarizes the cleaning cycles and the percentage increase in UV irradiance due to cleaning throughout the testing period. UV irradiance values in Table 4-1 are based on manual operator readings immediately before and after lamp cleaning. Readings not available (N/A) on Table 4-1 can be approximated from the UV irradiance data of Figure 4-2. The percent increase in the UV irradiance after cleaning ranged from -0.03 to 9.4 percent with an average increase of 2.6 percent. This indicates that the fouling of the lamp sleeves on a day to day basis was minimal. The cleaning cycles could be observed and the control panel provides an indication of the time interval to the next cleaning cycle.

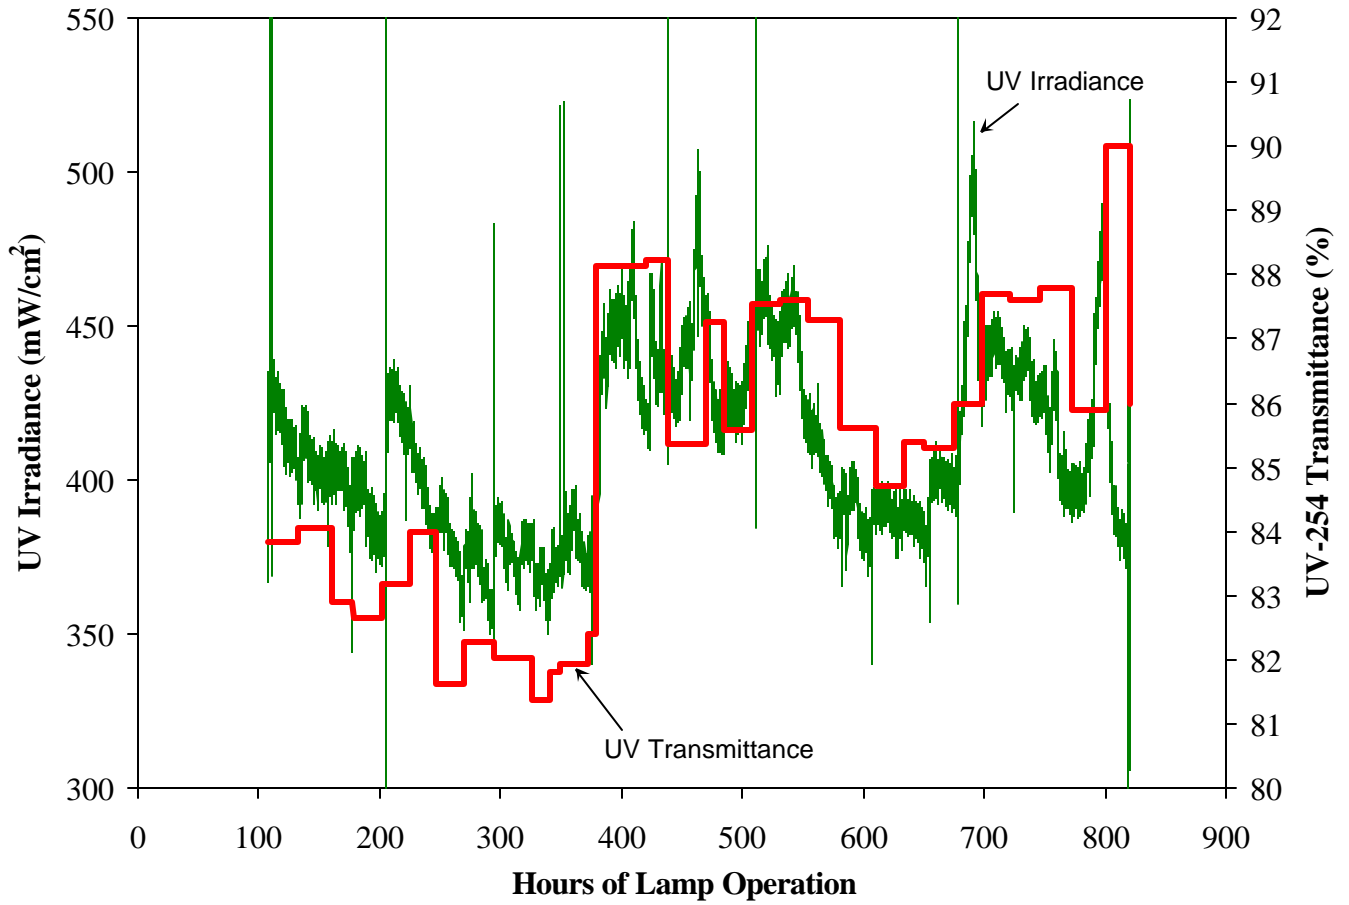
Figure 4-3. Onsite UV Irradiance and UV-254 Transmittance During Testing Period

Continuous monitoring of the UV irradiance did not indicate a clear fouling trend during the testing period as the UV irradiance measured is a strong function of the UV transmittance of the water, which varied between 81% and 90%. However at the end of the testing period visual inspection of the lamp and sensor sleeves indicated that while the lamp sleeves were relatively clean the sensor sleeve had fouled. A 7% increase in the UV irradiance was observed when the fouled sensor sleeve was replaced by a new sensor sleeve while replacing the lamp sleeve caused no further improvement. The sensor was found to drift from 1.8% to 11% from the reference sensor reading during the testing period. Handling of the sensor window was found to contribute to about half of the sensor drift.
