Environmental Technology Verification Report

Inactivation of MS2 Virus in Drinking
Water

Atlantic Ultraviolet Corporation
Megatron Unit, Model M250
Chula Vista, California

ETV Joint Verification Statement

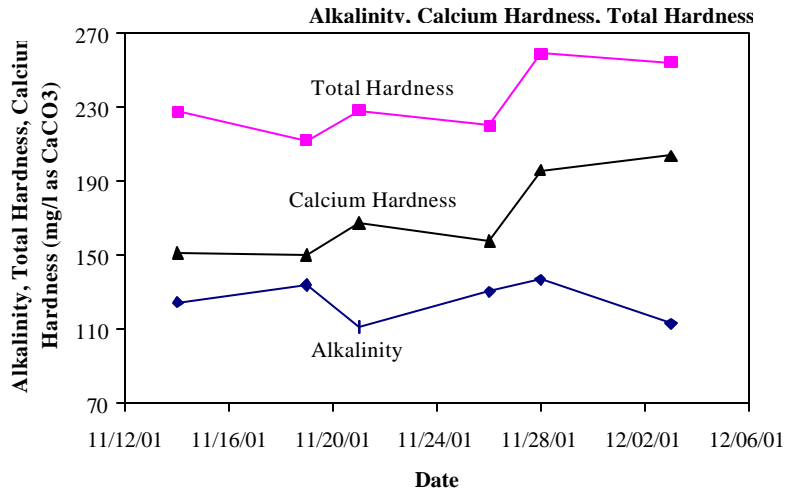
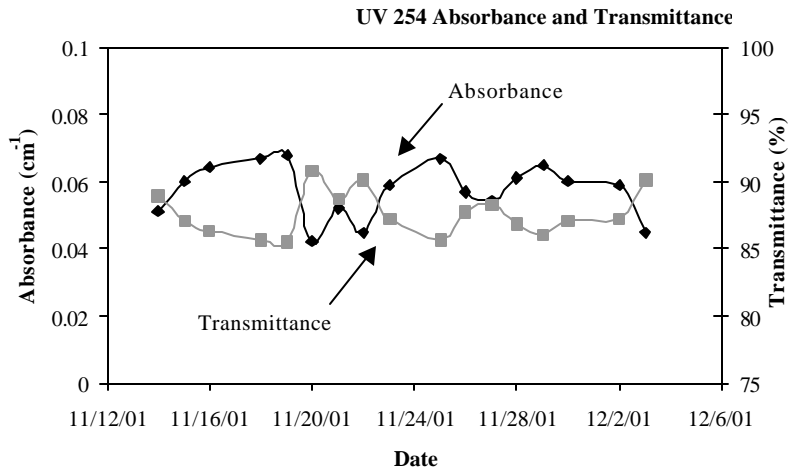
Figure 1-2. UV System Feed Water Characteristics: Atlantic Megatron M250 Verification Testing (11/14/01 – 12/03/01).

The objective of this recommended Initial Operations task was to obtain a chemical, biological and physical characterization of the feed water. Chapter 1 of this report includes the description of the source water quality during the course of the ETV testing in terms of key water quality parameters including: UV-254 absorbance and transmittance, total chlorine, and total organic carbon, total alkalinity, calcium, magnesium, and hardness.

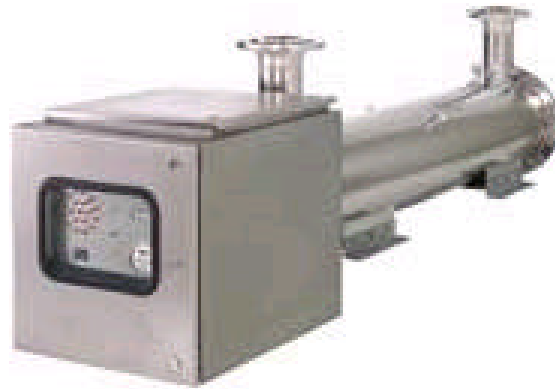
Figure 2-2. Photograph of the Atlantic Megatron M250 System.

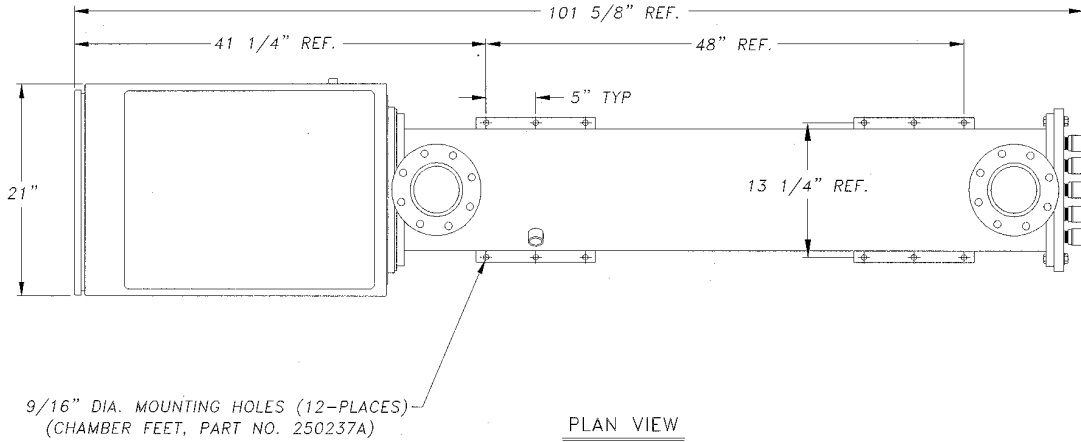
DIMENSIONAL DATA
 M250 MEGATRON W/4" INLET/OUTLET
 WITH AUTOMATIC WIPER

Figure 2-3. Schematic Diagram of the Atlantic Megatron M250 System.

A schematic diagram of plan and profile views of the Megatron Model M250 system process is shown in Figure 2-3. The Megatron Model M250 inactivation reactor is 12-inches in diameter and approximately 60-inches in length with axial inlet and outlet. The Megatron unit incorporates a UV Guardian Monitor within its enclosure. The UV Monitor visually indicates the level of UV energy that is measured by the UV irradiance sensor once it penetrates the quartz sleeve and the water within the disinfection chamber. Reduction of UV levels may be caused by 1) fouling of quartz sleeves, 2) decrease in ultraviolet transmission through the water, and 3) decrease in lamp output due to age. The UV Monitor has two operating modes identified as “Factory Preset” and “User Adjust”. The UV irradiance displayed in the former mode is based on a factory calibration using a digital radiometer under laboratory conditions. When operated in the latter mode, the UV irradiance displayed by the UV Monitor directly corresponds to the UV irradiance, but at a user assigned value. The UV irradiance sensor is connected to one of the nineteen lamps (Lamp No. 2) to monitor fouling of the quartz sleeve and changes in water quality affecting system performance. It is assumed that all lamps are equivalent in terms of fouling and UV output. The UV sensor is housed within a protective sensor probe. The sensor probe is equipped with a UV transmitting quartz window. The sensor generates an electrical signal based on the amount of UV light that penetrates the quartz window. This signal is then sent to the UV Monitor, which displays the corresponding value of the UV irradiance. An additional sensor was provided and manufactured by the Atlantic Corporation to verify the performance of the

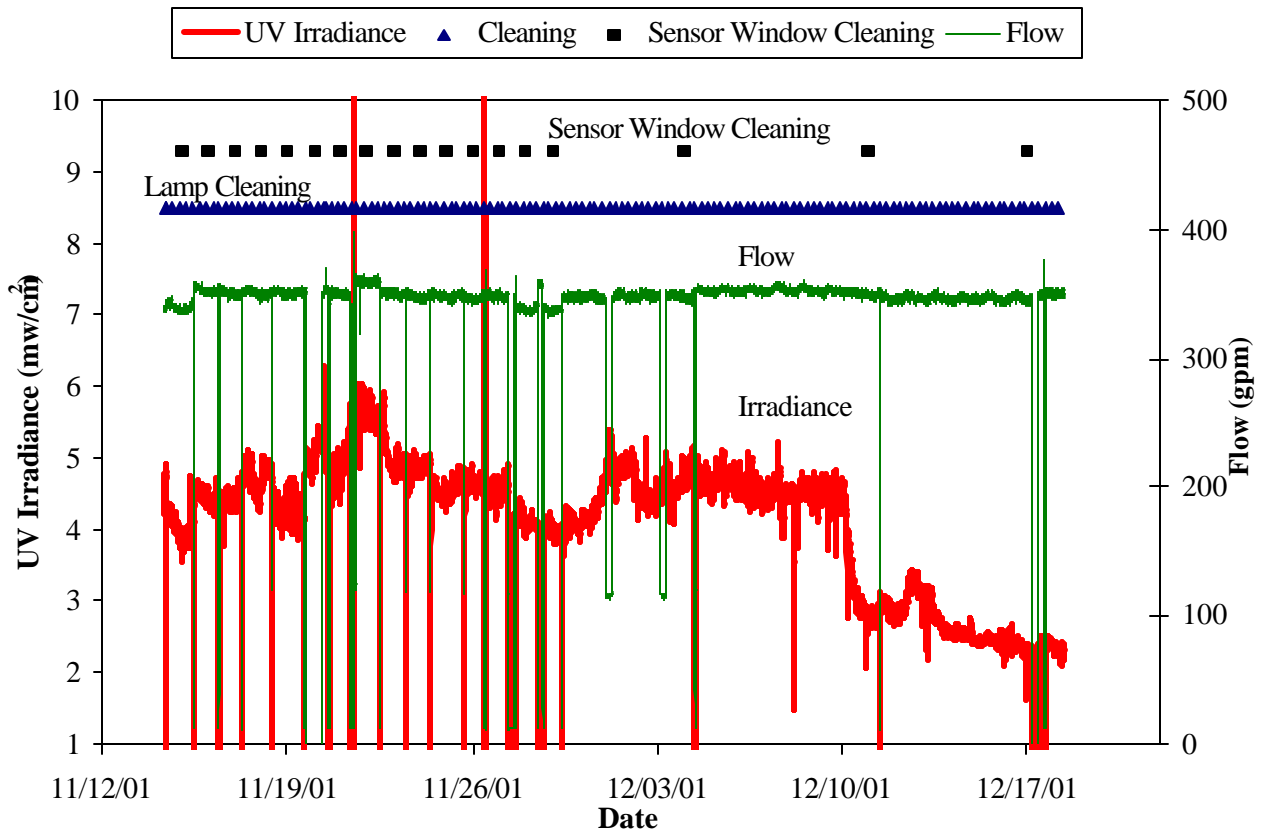
Figure 4-1. Operational Data During Atlantic Megatron M250 Testing Period.

The operational data collected during this period included flow rates and UV irradiance collected by the data logger. This data is presented in Figure 4-1. The flow was maintained within 10% of 350 gpm during the entire length of the testing, except for periods of shutdowns and low flow. Periods of low flow (100-150 gpm) occurred on 11/21/01, 11/30/01, 12/03/01 and 12/04/01 due to power failures of the pump supplying water to the UV unit. As shown in Figure 4-1, the extreme low values of UV irradiance and flow serve to indicate system shutdowns. The dark squares shown on Figure 4-1 indicate times when the system was shutdown to clean the UV irradiance sensor window. As shown, the sensor was cleaned daily during the time period of 11/14/01 through 11/29/01 and weekly thereafter. In addition, the low points of UV irradiance, near 1 mW/cm^2 , shown in Figure 4-1 can be explained as follows. During the testing period it was observed that the initial value of UV irradiance immediately after start up following a system shutdown was less than 0.5 mW/cm^2 . However, as the lamps warmed up the value would increase rapidly and stabilize after approximately 15 minutes. Because the data logger recorded UV intensity values every two minutes there were instances where low UV values were recorded during periods of lamp warm up. Furthermore, extreme high values of irradiance (*i.e.* $> 10 \text{ mW/cm}^2$) which occurred on 11/21/01 and 11/26/01 are shown as vertical spikes on Figure 4-1. These values resulted from failure of the irradiance sensor, which may have resulted from exposure to water during cleaning of the sensor window. Details on this occurrence are provided in Section 4.8.3.

The lamp cleaning cycles are also indicated in Figure 4-1. The system was operated with four regularly spaced automatic mechanical cleanings per day throughout the entire testing period. During each weekday of operation the irradiance (mW/cm^2) was recorded before and after a minimum of one automatic cleaning cycle. In addition to cleaning automatically, cleanings were also occasionally performed manually to test the cleaning system. It should be noted a manual cleaning was also conducted just prior to the virus inactivation challenge testing (See Section 4.5). Both cleaning modes (auto and manual) were found to operate reliably throughout the entire testing period. Table 4-1 provides specific details of the lamp cleanings that were recorded during the testing period including the cleaning type (e.g. Auto or Manual), lamp hour and the UV irradiance before and after cleaning. As shown, the percent change in irradiance after each recorded cleaning ranged from -1.53% to $+1.28\%$ with an average change of $+0.23\%$. Such data indicates that the cleanings had an insignificant effect on UV irradiance.

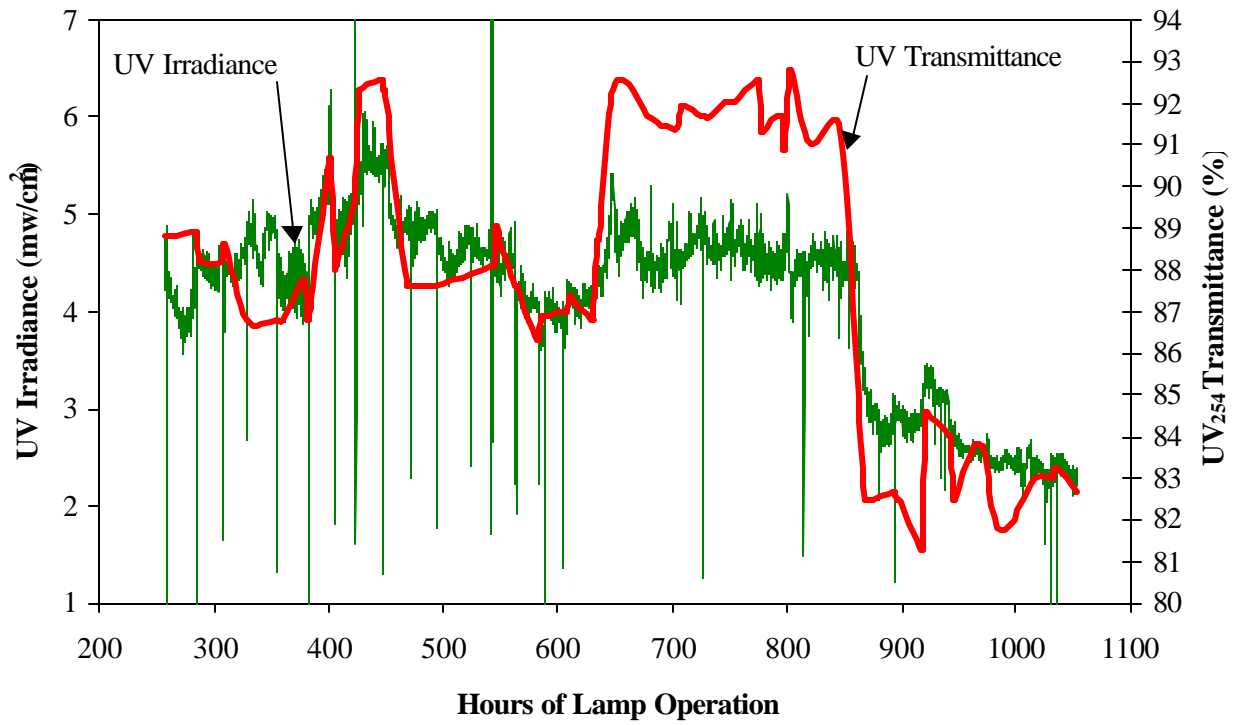
Figure 4-2. UV Irradiance and UV₂₅₄ Feed Water Transmittance During Testing Period.

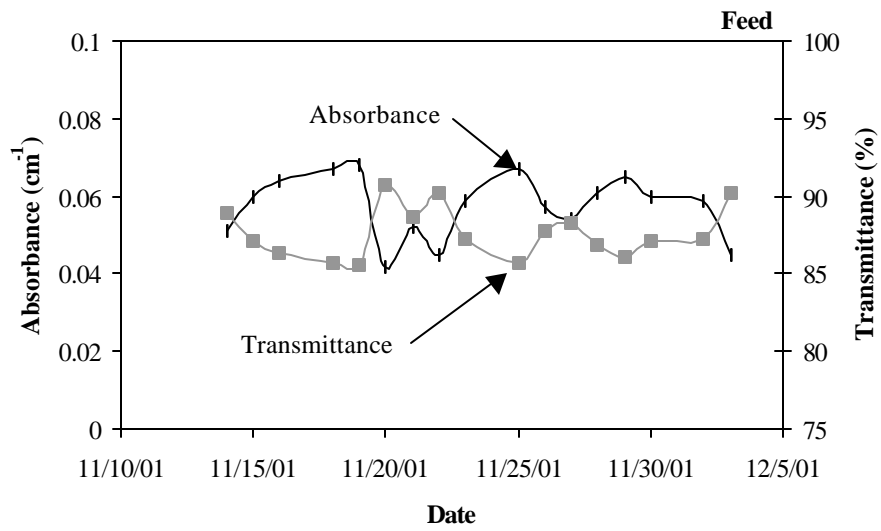
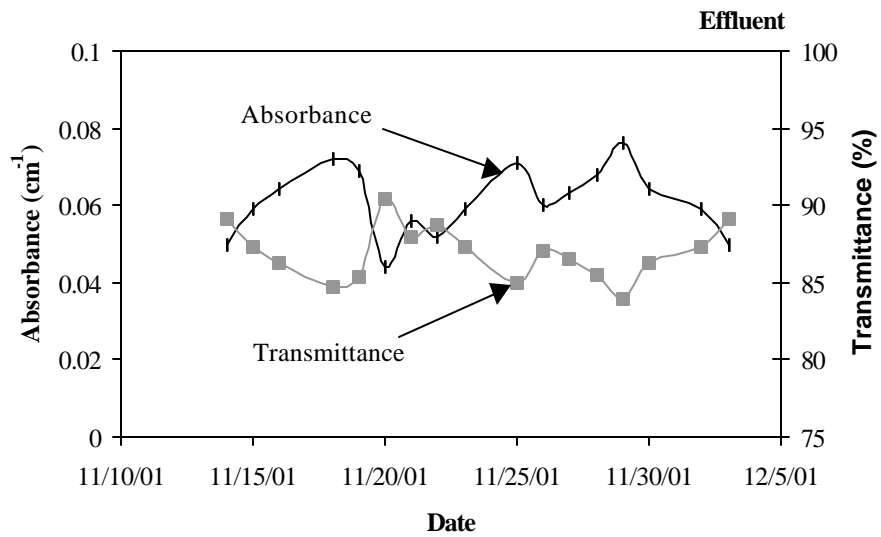
Figure 4-3. Laboratory UV Absorbance and Transmittance Feed and Effluent Water.
