ARCHEOLOGICAL EXCAVATIONS AT THE NORTHWEST COMPANY'S  
FUR TRADE POST, GRAND PORTAGE, MINNESOTA, IN 1936-1937

By the Minnesota Historical Society

Alan R. Woolworth

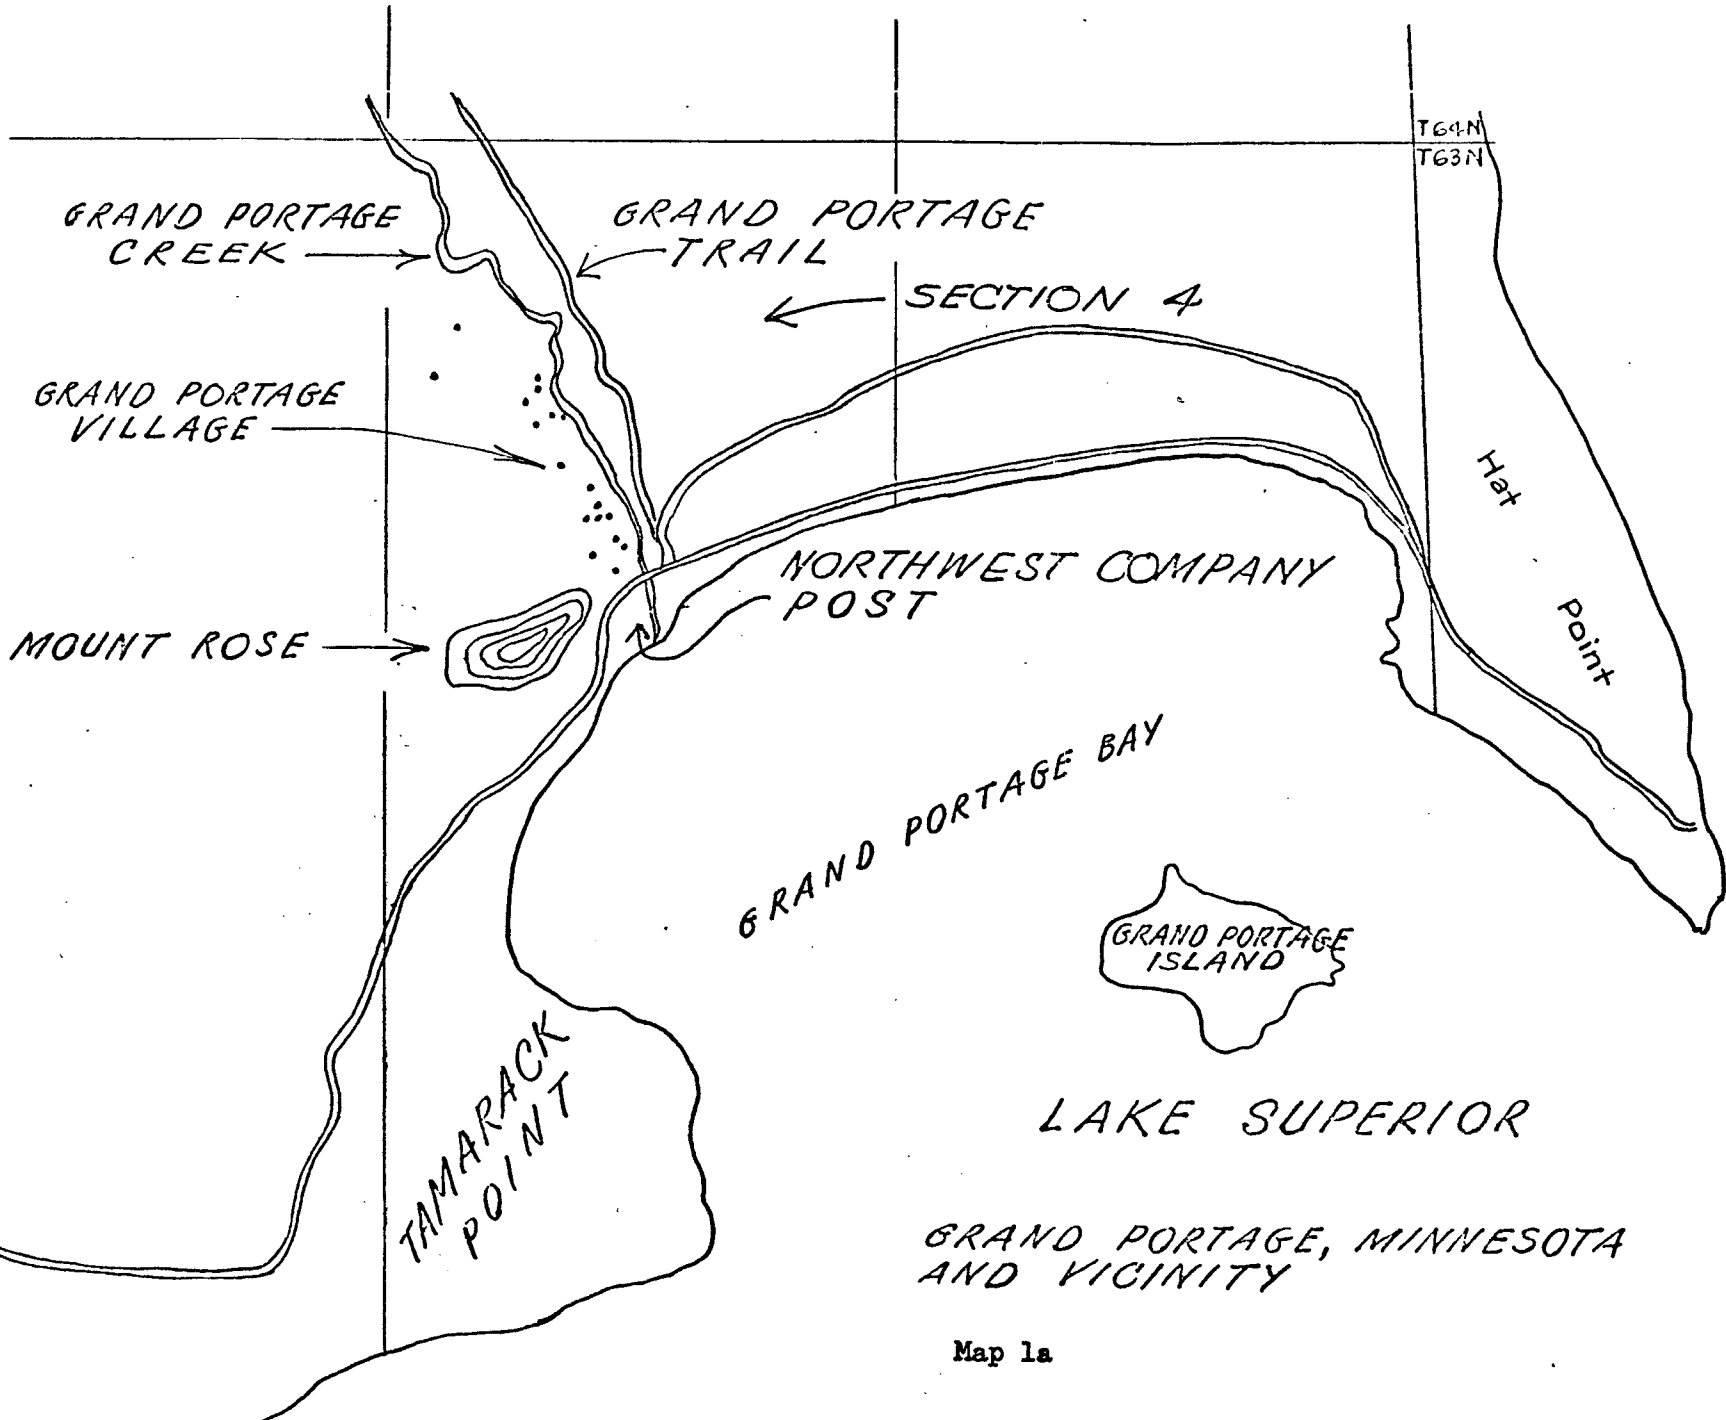
Map 1a

GRAND PORTAGE, MINNESOTA  
AND VICINITY

wave damage. The bay is approximately 1 3/4 miles across at its widest point, and more than a mile in depth. (Map 1a).

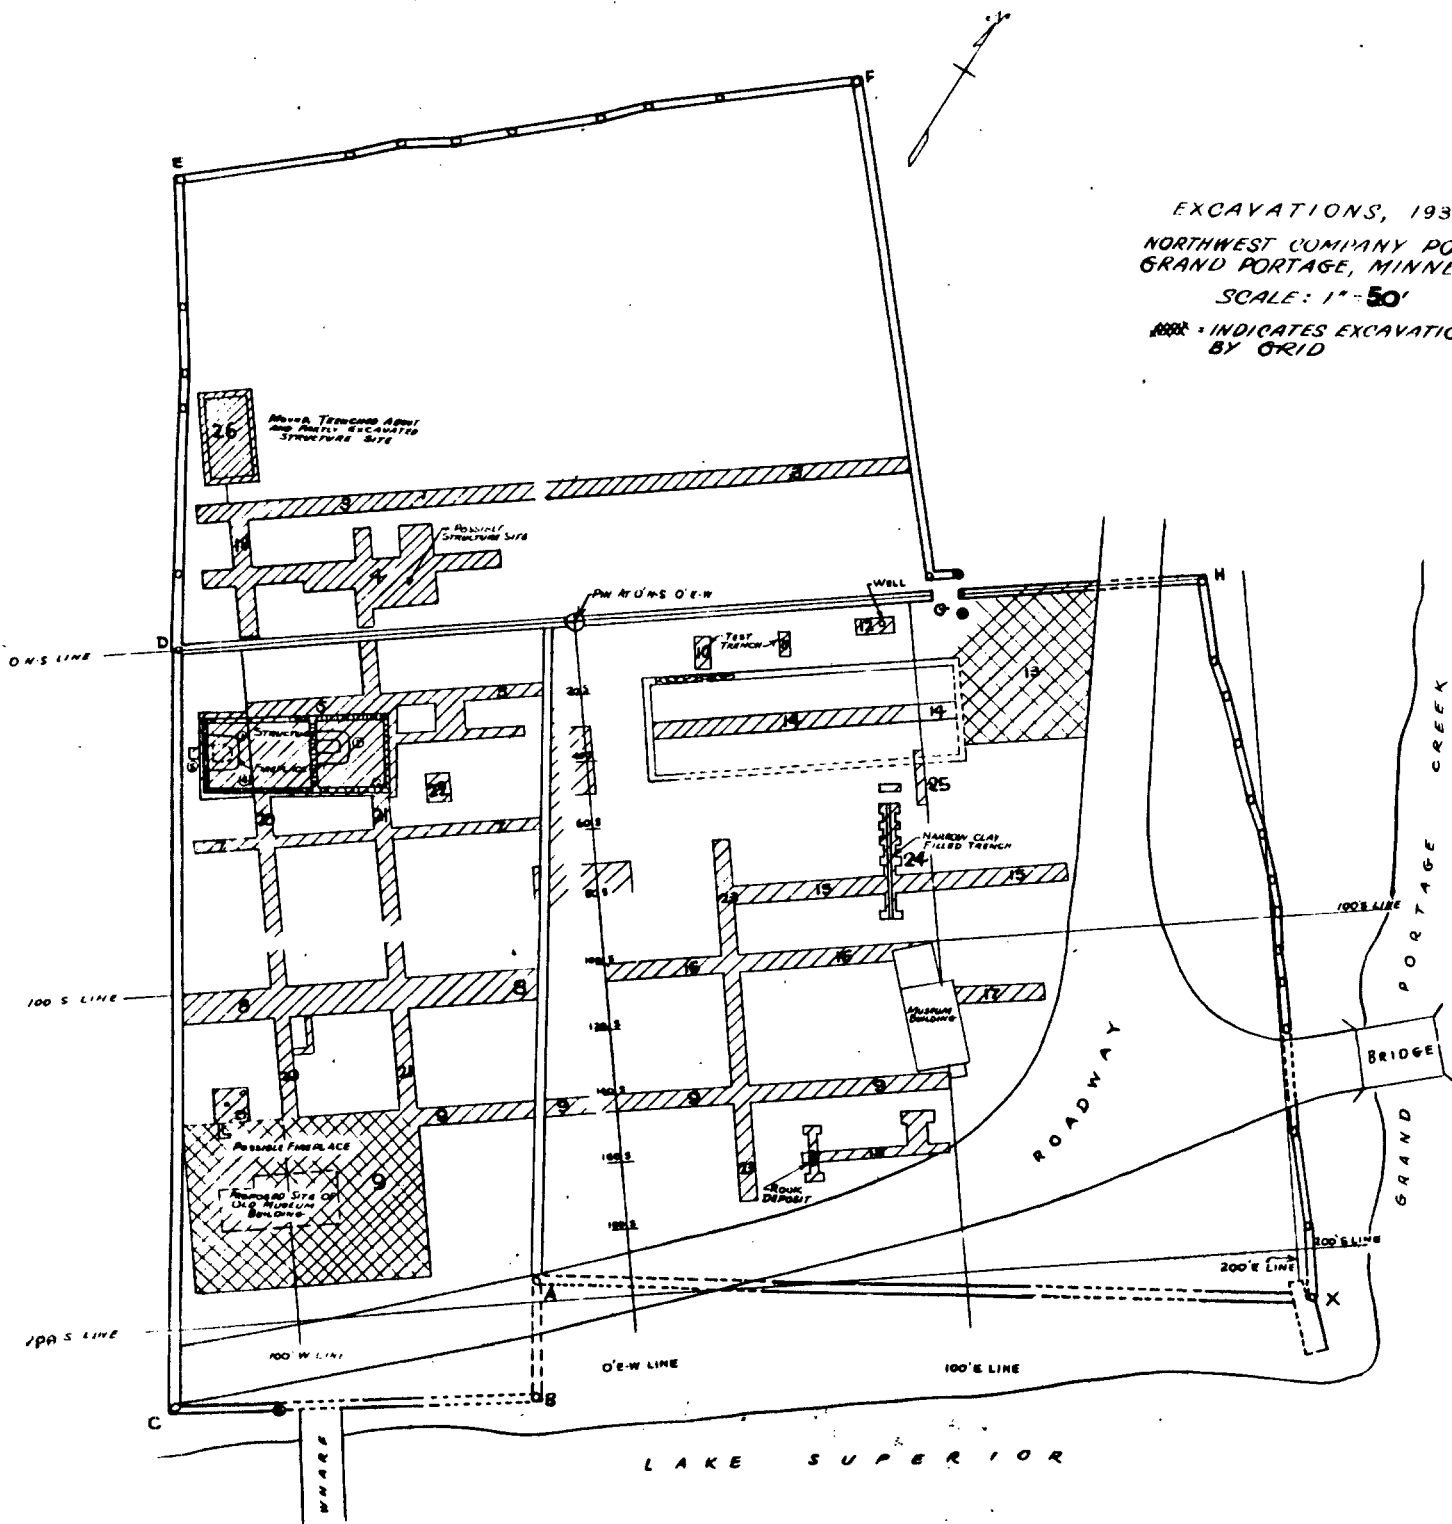
Map 8

EXCAVATIONS, 1937  
 NORTHWEST COMPANY POST  
 GRAND PORTAGE, MINNESOTA  
 SCALE: 1" = 50'  
 [Cross-hatched pattern] INDICATES EXCAVATION  
 BY GRID

Thereafter, a series of exploratory trenches were laid out in North-South and East-West directions. These trenches naturally intersected each other at right angles. They were expanded if something such as a portion of a structure was found. The resultant excavations almost defy description in verbal terms. They can best be understood by reference to a map of the 1937 excavations (Map 8).

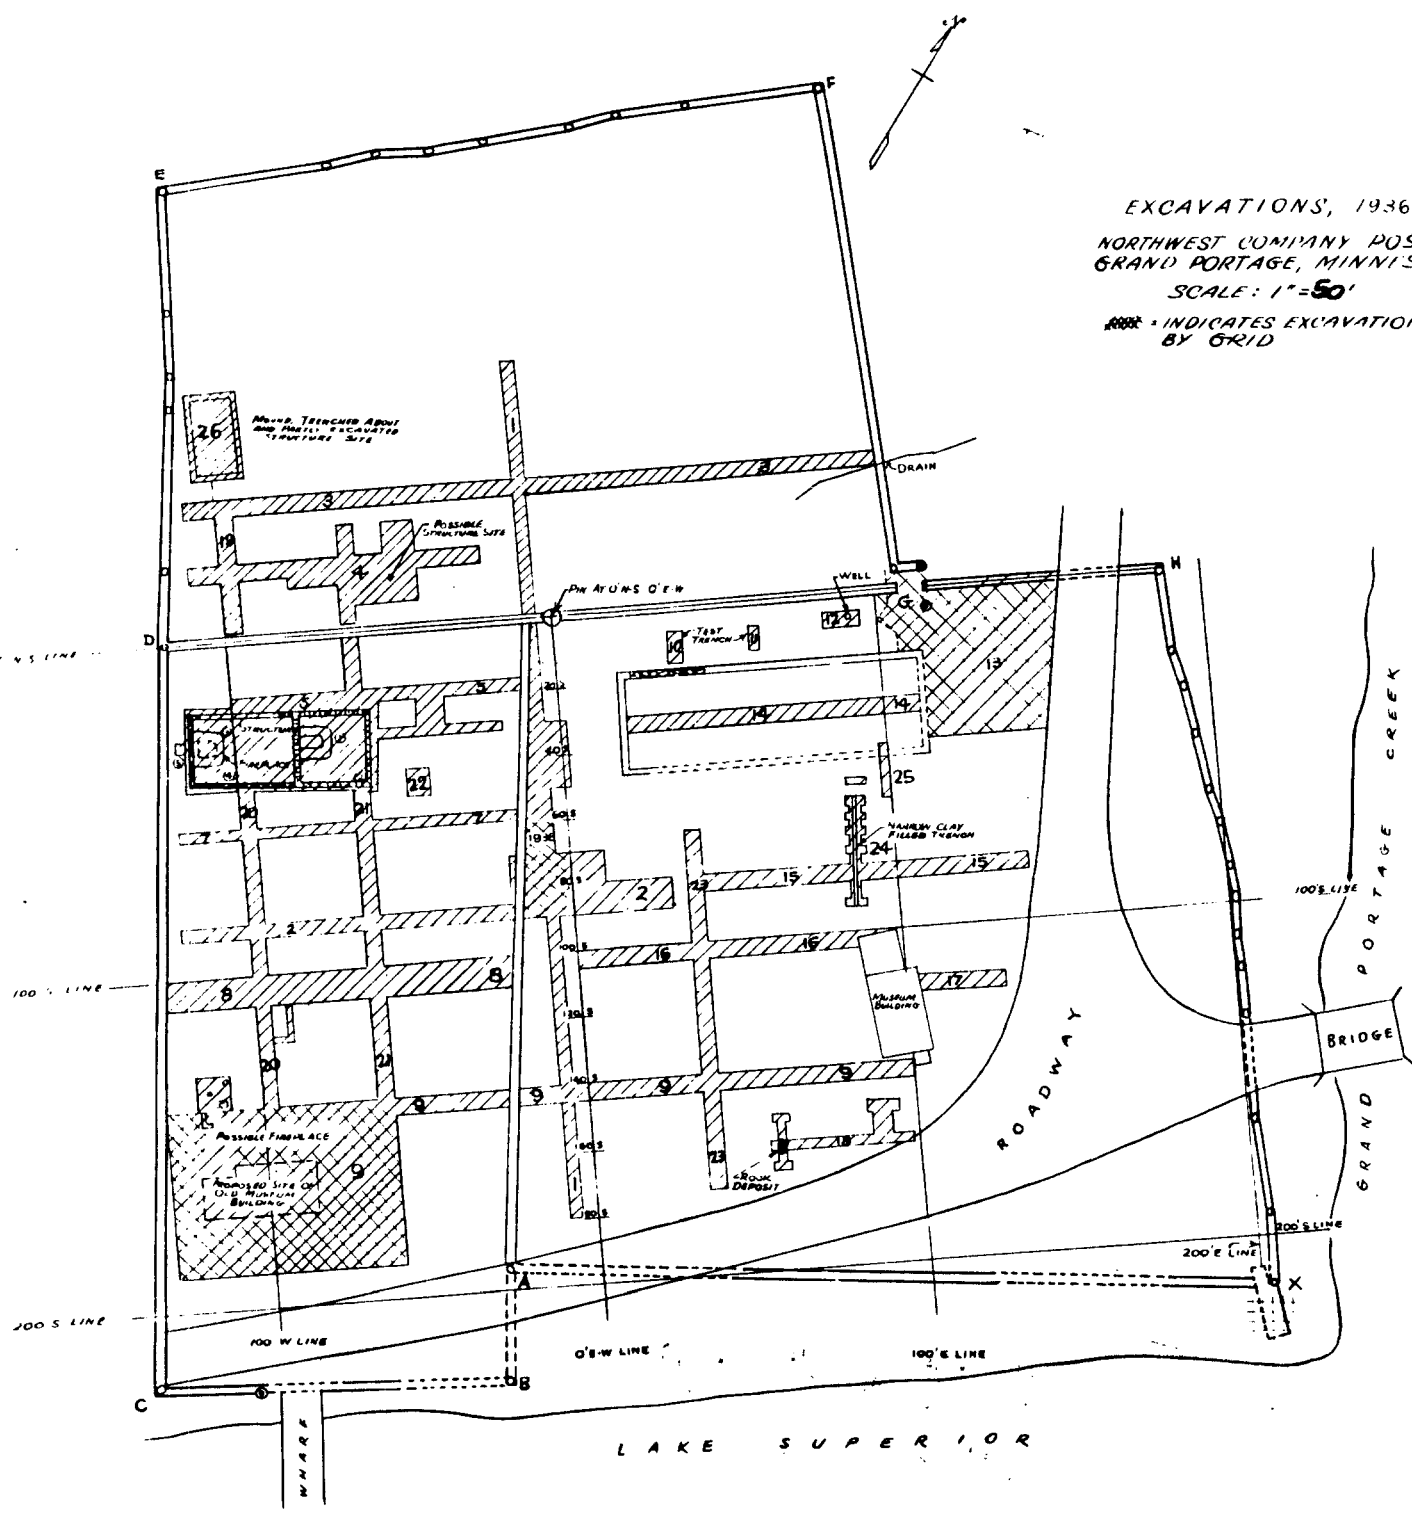
Map. 9

EXCAVATIONS, 1936-1937  
 NORTHWEST COMPANY POST  
 GRAND PORTAGE, MINNISOTA  
 SCALE: 1"=50'  
 [Hatched Area] INDICATES EXCAVATION  
 BY GRID

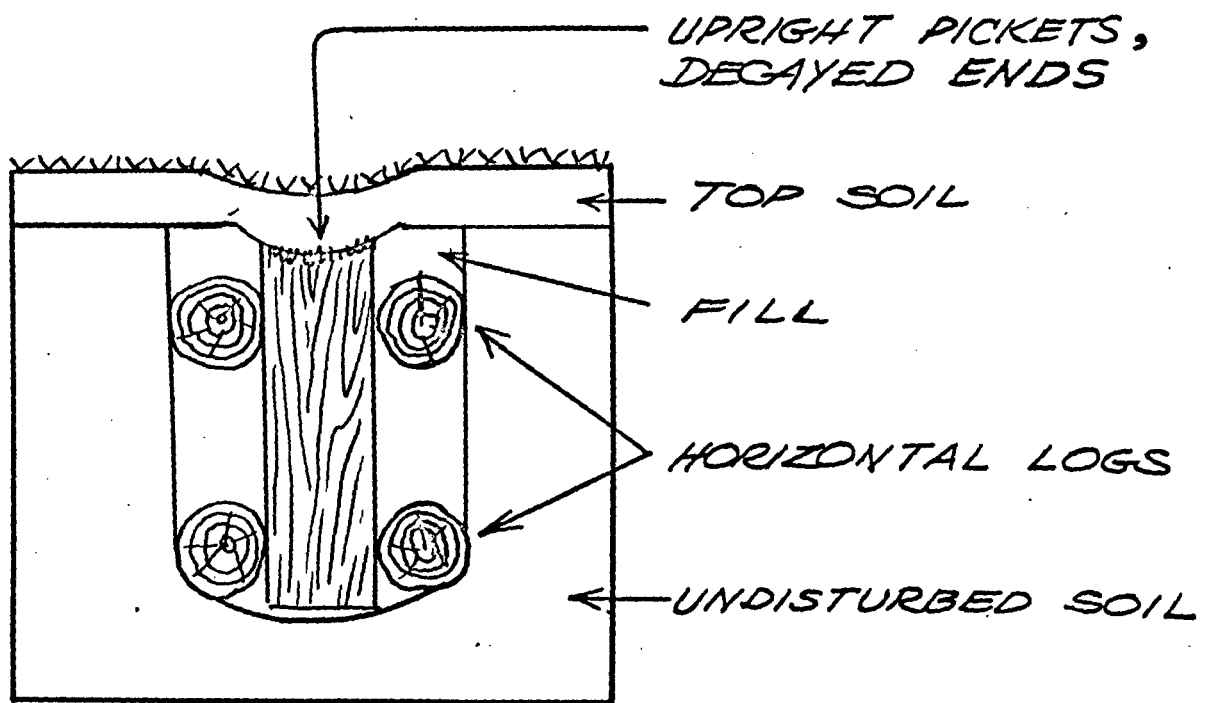
VERTICAL PROFILE WESTERN PALISADE  
TRENCH LINE-1936. REDRAWN-1963

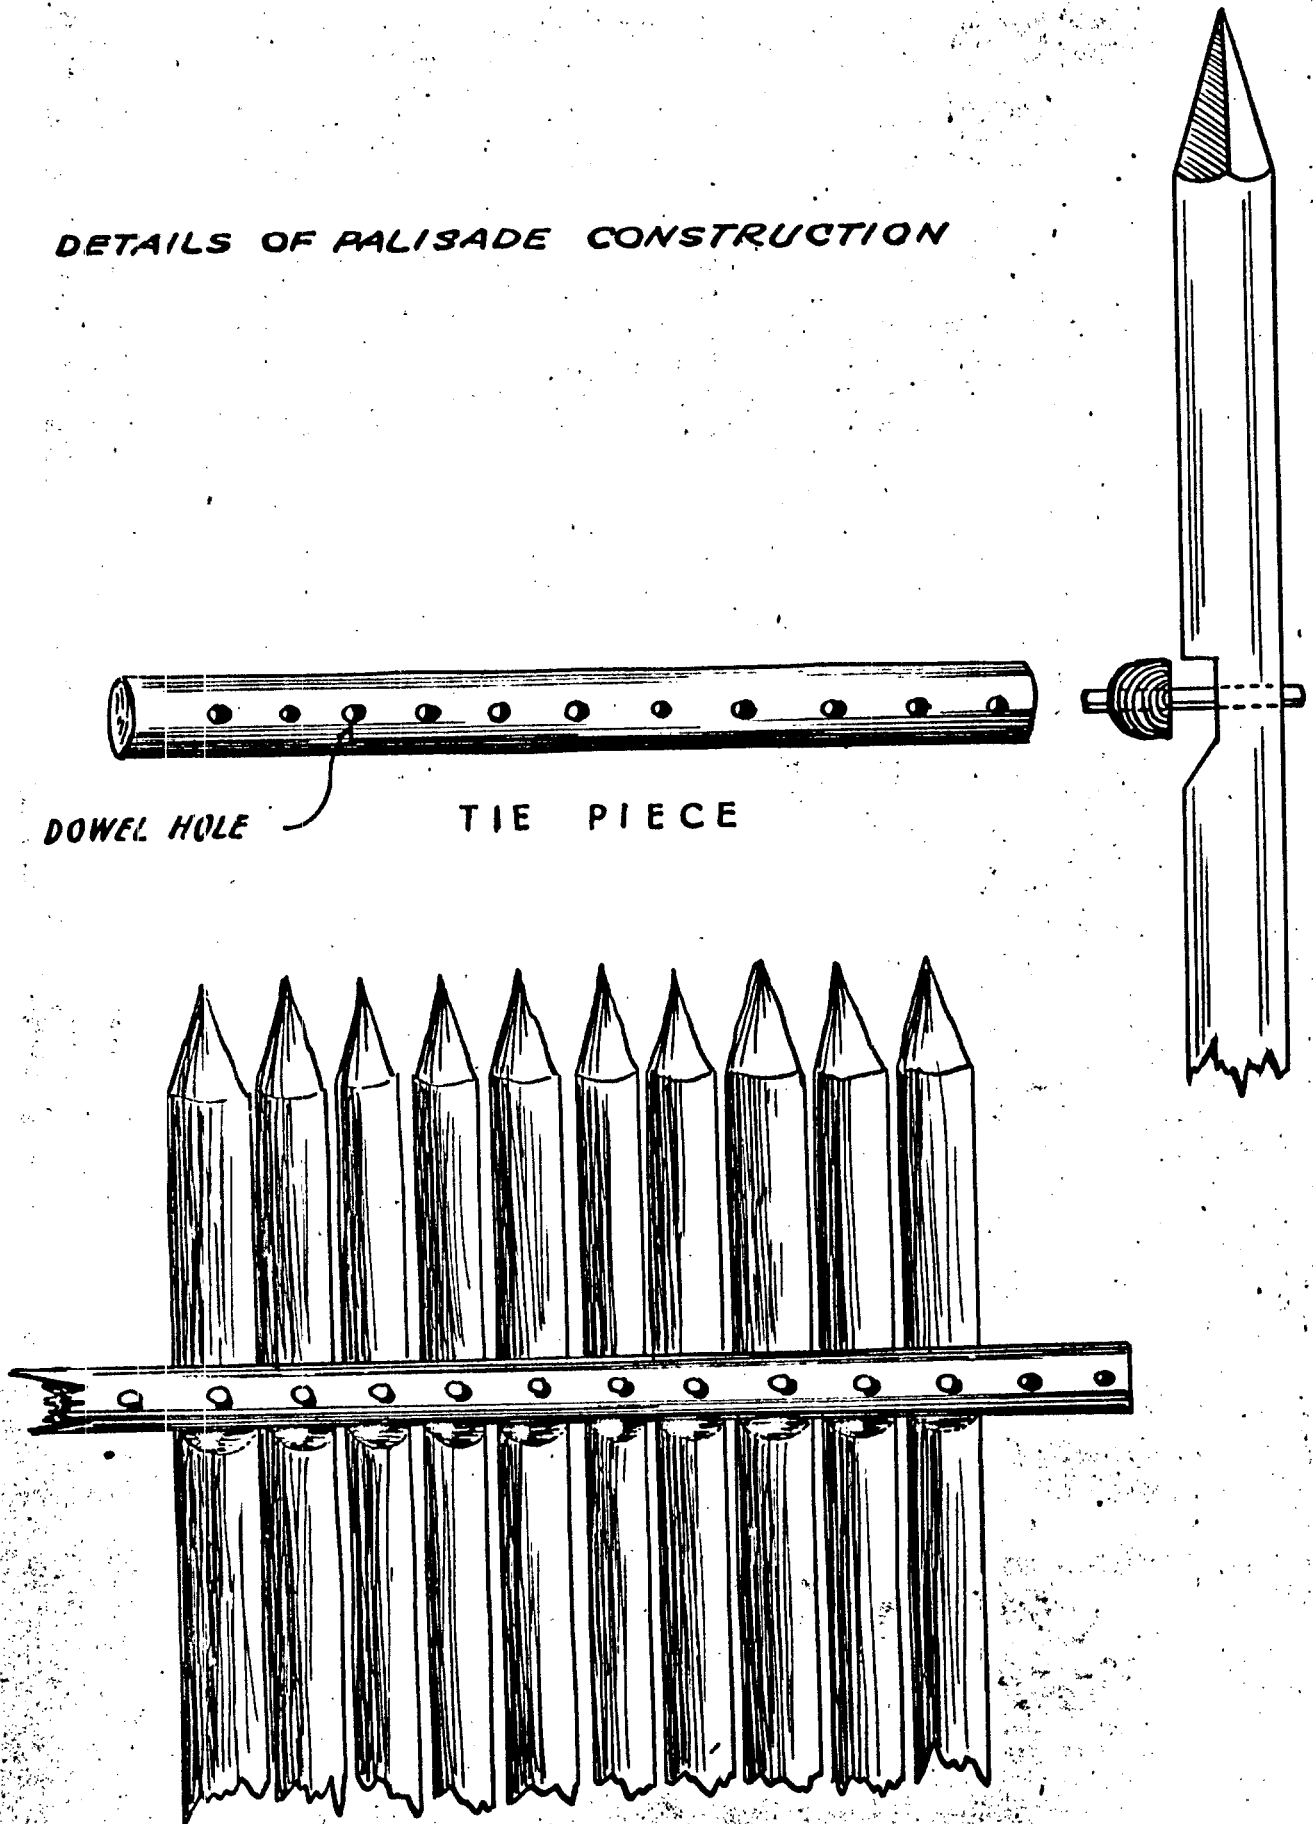
Figure 1a.

DETAILS OF PALISADE CONSTRUCTION

trenches cut through the slate were narrower and shallower than those in other portions of the site. Palisades in this area were not braced with horizontal logs. Boulders, placed on the ground surface appear to have been used instead of timbers in the rear palisade line between Corners E and F.

Large boulders, found everywhere on the site except in the sandy portions, were also packed into the palisade trenches, and were doubtless used to buttress the walls, inside and out, where signs of weakness were apparent. This form of bracing was especially evident in the interior palisade trench between Corners A and Y (Brown, 1938a, p.p. 11-12).

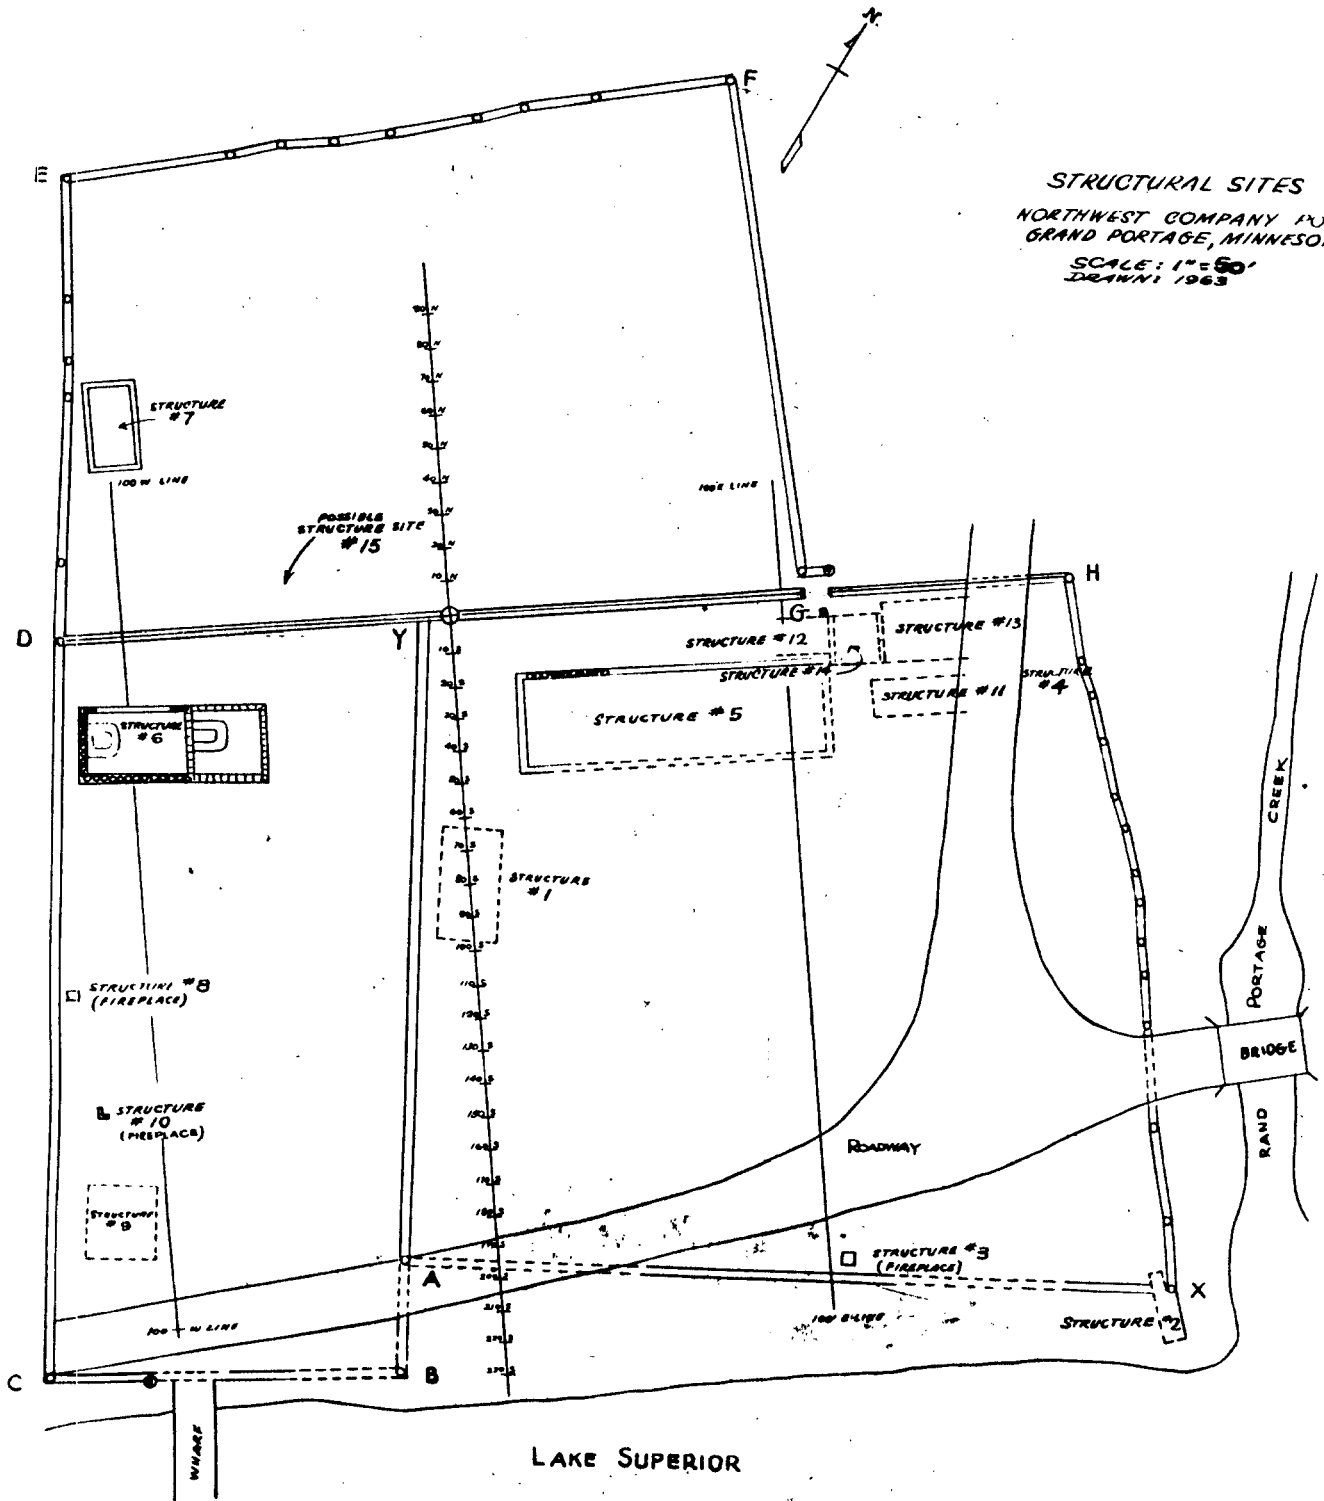
Map 11

STRUCTURAL SITES  
 NORTHWEST COMPANY POST  
 GRAND PORTAGE, MINNESOTA  
 SCALE: 1"=50'  
 DRAWN: 1963

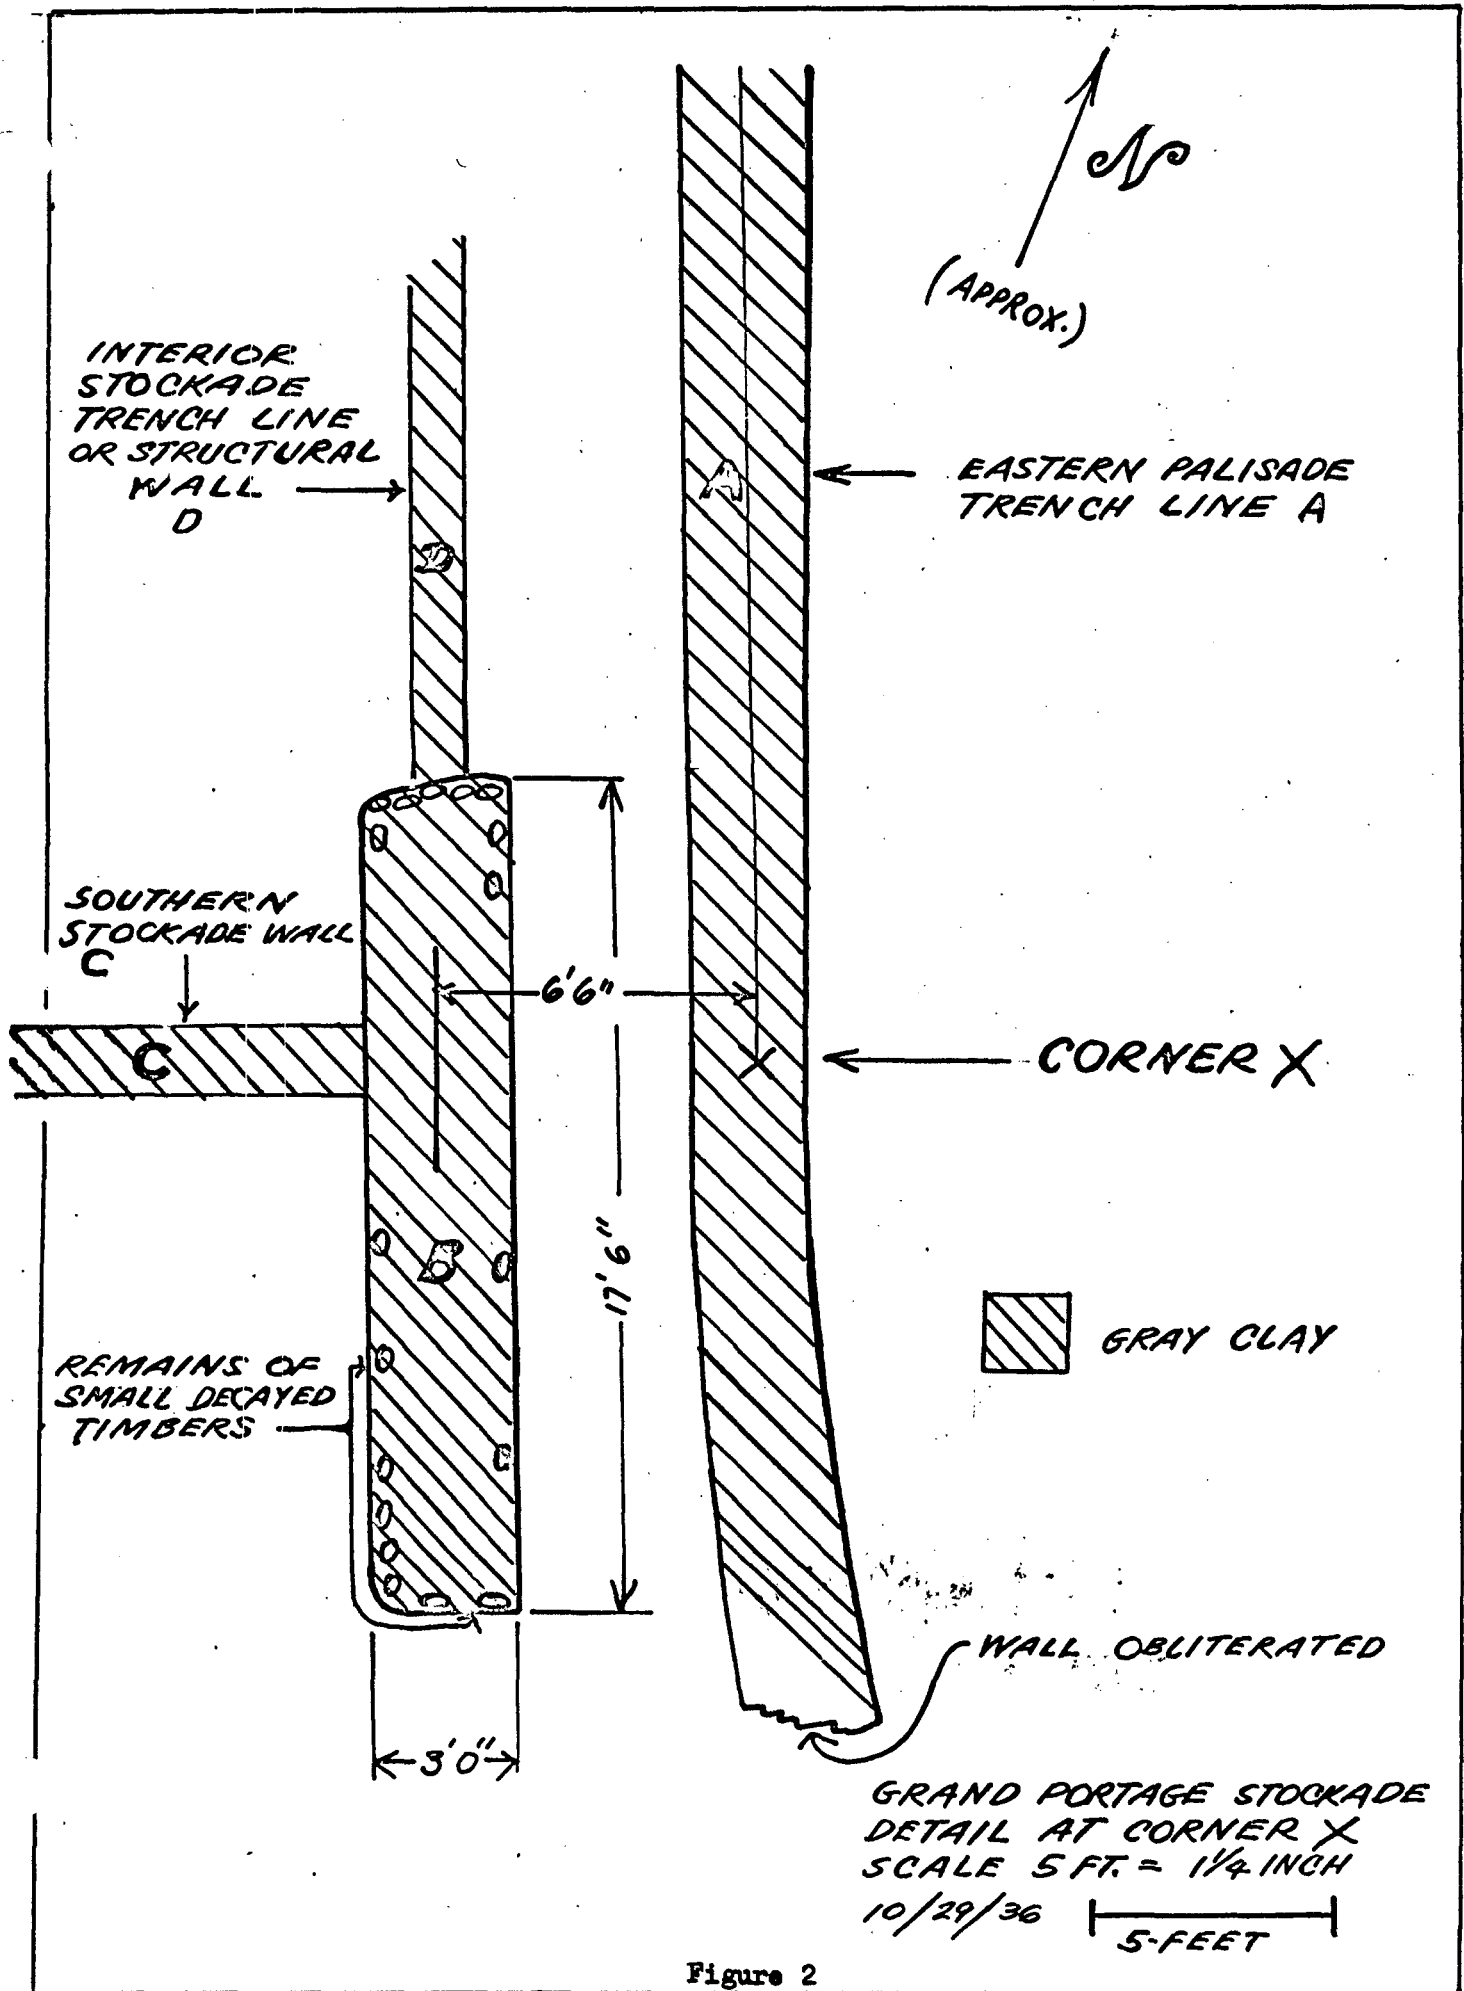
Figure 2

The bulk of the available evidence would suggest that a bastion or a covered entryway with a gate stood here, not a

blockhouse. (Figure 2).

This feature is situated at Corner X, the Southeastern stockade corner. The area was excavated in September, 1936 by G. Hubert Smith and Allan Holmberg. Here, they found the eastern palisade trench and another trench which was west of it. These trenches ran parallel to each other in a N-S direction. They were four feet apart, measured from the inside edges of the trenches which faced each other. They were six feet eight inches apart measured from their centers. Judging from this evidence, there must have been a passageway four feet in width between these two trenches as there was no evidence of an obstruction between them. There were also two other trenches in this area. These were the southern palisade trench and a N-S extension of the trench west of the eastern palisade trench.

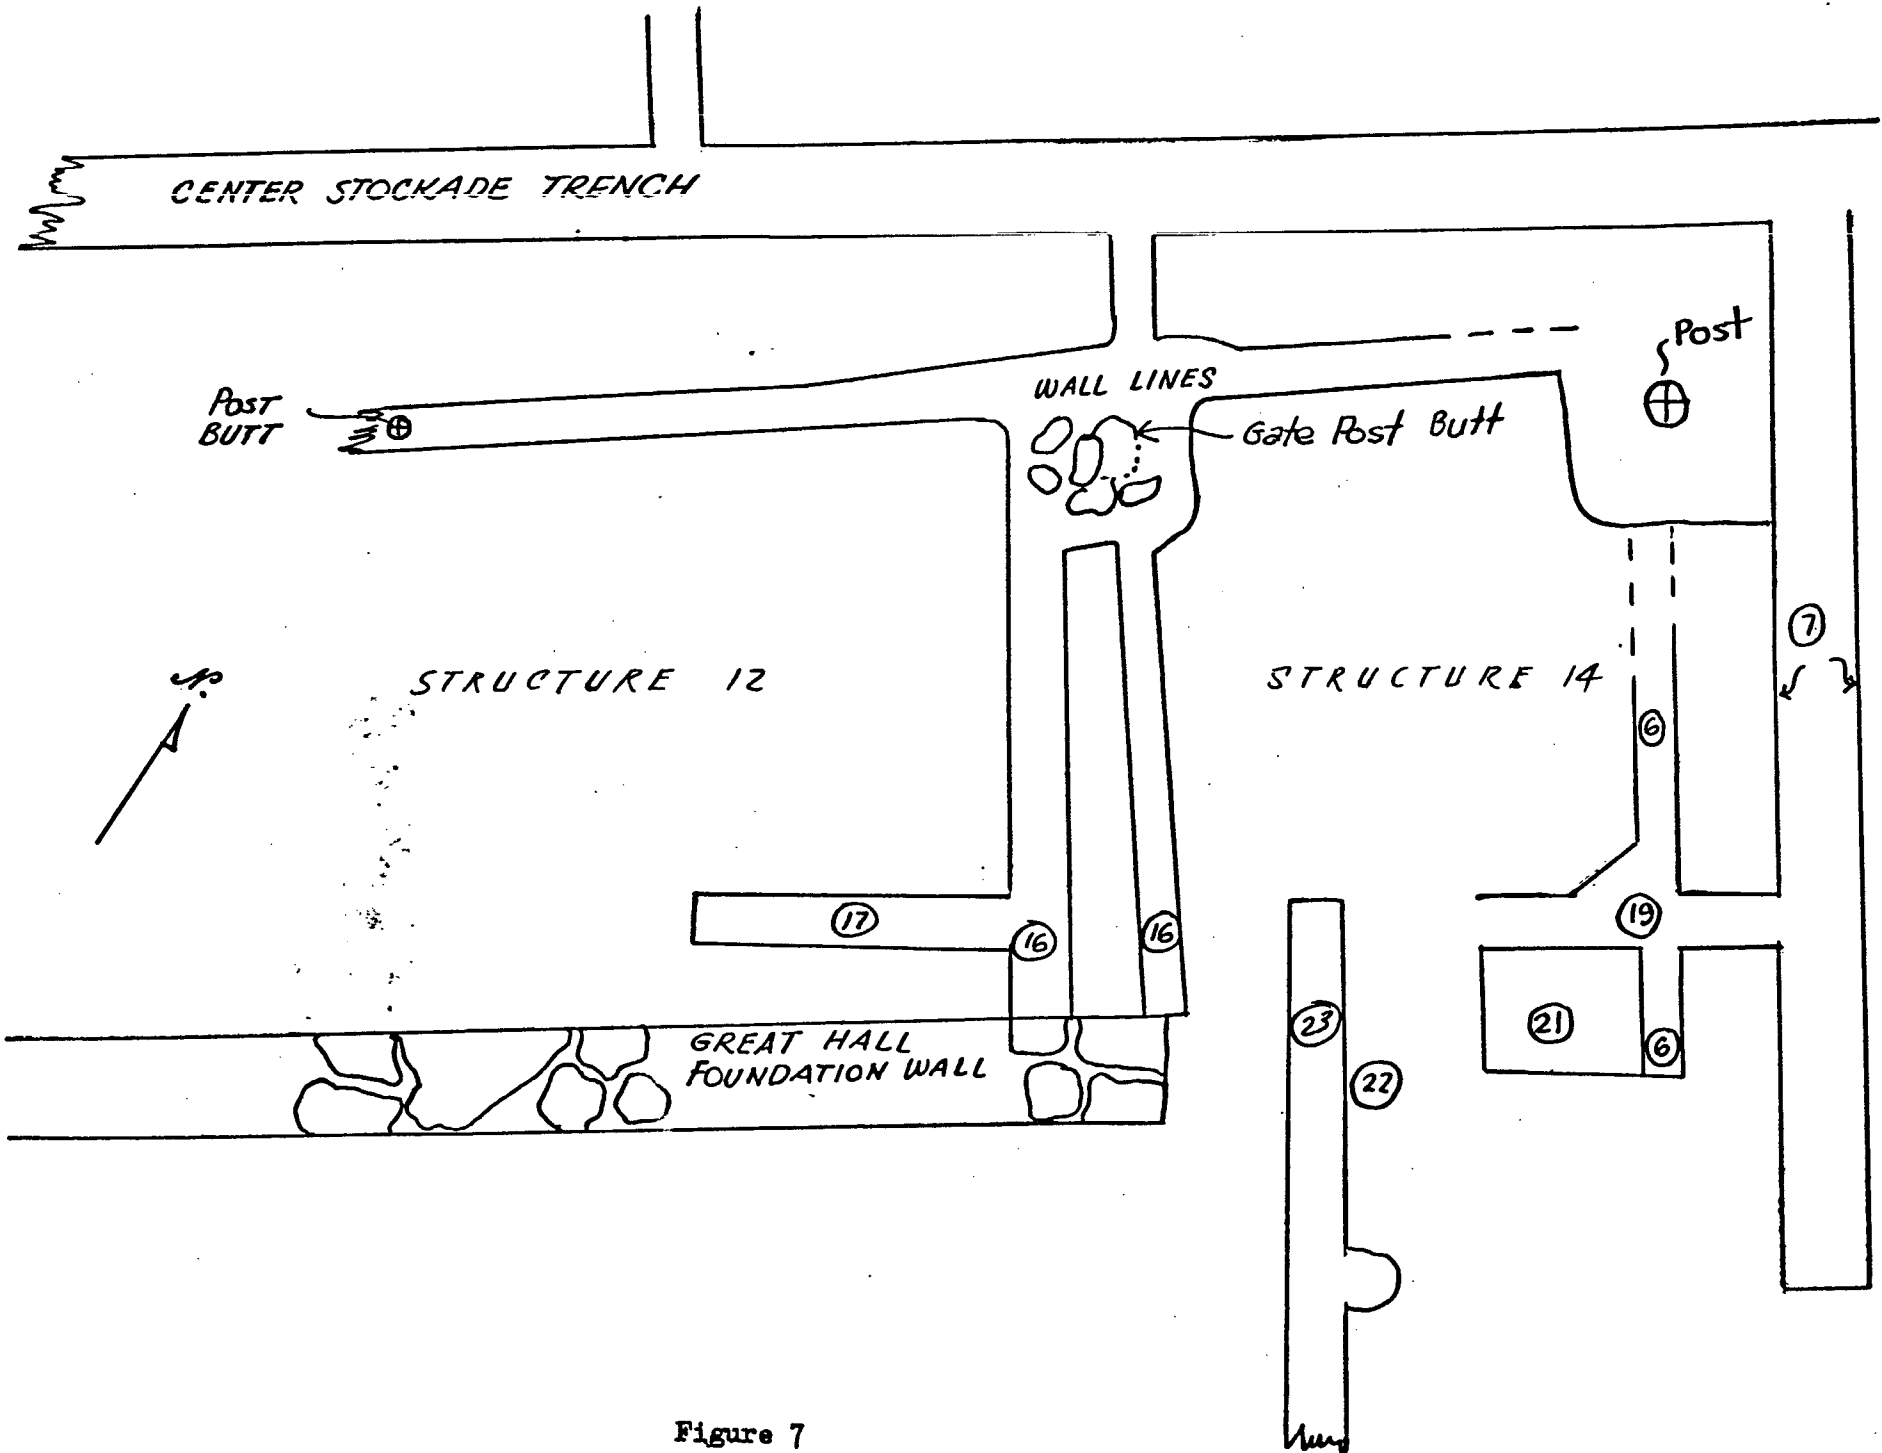
Figure 7

Here is another structure whose walls were probably formed by setting vertical timbers into foundation trenches.

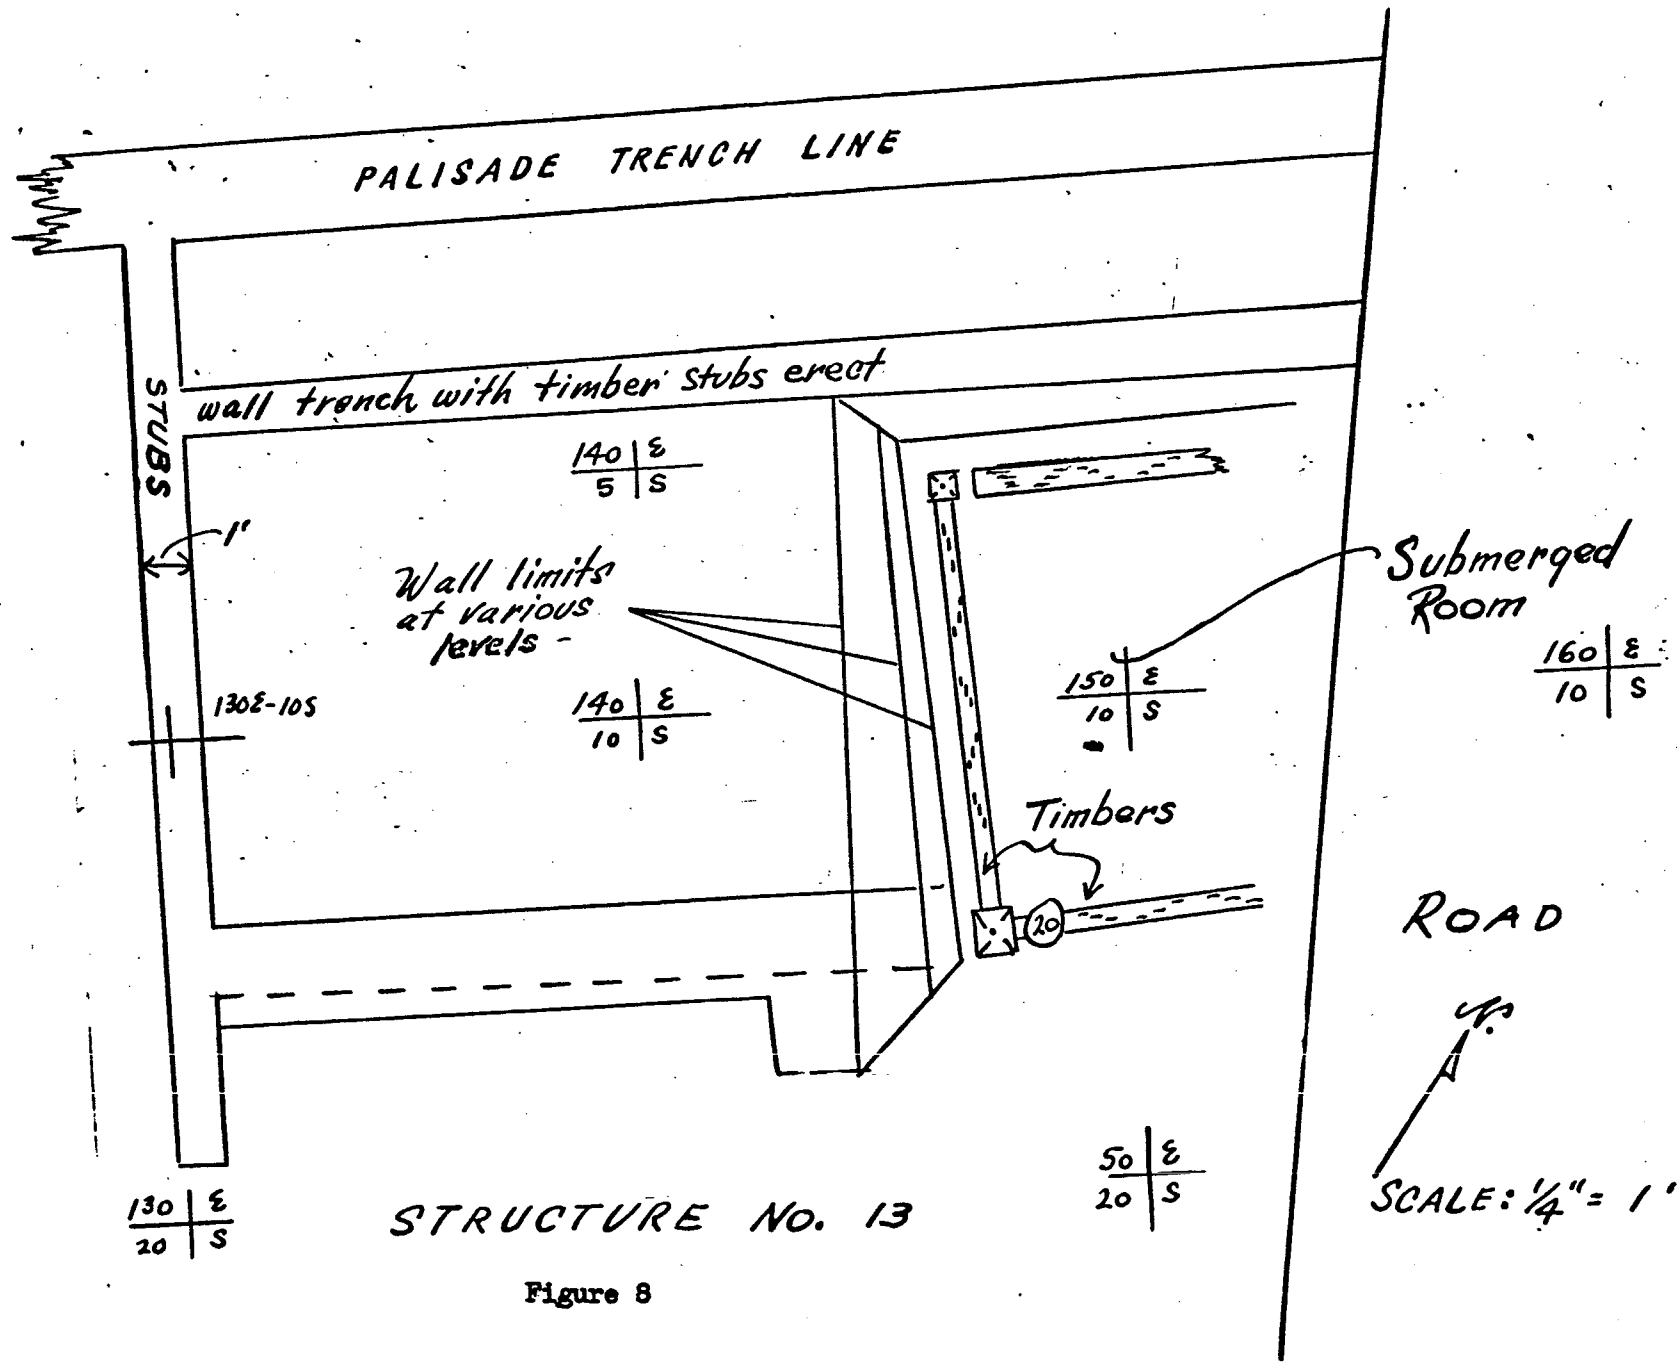
Figure 8

The structural evidence at this site demonstrates that a building formed of vertical timbers set into trenches once stood here. It measured approximately 13 feet in width on a N-S axis and at least 23 feet in length E-W. Within it was found a cellar about 4½ feet deep and 10 feet N-S and at least 6 feet E-W. No evidence to indicate the location of a doorway was discovered. This building probably served for storage as evidenced by the cellar.
