ARCHEOLOGICAL EXCAVATIONS AT THE NORTHWEST COMPANY'S  
FUR TRADE POST, GRAND PORTAGE, MINNESOTA, IN 1936-1937

By the Minnesota Historical Society

Alan R. Woolworth

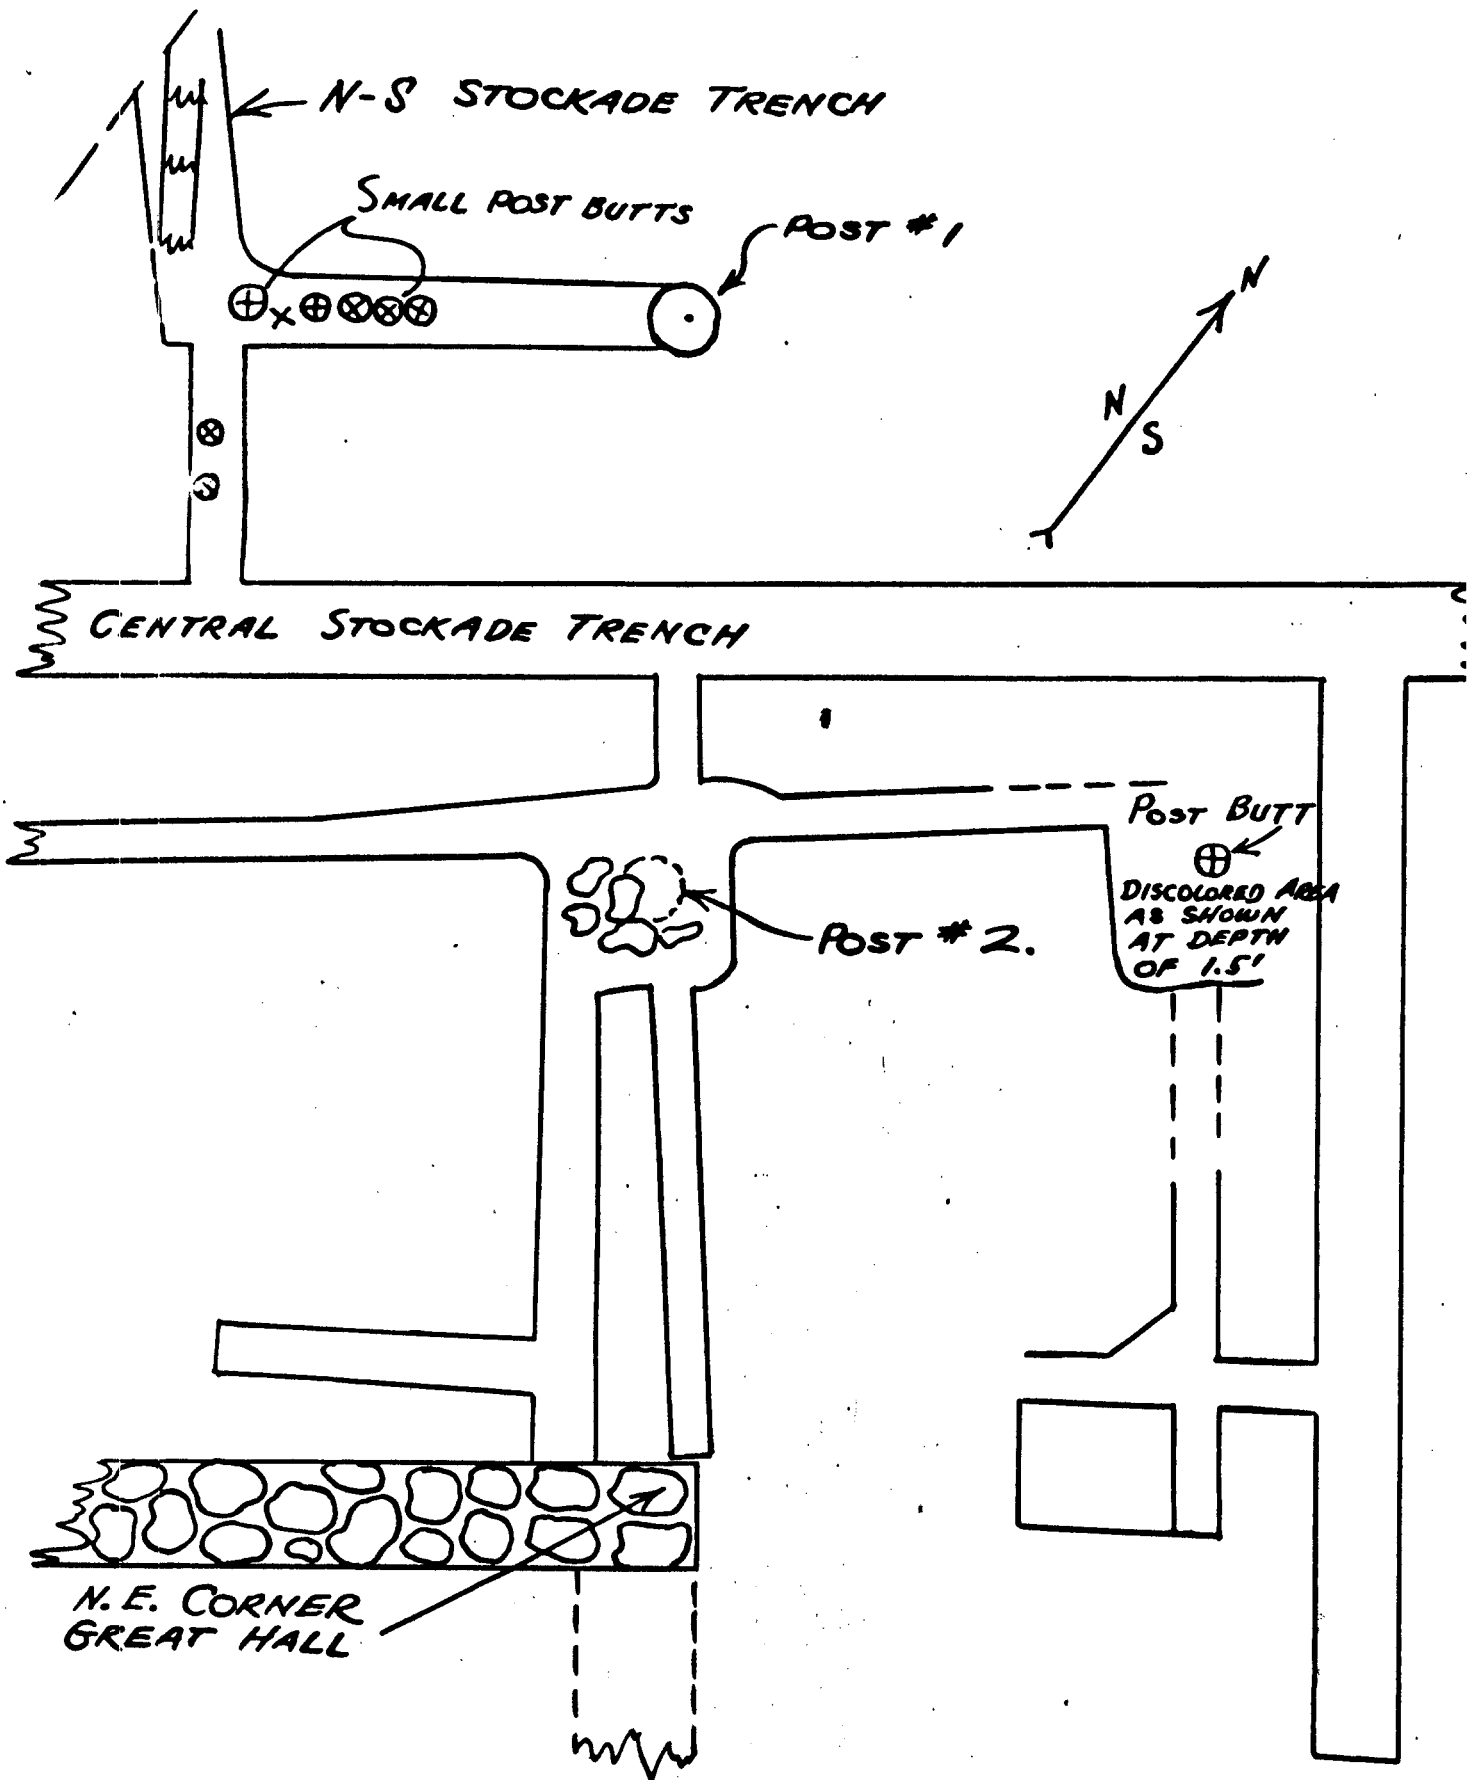
Figure 9

Structural evidence found at "The East Gate" in 1936-37.

Archaeological excavations in 1936-37 revealed two gates or gate areas. These are the "east gate" and the passageway at Corner X. No evidence has yet been uncovered to reveal the location of the third gate, which perhaps was situated on the southern palisade so that it gave access to Lake Superior. No trace has been found of the four "bastions" mentioned by Boucherville in 1803, although it is quite possible that he was referring to gate defensive structures when using

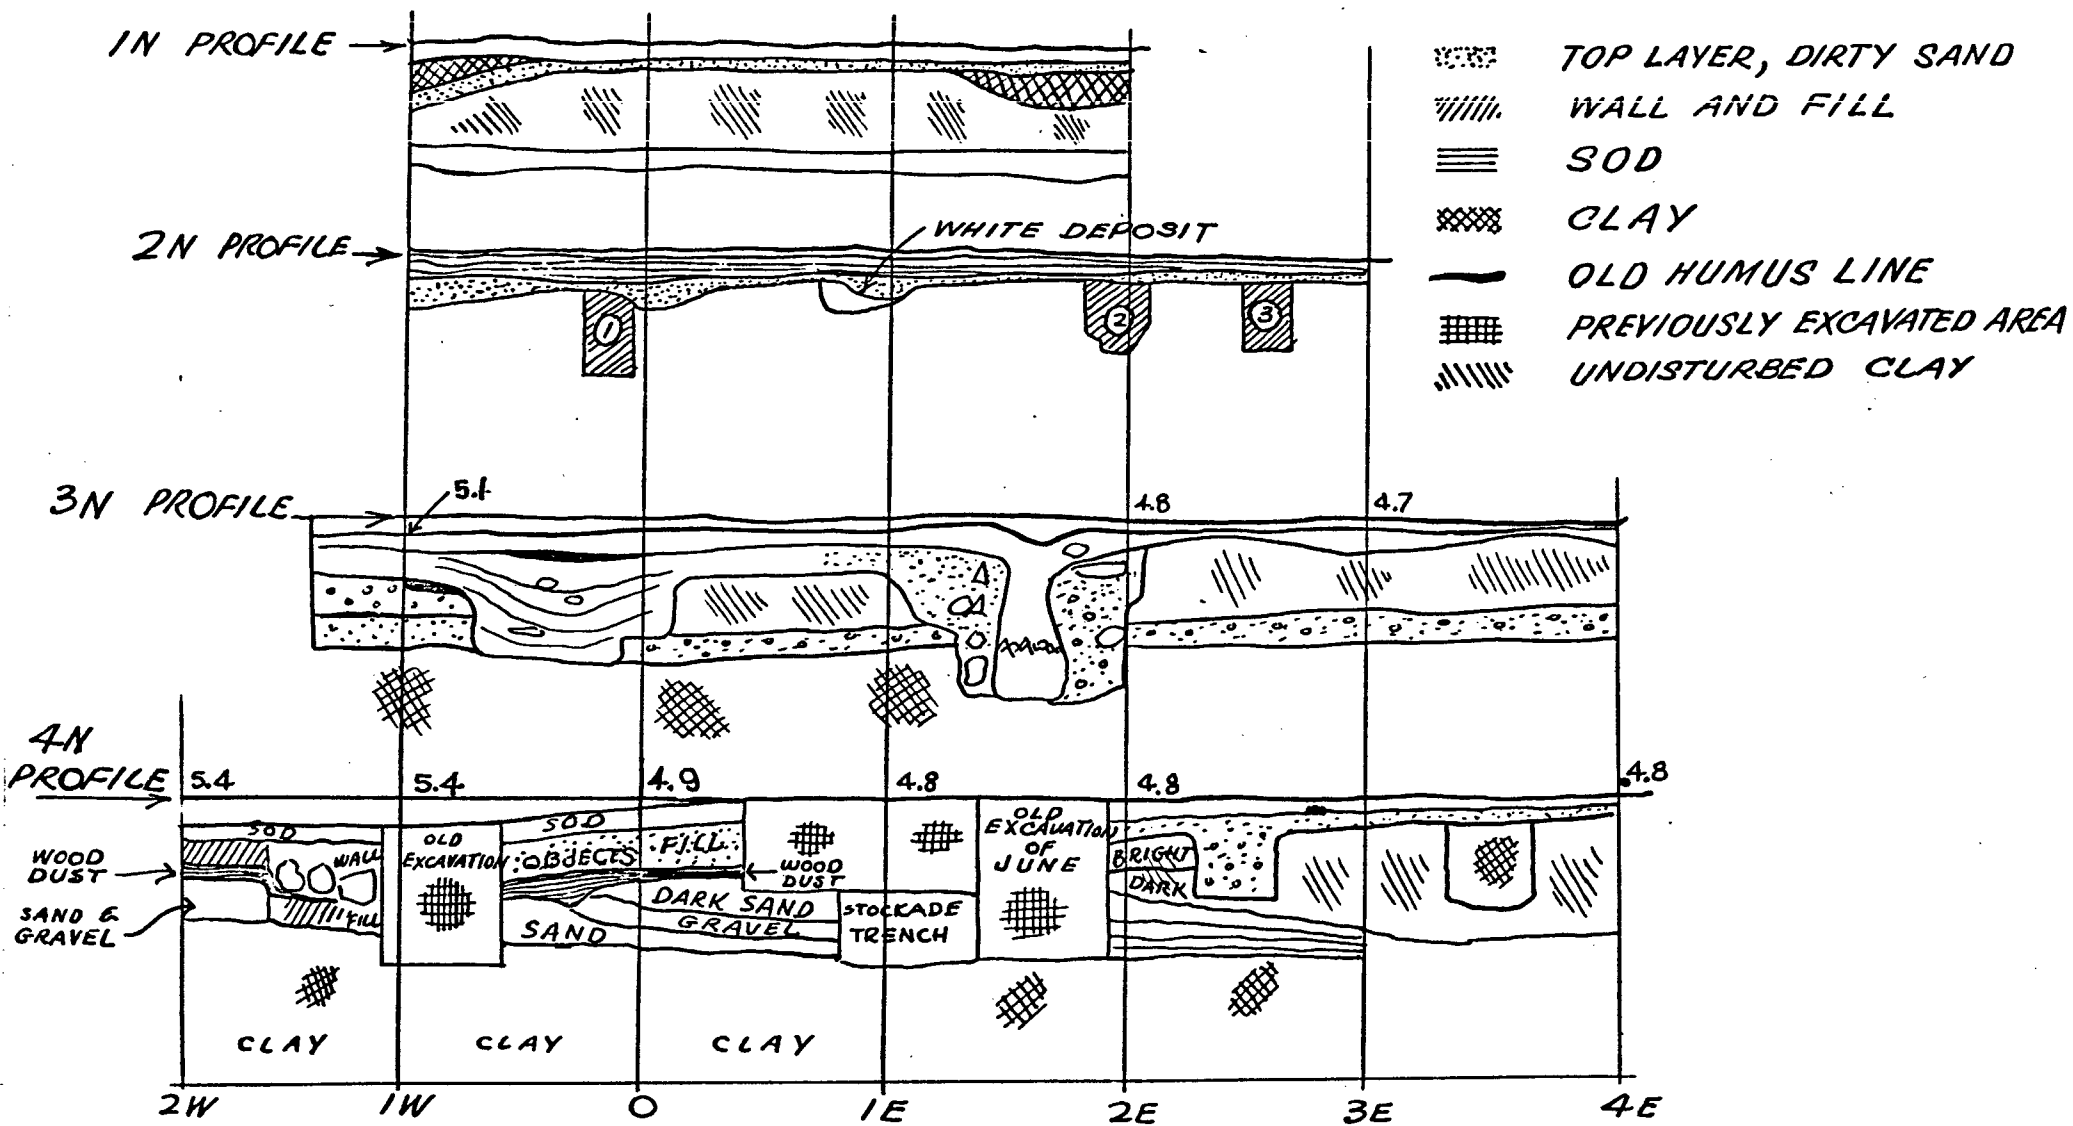
VERTICAL PROFILE OF THE EAST  
GATE AREA, 1936  
REDRAWN: 1963

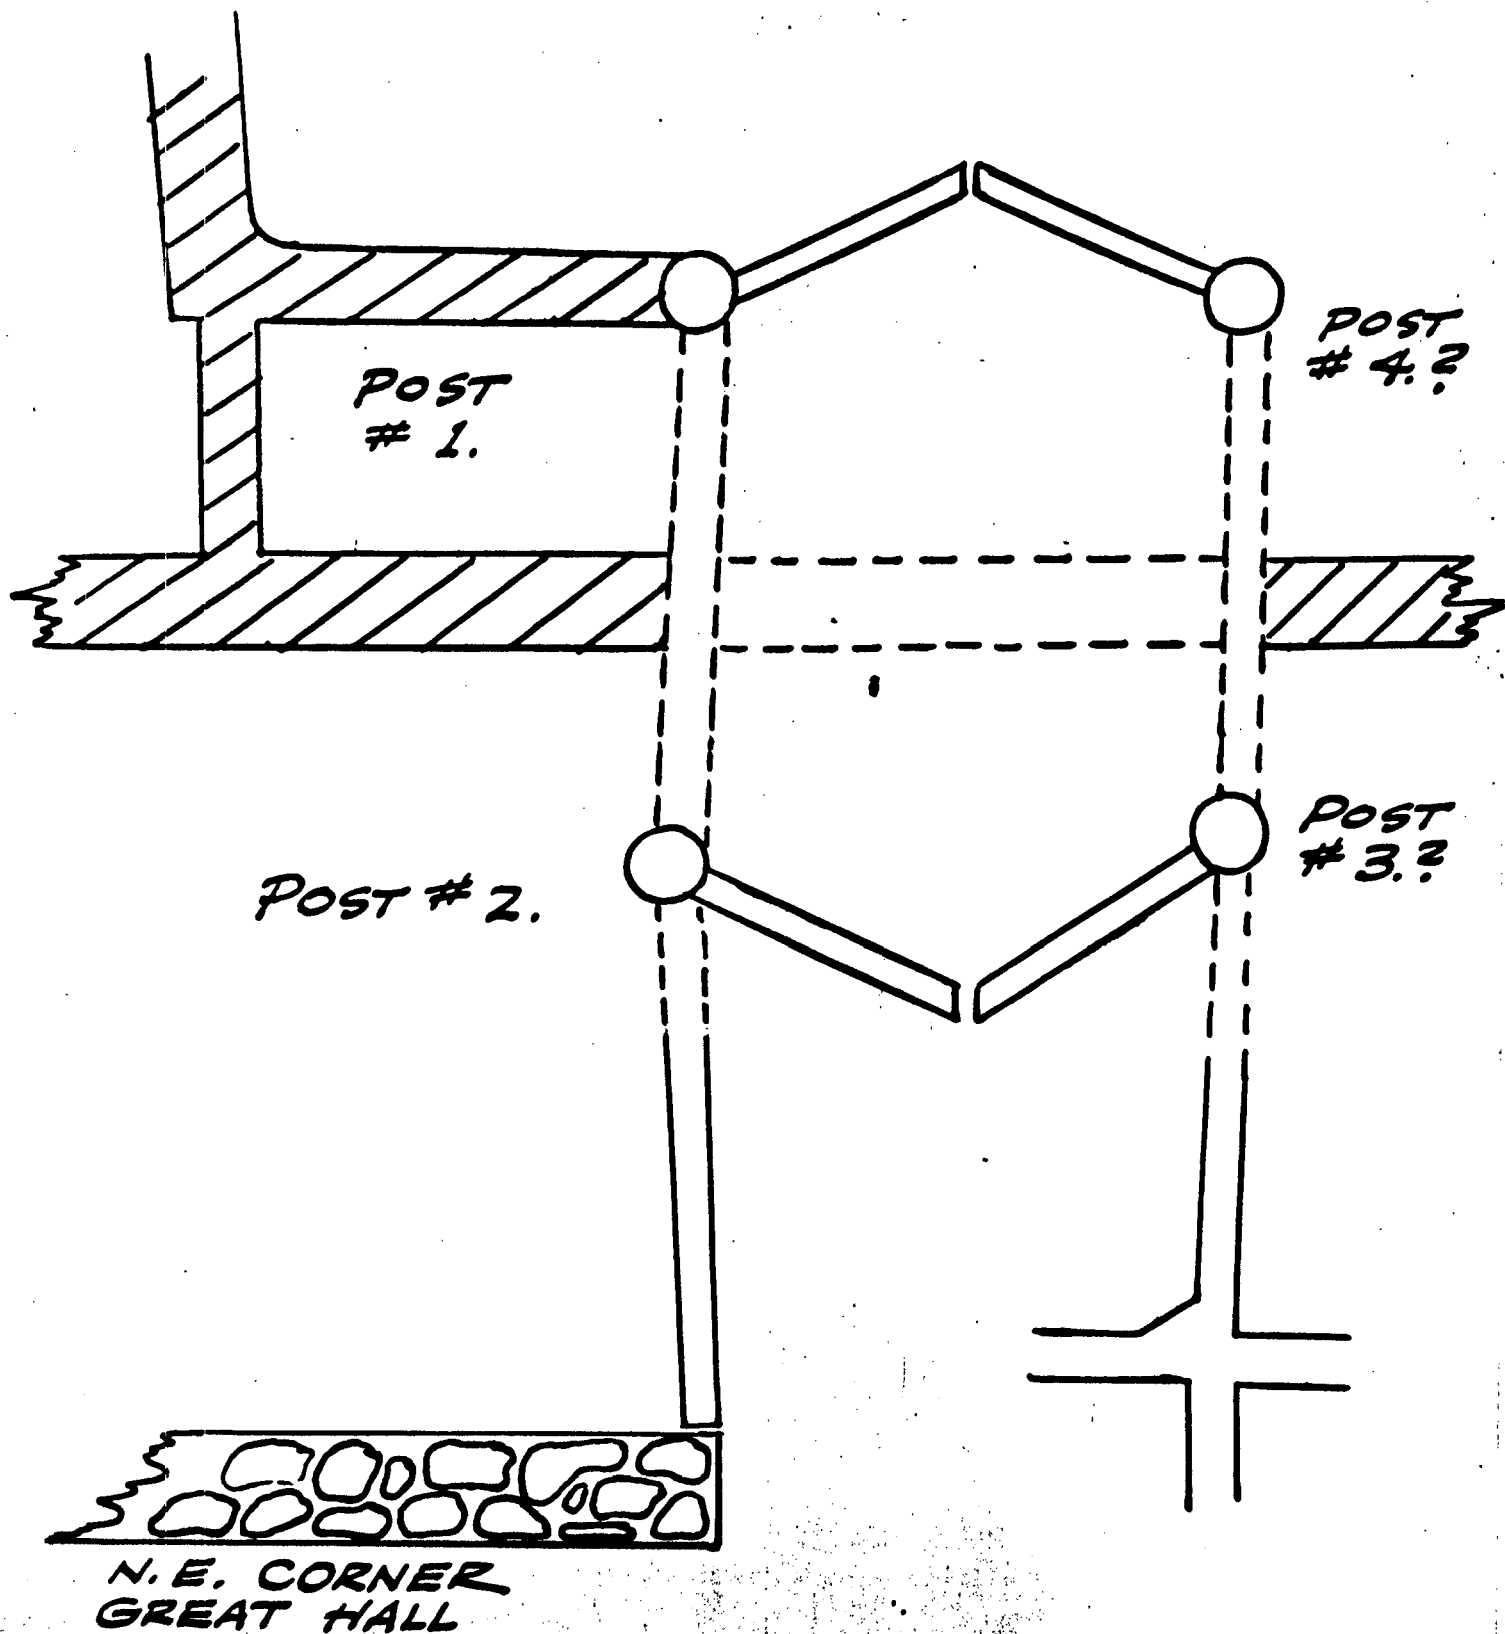
Figure 10

This is the most logical interpretation of the structural remains found in "The East Gate" area. Posts 3 and 4 are postulated on rather scanty evidence. With these four large posts, a square 12' on a side would have been formed. A guardhouse could have been erected overhead. This plan allows traffic to be routed in a direct line east of the Great Hall, and through a long passageway.

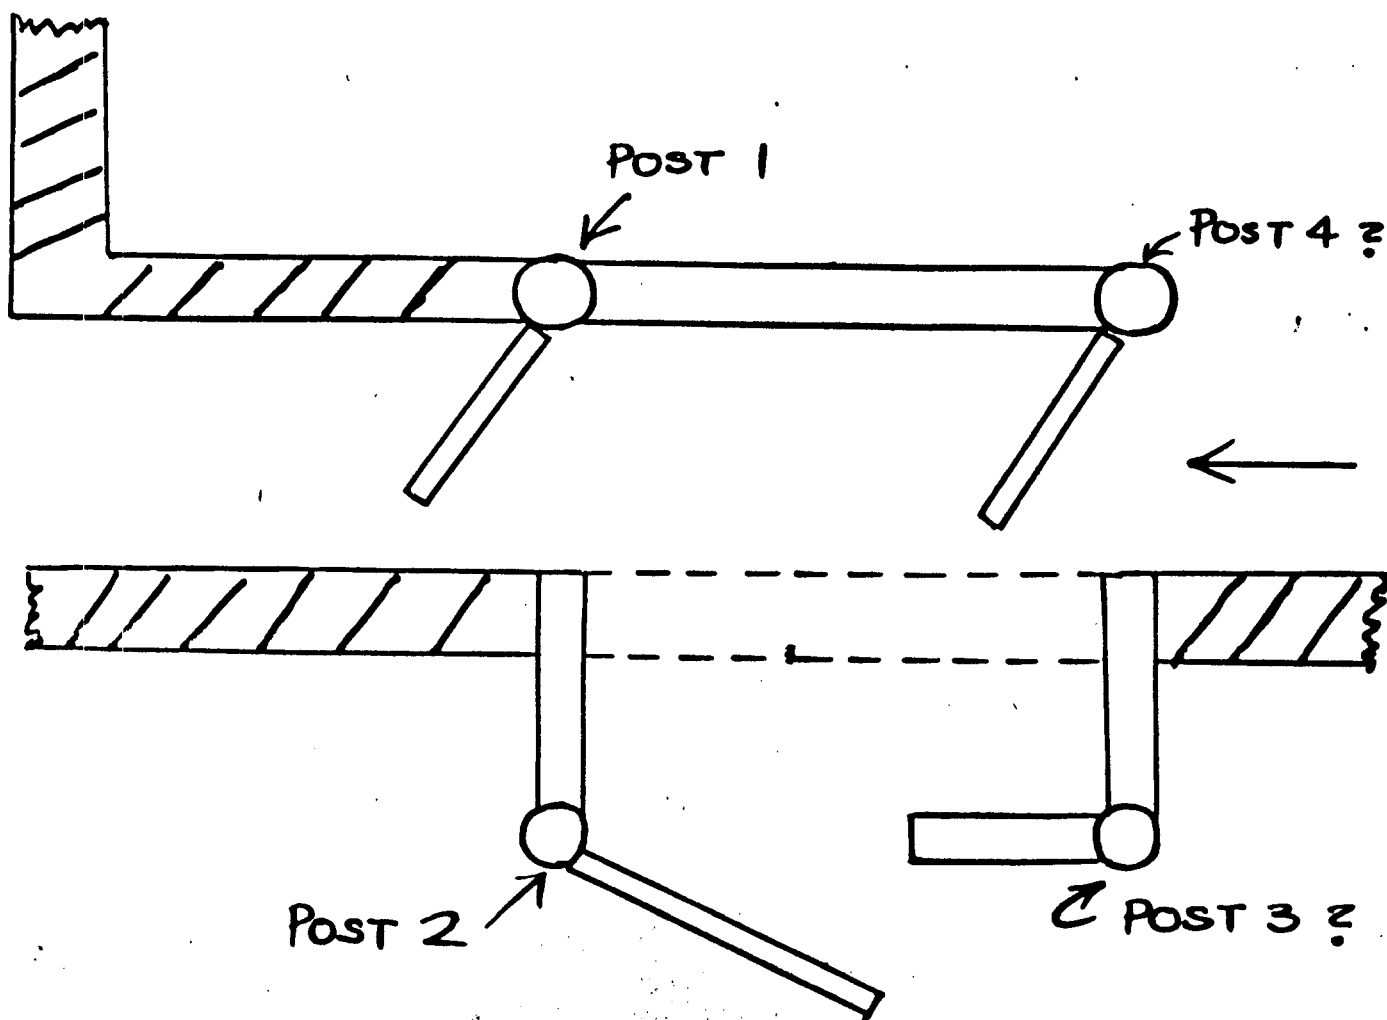
Figure 11

This interpretation is similar to that shown in Figure 10. A gate guardhouse could have been readily erected overhead on the four large posts. A direct access is provided to the rear portion of the enclosure. A right angled turn would have brought traffic to the east of the Great Hall.

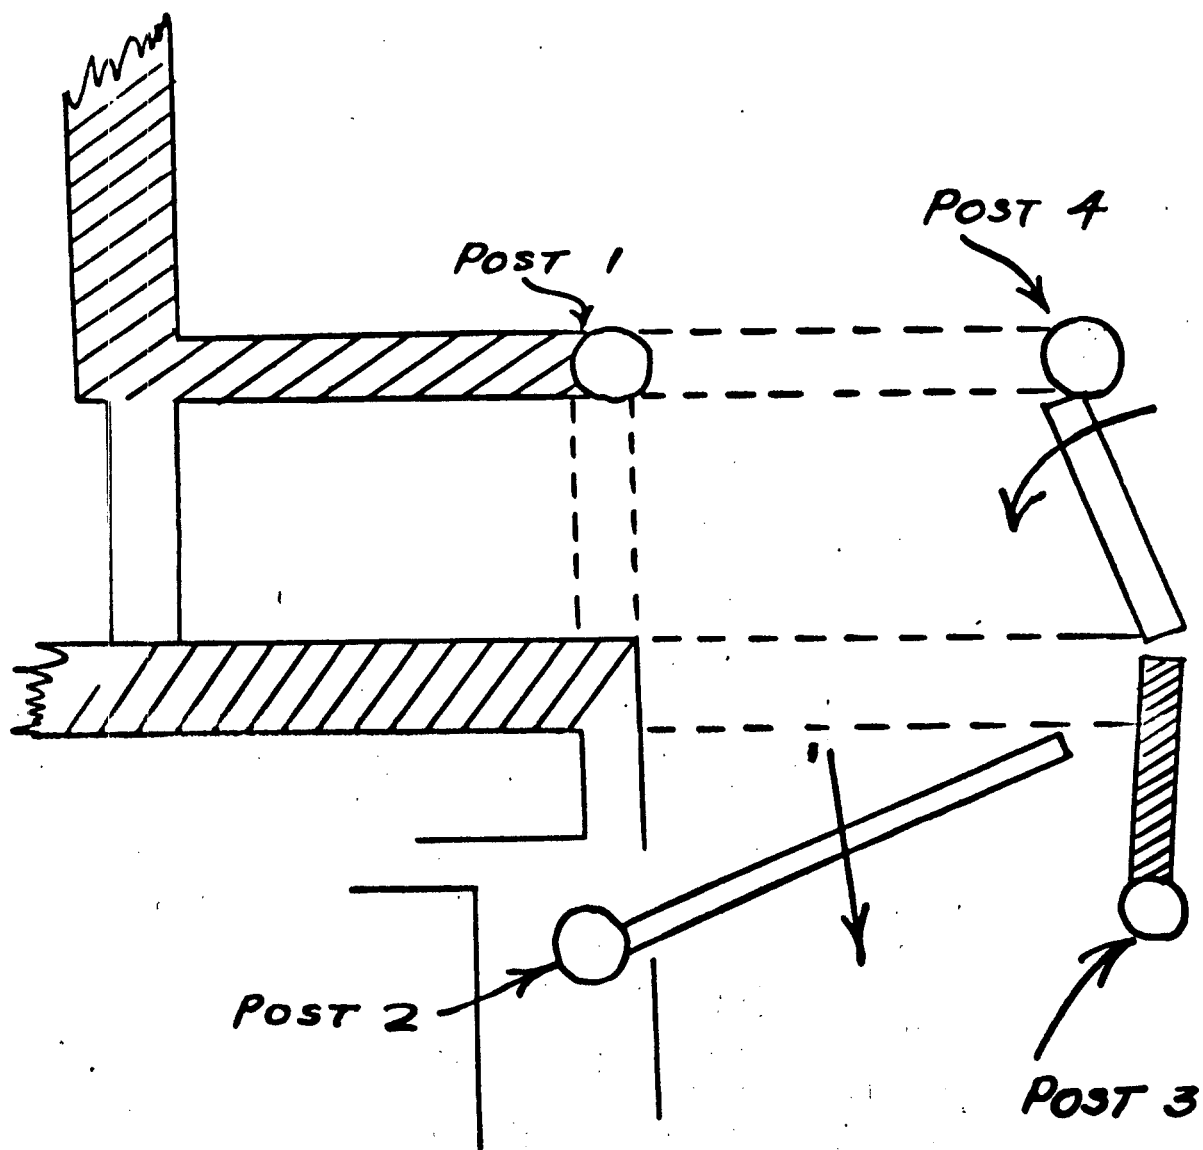
Figure 12

This plan is almost identical with that shown in Figure 11. It differs in that a gate does not pivot on Post No. 1, and a larger gate pivots on Post No. 2. A guard house could have been built overhead using the four large posts as a base. Here, traffic would also have been routed east of the Great Hall.

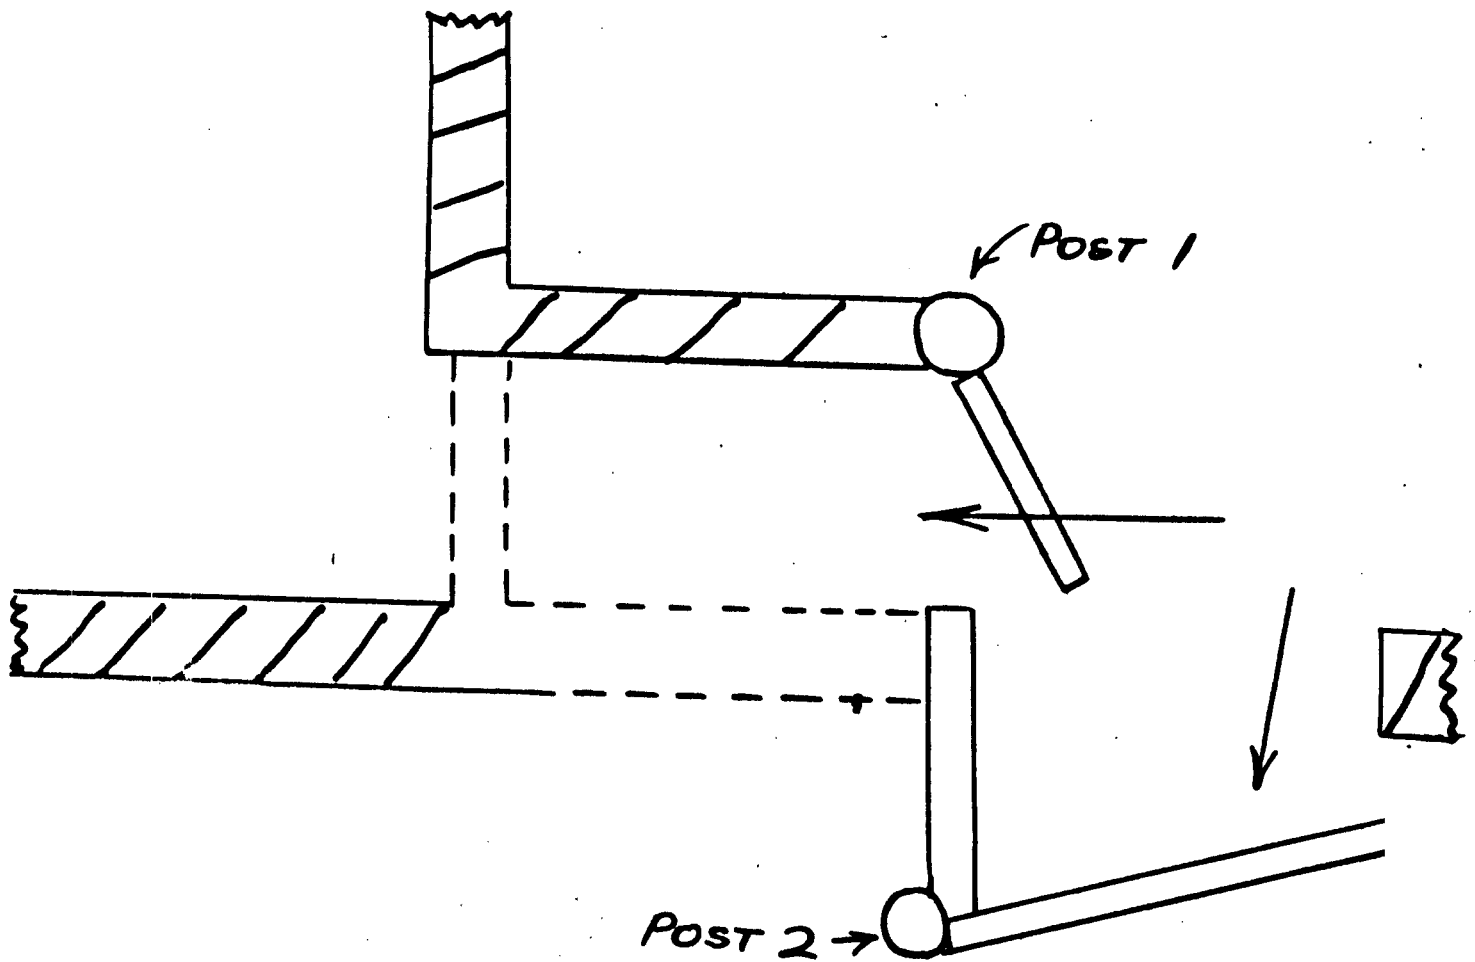
Figure 13

This plan utilizes structural evidence currently known from the site. A small gate, pivoting on Post No. 1, allows access to the rear portion of the enclosure. A larger gate, pivoting on Post No. 2, swings shut in a diagonal manner against posts in the "Central Stockade Trench." Such an arrangement, as it has only two large posts, would not have supported an overhead guard house. Here, traffic would have been routed to the east of the Great Hall.

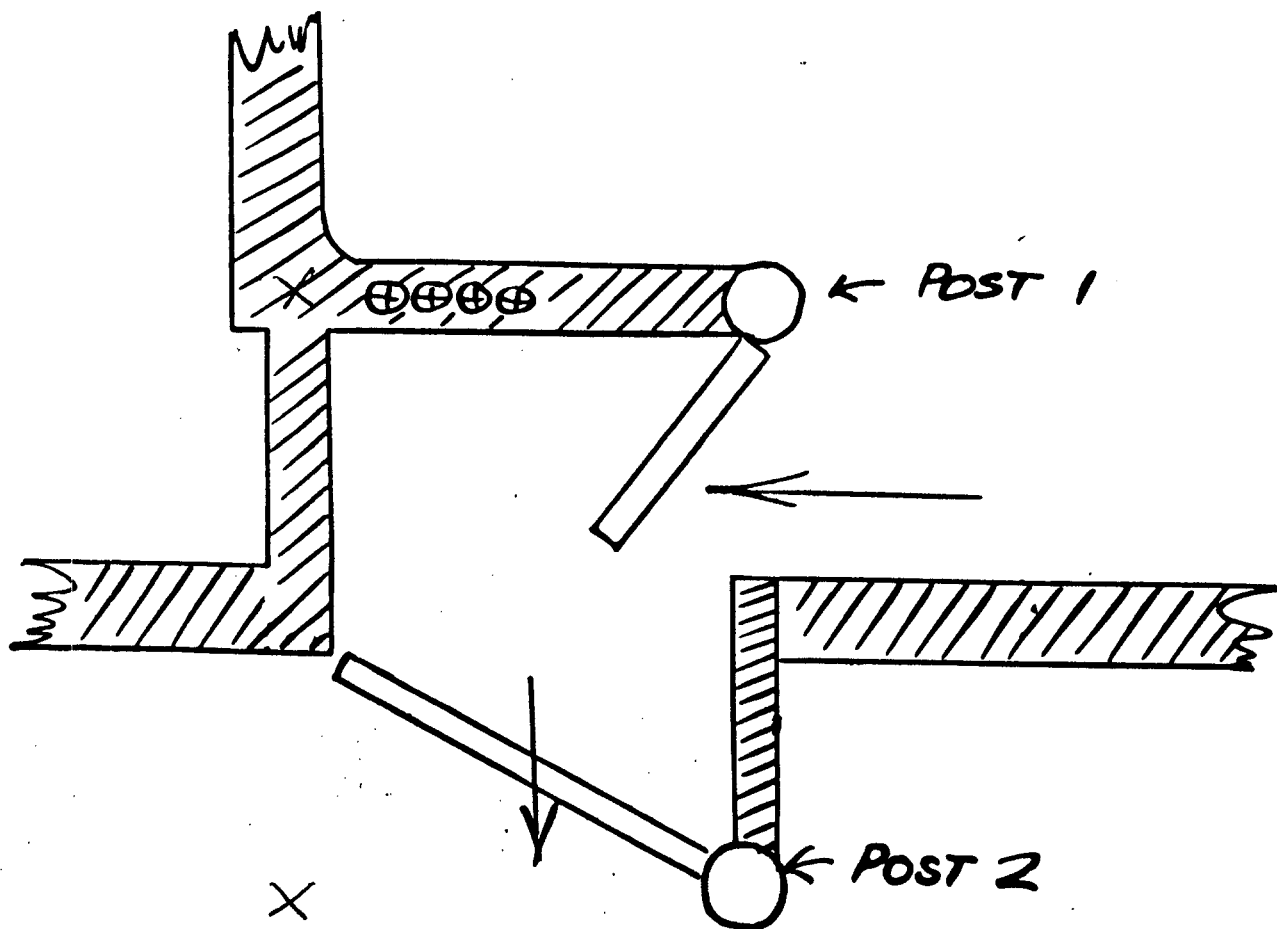
Figure 14

This interpretation is essentially the same as that of the present day blockhouse at the site. This type of design, however, would have been largely formed of walls of vertical logs set into trenches. Could it support the heavy superstructure of a guard house?

The reconstruction of a gate and a guard house, actually a blockhouse, at this site in the late 1930's ignored some archeological evidence such as the vertical post butts present in the trench running between the southern end of the northeastern palisade trench and Post No. 1. If a gate and a guard house had been erected at this exact location during the fur trade era, its walls would have consisted of vertical timbers. Note that no evidence of massive posts set into the ground as the locations marked with an "X" exists. This plan would have routed traffic directly into the northern wall of the Great Hall.

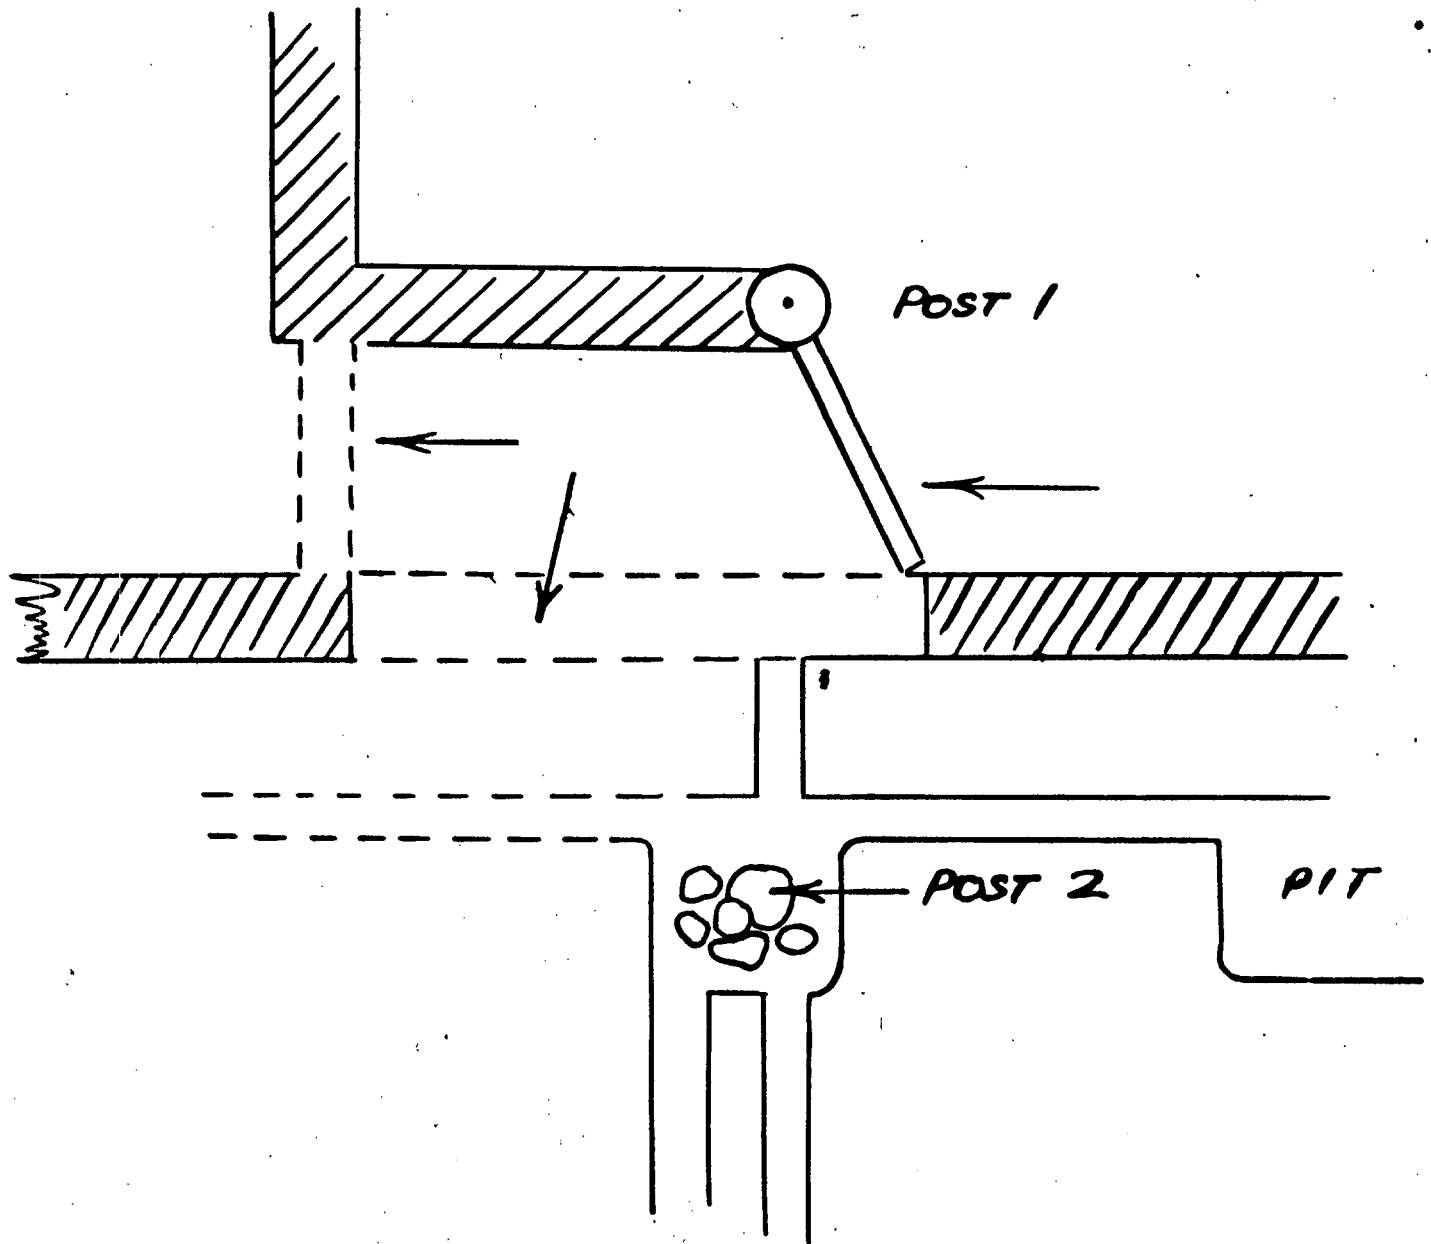
Figure 15

Here is another simple form of entry into the post enclosure. A single gate, pivoting on Post No. 1, closes against a portion of the "Central Stockade Trench". No function is assigned to Post No. 2, which may have been left from an earlier construction era. Traffic could have entered the rear portion of the enclosure or have turned at a right angle, and have been routed into the northern wall of the Great Hall, and thence eastward. It does not seem probable that these scanty underpinnings would have supported a guard house.

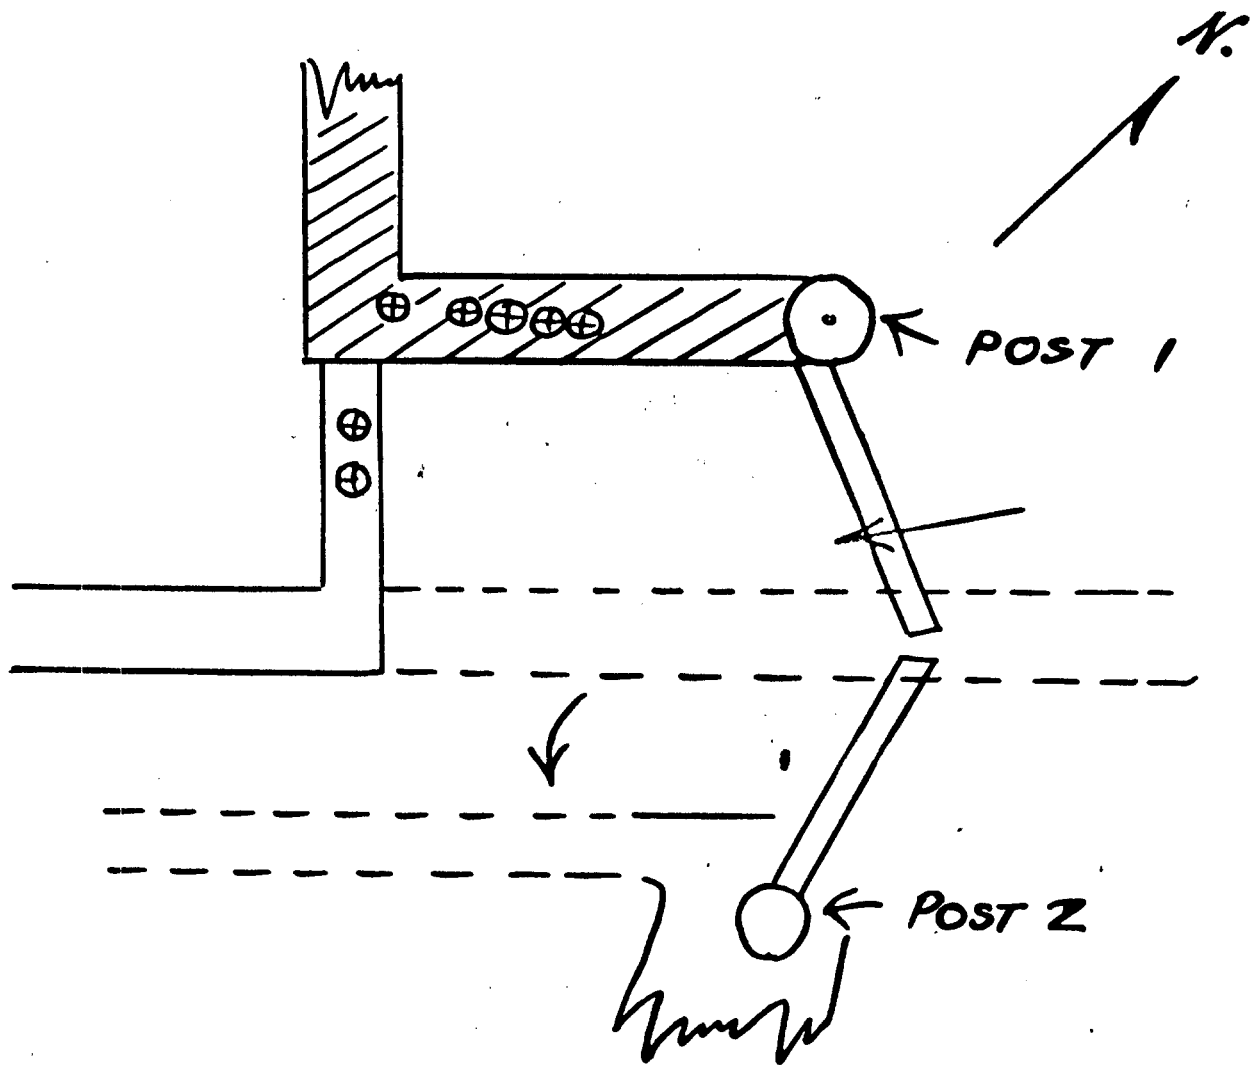
Figure 16

This entrance has two gates which pivot on Post No. 1, and No. 2. It would have served the functional purposes of an entry into the post enclosure, but would not have provided an adequate base for a superimposed guard house. Some means of closing the open space to the right of Post No. 2 would have been essential. This gate system would have routed traffic into the northern wall of the Great Hall.

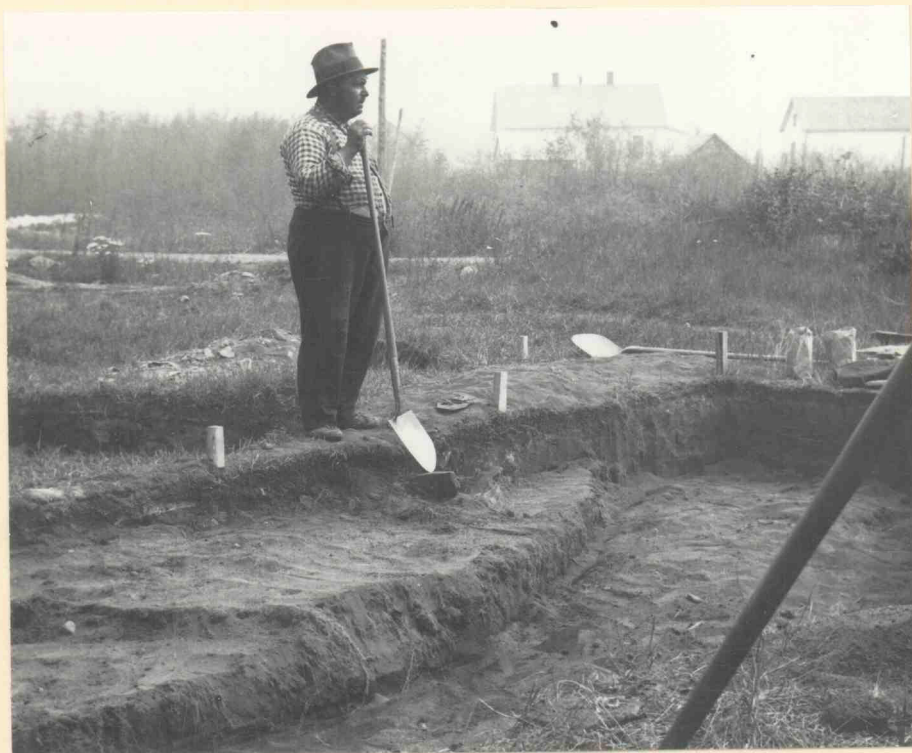
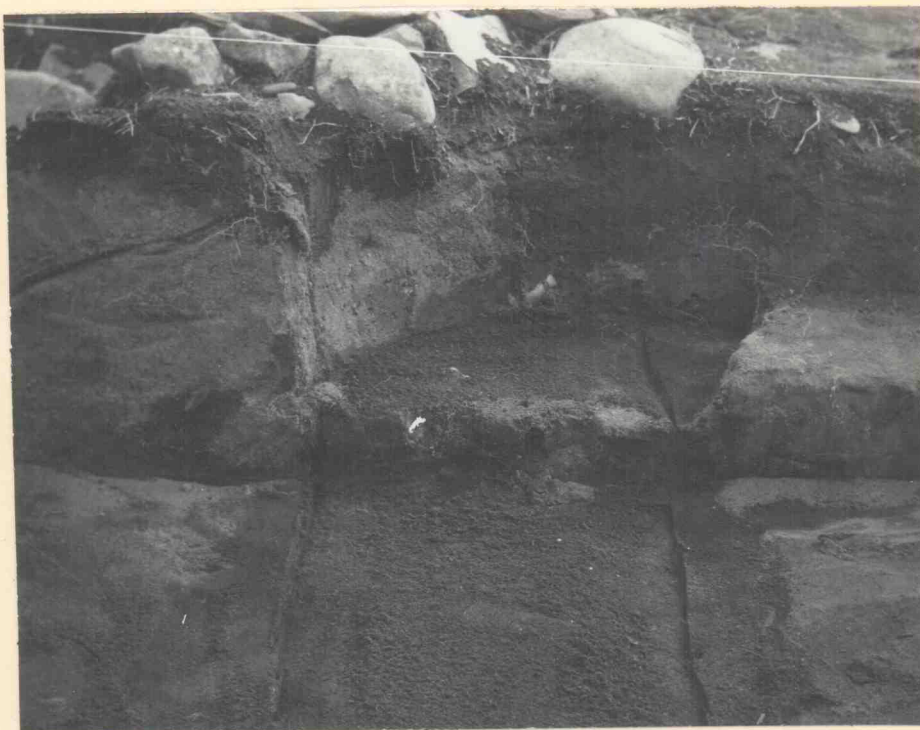
Plate 6.

Excavation techniques in the "east gate area"

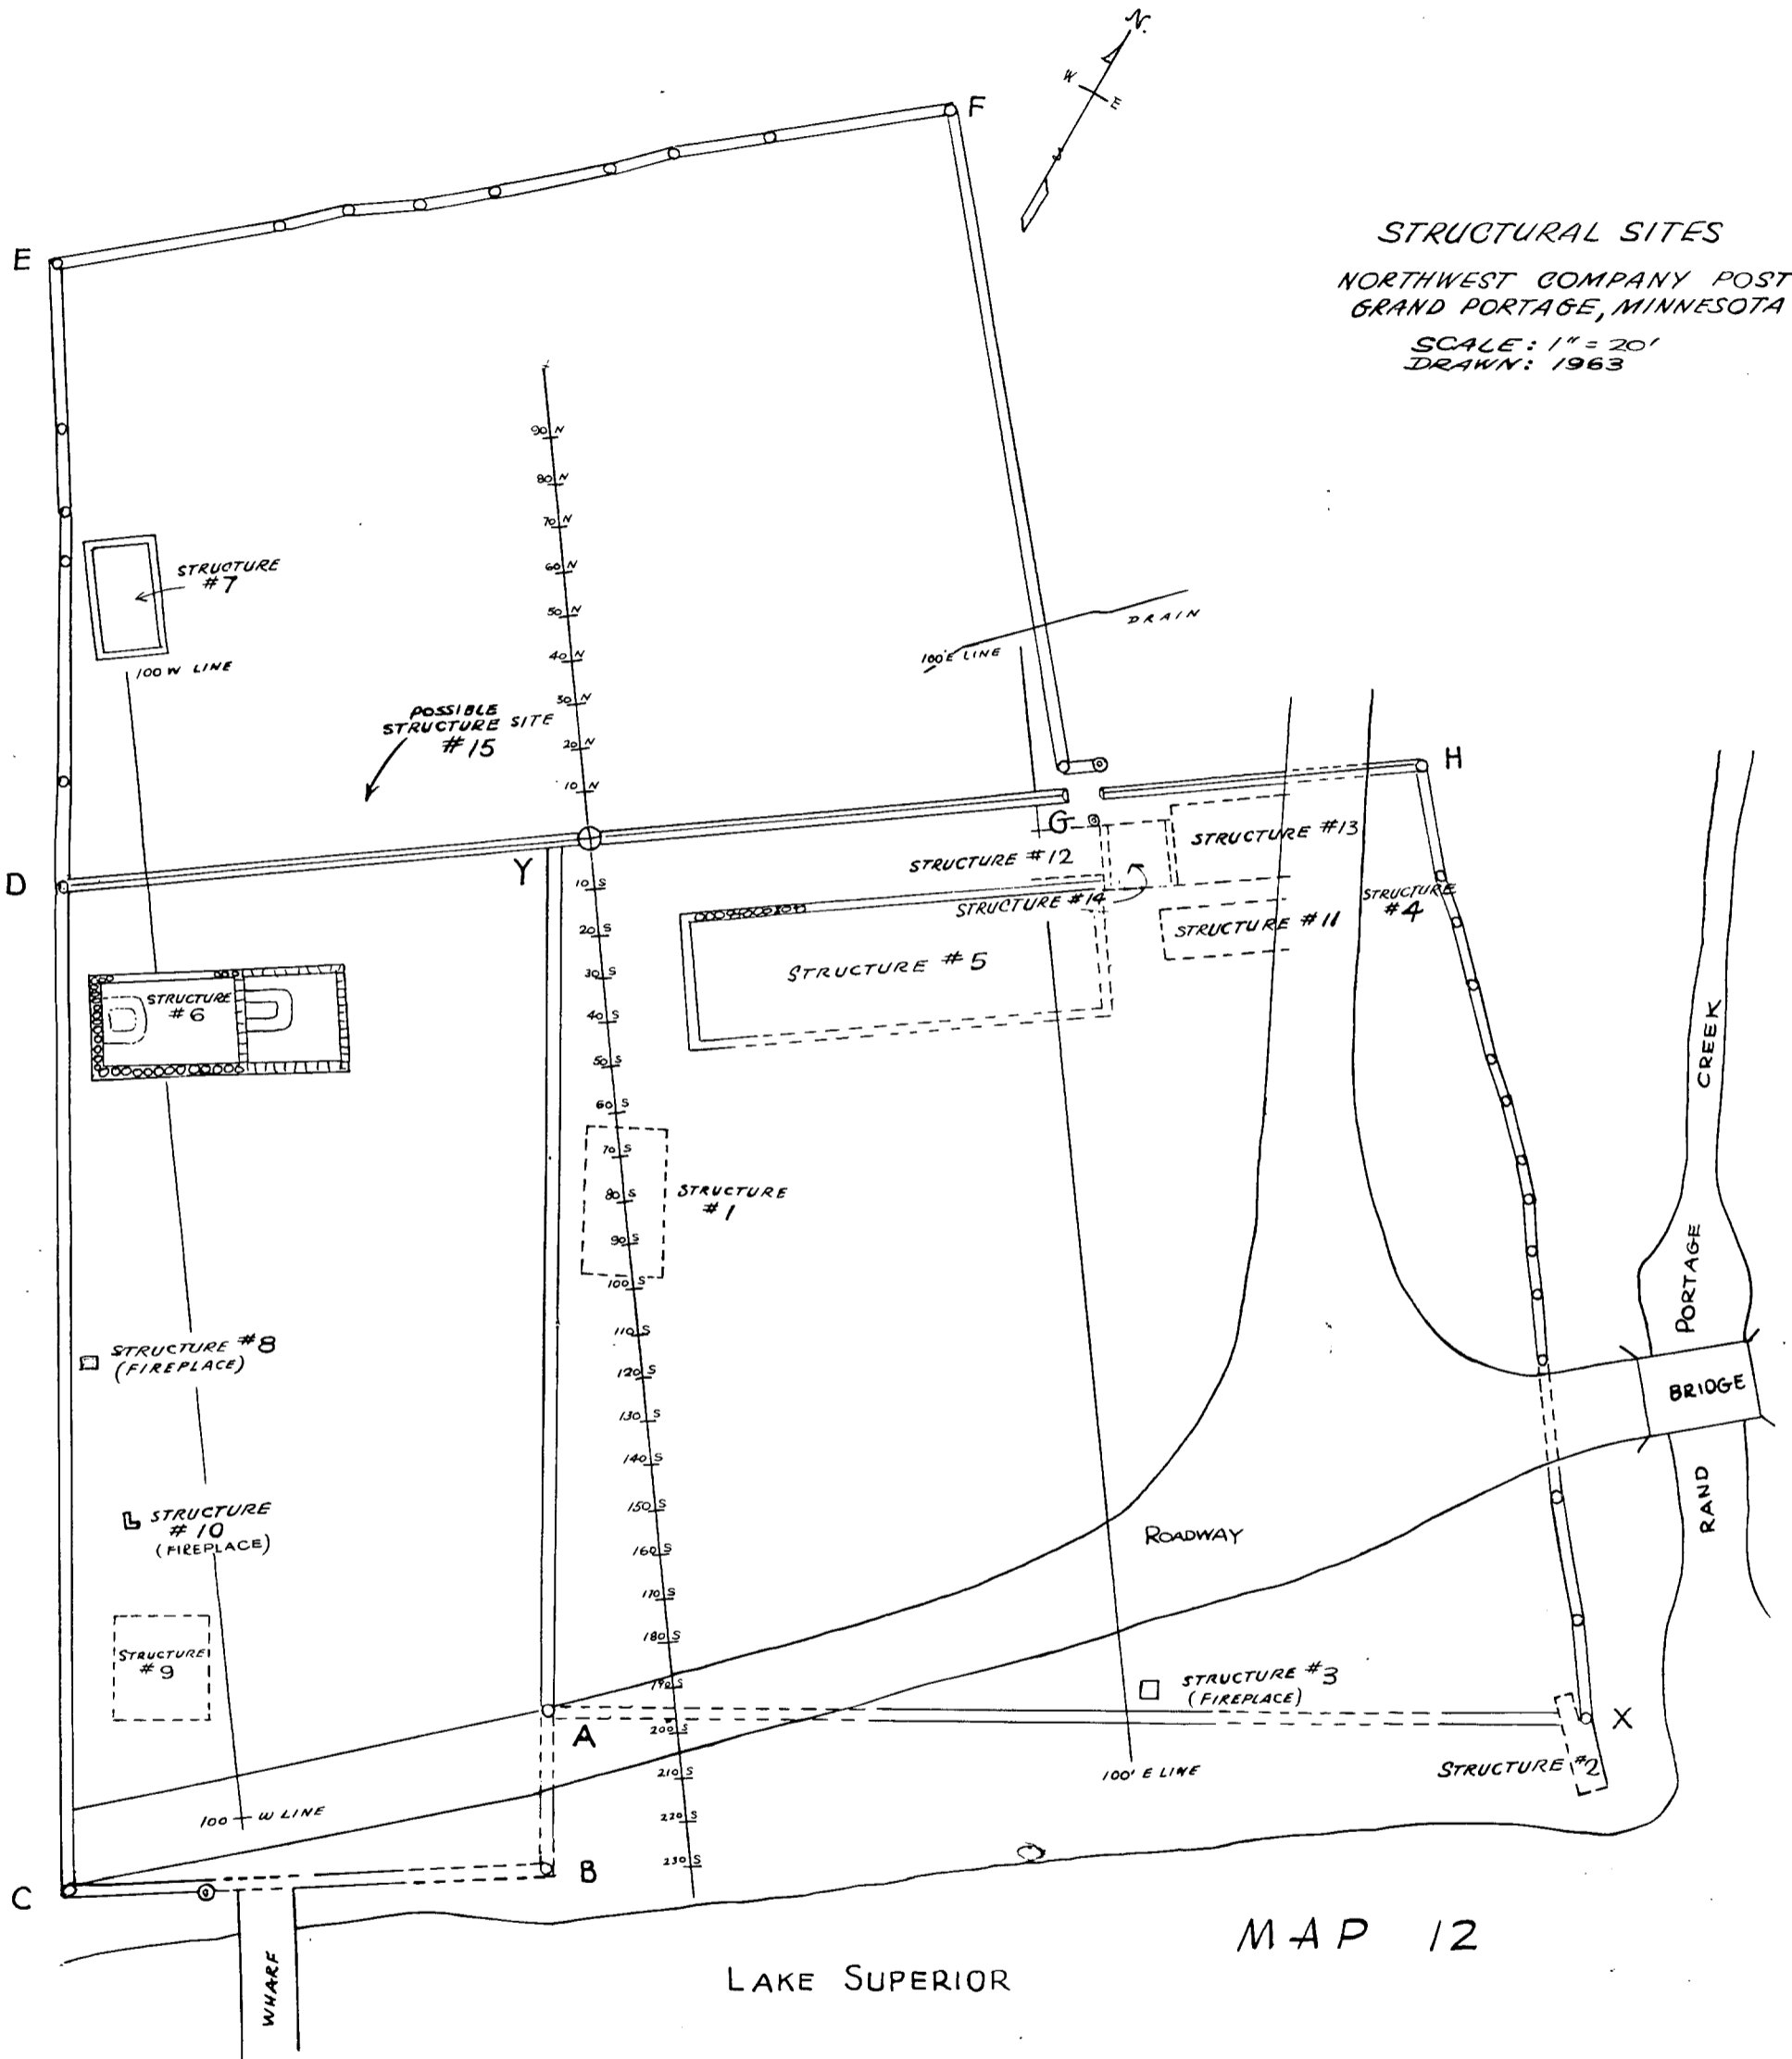
MAP 12

STRUCTURAL SITES  
 NORTHWEST COMPANY POST  
 GRAND PORTAGE, MINNESOTA  
 SCALE: 1" = 20'  
 DRAWN: 1963
