ARCHEOLOGICAL EXCAVATIONS AT THE NORTHWEST COMPANY'S  
FUR TRADE POST, GRAND PORTAGE, MINNESOTA, IN 1936-1937

By the Minnesota Historical Society

Alan R. Woolworth

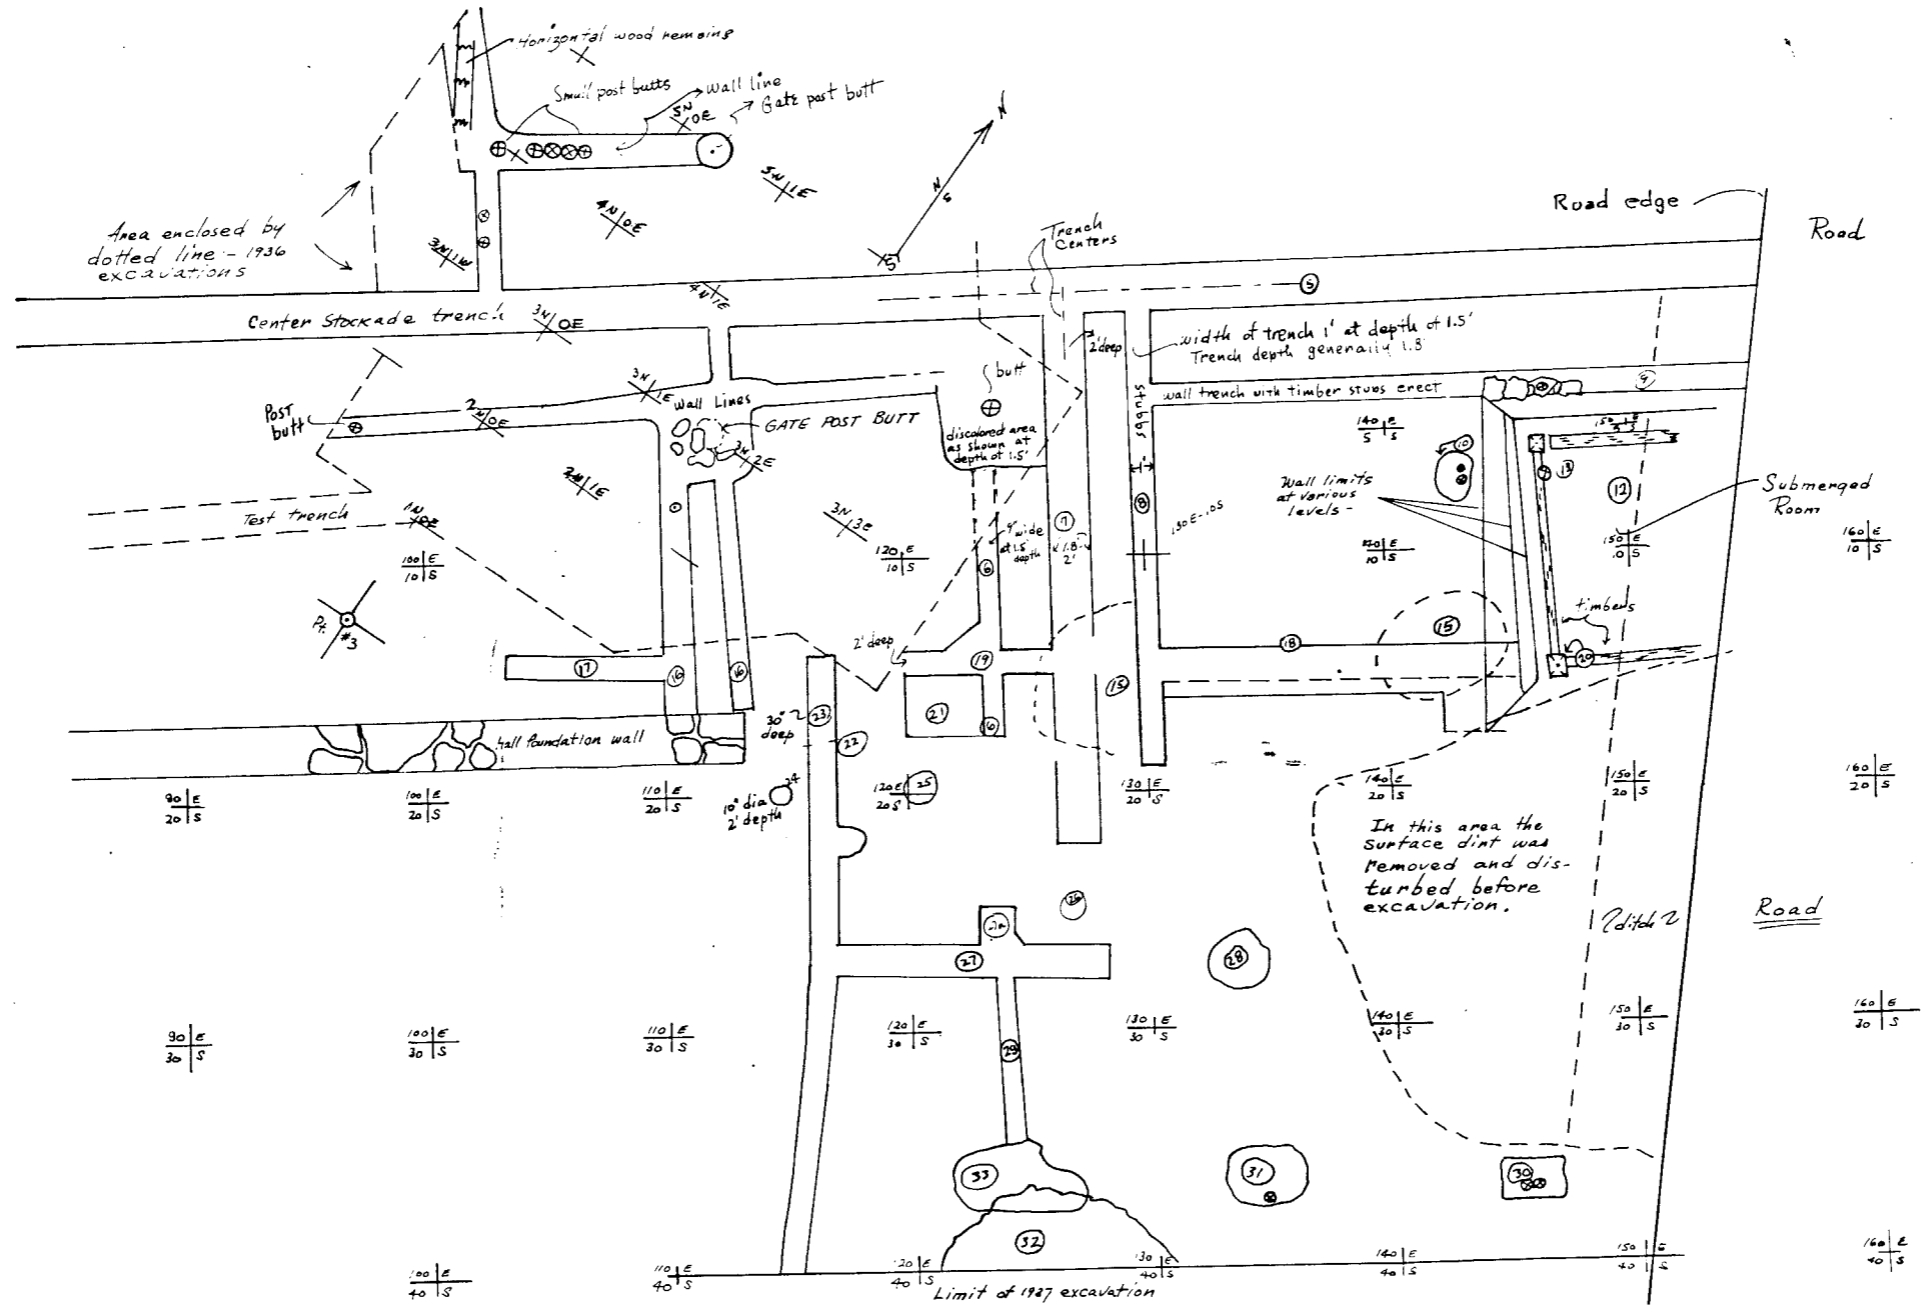
SHEET A-6

DETAIL OF EAST GATE AREA, FROM GATE TO ROAD - 1936-1937 EXCAVATIONS
