**Arsenic Removal from Drinking Water by Coagulation/Filtration
U.S. EPA Demonstration Project at Village of Pentwater, MI
Six-Month Evaluation Report**

**Battelle
Columbus, OH 43201-2693**

**Contract No. 68-C-00-185
Task Order No. 0029**

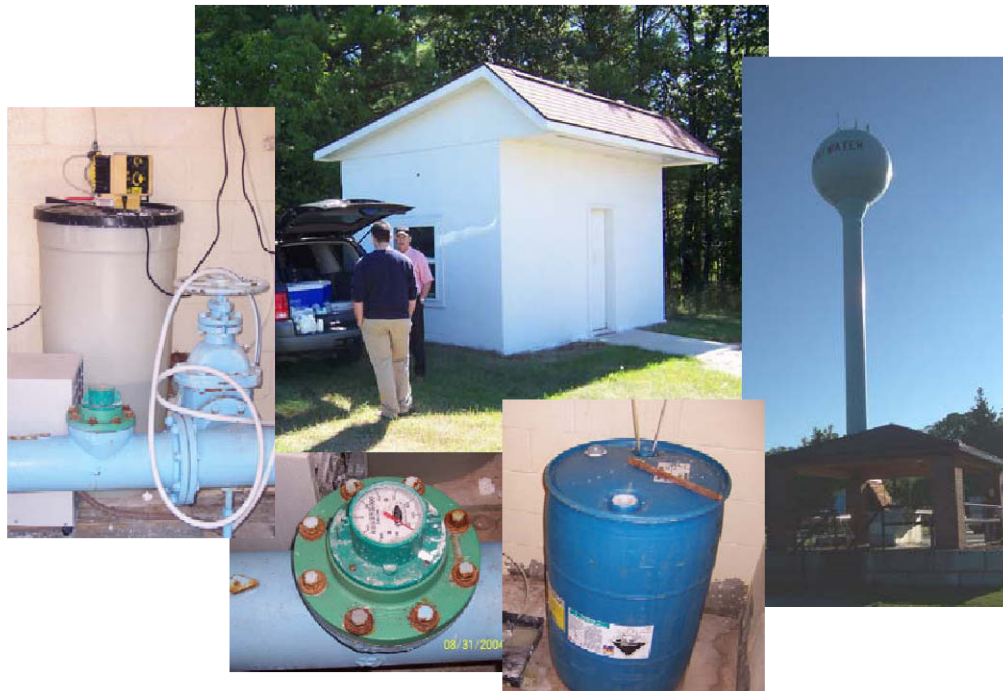
Figure 4-1. Existing Facility and System Components
(Clockwise from Top: Well No. 2 Pump House, Water Tower, Polyphosphate Drum, Wellhead Totalizer, and Piping and Chlorine Addition Equipment)

Prior to the installation of the arsenic removal system, treatment consisted of only chlorine and polyphosphate addition, which was carried out in the Well No. 2 pump house (Figure 4-1). A 15% NaOCl solution stored in a 55-gal drum was injected at 2 to 3 mg/L at the wellhead using a 1.0-gal/hr (gph) pump to attain a chlorine residual of approximately 0.5 mg/L. A phosphate mixture (i.e., 85% polyphosphate and 15% orthophosphate) also was added at 2 mg/L using a 2.5-gph pump for iron sequestration and corrosion control. The treated water was stored in a 150,000-gal water tower with level sensors for pump control.

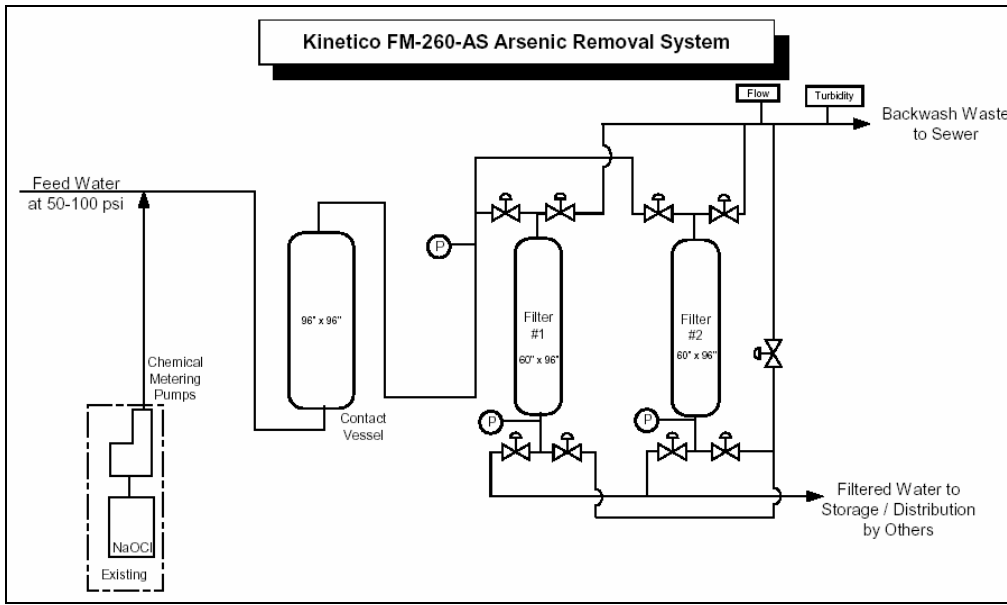
Figure 4-2. Schematic of Kinetico’s FM-260-AS System

One 96-in-diameter, 96-in-tall epoxy-lined steel tank, designed to allow 6 min of contact time, was used to improve the formation of iron flocs prior to pressure filtration. The 2,400-gal tank had 6-in top and bottom flanges, which connected to the exit and inlet piping, respectively, for an upflow configuration.

- **Pressure Filtration.** Floc removal from the contact tank effluent was achieved via downflow filtration through two 60-in-diameter, 96-in-tall pressure tanks configured in

parallel. Each tank contained 40 ft³ (or 24 in) of 40 × 60 mesh Macrolite[®] media loaded on top of fine garnet underbedding filled to 1 in above the 0.006-in slotted, stainless steel wedge-wire underdrain. The epoxy-lined steel pressure tanks featured windows for media and backwash observation and were rated for a working pressure of 150 pounds per square inch (psi). The tanks were floor mounted and piped to a valve rack mounted on a welded, stainless steel frame. The flow through each tank was regulated to less than 200 gpm using a flow-limiting device to prevent filter overrun. System operation with both tanks in service could produce a total flowrate of 400 gpm.

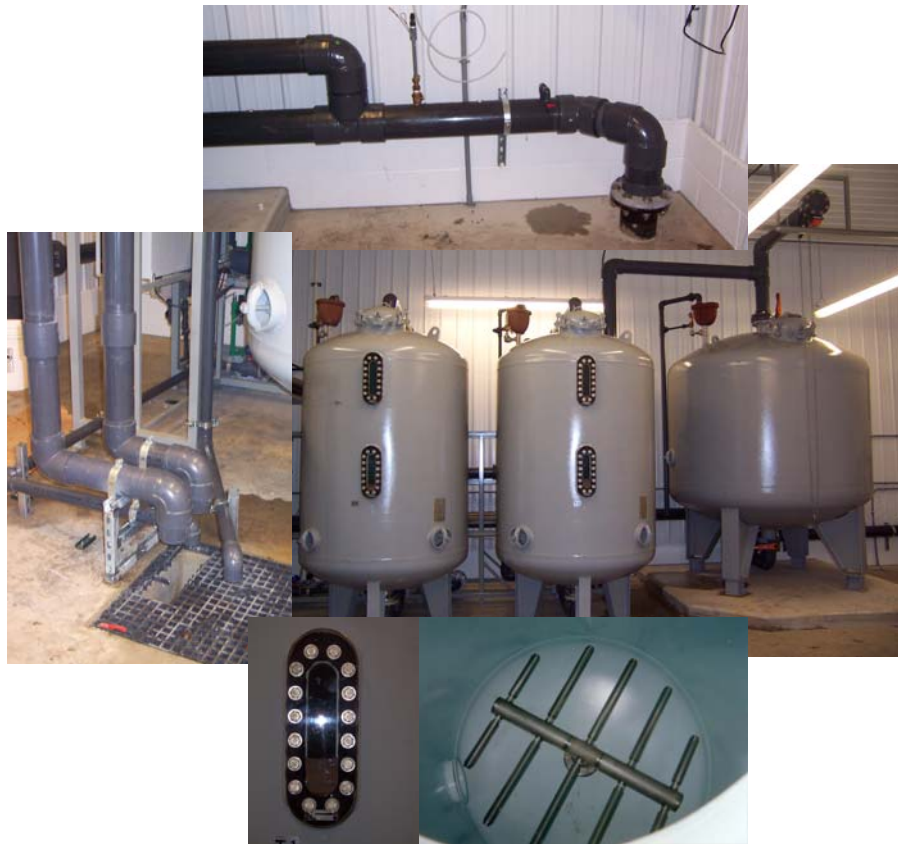
Figure 4-3. Treatment System Components

(Clockwise from Top: Well No. 2 Entry and Bypass Piping; Two Filter Tanks and a Contact Tank; Filter Tank Laterals and Viewing Window; and Backwash Discharge Piping to Building Sump)

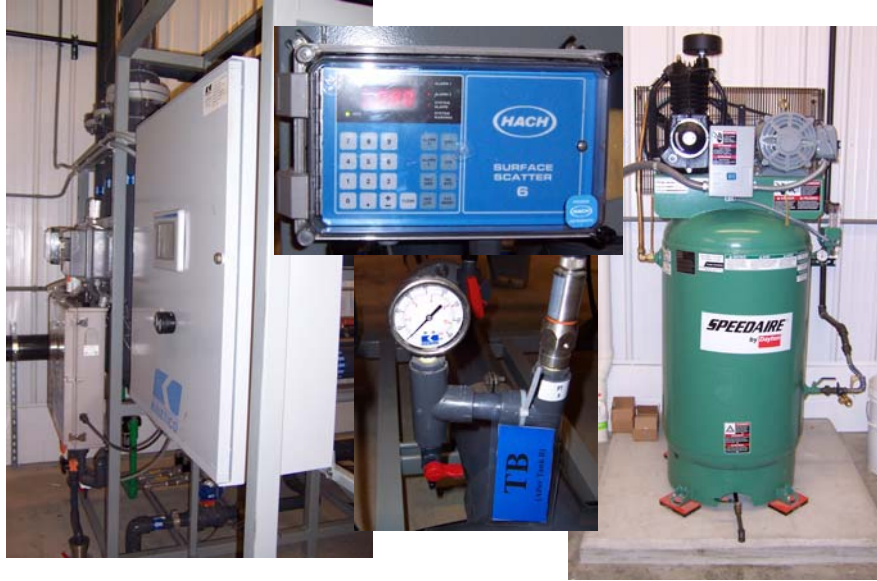
Figure 4-4. Control and Instrumentation

(Clockwise from Left: Control Panel Housing PLC; Turbidimeter Display; Compressor; and Sample Tap and Pressure Gauge)

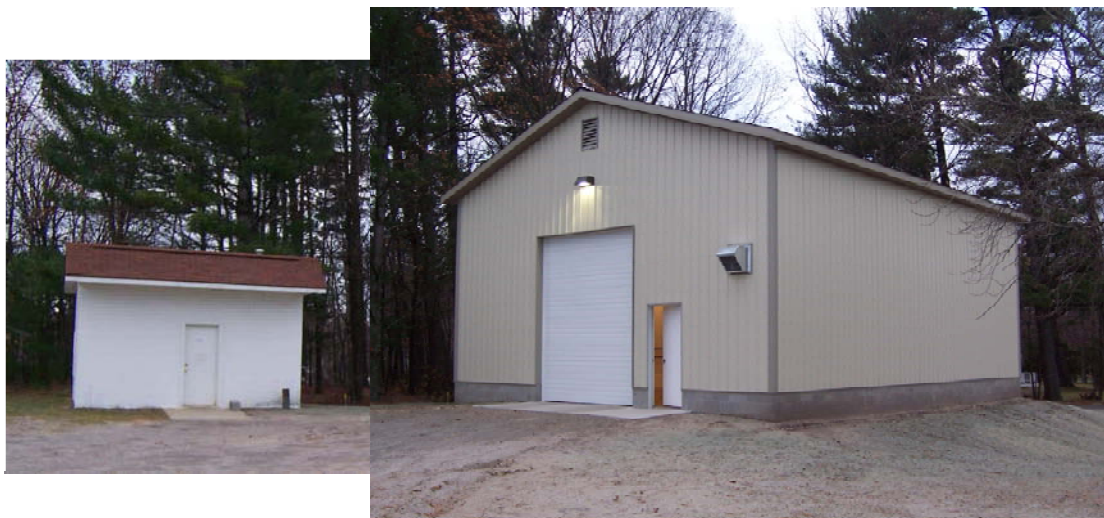
Figure 4-5. New Building Constructed Next to Existing Well No. 2 Pump House

4.3.2 Building Construction. A permit for building construction was applied for by the village and issued by Oceana County on August 17, 2005. Construction began on the following day and was completed on October 21, 2005. The building was 37 ½ ft × 33 ½ ft with sidewall and roof peak heights of 16 and 22.7 ft, respectively. The foundation had a 42-in-depth overlain with a 6-in concrete slab. A 12-ft-wide overhead door enabled ease of equipment placement and installation. Wastewater discharge was facilitated with a 1,500-gal underground sump that emptied by gravity into the sanitary sewer. Figure 4-5 shows the new building constructed adjacent to the existing Well No. 2 pump house. In addition to electrical and plumbing connections, a phone line also was installed on January 19, 2006 with service available on February 22, 2006 to enable the equipment vendor to dial into the modem in the control panel for any troubleshooting.

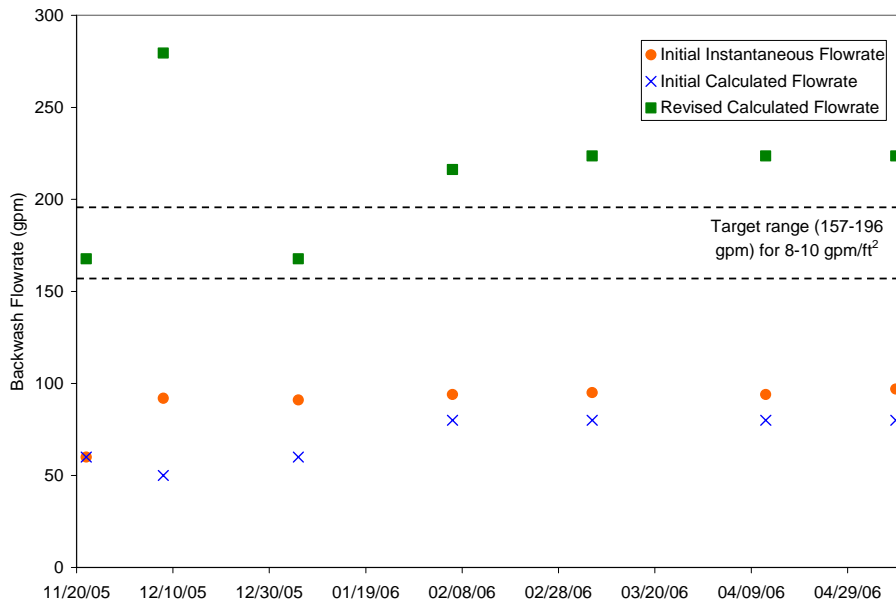
Figure 4-7. Backwash Flowrates According to Initial and Revised Calibration Values

Due to incorrect calibration of the backwash flow meter, the backwash flowrate readings were substantially lower than the design values. This problem, not identified until the vendor's site visit on May 15, 2006, had created a great deal of confusion concerning backwash flowrate, sump capacity, and media loss. Prior to the May 15, 2006 site visit, the maximum attainable backwash flowrate was thought to be only 104 gpm (which, in fact, was 295 gpm with proper meter calibration). At the "low" 104-gpm backwash flowrate, recurring overflow was observed from the building sump, which was designed for a discharge capacity of at least 150 gpm according to the Village Engineer. Further, some Macrolite[®] media was found in and around the sump after each backwash, with the loss confirmed and measured during the vendor's May 15, 2006 visit to be 3 and 4 in (or 5 and 7 ft³) from Tanks A and B, respectively. Prior to the vendor's site visit, several attempts had been made to verify the accuracy of flowrate readings (including using a portable flow meter) and to establish strategies to overcome problems associated with the "underdesigned" sump (including decreasing the maximum backwash time and low flowrate threshold and adding stagger time to allow the sump additional drain time between consecutive backwash cycles). After the flow meter was recalibrated, the backwash flowrate was adjusted to 180 gpm using a diaphragm valve. It also was determined that the filter-to-waste rinse was actually performed at approximately 350 gpm instead of the 200-gpm design value because all of the influent flow was going through one tank during this step.

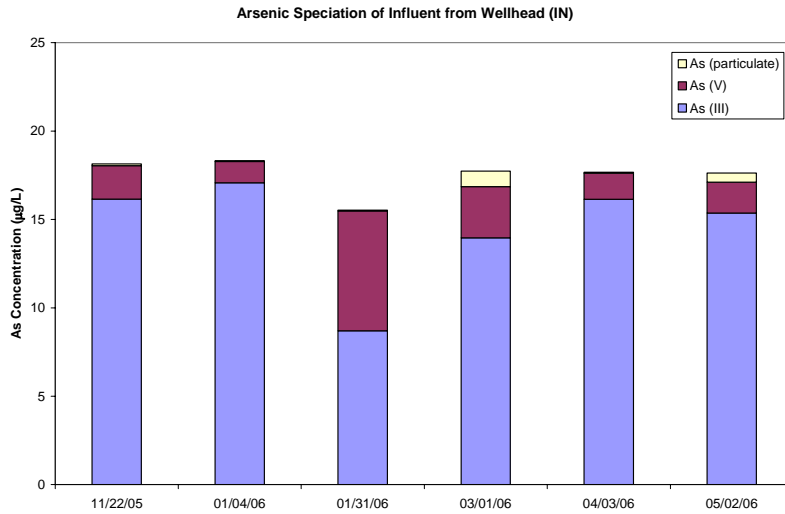
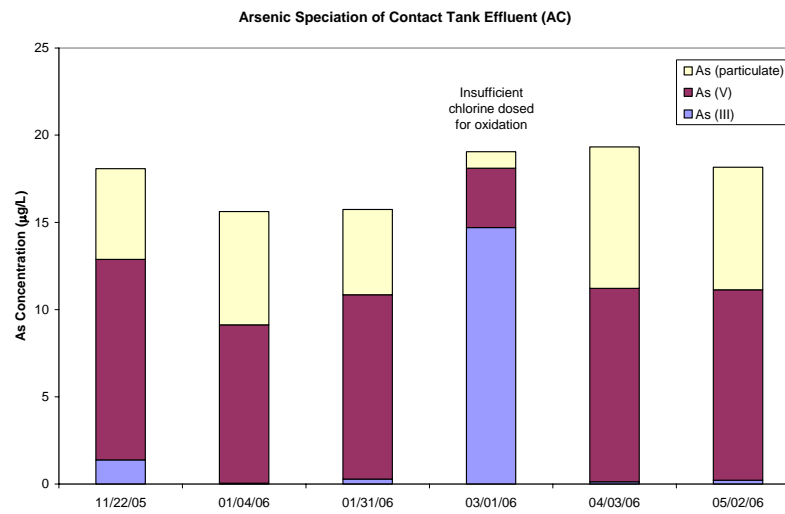
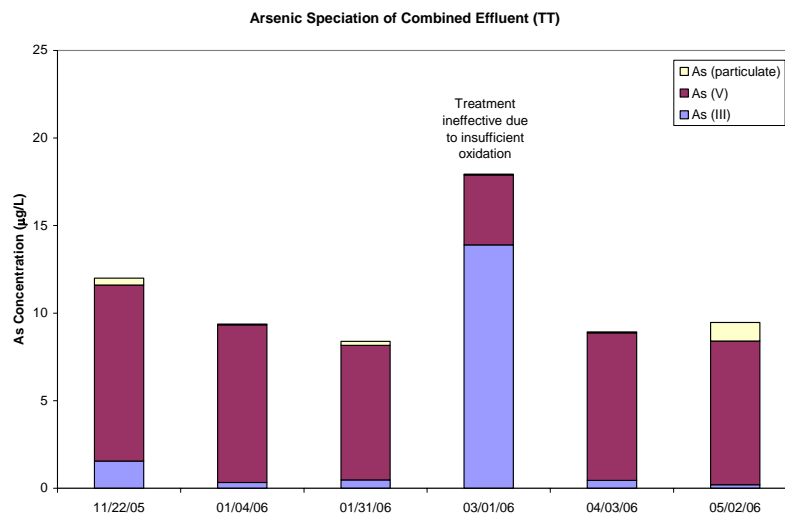
Figure 4-8. Arsenic Speciation Results at Wellhead (IN), After Contact Tank (AC), and After Tanks A and B Combined (TT)

The analytical results for water samples collected from February 22 to March 7, 2006 indicated insufficient chlorine addition for As(III) oxidation (Figures 4-8 and 4-9). For all other events, the results obtained after prechlorination and the contact tank indicated that As(III) was effectively oxidized to As(V). Average concentrations of As(III), As(V), and particulate As were 0.4, 10.6, and 6.3 µg/L, respectively. The high As(V) levels in water after the contact tank indicated incomplete adsorption of As(V) onto iron solids. Ideally, high levels of particulate As and low to non-detectable levels of As(III) and As(V) should exist prior to entering the pressure filters.

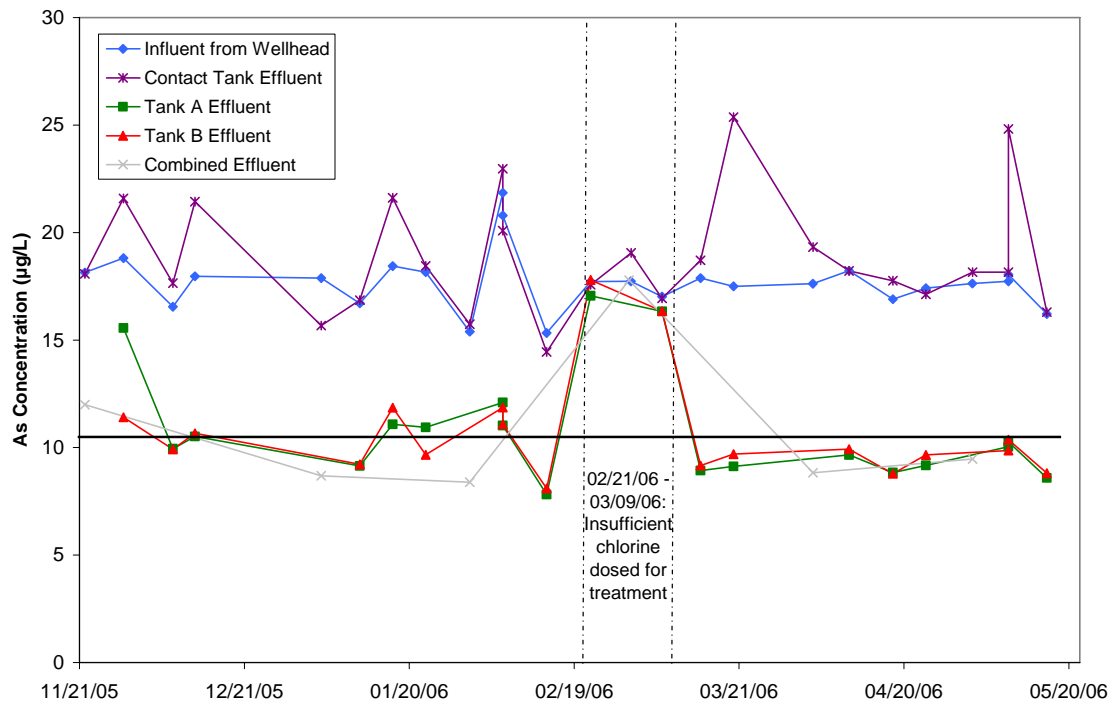
Figure 4-9. Total Arsenic Concentrations Across Treatment Train

With sufficient chlorine addition, total arsenic concentrations after the pressure filtration at the TA, TB, and TT sampling locations ranged from 7.8 to 15.6 µg/L and averaged 10.0 µg/L. It became evident soon after startup that the treatment system was not able to consistently remove arsenic to less than 10 µg/L. This observation was supported by the fact that the ratio of soluble iron to soluble arsenic was just over 21:1, which was on the borderline with the rule of thumb ratio of 20:1 for effective arsenic removal. Two
