MIDESSA (MIDLAND COUNTY) MIDLAND, TEXAS

EPA ID# TXN000606668
Site ID: 0606668

Updated: May 2009

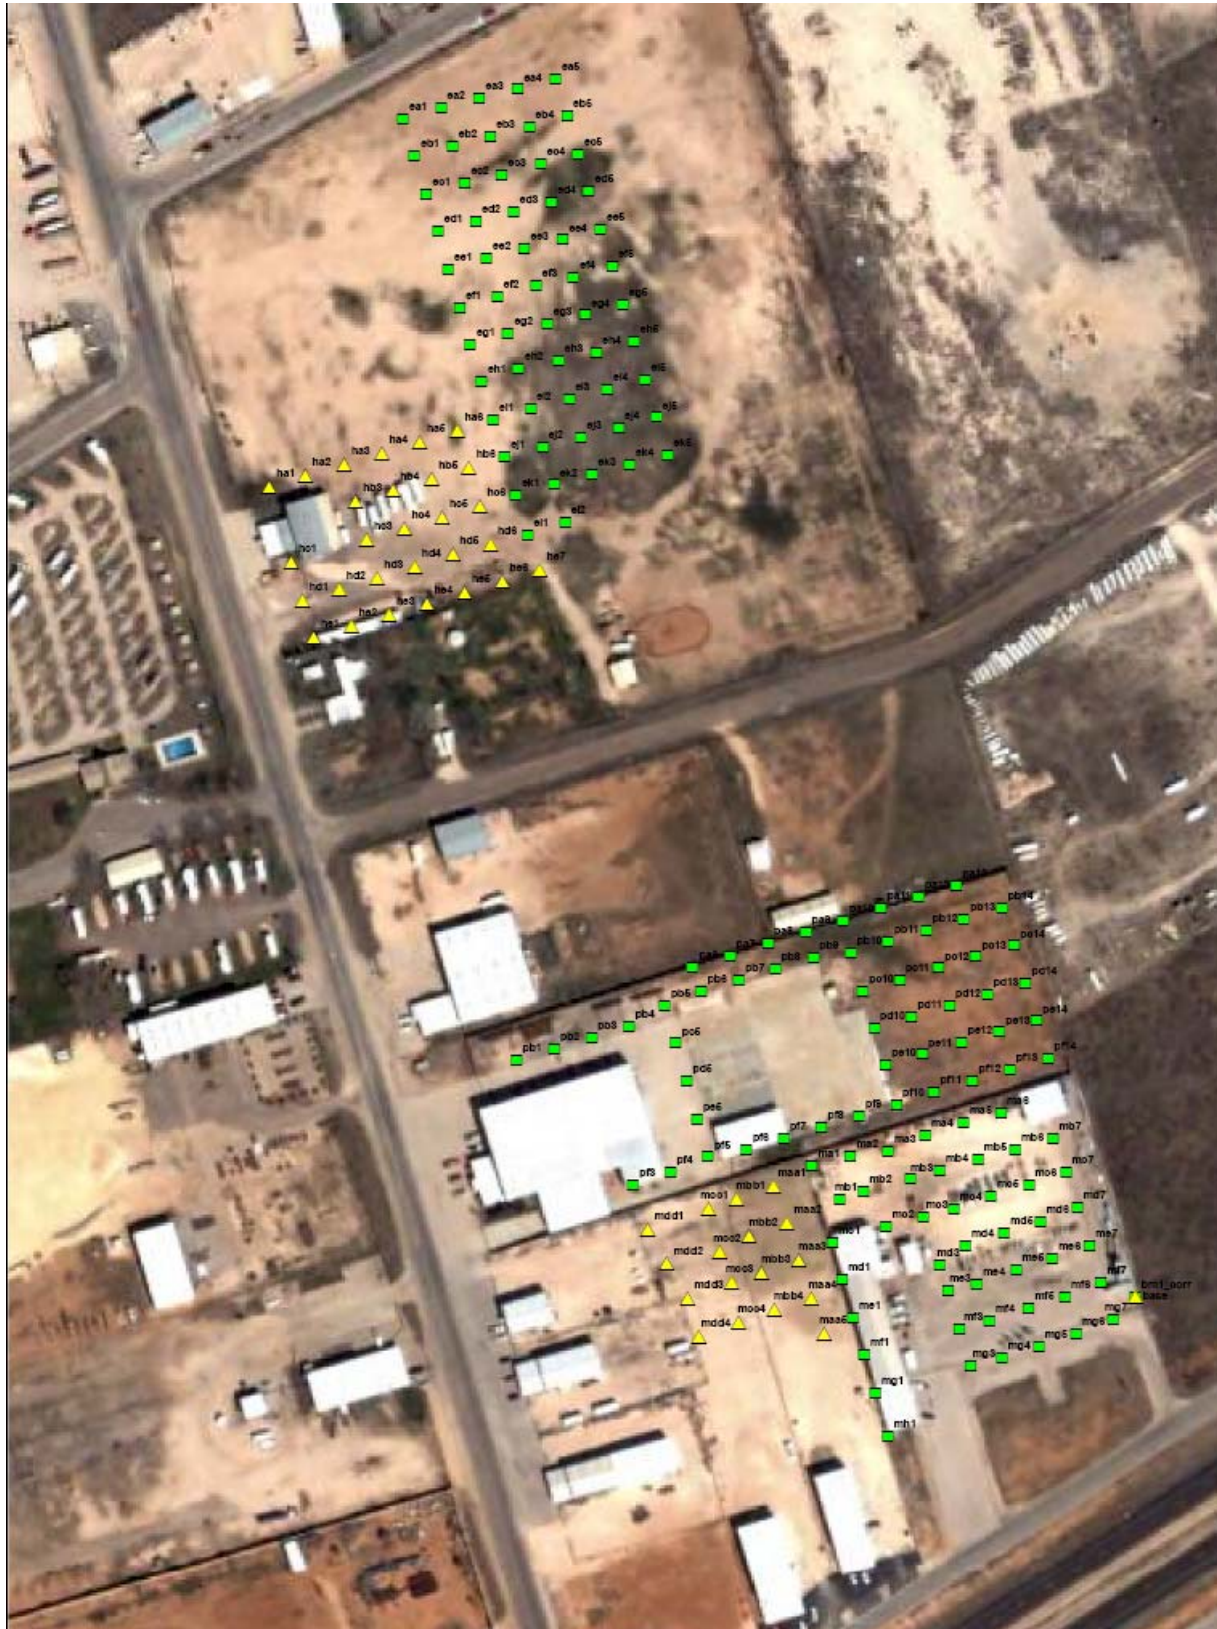
The following site map illustrates the locations of the passive soil gas samplers installed in the eastern side of the site. The green squares mark the location of individual samplers installed in April 2008. The yellow triangles mark the locations of individual samplers installed in June 2008.

EPA has installed and collected data from 295 passive soil gas samplers across the Site between March and June 2008. The soil gas data assists in identifying nearby source areas with past releases of volatile organic chemicals (VOCs) (see site map below). The samplers installed in the southern area of the Site detected a significant presence of tetrachloroethene in the soil gas. No other significant VOC detections were noted in the remainder of the Site.

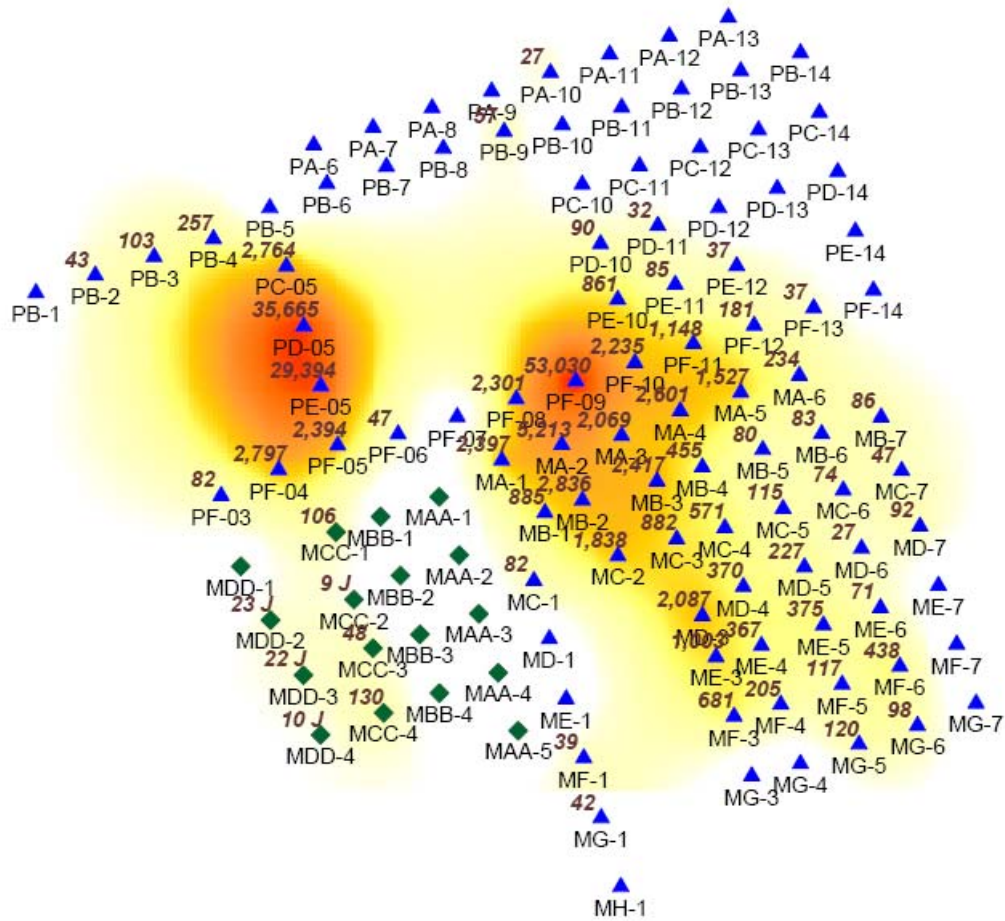
The following site map illustrates the detections of tetrachloroethene in the passive soil gas samplers installed at the south side of the site (see site map above). The blue triangles and green diamonds mark the location of individual samplers (see site map above). The passive soil gas samplers installed on the north side of the site did not detect tetrachloroethene or any of the other contaminants of interest at the site.

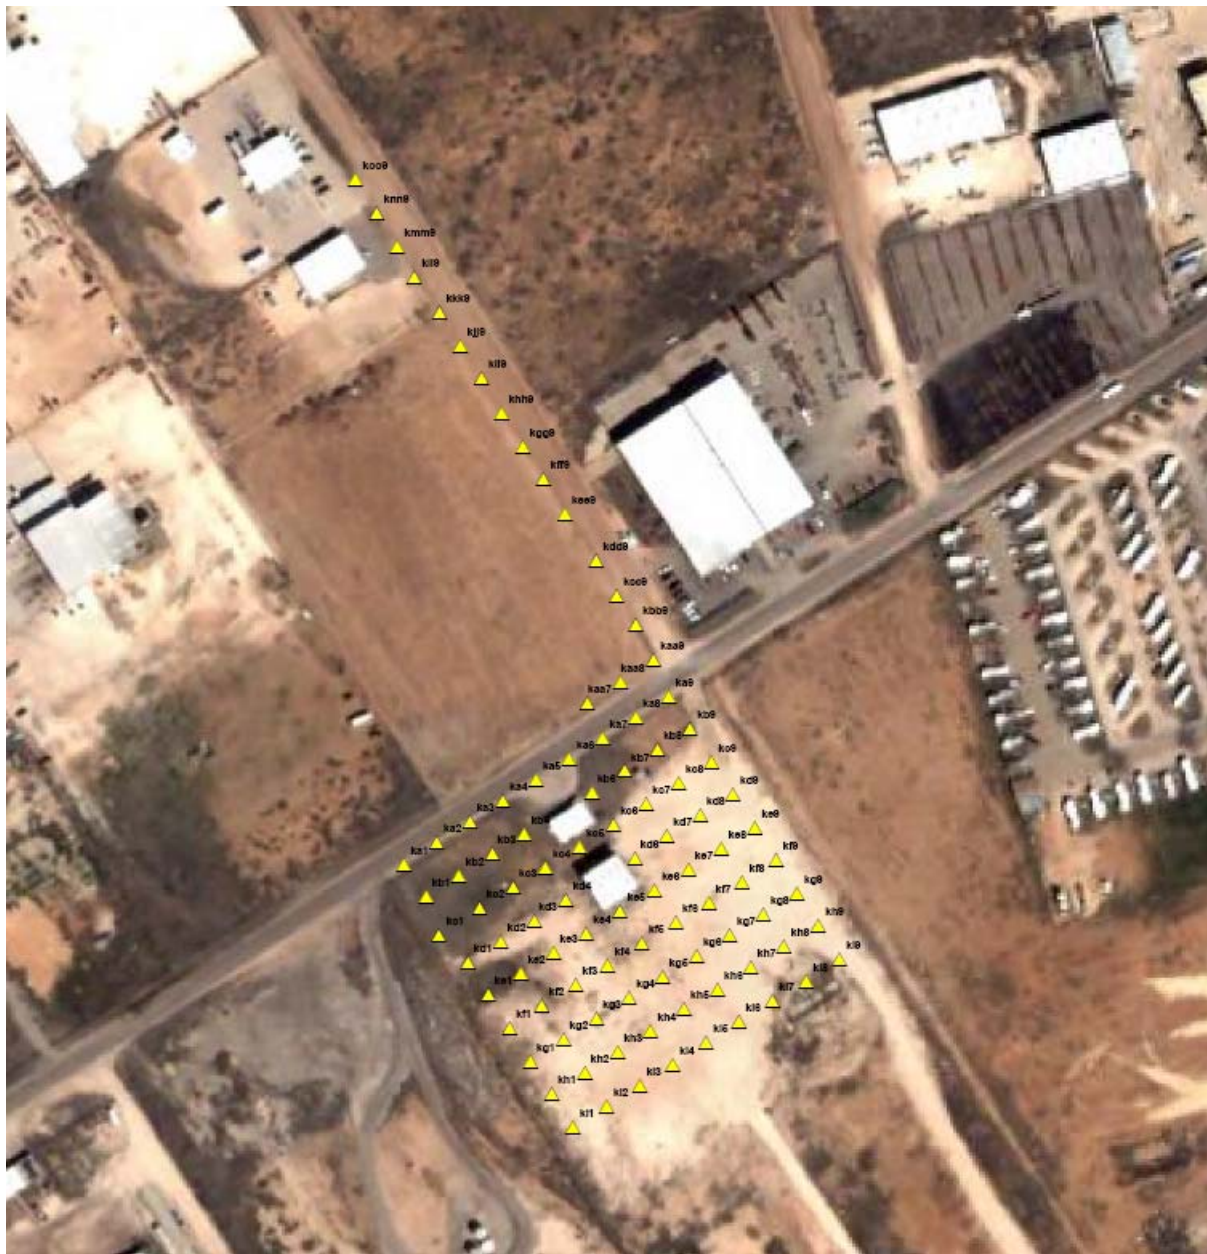
The following site map illustrates the locations of the passive soil gas samplers (yellow triangles) installed in the western side of the site in June 2008. Tetrachloroethene was only detected in one sampler.
