Safety of High Speed Guided Ground Transportation

Collision Avoidance and Accident Survivability Volume 1: Collision Threat

DOT/FRA/ORD-93/02.1 DOT-VNTSC-FRA-93-2.1

Final Report March 1993 This document is available to the public through the National Technical Information Service, Springfield, VA 22161

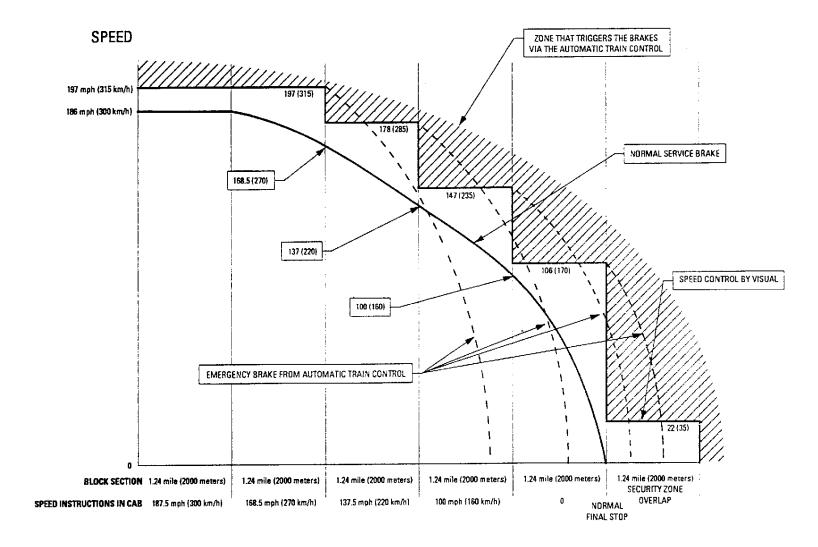
Figure 3-2. Speed Control and Braking Distances on the TGV Atlantique

a. The TVM 300 signalling system, used on both the TGV Paris-Southeast and Atlantique lines, depends on coded track circuits for track-to-train communication. At the beginning of each block the train receives data from the coded track circuits indicating the maximum permitted speed at the end of the block, as illustrated in Figure 3-2. The operator cab displays providing the speed commands are shown in Figure 3-3. There are no lineside signals, only marker boards to indicate the start of each block. Blocks are 2.1 km long on the PSE line, 2.0 km on the Atlantique line, and will be 1.5 km on the TGV Nord to the Channel tunnel with an enhanced signal system called TVM 430. The permitted speed, or the target speed at the next marker if a speed reduction is required, is displayed in the cab. If the "control" speed (as shown on Figure 3-3) is exceeded, then an automatic brake application is made. Normally, this speed is 15 km/h (10 mph) above the maximum speed allowed in the block. "Stop and proceed" is allowed from a stop at selected markers (those not protecting a turnout) at a maximum speed of 30 km/h (19 mph). The engineer also has a voice radio contact with the TGV control center.

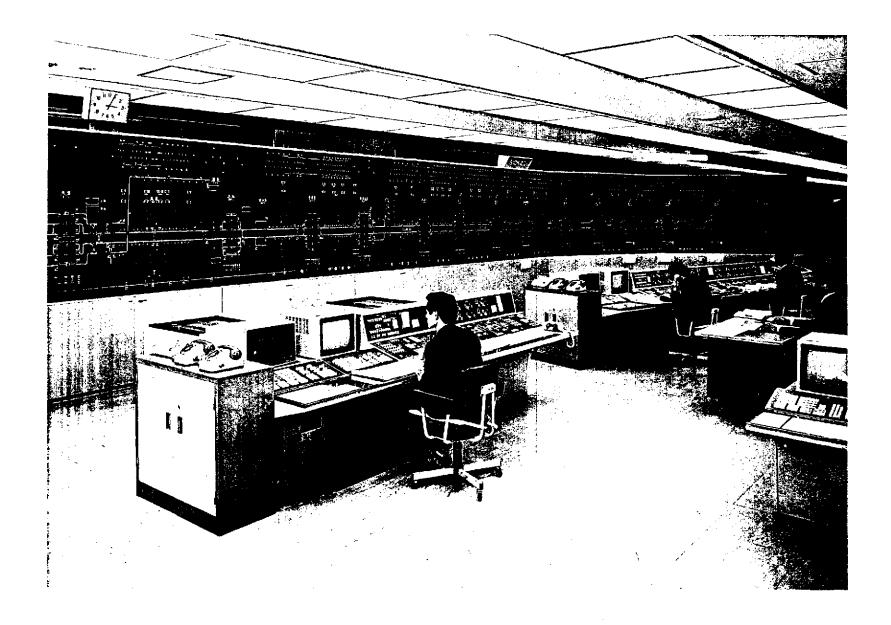
Figure 3-4. General View of Shinkansen Control Center

The three major components of the signal and control system on the Shinkansen high speed lines are an ATP system, a Centralized Train Control (CTC) system with the COMTRAC traffic control system, and voice radio.

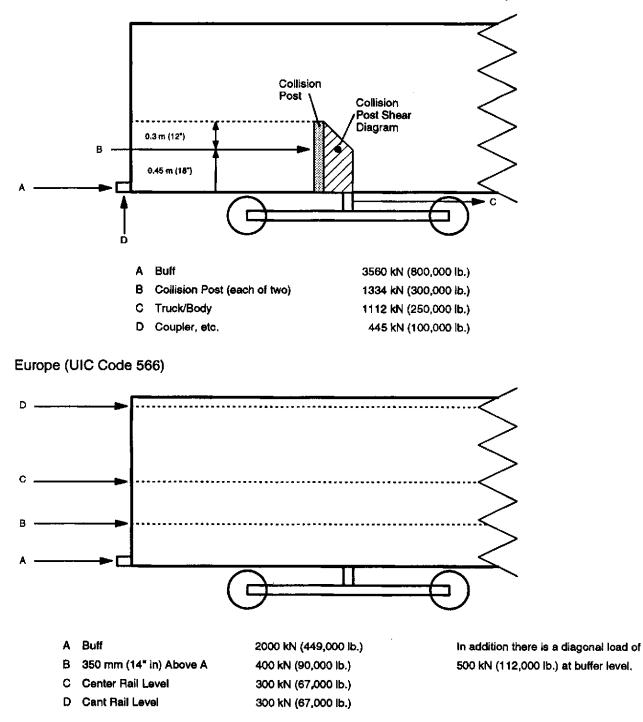
Figure 3-6. Comparison of North American and European Car Body Strength Requirements

North America (AAR/FRA), for trains exceeding 272 tonnes (600,000 lb) empty mass

The Association of American Railroads (AAR) requirements apply to passenger cars operated in trains exceeding 27,200 kg (600,000 lb.). They are identical to the FRA standards for MU locomotives.

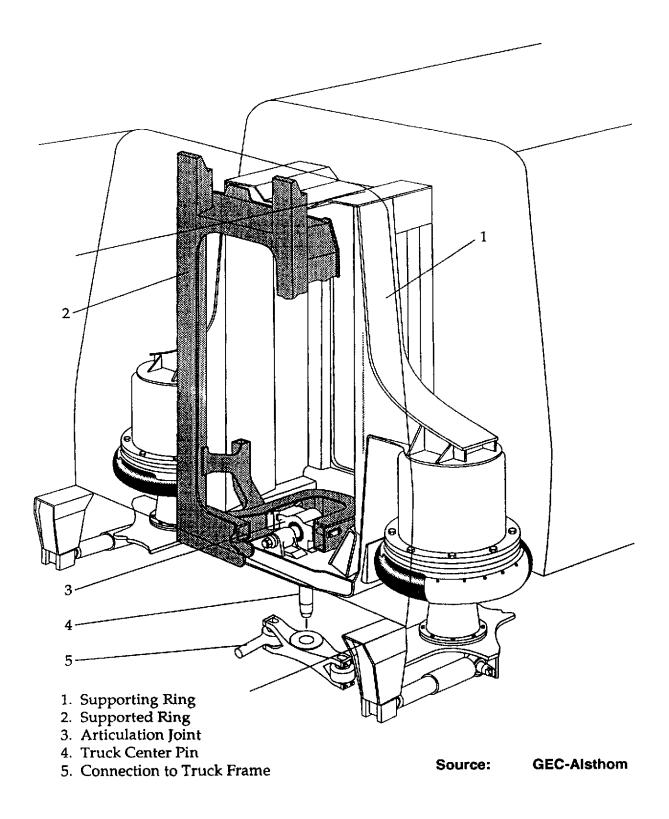
Figure 3-7. Articulation Arrangement of the TGV Atlantique

Note that these are minimum requirements, and actual strength could be significantly higher. This may be particularly so in the case of articulated trains such as Talgo and TGV, where the truck is effectively trapped between two vehicle bodies.

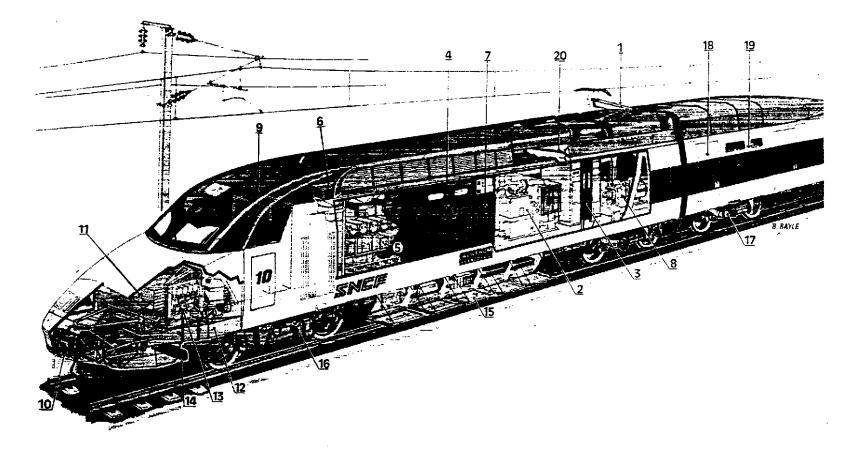
- 1 SINGLE ARM PANTOGRAPH 2 - MAIN TRANSFORMER **3 - CIRCUIT BREAKER, LINE FILTER** 4 - MICROPROCESSOR-CONTROLLED TRACTION MOTOR 5 - FREON COOLING FOR SEMICONDUCTORS 6 - BRAKING RHEOSTAT 7 - AUXILIARY POWER SUPPLY
- 8 MAIN COMPRESSOR

10 - AUTOMATIC COUPLER

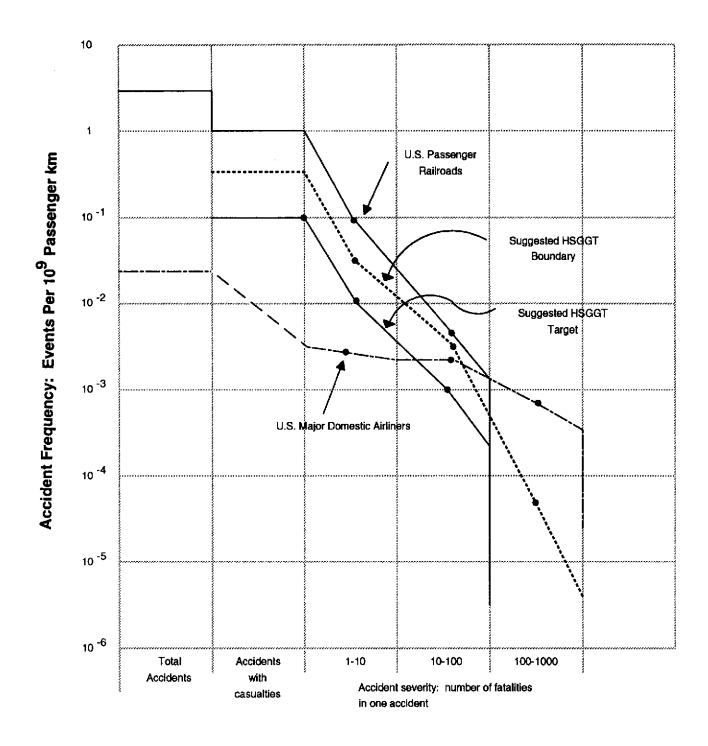
Figure 4-2. Risk Profiles for Passenger Railroad and Airline Operations in the United States

The risk profiles shown in Figure 4-2 illustrate the significant differences in the frequency and severity of commercial aviation accidents relative to intercity railroad accidents. At severity levels below ten fatalities per accident, there are substantially fewer aviation accidents than railroad accidents per billion passenger-km. The different is less marked at severity levels between 10 and 100 fatalities per accident, and only aviation accidents result in severity levels exceeding 100 fatalities per accident. The flatter slope of the aviation profile reflects the all-ornothing nature of aviation accidents. Overall, the aviation accident rate is substantially lower than the railroad accident rate. However, this appears to be inconsistent with the public perception of the safety of the two modes, illustrating how perception is influenced strongly by accident severity, but only weakly by the fact that the amount of air travel is much greater than rail travel in the U.S. Accidents that result in personal injury but no reportable damage to the train or airplane have been excluded from the data for both modes. The data from which the profiles were obtained is given in Table 4-2A.
