Commuter Rail Seat Testing and Analysis of Facing Seats

DOT/FRA/ORD-03/06

Final Report
December 2003

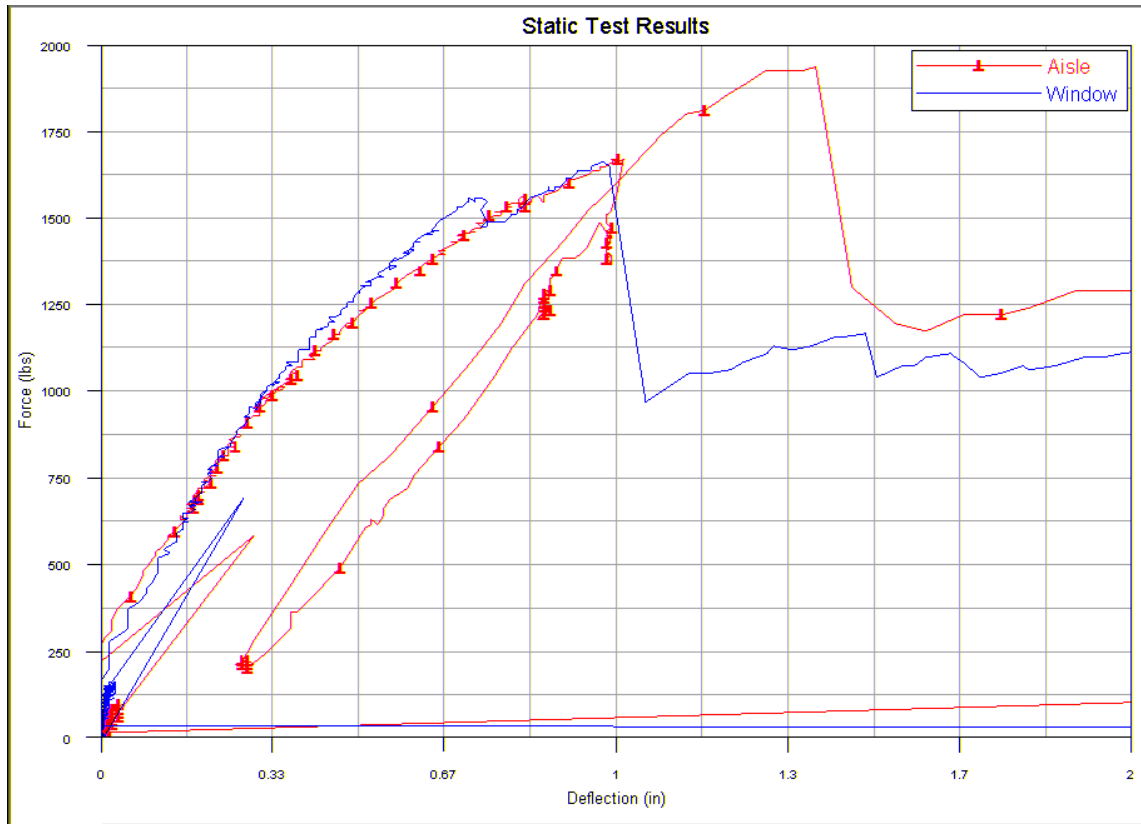
Figure 6. Static Test - Load-Deflection Curve

One static test was conducted on August 23, 2000. The load was applied independently at the top of each seat back at a rate of 2 inches/minute. The seat proved to be stiffer than anticipated. The seat stiffness was greater than that measured for the Long Island Railroad commuter seat (tested in October 1998), which is a cantilevered two-place passenger seat system comprised of a thermoplastic casing surrounding an extremely rugged tubular frame². Failure of the thermoplastic casing of the seat occurred at the seat/pan junction. The primary failure on the aisle side of the seat was initiated at the point where the seat pan turns upward to the seat back. The failure propagated at a 45-degree angle toward the outer corner of the seat pan/seat back intersection. The window side of the seat also experienced a fracture at the same location, but the primary failure occurred across the top of the seat back. The load-deflection curve (Figure 6) shows that while the aisle- and window-side seats had different modes of failure, the stiffness characteristics were identical up to failure. Figures 7 and 8 show the window- and aisle-side seats and their failure modes.

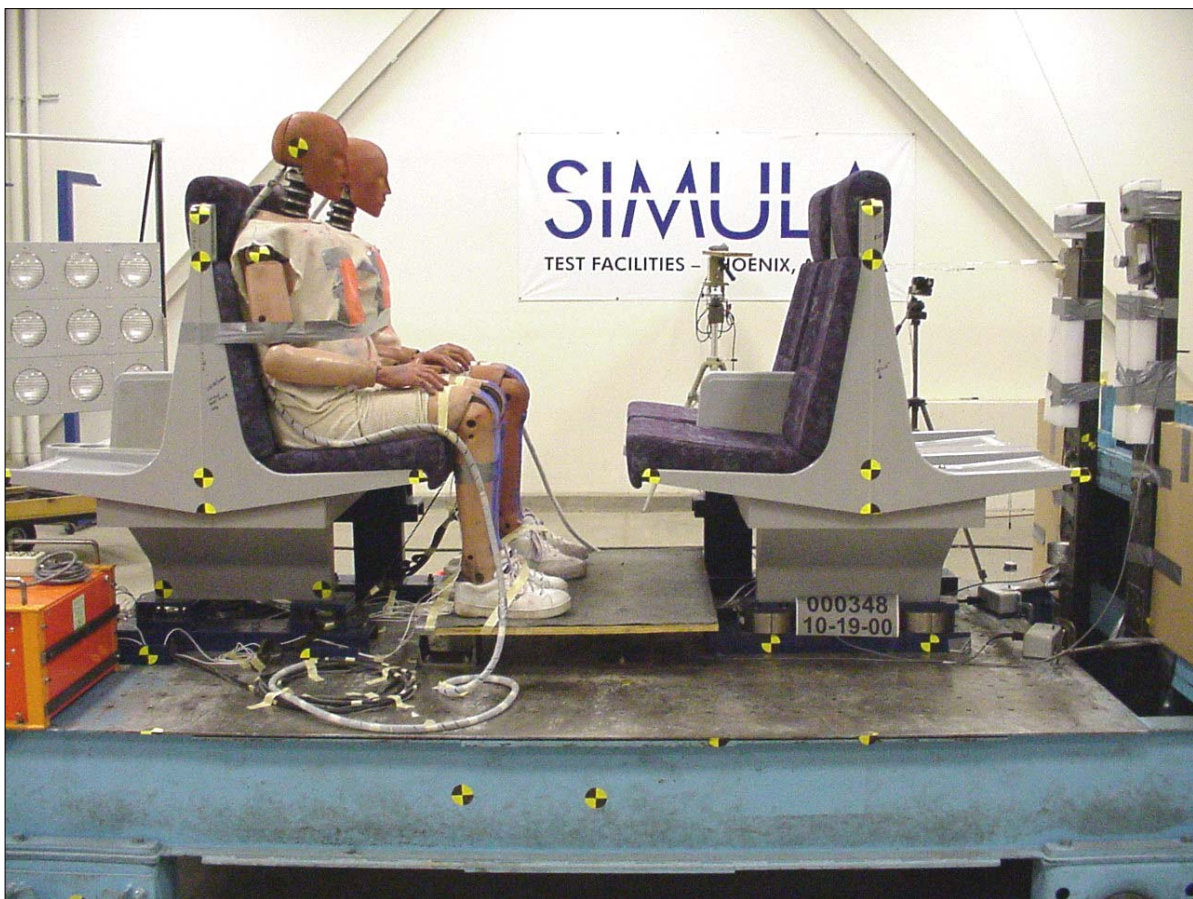
Figure 9. Dynamic Sled Test Configuration of Two Back-to-Back Facing Seats with 65-inch Seat Pitch, No Table

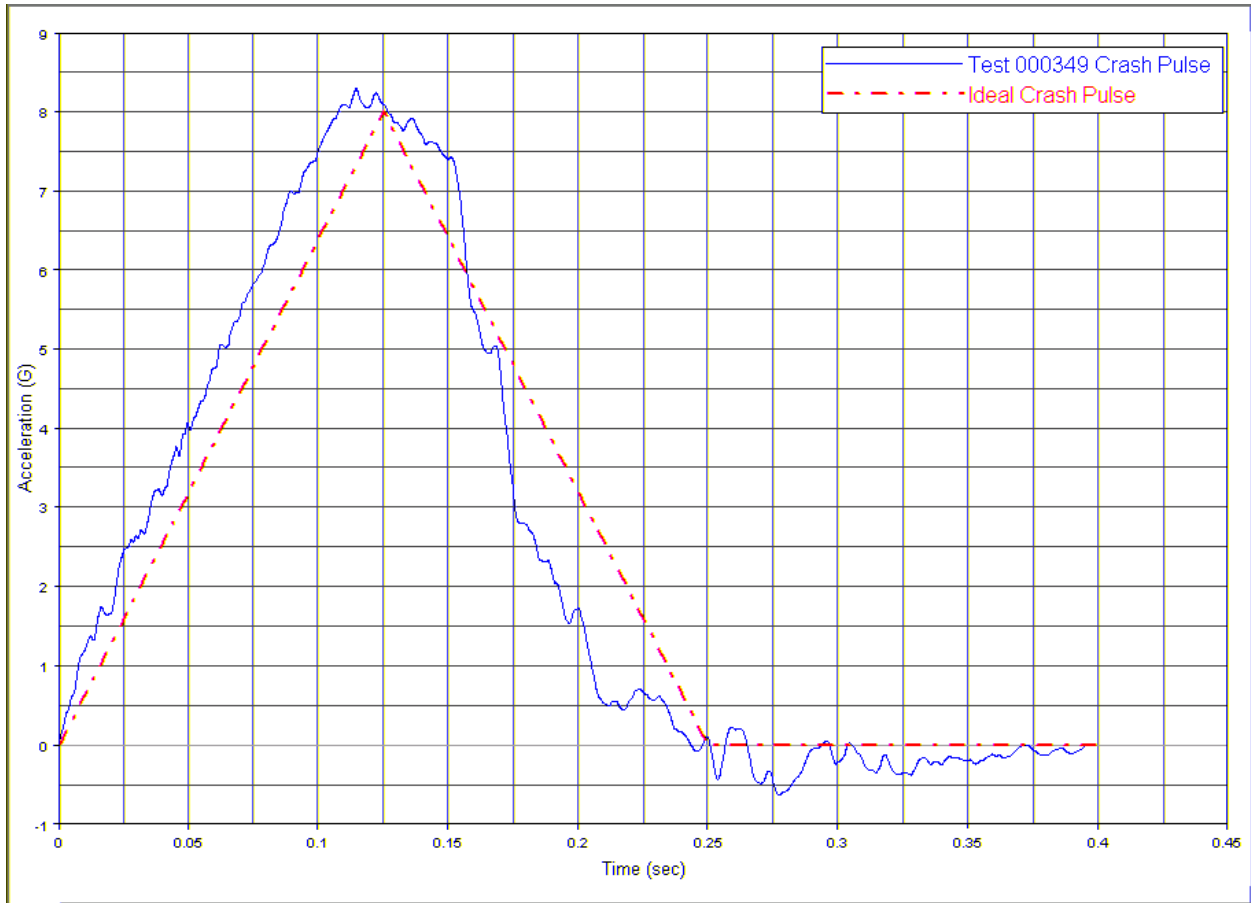
Figure 15. Sled Crash Pulse (Actual and Ideal)

All dynamic tests represented a triangular crash pulse with a duration of 250 msec and, except for third test, an 8 G peak acceleration that occurs at approximately 125 msec. Test No. 3 was conducted with a 9 G peak acceleration. Figure 15 shows the “ideal” triangular crash pulse and a corresponding pulse that was produced during an actual sled test (Test No. 4).

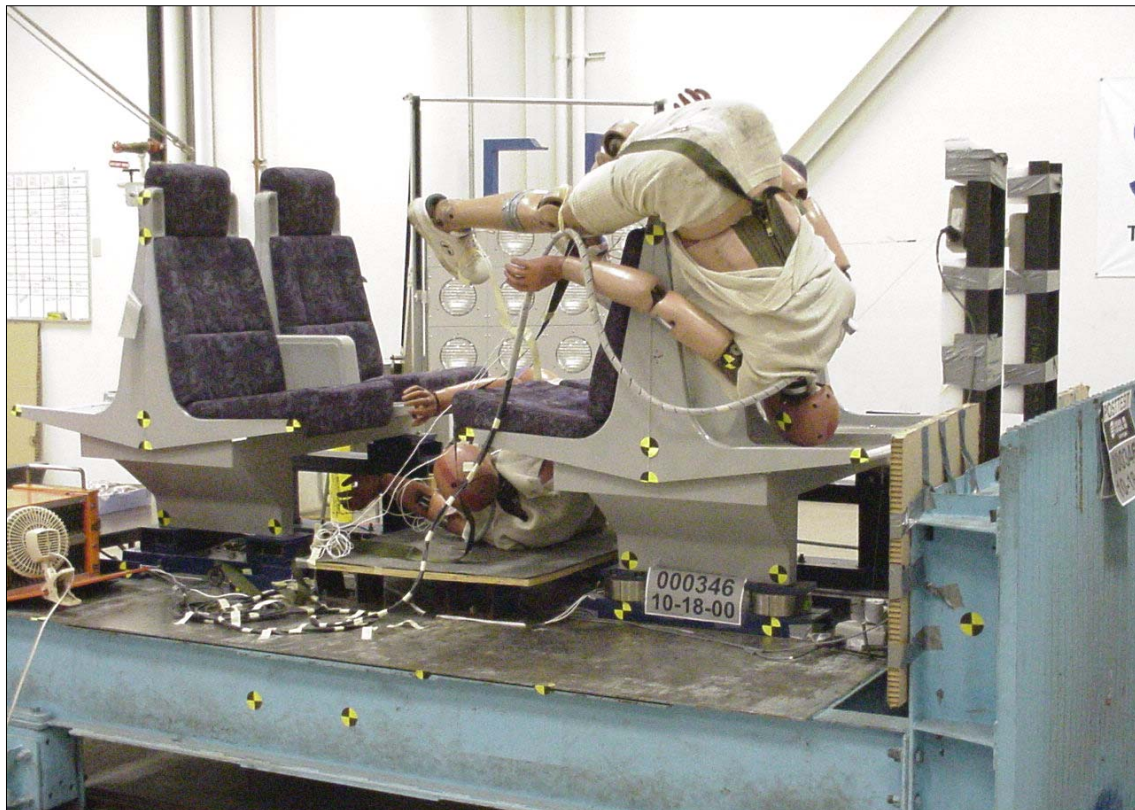
Figure 18. Post-test Photo of Test No. 1, Baseline Test

5.2.1.2 Post-test Description - The seat components remained attached during this test. While there was no damage to the aluminum base frame, the thermoplastic grab handles cracked. The cracks did not propagate, however, so the entire headrest did not tear off of the seat back. The seat cushions remained attached as well. The window-side ATD remained compartmentalized, while the aisle-side ATD traveled over the seat back in front of it, landing on top of the headrest.

The head of the window-side ATD in this test impacted relatively low on the seat back in front of it, while the head of the aisle-side ATD hit higher up on the seat back, near the top of the headrest, causing it to crack almost to complete failure. The reason for the difference in head impact location is due in part to the translational differences of the ATD's feet. While both ATDs wore shoes that complied with the standard (J211), the shoes' soles were not made of the same material, and they reacted differently across the floor; specifically, the shoes on the aisle-side ATD had "bumpier" soles, which caused greater friction, and this caused the ATD to rotate forward nearly about the tip of its feet. For the window-side ATD, the shoes allowed the ATD's feet to slide along the floor, carrying the entire body of the ATD across to the seat in front. The

ATD's knees impacted the lip of the seat pan, causing the ATD to rotate at that time about the knees, with the head impacting the top of the seat back below the headrest. This ATD rebounded back toward the launch seat. The feet on the aisle-side ATD, however, stuck to the floor near their initial position, so the body of the ATD pivoted more about the feet than the knees, which then impacted the seat cushion (not the front lip of the seat pan) keeping the ATD more upright, allowing its head to impact the uppermost portion of the seat back, at the top of the headrest. This aisle-side ATD then traveled over the top of the seat back and did not remain compartmentalized. Figure 17 provides a three-frame sequence of the occupant kinematics for the Baseline Test No. 1, and Figure 18 provides the post-test view.

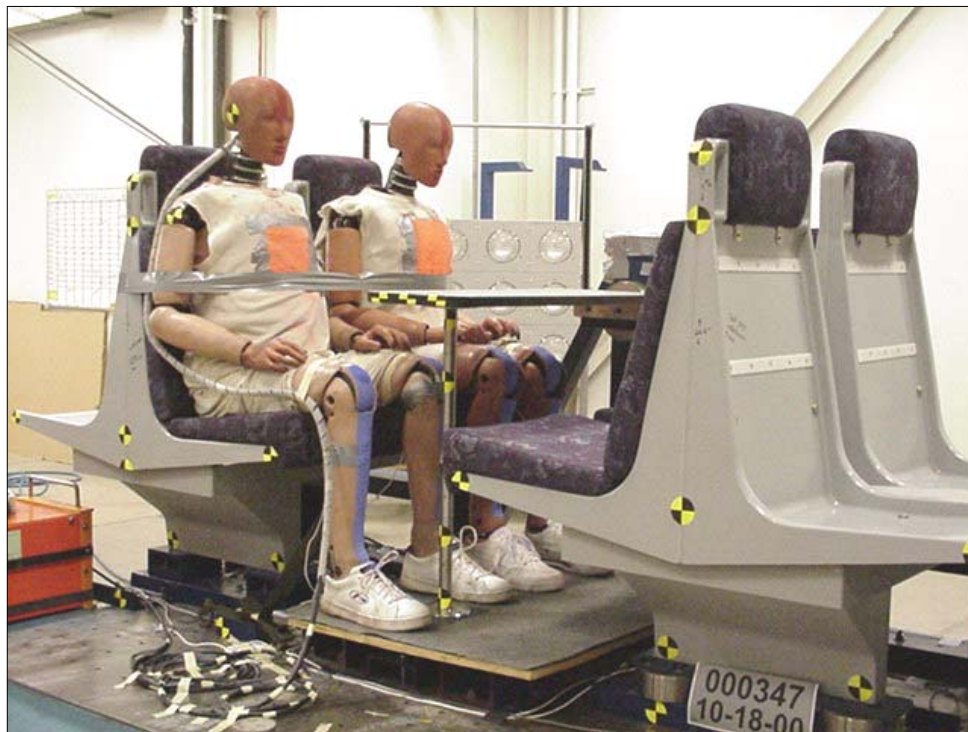
Figure 19. Pre-test Photo of Test No. 2, Baseline with Table

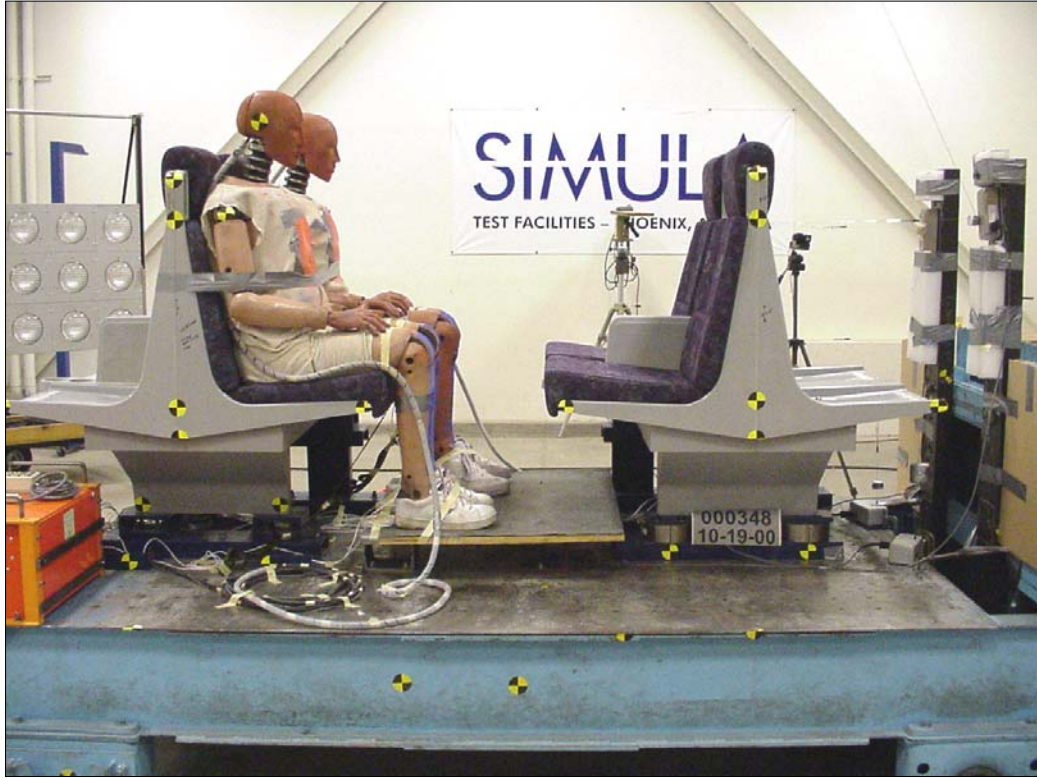
Figure 23. Pre-test Photo of Test No. 3, Baseline Configuration with 9 G Peak Acceleration

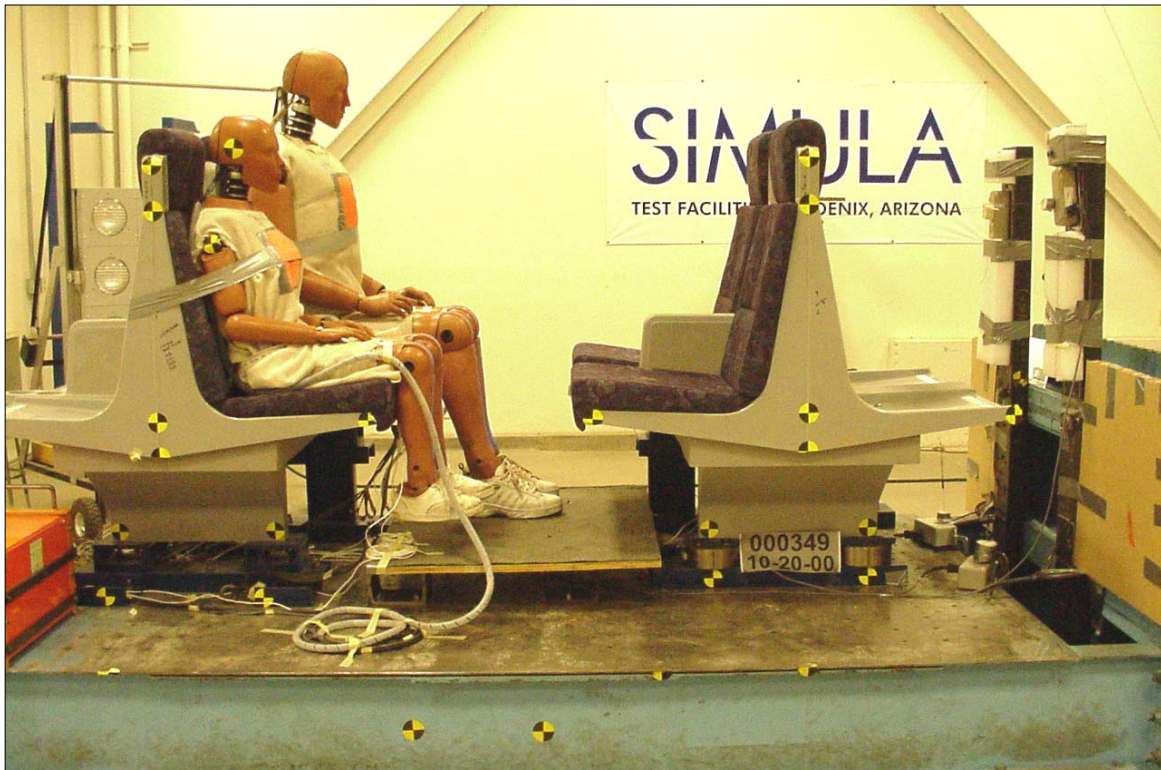
Figure 26. Pre-test Photo of Test No. 4, Baseline with 5th- and 95th-Percentile Size ATDs

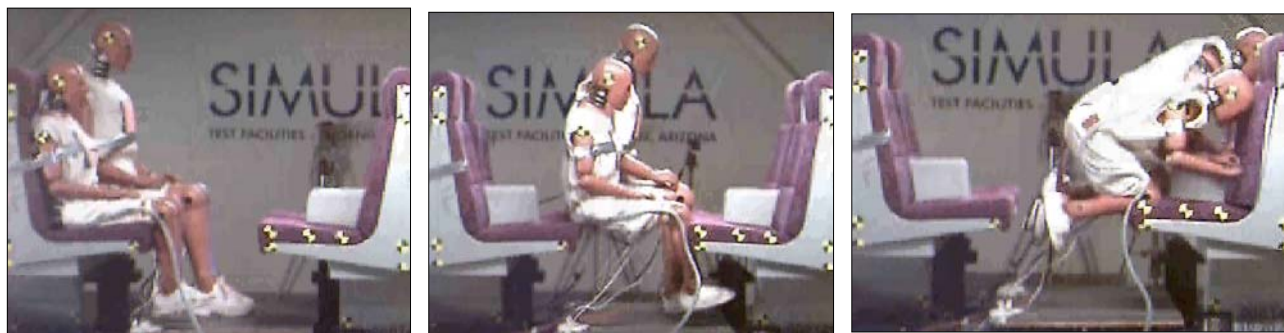
Figure 27. Test No. 4, Occupant Kinematic Sequence for the 5th- and 95th-Percentile ATDs, 8 G Peak Acceleration

impact the upper part of the seat back (the headrest area), failing the headrest. There was very little head/neck bending during the transition of the ATD through the headrest. The ATD's chest hooked on top of the headrest, and then the body traveled forward until the abdomen landed on the headrest. The top of the head of the ATD landed severely on top of the seat pan of the forward-facing front-row seat. The window-side ATD did not stay compartmentalized.

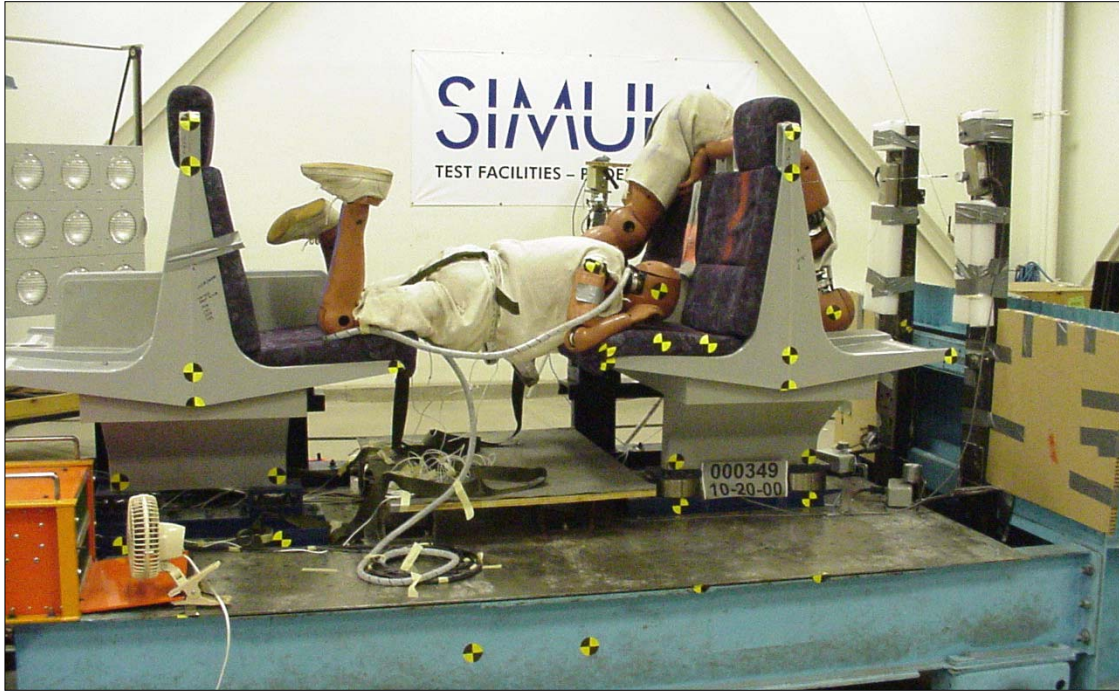
Figure 28. Post-test Photo of Test No. 4, Baseline Test with 5th- and 95th-Percentile ATDs

5.2.4.2 Post-test Description - While there was no damage to the aluminum base frame, there was significant damage to the window-side grab handle, causing complete failure of the headrest on the window side. In previous tests, the headrests on the aisle side failed, but in this test, the window-side seat was occupied by a 95th-percentile ATD that created a higher impact load on the headrest. Additionally, the added height of the 95th-percentile ATD caused its head to

The aisle-side was occupied by a 5th-percentile ATD that did not have the height or the weight to impact high on the seat back or induce forces high enough to cause seat failure. The 5th-percentile ATD's feet did not touch the floor, so its shoes or feet did not play any role in the ATD's motion. The top of the head of the 5th-percentile ATD impacted well below the base of the headrest, causing its head/neck to bend severely. Since the seat did not absorb as much energy through a structural failure, the 5th-percentile ATD absorbed the loads instead, thus creating neck forces and moments that exceeded the injury criteria. The seat cushions remained attached in this test (there was no translational motion of the seat pan cushion from the knees of the 5th-percentile ATD). The 5th-percentile ATD remained compartmentalized between the two seat rows.

This seat did not meet the structural requirements of the APTA Standard. While the 95th-percentile ATD did not remain compartmentalized, it is currently only a requirement for the 50th-percentile ATD to remain compartmentalized during testing. Figure 27 provides a three-frame sequence of the occupant kinematics, and Figure 28 is a post-test view of the test. See Table 14 for the results of the test.

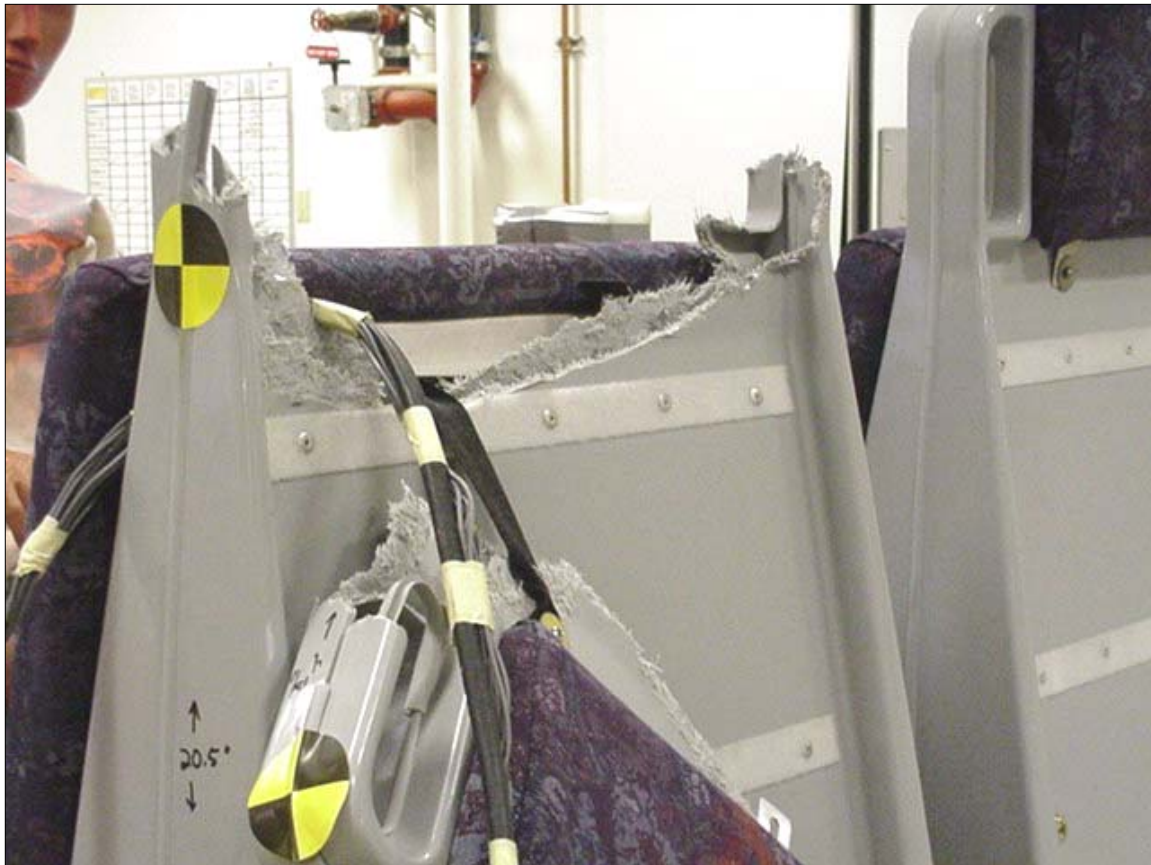
Figure 29. Jagged Seat Back Edge Resulting from Failed Headrest

There were several seat failures that were repeated in all four tests. The headrest portion of the seat back sheared completely from the remaining part of the seat back, leaving a jagged, fiber-pronged edge (see Figure 29). The headrest failure occurred after the grab handles cracked (see Figure 30). Figure 31 shows the markings of a typical collision between the launched ATD and

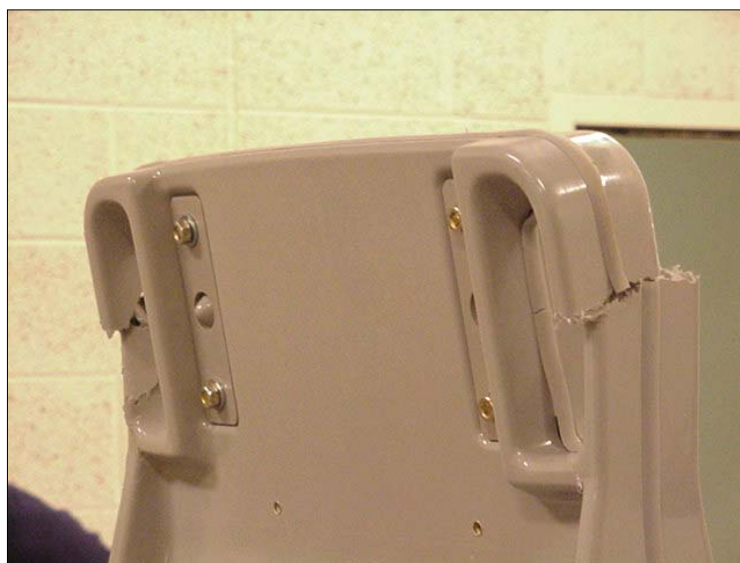
Figure 30. Broken Grab Handles

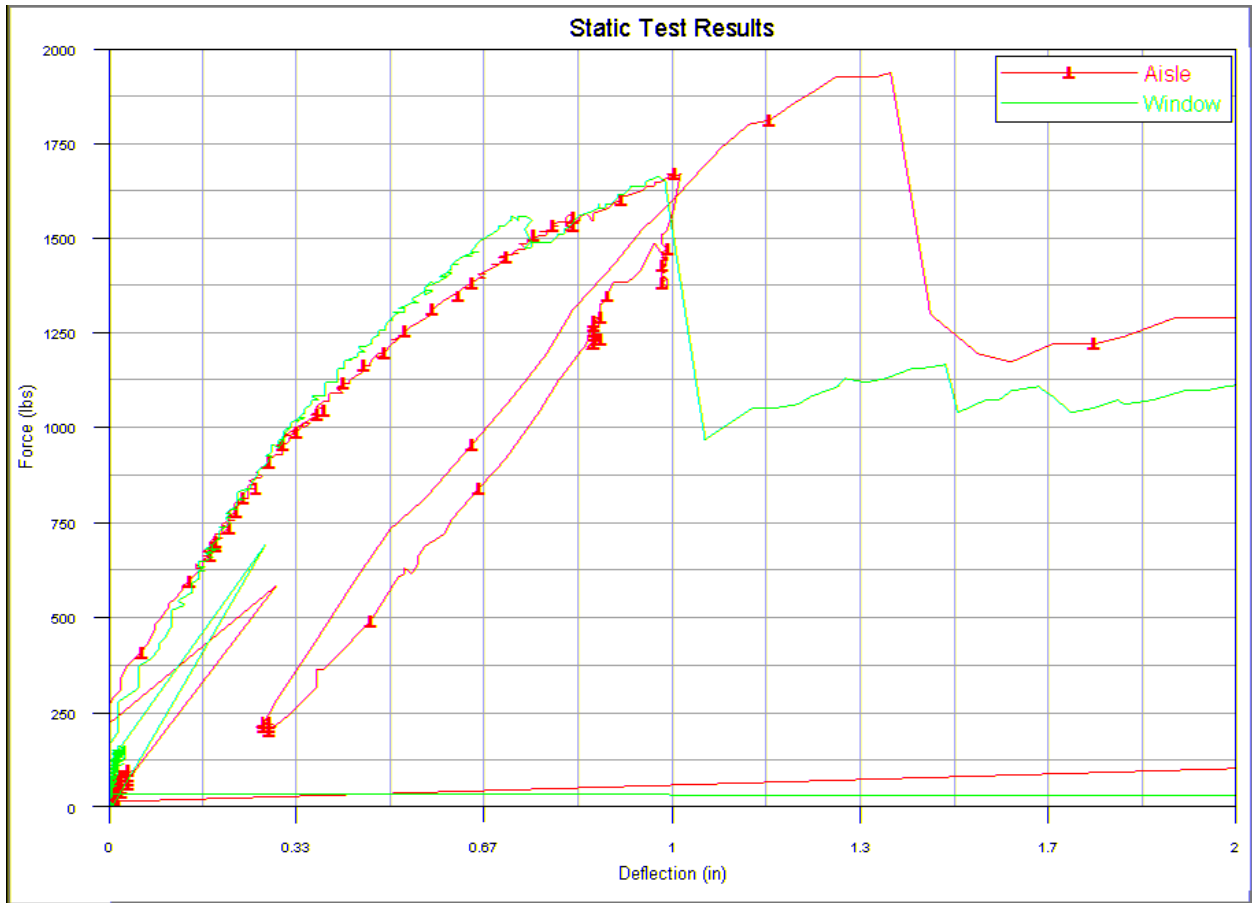
Figure A2. Static Test - Load-Deflection Curve on a 2-in. Scale

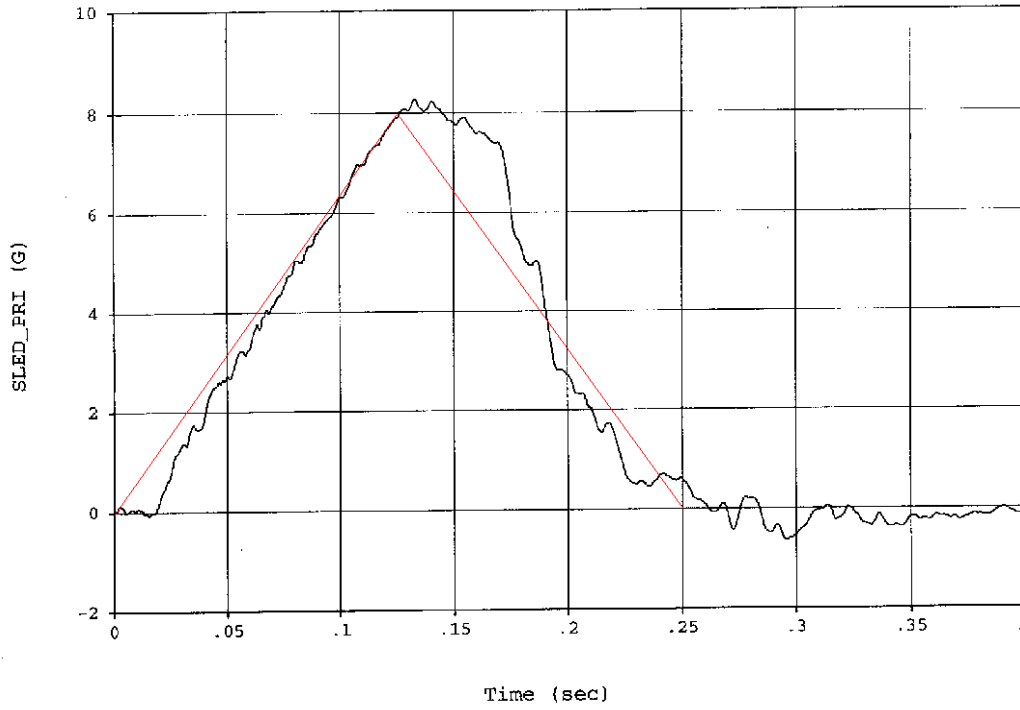
Figure B4. Comparison of Test No. 4 Crash Pulse vs. Ideal Crash Pulse

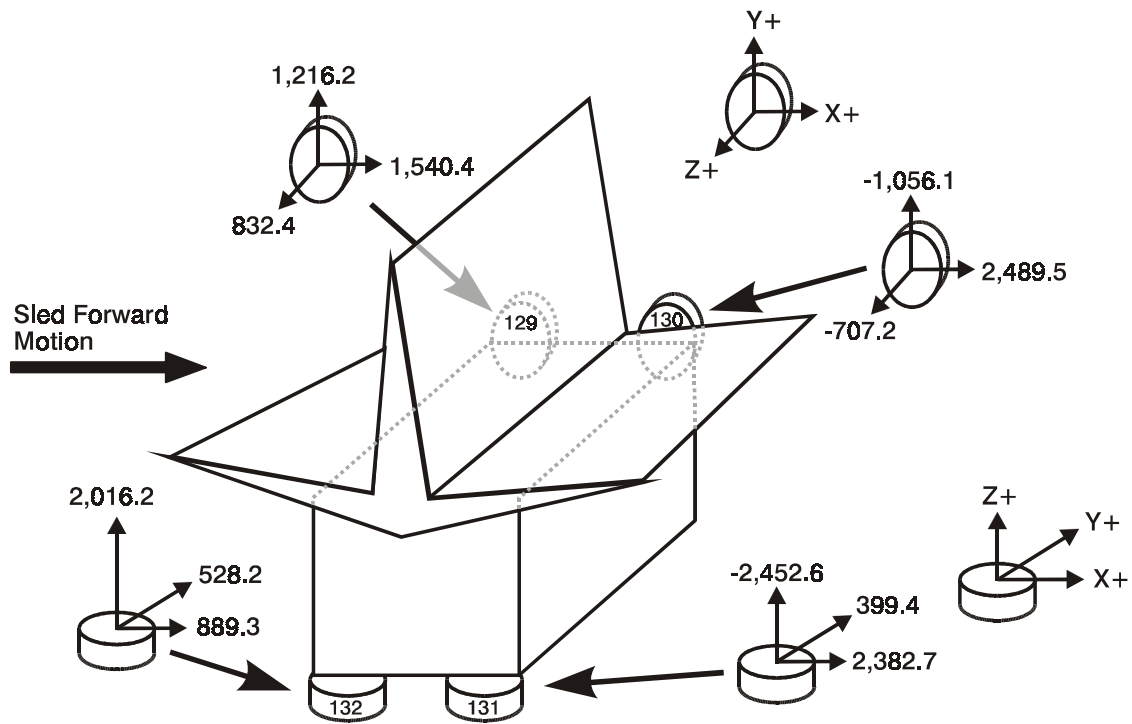
Figure E1. Peak Measured Seat Attachment Loads (lb) for Test No. 1 - Baseline Test
