Crashworthiness Testing of Amtrak's Traditional Coach Seat

Safety of High-Speed Ground Transportation Systems

DOT/FRA/ORD-96/08
DOT-VNTSC-FRA-96-11

Final Report
October 1996

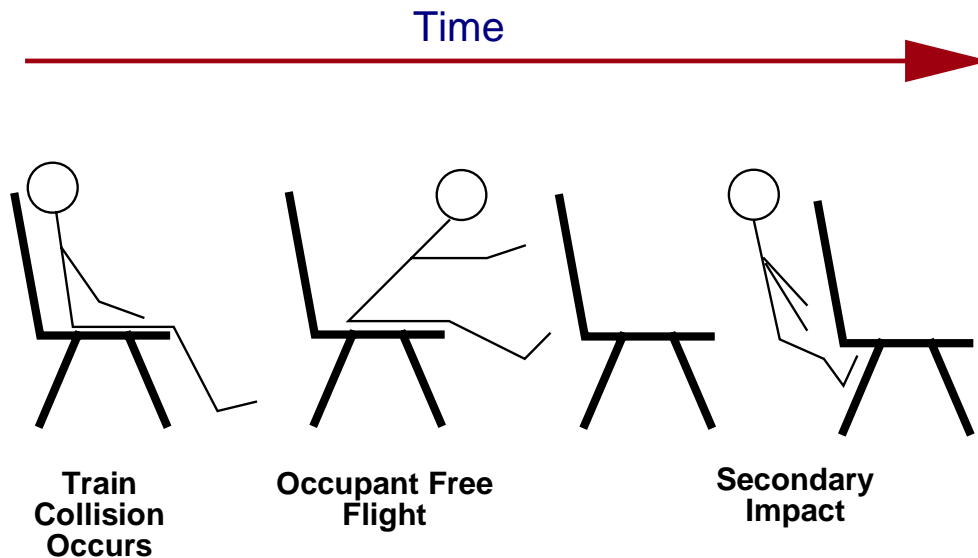
Figure 2-1. Occupant Motion During a Collision

Figure 2-1 illustrates the motion of an unrestrained occupant during a train collision. Prior to a collision, the occupant and the train are traveling at the same speed. Once the collision occurs, the train begins to decelerate, while the occupant continues to travel at the speed prior to impact. The occupant is said to be in “free flight.” The occupant is decelerated rapidly when he or she strikes some part of the train interior, typically the forward seat back. This collision with some part of the train interior is known as the secondary impact.

The secondary impact can cause injuries and fatalities. Injury level and fatality are functions of the secondary impact velocity (i.e., the velocity of the occupant relative to the velocity of the train), and the effective stiffness of the seat back, or other secondary impact object.

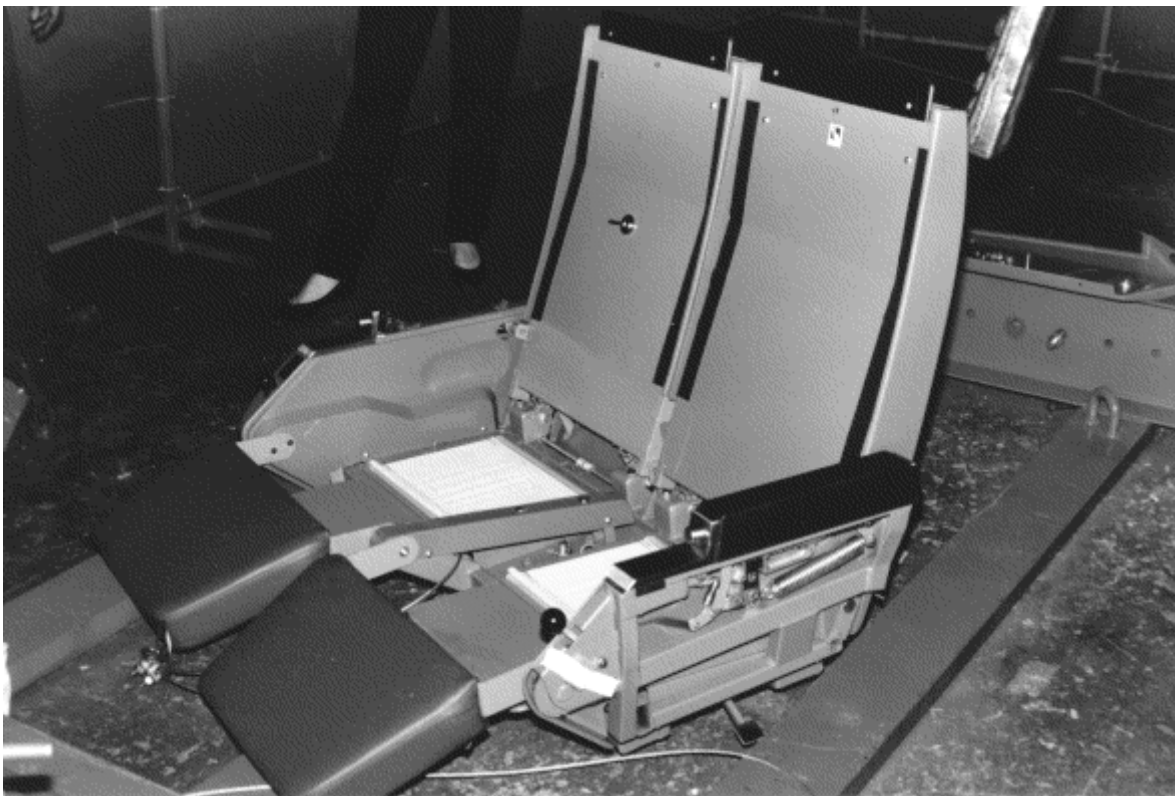
Figure 3-1. Photograph of Frame of Amtrak's Traditional Seat Pair

Figure 3-1 shows a photo of Amtrak's traditional seat pair frame, without the cushions or mounting hardware. The seat pair is manufactured by Coach and Car, Inc. of Chicago, Illinois. It carries two passengers, and can rotate 180° about the vertical to face forward or backward. One passenger rides inboard, near the aisle, while the other passenger rides outboard, near the window or wall of the car. There are two mounts for the seat. In the Amfleet cars, one pedestal mount attaches the seat to the floor underneath the inboard seat, and another bracket mount attaches the seat frame to the wall. The mounts attach to floor and side-wall tracks, which allow (longitudinal) positioning of the seat pair in one inch increments. In the Viewliner cars, there are two pedestal mounts, one under each seat, attached to two floor tracks. In the Horizon cars, the seat pair is attached with two floor mounts at fixed locations.

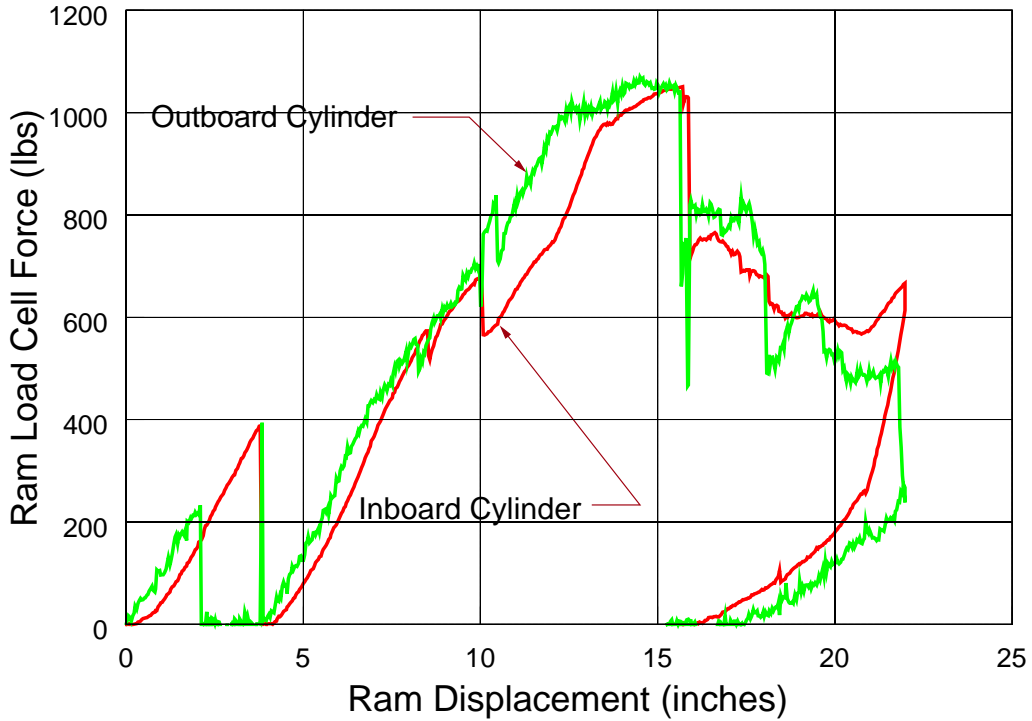
Figure 5-1. Head-Load Test, Measured Force vs. Displacement

The loads were applied to the centers of the stowed tray tables, slightly below the approximate locations where the heads of seated passengers would strike the seatback in the event of a collision. The displacements at the locations indicated in Figure 4-2 were measured. Figure 5-1 shows a plot of the forces exerted by the hydraulic ram on the left (inboard) and right (outboard) seats as a function of the displacement of the ram. At the start of the test, the seat backs were placed at an intermediate recline angle of 10° back from the full upright position, which engaged the recline mechanism at an intermediate setting. When the load was initially applied, it was resisted by the recline mechanism of the seat. At a force of approximately 200 to 400 pounds, the mechanism could no longer hold the seat back in the reclined position and it bottomed out, returning the seat to the full upright position. When the applied forces reached approximately 1050 pounds, the threaded recline rods in each seat broke at the through-holes where they were mounted to the seat backs. The test was taken to a total displacement of 22 inches, at which point the hydraulic ram was fully extended.

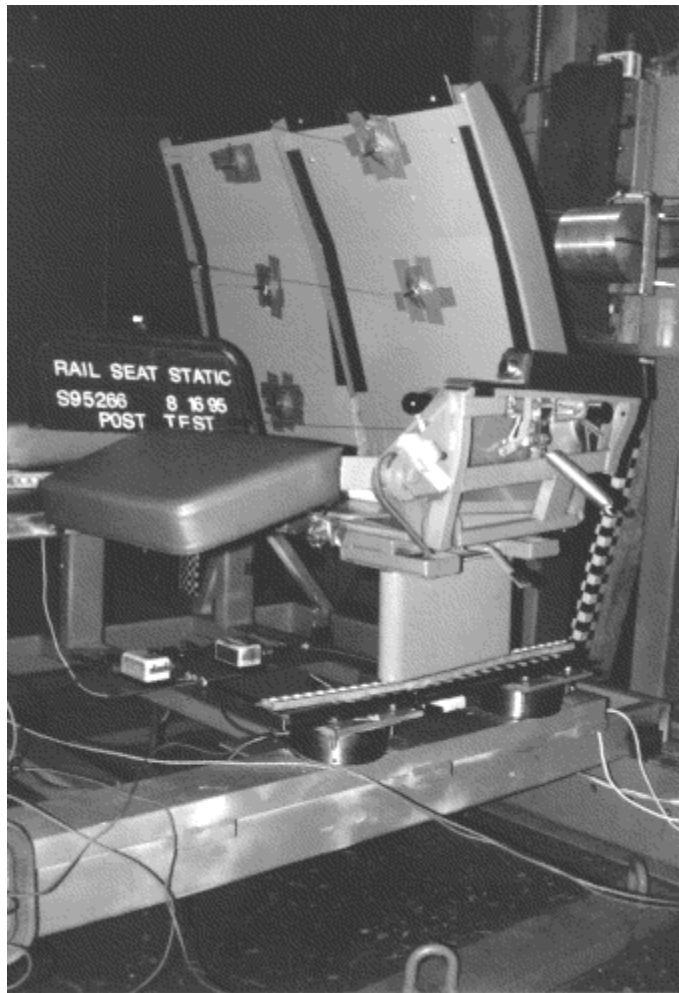
Figure 5-2. Head-Load Quasi-Static Test, Seat Pair Post-test Condition

Figure 5-2 shows the seat pair after the head-load quasi-static test. Damage to the seat pair and mounting included failure of the recline mechanism and some permanent deformation of the seat back, as well as the floor track and hat section.

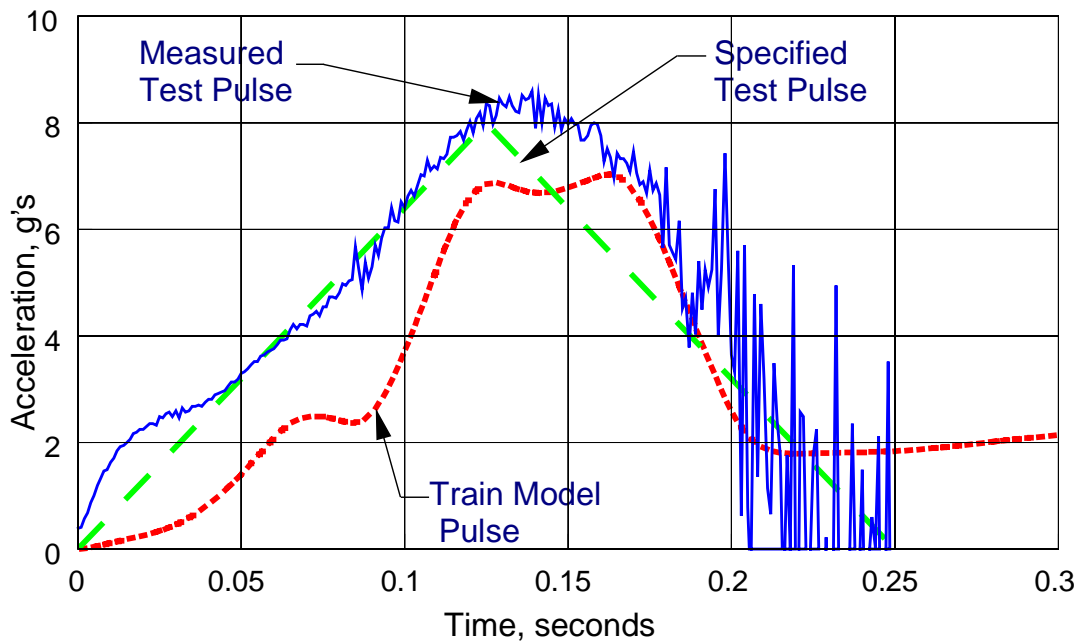
Figure 5-5. Desired and Actual Sled Acceleration, Test Run 3 (H95248)

Figure 5-5 is a graph of the train model crash pulse, the specified test crash pulse, and the measured test crash pulse. Actual acceleration of the sled varies slightly from the specified acceleration, owing to the accuracy of control of the acceleration mechanism, as well as the motions of the components on the test sled.

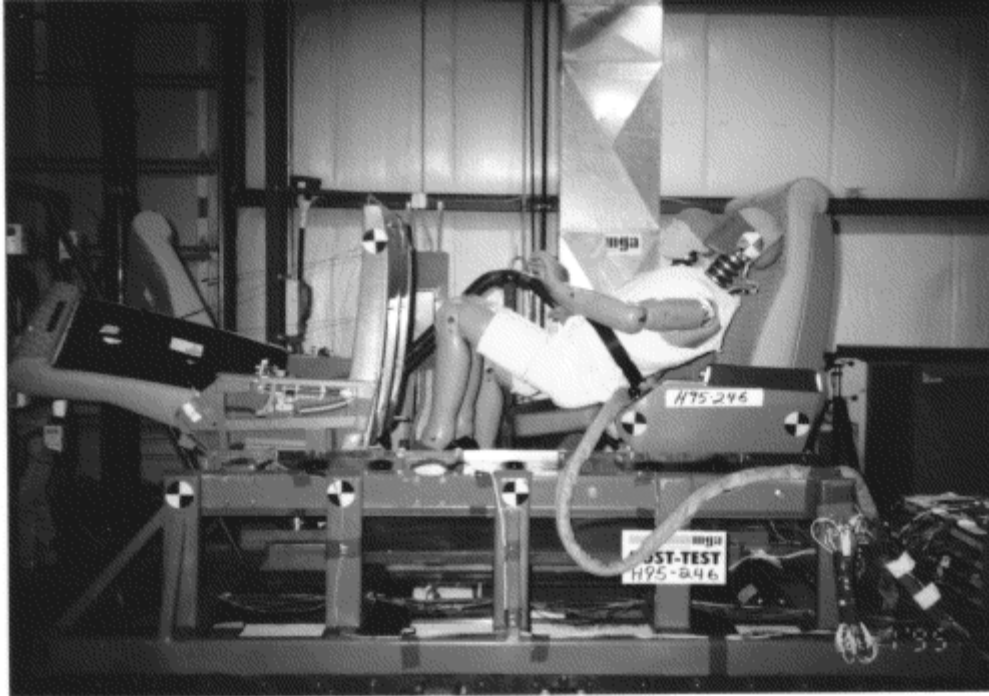
Figure 5-6. Dynamic Test 1 (H95246), Post-test Condition

In the 5 g test, the secondary collision was elastic, i.e., there was very little permanent deformation of the forward seat pair. The dummies rebounded back into the rear seat pair near the end of the collision. Because the forward seat did not deform significantly in the 5 g test, the seat back appeared to have a larger effective stiffness. The effective stiffness of the seat changes significantly depending upon the loading conditions, which has a significant influence on the injury criteria.

The rear seat pair remained intact, and was not subject to any damage. Figure 5-6 is a photograph of the post-test condition of the test sled and dummies.

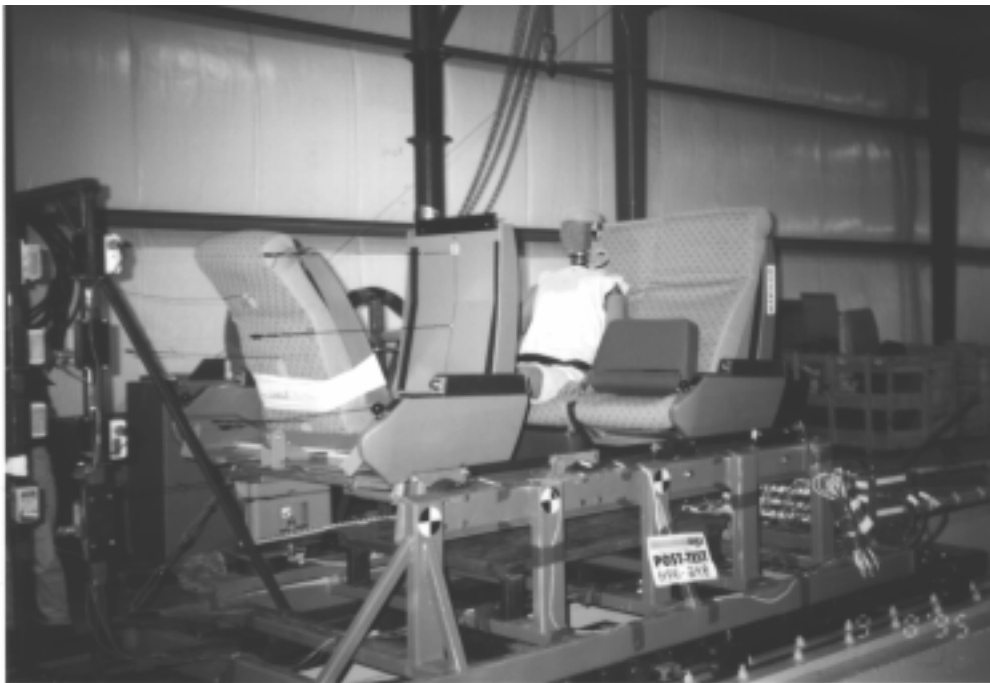
Figure 5-11. Dynamic Test 3, Post-test Condition

The seat locking mechanism remained intact during this test. There was virtually no permanent deformation of the forward seat frame. No seat mounting failures were observed, although there was a small amount of permanent deformation of the floor track and hat section. The inboard tray table fell away from the forward seat back when the seat pair was struck by the dummy's knees. The dummy's head struck the partially deployed tray table, pushing it back towards its original position. The head did not contact the seat back cushion of the front seat, even though it was taped to the seat back.

The forces and decelerations experienced by the dummy remained within human survivable limits. The rearward seat pair remained intact during this test. Figure 5-11 shows a photograph of the post-test conditions for dynamic test 3.

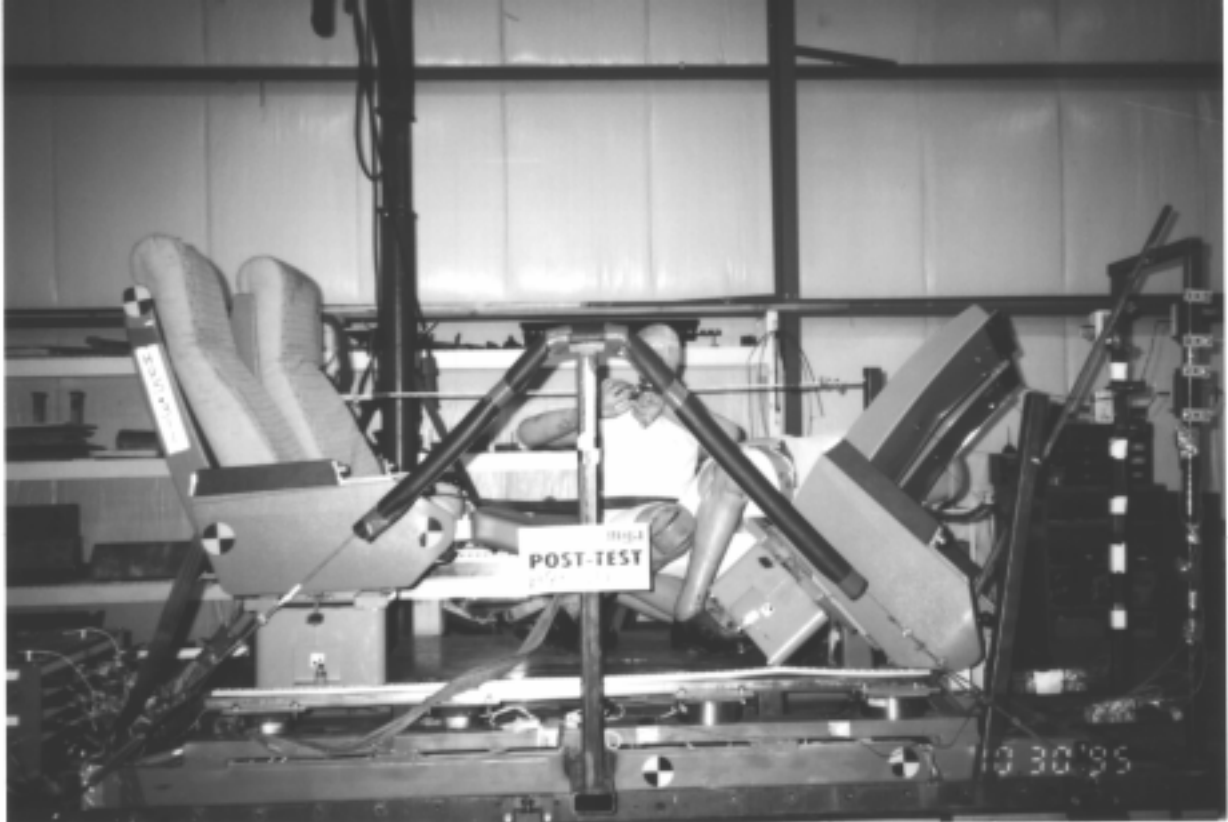
Figure 5-15. Dynamic Test 6, Post-test Condition

The forces and accelerations experienced by the dummies were within human survivable limits. The tray tables deployed when the dummy's knees struck the forward seat backs. The dummies' heads were effectively pinched between the tray table and the seat back when their chests pushed the tables back towards their original positions. Although the injury criteria was within survivable limits, the inability of the tray table locking mechanism to restrain the table during a collision may increase injuries to the face and head. Figure 5-15 shows a photograph of the post-test conditions for dynamic test 6.

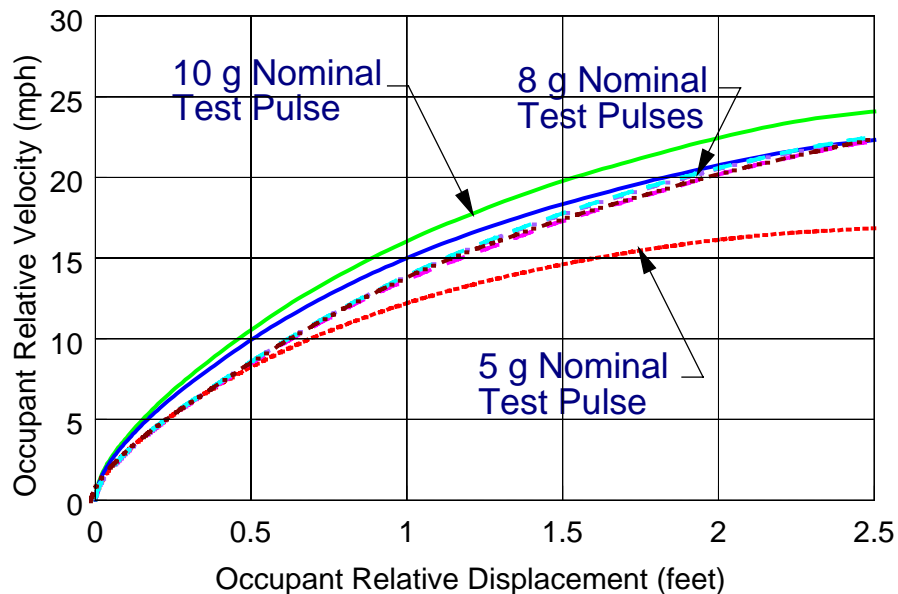
Figure 5-17. Secondary Impact Velocity

In the first series of dynamic tests, the interior configuration was held constant while the crash pulse was varied. The results indicate that the crash pulse does not have a significant influence on the dummy kinematics, but it does affect the dummy's secondary impact velocity. Figure 5-17 plots the dummy's velocity relative to the test sled versus the dummy's displacement relative to the test sled to illustrate the influence of the crash pulse on the secondary impact velocity.

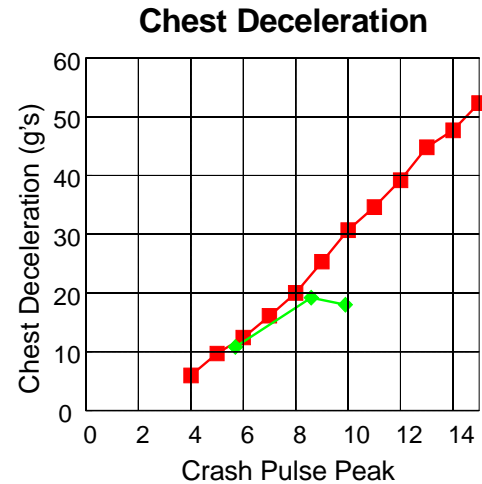
The chest injury criteria calculated from the test data from the 5 and 8 g tests approximate the predicted values. The chest deceleration from 10 g test results is significantly lower than predicted. The probable cause of this discrepancy is the massive structural permanent deformation of the forward seat during this test, which dramatically lowered the effective stiffness of the seat. The deformation allowed the dummy to be decelerated over a longer distance, resulting in lower peak decelerations.

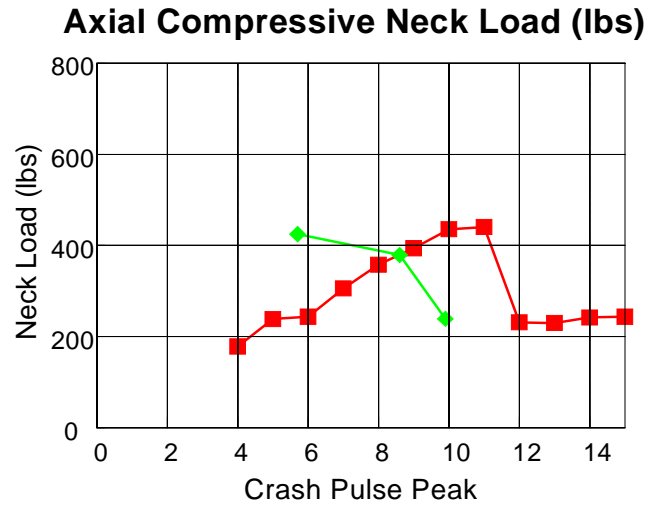
The axial compressive neck load is plotted against the varying crash pulse peak in Figure 6-4. The neck load increases nearly linearly from 4 g's to 11 g's. At that point, the neck load decreases as the crash pulse increases. This trend occurs due to the change in neck loading. When the forces on the head

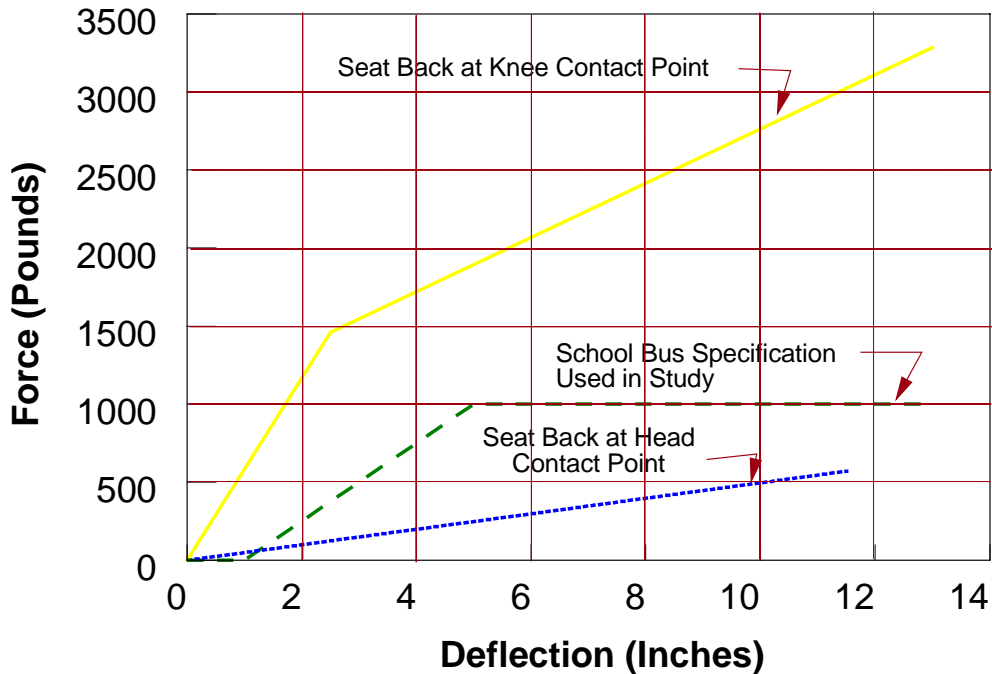
Figure 6-6. Seat Back Force/Deflection Characteristics

Figure 6-6 shows a plot of the force/displacement characteristics derived from the measured data for the outboard seat in the high load quasi-static test and the low load quasi-static test. The measured data from Figures 5-1 and 5-3 were adjusted to account for the height difference between the head/knee load applications and the hydraulic ram load applications. These characteristics correspond to the seat stiffness at the location of head impact and the location of knee impact. The static test results show that the Amtrak traditional seat pair has significantly different force/displacement characteristics at the head and knee contact points. The school bus seat stiffness specification [2], which was used in the previous analysis [1], is also plotted in Figure 6-6 for comparison.

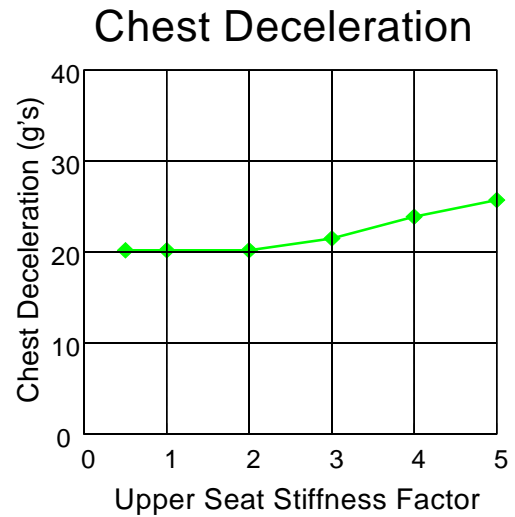
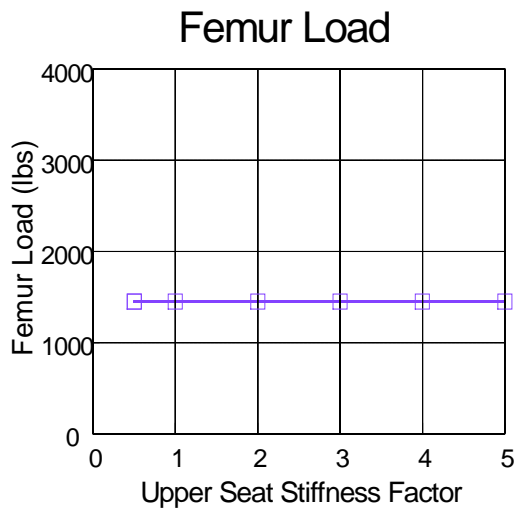
The influence of the upper seat stiffness on injury criteria is illustrated in Figures 6-7 through 6-10. These figures graph the four injury criteria as a function of seat stiffness. An upper seat stiffness factor equal to one corresponds to the upper seat stiffness used for the head contact point in the computer simulations of the seven dynamic tests.

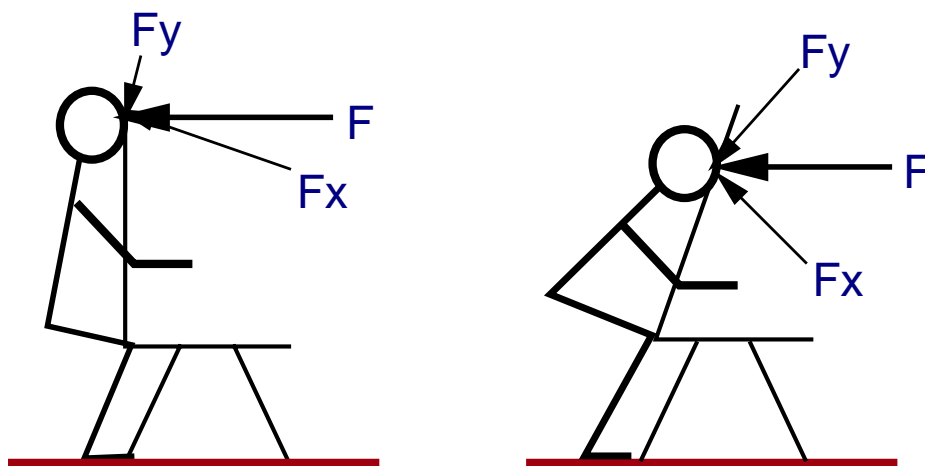
Figure 6-11. Influence of Head/Neck Position on Axial Compressive Neck Load

The axial compressive neck load is a function of the stiffness of the top of the seat back. However, changes in the upper seat stiffness also affect the orientation of the head and neck during the head impact, which affects the portion of the load that is transmitted axially to the neck. As the seat's rigidity increases above a factor of one, the stiffer seat back acts to keep the neck and head in a vertical line. The softer seat allows the head to fall forward, increasing the magnitude of the axial component of the force on the neck (see Figure 6-11). Because of the influence of the

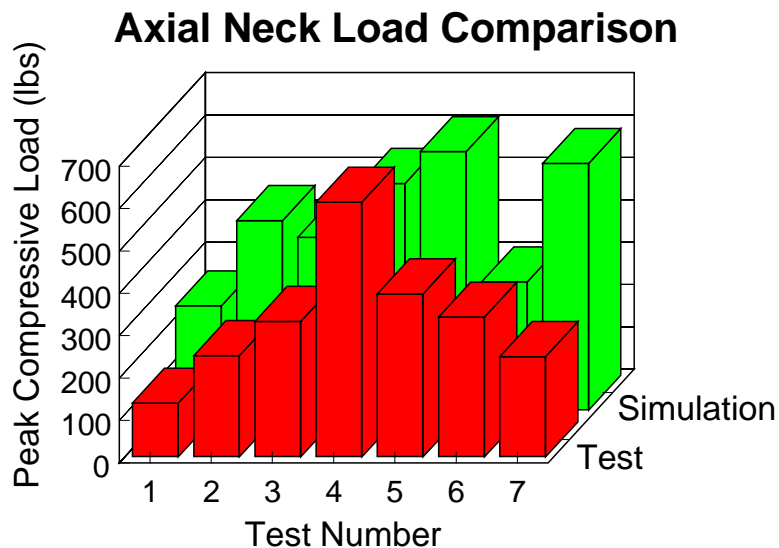
Figures 6-12 through 6-15 graphically represent the head injury criteria, chest injury criteria, peak axial compressive neck load, and femur load, comparing injury criteria measured from test instrumentation with injury criteria calculated from the simulation for each of the seven test scenarios.

stiffness under the quasi-static loading condition. Therefore, the dummy's head is decelerated more gently than predicted, resulting in HIC values lower than predicted.

Both the HIC and chest injury criteria from the tests and simulations are well below the injury criteria levels accepted by the National Highway Transportation Safety Administration (NHTSA) and the Federal Aviation Administration (FAA) of 1000 and 60 g's, respectively.

Requirements for maximum femur loads are also specified by NHTSA and FAA. The force transmitted axially through the upper legs shall not exceed 2,250 pounds. This injury criteria was also met in every case, for both the measured and simulated data. The measured femur load in Test 3 was near the limit at 2,202 pounds. The load in this test was about 34% larger than the next largest load measured in any of the tests. The cause is most likely because only one dummy was used in this test. The effective stiffness at the knee contact point was larger because the seat was only subjected to half of the inertial load and therefore did not undergo the same degree of permanent deformation.
