# TECHNICAL PRESERVATION GUIDELINES

APRIL 2009

## HISTORIC BUILDING ROOFING

CAROLINE ALDERSON

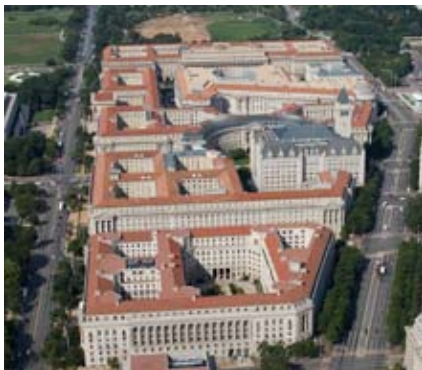
FIGURE 1 Clay tile roofing dominates and unifies aerial views of Washington's Federal Triangle, a vantage point also enjoyed by visitors to the Old Post Office tower in the center of the complex. Tile roof repairs require special care to achieve consistent color distribution across an entire roof.

Design and installation of variegated roofing requires special care to achieve consistent color distribution across the entire roof. Require matching not only the colors of the historic roofing but replication of the overall color distribution pattern. Removal and relaying of historic roofing is sometimes necessary to mix old and new for a well integrated result.

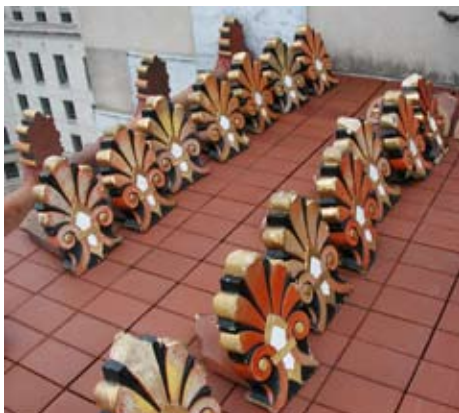
FIGURE 2 Damaged or missing features such as decorative acroteria should be repaired or replicated as part of a major roof project.

as decorative acroteria and roof finials should be replicated and reinstalled as part of major roof repair or replacement projects.

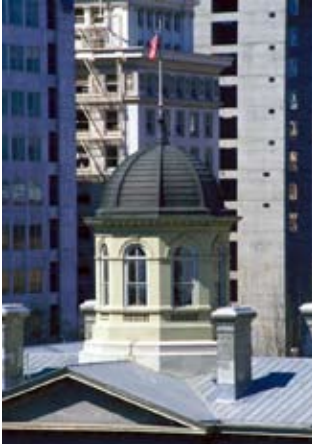
FIGURE 3 Repair and installation of slate, clay tile and metal roofing requires specialized construction skills. Competency of Restoration Specialist requirements reduce GSA risk by limiting competition to firms having successful experience with historic building projects of comparable complexity.

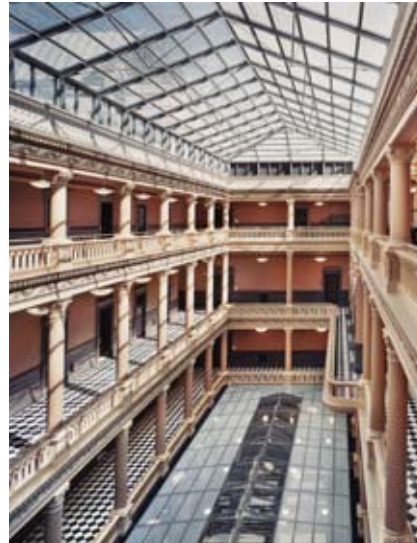
FIGURE 4 Include repair or replication of skylights concealed by previous roof repairs to improve the marketability of windowless workspaces.

Many historic buildings include skylights designed to admit daylight to interior cores, underground spaces and other windowless areas. Roofing projects may provide opportunities to improve the thermal performance and life cycle of these assemblies while improving the marketability of windowless workspaces. Explore restoring covered over skylights in occupied locations where they provide the only source of daylight. Where funding for restoration is not available, skylights should be stabilized to protect the building from infiltration and retained in place to allow for the possibility of future restoration.

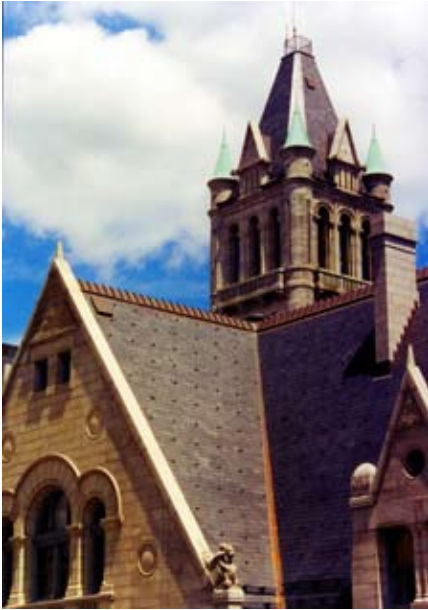
FIGURE 5 Sample review of materials, repair techniques and mock-ups ensure successful projects.

For all roofing work within historic building restoration zones, be sure to specify sample review of any new materials and repair techniques and require a mock up installation of new materials or assemblies for RHPO review, prior to overall fabrication and installation, to ensure that preservation design criteria have been met. Budgeting time and funding for mock ups helps to ensure against cost increases and delays that occur when a planned solution falls short of GSA expectations.
