Coastal Change During Hurricane Dennis 2005

Hurricane Dennis made landfall as a Category 3 storm on Santa Rosa Island in the Florida Panhandle on July 10, 2005. Exposed to some of the strongest winds, Santa Rosa Island suffered erosion, as well as severe overwash. A storm surge of 2 m was recorded near Navarre Beach.

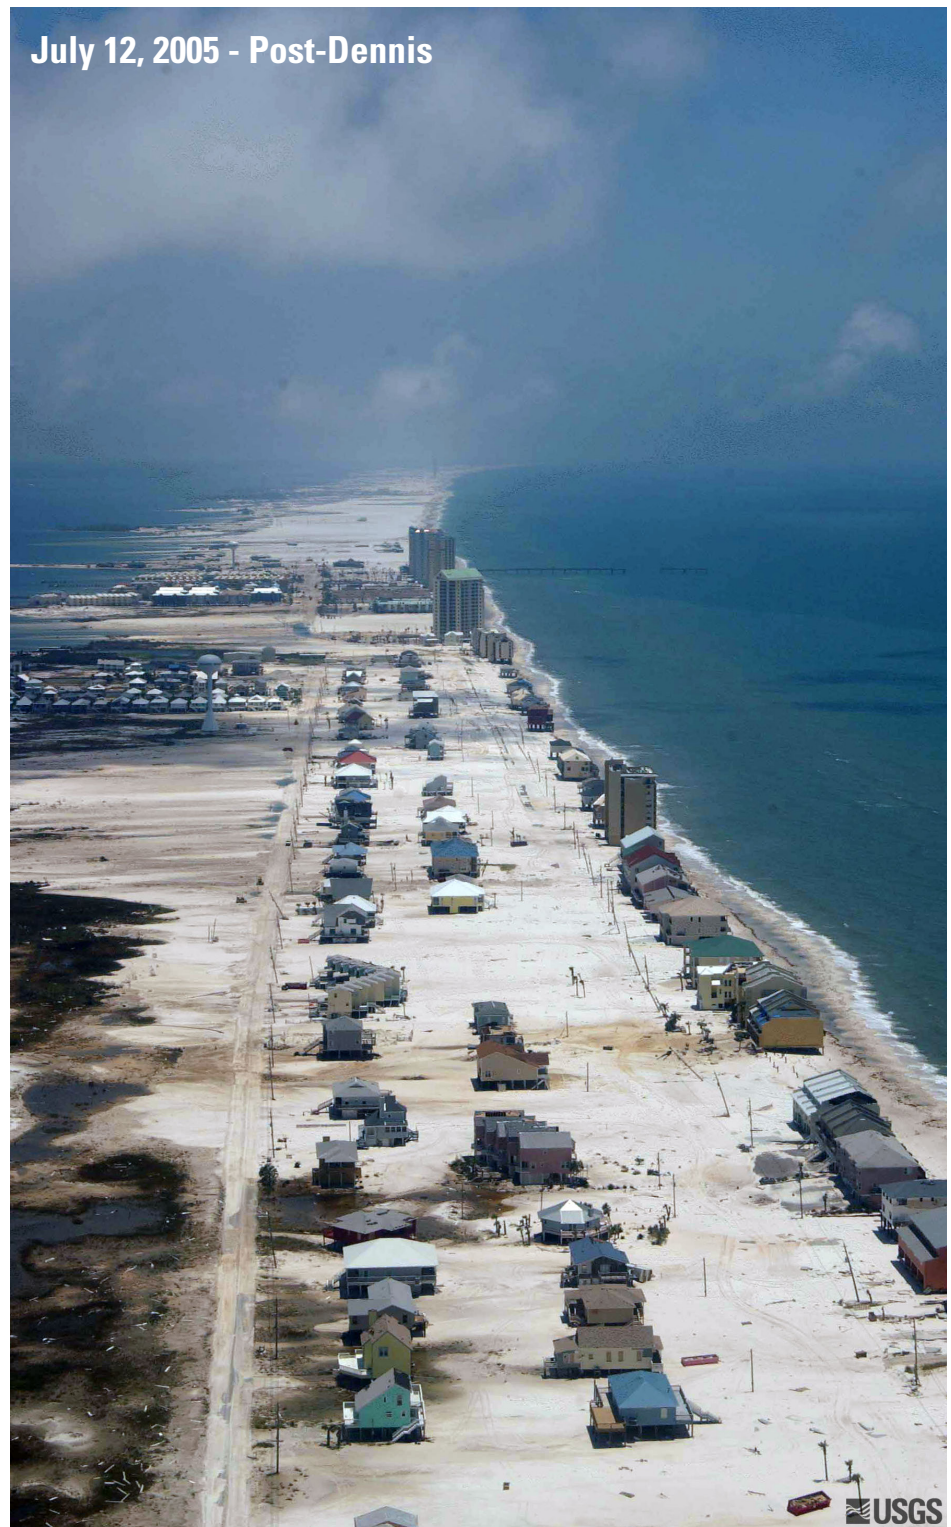
Figure 2. Santa Rosa Island, Florida, suffered severe erosion and overwash during Hurricane Dennis. Looking east, the magnitude of the overwash is evident. Overwash fans extend northward across the island, covering roads with sand eroded from the beach and dunes. In some cases, the overwash extends into the back bay.

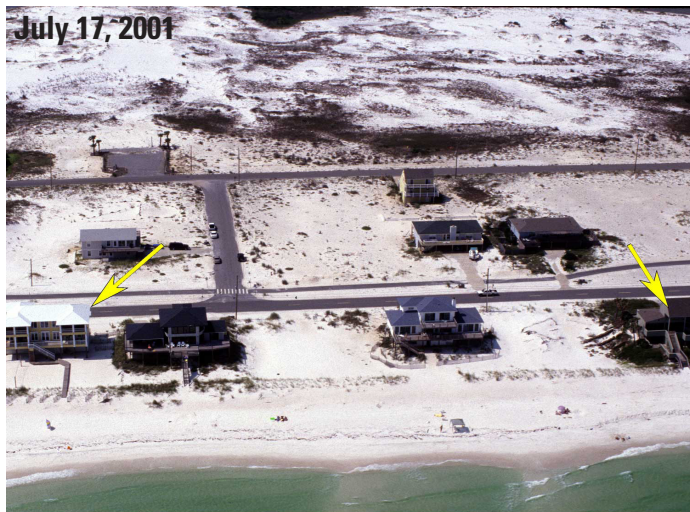
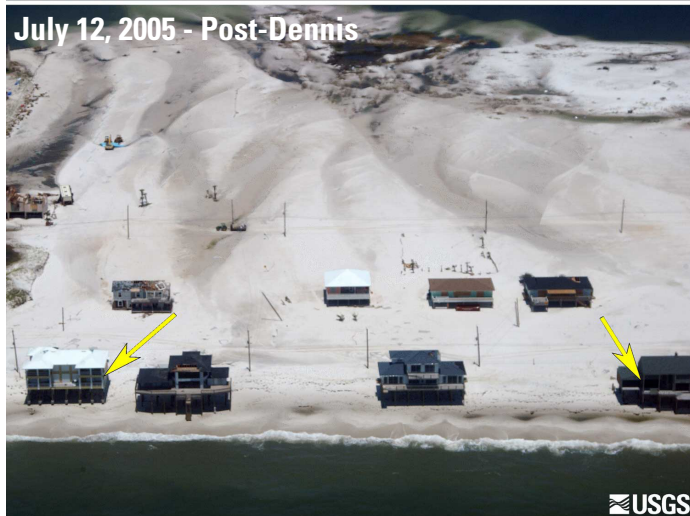
Figure 3. Navarre Beach, Florida. On this part of Navarre Beach, overwash deposits from Hurricane Dennis extend farther landward than overwash deposits from Hurricane Ivan. Deposits from both storms covered the two coast-parallel roads. (Arrows in all images point to the same features.)

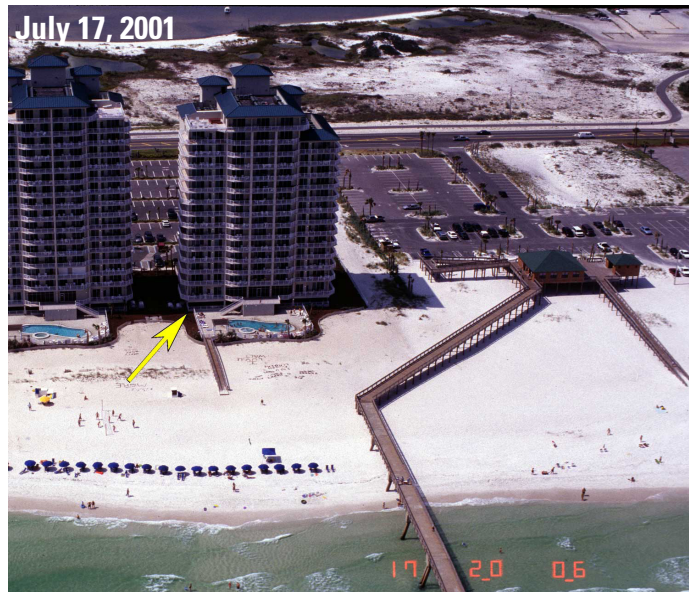
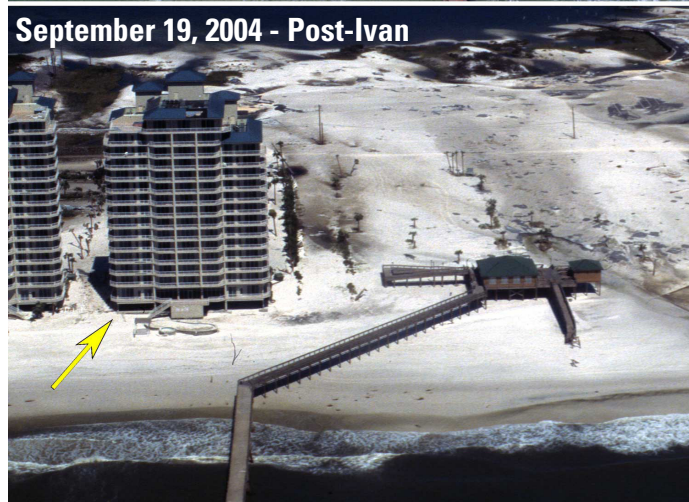
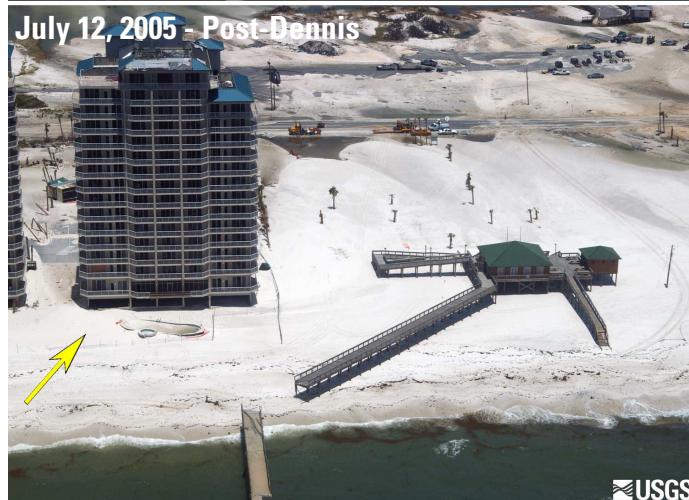
Figure 4. Navarre Beach, Florida. Overwash during Hurricane Ivan covers the parking lot and road with sand. Overwash from Hurricane Dennis covers the parking lot with sand, but does not extend as far inland as did the overwash during Hurricane Ivan. A section of the pier is missing following landfall of Hurricane Dennis. (Arrows in all images point to the same features.)
