United States Environmental Protection Agency
EPA New England
One Congress Street, Suite 1100
Boston, MA 02114-2023

October 8, 2008

RE: 2008 Summer Inspection Reports
1 ½ Mile Reach Removal Action
GE-Pittsfield/Housatonic River Site, Pittsfield, Massachusetts

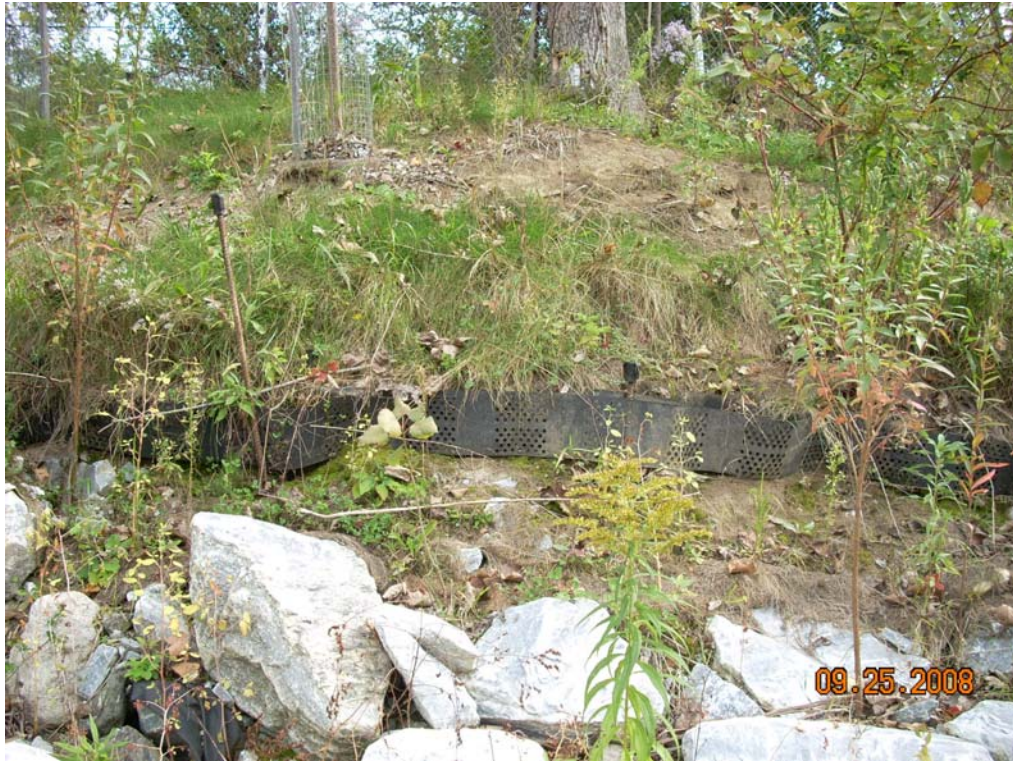
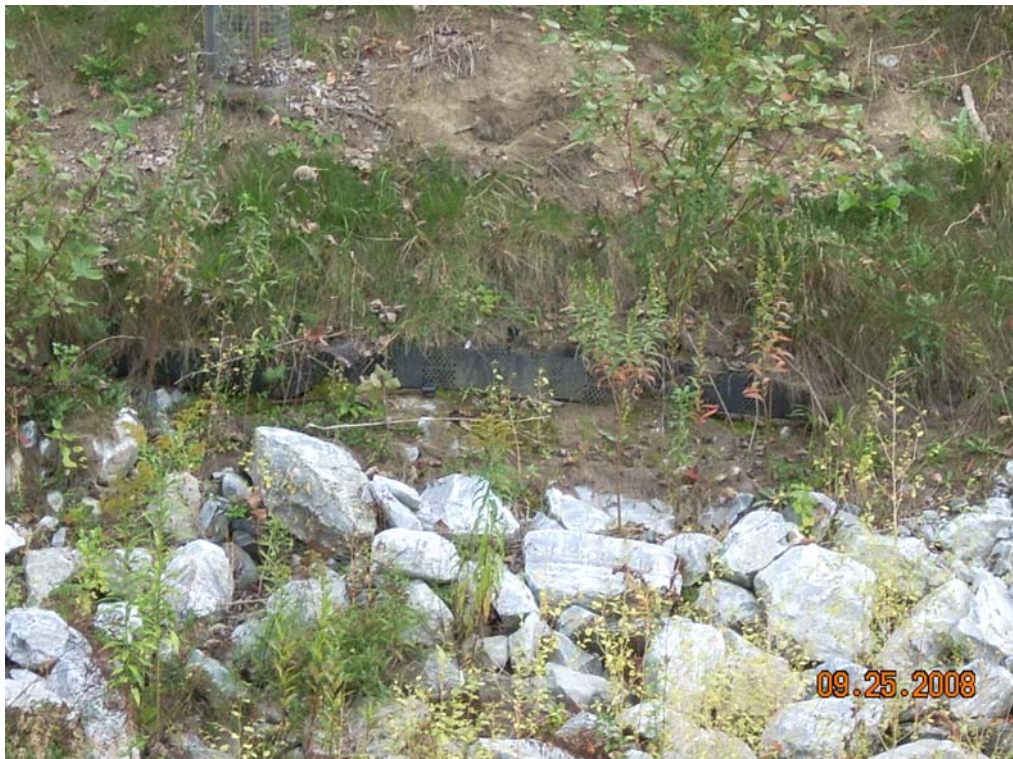
- c. Eroded soil and exposed Geoweb at the top of riprap on Parcel I6-1-68 at the approximate property line with Parcel I6-1-68 and I6-1-67. See the attached photographs. In order to stabilize the area of the eroded riverbank and prevent continued erosion, GE shall plant 2 red-osier dogwoods within the eroded area or place additional riprap.

Photographs of Erosion above the riprap on Parcel I6-1-68 that requires stabilization
