**Southern Nuclear Operating Company, Inc.**  
40 Inverness Center Parkway  
P.O. Box 1295  
Birmingham, Alabama 35201  
Tel 205.992.5086

Joseph M. Farley Nuclear Plant  
Responses to NRC Questions on  
Relaxation Request to Order EA-03-009

**Enclosure 3**

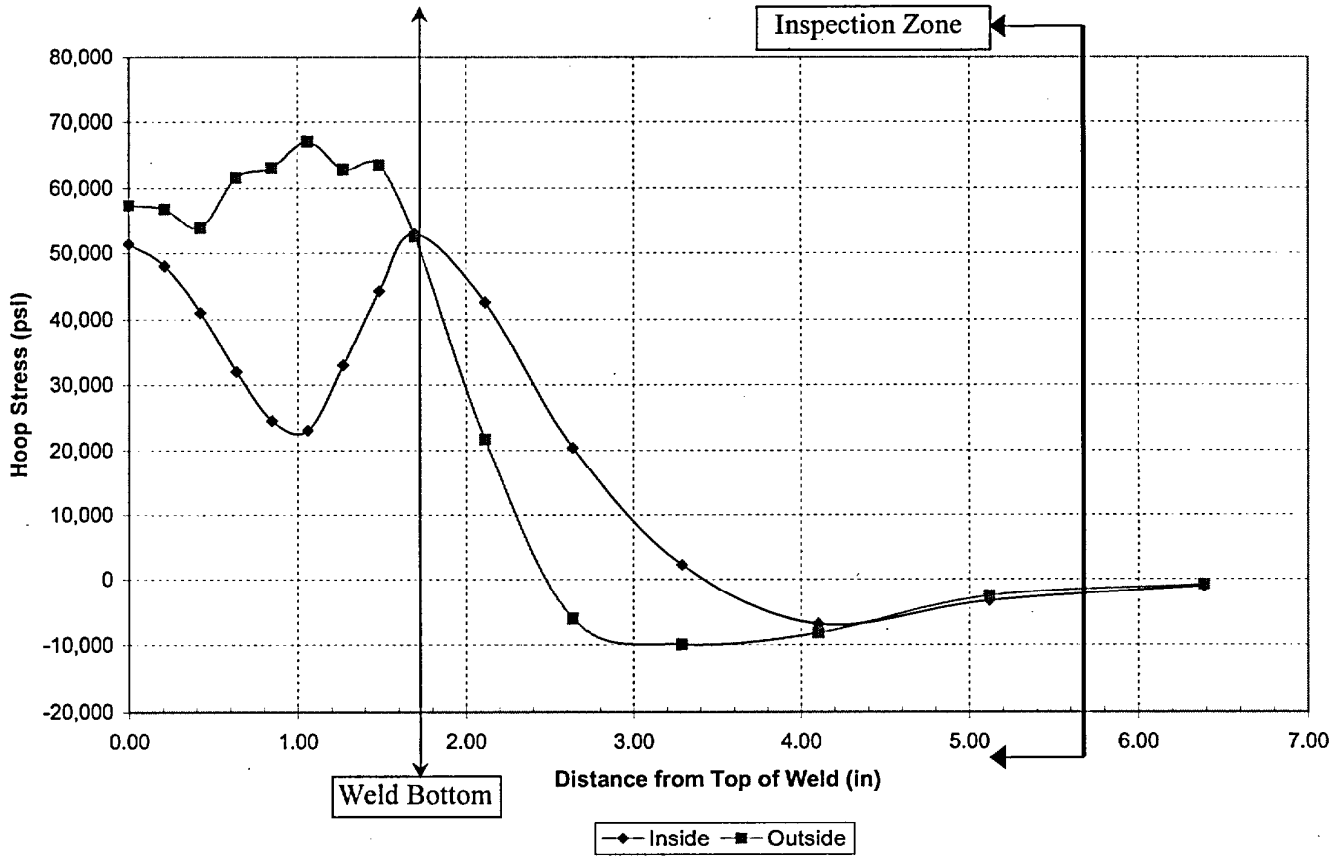
Figure 1  
Hoop Stress Vs Distance from Top of Weld  
0° CRDM Center Penetration Nozzle – Uphill and Downhill

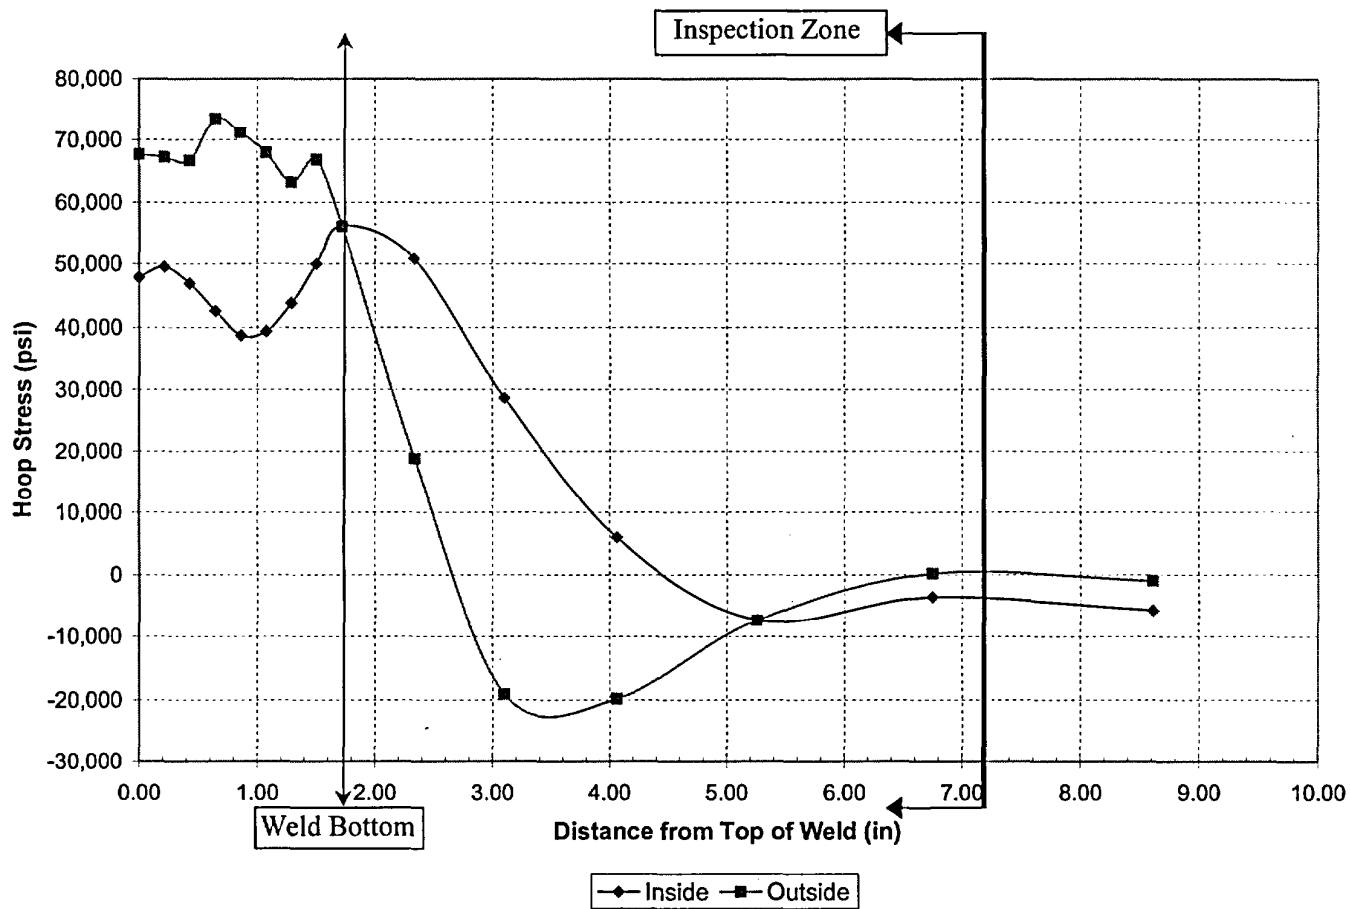
Figure 2  
Hoop Stress Vs Distance from Top of Weld  
28.6° CRDM Penetration Nozzle – Uphill

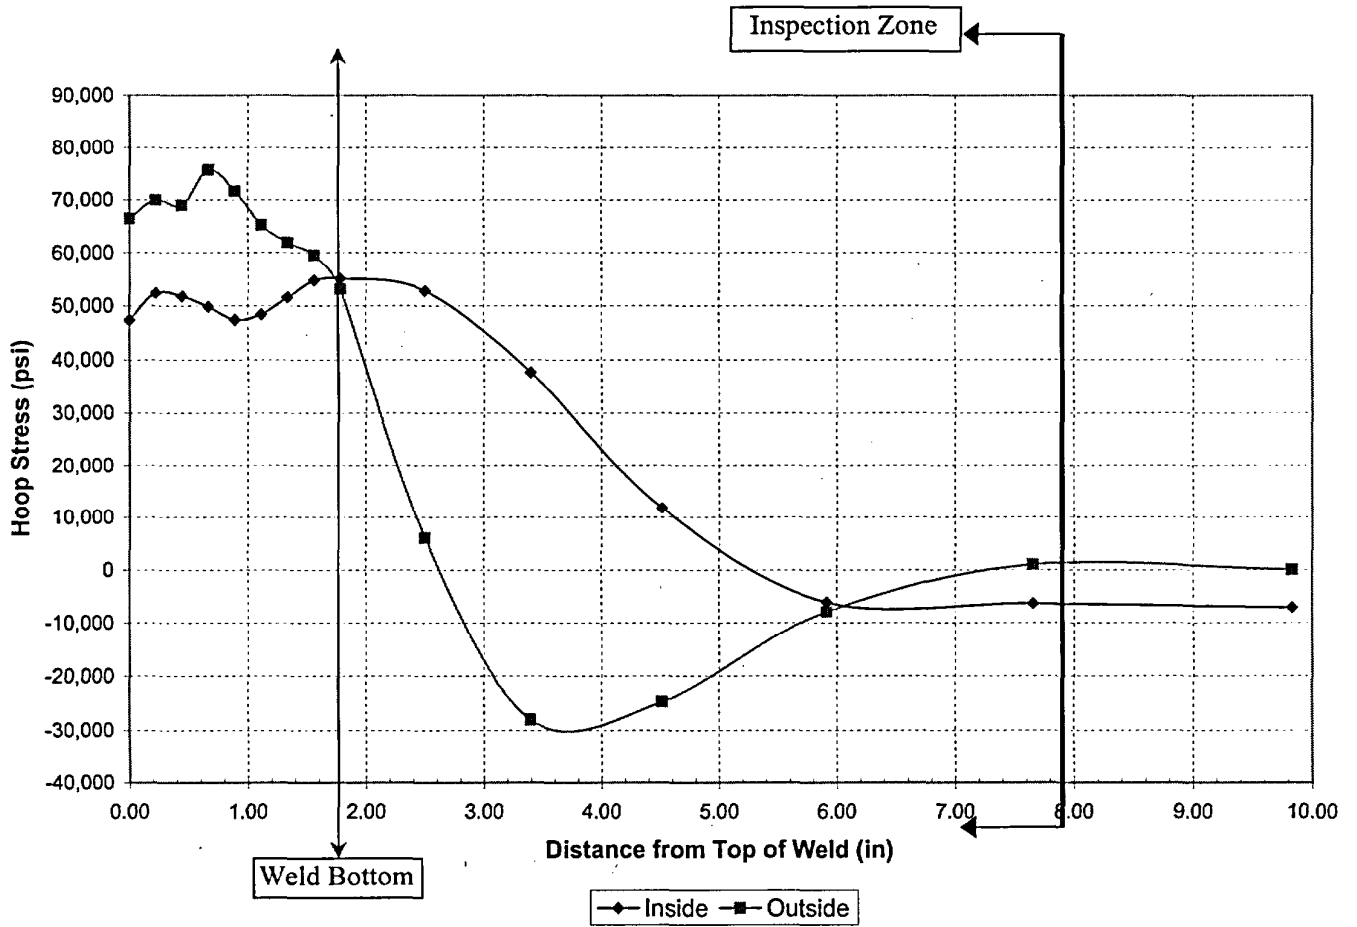
Figure 6  
Hoop Stress Vs Distance from Top of Weld  
40.0° CRDM Penetration Nozzle - Uphill

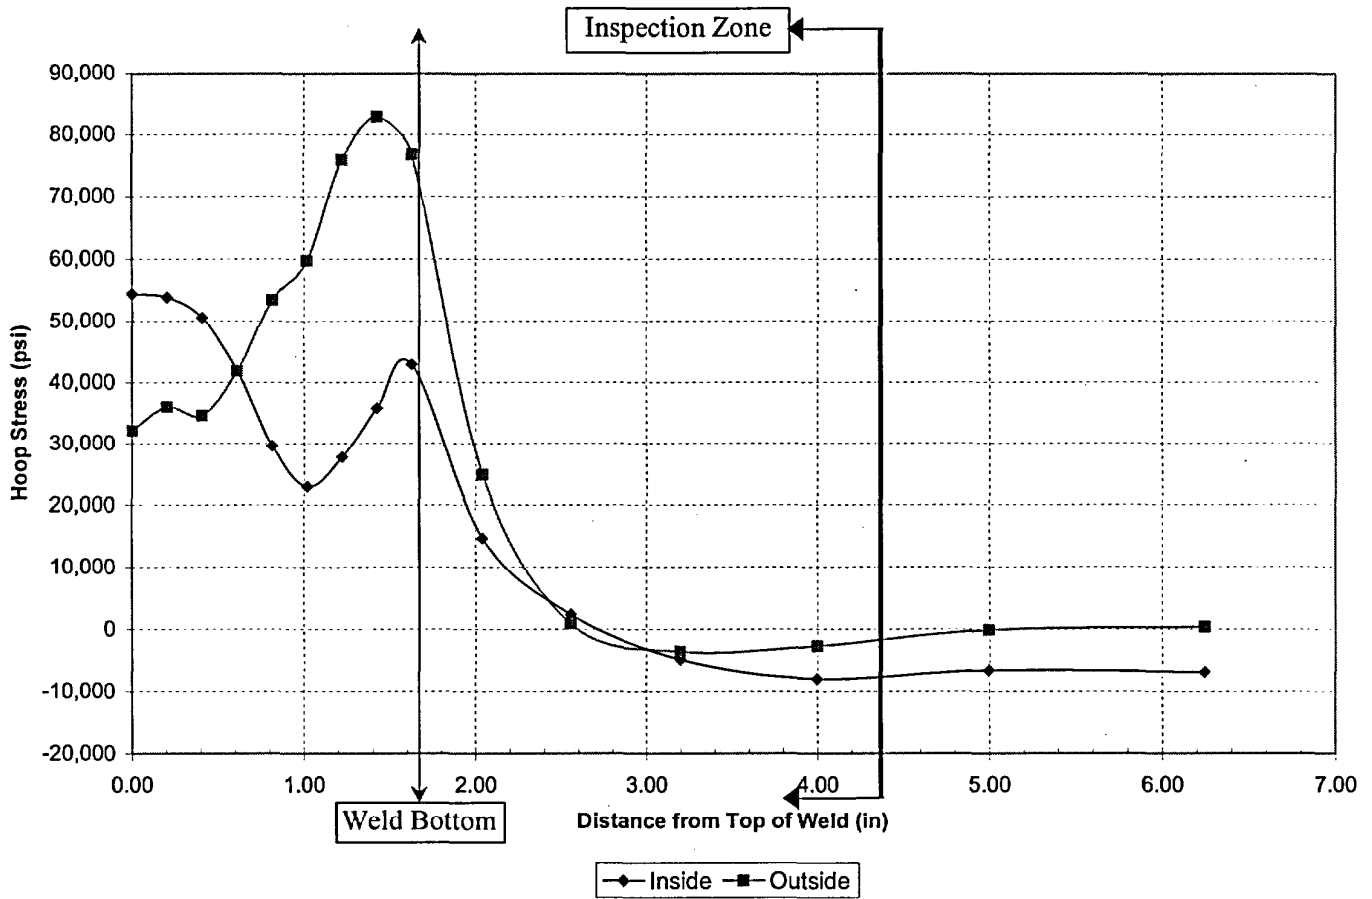
Figure 7  
Hoop Stress Vs Distance from Top of Weld  
40.0° CRDM Penetration Nozzle -Downhill

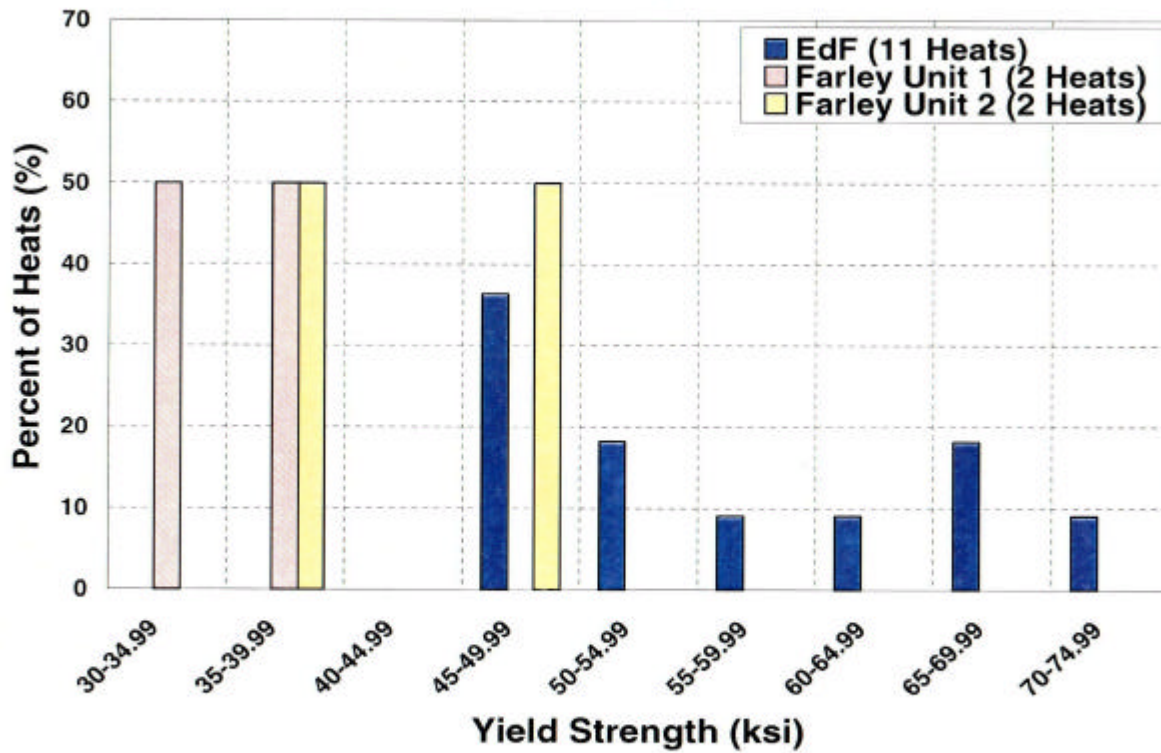
Figure 4-1 Yield Strength of the Various Heats of Alloy 600 Used in Fabricating the Farley Units 1 and 2 and French Head Penetrations

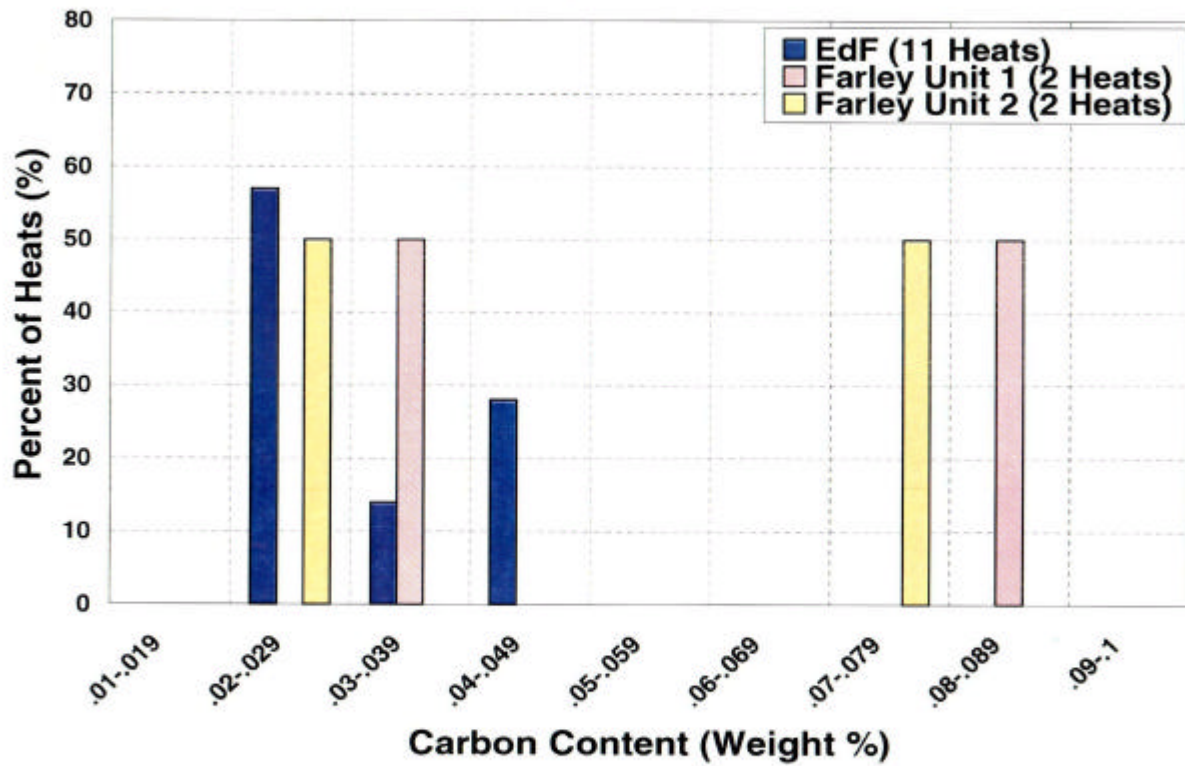
Figure 4-2 Carbon Content of the Various Heats of Alloy 600 Used in Fabricating the Farley Units 1 and 2 and French Head Penetration

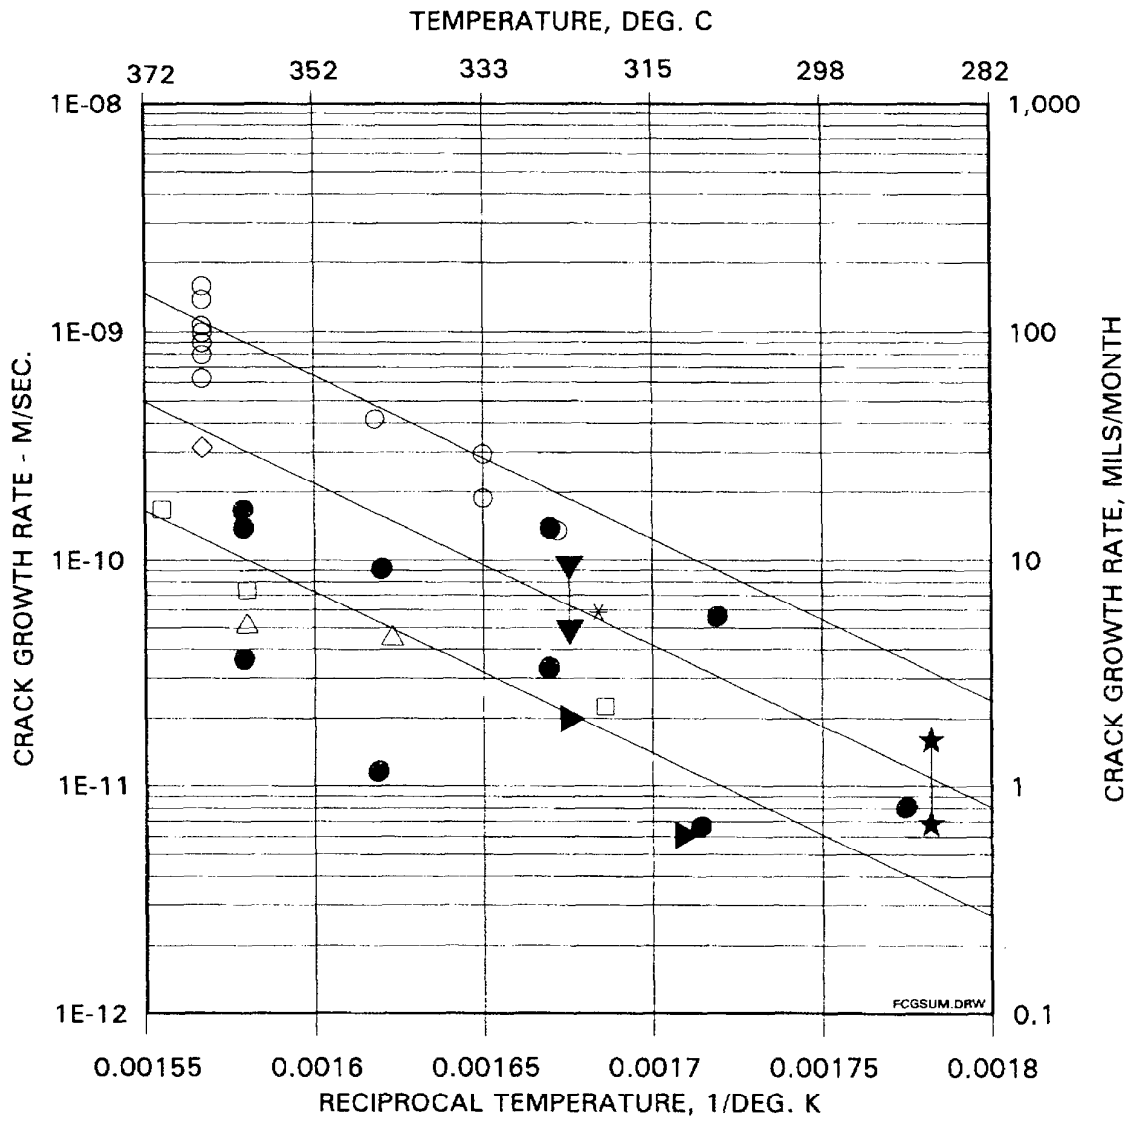
Note: All symbols are for steam generator materials, except the solid circles, which are head penetration laboratory data.

Figure 4-5 Summary of Temperature Effects on PWSCC Growth Rates for Alloy 600 in Primary Water [4A]

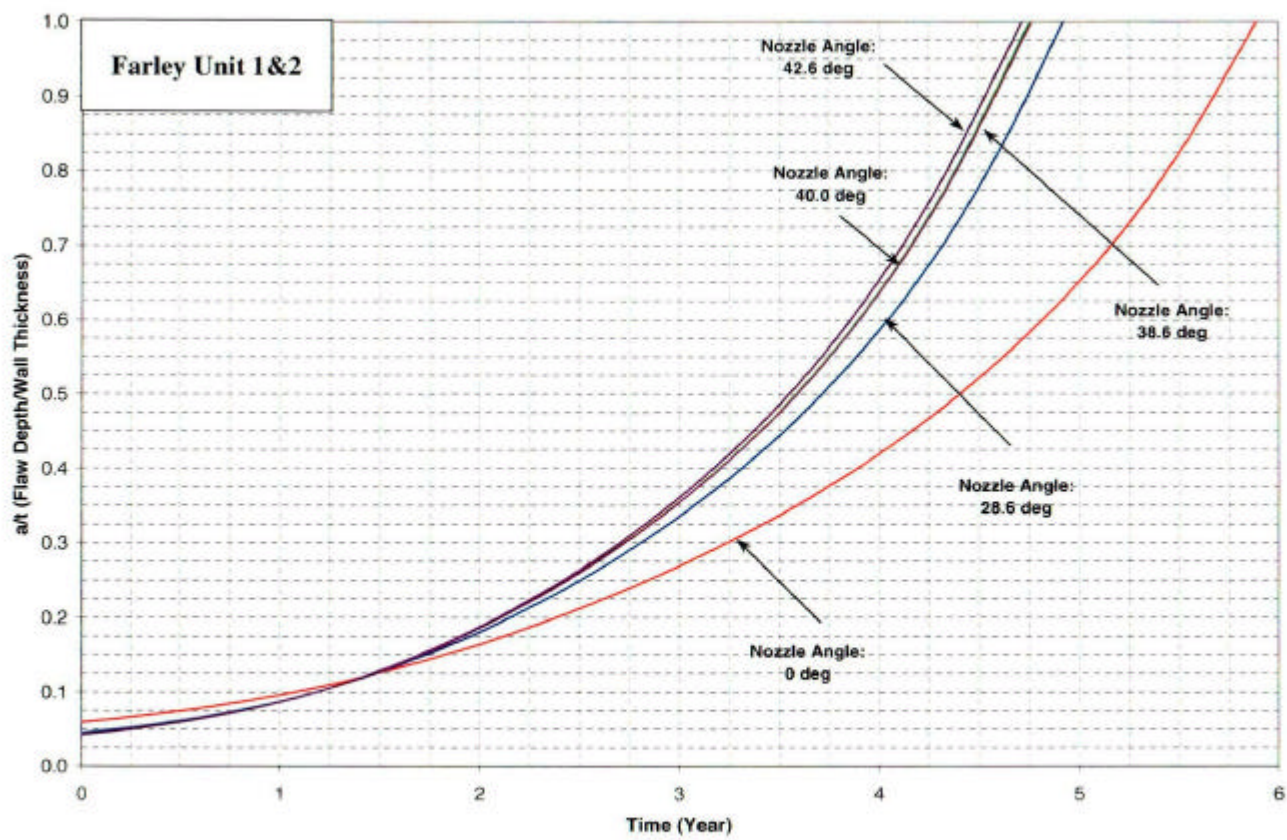
Figure 6-2 Crack Growth Predictions for Axial Inside Surface Flaws Below the Attachment Weld by More Than 0.5 Inches – Nozzle Uphill Side
