OPERATING EXPERIENCE SUMMARY

U.S. Department of Energy
Office of Health, Safety and Security
OE Summary 2007-02
February 28, 2007

Ladders: What Goes Up Must Come Down — Safely

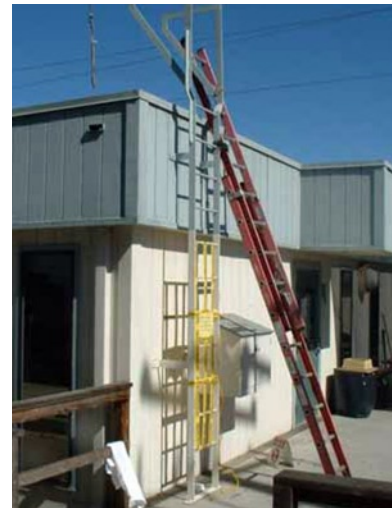
Figure 1-1. The accident scene showing the fixed ladder and an extension ladder added post-accident for temporary roof access

The Board also determined that the fixed ladder was not OSHA-compliant in the following four areas.

1. The first rung was about 17½ inches from the ground instead of the required 12 inches.
2. The ladder rungs were not skid-resistant, which is a requirement for fixed metal ladders manufactured after March 15, 1991. (The ladder was installed after 1991.)
3. The rear ladder clearance in the upper section was less than the required 7 inches.

The Accident Investigation Board determined that human error (missing the step) was the direct cause of the accident. They also concluded that the accident could have been prevented if the worker had used the prescribed climbing technique of maintaining three points of contact with the ladder (i.e., using

The proper climbing technique of moving only one limb at a time while three others remain in contact with the ladder is required by ANSI A14.3-2002, *American National Standard for Ladders - Fixed - Safety Requirements*, which is addressed in LLNL's ladder safety training. However, the Board believes that the training did not instill an adequate understanding of the safety importance of this climbing technique and did not ensure that the electrician was proficient in using it.

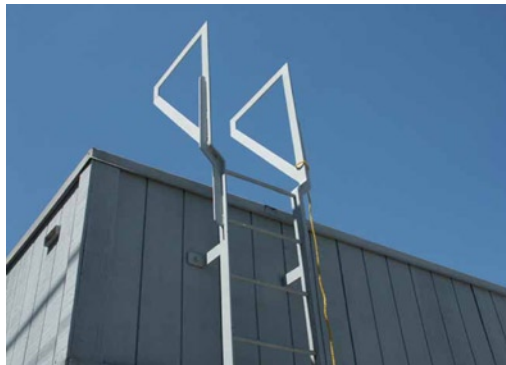
- The side rails of the upper portion of the ladder were constructed with angle iron, which does not afford an adequate gripping surface (Figure 1-2).

The first two areas were likely contributors to the accident; the last two could have resulted in a misstep similar to what the electrician experienced.

Figure 1-2. Walk-through section of the ladder with angle iron at the grips

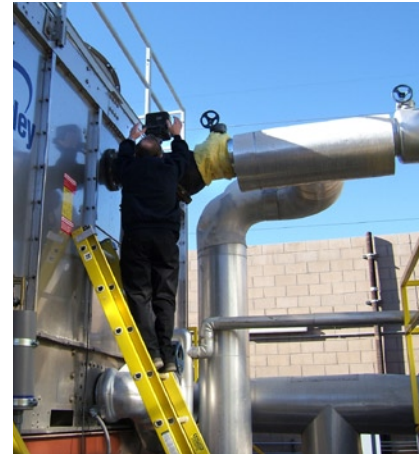
The investigation of this event is ongoing. However, what is known is that the valve is located approximately 15 feet above a gravel area, and the height of the valve required the worker to reach above his head while standing on the ladder. Also, the position of the ladder required the worker to turn his body sideways 90 degrees from the ladder to face the valve. Figures 1-3 and 1-4 show the position of the ladder and the valve

handwheel on the gravel. The worker's awkward position on the ladder, coupled with an inadequately installed valve handwheel, resulted in the worker falling from the ladder.

Figure 1-3. A reenactment showing a worker reaching to operate the valve

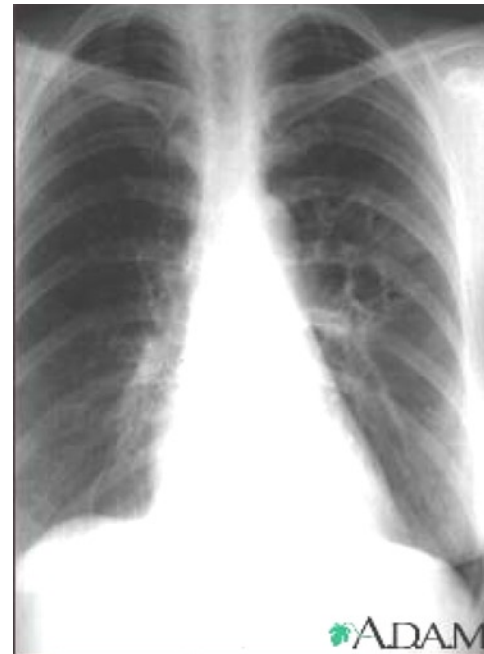
Figure 2-2. Chest x-ray showing effects of Valley Fever on the lungs

The chest x-ray in Figure 2-2 shows some effects of Valley Fever in the lungs. In the middle of the left lung (seen on the right side of the picture) there are multiple, thin-walled cavities

(seen as light areas) with a diameter of from 2 to 4 centimeters. To the side of these light areas are patchy light areas with irregular and poorly defined borders. Cavities such as these occur in about 5 percent of patients who develop pneumonia as a result of inhaling spores; in about one-third of these cases, patients may cough up blood. The severity of the disease is, to some extent, related to the number of spores inhaled.

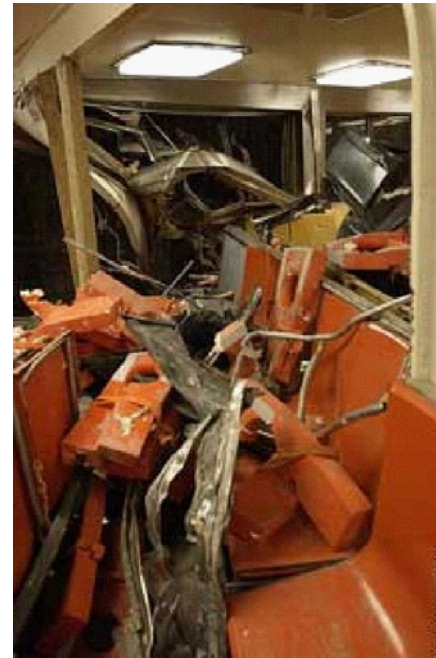
OE Summary 2006-02 described lessons learned from the 2003 Staten Island Ferry crash—one of the worst mass-transit disasters in New York history (Figure 3-1). The boat's pilot was convicted of manslaughter for the crash, which killed 11 people and injured more than 30, including a young man who lost both legs.

The ferry, carrying 1,500 passengers, was on a routine run across New York Harbor from lower Manhattan with its captain alone in the wheelhouse. The captain blacked out, and the ship ran full speed into a concrete pier. At his trial, he admitted to suffering from extreme fatigue and using painkillers, stating, "I will regret for the rest of my life that I did not call in sick." He was sentenced to 18 months in prison, and his supervisor was sentenced to a year in prison for failing to enforce the regulation that a ferry must be operated by two pilots whenever it is docking. Enforcement of that two-person

Figure 3-1. Interior of Staten Island Ferry post-accident (AP photo)

rule would have prevented this accident. (Sources: CNN News October 16, 2003; Fox News January 9, 2006; Gotham Gazette, November 9, 2006; and NTSB Abstract, MAR-05/01)
