# Suspect/Counterfeit Items Awareness Training

**U.S. Department of Energy  
Health, Safety and Security  
Office of Corporate Safety Analysis**

**October 2006  
Revision 5**

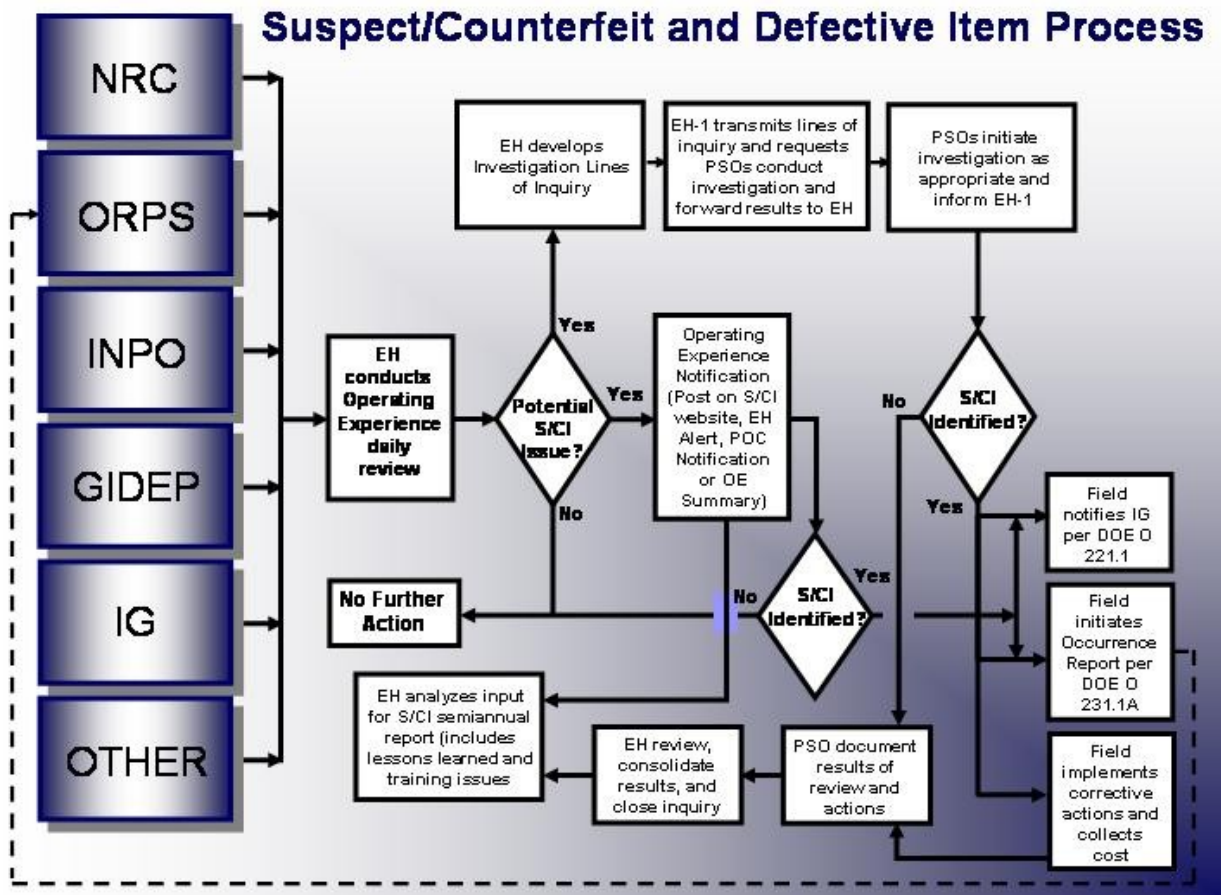
Below is a graphic depiction of the S/CI Process DOE has developed to aid in identifying suspect/counterfeit and defective items.

The S/CI process flow chart is included in the *Office of the Environment, Safety and Health Process Guide for the Identification and Disposition of Suspect/Counterfeit Items at Department of Energy Facilities*. The detailed Process Guide can be found on the Office of Corporate Safety Analysis Suspect/Counterfeit-Defective Items website at <http://www.eh.doe.gov/sci> that includes S/CI-related information and links to other related websites.

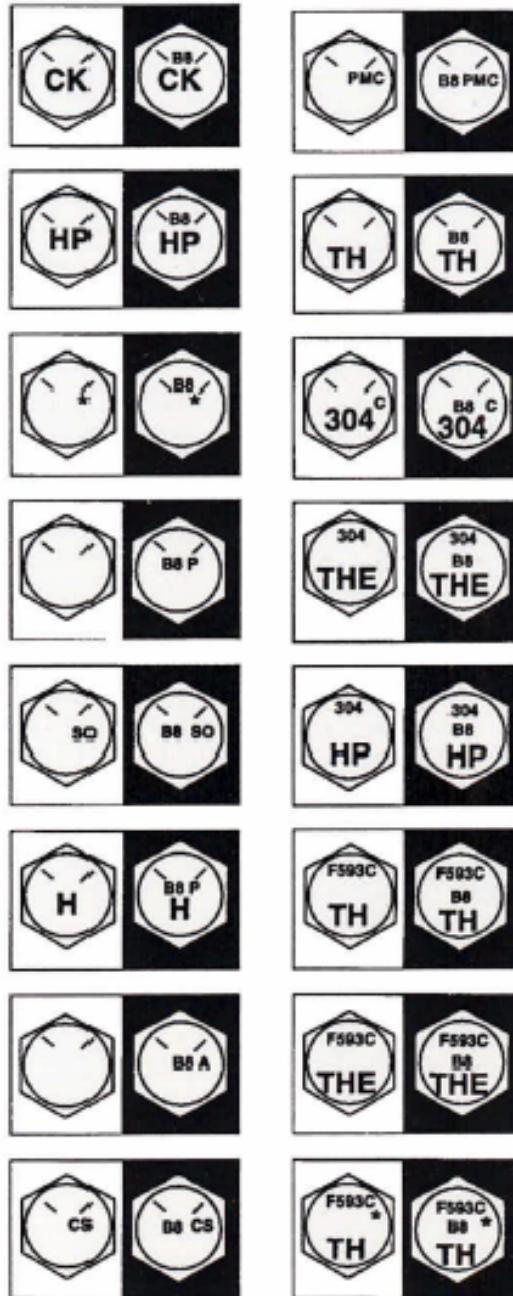
SUSPECT STAINLESS STEEL FASTENER HEADMARK LIST

Examples of stainless steel fasteners that have been upgraded from 18-8 to ASTM A320 or ASTM A193 Grade B8 after hand stamping. The last three examples show samples of fasteners to indicate conformance to two non-compatible standards, ASTM A193 and ASTM F 593C.

Any bolt on this list should be treated as defective without further testing and process in accordance with HNF-PRO-301. Note: This list was originally Published by DOE/EH-0196, Issue No. 97-6

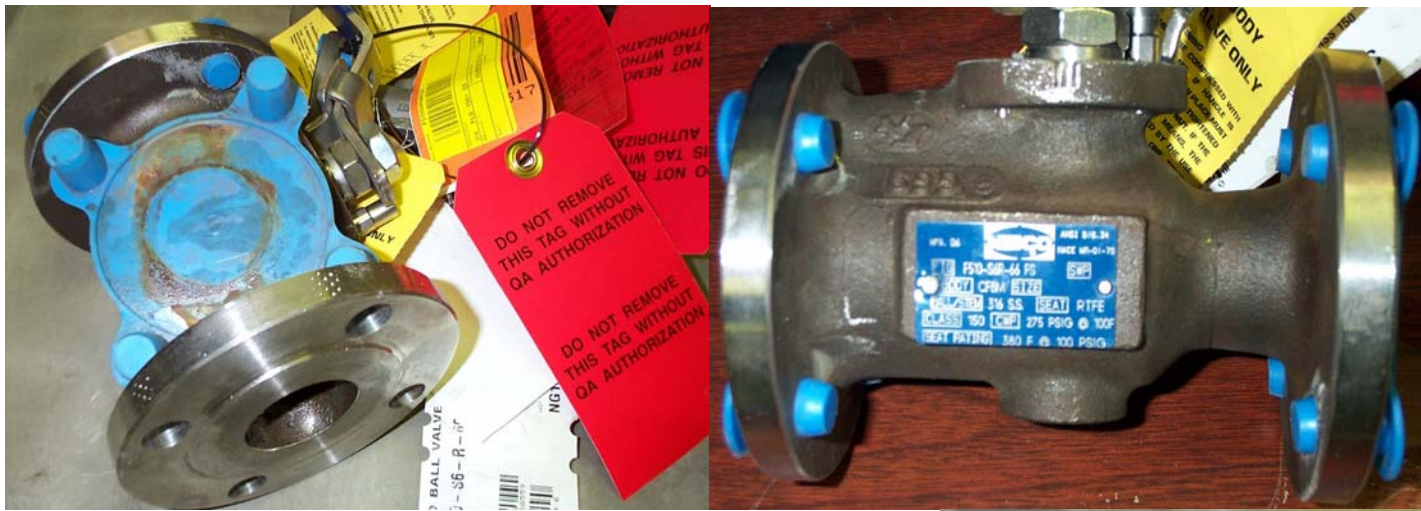
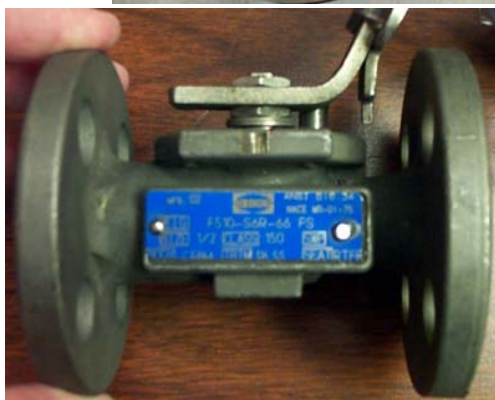
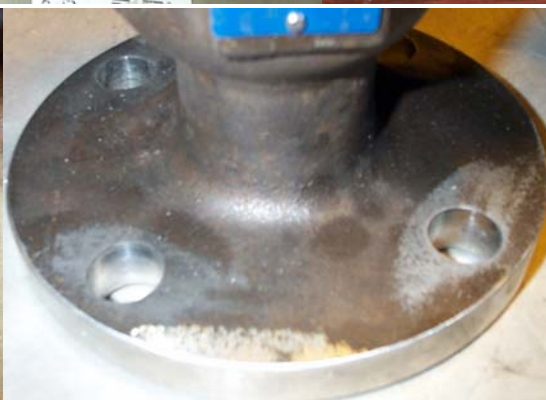
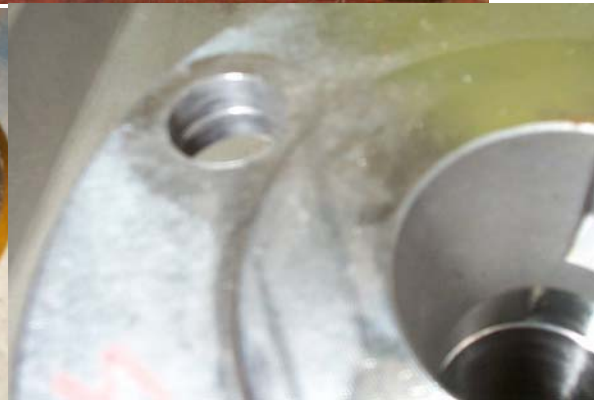
Flanges Received as “New” at the Savannah River Site – note clamp marks, different rivet sizes on tag, scratches, groove in bolt hole, lack of cleanliness

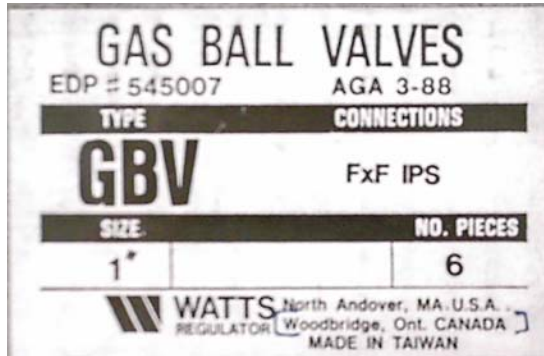
The WATTS Gas Ball Valve label above is S/CI because WATTS does not have a Woodbridge, Ontario, Canada facility

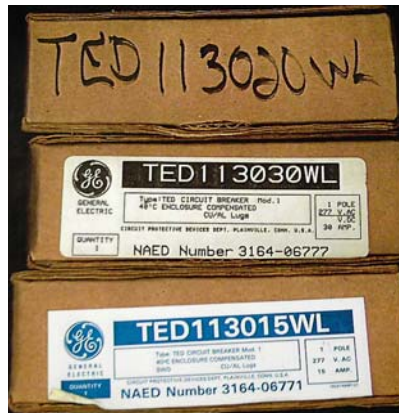
The blue and white colored GE label above is authentic. GE does not affix black and white labels on boxes for this item nor should the product number be handwritten without any proper GE labeling.

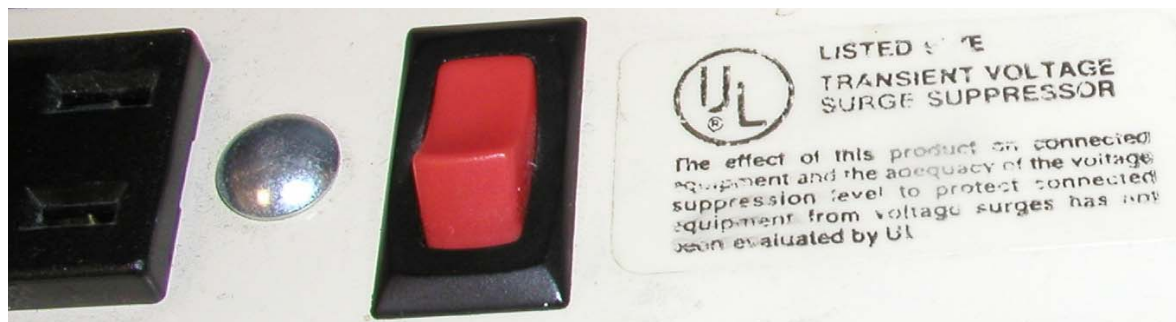
## Brooks (Philadelphia, PA) Transient Voltage Surge Suppressor

This item was initially deemed “suspect” because of the label statement that reads, *“The effect of this product on connected equipment...has not been evaluated by UL.”* However, discussion with Underwriters’ Laboratory (UL) representatives revealed that this is acceptable language accompanying the UL listing logo. In the guides for product types found on the UL Online Certifications Directory website at <http://www.ul.com/onlinetools.html>, UL states when specific factors have not been evaluated. The guides can be accessed by conducting a Specific Search using the UL Standard Number associated with the product type. The UL standard number associated with Transient Voltage Surge Suppressors is “1449”. After the word “LISTED” on the label, “977E” has been rubbed out. The Model number on the back of the item is VCN-66. The product had been performing as intended when the label statement was questioned.

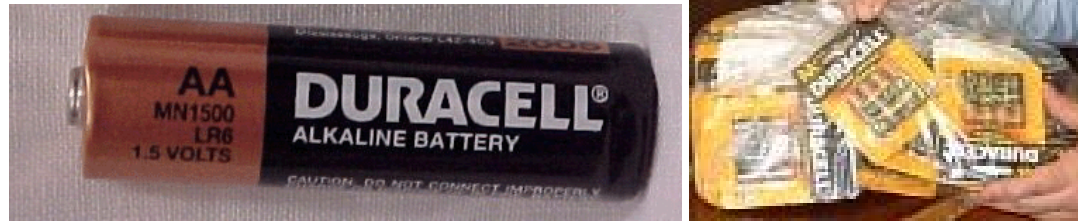
## Counterfeit DURACELL® Batteries

Authentic **DURACELL**® battery on the left. Counterfeit **DURACELL**® batteries on the right spell the name the same as the authentic batteries.

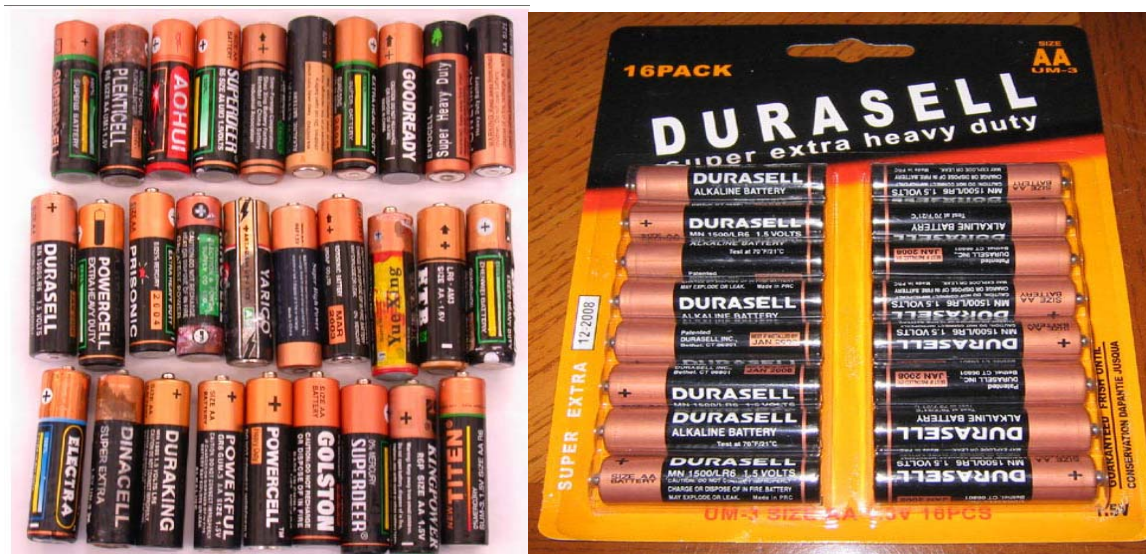
On the left - Examples of DURACELL clones simulating trademarked DURACELL colors (note several are leaking). Some have flimsy casings that crush easily under pressure by hand. The counterfeit batteries on the right the batteries are spelled differently but constitute trademark infringement (black and gold copper top).

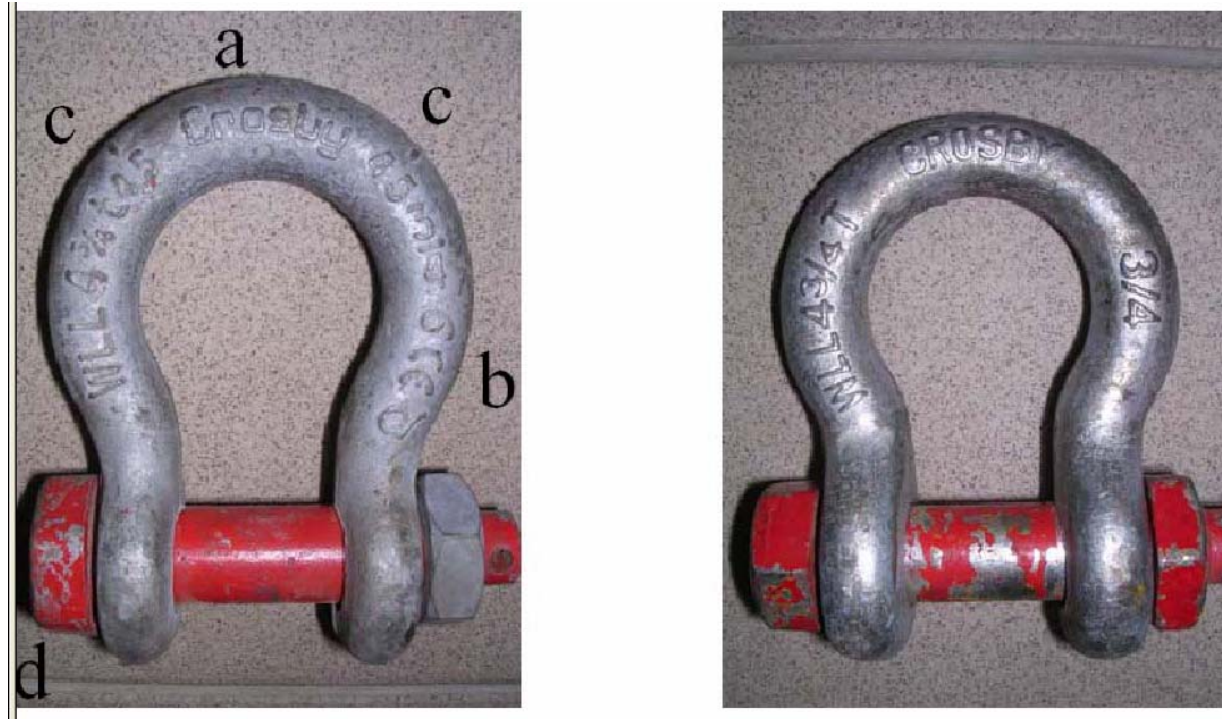
## Counterfeit Crosby Shackle

Counterfeit Crosby Shackle found in Europe. Not yet seen at DOE facilities as of early 2006. The one on the left is authentic and the one on the right is counterfeit. Note the spelling of “Crosby” on the left (authentic) with the first letter capitalized and the rest in lower-case letters. a) Crosby name embossed per Crosby logo, b) should see CE mark, c) 45-degree angle markings, d) pin stamped on head with traceable ID number.

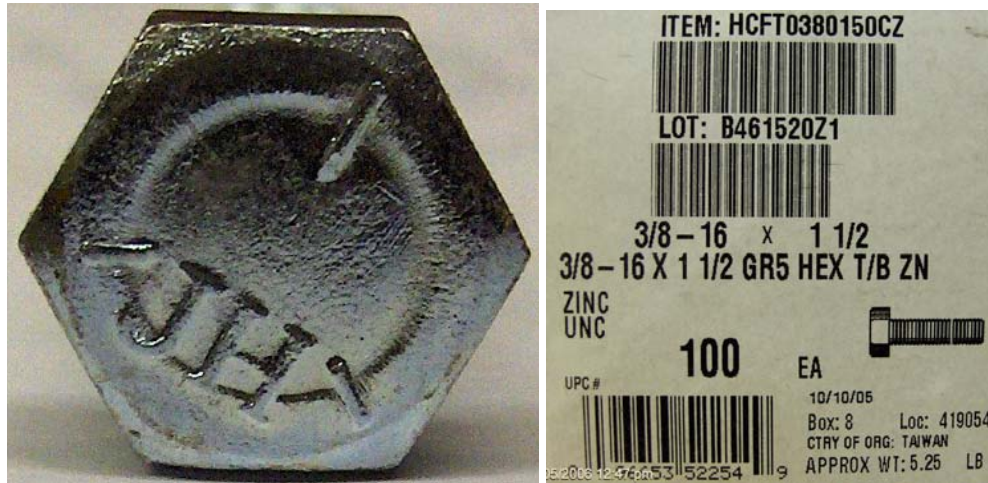
## Jinn Her “JH” Grade 5 Hex Bolt from the West Valley Demonstration Project

This Jinn Her “JH” Grade 5 Hex Bolt from the West Valley Demonstration Project (WVDP) was received in December 2005. Jinn Her “J” headmarks on grade 5 and grade 8 high-carbon steel fasteners are deemed counterfeit. However, Jinn Her has the “JH” insignia currently registered in the U.S. through the U.S. Patent and Trademark Office. The fasteners were ordered as domestic, yet the supplier provided the foreign-made Jinn Her fasteners from Taiwan. The fasteners were tested and found to meet WVDP specifications. WVDP has chosen to use these fasteners. This insignia (headmark) appears on the FQA Register of Active Fastener Insignias at <http://www.uspto.gov/web/offices/tac/fqa/fqa.htm>.

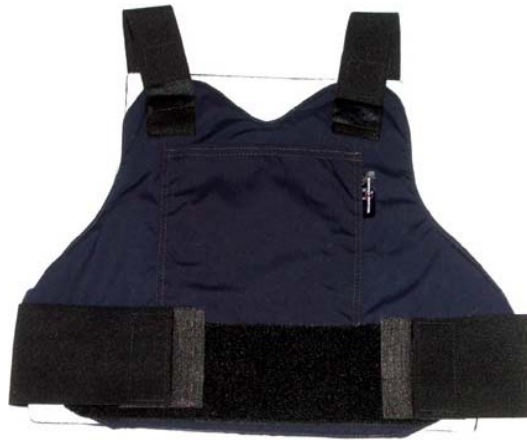
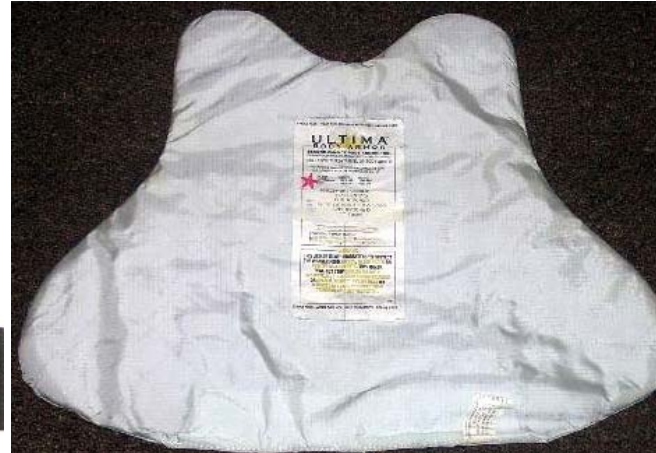
## Suspect/Counterfeit Bulletproof Vests Manufactured by Second Chance Body Armor, Inc

Bulletproof vests manufactured by Second Chance Body Armor, Inc. ("Second Chance"), which contains Zylon<sup>®</sup>, a fiber manufactured and sold by Toyobo Co., Ltd. and Toyobo America, Inc., and sold by Second Chance and its distributors under the trade names ULTIMA, ULTIMAX, and TRIFLEX. These vests fail to meet the performance characteristics for which they were warranted, degrading at a quicker than expected rate from light, humidity, and temperature. Allegedly, the defective condition of the vests was withheld from the marketplace. Upwards of 20% of the ammunition fired at these vests penetrated the fabric.

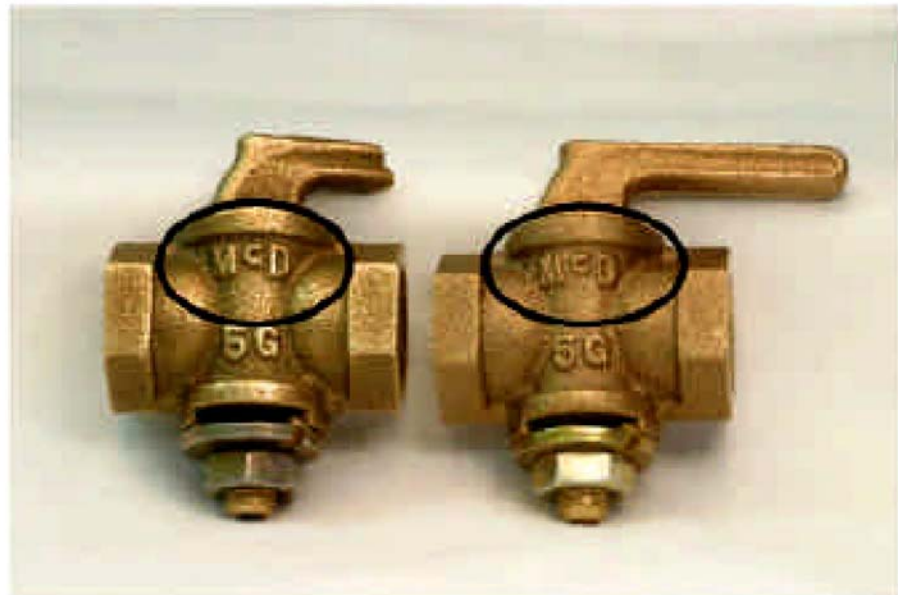
**Comparison of 1/2" Lever Handle with  
Check low pressure gas valve – Plug style**

Left – Counterfeit  
Markup similar to McDonald

Right – Good  
A.Y. McDonald

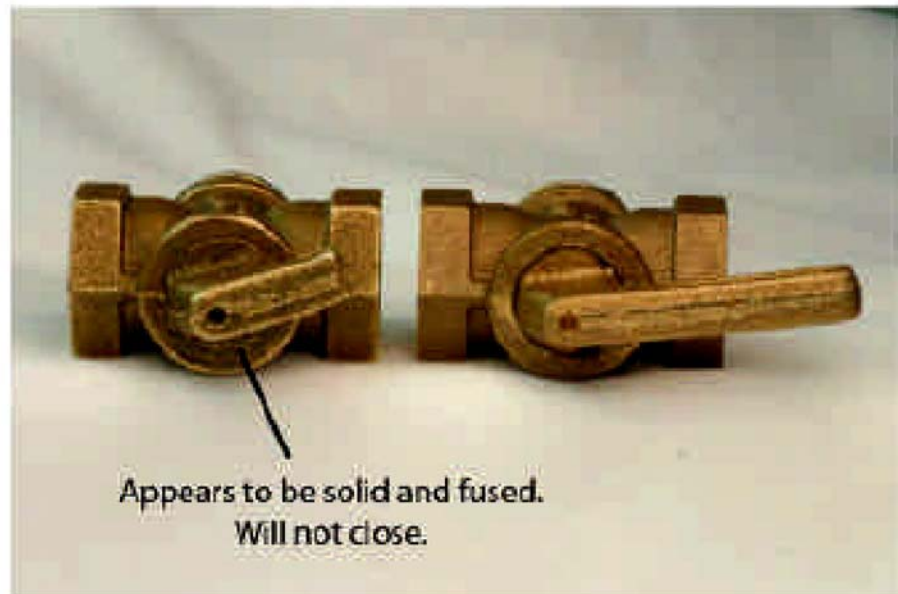
Left – Counterfeit

Right – Good

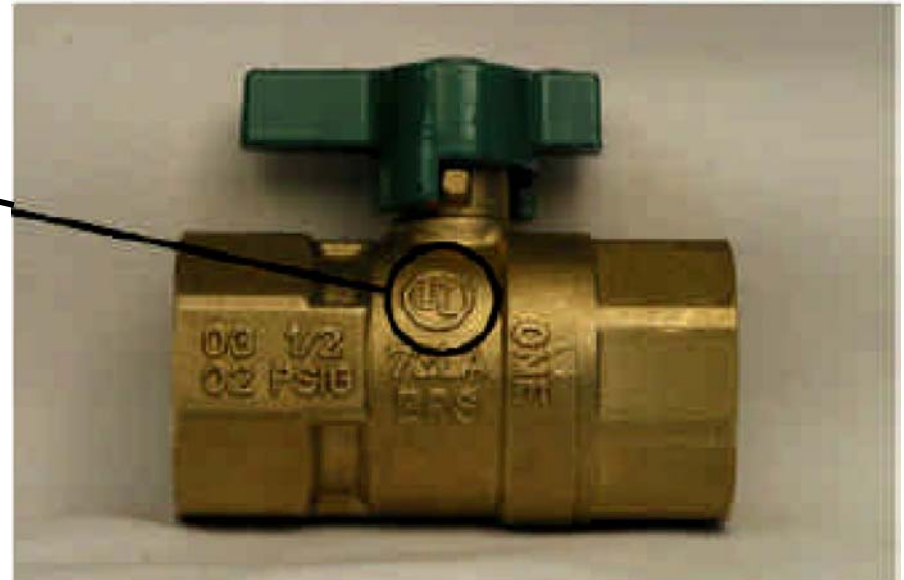
**1/2" Forged CSA Ball Gas Valve – Good**

UL logo  
(Underwriters' Laboratory)

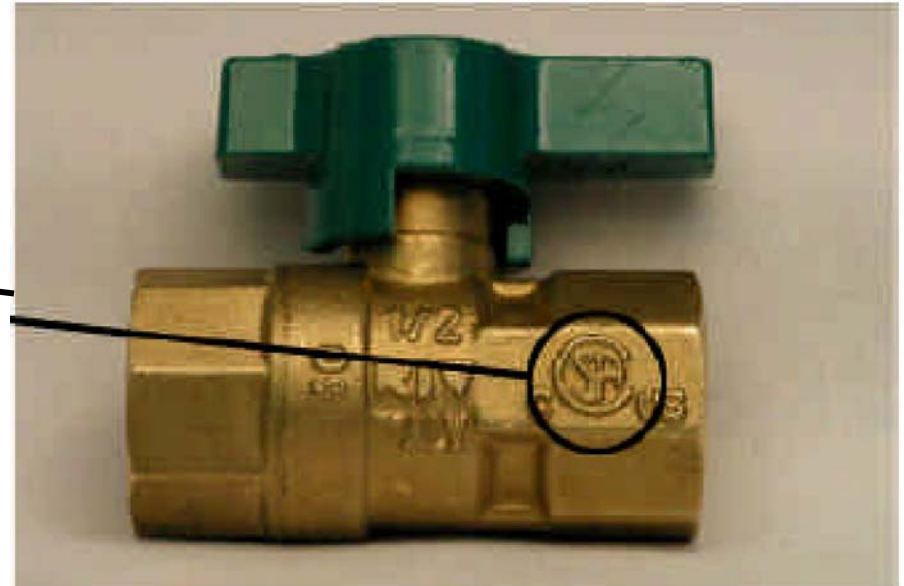
CSA logo  
(Canadian Standards Association)

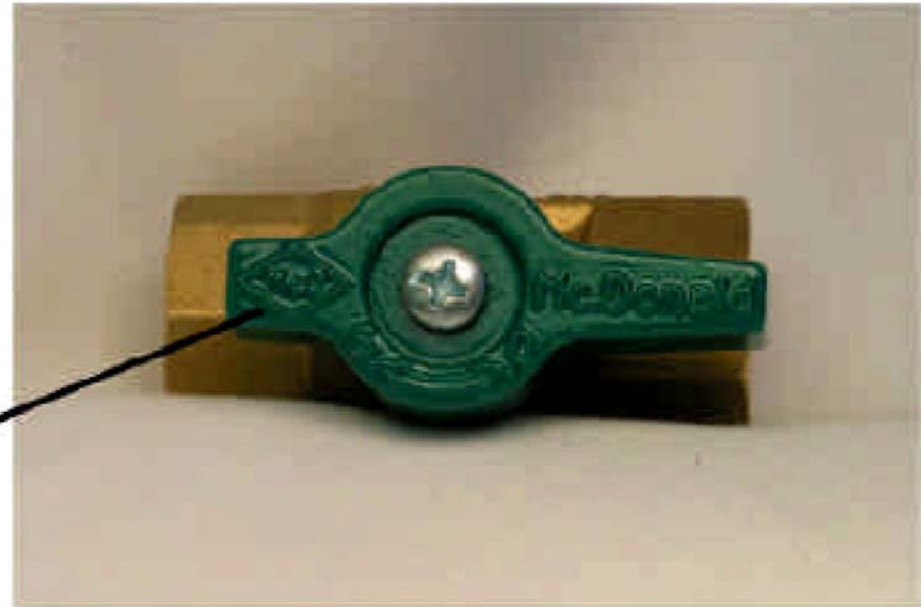
**1/2" Forged CSA Ball Gas Valve  
Good**

Top View

McDonald logo

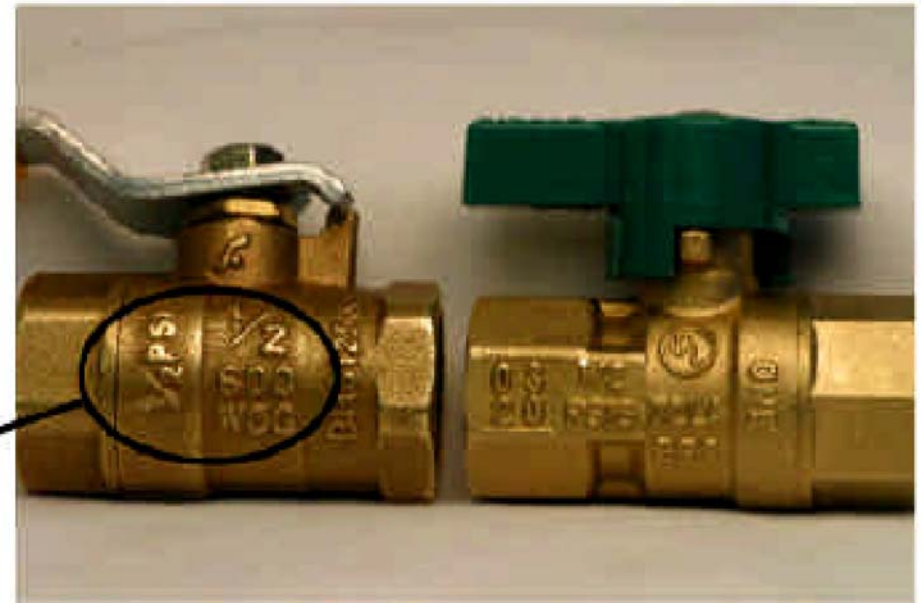
**Comparison between two 1/2" Forged CSA Ball  
Gas Valves**

Left - Counterfeit

Right - Good

Conflicting information  
1/2 psi - 608 WOG

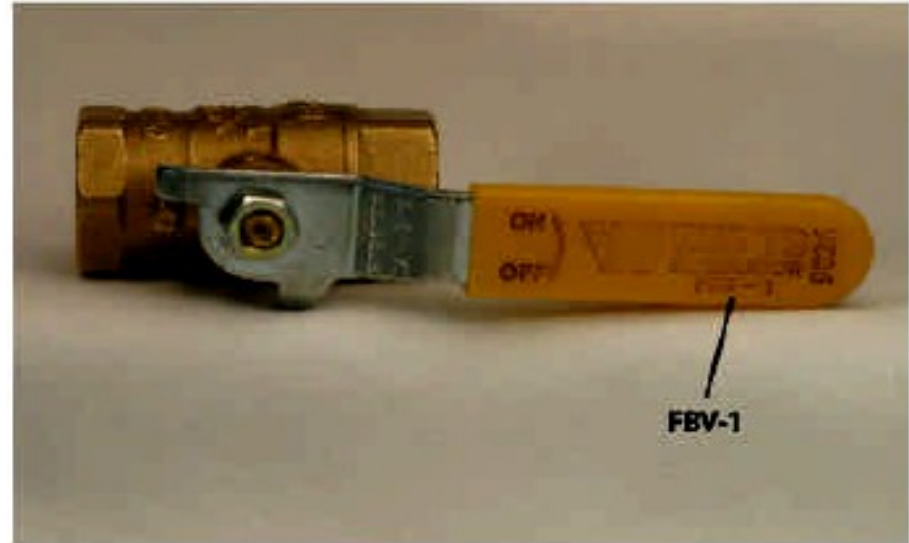
## 1/2" Forged Ball Gas Valves Counterfeit

Handle marked Watts Regulator FBV-1  
Watts doesn't manufacture a FBV-1 series valve.

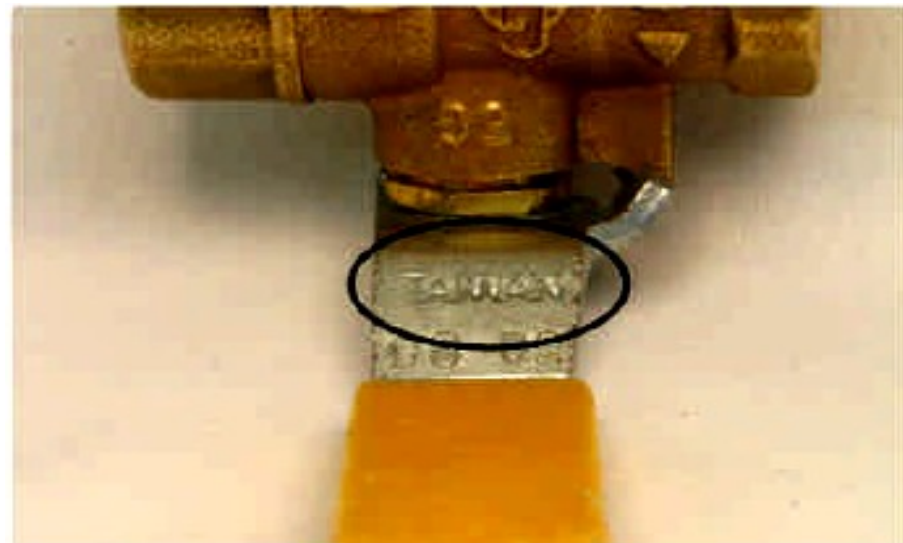
Taiwan stamped on the back of handle.  
Watts doesn't have a facility in Taiwan.

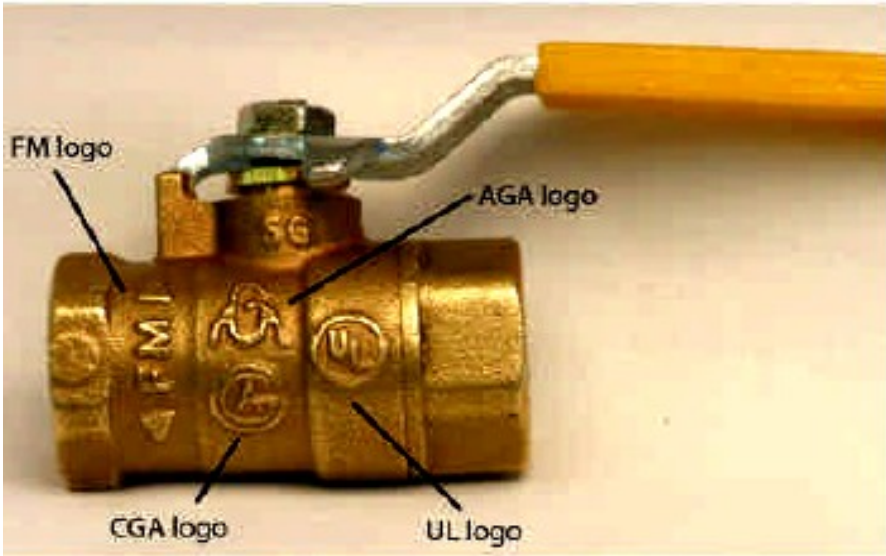
# 1/2" Forged Ball Gas Valves Counterfeit

Four logos:

- FM (Factory Mutual)
- AGA (American Gas Association)
- CGA (Canadian Gas Association)
- UL (Underwriters Laboratory)

Watts only manufactures to UL and CGA

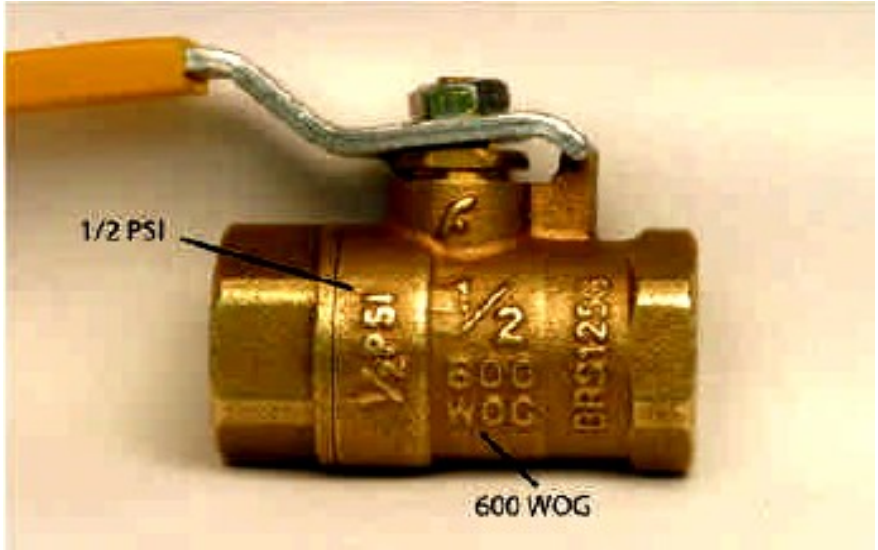
1/2 psi and 600 WOG markings

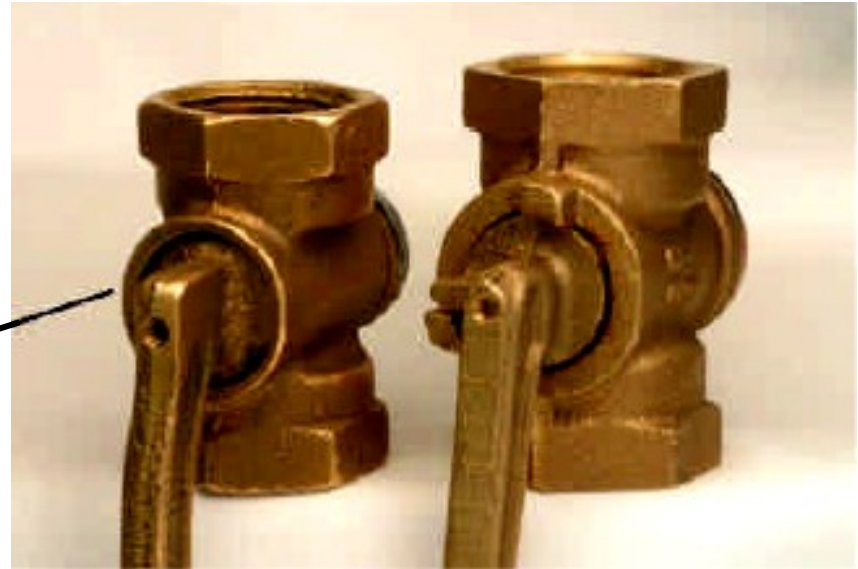
**Comparison of two 1" lever handle with check  
low pressure gas valves - plug style**

Left - Counterfeit  
Will not close; appears fused.

Right - Good

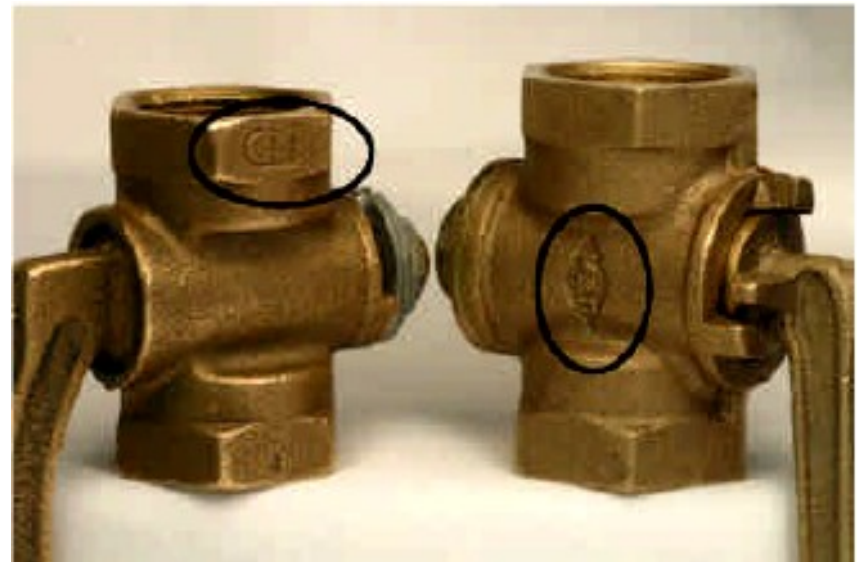
Comparison of markings

Left - Counterfeit  
CI (Coalition of Indian Industries) marking

Right - Good  
McDonald marking

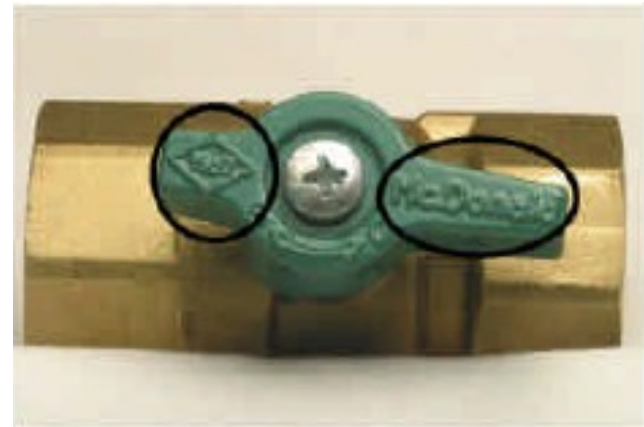
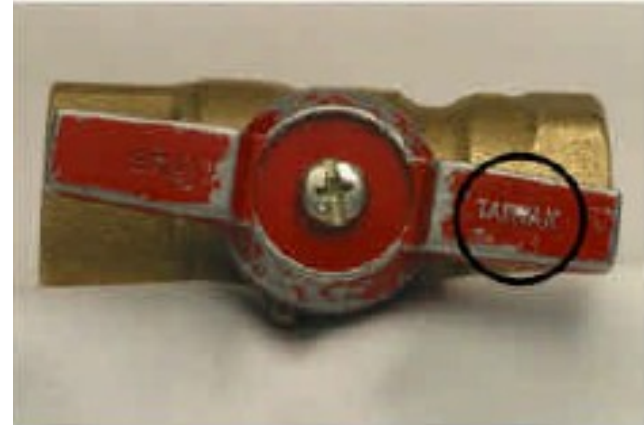
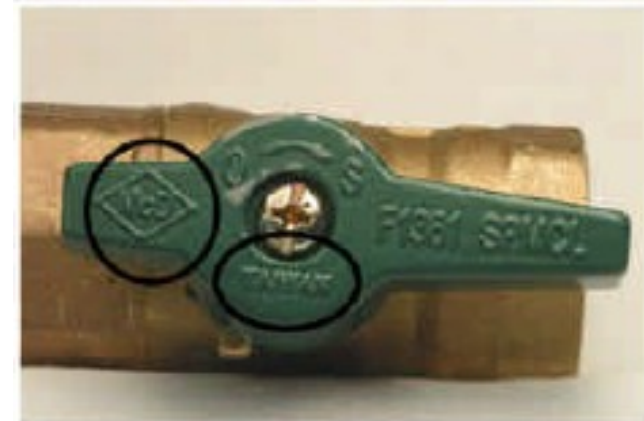
**Comparison of three valves**  
**All foreign by indicators on valves**  
**Top - Good**  
**Middle - Counterfeit**  
**Bottom - Good**

McDonald manufacturer  
Clear manufacturer per standards

Unknown manufacturer

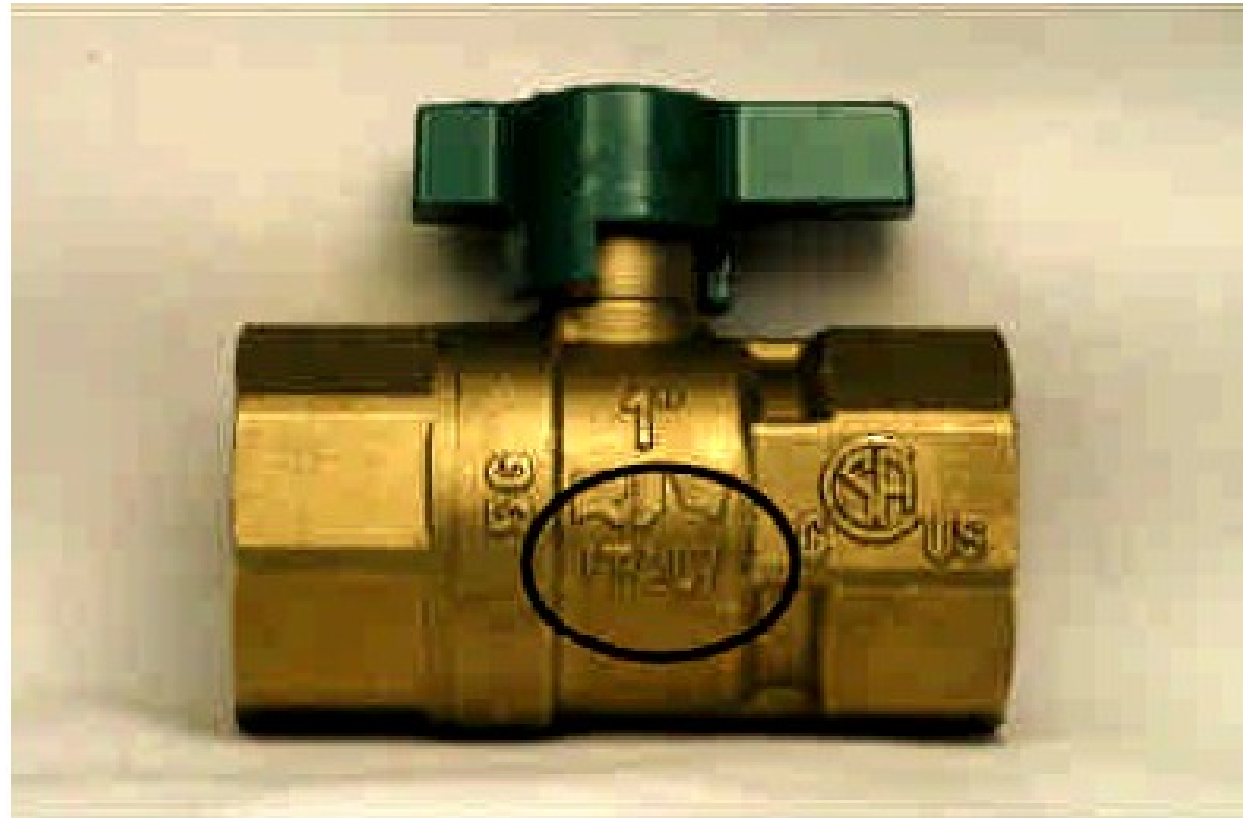
**1" Forged Ball Gas Valve  
Good**

McDonald valve manufactured  
in Italy

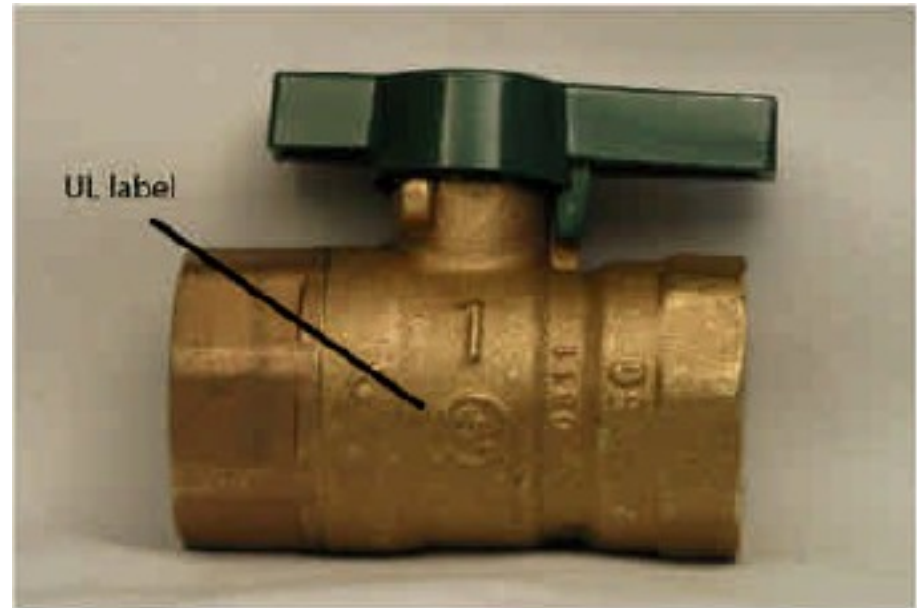
**1" Forged Ball Gas Valve  
Good**

McDonald valve manufactured in Taiwan  
UL (Underwriters' Laboratory) label marking  
Refer to page 33 for comparison

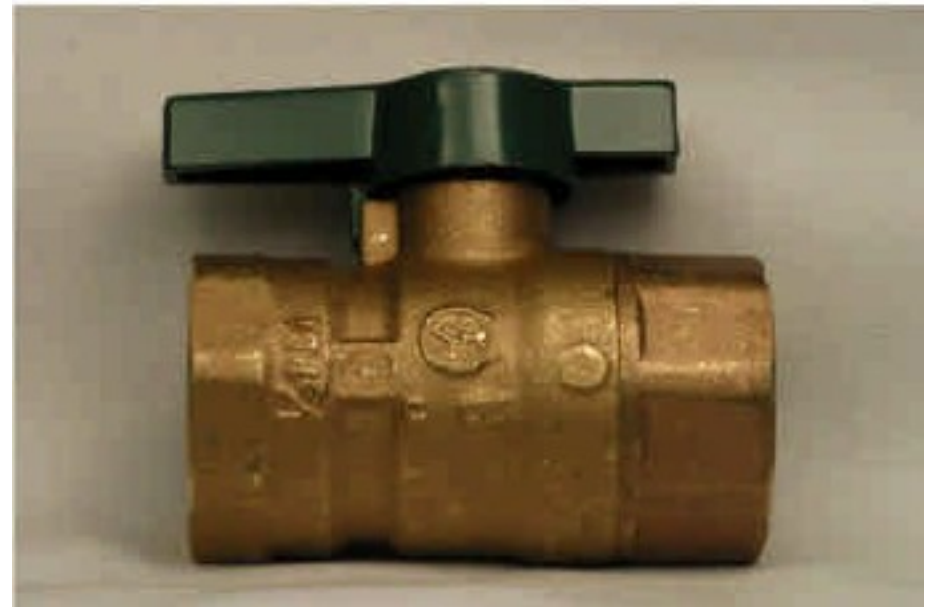
McDonald valve manufacturer in Taiwan  
Opposite side view  
Refer to page 33 for comparison

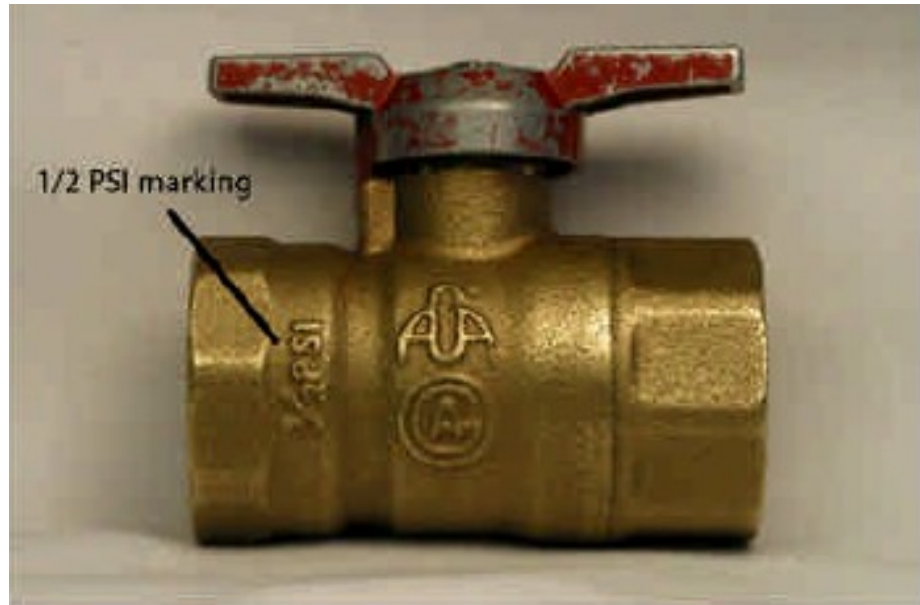
**1" Forged Ball Gas Valve  
Counterfeit**

Unknown manufacturer  
1/2 psi marking  
Represented as new  
No manufacturer marking  
Refer to page 33 for comparison

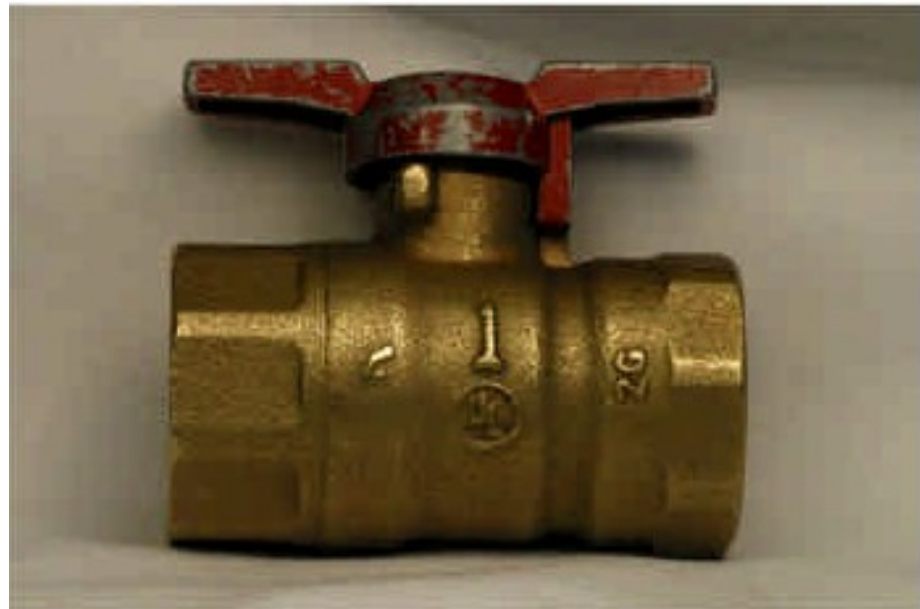
Unknown manufacturer  
Opposite side view  
Refer to page 33 for comparison

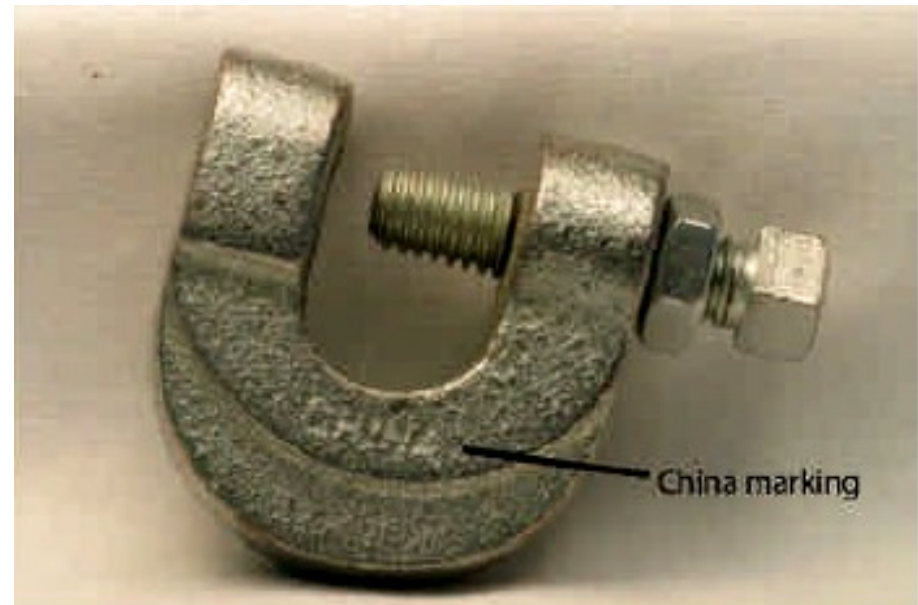
**Zinc-Coated Beam Clamp  
Counterfeit**

Product ordered domestic  
Label on box indicated domestic  
All products inside marked with "China"  
No manufacturing name or logo on part  
Supplied by a B-Line distributor

For example, the photo of the clamp with the “*CHINA*” marking and the caption “*zinc-coated beam clamp counterfeit*” on page 42 is the result of research leading to the declaration that this particular clamp is counterfeit. The “*CHINA*” marking was an initial clue that led to a declaration of the item being “suspect” or “suspect/counterfeit” depending on the site use of the terms, but was not initially declared as “counterfeit.” When conducting research to make a final declaration on an item, it is very often necessary to trace the item back to its origins and look into documents such as purchase orders, contracts and certifications. Subsequently, it is possible that a site might receive a “*CHINA*” marked clamp such as this and site policy prohibits non-domestic items on the site for use in operations. However, after conducting research, it might be revealed that there was no input from QA or engineering or safety that set specifications or standards for the purchase order and the procurement staff did not seek that information before sending out the request. This then could result in a vague purchase order being generated and sent to the vendor. The vagueness may not preclude “*CHINA*” marked items from being supplied. The vendor might then supply a “*CHINA*” marked clamp from their inventory. Further, the contract with the vendor might be silent on S/CI prohibitions. So, the site gets what it ordered, but not what it wanted. In such an example, the item declared initially as “suspect” would not become “counterfeit”, because the error was on the part of the site, and no evidence of intent-to-defraud was identified. Hence, it is important to understand that when viewing a picture such as the “*CHINA*” marked clamp, it does not mean that all clamps marked “*CHINA*” are “counterfeit.”

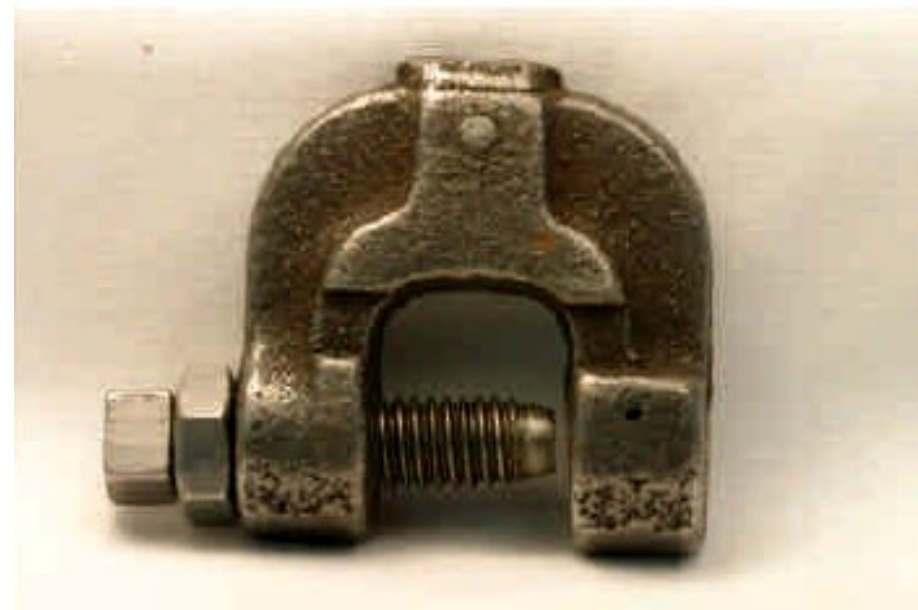
**Beam Clamp  
Counterfeit**

No manufacturing name or logo on part  
No part number or size

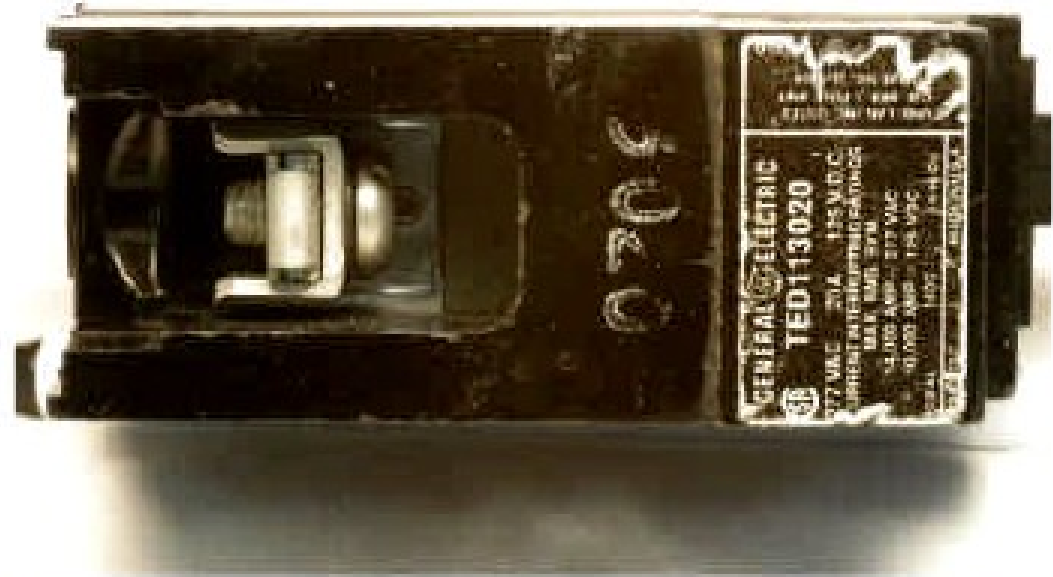
## GE Molded Case Circuit Breaker Counterfeit

Label marked General Electric and "GE"  
Manufacturer stopped marking with both indicators over 20 years ago  
Label very worn

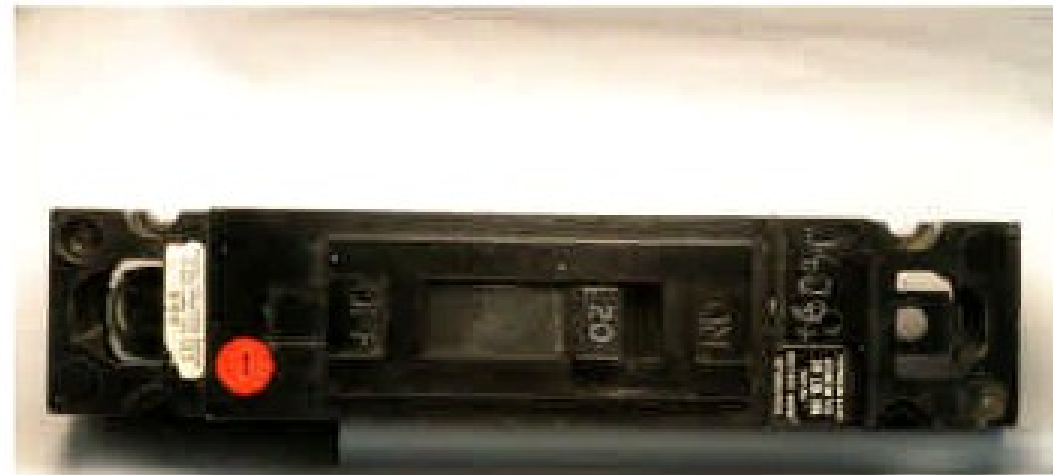
### Top view

Represented as being new in condition shown

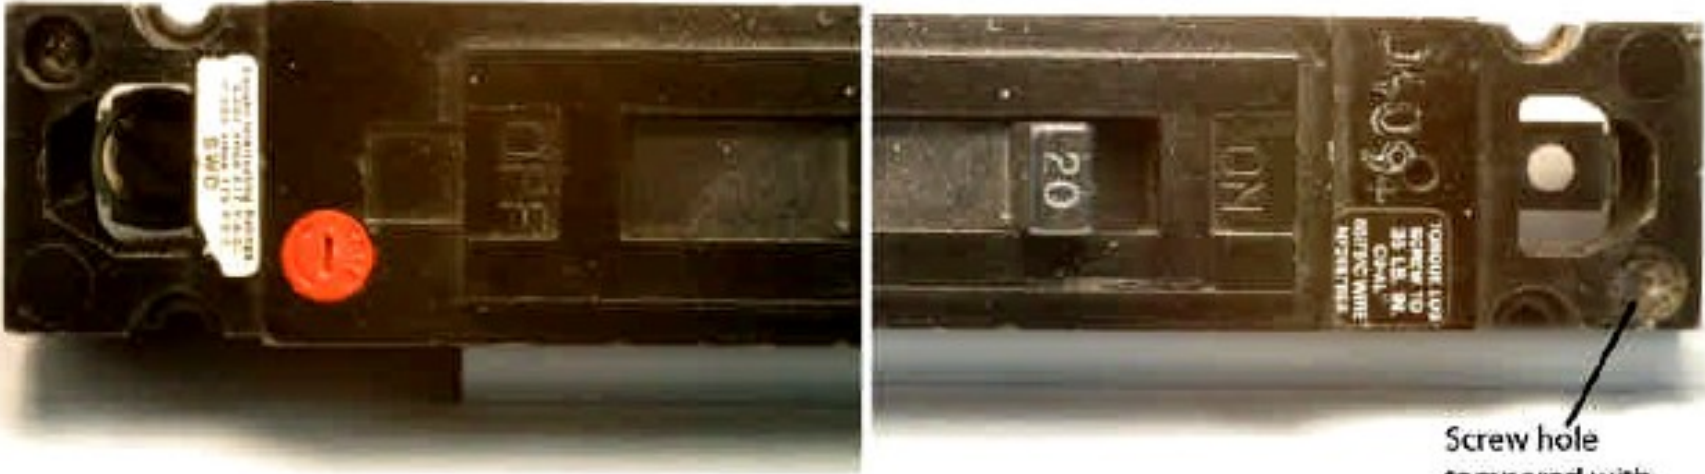
**GE Molded Case Circuit Breaker Counterfeit**

Sold as new by supplier  
Indications of being used or refurbished  
Label worn and torn

Potting material in bottom screw hole tampered with;  
should be smooth and even with surface of case  
Appears dirty and worn  
Represented as being new in the condition above
