# Suspect/Counterfeit Items Awareness Training

**U.S. Department of Energy  
Health, Safety and Security  
Office of Corporate Safety Analysis**

**October 2006  
Revision 5**

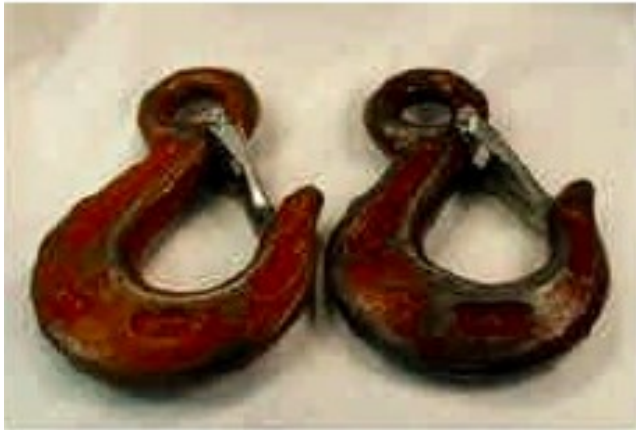
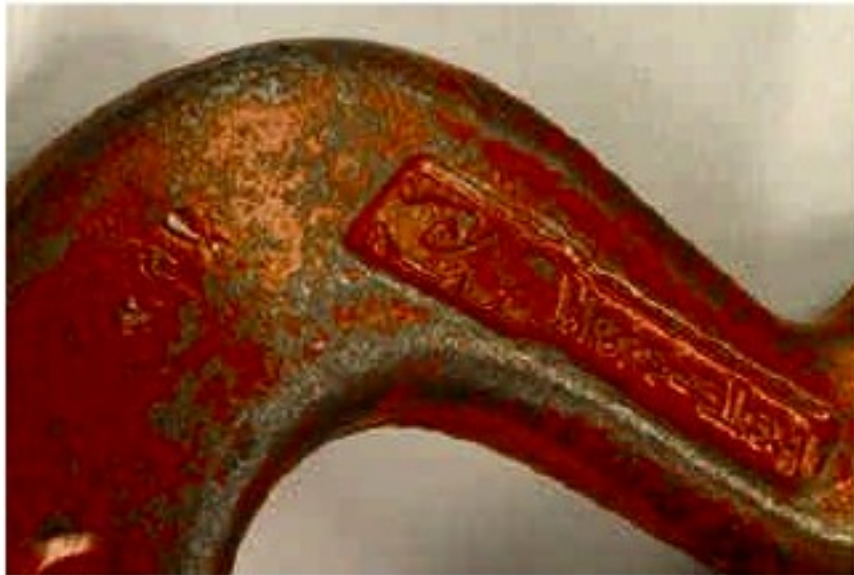
### Comparison of two Latching Eye Hooks Both Counterfeit

**NOTE:** If you order carbon-steel hooks (without specifying the Crosby brand) and receive hooks that are painted red but not identified as Crosby, consider the hooks suspect. The Crosby Group, Inc. has a trademark on painting its carbon-steel hooks red and does not license others to manufacture such hooks. If you discover suspect hooks like these, we suggest that you call the Crosby Group at (800) 772-1500 as a courtesy so that they can investigate and address the issue of potential trademark infringement. Further, the hooks should be evaluated according to hoisting and rigging guidelines to ensure that they have all the proper certifications, the manufacturer is traceable, and the hooks meet specifications. If the hooks were ordered new but show signs of wear, or if they appear to be improperly marked, consider the hooks suspect and counterfeit. Do not return the hooks to the source from which they were purchased.

Represented as being new in condition shown above  
Appearance very worn  
Are correct manufacturer markings for orange hook

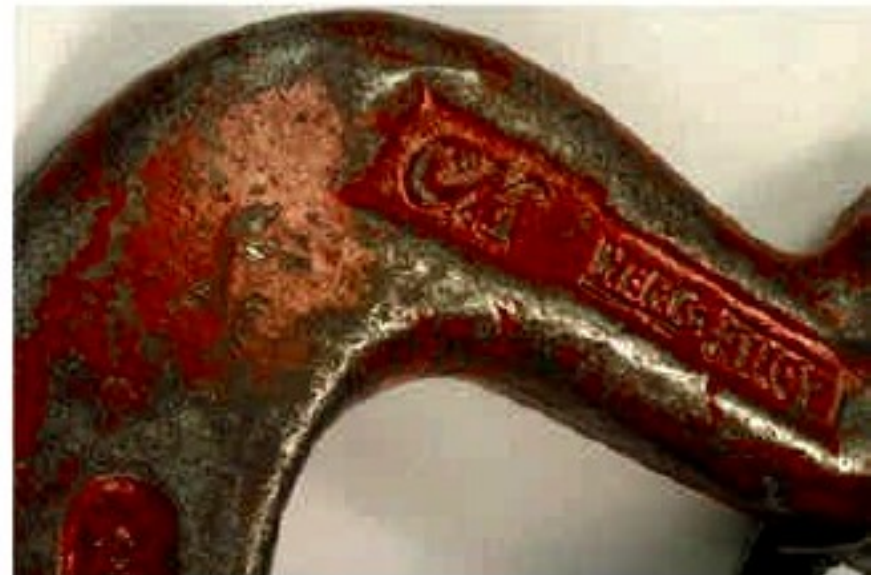
Red color is the Crosby Group, Inc. trademark-patented color  
Represented as being new in condition shown above  
Appearance very worn

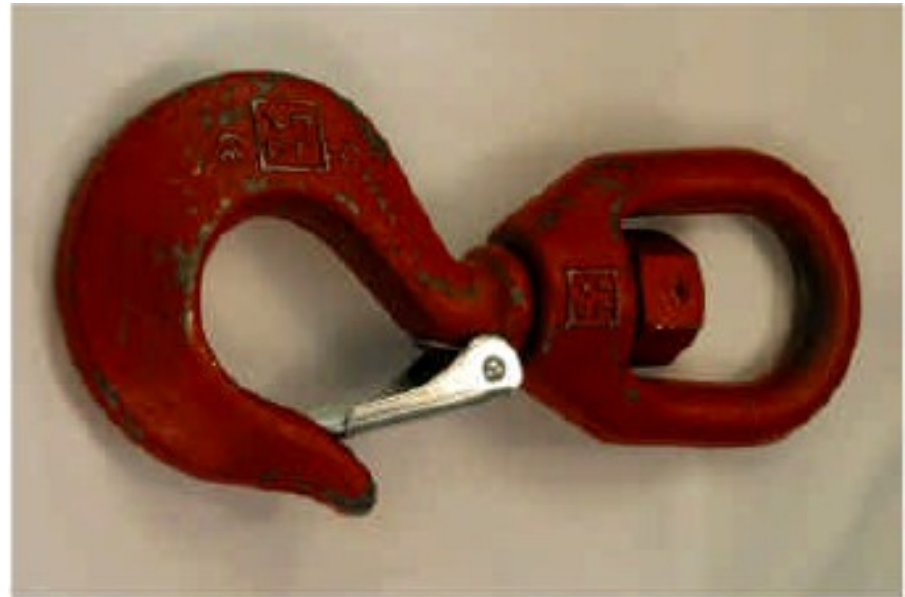
### Swivel Hook - Red Counterfeit

Color of hook is RED. Crosby Group, Inc. has the patent, trademark registration for the color RED in the United States

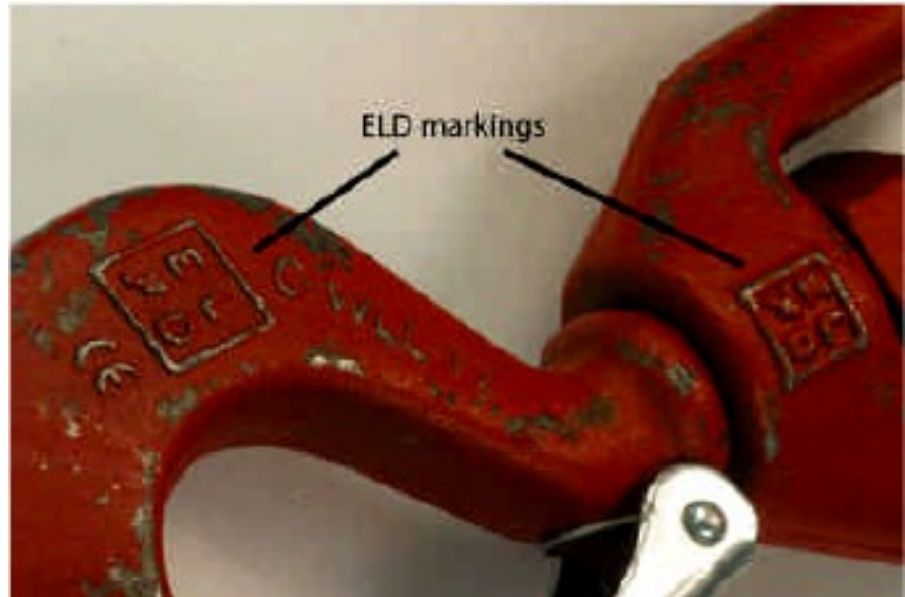
Hook received from Crosby distributor and represented as being Crosby.  
Marking on hook "ELD," not "CG" or "Crosby" - Crosby markings

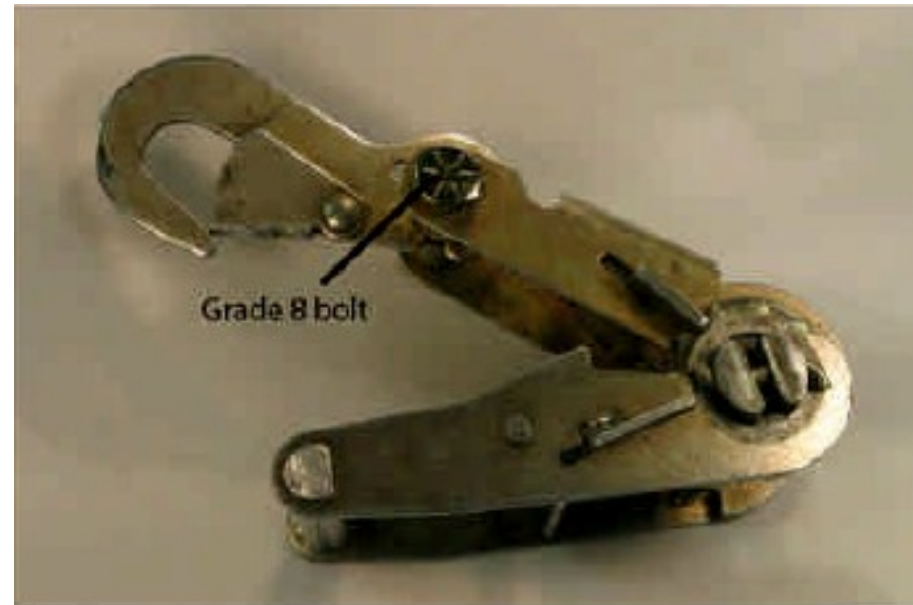
**Ratchet tie-down without strap  
Counterfeit**

Bolt in ratchet is a Grade 8 with no manufacturer marking, which is on the DOE Suspect/Counterfeit Headmark list.

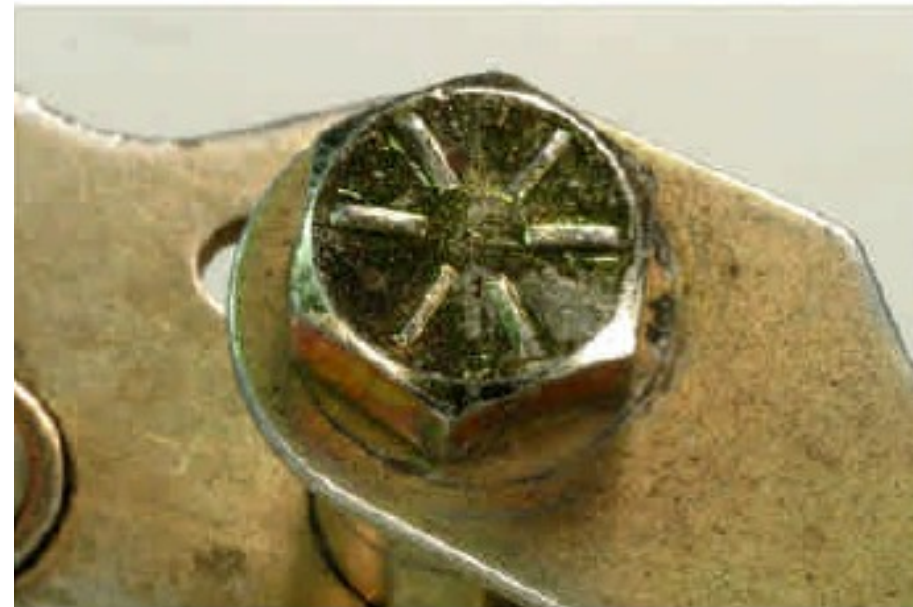
Close-up of Grade 8 bolt

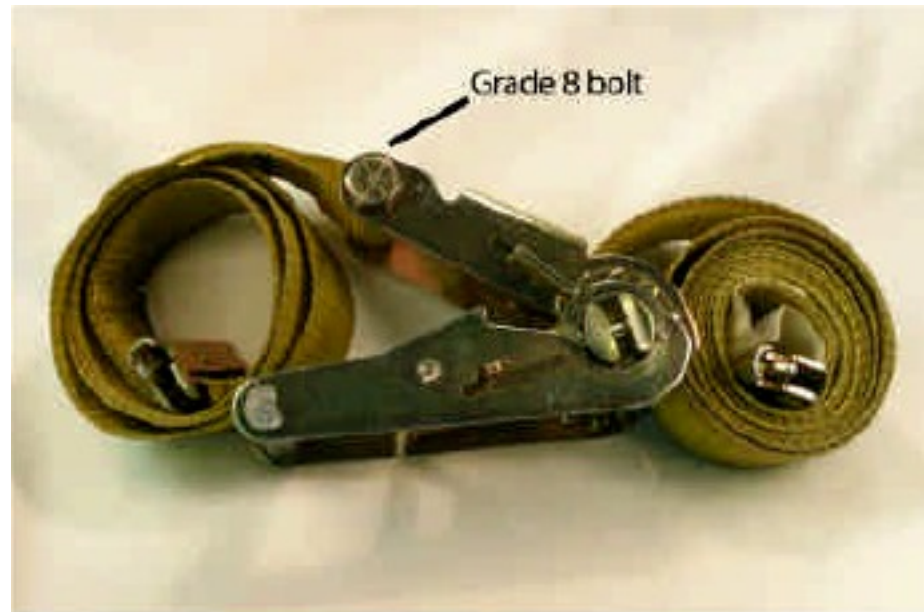
### **Ratchet Strap Tie-Down Counterfeit**

Bolt in ratchet is Grade 8 with a manufacturer marking of "H," which is on the DOE Suspect/Counterfeit Headmark list.

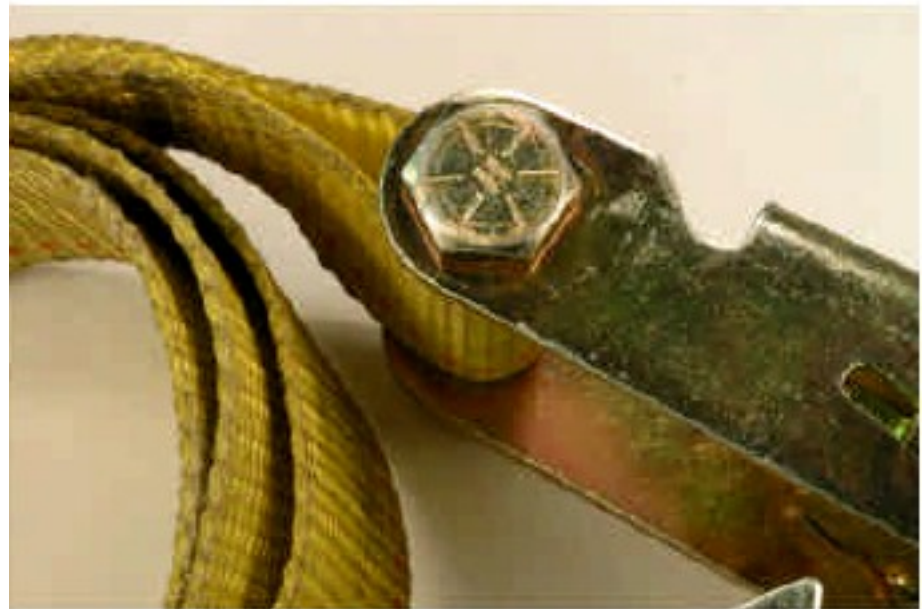
Close-up of Grade 8 bolt

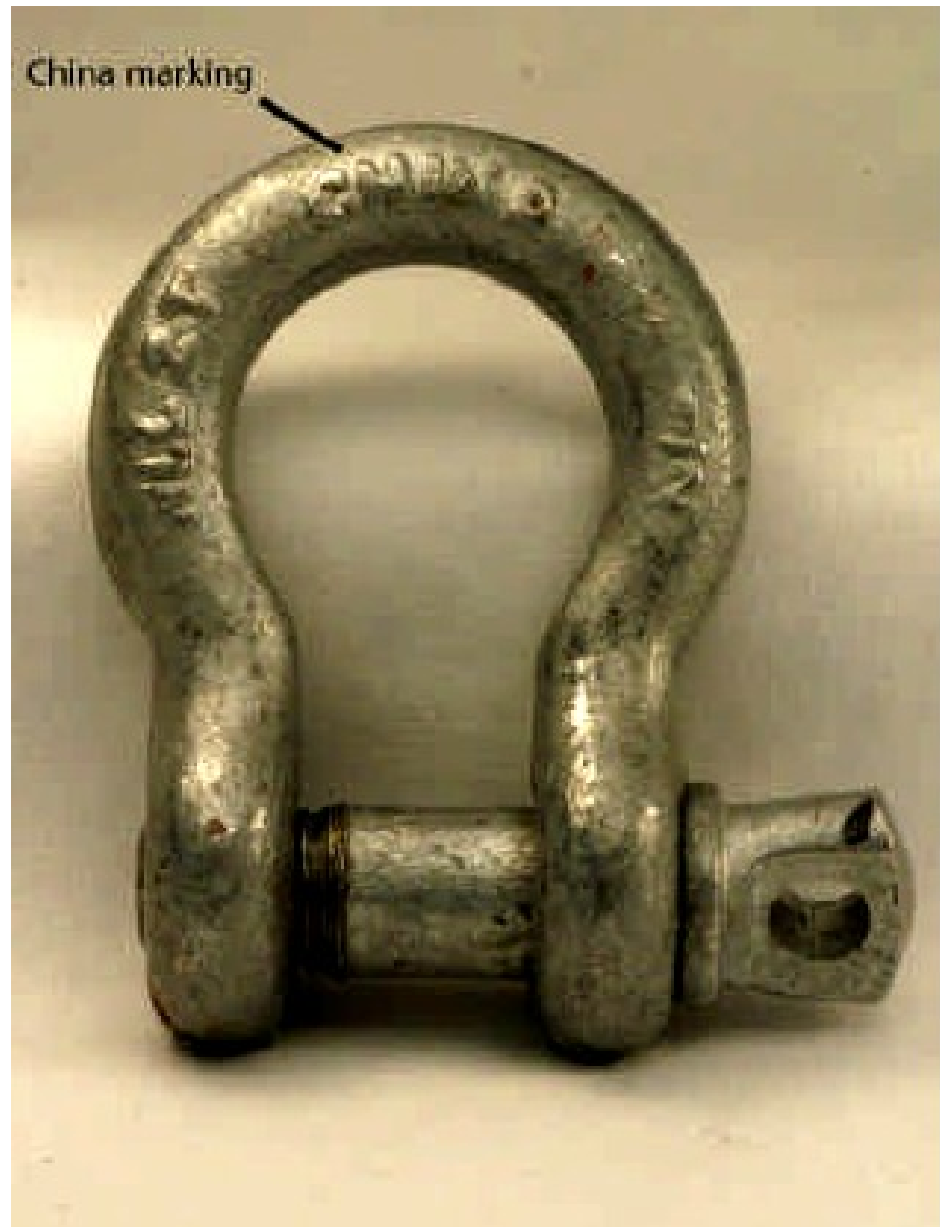
**Shackle  
Counterfeit**

No manufacturer markings.  
“China” is marked; however, this is unacceptable as standard requires the manufacturer’s name or trademark.

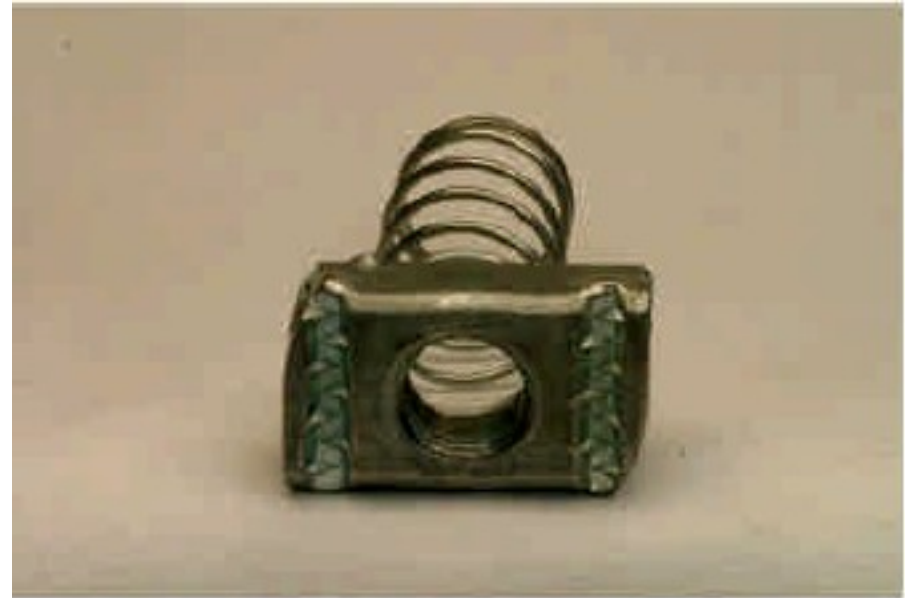
**Spring Clip  
Counterfeit**

Bottom view

No manufacturer's name or logo on part  
No part numbers or size

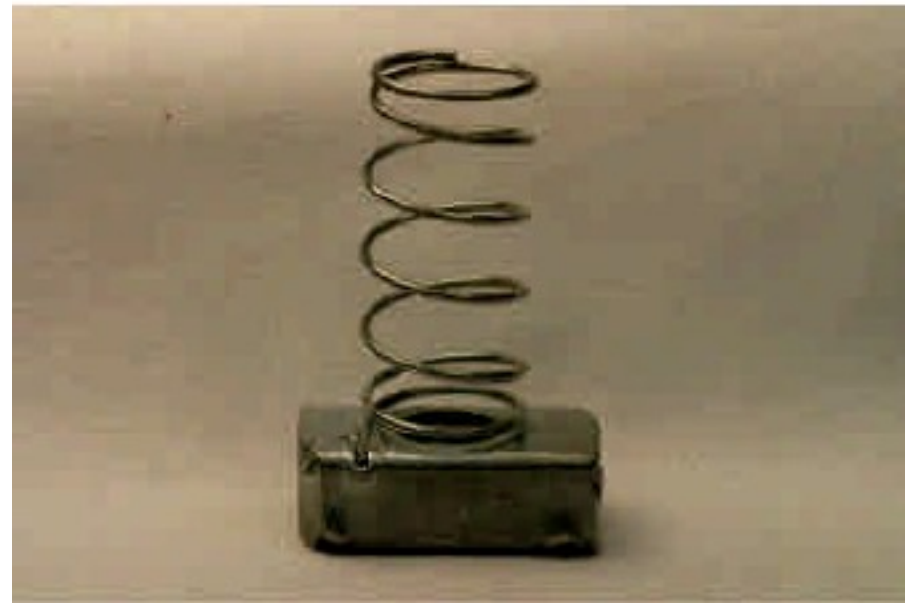
Side view

No manufacturer's name or logo on part  
No part numbers or size

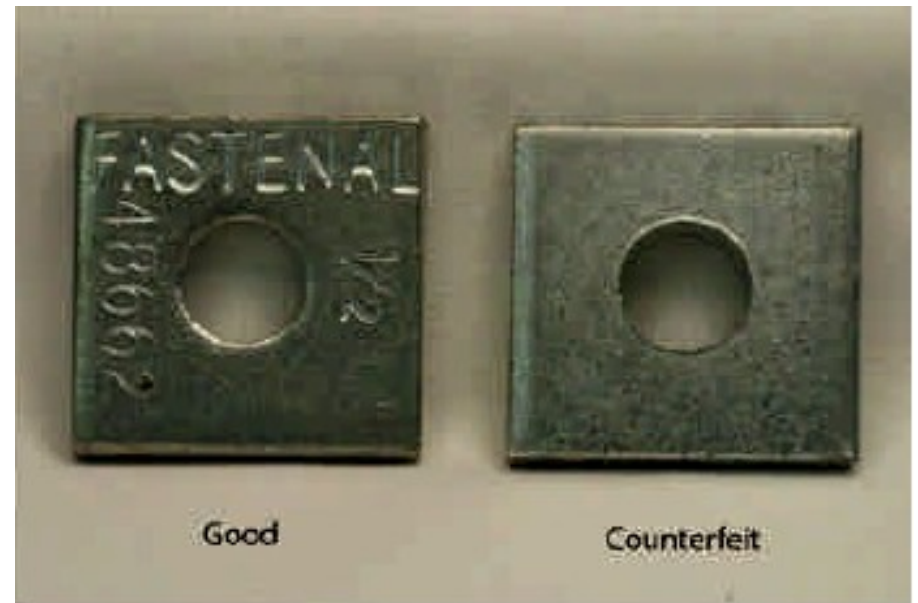
### Square Washers/Spacers

Received in the same box together

Left - has proper markings. Good.

Right - has no markings. Unknown manufacturer.

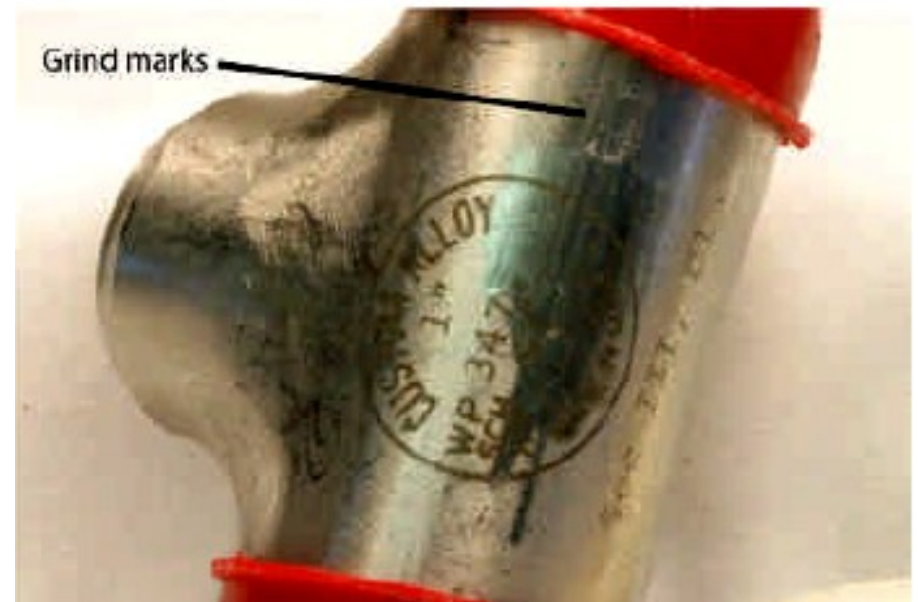
### Stainless Steel "T" Weldolet Counterfeit

Grind marks where information was removed  
New information stamped on

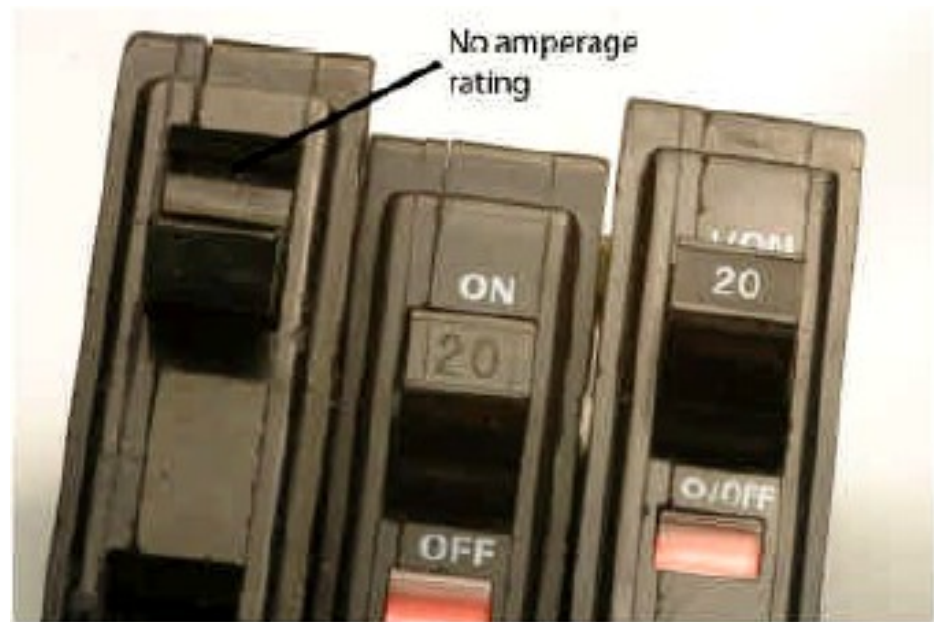
## Comparisons of Square D Breakers

- Left - Counterfeit
  - No amperage rating on end of switch
  - Original number filed off
- Middle and Right - Good
  - 20-amp rating clearly displayed

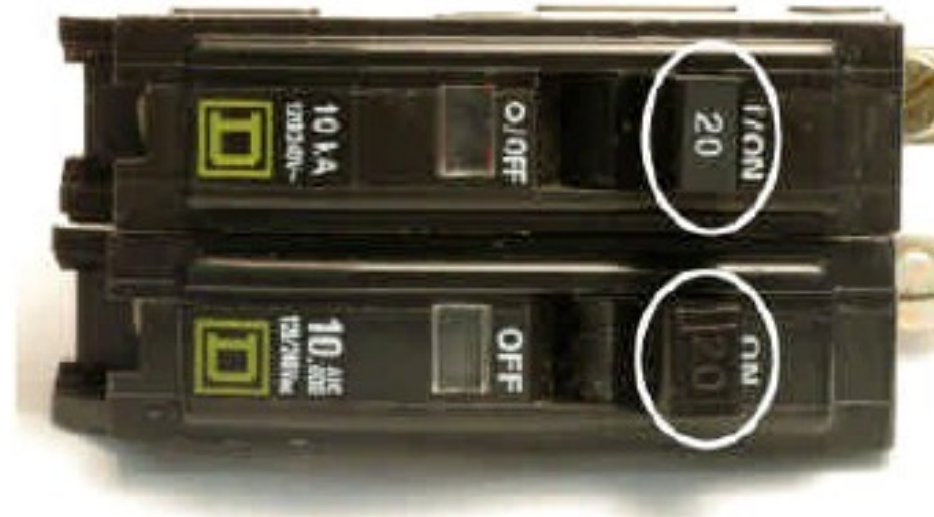
## Square D Breakers Both Good

- Clearly marked amperage rating on end of switch
  - Rating on top switch is silk-screened (Square D started silk-screen process in 2003)
  - Rating on bottom switch is molded

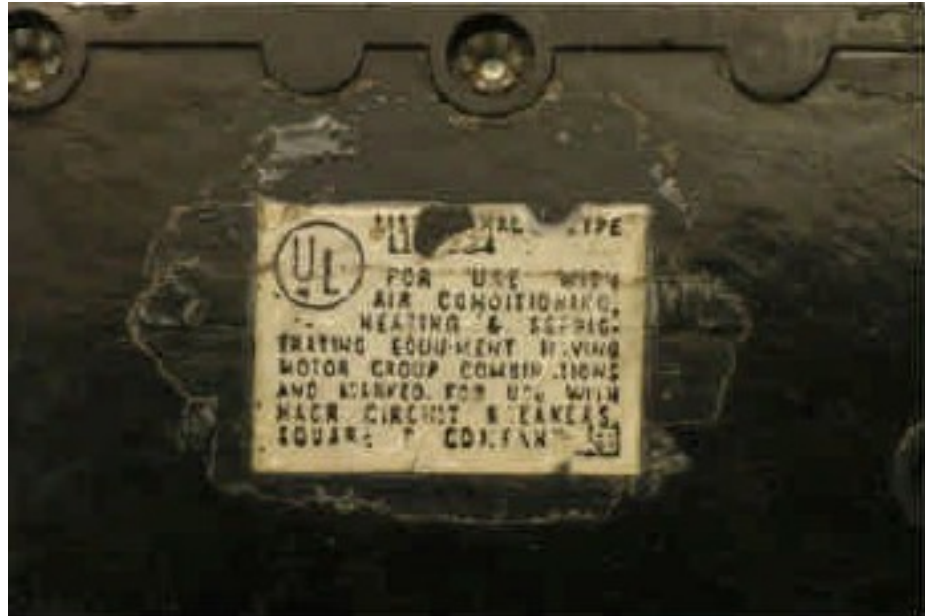
## Square D Circuit Breakers

Copied UL label taped on side of breaker

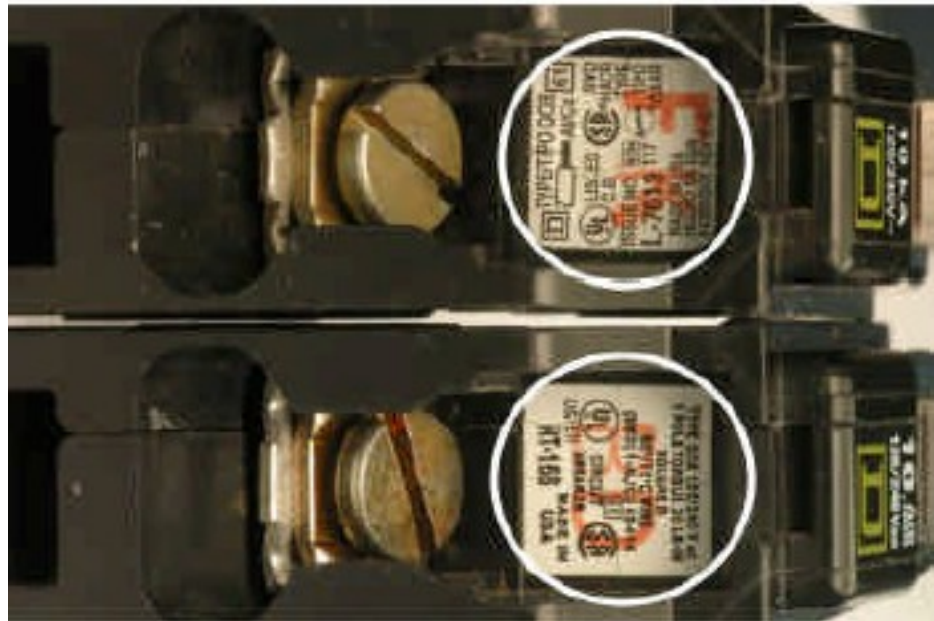
### Good Breakers

"UL" label on end of switch (black lettering on white background - two larger pinkish-red letters stamped on label)

Manufacturer can identify date period manufactured from two larger letters

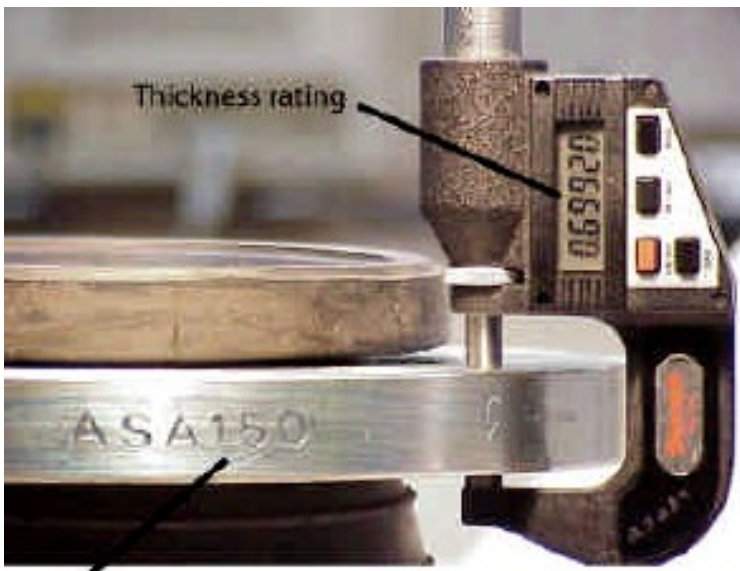
## Expansion Connectors Counterfeit

150 lb. rated flange  
Should be 0.940" thick - 0.000+0.125  
This one is 0.69920" thick.

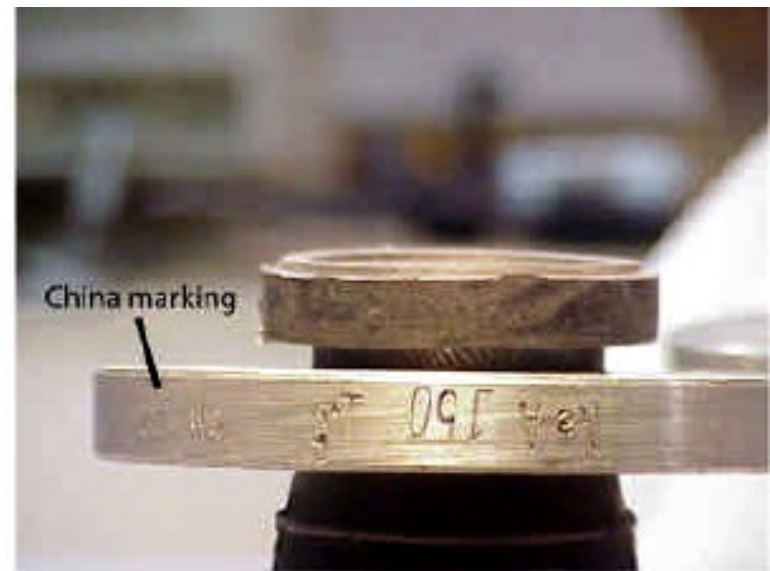
Apparently hand-stamped  
No manufacturer marking. "China" unacceptable as  
manufacturer. NO STANDARD MARKING (i.e. B 16.5)  
No material type identified.
