# Apollo Television

By [Bill Wood](#), former Apollo MSFN station engineer

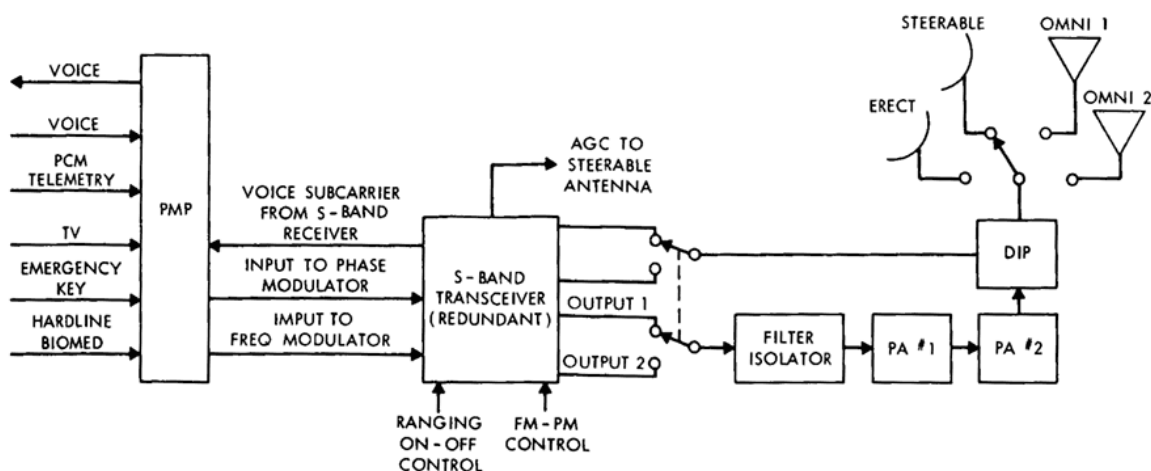
Lunar Module S-Band Block Diagram

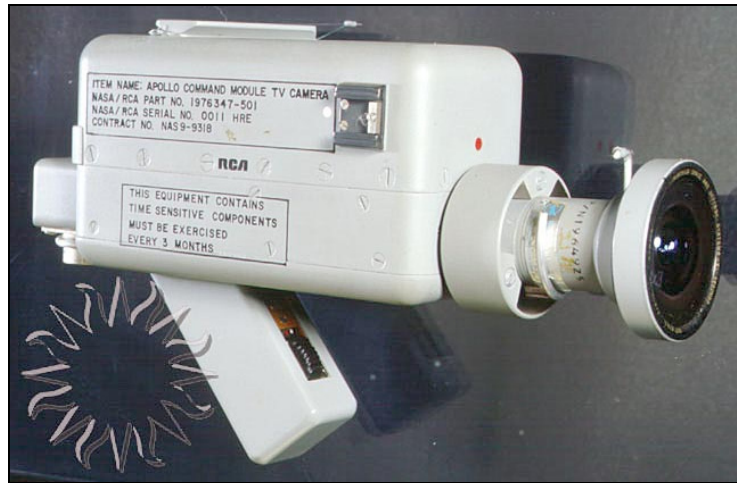
The television camera first used on Apollo 7 was the CSM, slow-scan, black and white, camera made for NASA by RCA. The 85-cubic-inch TV camera weighed 4.5 pounds and required 6.75 watts at 28 volts dc. It had a 1-inch vidicon tube. It was fitted with a wide angle lens with coverage of 160 degrees. It used the same 320 line, 10 frames per second, progressive scan format that was dictated by the limited bandwidth available on the sole Lunar Module S-band downlink transmitter.

The actual camera carried on Apollo 7 *NASM Photo*

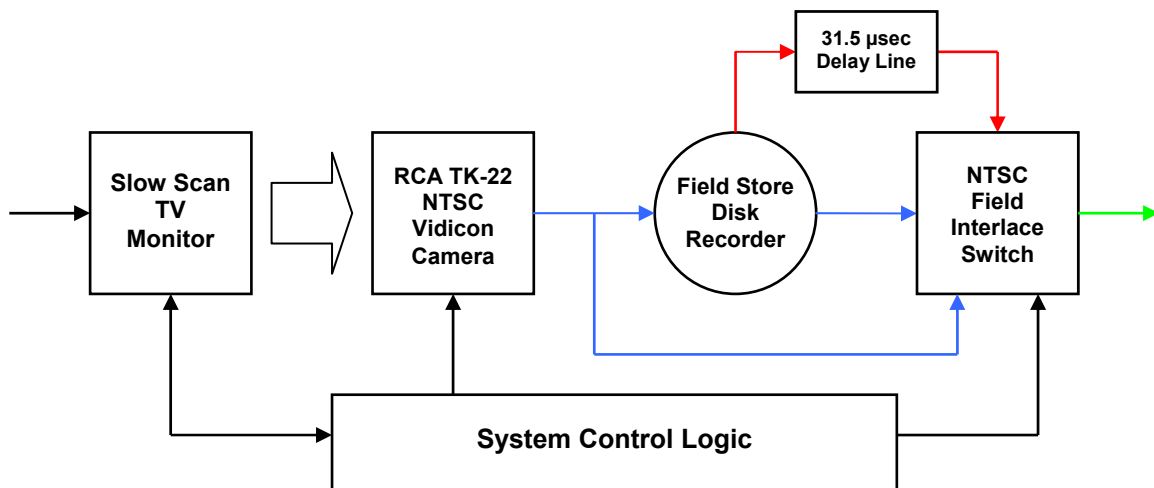
Scan Converter Simplified Block Diagram

This left the problem of how to fill in for the missing second 262.5 line field in the converter video output. To do this RCA used a quartz video delay line to shift the first 262.5 line field so that it would fall halfway between the displayed lines of the first field.

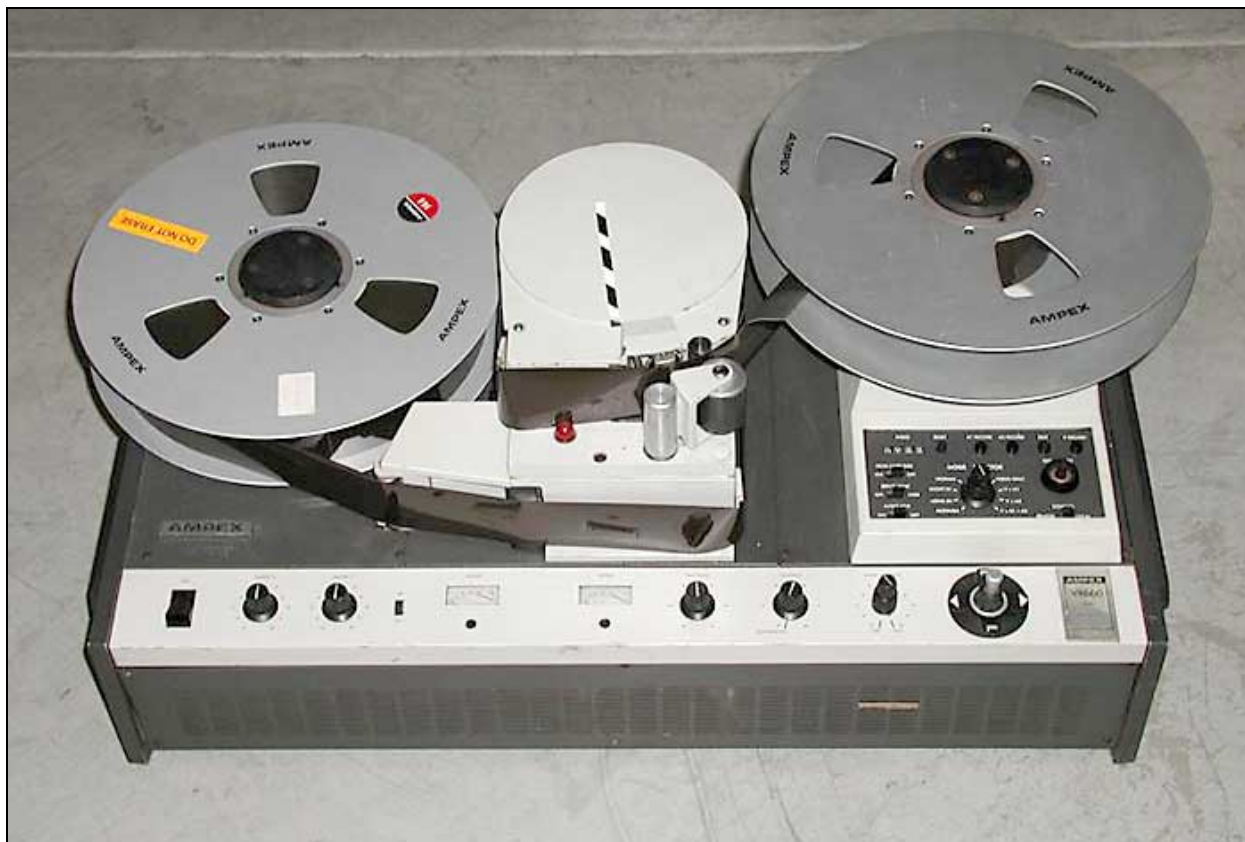
Photo courtesy Richard Diehl, webmaster [Lab Guy's World](#)

The NTSC output of the slow scan converter was recorded on Ampex VR-660B video recorders for later playback in the event of a microwave circuit failure between the station and Houston. The VR-660 was one of the first professional recorders using helical scan that was to become the standard scan method for Beta and VHS VCR's used throughout the World in the 1980's and 1990's. The VR-660 recorder used two-inch wide tape and operated at a tape speed of 3.7 inches per second. The recorder was normally loaded with 5540 foot, 12.5 inch diameter, reels that could record up to five hours of NTSC television signals.

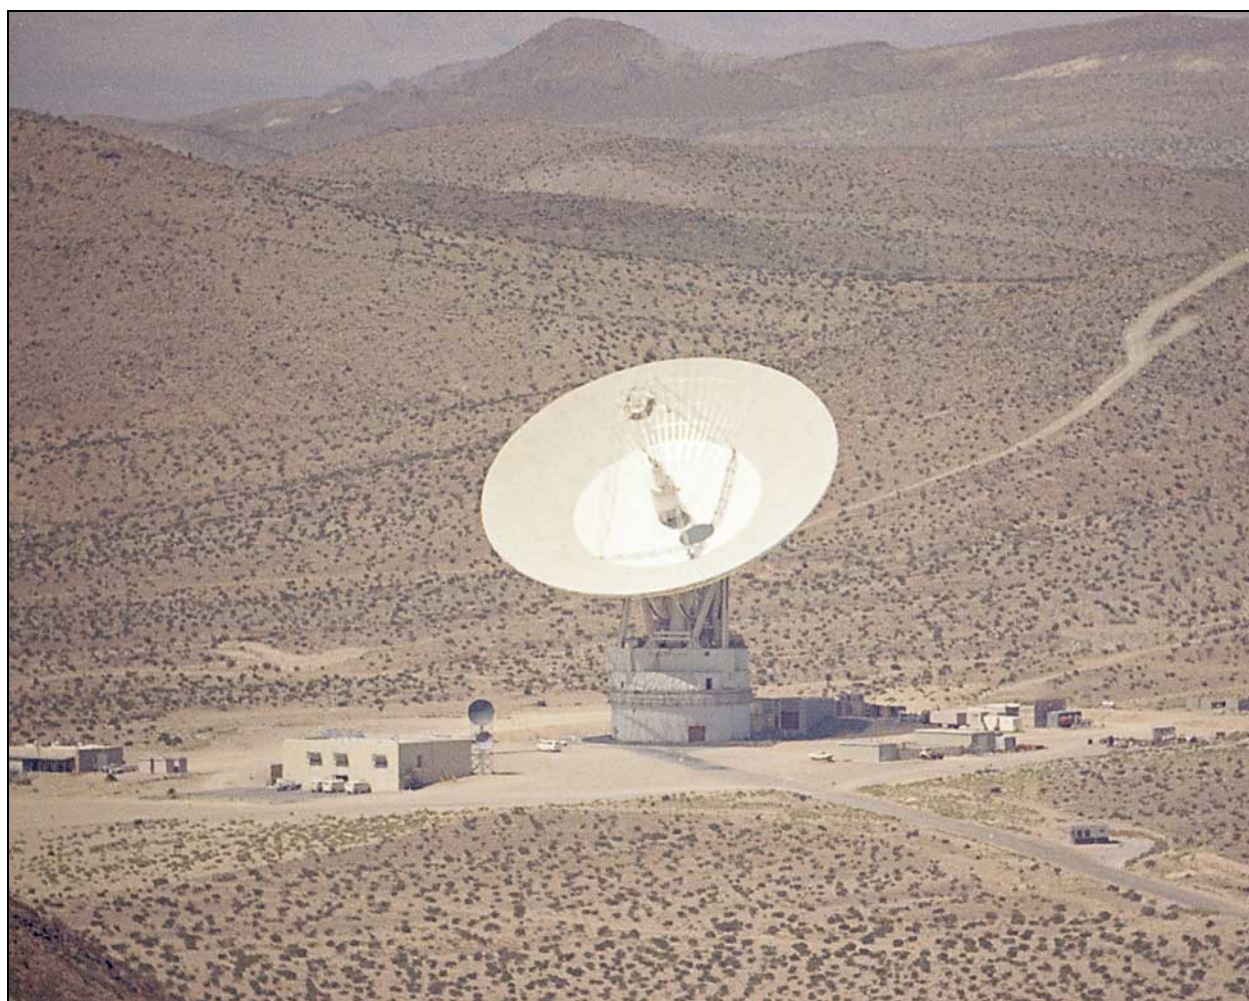
Goldstone DSS-14 64-meter Antenna, July 1969

At Goldstone the DSS-14 Mars DSN Block III S-band receiver 50 MHz IF and baseband outputs were sent over a new Collins Radio C-band microwave link to the nearby Apollo MSFN station to be demodulated and processed there. The top microwave dish next to the operations building in this photograph sent the signals to a similar dish at the Goldstone Prime site via a passive repeater located on a hilltop between the Mars station and the Apollo station.

Before the Apollo 11 mission NASA arranged for the support of the first lunar landing by two 64-meter diameter antennas at Goldstone, California and at Parkes, Australia. The larger dishes improved the Apollo downlink signal levels by between 8 and 10 dB making it possible to receive signals considerably weaker than those received by the normal 26-meter Apollo antennas.

The added sensitivity of the Goldstone 64-meter antenna proved invaluable when the Apollo 11 Lunar Module encountered antenna pointing problems during the powered descent. It allowed controllers at Houston to see the LM data and to tell the Astronauts that they were “GO” on computer overload alarms displayed just before the landing on the Moon

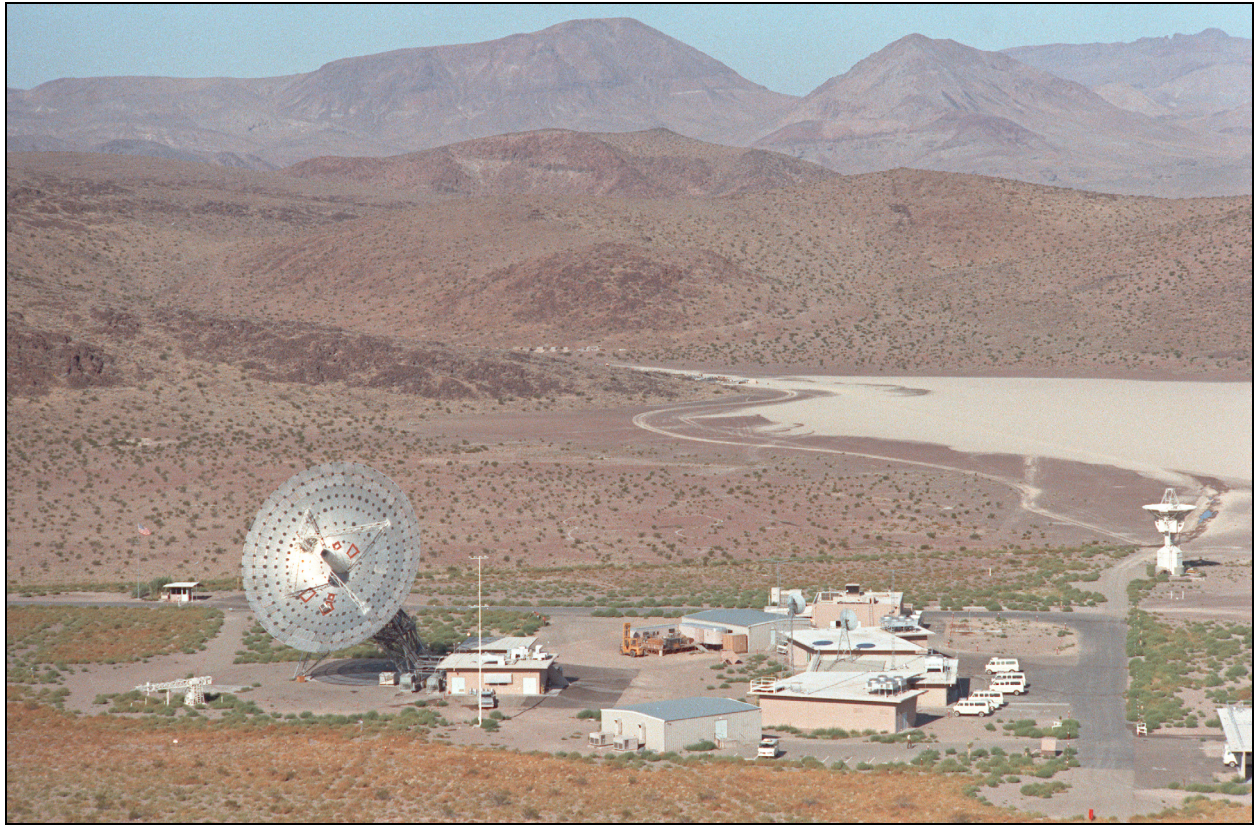
Pioneer DSS-11 DSN Station, 1969

Additional back-up support was provided by the Pioneer Deep Space Network station at Goldstone. This station had a MSFN wing added to the operations building that duplicated the antenna and Unified S-band equipment that was available at the Prime Apollo station. The Wing station was connected to the Prime station by an X-band microwave link.

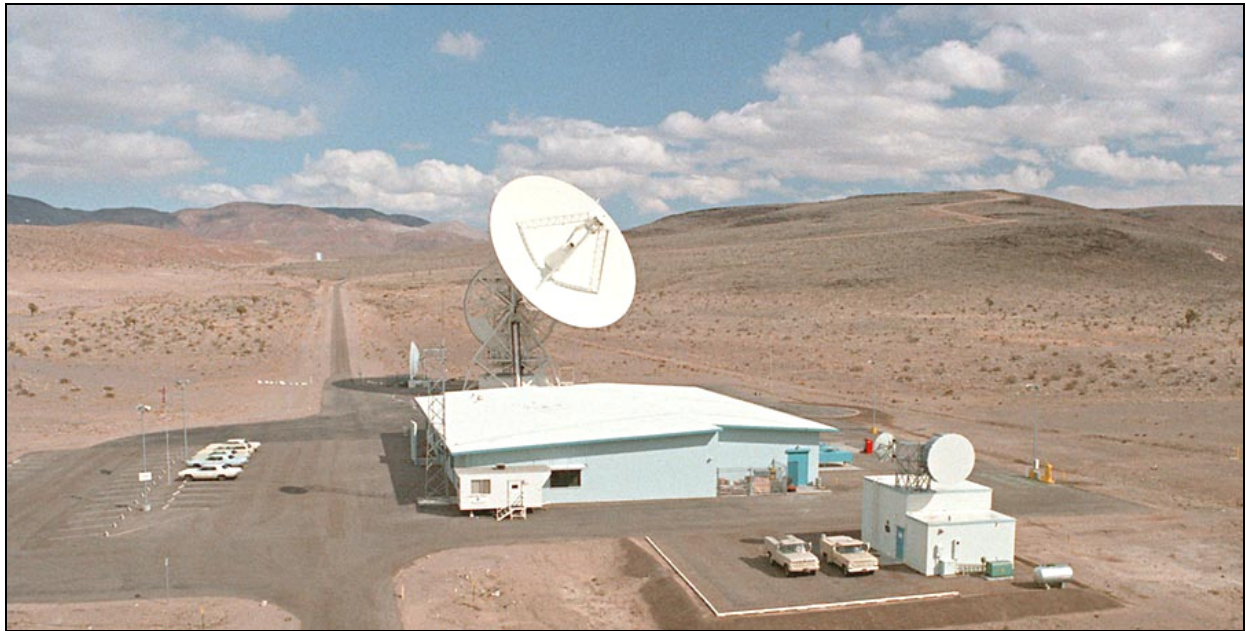
Goldstone 26-meter MSFN Station, July 1969

The FM modulated downlink television signals were demodulated and sent along to Houston via two different common carrier microwave links housed in the small building in the right foreground of the photograph above. Two different microwave paths were used to provide redundancy in case of a failure of one link to Houston.

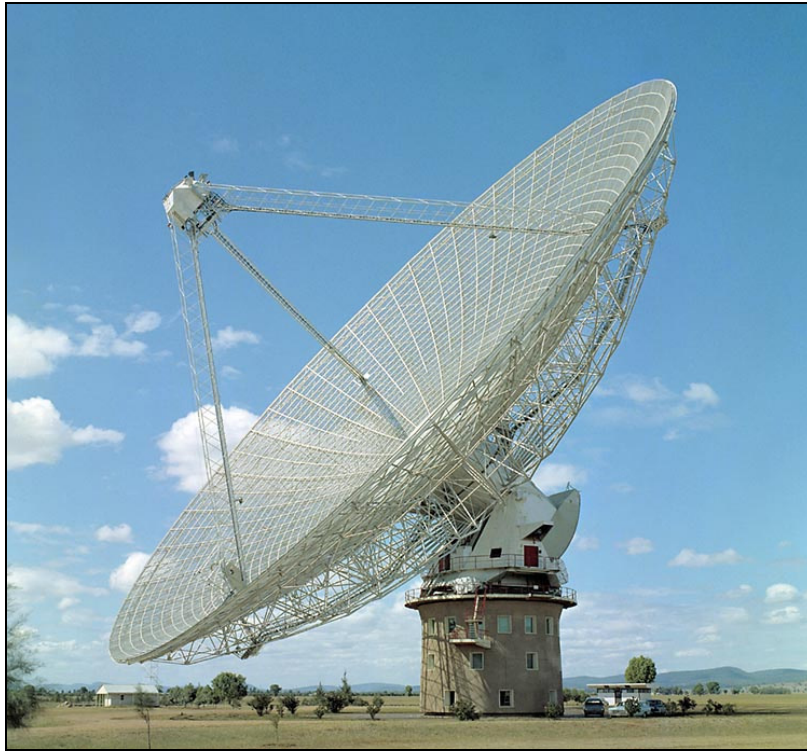
64-meter Radio Telescope, Parkes, Australia, 1969 [CSIRO Photo]

In Australia, the 64-meter radio-telescope at Parkes was made available by the Australian government to improve the signal gathering capabilities when the Moon was within view of the MSFN station near Canberra, Australia. Goddard Space Flight Center dispatched engineers and equipment to Australia to assist in the modification of the Parkes antenna to receive the Apollo downlink. A very complete account of how the Parkes radio-telescope was used to support the Apollo 11 mission was published by the Astronomical Society of Australia in 2001. Go here for a PDF version: [On Eagles Wings](#).

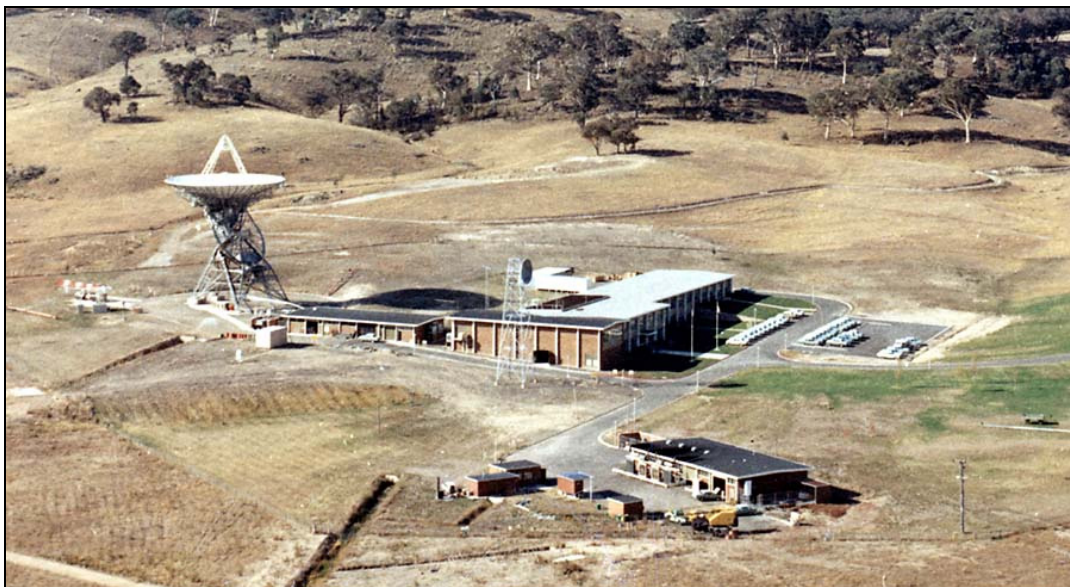
26-meter DSS-42 Deep Space Network Station, Tidbinbilla, Australia, 1969

As at the two other 26-meter MSFN stations, a nearby 26-meter DSN station was equipped with a duplicate Unified S-Band system to provide an additional backup tracking capability in case the USB system at the Honeysuckle Creek Prime suffered a failure. The baseband and 50 MHz IF signals were sent to HSK over a microwave link.

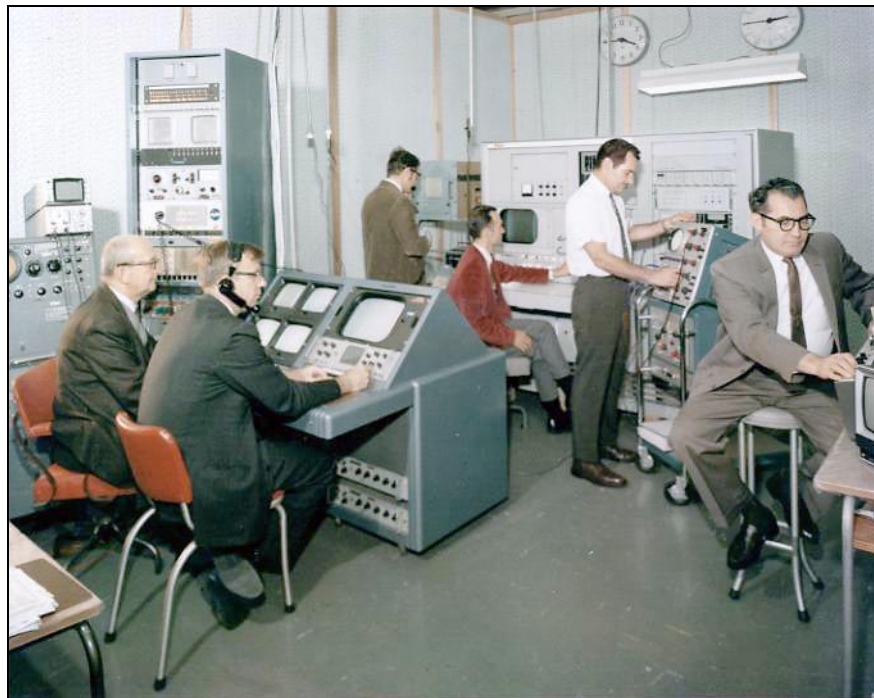
The television signal from Parkes was sent direct to Sydney Video, over a separate PGM microwave link, where a choice was made between the HSK or Parkes television signals as to which would be sent on to Houston via satellite. The RCA Slow Scan Converter in the center of this photograph was used for the Parkes video feed. Sydney Video also fed the Australian Broad-

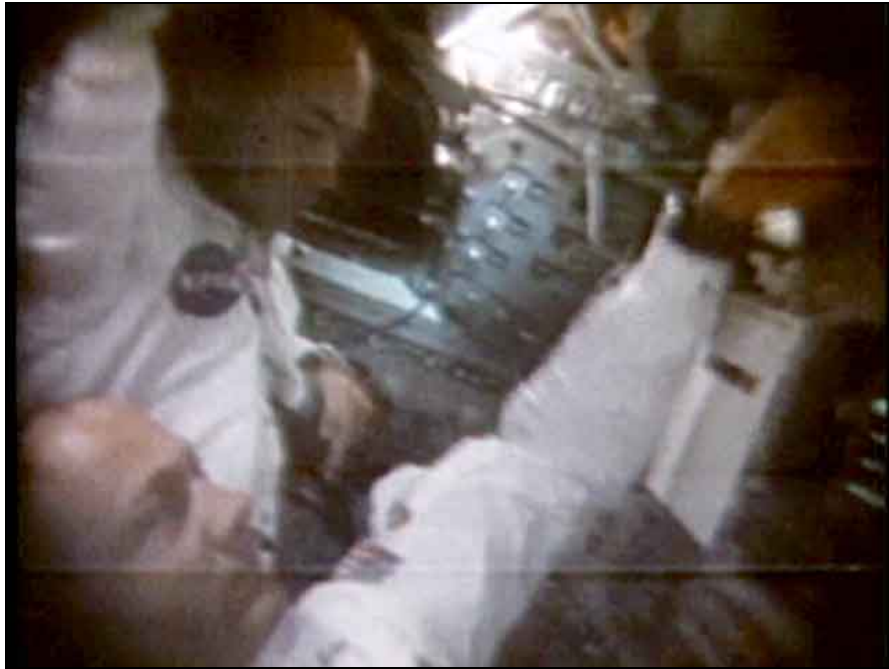
Apollo 11 CSM Interior video showing motor drive hum bars

One problem was uncovered with the color camera during Apollo 11. During the relatively dim lighting inside the CSM two horizontal bars could be seen in the picture. The camera AGC circuit increased the video gain during dim lighting and made the problem more visible. After the mission Westinghouse found and corrected an internal ground loop that caused color wheel motor drive current variations to be induced in the camera video output.

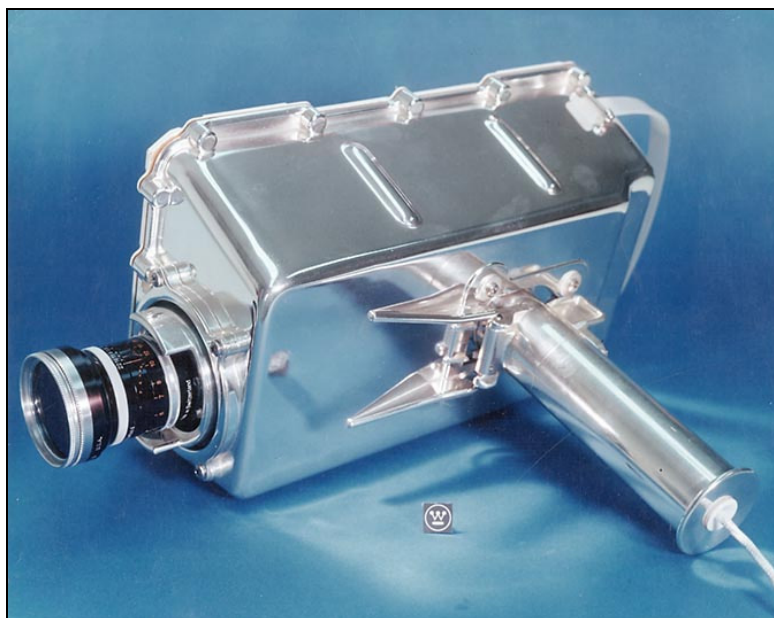
To meet the DOD requirements Westinghouse developed a sensitive image tube that combined a variable-gain light intensifier with a secondary electron conduction (SEC) target. The SEC tube had the capability to reproduce objects in motion, at low light levels, without the normal smearing produced by vidicon or image orthicon tubes.

Westinghouse Lunar Surface Camera

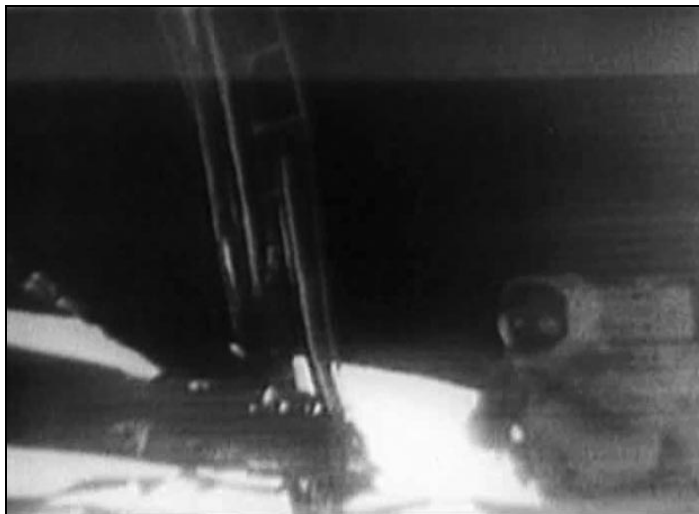
The Same DSS-14 video frame re-inverted to Positive

After the Apollo 11 mission NASA restored the negative video to positive for the archive copy of the EVA telecast. This shows a much improved picture for this short section of video. At the time no one realized the significance of this.

Only recently (2004) was the cause of the problem with the Goldstone Slow Scan Converter discovered. After a careful review of archived video sources it was found that the GDS Slow Scan Converter internal monitor black level was set at a level that compressed the dim shadow details into black. The HSK and Sydney Video scan converters were set properly.

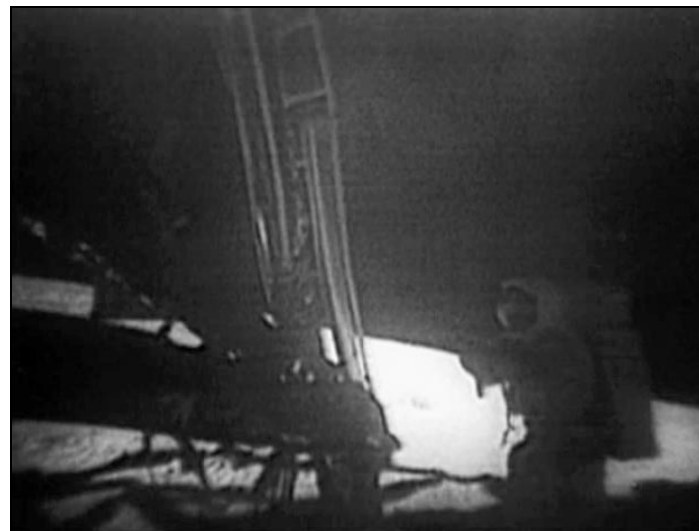
Parkes video via Sydney, GET109:31:00

After Houston saw the much improved television image from the Parkes 64-meter antenna they stayed with Parkes for the rest of the Apollo 11 EVA.

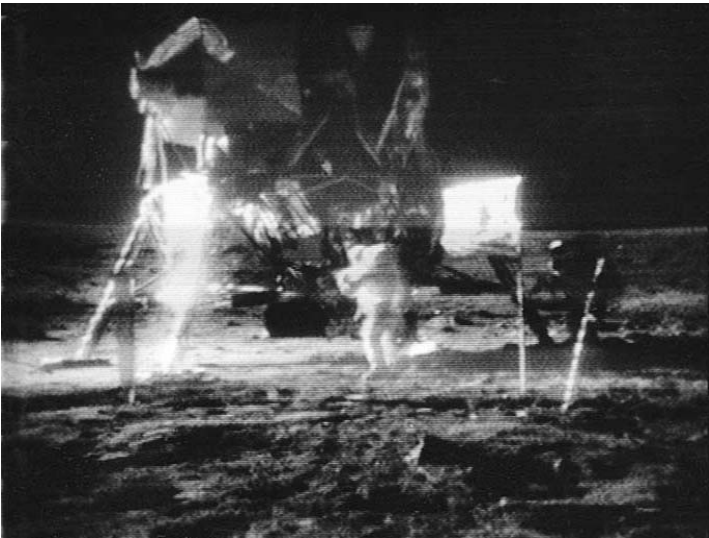
Goldstone Fairchild Monitor Polaroid Photo

This photograph was taken in real-time off the Slow Scan monitor used by the GSFC Public Affairs Officer to provide press representatives with photographs of the EVA. It shows the higher resolution and increased shadow detail that the Westinghouse camera was capable of producing.

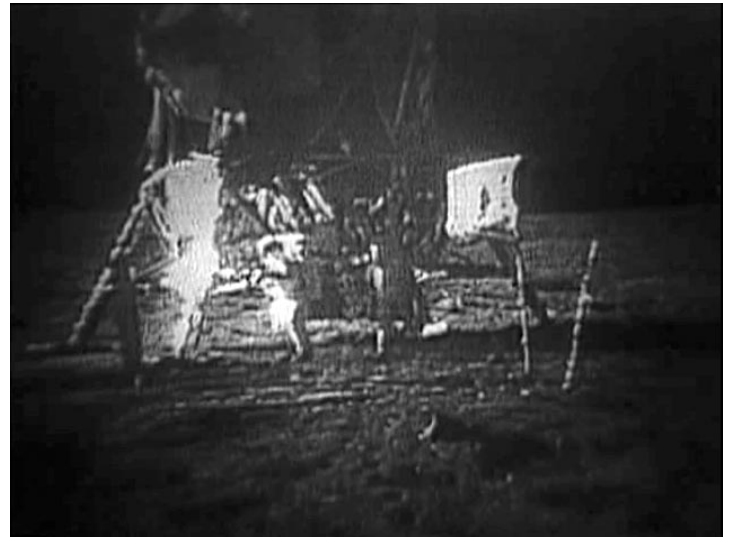
Similar scene from NASA video archive

This is a frame capture of a similar scene from Spacecraft Films Apollo 11 DVD set, disk 2, EVA TV. The source was from the NASA archive of Apollo television material. What looks like a staff in the Moon dirt to the right of the flag is actually an internal lens reflection from the very bright quad leg to the left of the Astronaut.

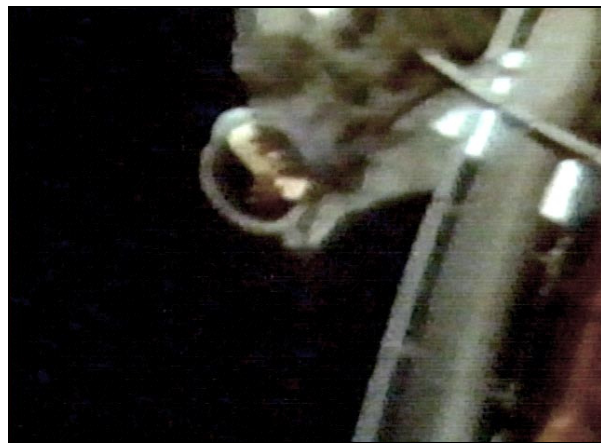
Alan Bean on the lunar surface after the TV camera is flipped out for removal

As with the Apollo 11 lunar camera, the color TV camera was installed on a special angled adapter that would place the camera roughly vertical when the MESA was first deployed. When the strap is removed from the front of the adapter it could swing out allowing the astronaut to remove the camera from the MESA.

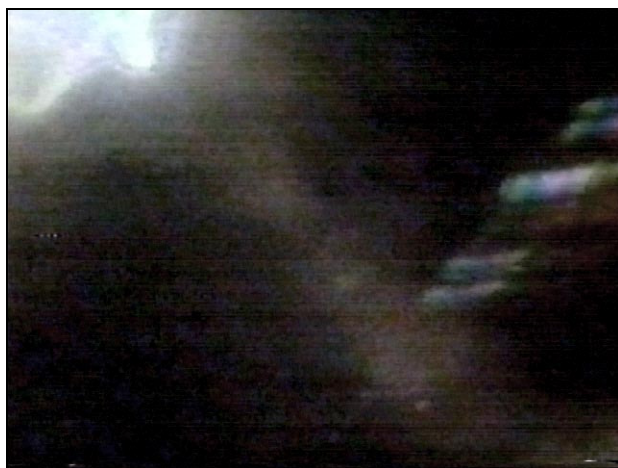
The camera has just started to directly image the Sun at GET 115:58

At GET 115:58, Alan Bean removed the TV camera from the MESA camera mount. In the process of placing the camera on the tripod it was pointed directly into the Sun. Go to the [Apollo 12 transcript](#) to follow the discussion between the astronauts and Mission Control as they try to resolve this problem.

The damaged TV camera would never provide a usable picture after the Sun pointing, in spite of considerable effort by people on the ground and on the Moon. The crew was asked to bring the camera back with them so that it could be examined. The Apollo 12 camera when returned to NASA was carried directly to Westinghouse and unpacked and where all of the work was performed to verify cause of failure, power up the camera and disable the ALC to allow for viewing the camera image.

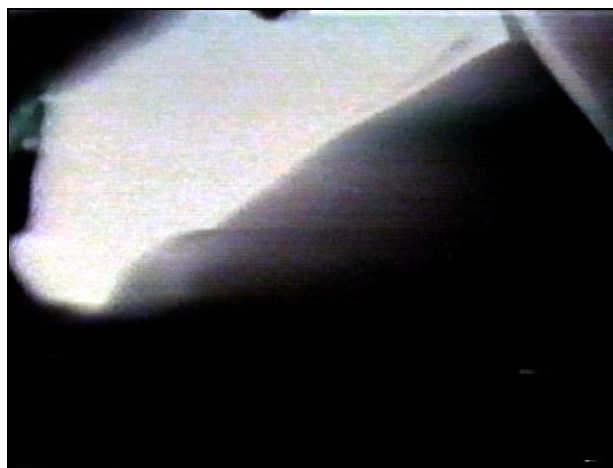
Downlinked TV picture after second series of hammer blows

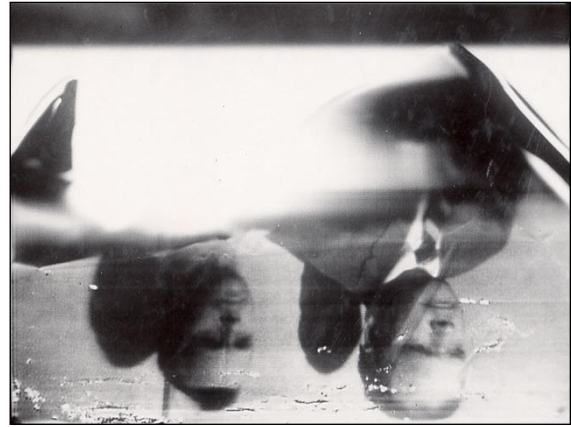
The camera then reproduced good scene detail in that area of the picture which had previously been black, verifying that the black area of the target was undamaged (as shown in the figure). The finding also proved that the combination of normal automatic light control action and a damaged image-tube target caused the loss of picture.

After decontamination and cleaning, the flight camera [which Pete and Al brought back to Earth] was inspected and power was applied. The image, as viewed on a monitor, was the same as that last seen from the lunar surface. The automatic light-level control circuit was (then) disabled by cutting one wire.

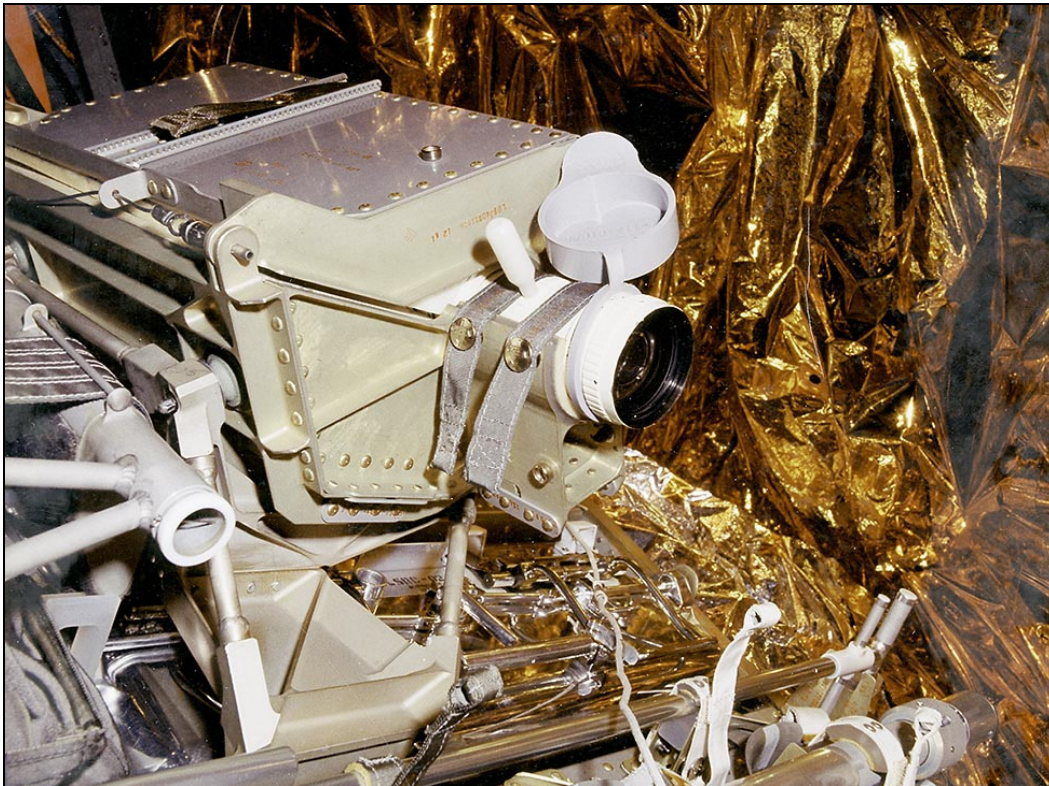
Westinghouse Color Camera in MESA mount, with the added lens cap, before Apollo 13 LM Closeout

To reduce the chance of accidental exposure to direct sunlight the Apollo 13 camera was fitted with an easy-to-handle soft rubber lens cap permanently attached to the lens neck. Astronaut camera handling procedures were changed to cap the lens whenever the camera was moved from one place to another on the Moon. See the Westinghouse [Apollo 13 Press Release](#) for more detailed information.

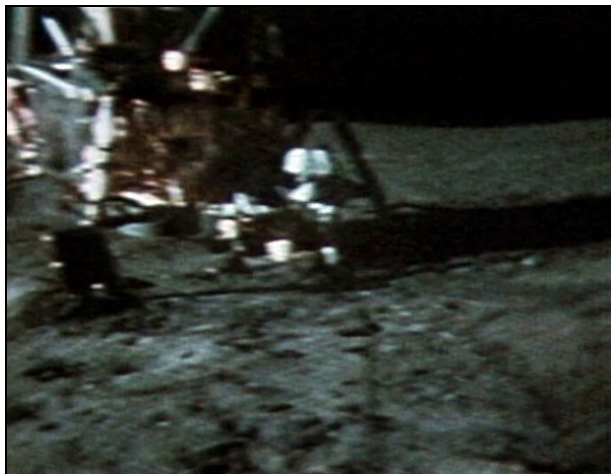
Scene with Camera set to "Peak"

Starting at 114:08 MET the crew and ground controllers tried a number of different settings that included changing the camera peak-average switch and the lens aperture settings. The "peak" camera setting produced very dark scene details while the "average" setting produced good shadows but scene highlights, especially the white spacesuits, appeared overexposed and blooming.

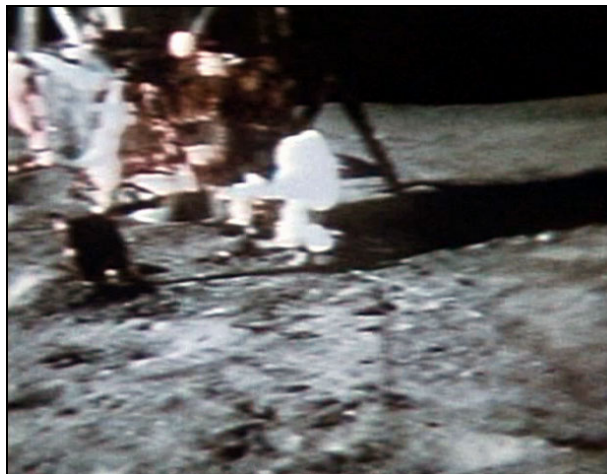
Scene with Camera set to "Average"

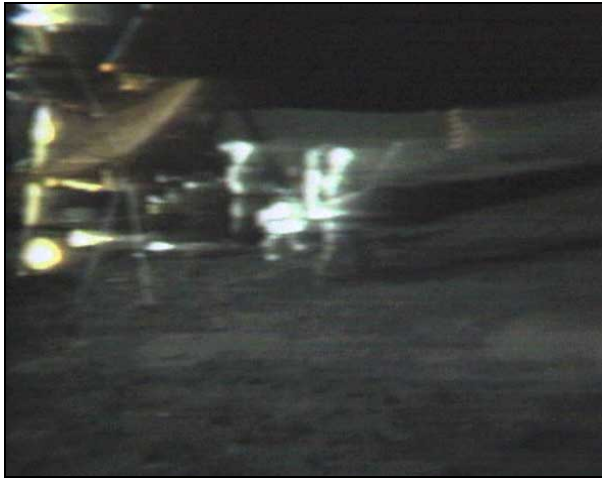
Al's famous Golf Shot with the camera set to "peak"

If the Apollo 14 lunar camera video had been gamma corrected from 1.0 to the current 2.2 broadcast TV gamma, the lunar scenes would have looked like this with the camera set to "peak" instead of the degraded images actually observed at the time.

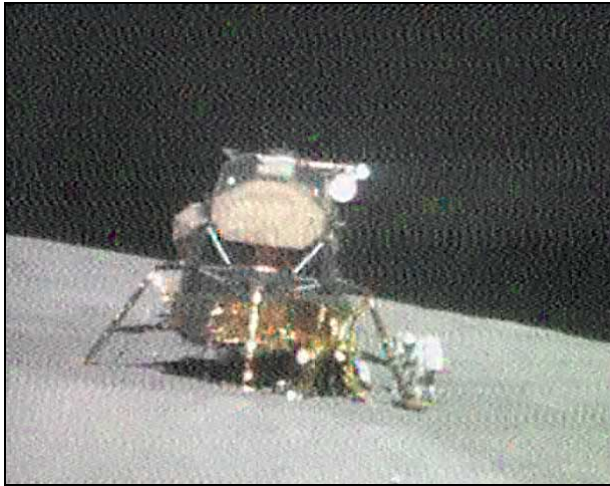
Photo taken during SCU manual adjustment

Both the level and phase of the reinserted subcarriers could be adjusted manually to ensure the maximum rejection of the subcarriers was obtained. It was occasionally necessary for the MSFN station television technician to manually tweak the level and phase settings during the television downlink transmission. These photos show the effect on picture quality by even a slight misadjustment of the Subcarrier Cancellation Unit.

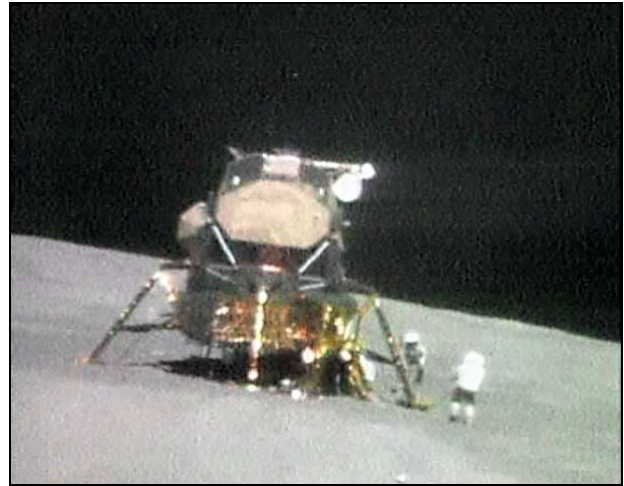
Photo taken after the adjustment was completed

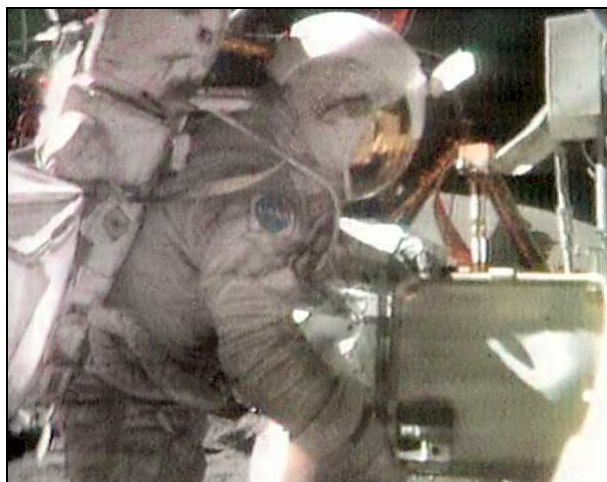
Loading the Rover with Moon samples

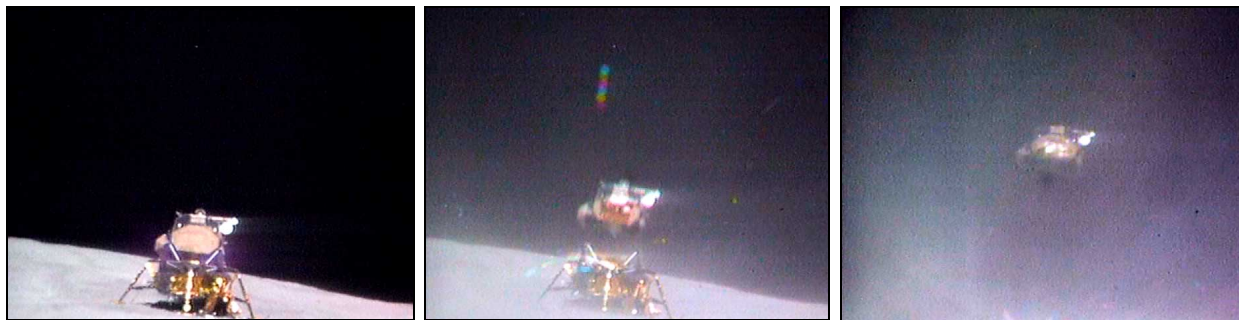
Apollo 16 Liftoff from the Moon

The Rover's camera was able to capture the Lunar Module's ascent stage departing the Moon's surface by the careful programming of elevation motion commands by Ed Fendell's INCO crew in the Houston mission control center. The timed command sequence was started slightly before the actual firing of the engine to take into account the 1.25 seconds it took for the signal to travel from the Earth to the Moon. One can see the cloud of Moon dust stirred up by the rocket engine as the LM ascent stage departs

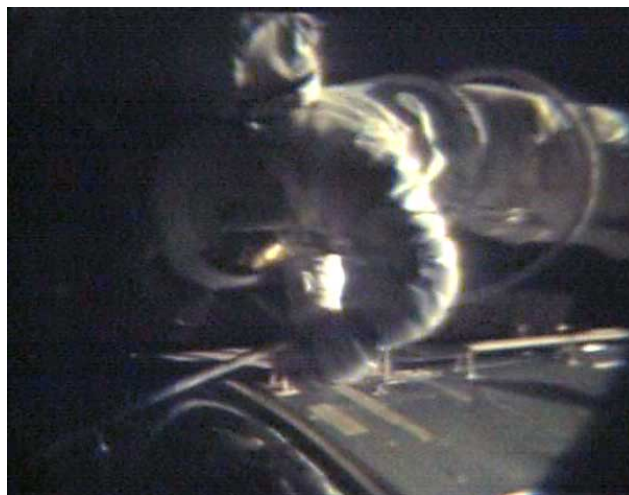
This photo shows Apollo 16 astronaut "TK" Mattingly returning the PAN camera cassette to the Command Module from the Service module SIM bay. Later "TK" retrieved the Mapping camera film cassette.

All three Apollo J-series missions (15, 16 and 17) conducted CSM EVA's on the way back to the Earth. This was necessary to recover film packages from the Service Module SIM bay. The Westinghouse field-sequential color camera was mounted as shown in the drawing to cover each of the EVA's.

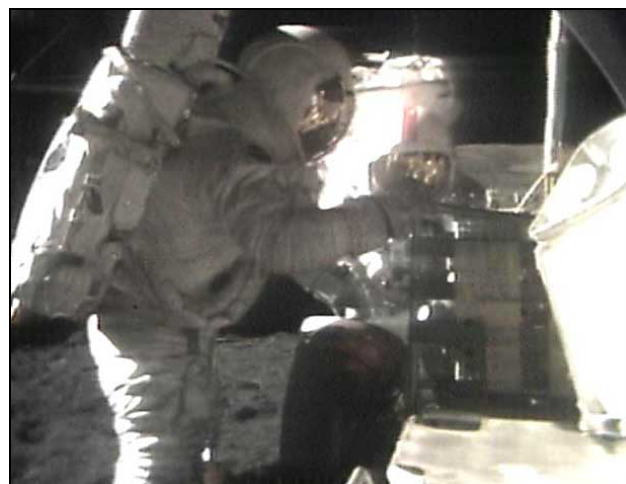
After a misplaced hammer ripped off part of the right read fender during EVA 1, the crew works to install a jury-rigged extension made from a map and "duct" tape.

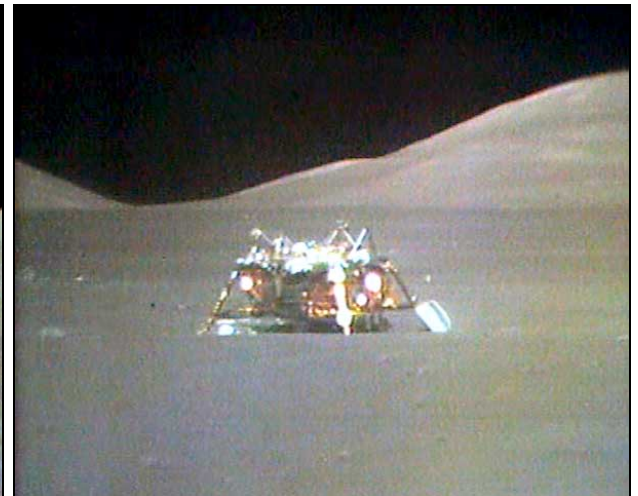
Apollo 17 LM descent stage remains on the Moon

The performance of the Ground Controlled Television Assembly (GCTA) and the Lunar Communications Relay Unit (LCRU) was nearly flawless during the Apollo 17 stay in the Taurus-Littrow region on the Moon. The Rover color TV camera continued to operate for at least 27 hours after the Challenger liftoff at GET 188:01:36 when it was used to observe the detonation of Explosive Package Nr. 7. Some time after this the LCRU suffered an over-temperature failure preventing further use of the camera.
