# Progress Report on the Use of Piligrass (*Heteropogon contortus*) Hay Bales for the Island of Kaho`olawe's Highly Erodible Sites

Glenn Sakamoto, September 2008

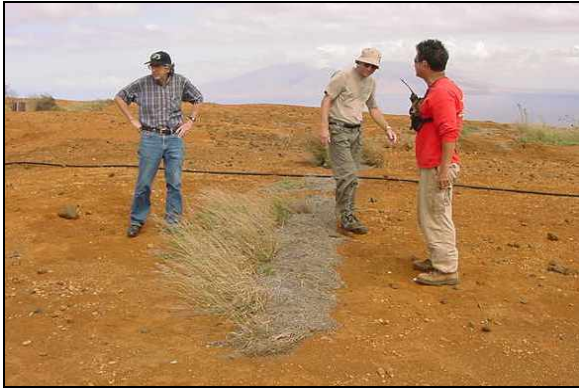
**Robert Joy, USDA NRCS; Paul Scales USDA NRCS; and Paul Higashino, KIRC April 2005 look at pilgrass flakes installed in 2004. Photo taken October 2005**

Mulching by separating flakes or sections from bales and placing them on the hardpan areas is working. At one site visited, it was observed that by placing these flakes across the slope on gently sloping areas (less than 2 percent) enabled wind blown sediment and soil runoff to accumulate within and up slope of these flakes. This accumulation of soil provided a suitable environment for seeds within the piligrass bales to germinate and grow along these flakes. These flakes were approximately 2-3 inches thick and laid side by side in a single row. According to Paul Higashino, Natural Resource Specialist for KIRC, the sheets were installed in February 2005. During a site visit in October of 2005 of the same area, the piligrass was approximately 14 inches tall and soil deposition by wind and runoff was very noticeable. The growing piligrass formed a vegetative barrier along the edges of these flakes and trapped sediment. Though the treatment area visited was small (less than 10 feet long), the effects were positive and effective in controlling erosion. In August of 2008, a site visit to the same area showed piligrass, natal redtop, (*Rhynchelytrum repens*) and `Uhaloa, (*Waltheria indica*) growing within and along these piligrass sheets. The overall vigor of these plants was good, considering it was in the middle of summer and not irrigated. The use of this method also enabled the KIRC staff to maximize the use of the bales. Mr. Higashino estimates that for each bale used in this method, one could cover approximately 15 to 20 linear feet of mulch. In contrast, using entire bales that have not been separated would require 24 bales.

It was interesting to note that the flakes did not blow away with the wind. This was either due to the placement of the flakes in a slight depression or direction of the prevailing trade winds. Placing these flakes along the contour of a slope, staking the flakes to the ground in the hardpan areas, would be most beneficial. Mulching as a conservation method is simple and requires minimal amount of resources.

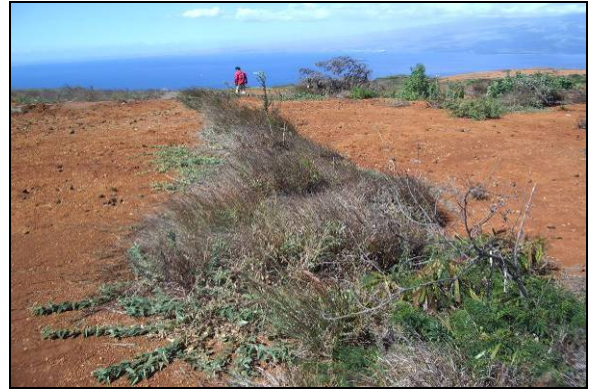
**Established Piligrass mulch flakes installed 2004. Note pilgrass and *Walthria indica*, *Ualoa* growing along mulch line. August 2008**

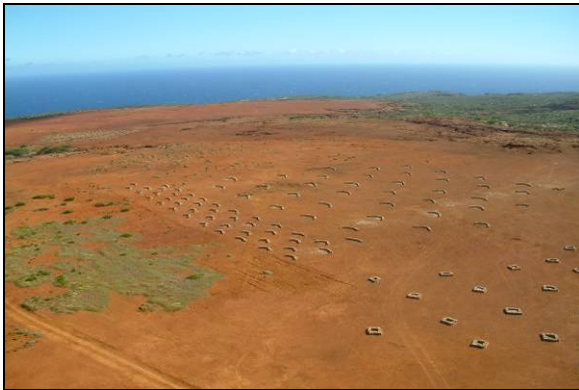
**Piligrass hay bales at LZ-3, Kahoolawe "C" and Box configurations. Photo by Paul Higashino, KIRC, May 2006**

In one area of LZ-3, adjacent to and directly downwind of Rene Silva's native planting site, the "C" hay bale method was placed in rows perpendicular to the prevailing trade winds. Each succeeding row was slightly off set from the previous row and formed a staggered formation. A total of four rows approximately 250 feet long were installed. The spacing between and within the rows are approximately 12 to 15 feet. Further downwind of these crescent structures, larger "C" bales were situated, using more than 6 bales per crescent and spaced farther apart. Seven rows of this configuration were installed. These structures collect a considerable amount of windblown sediment. On some of these structures, soil deposition by wind erosion reached the top of the bales (15") within a one year period. Plants such as Pili, `Aweoweo, and `A`ali`i were growing in good condition and mainly growing along the edges of the piligrass bales and sediment deposits. The plant height of the piligrass ranged from between a few inches to over 22 inches in height. `A`ali`i plant heights ranged from several inches to heights of 32 inches. These plants grew from seed under natural rainfall conditions and were either naturally windblown into these "C" structures or manually distributed by KIRC staff. The original "C" structures (2003) remain intact, though the baling twine and hay were brittle. The decomposition of the bales has been slow and thus, should withstand the elements, as long as the bales are not trampled or stepped on.

Just north and adjacent to the "C" structures, are the box or kipuka configurations. These boxes were also initially installed in August of 2003. The use of the piligrass box configuration was gradually increased, as piligrass became readily available at the PMC. These boxes were installed in rows approximately 15 to 20 feet apart. The number of rows was estimated to be between 10 to 15 rows and 250 or more feet in length. Seed of Pili, `A`ali`i, `Aweoweo and Kawelu were sprinkled in these boxes prior to the rainy season. If recycled potting mix was available from other planting projects, they were deposited in these boxes. According to Paul Higashino, after the 2003 rainy season, native plant seeds germinated and grew. `Aweoweo, Pili and `A`ali`i fared the best and survived the first dry summer of 2004. The Kawelu seedlings, however, did not fair as well. During a site visit in October of 2005, `Aweoweo plants were the dominant species within these boxes. Their height was approximately 20 to 30 inches and in good vigor. Piligrass and `A`ali`i were noted within and along the boxes, their numbers were few, and plant heights were between a few inches to a foot tall. During another visit in August of 2008, `Aweoweo continued to be the dominant species within the boxes, but in fair vigor. `A`ali`i and piligrass were noted in the original boxes and growing in fair to good vigor, 12 to 24 inches in height.

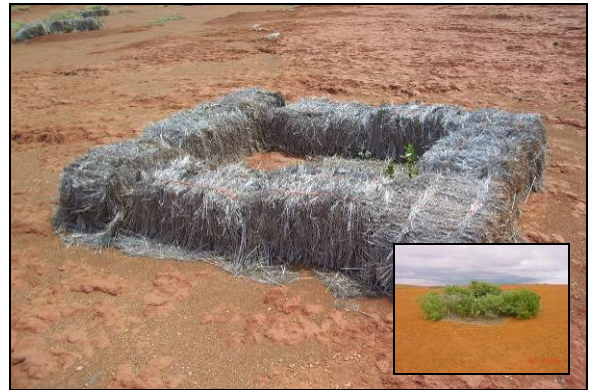
**Piligrass hay bales in box configuration installed in 2004 at Moiwi bypass road on Kahoolawe. Photo inset of *Aweoweo* growing in box October 2005, LZ-3**

The "kipuka's" or boxes have proven to be one of the successful methods to establish native plants on the Kahoolawe hardpan. It traps windblown soil deposition and provides the needed environment for plants to grow. Wind protection and moisture retention is one of the positive attributes of this design. The concept is simple, with no materials other than bales and seed. No wooden staking or mechanical intervention was involved to secure the bales or to establish the plants. This concept is extremely important due to the hazards of unexploded military ordinances.

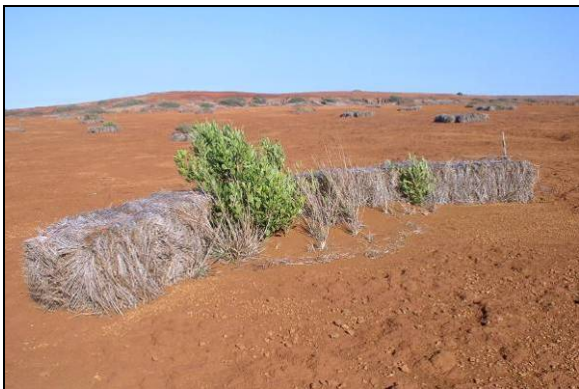
**Piligrass hay bales "C" configuration August 2008, LZ-3 Kahoolawe**

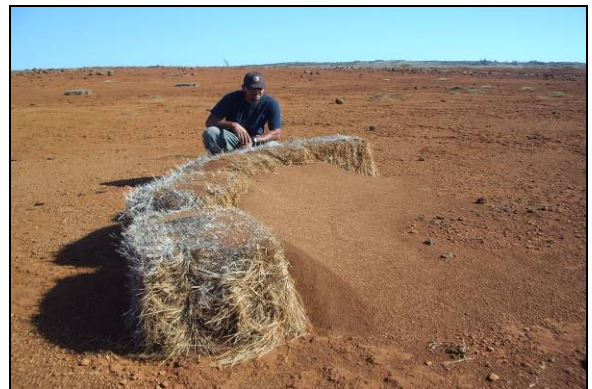
**LZ-3, David Duvauchelle next to "C" configuration installed April 2007. Photo taken August 2008, 16 months later**

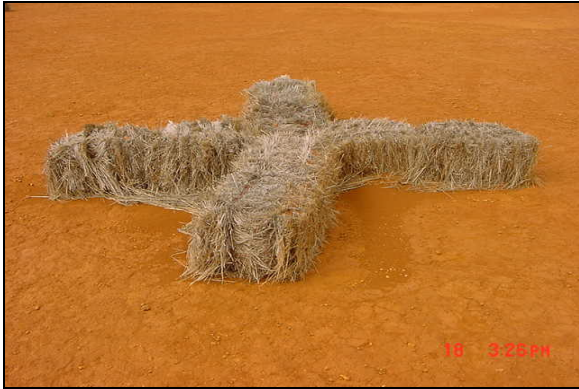
**X configuration using 8 piligrass bales LZ-3  
2005**

Other configurations, such as the "C" and "X" have proven to work well utilizing the piligrass hay bales. The "C" or crescent shape configuration works as such: six piligrass bales are lined up to form a crescent shape, with the opening facing the prevailing trade winds. These configurations range in length of between 10 to 12 feet. This allows windblown sediment deposition and seeds to be captured in the cup of the crescent shape structure. And the "X" configuration works with the concept of the bales forming an "X" shape, the center of the "X" forming a square hole. This method utilizes four to eight bales per "X", and is designed to trap windblown soil deposition and seed from the any direction. Depending on the availability of bales, four bales created a 6' x 6' "X". An eight bale "X" configuration created a 10.5' x 10.5' "X". The center of the "X" with its square (18" by 18") hole acted as a planter box where seeds could be planted.

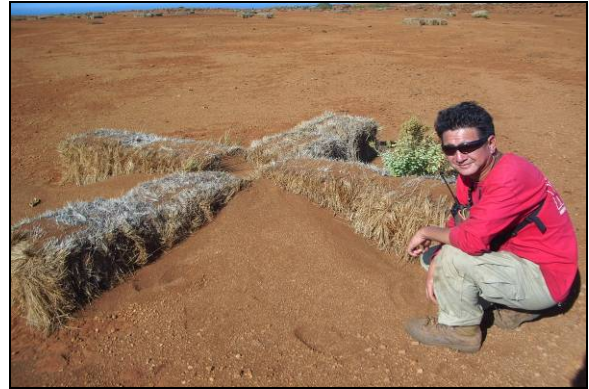
**Paul Higashino, KIRC at one of the 'X' structures  
at LZ-3 August 2008. The "X" was installed in  
April 2007 Note wind blown soil deposits**

The use and placement of these configurations is by far the most eye catching, as one approaches LZ-3 (West of Kanapou) and the Moiwi area on Kahoolawe. From a distance, whether you approach by air or vehicle the "X" and "C" boxes look out of place in the barren, windy and desolate hardpan of Kahoolawe. As one gets closer, you begin to realize that these configurations are sustaining plant life. The first of these configurations was installed in August of 2003 at LZ-3 and with each succeeding year, more of them were installed and expanded to include the Moiwi bypass road area. It is clearly evident that each of the different shapes did have an impact in collecting sediment and or promoting plant life. In an area that is totally dependent on natural rainfall, it was impressive to note at many native plants such as `Aweoweo, *Chenopodium oahuense*; `A`ali`i, *Dodonaea viscosa*; Piligrass, *Heteropogon contortus*; and Kawelu, *Eragrostis variabilis* are growing within these structures. Whether native seeds were intentionally seeded by KIRC employees or naturally windblown into these structures, it does indicate a positive step toward the vegetation recovery of the island.

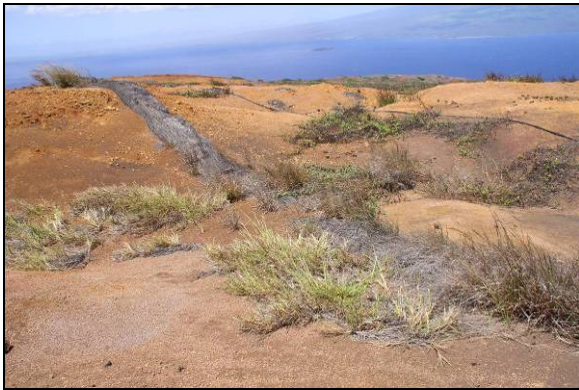
**Piligrass wrapped in geotextile fabric were  
named the bundle or berm method. Native  
Kamanomano and Piligrass growing along  
bundles, August 2008**

Another method utilized to trap sediment, is the construction of berms. Due to the nature in which the piligrass is compressed during the baling process, the bales can be peeled apart into various sized "flakes" or sections. The KIRC staff has taken advantage of this characteristic and fabricated "bundles" with piligrass flakes encased in commercially manufactured erosion control matting (geotextiles) in an attempt to conserve materials. Geo-textile matting is comprised either of straw, coconut fibers or polypropylene yarn, which are encased within polypropylene netting. Bundles are constructed by placing piligrass sheets or flakes within the geotextile matting and rolling it like a "burrito". These bundles are placed cross-slope on highly erodible sites and fastened in place with short wooden stakes.

Piligrass berms, as described earlier, essentially works in the same manner as mentioned above. The use of these berms has proven to be somewhat successful in areas, where the land is sloping less than 5 percent. Along the north to northeast rim of Lua Makika, berms such as these were installed as early as August of 2002. These small berms are successful in controlling low flow sheet and rill erosion. Although the original berms have not been revisited, newer berms have since been installed on the northeast rim and southeast rim of Lua Makika. Berms on slightly sloping land provided enough sediment deposit for KIRC employees to plant grasses and shrubs such as *Cenchrus agrimonioides*, Kamanomano and *Achyranthes splendens* respectively. During a site visit in August of 2008, three year old berms were still intact and providing erosion control to surrounding areas. The coconut fibers within the polypropylene netting have decomposed somewhat, but piligrass straws still remain. The use of this method, though expensive and time consuming, may prove to be a good candidate for areas such as the LZ-3 hardpan area. The use of piligrass is effectively and efficiently used with minimum waste. By placing these berms on contours and are spaced appropriately, sedimentation deposit and erosion may be minimized.

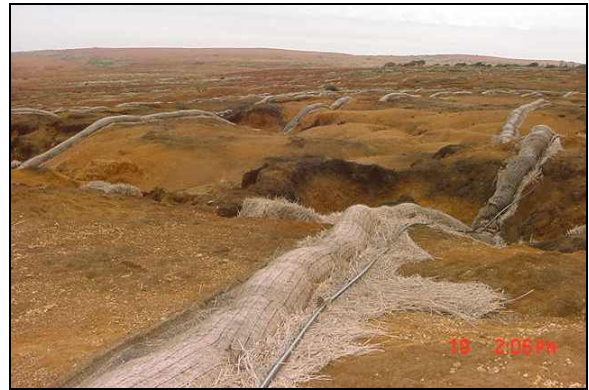
**Piligrass bundles installed in 2005 on southeast rim  
of Lua Makika, Kahoolawe**

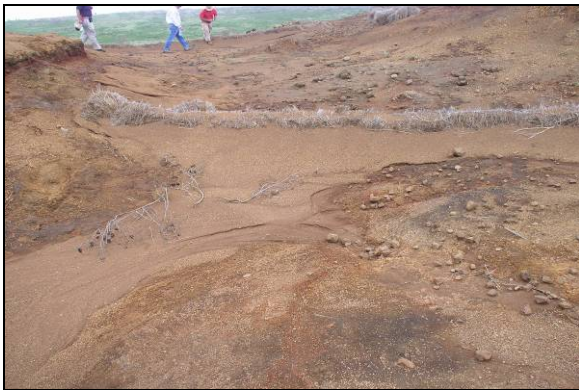
**Piligrass bales used to trap sediment runoff in  
washouts and small gullies at the summit of Lua  
Makika, 2005**

This method of using piligrass for sediment trapping, was initially installed in the summer of 2002 along the outer rim of the Lua Makika summit. Pili bales were used to trap and slow down the movement of soil in depressions and gently sloping (less than 5% slope) washouts. Piligrass bales were simply laid length wise, end to end to create a wall of piligrass. By installing the bales perpendicular to the direction of the flow of water, sedimentation of soil after a storm was immediate. The concept has been somewhat successful and its use is being increased with in specific areas of Kahoolawe. The sedimentation that has occurred upslope of these bales has made it an excellent medium to plant native grasses and shrubs. The original bales that were installed in 2002 are currently in place, as of the August 2008 site visit. These bales, though old and crumbly are still doing the job it was intended to. The disadvantage of this method, in the long term (7 to 8 years) would be the maintenance of these sediment traps. As stated earlier, hay bales should be used as a temporary structure to aid in a series of steps towards a permanent erosion control system. It was noted that though the bales worked well in trapping soil, eventually, the sediment traps filled up with soil, and water overtopped these bales. This overtopping of water during storms on the down slope of the bales began to undermine and erode beneath the bale. The proper construction of these sediment traps is crucial. The USDA NRCS does provide information on the construction of "checkdams" that is quite similar to the ones being used on Kahoolawe.

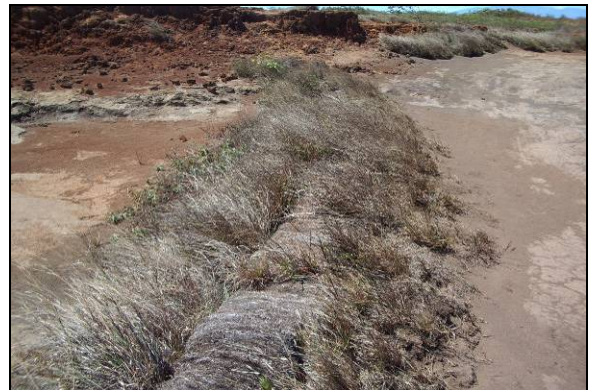
**Piligrass bales installed in 2002 continue to trap  
sediment. Note piligrass growth both up slope and  
down slope of bales. August 2008**

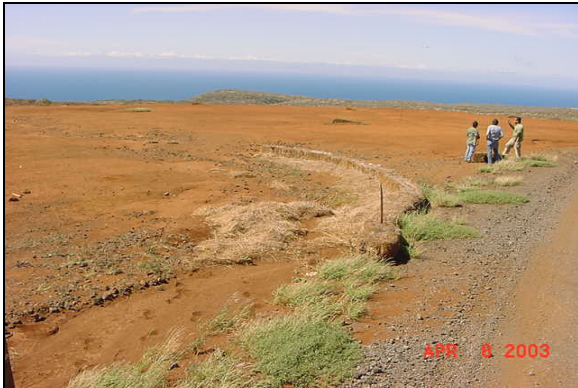
**Piligrass bales used to divert water away from road shoulders before causing further damage down stream. Structure was installed in early 2003. Photo taken in April 2003**

Piligrass bales have been used, but to a lesser degree, in channeling water away from the main access road from Honokanai`a Bay to Lua Makika Crater (approximately 11 miles long). During heavy storms, water runoff along the access roads can severely damage road shoulders. Piligrass hay bales were installed to divert surface runoff before it caused further damage down stream along road shoulders. One noted hay bale diversion was installed in 2003 near the Moivi bypass road area and is still intact

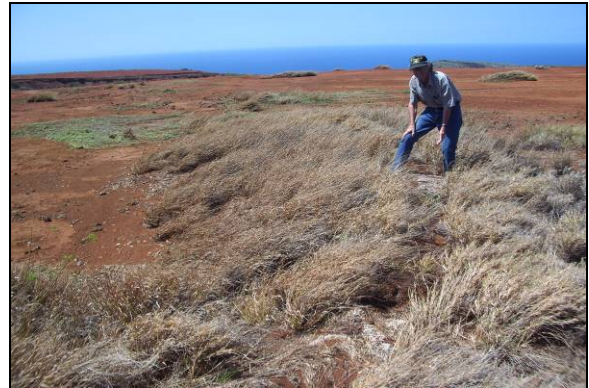
**Bob Joy stands along the same structure taken in August of 2008. Piligrass bales are barely visible but continue provide the function as it was intended.**

today. It has weathered through several major storms and continues to function for the purpose intended. It is uncertain if staking the bales was ever done, as they did not appear to have moved in any way, by the force water flow. It was interesting to note that volunteer piligrass has grown along the edges of the bales and possibly aided in the bales stability during heavy water flow. Sedimentation was also noted being trapped along side and within the bales and being slowed by the piligrass vegetation. Although the accumulation of sedimentation, and vegetation is forming a natural water bar to re-direct water flow away from road shoulders, the use of hay bales for this practice should be used with caution and in conjunction with other conservation practices.
