RAIL PASSENGER EQUIPMENT COLLISION TESTS: ANALYSIS OF OCCUPANT PROTECTION MEASUREMENTS

ABSTRACT

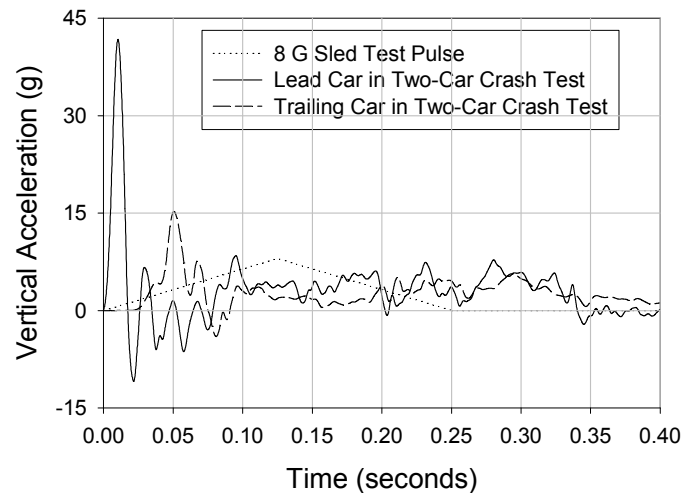
Figure 4. Longitudinal Carbody Accelerations vs Time

Figure 4 is a plot of the longitudinal deceleration time-histories of the leading and trailing cars during the two-car test. The longitudinal deceleration time-history, or crash pulse, of the lead car is characterized by a high initial peak with a short duration, followed by oscillations around zero, followed by a fairly steady deceleration. The initial peak is owing to the high load required to initiate collapse of the car structure impacting the wall, the oscillations about zero are owing to the impact of the trailing car with the leading car, and the final steady deceleration is both cars riding down the collision as the structure of the lead car crushes. The trailing car crash pulse is characterized by a peak that is substantially lower (less than half) than the peak of the lead car, followed by a fairly steady deceleration. The trailing car's peak deceleration occurs when the lead car's deceleration is oscillating about zero. The average deceleration for the lead car over the 0.4 seconds shown in Figure 4 is 3.1 g's, while it is 3.2 g's for the trailing car.

For comparison, the plot shown in Figure 4 includes the 8 g triangular pulse used in previous sled testing [4]. This pulse has a significantly different characteristic from the longitudinal decelerations measured during the test. The average value of this pulse, however, is 4 g's, which is greater than averages for the pulses measured during the test. The influence of the shape, or characteristic, on the likelihood of injury depends upon the interior configuration. The average deceleration is greatest for the 8 g triangular pulse and consequently, for unrestrained forward facing occupants seated in rows, the likelihood of injury is probably greatest for this pulse. For restrained occupants the principal concern is the loads imparted to the neck. Since, in effect, the occupant 'impacts' the restraints earlier for the crash pulse measured in the leading car, owing to its initial peak, than for the other two crash pulses, it is expected that the leading car crash pulse is most likely to result in injury. Similarly, for rear facing occupants the crash pulse of the leading car is likely to be most severe because of the initial peak.

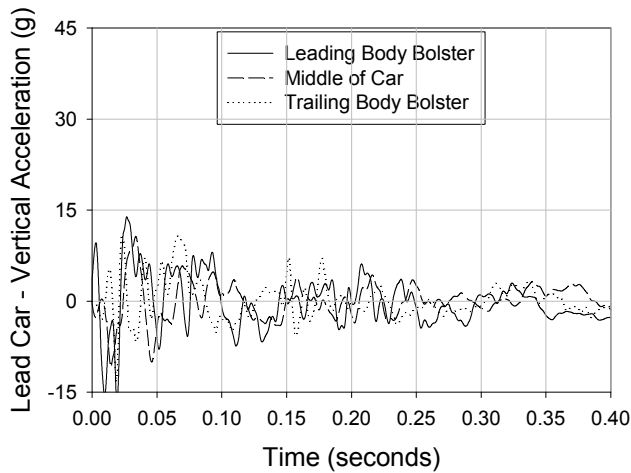
Figure 5a. Vertical Carbody Accelerations vs Time, Leading Car

Figures 5a and 5b shows the vertical accelerations of the leading and trailing cars in the two-car test, respectively. Both plots show the vertical accelerations at the leading body bolster, at the center of the

floor, and at the trailing body bolster. The measurements include the influence of the pitch and bounce of the cars, as well as the elastic vibrations of the carbody and accelerometer mountings.

Observation of the high-speed film taken during the test indicates that both cars essentially rotated about a point near the trailing body bolster while they pitched upward. This motion resulted in a maximum elevation of approximately 6 inches at the front body bolster for the leading car, and 3 inches for the trailing car. The elastic vibrations of the carbody dominate the vertical accelerations of both cars – the acceleration signatures appear to oscillate about zero for the duration of the impact.

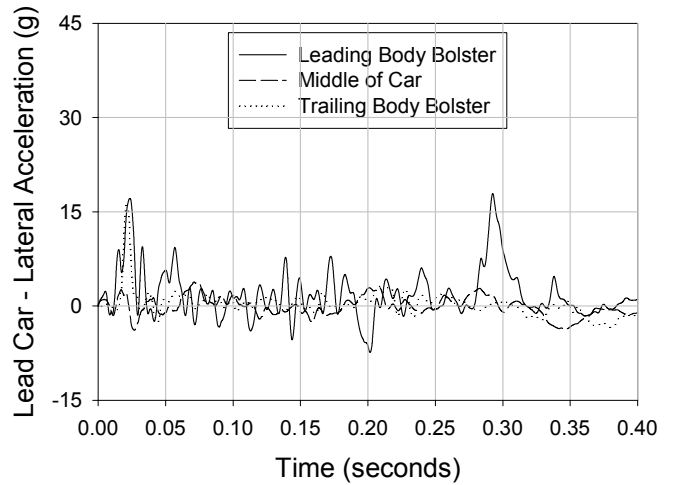
Figure 6a. Lateral Carbody Accelerations vs Time, Leading Car

The lateral accelerations measured in the leading and trailing cars in the two-car test are shown in Figures 6a and 6b, respectively. The lateral acceleration for the leading car has an initial peak whose timing corresponds with the impact from the trailing car. The trailing car lateral acceleration is smaller than the leading car lateral acceleration. Similar to the vertical acceleration measurements, the lateral acceleration measurements include the influence of the yaw and sway of the cars, as well as the elastic vibrations of the carbody and accelerometer mountings. During the test, both cars yawed in a counter clockwise direction, which resulted in a ‘sawtooth’ lateral

buckle of the coupled cars. From the high-speed film, both cars apparently yawed about their trailing body bolster.

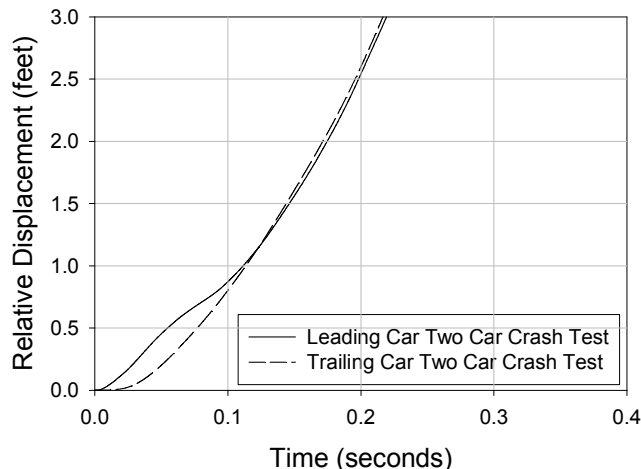
Figure 7. Forward-Facing Unrestrained Occupant Longitudinal Relative Displacement Time History

Figure 7 shows a plot of the time-history of the displacement, relative to the interior of the cars, of the head of an unrestrained forward facing occupant. This plot is derived from the test data and the assumption that the occupant is in free-flight during the impact [3]. The distance from the front of an occupant's head to the seatback ahead is approximately 2 feet for typical commuter seat spacing and approximately 2.5 feet in typical inter-city seat spacing. The plot indicates that the head of a forward facing unrestrained occupant seated in rows of seats would impact the back of the seat ahead at 0.18 to 0.20 seconds after the leading car impacts the wall; the secondary impacts occurs at about the same time in both the trailing and leading cars.

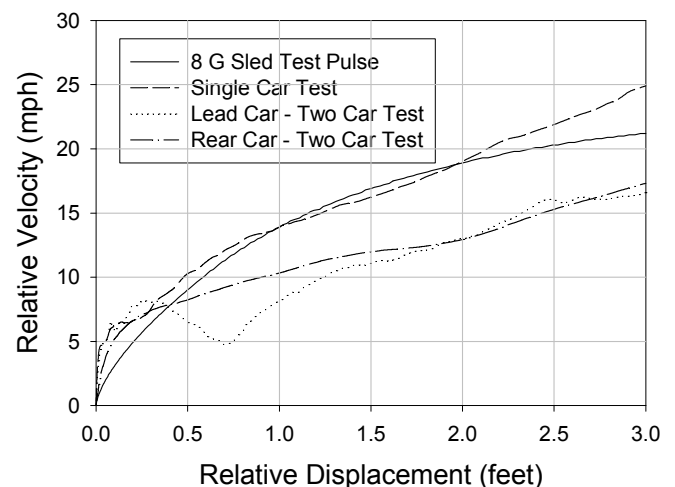
Figure 8. Relative Longitudinal Velocity of an Unrestrained Occupant as a Function of Relative Longitudinal Displacement

Figure 8 shows a plot of the longitudinal velocity of an unrestrained occupant relative to the interior of the car as a function of that occupant's longitudinal displacement relative to the interior of the car. The greater the relative velocity of the secondary impact is, the greater the likelihood of occupant injury. The plot shows the relative velocity for test dummies in the leading and trailing cars, the longitudinal velocity associated with the 8 g triangular crash pulse used in previous sled testing, as well as the relative velocity measured in the single-car test conducted in November, 1999. The 8 g triangular pulse results in a secondary collision velocity that is approximately 30% greater than the pulses measured during the two-car test. The 8 g crash pulse is more likely to result in passenger injury than the crash pulses measured during the two-car test, for forward facing unrestrained occupants.

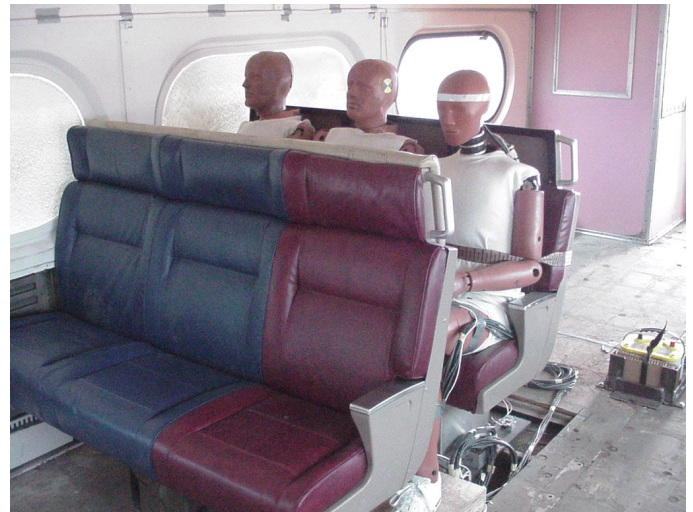
Figure 9. Experiment 2-1, Forward Facing Rows of Seats, Trailing Car, Pre-Test

Figure 9 shows the forward-facing unrestrained test dummies seated in rows in the trailing car. This experiment included three 50th percentile male test dummies.

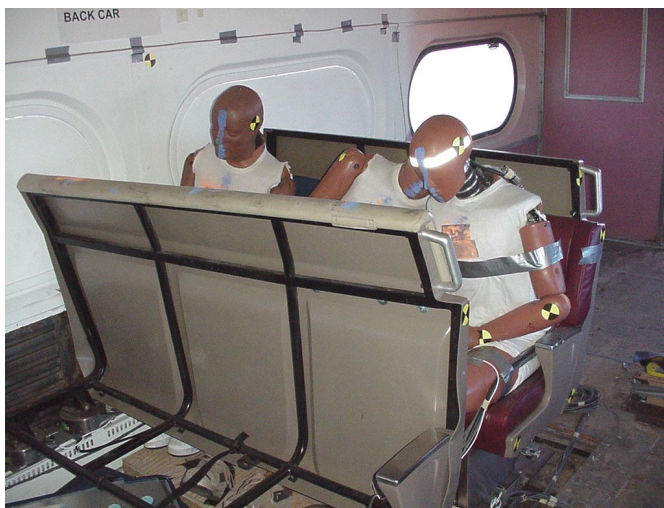
Figure 12. Experiment 2-1, Forward Facing Rows of Seats, Trailing Car, Post-Test

After the test, there was no observable deformation in the aft-row seat, nor did the aft-row cushions detach from the frame. The modified pedestal in the front-row seat did not deform. The side wall frame and its shroud both deformed slightly on the window side of the seat. The side arm on the aisle side did not deform. The upper part of the seat back absorbed much of the energy from the impacting test dummies. The side wall and the floor attachments of the seat to the car remained intact. All of the front-row seat cushions detached. Figure 12 shows a post-test photograph of this experiment.

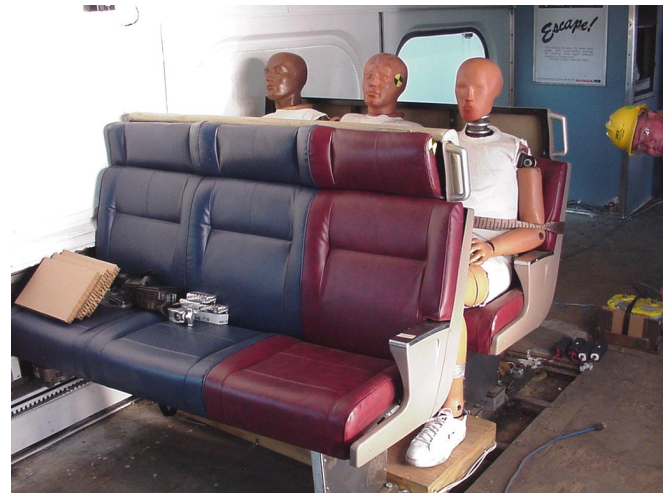
Figure 13. Experiment 1-1, Forward Facing Rows of Seats, Leading Car, Pre-Test

Figure 13 shows experiment 1-1, the forward facing rows of seats in the leading car. The differences with experiment 2-1 include being in different cars, and the forward seat used in this experiment was not modified, but simply an off-the-shelf M-Style commuter seat.

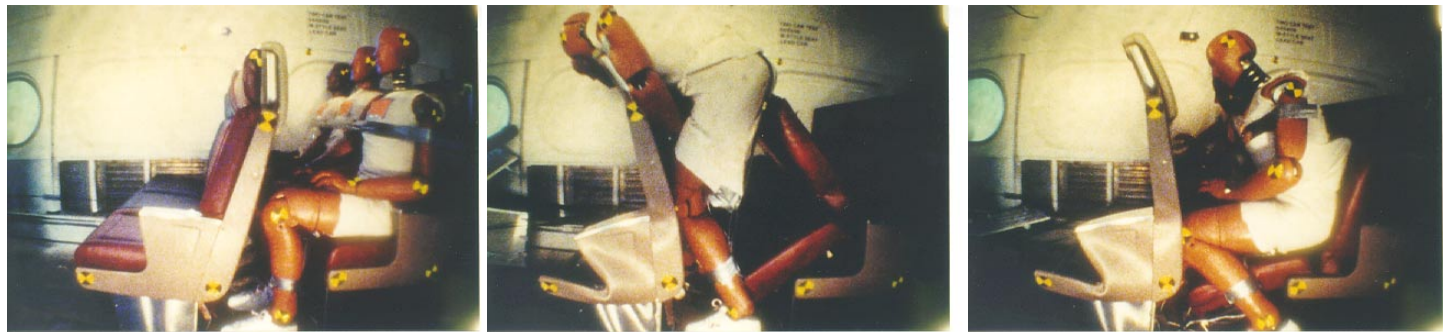
Figure 14. Time-Sequence for Experiment 1-1, Forward Facing Rows of Seats, Leading Car

All injury load measurements were made from instrumentation installed in the Hybrid III 50th-percentile test dummy seated in the aft row, in the aisle seat. This test dummy's knees impacted the seat back ahead of it and peaked at approximately 70 msec and then again at approximately 120 msec and 200 msec. After the knees impacted the seat back, the test dummy began to stand and travel forward, catching its chin on the upper seat back, causing the neck to measure a neck flexion moment that exceeded the injury criterion. The side

arm of the seat deformed primarily as a result of the test dummy's upper body impacting the seat rather than the knees' initial impact, which appeared to have little effect on the initial seat deformation. Table 3 lists the values for the occupant injury criteria for this experiment. Three photographs, taken from the side-view high-speed film, are shown in Figure 14. The middle photograph shows the aisle-side dummy's head above the top of the seatback. (The heads of the other two dummies are not clearly visible in the photograph, although the front-view high-speed film shows these heads also were above the top of the seatback.)

Like experiment 2-1, the test dummies' heads rose above the seatback ahead, and consequently the chins caught on the seatback. As a result, a neck injury criterion was exceeded for the instrumented dummy. The dummy motions appear to have been influenced by the vertical motion of the car, which sank at the location of this experiment.

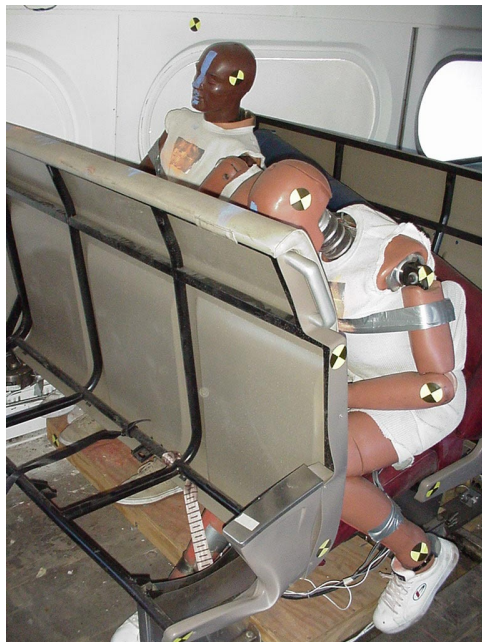
Figure 15. Experiment 1-1, Forward Facing Rows of Seats, Leading Car, Post-Test

After the test, there was no observable deformation in the aft-row seat, however, all of the aft-row cushions detached from the frame. The pedestal in the front-row seat deformed a small amount. The

side arm frame and its shroud both deformed slightly on the aisle side of the seat, while the side wall attachments rotated forward under the impact load from the occupants in the row behind it. The seat back rotated forward, but not enough to cause the test dummies to travel over the seat back. The seat and the floor attachments of the seat to the pedestal remained intact. The load cell attachment of the seat to the side wall remained intact. All of the front row seat cushions detached. Figure 15 shows a post-test photograph of this experiment.

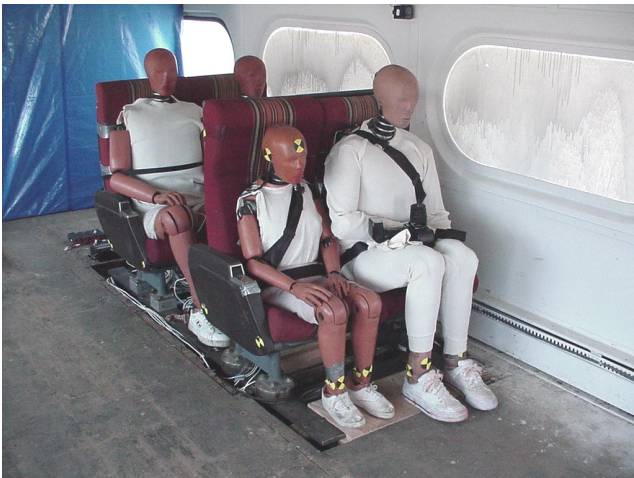
Figure 16. Experiment 1-2, Forward Facing Rows of Seats with Lap and Shoulder Belts, Leading Car, Pre-Test

Figure 16 shows experiment 1-2, the forward facing rows of seats with lap and shoulder belts in the leading car. The intercity seats used in this two-car test were the same seats used in the single-car test [6]. Modest changes were made to the front-row seat from the first test. These modifications included lowering the position of the energy-absorbers to increase the effective moment arm between the point of knee impact and the horizontal actuation of the energy absorbers, and moving the seatback stops in order to decrease the maximum rotation of the seatback relative to the seat pan. The change to the energy absorbers was made in order to prevent the energy absorbers from being exhausted by the seatbelt load. The change to the seatback stops was made in order to prevent the seatback from making a ramp that could allow the unrestrained dummies to catapult over.

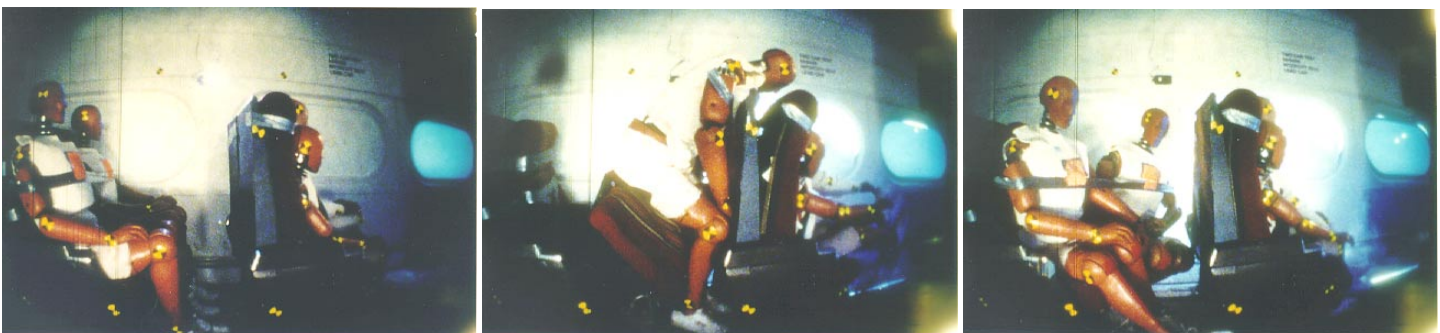
Figure 17. Time-Sequence for Experiment 1-2, Forward Facing Rows of Seats with Lap and Shoulder Belts, Leading Car

Like experiment 2-1 and 1-1, the unrestrained test dummies' heads rose above the seatback ahead, the chins caught on the seatback and a neck injury criterion was exceeded for the instrumented dummy. In this case however, it was expected that the vertical motion of the car, which rose at the location of this experiment, would tend to cause the head of the unrestrained test dummies to impact the back of the seat ahead. The likely principal cause of the heads not striking the top of the seatback is that the top of the seatback was too low for the stature of the test dummies. The unrestrained test dummies used in this test have the size of the 95th percentile male. In previous sled testing, where the dummies' heads were *not* observed to rise above the seatbacks, the test dummies were of the size of a 50th percentile male. Three photographs, taken from the side-view high-speed film, are shown in Figure 17.

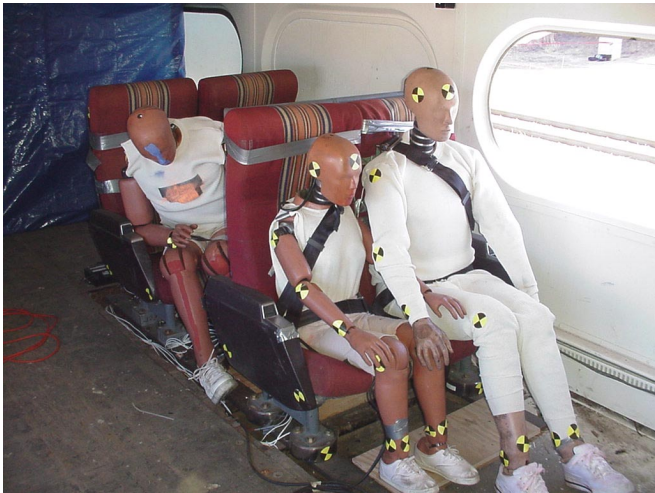
Figure 18. Experiment 1-2, Forward Facing Rows of Seats with Lap and Shoulder Belts, Leading Car, Post-Test

The forward motion of the front seat's back panel was greatly reduced from the first test. There was very little seat back panel deformation. What little seat back panel deformation did occur was due to the unrestrained test dummy's knees impacting the seat from behind. While the seat stiffness helped compartmentalize the unrestrained test dummies in the rear seat, it may have contributed to the excessive loads measured in the unrestrained and instrumented test dummy's knees. After the test, there was no notable deformation in the pedestals or in the longitudinal metal floor beams to which the seat was attached (floor beams in single-car test deformed.) The aft-row seat cushions detached during the test. Figure 18 shows a post-test photograph of this experiment.

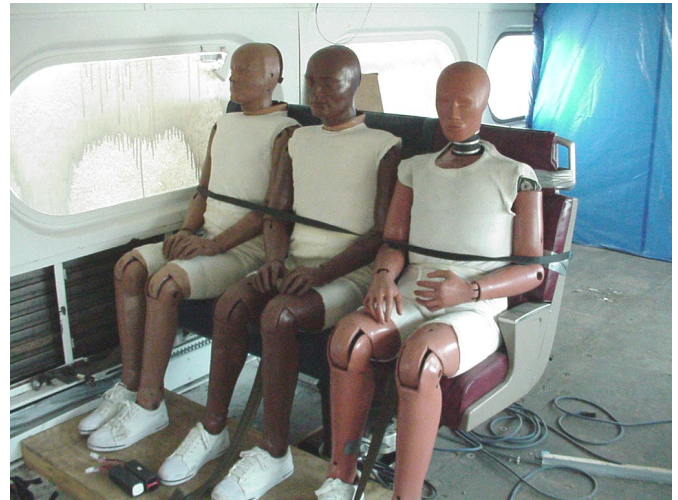
Figure 19. Experiment 1-3, Rear Facing Seat, Leading Car, Pre-Test

Figure 19 shows the rear-facing unrestrained test dummies seated in the leading car. This experiment included three 50th percentile male test dummies. The seat in this experiment was an M-style Seat with the same modifications as the forward seat in experiment 2-1, which are illustrated in Figure 10. The modifications consisted principally of a stronger seat pedestal, and additional gussets on the wall mounting lugs.

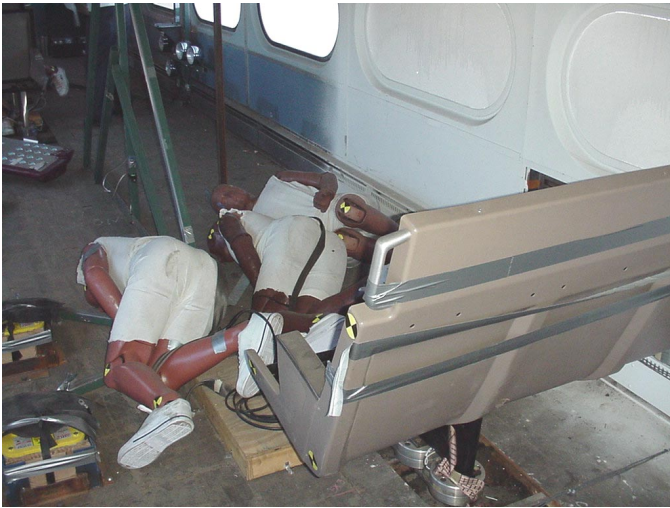
Figure 21. Experiment 1-3, Rear Facing Rows of Seats, Leading Car, Post-Test

All three 50th-percentile test dummies were found lying on the floor in front of the seat after the test was over. It is likely that these test dummies may have been found in their seats post-test if there had been a seat installed in front of them. Without the additional row of seats, the test dummies were able to fall to the floor after rebounding in their seat. Most of the test dummies' rebound was likely due to the seat releasing some of the energy it absorbed during the impact. Figure 21 shows a post-test photograph of this experiment.
