## Crushing Hazards Associated with Dumpsters and Rear-loading Trash Trucks

### Safety and Health Information Bulletin

SHIB 12-09-2003

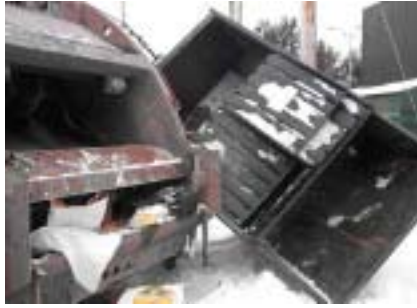
Figure 2 - Rotated Dumpster

began to fall from the dumpster into the truck. While the dumpster was in the elevated position, the employee apparently operated the packer slide and sweep of the truck. When this was done, the load apparently shifted, pushing the bottom of the dumpster away from the truck. When this occurred, the dumpster rotated toward the passenger side of the vehicle, where the employee was standing and operating the controls. The employee was killed when he was caught between the

dumpster and the side of the truck. In this case, the locking bars (also called “latch-up mechanisms”) had not been utilized to secure the dumpster’s trunnion bar.

1. Inspect that all devices used to tip up and empty dumpsters into rear-loading trucks, including the trunnion bar locking mechanism, wire rope and hooks with safety latches, to assure that the devices are present, appropriately connected, and in full-working order.
2. Develop a training program and procedures regarding the use of securing devices when emptying dumpsters into rear-loading trash trucks. Train all employees to cycle the compactor only when the dumpster is on the ground.
