HEROISM AND HORROR

9.1 PREPAREDNESS AS OF SEPTEMBER 11

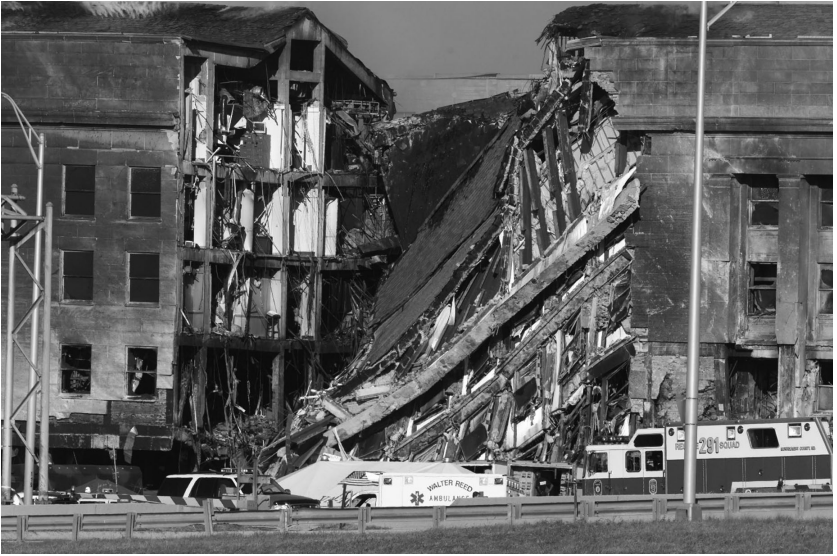
The Pentagon, after being struck by American Airlines Flight 77

At 9:37, the west wall of the Pentagon was hit by hijacked American Airlines Flight 77, a Boeing 757. The crash caused immediate and catastrophic damage. All 64 people aboard the airliner were killed, as were 125 people inside the Pentagon (70 civilians and 55 military service members). One hundred six people were seriously injured and transported to area hospitals.¹⁹²
