**Eradication and Surveillance of *Caulerpa taxifolia* within
Agua Hedionda Lagoon, Carlsbad, California
Fifth Year Status Report**

January to December 2005

March 2006

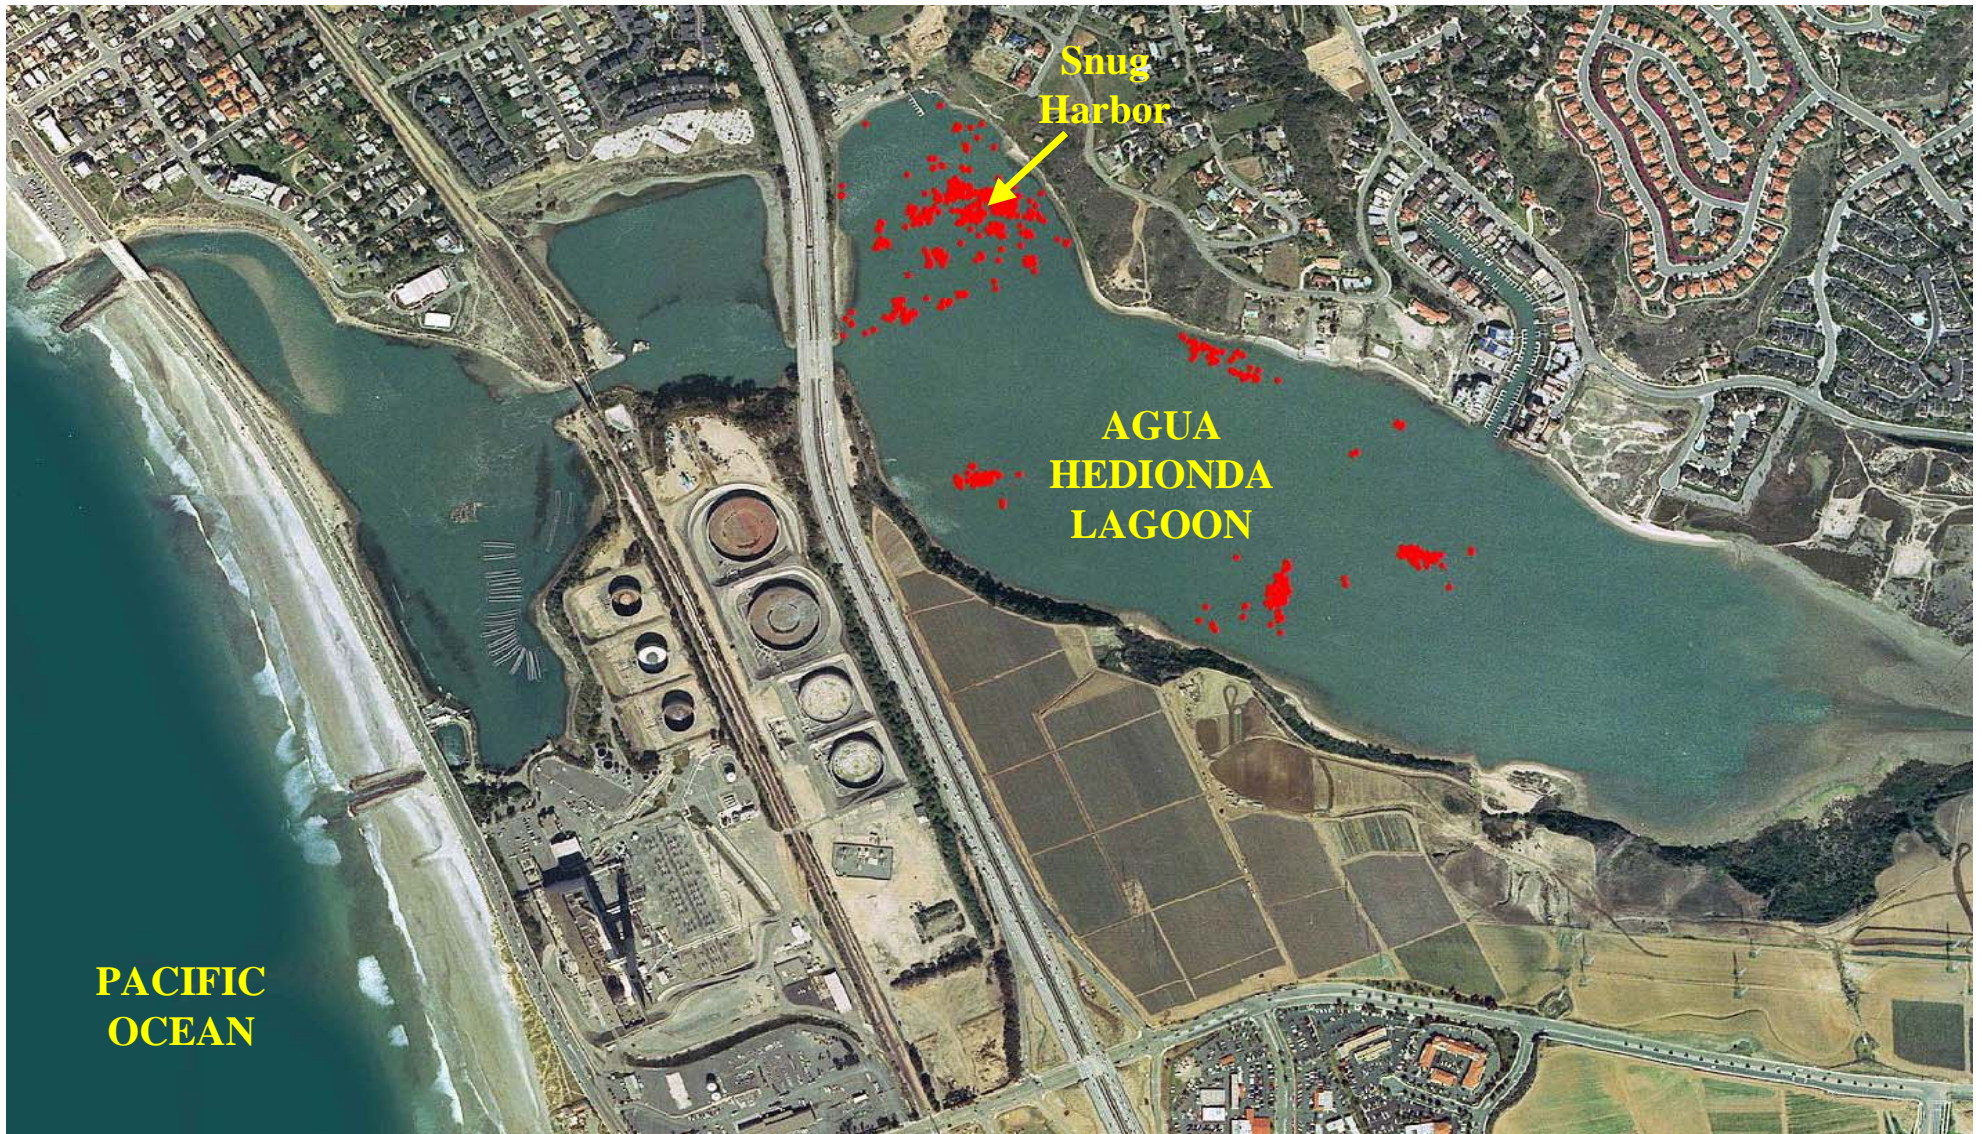
Figure
1

Caulerpa taxifolia discovered since June 2000
Agua Hedionda Lagoon, Carlsbad, CA
Last find: September 2002

The highly invasive Mediterranean strain of the tropical marine alga *Caulerpa taxifolia* was discovered in Agua Hedionda Lagoon, Carlsbad, California in June 2000 (Figure 1). Its discovery represented the first known occurrence of this strain within the Western Hemisphere and is believed to pose a major threat to coastal ecosystems and recreational and commercial uses dependent upon coastal resources. While the species was also identified at a second site in California (Huntington Harbour, Orange County), the Agua Hedionda Lagoon infestation is the larger of the two known infestations. It is likely that *C. taxifolia* had been in the lagoon for at least four years prior to its discovery. It is not known whether other infestations also exist elsewhere in the United States. The continued availability and use of this species by saltwater aquarists is cause for concern.

From the date of discovery (June 2000) until the end of the Summer 2001 survey, the eradication effort at Agua Hedionda Lagoon primarily involved the treatment of all detected *C. taxifolia*. The amount of *C. taxifolia* present in the lagoon at the time of discovery was estimated to be 1,047 m² (Merkel & Associates, 2001a). By the end of the second year of eradication efforts at Agua Hedionda Lagoon the amount of *C. taxifolia* discovered had been reduced to 0.4 m² (Merkel & Associates, 2003). The last discovery of *C. taxifolia* at Agua Hedionda Lagoon was on September 11, 2002. The location of all *C. taxifolia* discovered since the beginning of the eradication effort is indicated in Figure 1.

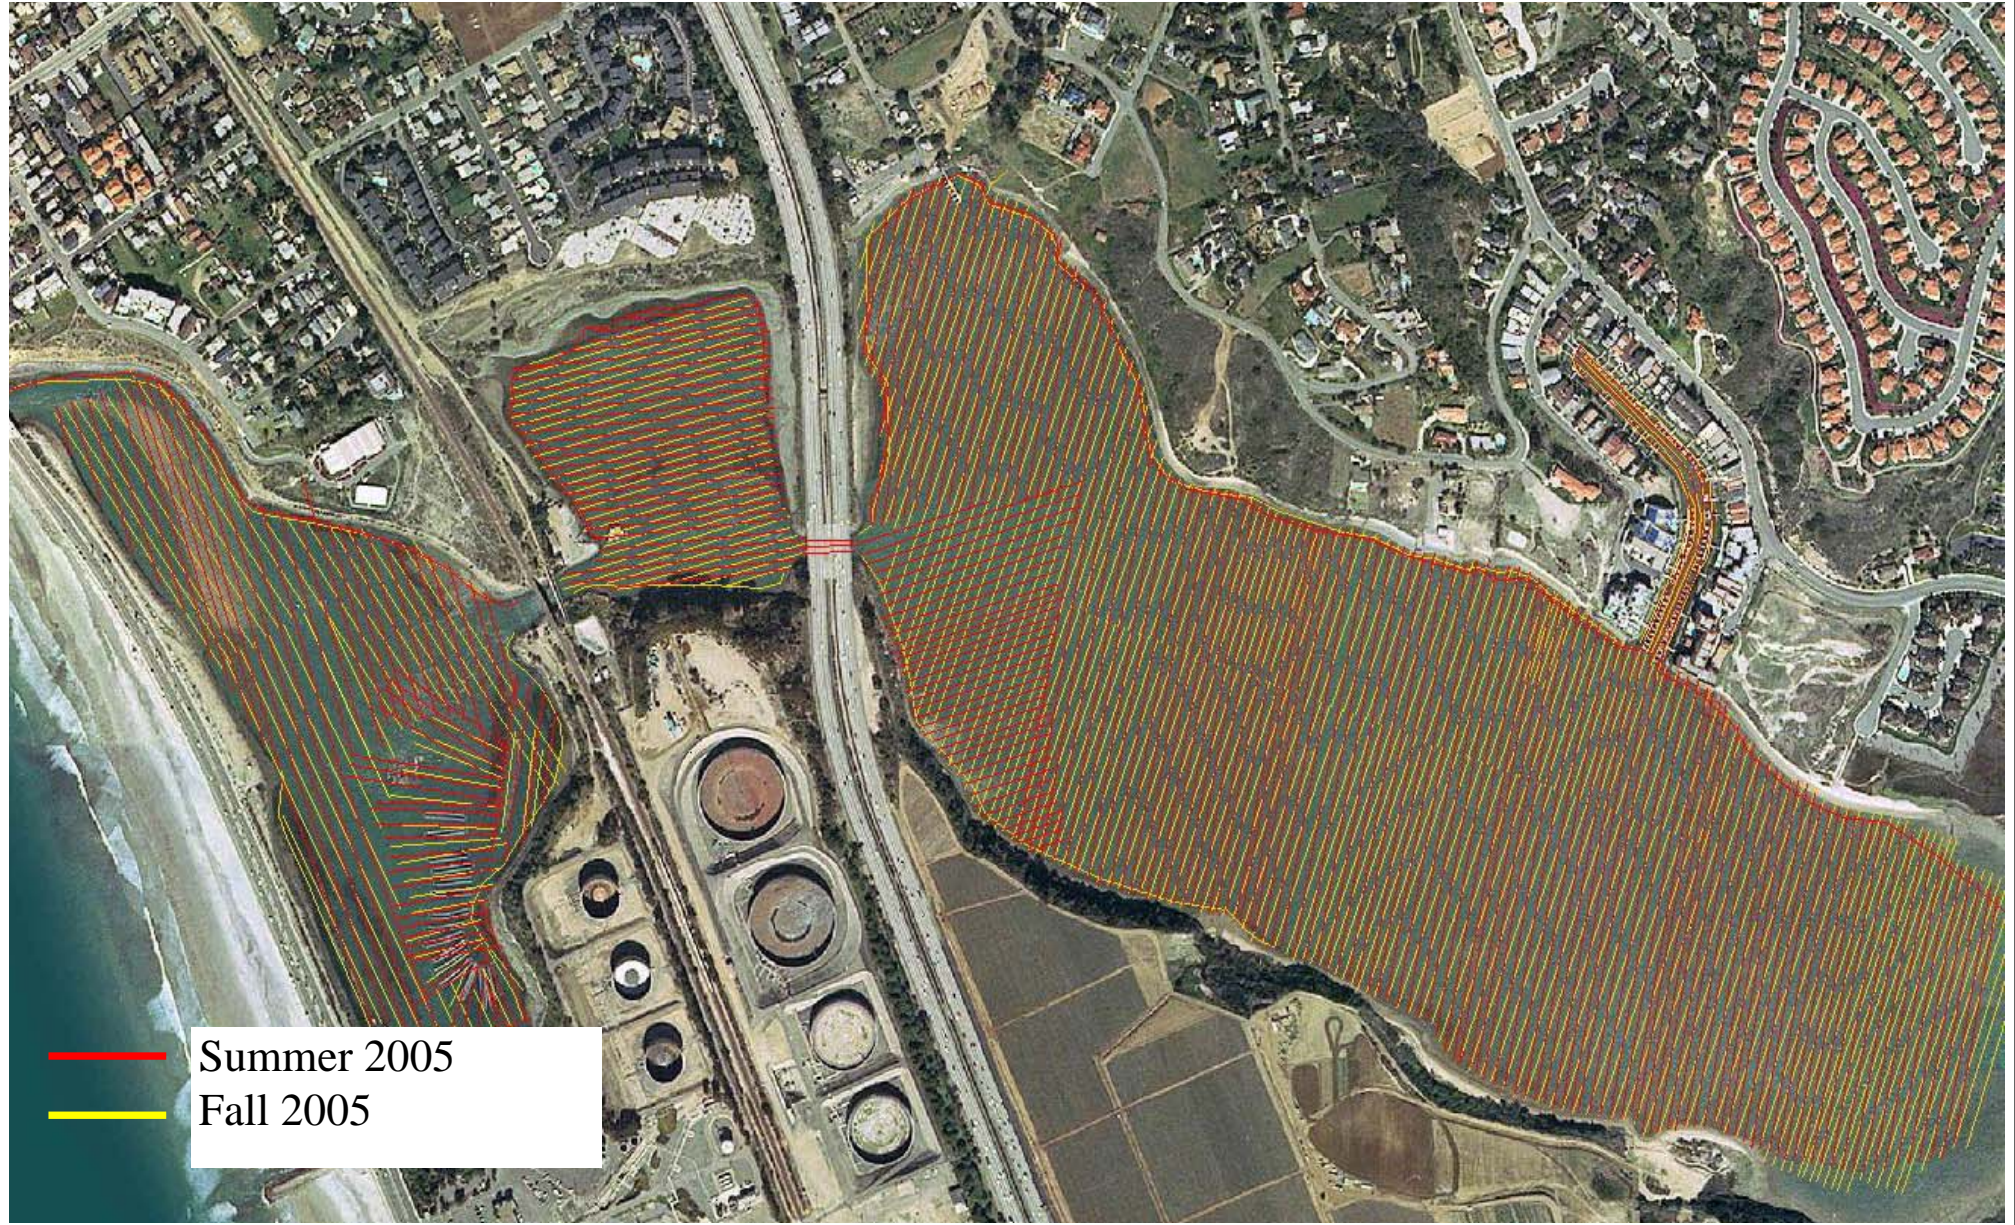
Figure
2

Transects surveyed for *Caulerpa taxifolia* during Year 5 of the eradication effort
January - December 2005
Agua Hedionda Lagoon, Carlsbad, CA

All basins of the lagoon were surveyed using the laid line methodology with divers at 1-meter spacing (Figure 2). No *C. taxifolia* was found in the lagoon during this survey.

The Fall 2005 survey effort was conducted from October 7 to December 22, 2005. All basins of the lagoon were surveyed using the laid line methodology with divers at 1-meter spacing (Figure 2). No *C. taxifolia* was found in the lagoon during this survey.

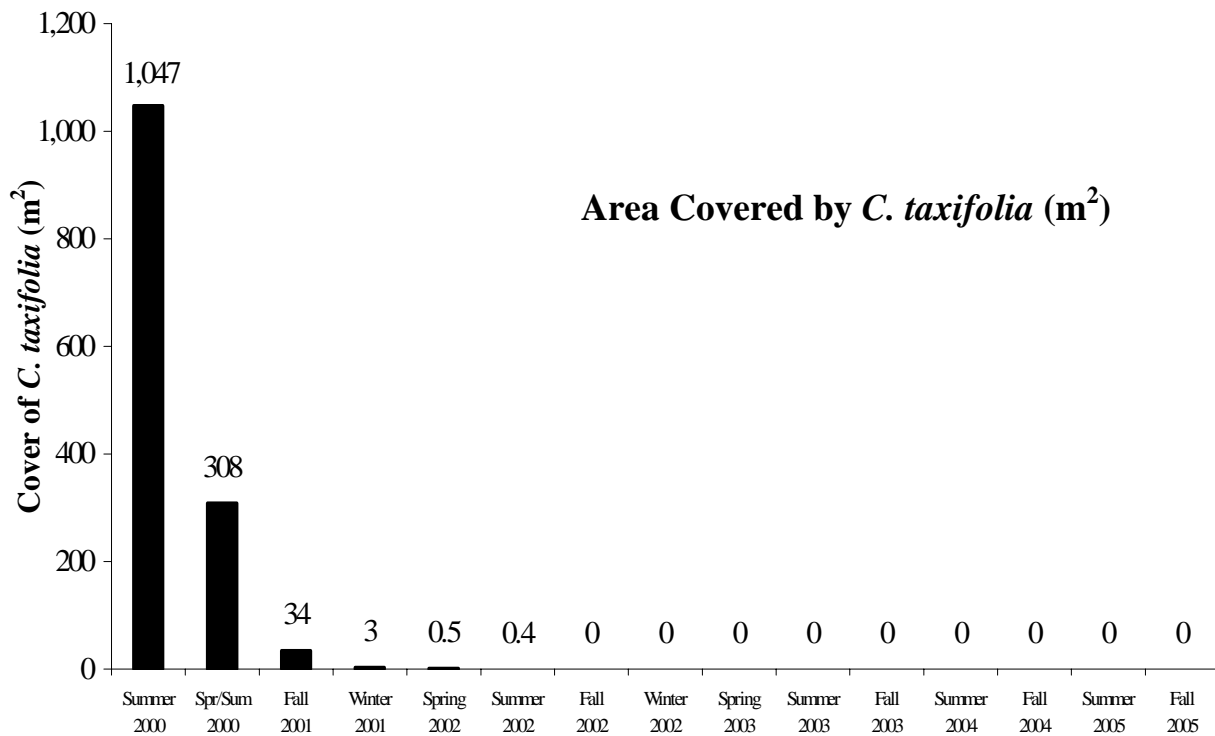
Figure 3. Areal coverage of *Caulerpa taxifolia* in Agua Hedionda Lagoon in square meters.

The completion of the Fall 2005 survey marked the third year of surveys of Agua Hedionda Lagoon with no *C. taxifolia* found. It was estimated that 1,047 m² of *C. taxifolia* was present lagoon-wide at the start of the eradication effort in summer 2000. This amount declined steadily throughout the eradication effort, with only 0.4 m² found lagoon-wide in summer 2002. No *C. taxifolia* has been detected since that date.
