# Health Consultation

HOPI SHEEP DIP VATS

HOPI INDIAN RESERVATION, ARIZONA

MARCH 29, 2006

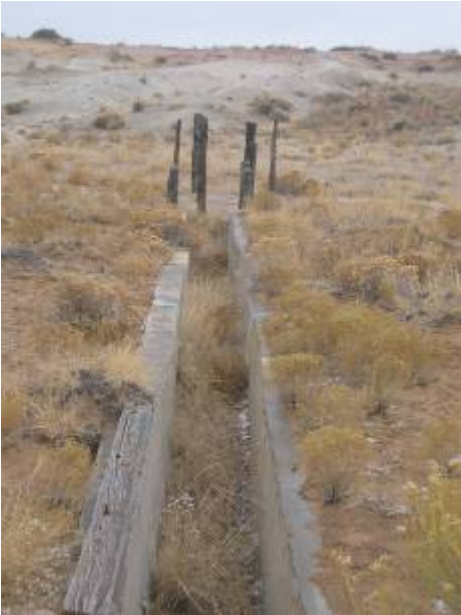
**Site Name:** Badger/Bat Spring 36° 02.715N 110°51.928W

The cement trench with protruding bolts, wooden posts, and broken masonry are present at the site as documented in the photos.

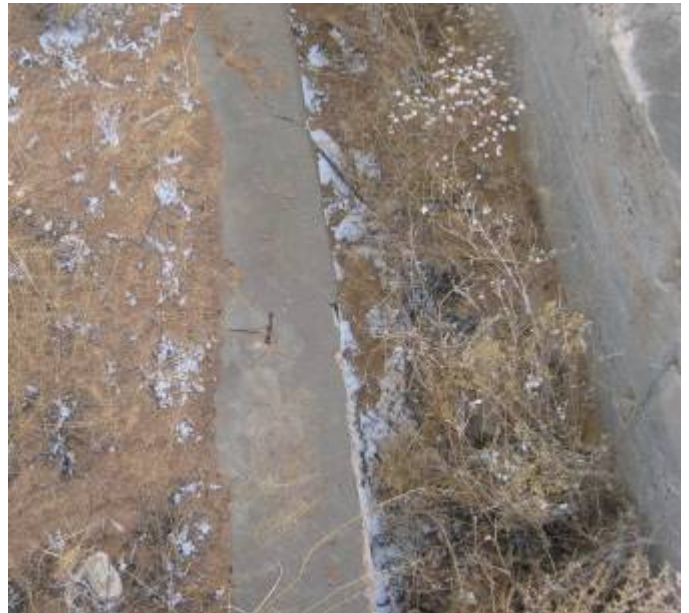
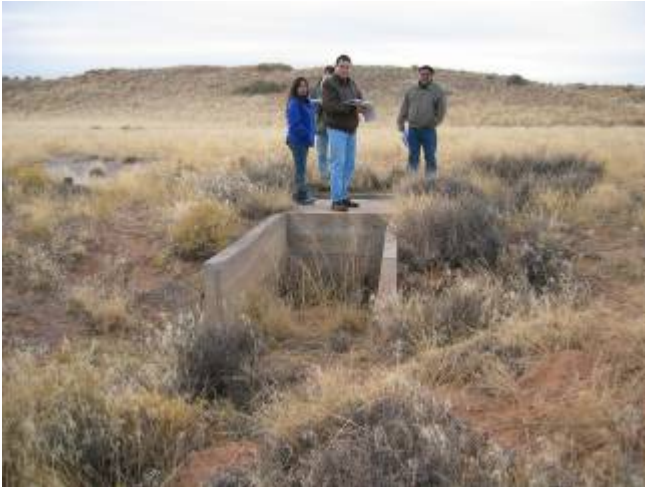
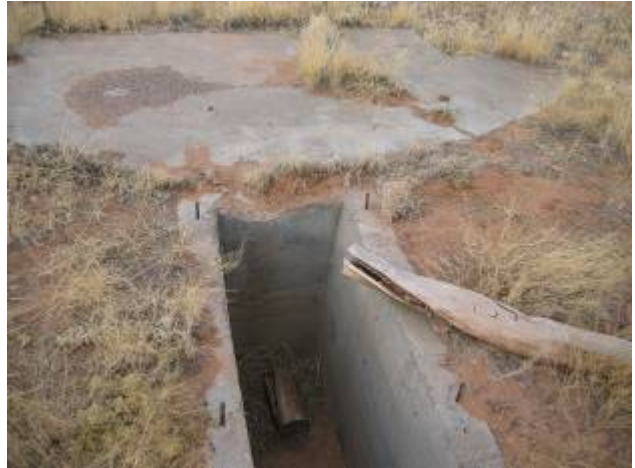
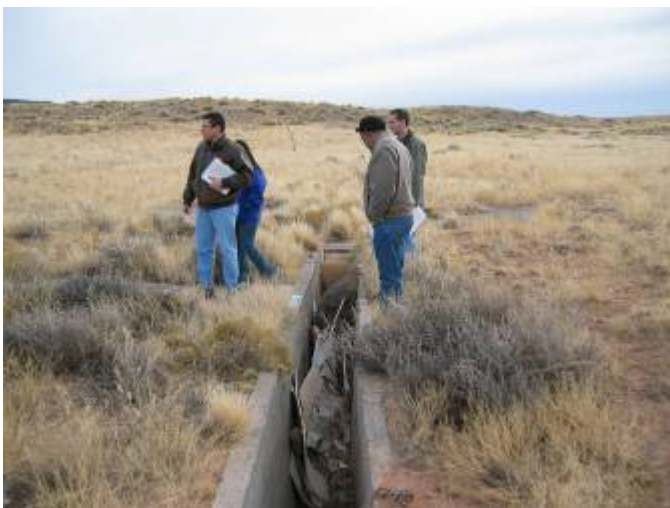
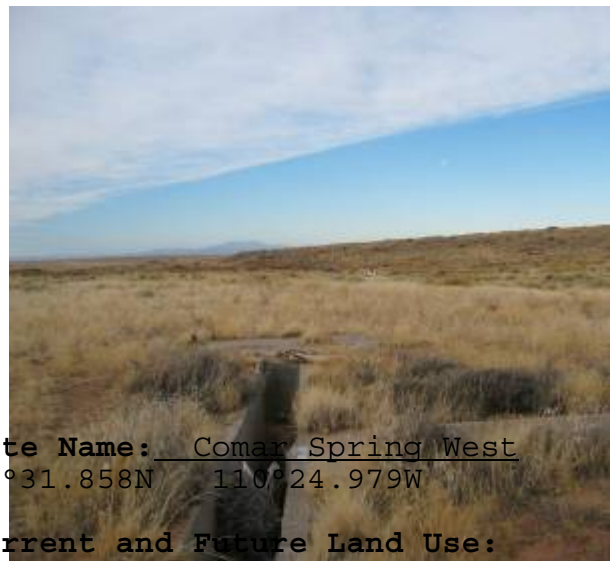
**Site Name:**  
Comar Spring East

The cement trench with protruding bolts, debris, and broken masonry are present at the site as documented in the photos.

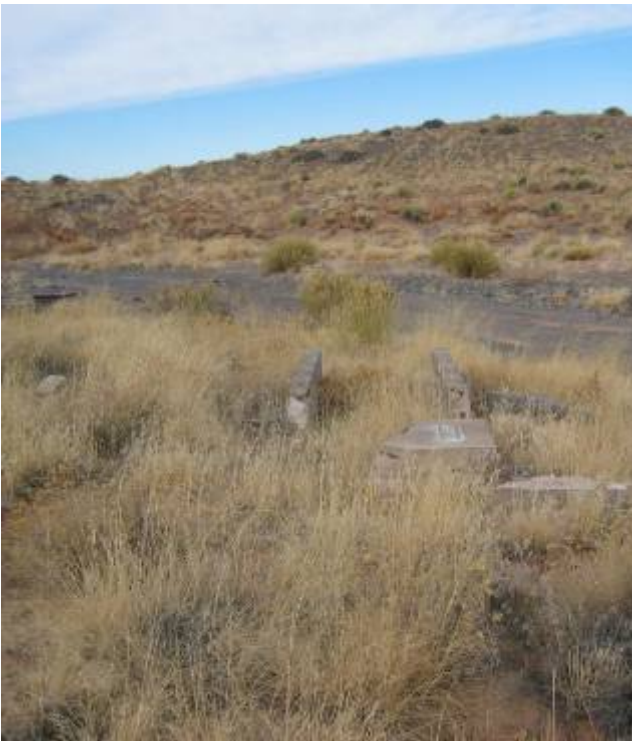
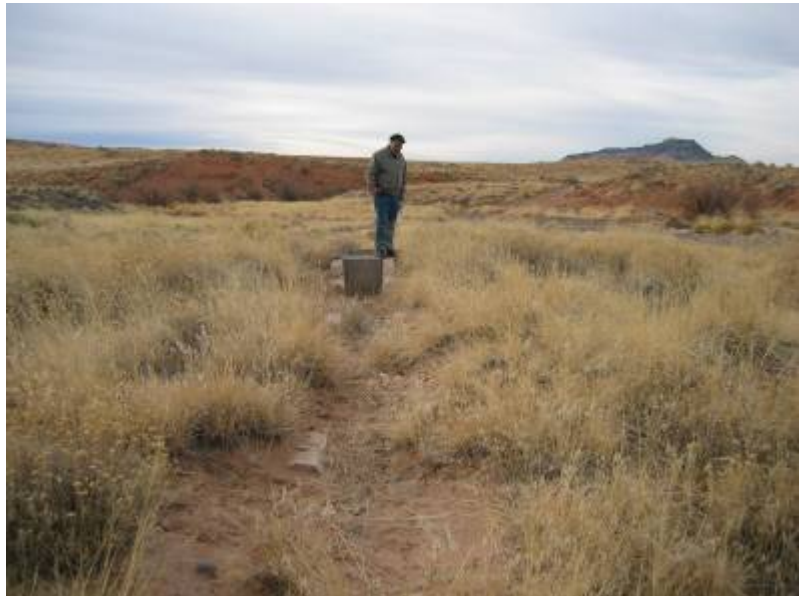
**Site Name:** Comar Spring West  
35°31.858N 110°24.979W

The cement trench with protruding bolts, wooden posts, and broken masonry are present at the site as documented in the photos. The well lid was unlocked which could allow a child to become trapped.

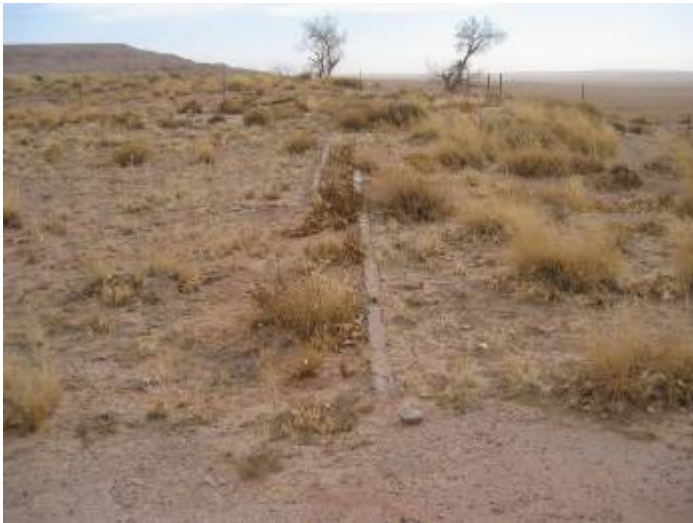
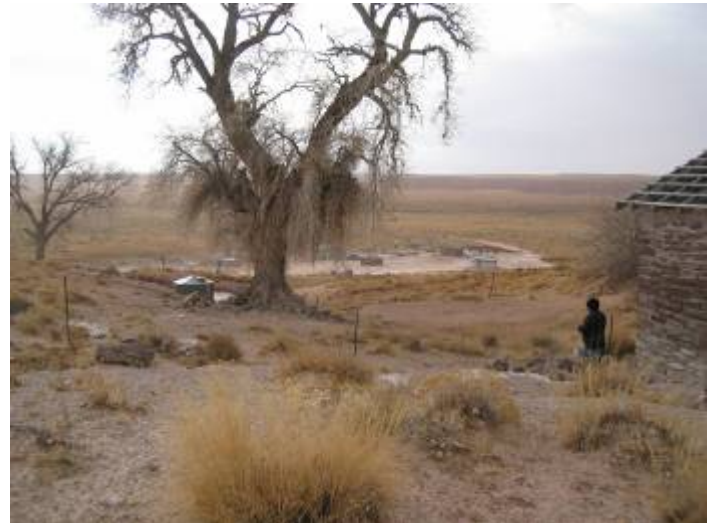
**Site Name:** Sand Spring 35°43.109N 110°55.760W

The cement trench with protruding bolts and pipes, broken masonry are present at the site as documented in the photos.

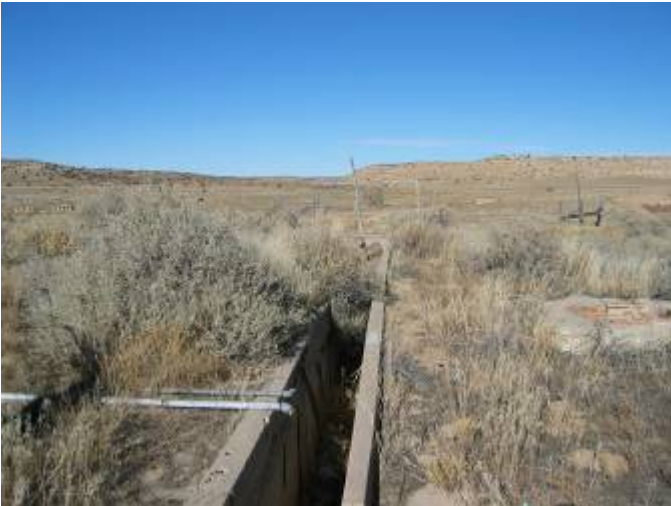
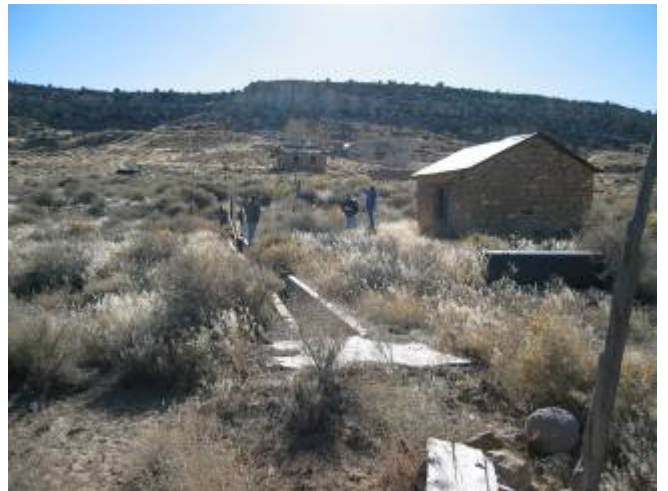
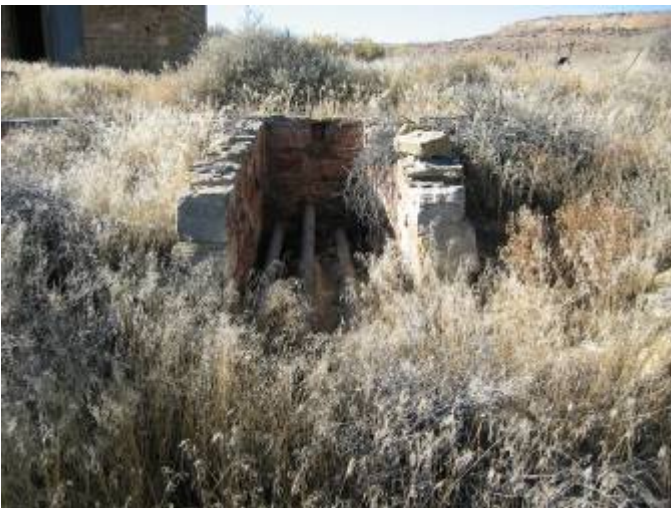
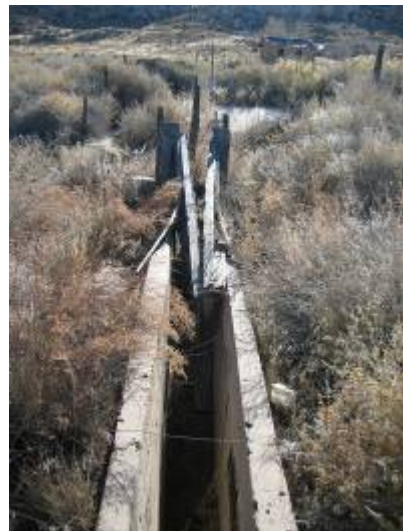
**Site Name:** WEPO 35°53.569N 110°22.258W

The cement trench with protruding bolts and pipes, broken masonry are present at the site as documented in the photos.

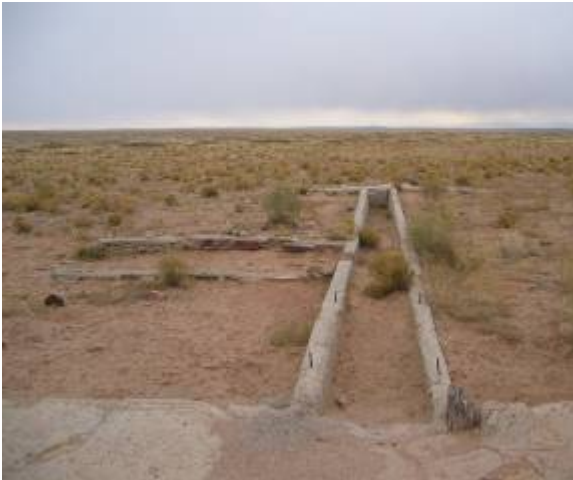
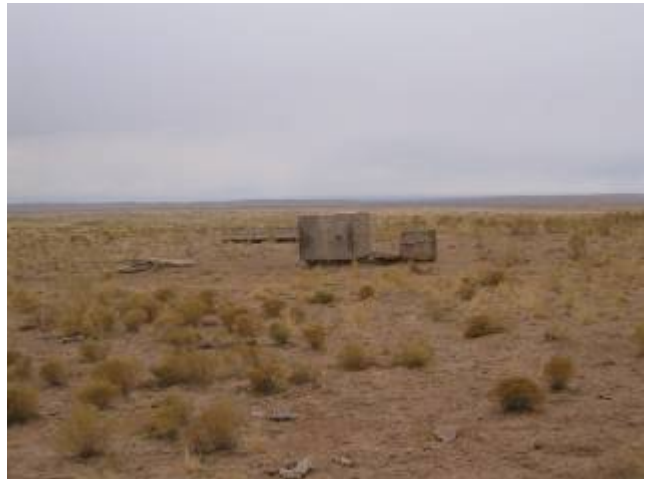
**Site Name:** Windmill 3M-175 35°52.121N 110°58.367W

The cement trench with protruding bolts and broken masonry are present at the site as documented in the photos.

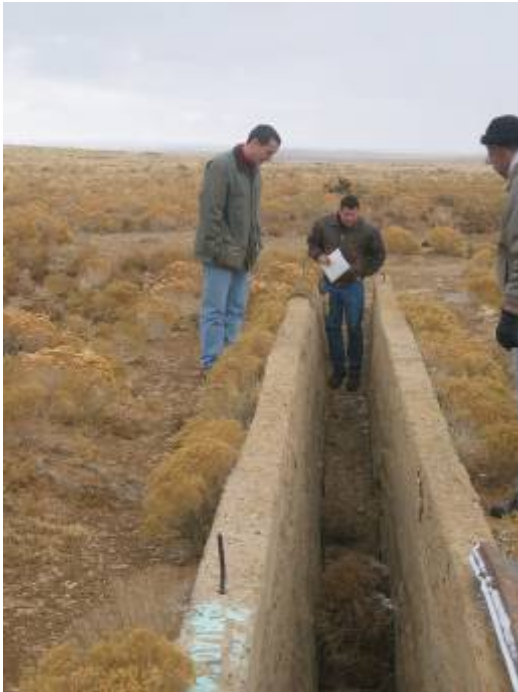
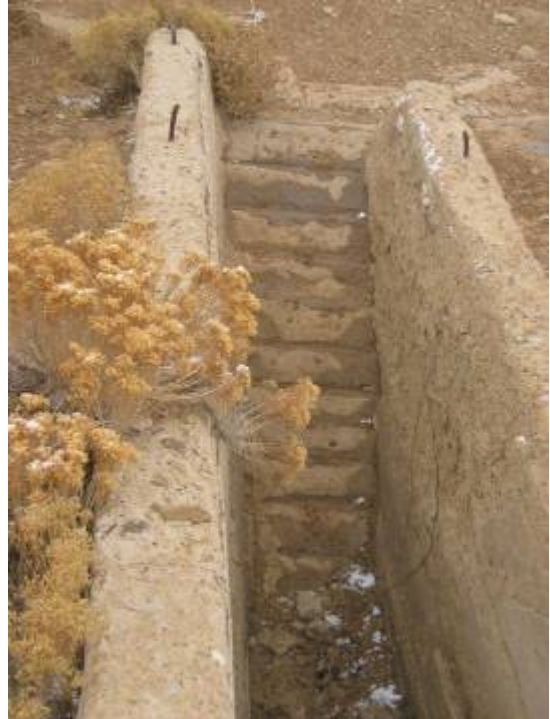
**Site Name:** Windmill 4T-383 36°05.928N 110°40.938W

The cement trench with protruding bolts and broken masonry are present at the site as documented in the photos.

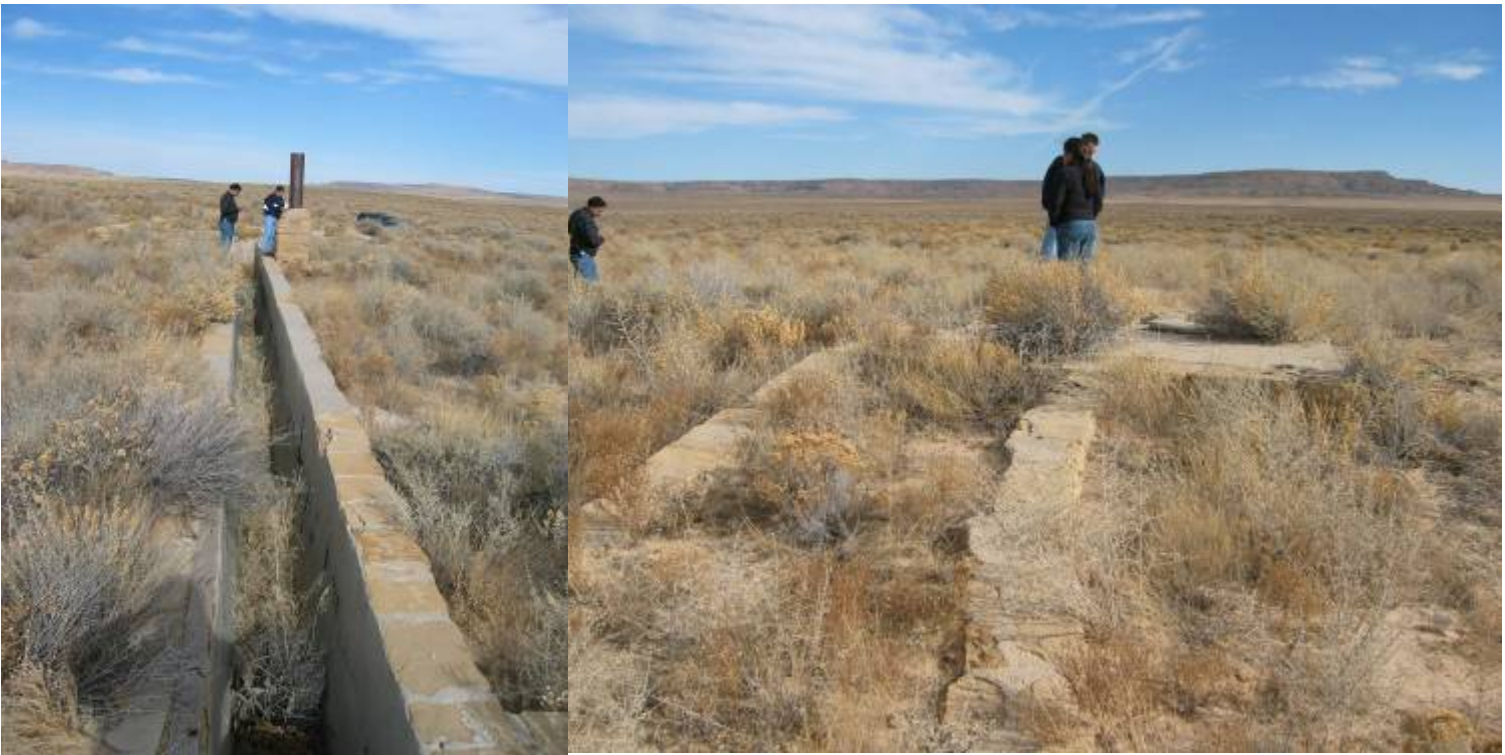
**Site Name:** Windmill D-6-3501 35°49.827N 110°38.208W

The cement trench with protruding bolts and pipes, broken masonry are present at the site as documented in the photos.

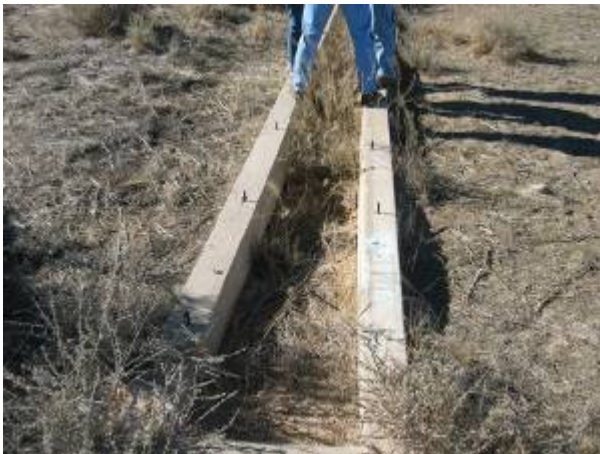
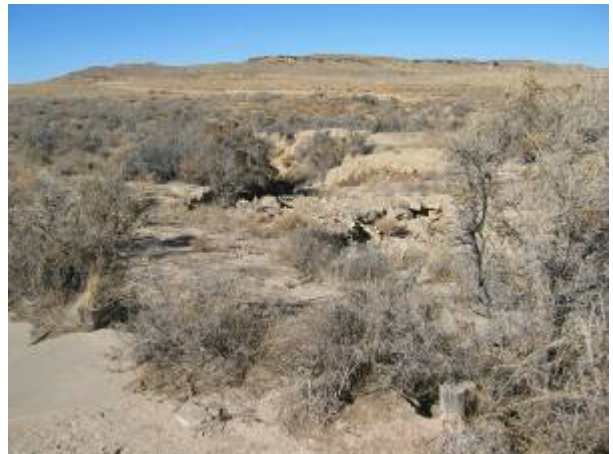
**Site Name:** Windmill 4M-89A 36°04.684N 110°26.346W

The cement trench with protruding bolts and broken masonry are present at the site as documented in the photos.
